**Hamilton Township (Mercer County)
Stormwater Basin Assessment Summary
Past Priority Addendum (Year 5B)**

Developed by the Rutgers Cooperative Extension Water Resources Program
Funded by Hamilton Township, Mercer County, New Jersey

November 27, 2019

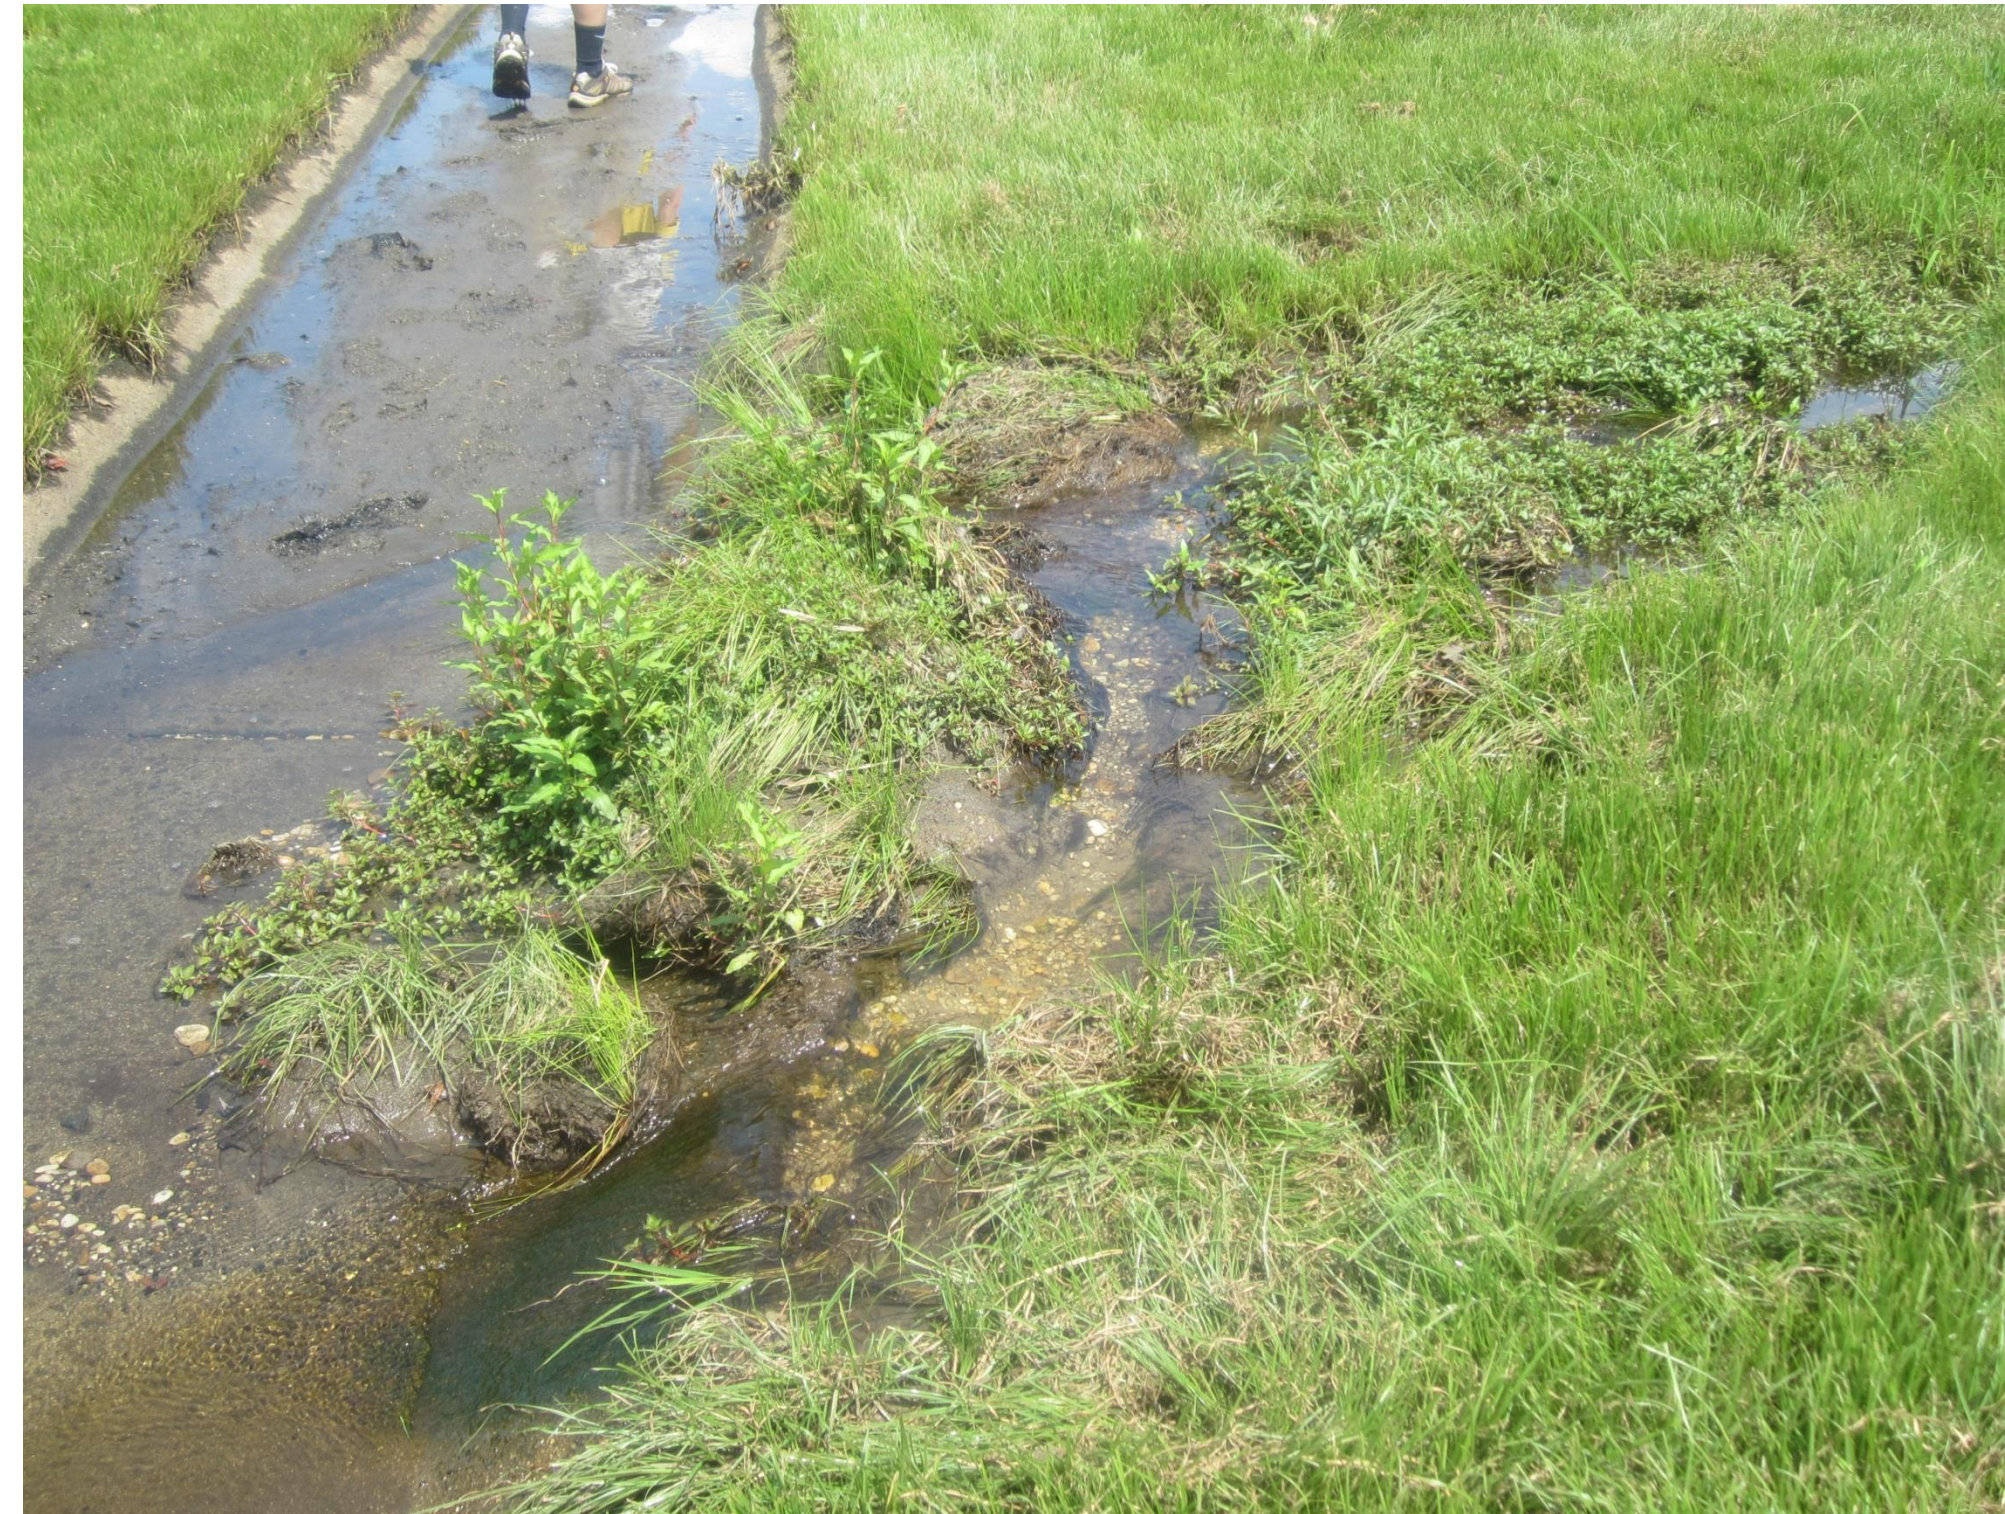
Stream connecting to low flow channel

- The basin intercepts a stream from the east that doesn't seem planned
- There is excess sediment accumulated in the low flow channel near the southeastern inlet and in front of the outlet
- The outlet has some cracking and the trash rack is held open by crates

- Large basin with 4 inlets
- Large vegetation growth around the low flow channel and inlets creating standing water in low flow channel
- Maintain inlets and outlets areas
- Clear low flow channels to stop standing water or replace with stone channel

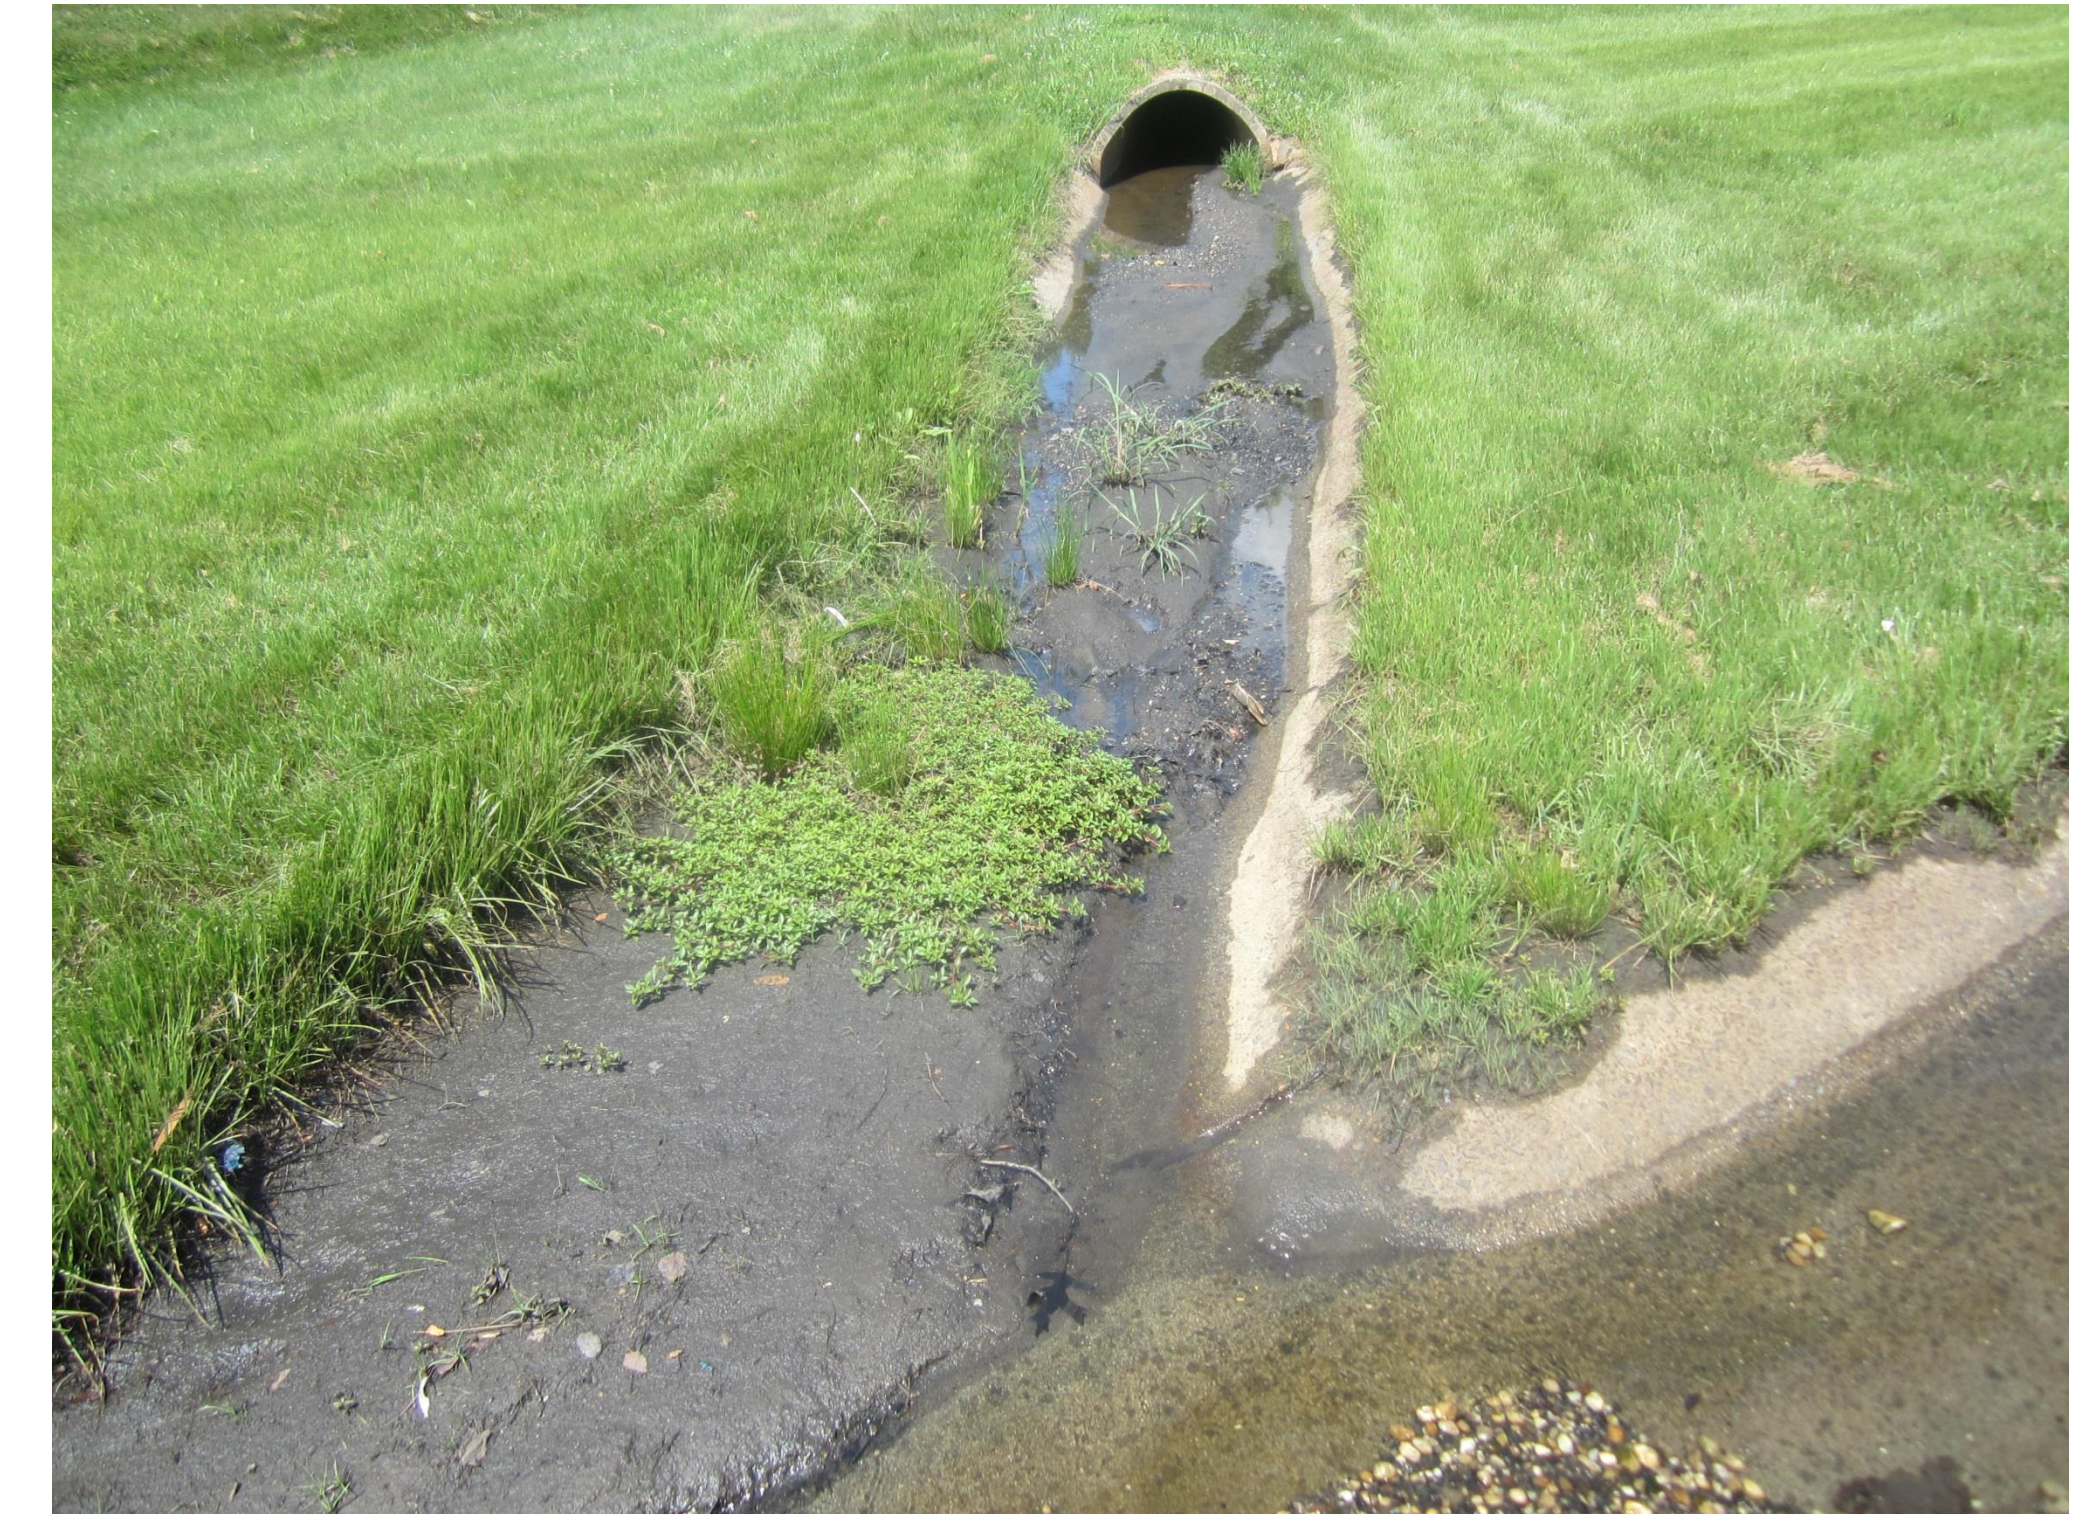
Southeastern inlet

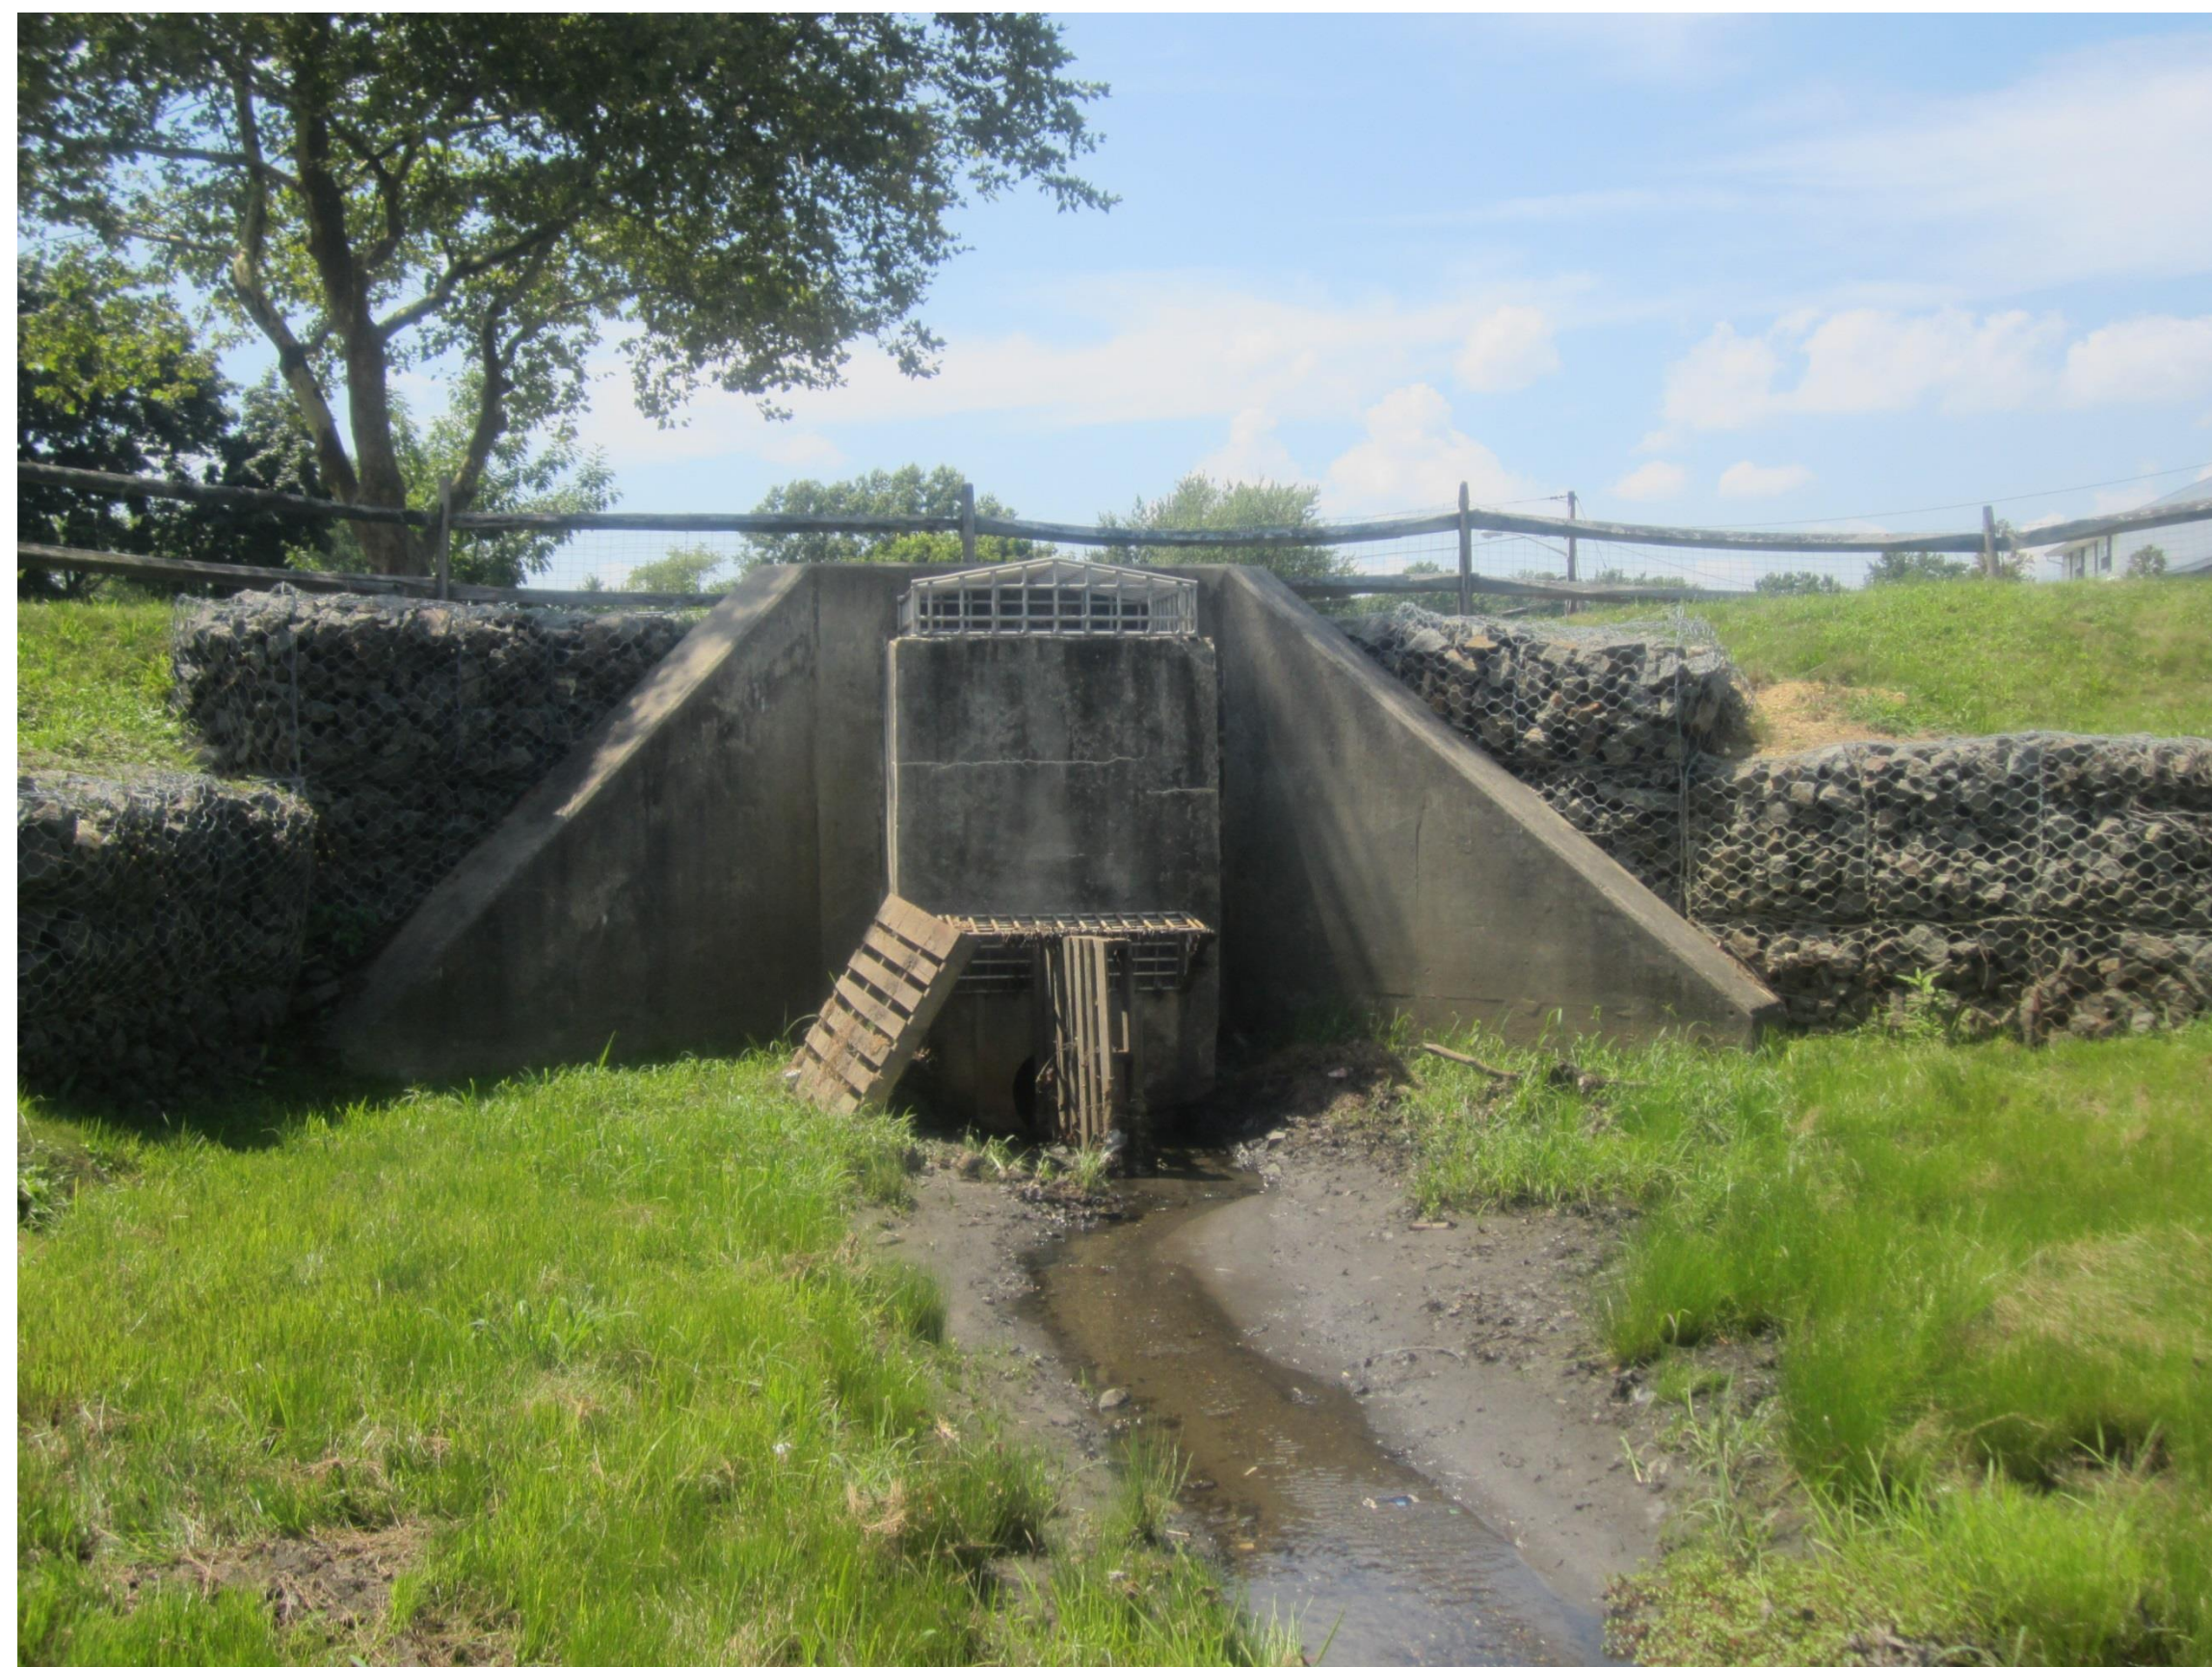
Outlet structure

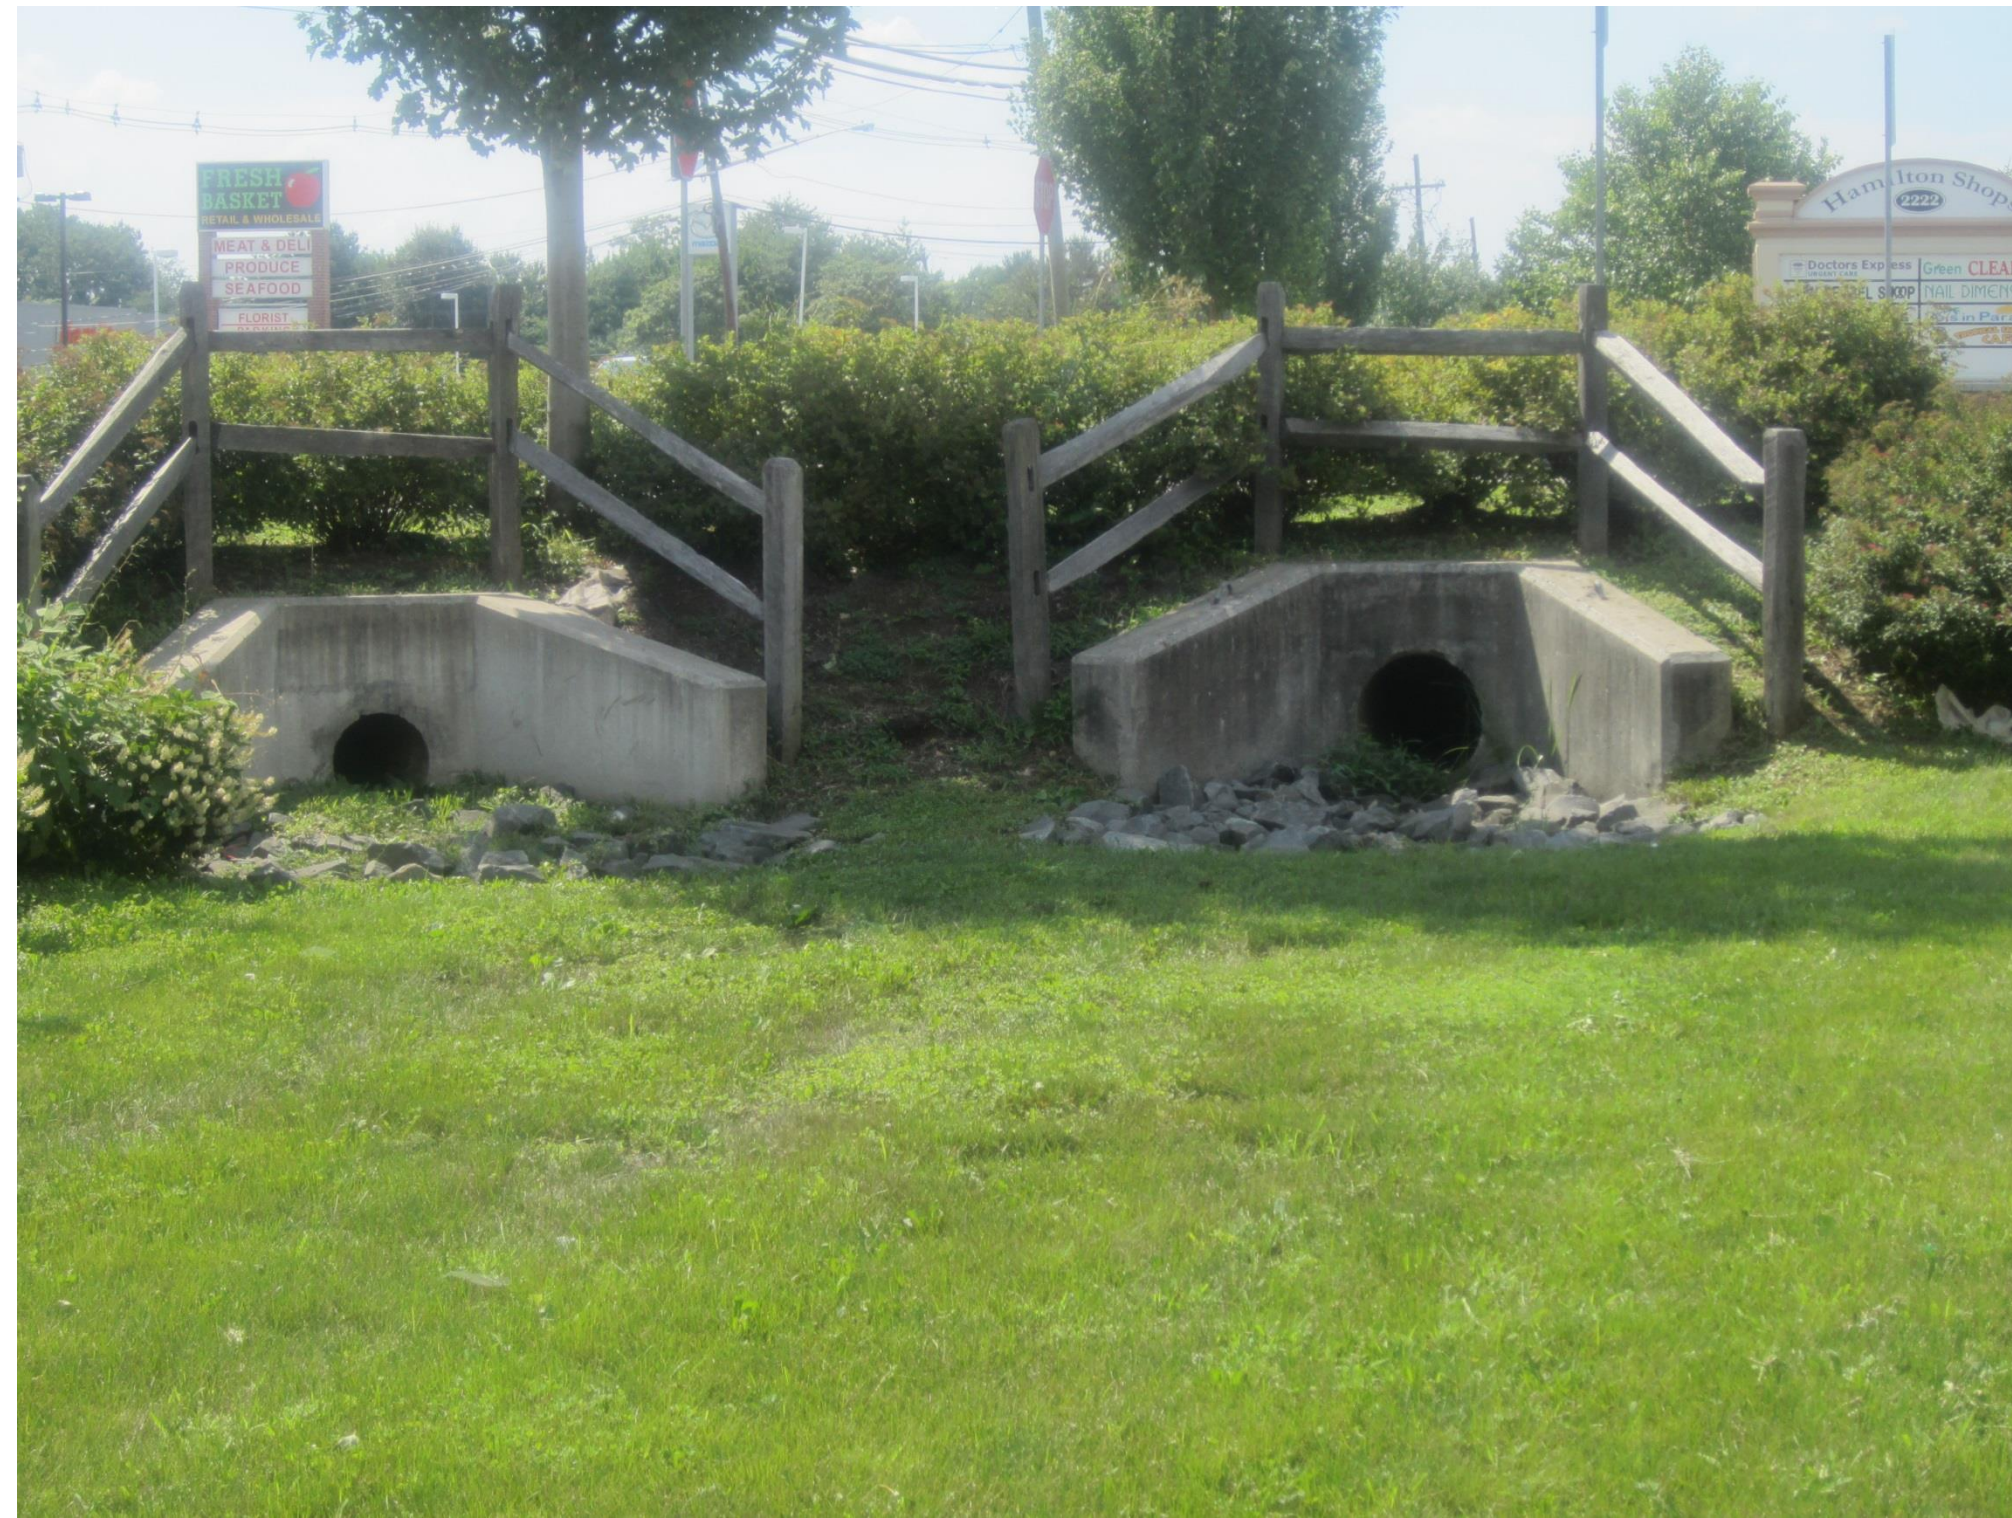
Two western inlets

- There is excess sediment accumulated in front of all inlets
- There is ponding in front of the outlet structure that is caused by a clogged trash rack

- Outlet to basin is clogged with leaves and debris. Inlet number five for this from Route 33 has standing water. Mosquitoes present at time of inspection October 30
- Clear outlet and repair inlet five to allow remove the standing water issue

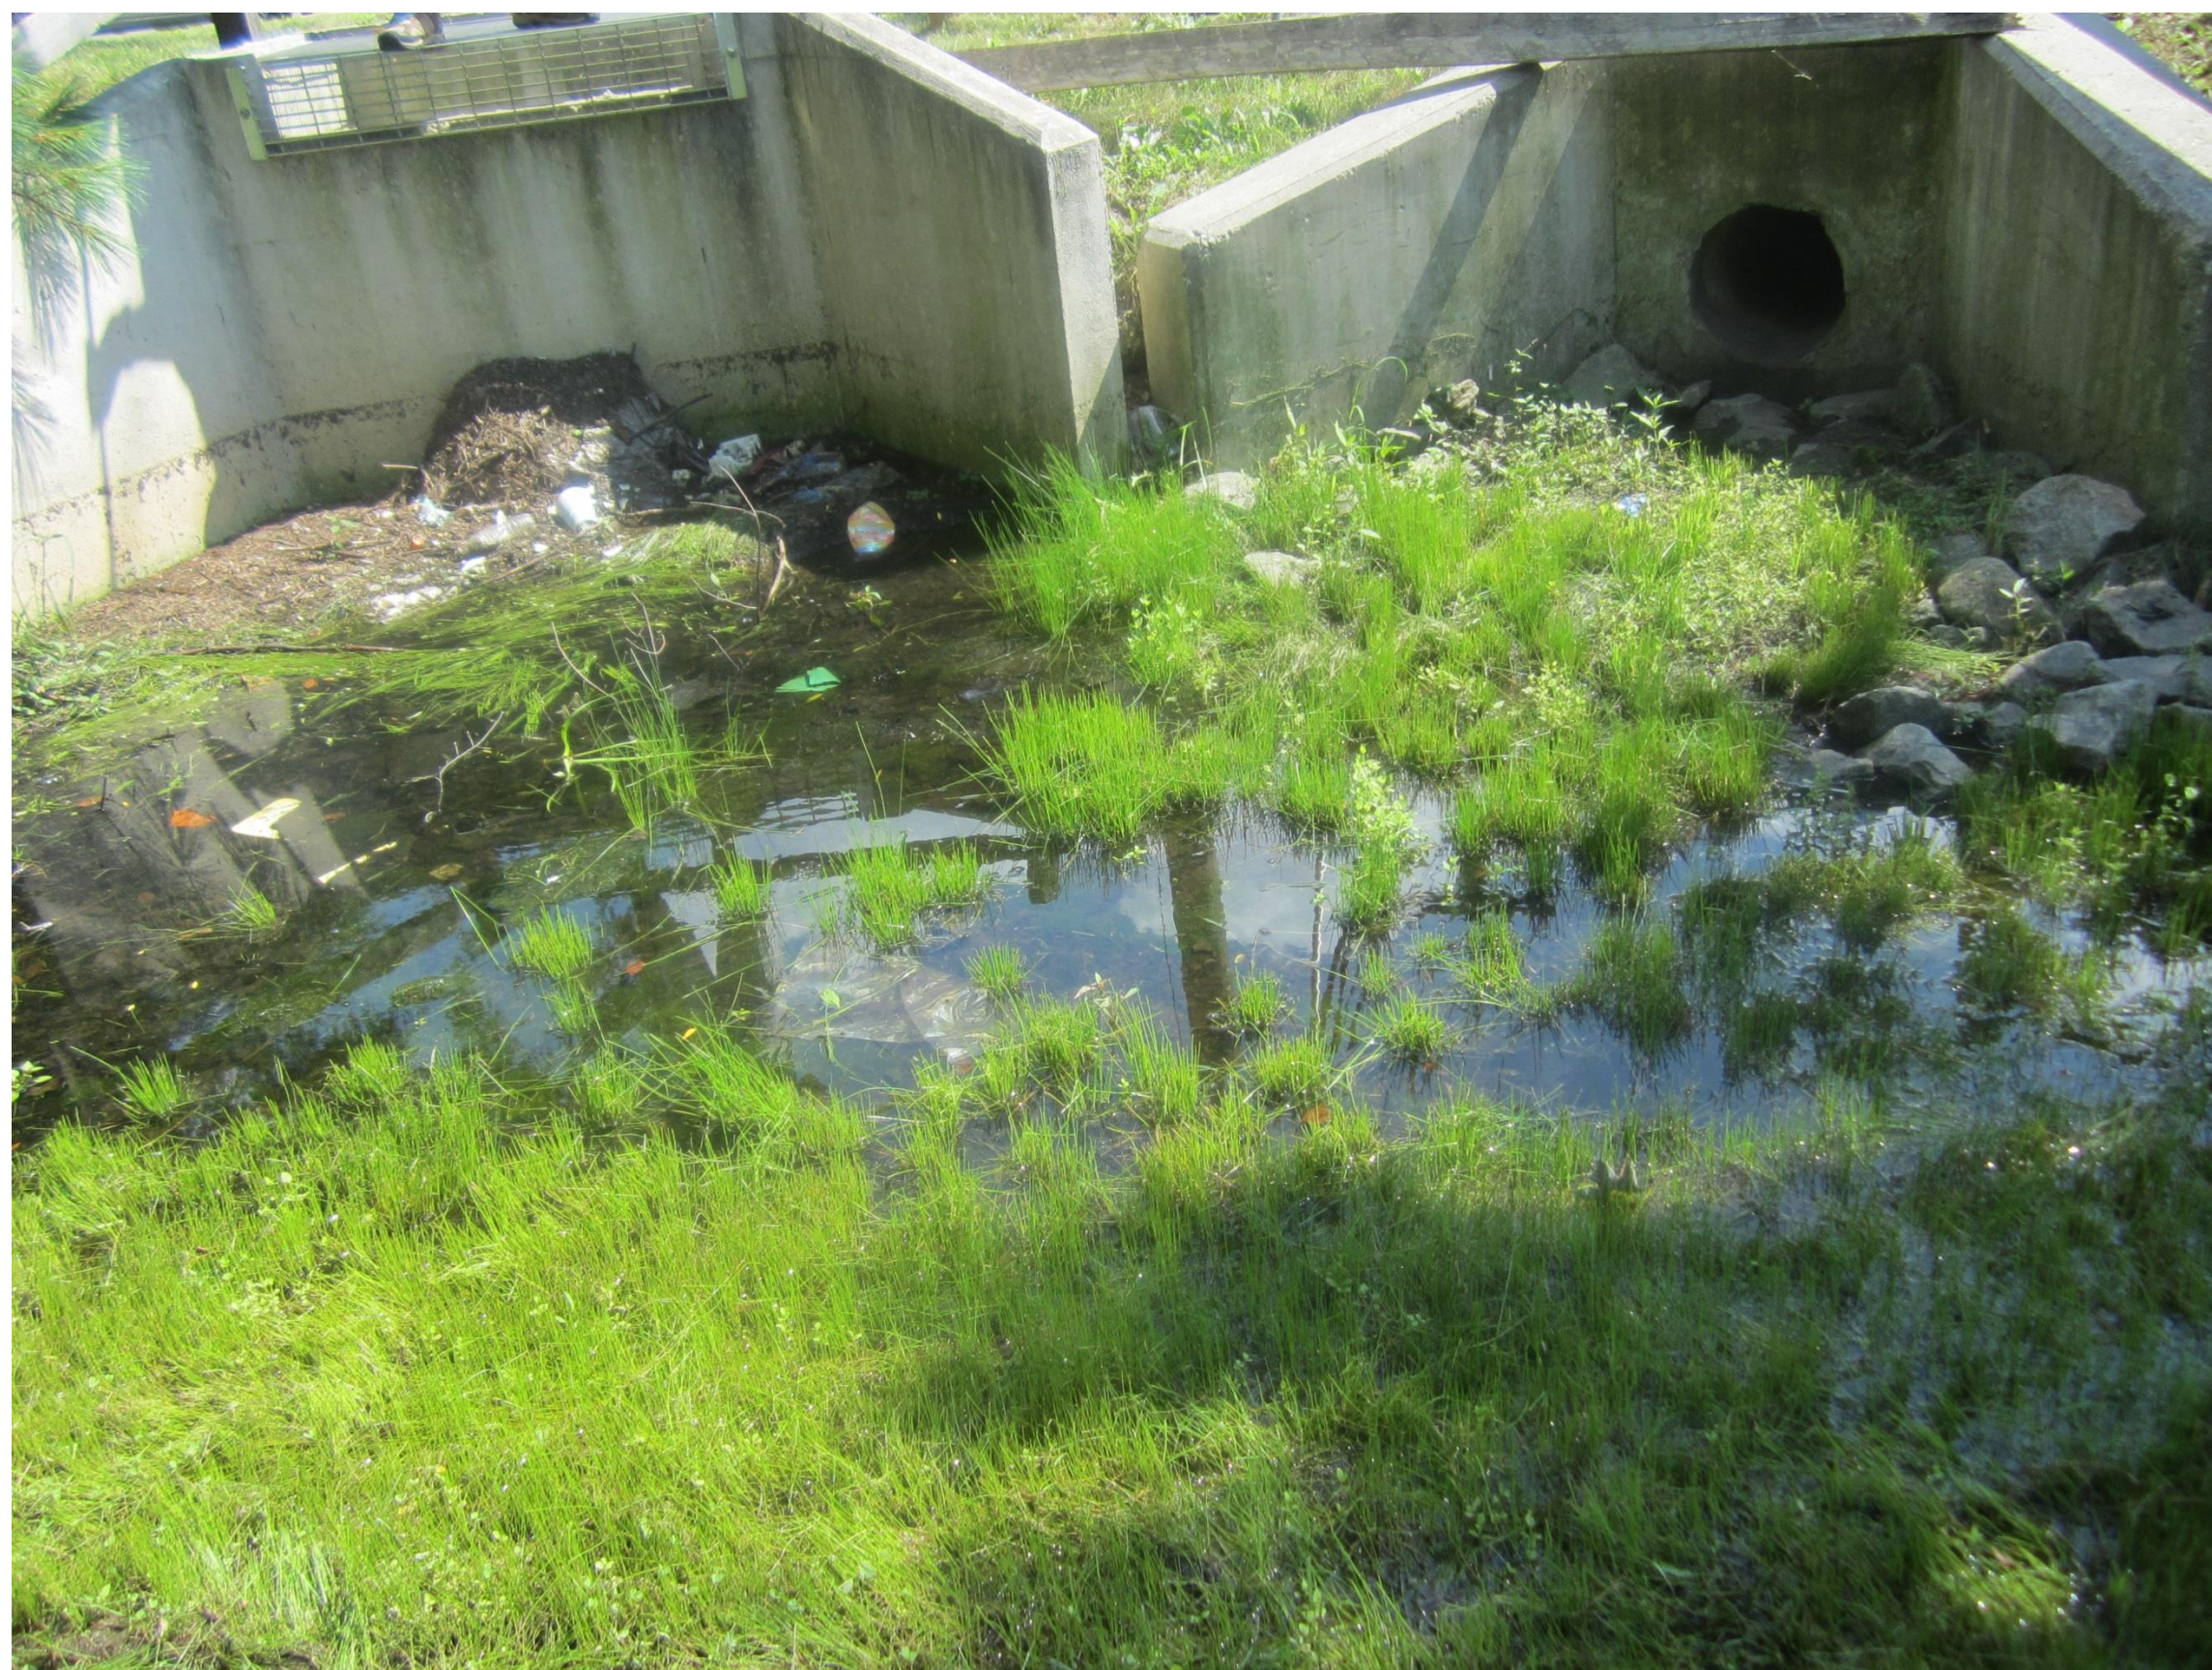
Inlet and outlet structures

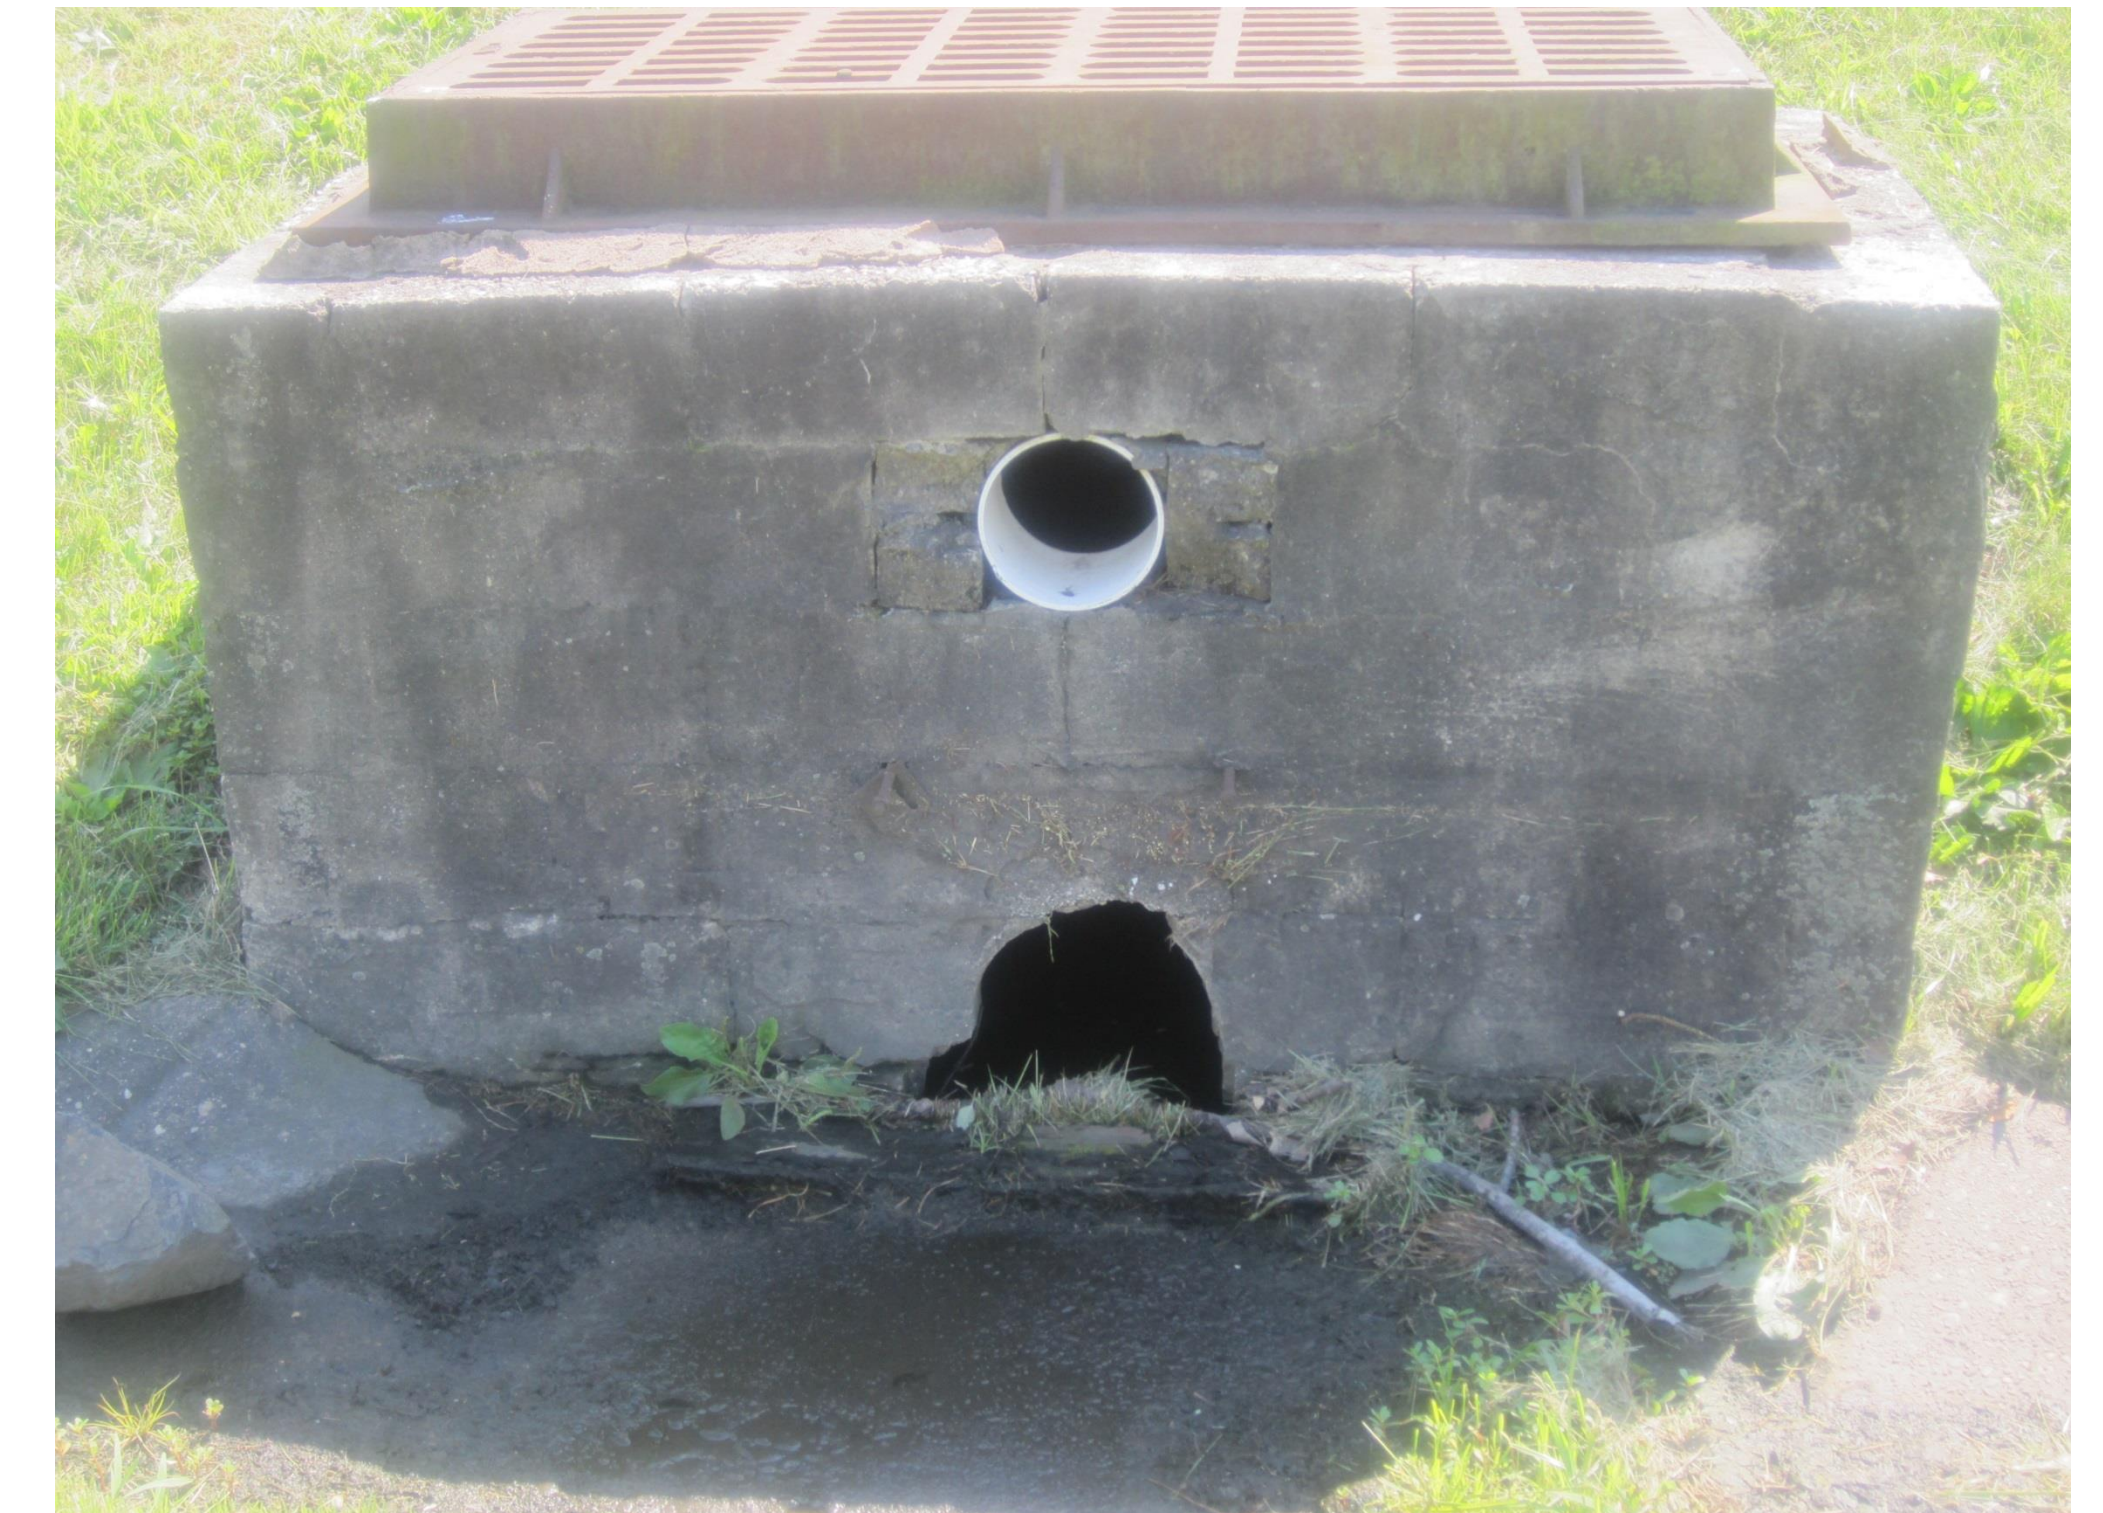
Outlet structure
