**Hamilton Township (Mercer County)
Stormwater Basin Assessment Summary
Past Priority Addendum (Year 5B)**

Developed by the Rutgers Cooperative Extension Water Resources Program
Funded by Hamilton Township, Mercer County, New Jersey

November 27, 2019

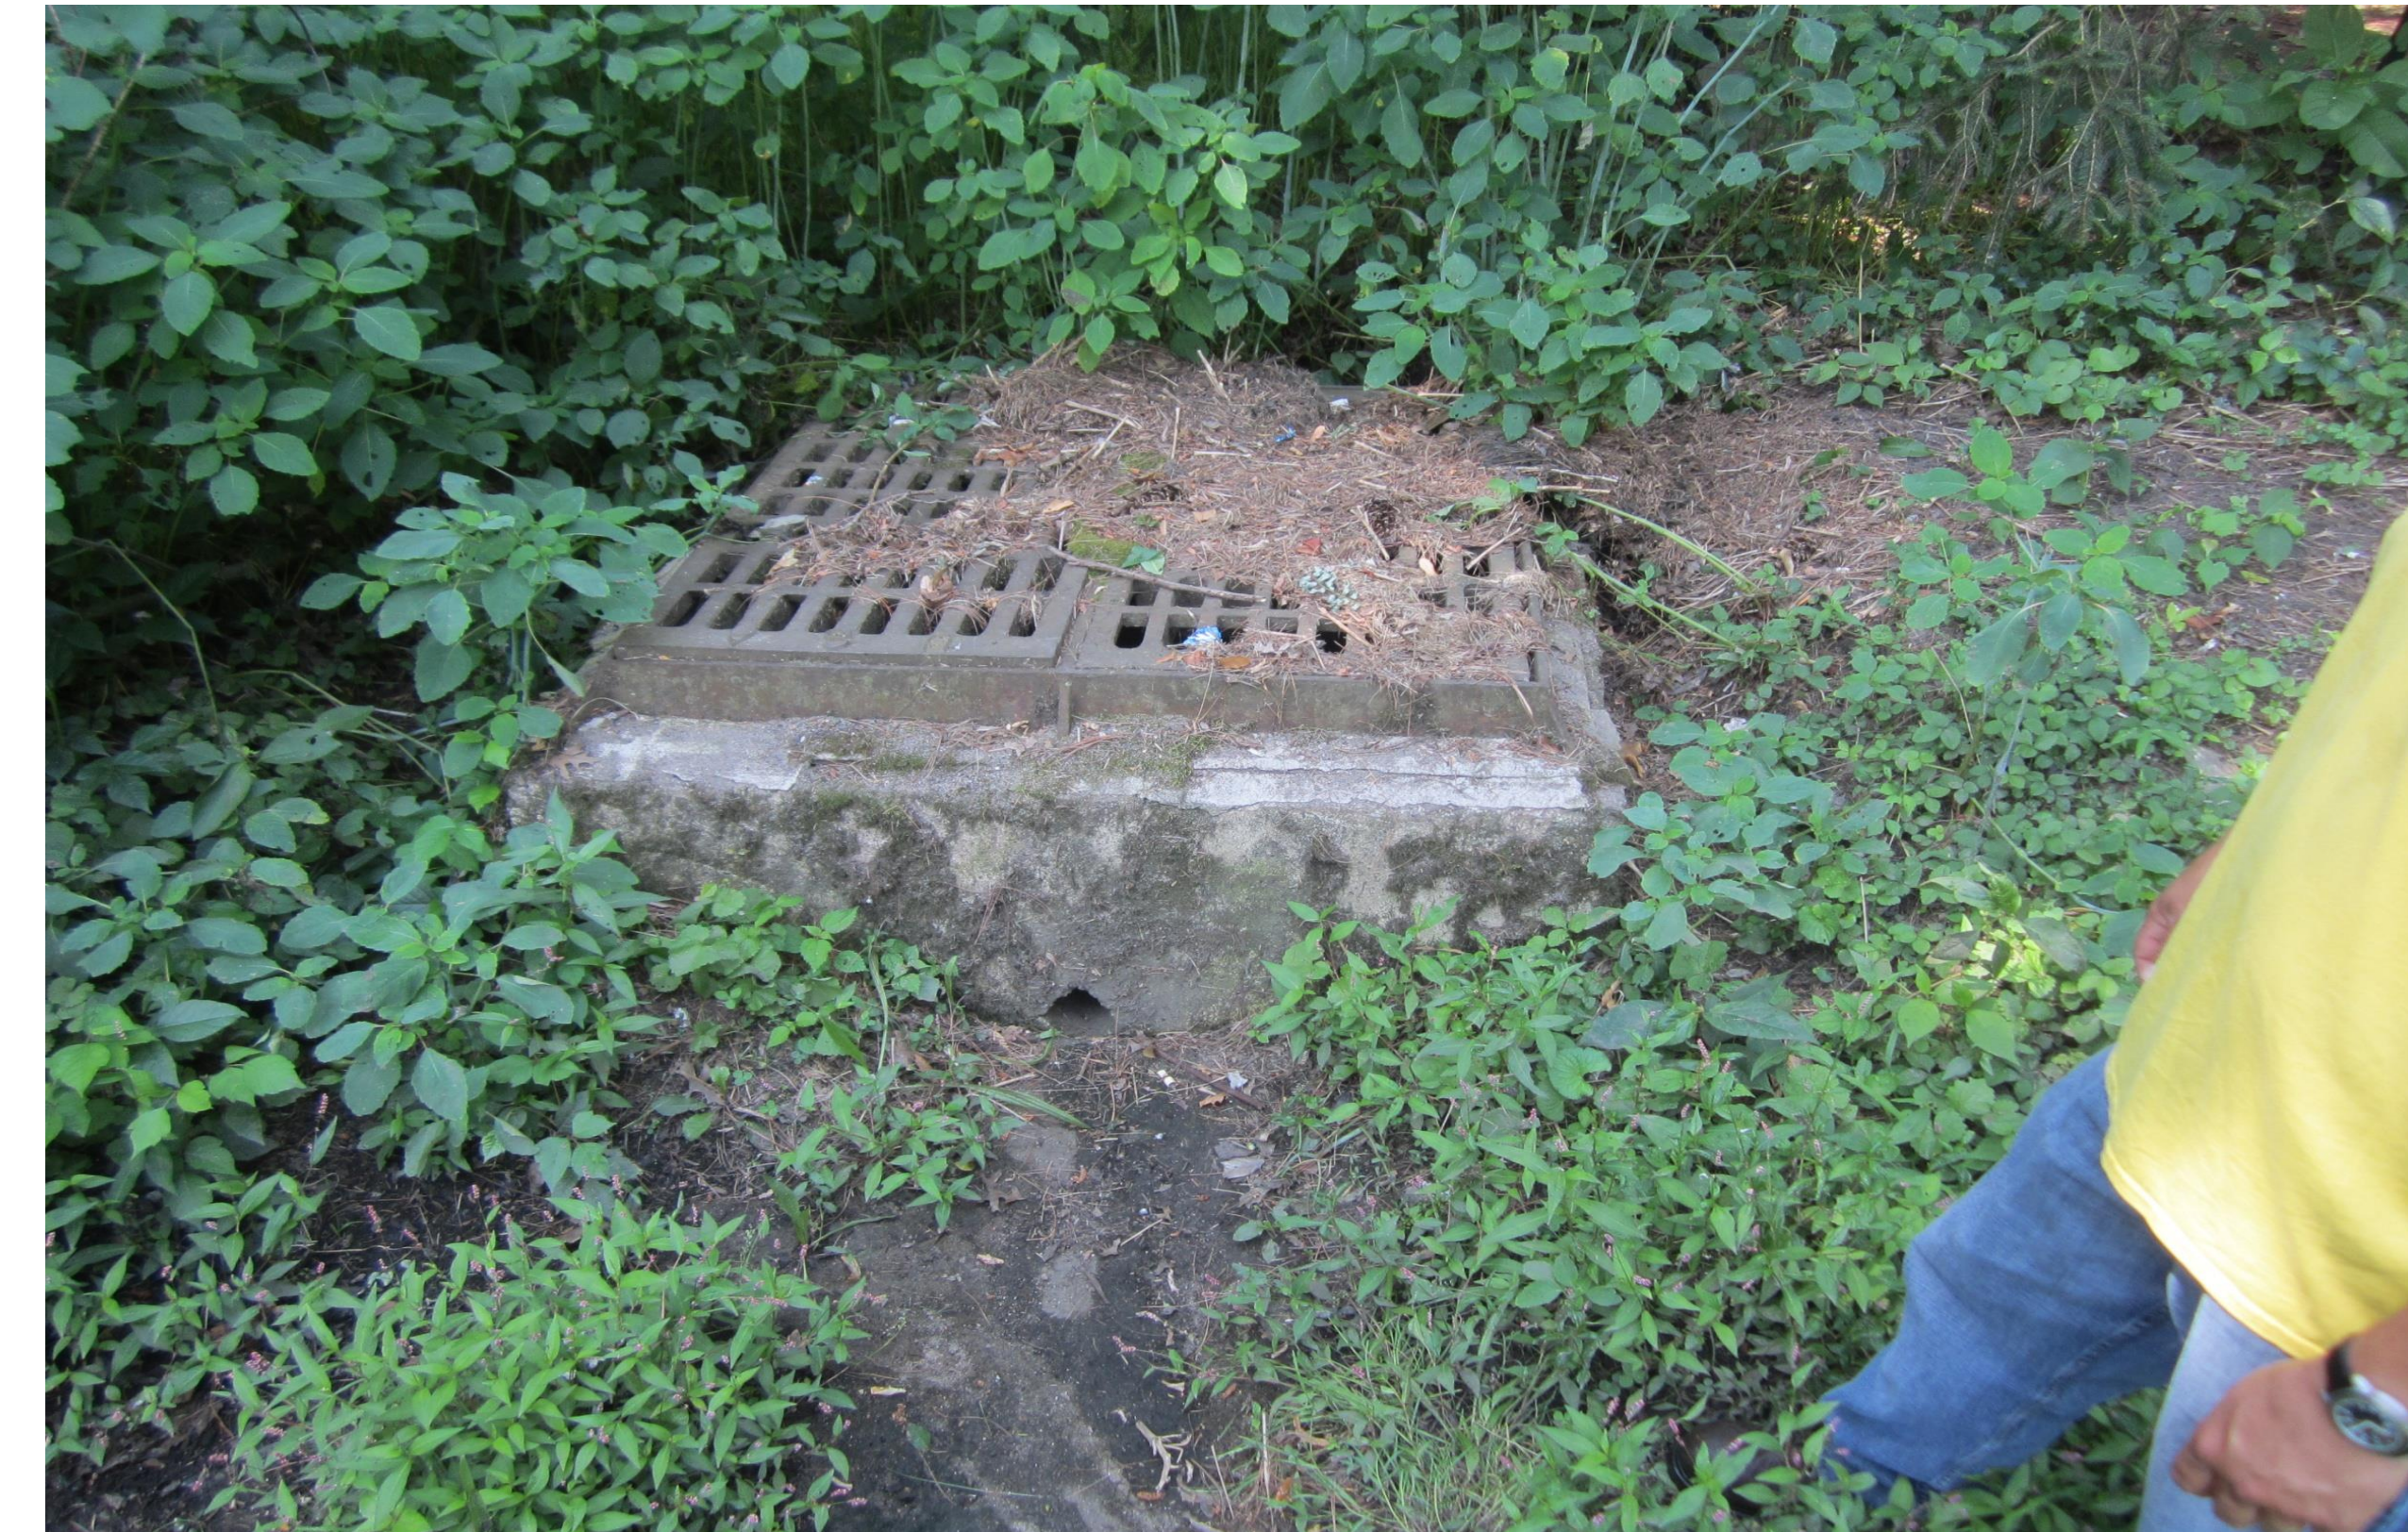
Outlet

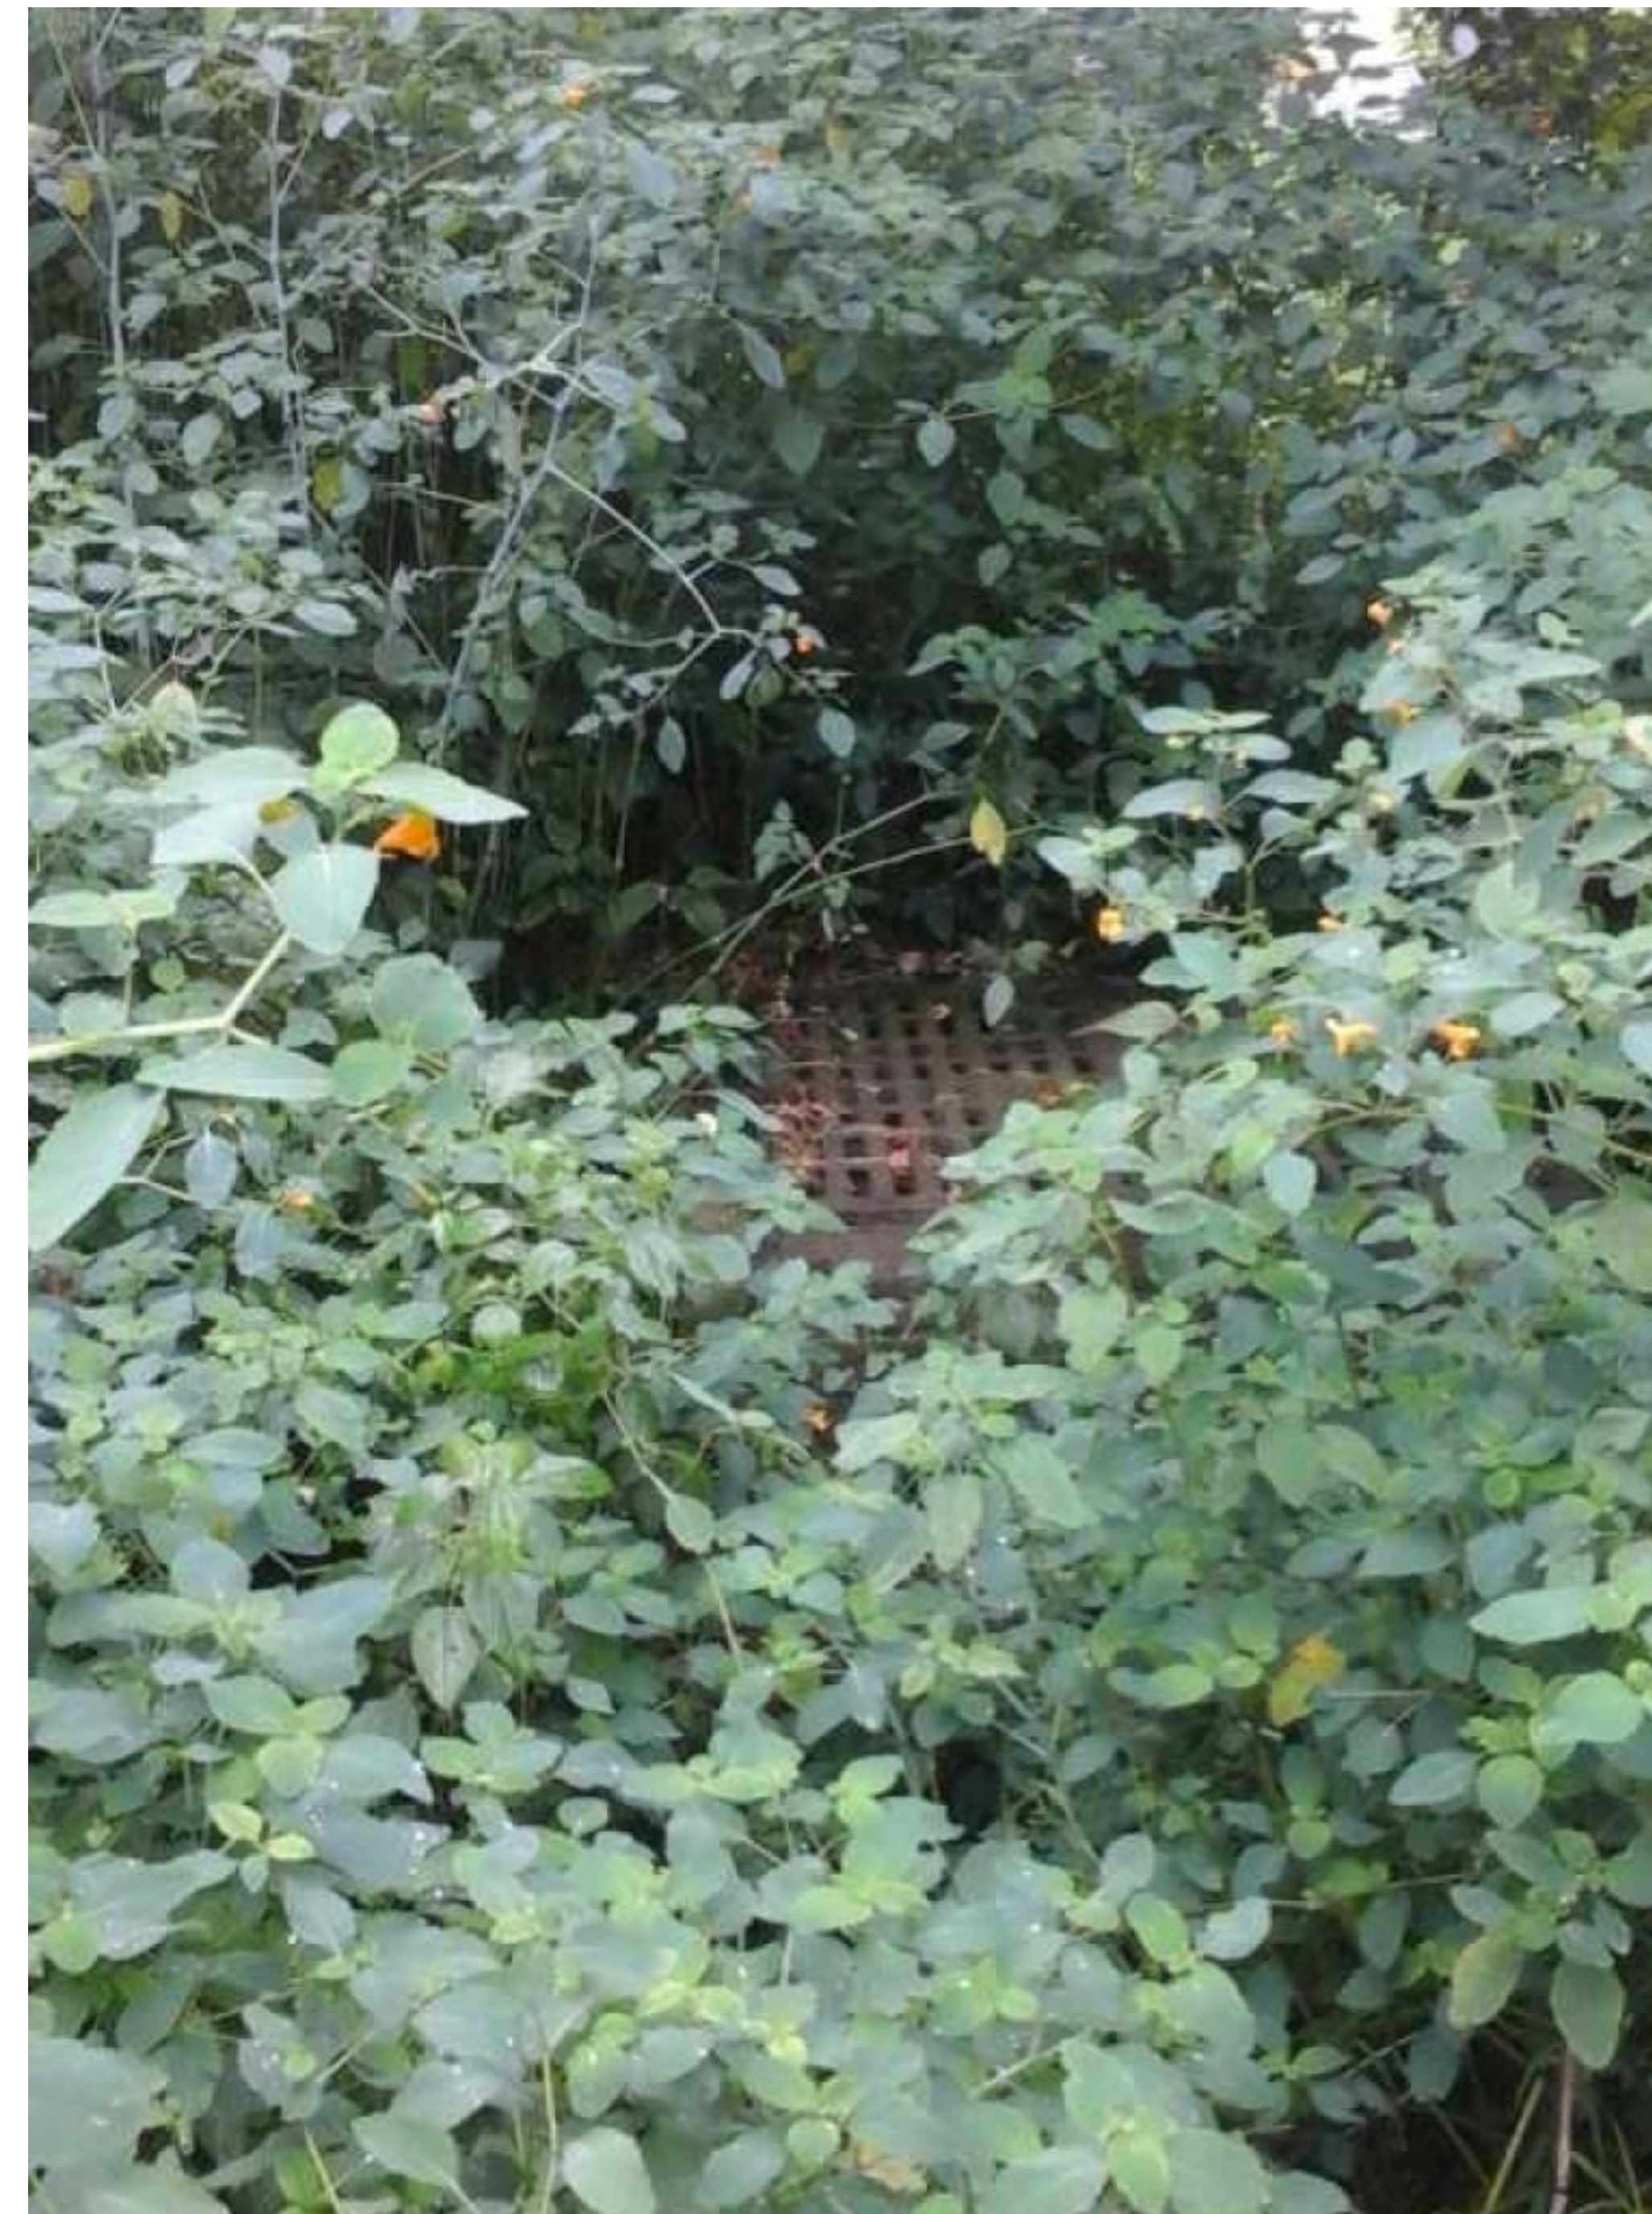
183. Meredith Road Residential Basins

- Channel slightly overgrown with Jewel Weed, a beneficial native
- Clear out channel, inlets, and outlet to maintain access

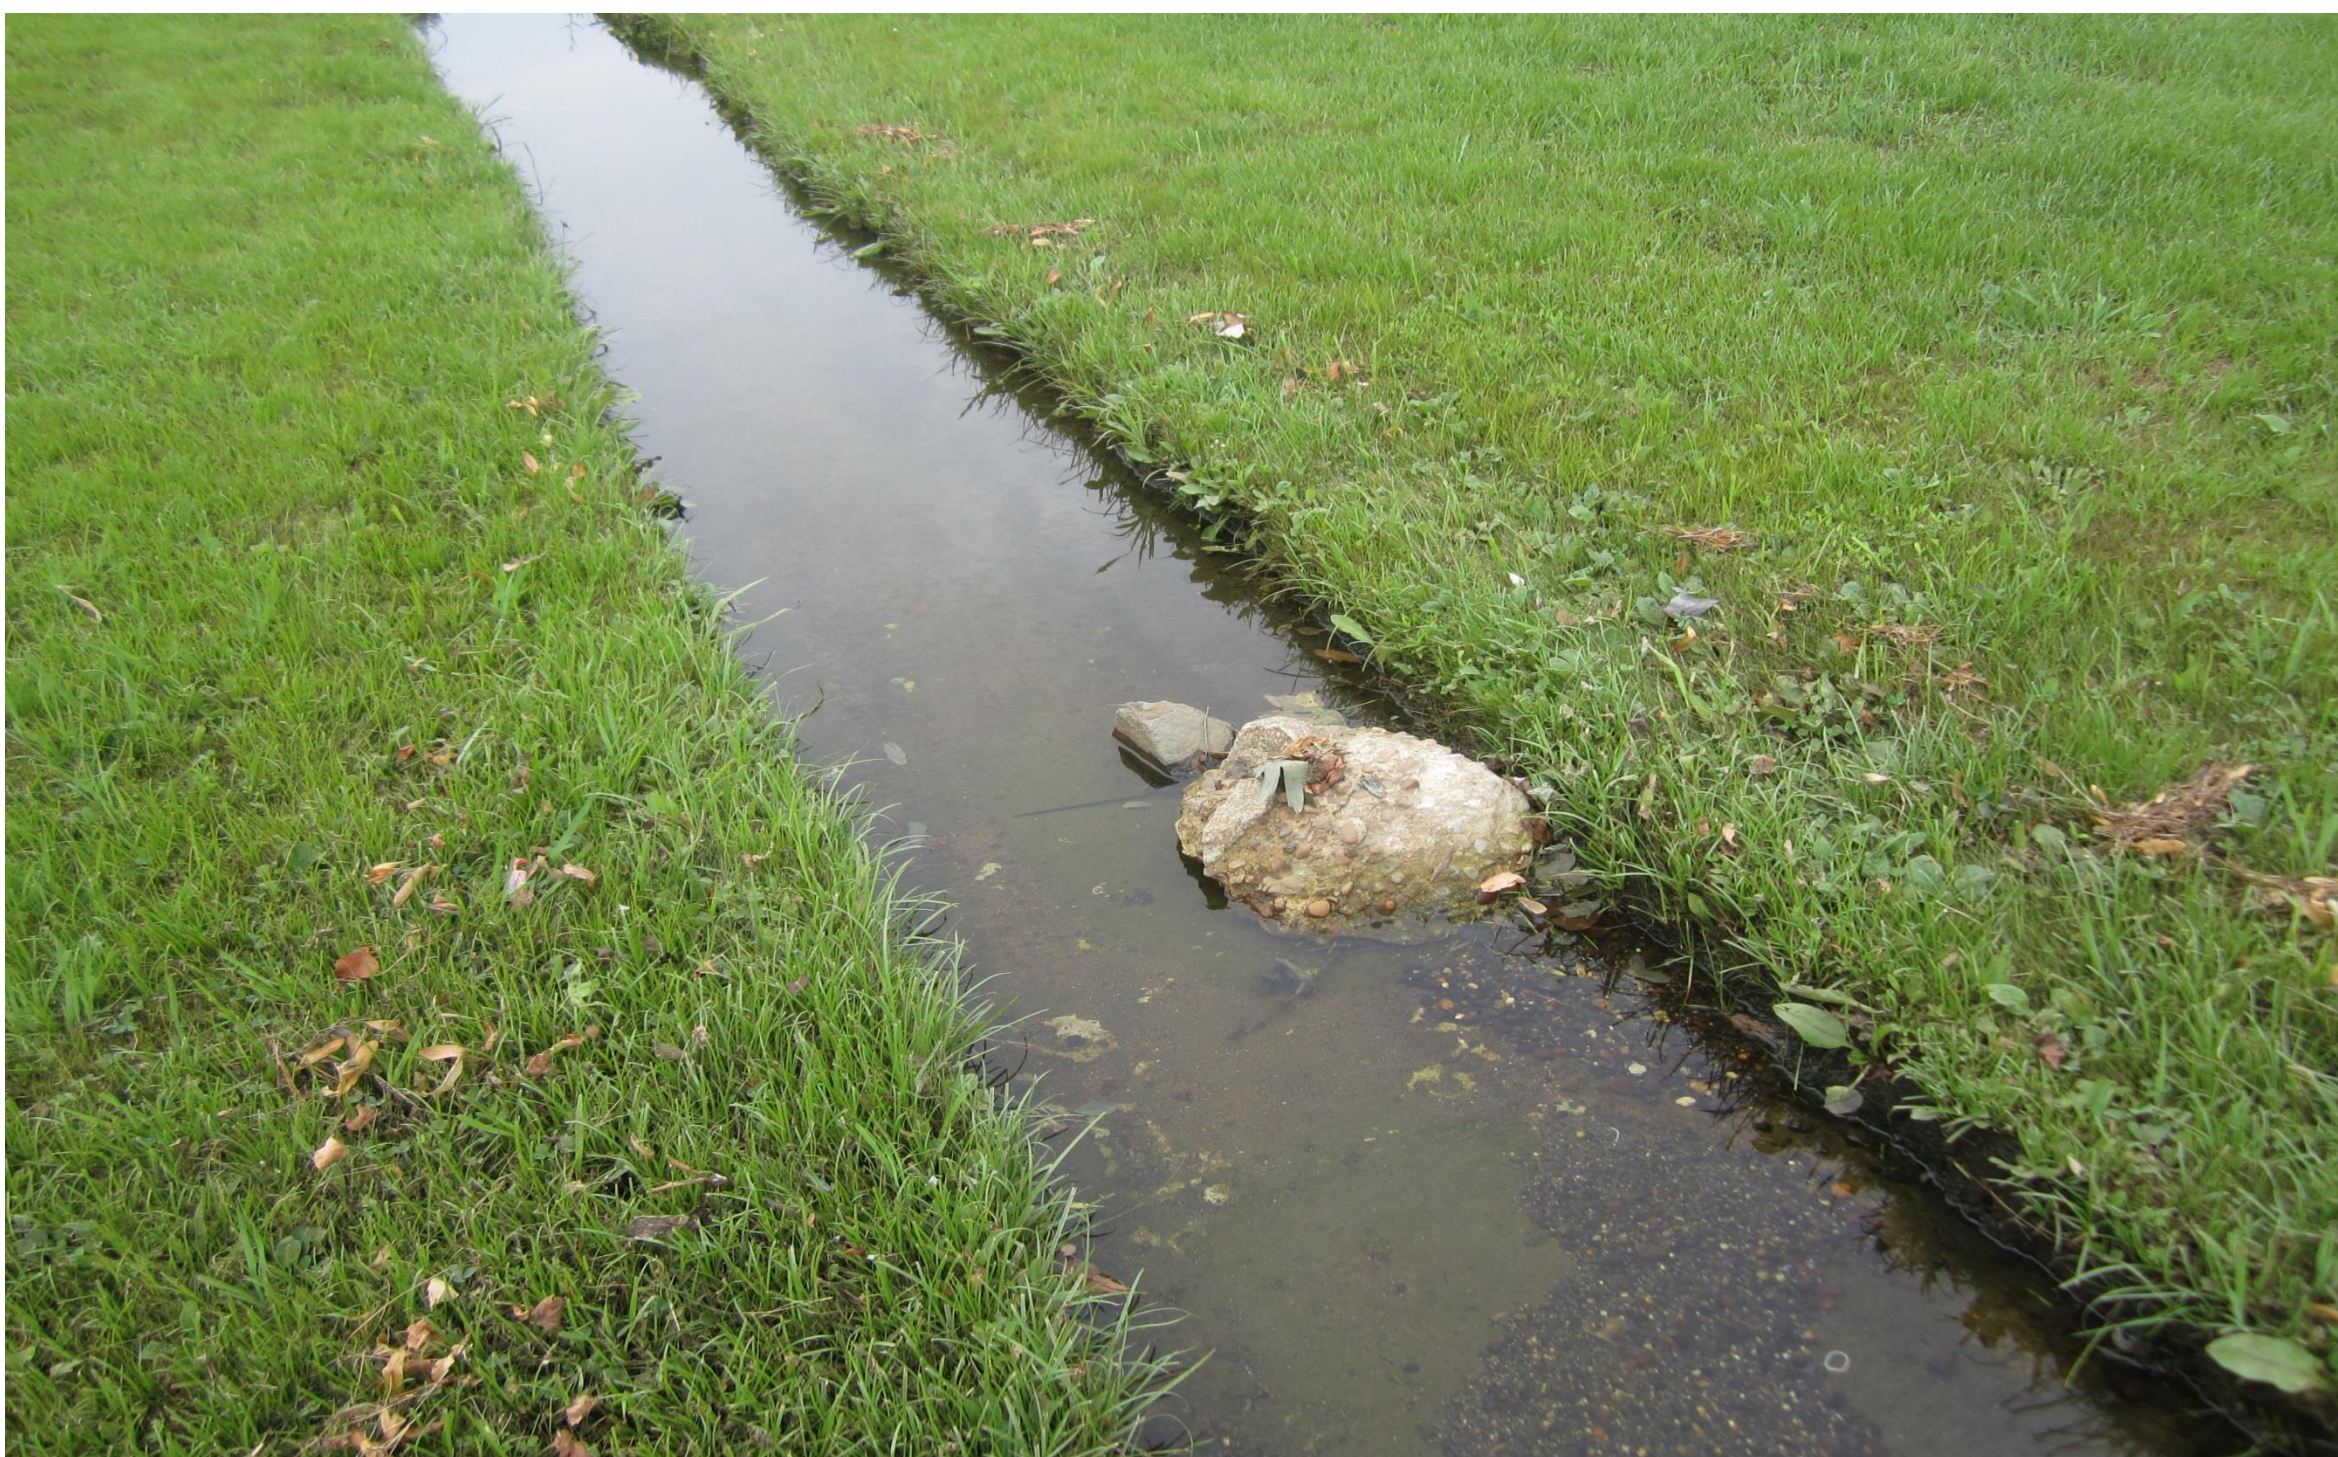
Standing water in low flow channel

- Severe standing water in low flow channels caused by outlet structure that needs maintenance
- Remove low flow channel for rock channel
- Plant native herbaceous plants to help naturalize

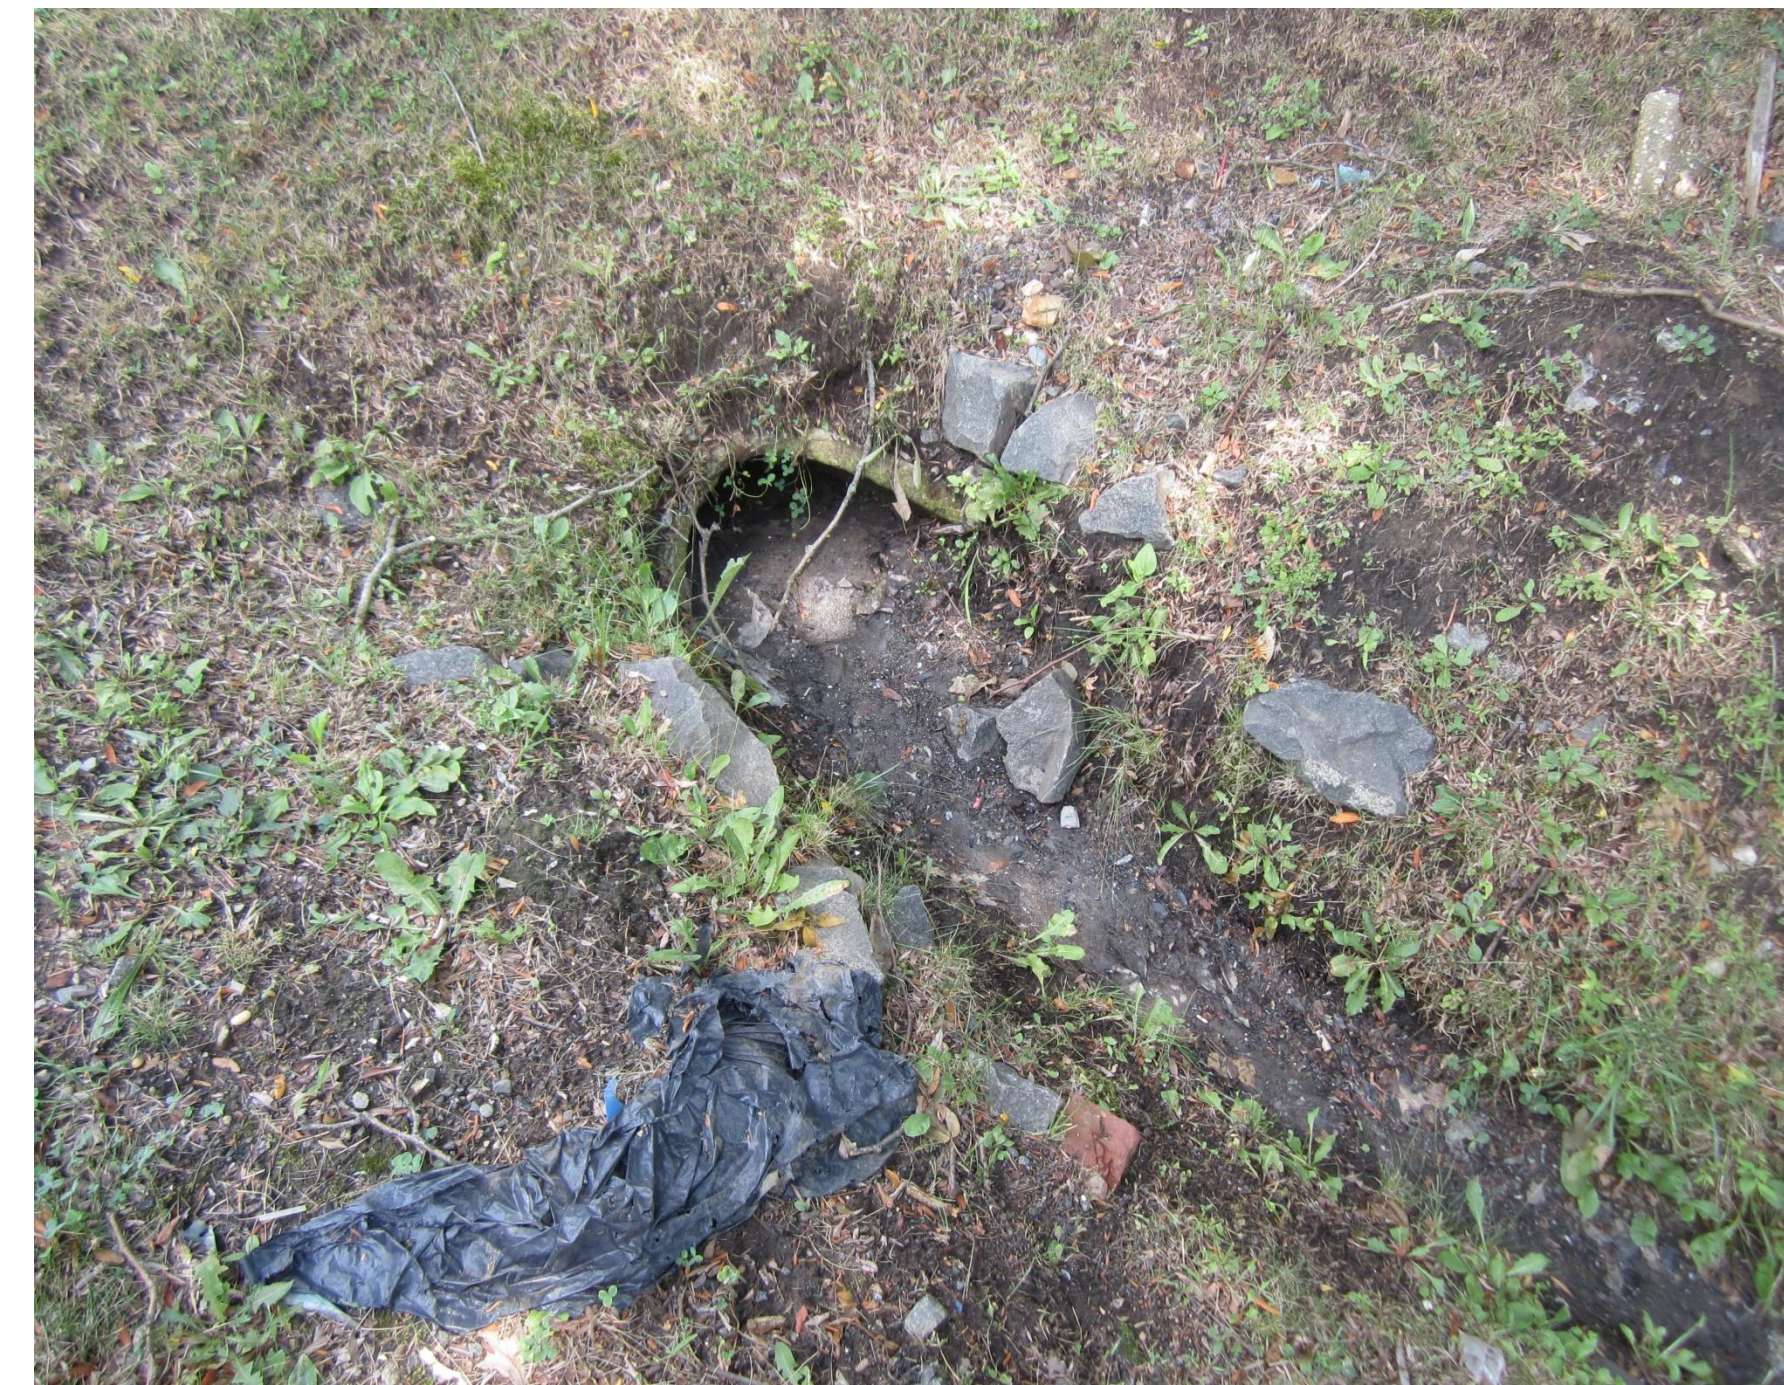
Obstructed inlet

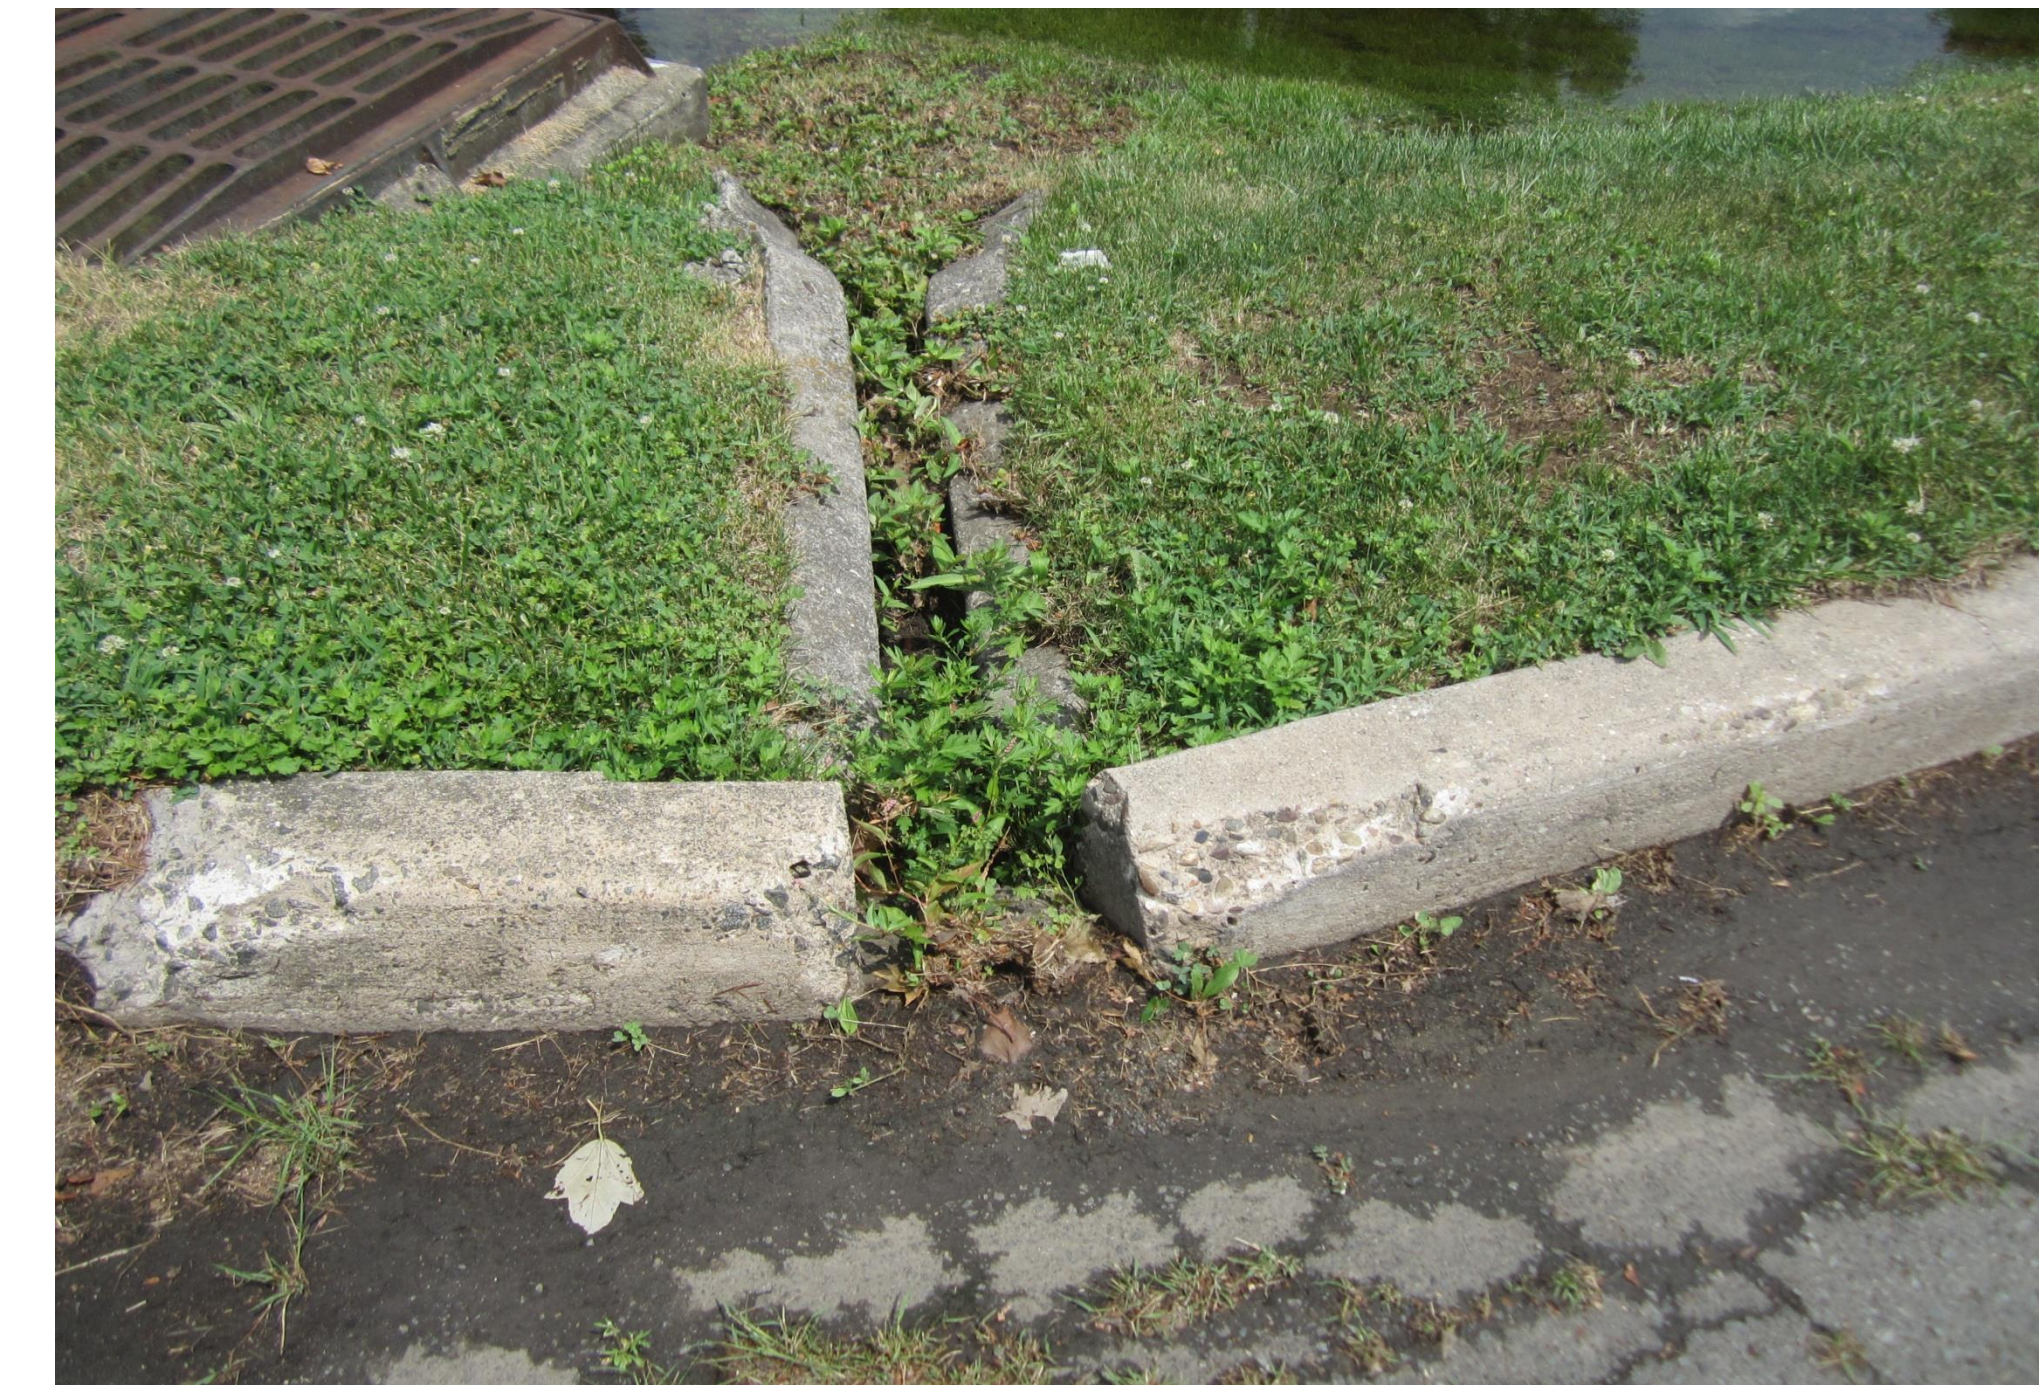
Overgrown curbcut

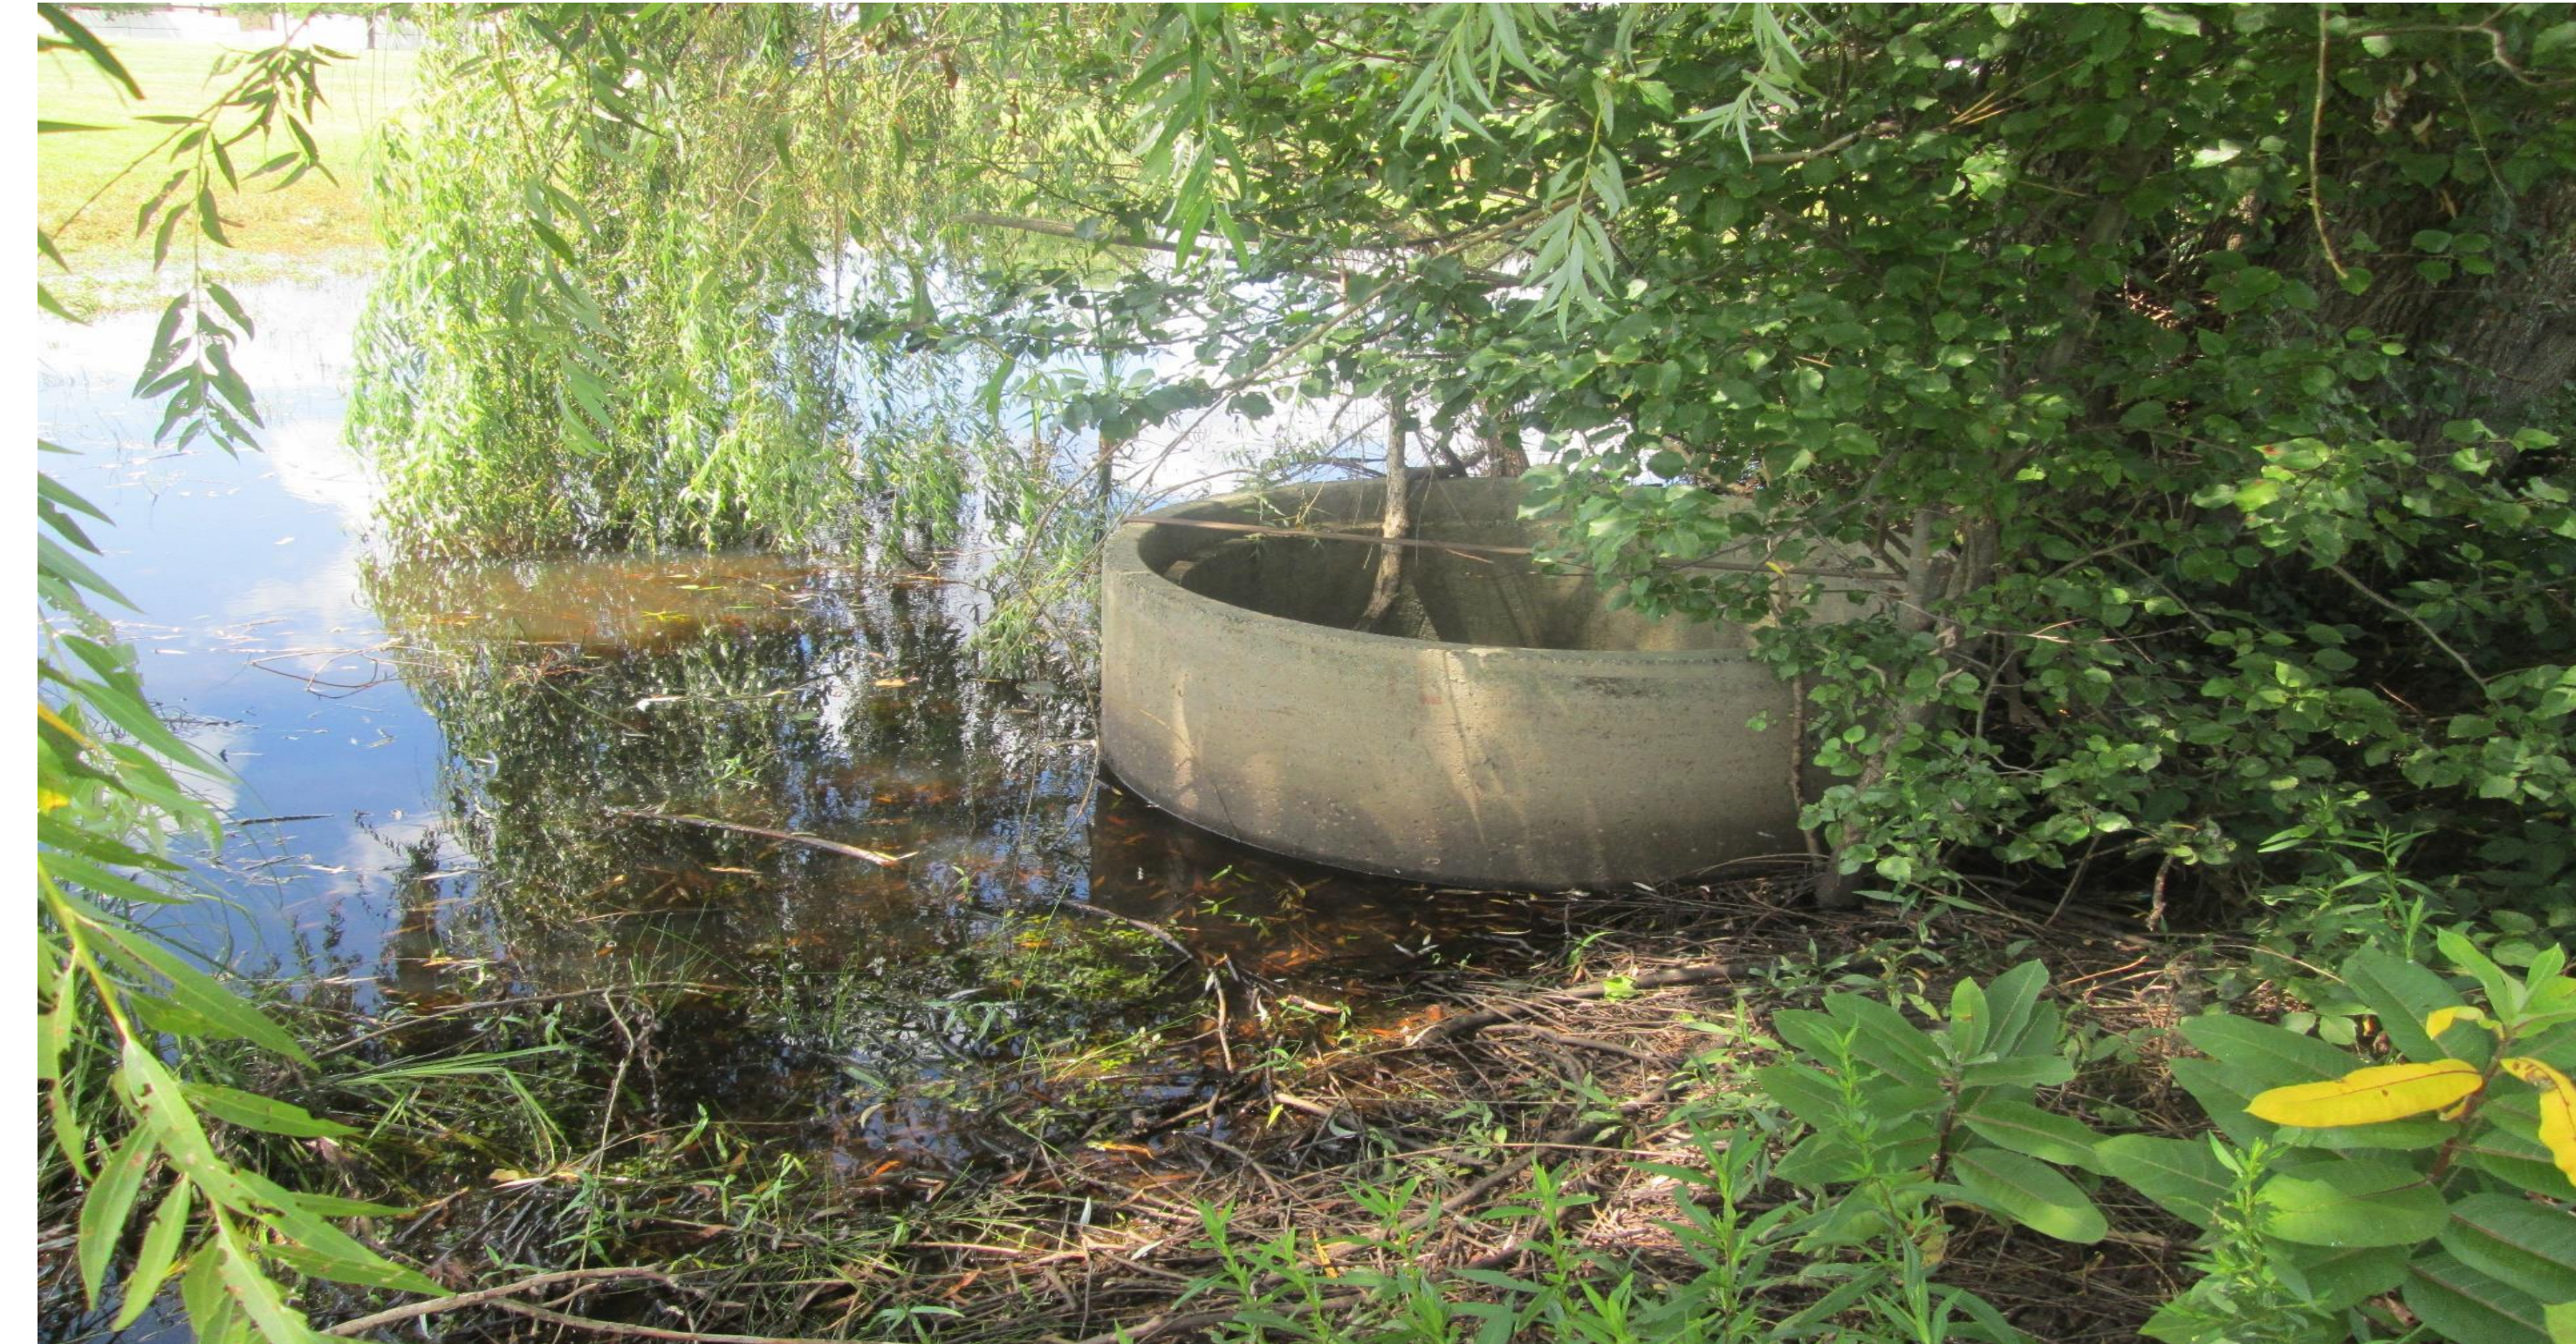
Outlet

- Outlet structure is clogged with sediment and debris
- Standing water in the basin bottom
- Outlet structure is missing secondary spillway grate
