**Hamilton Township (Mercer County)
Stormwater Basin Assessment Summary
Past Priority Addendum (Year 5B)**

Developed by the Rutgers Cooperative Extension Water Resources Program
Funded by Hamilton Township, Mercer County, New Jersey

November 27, 2019

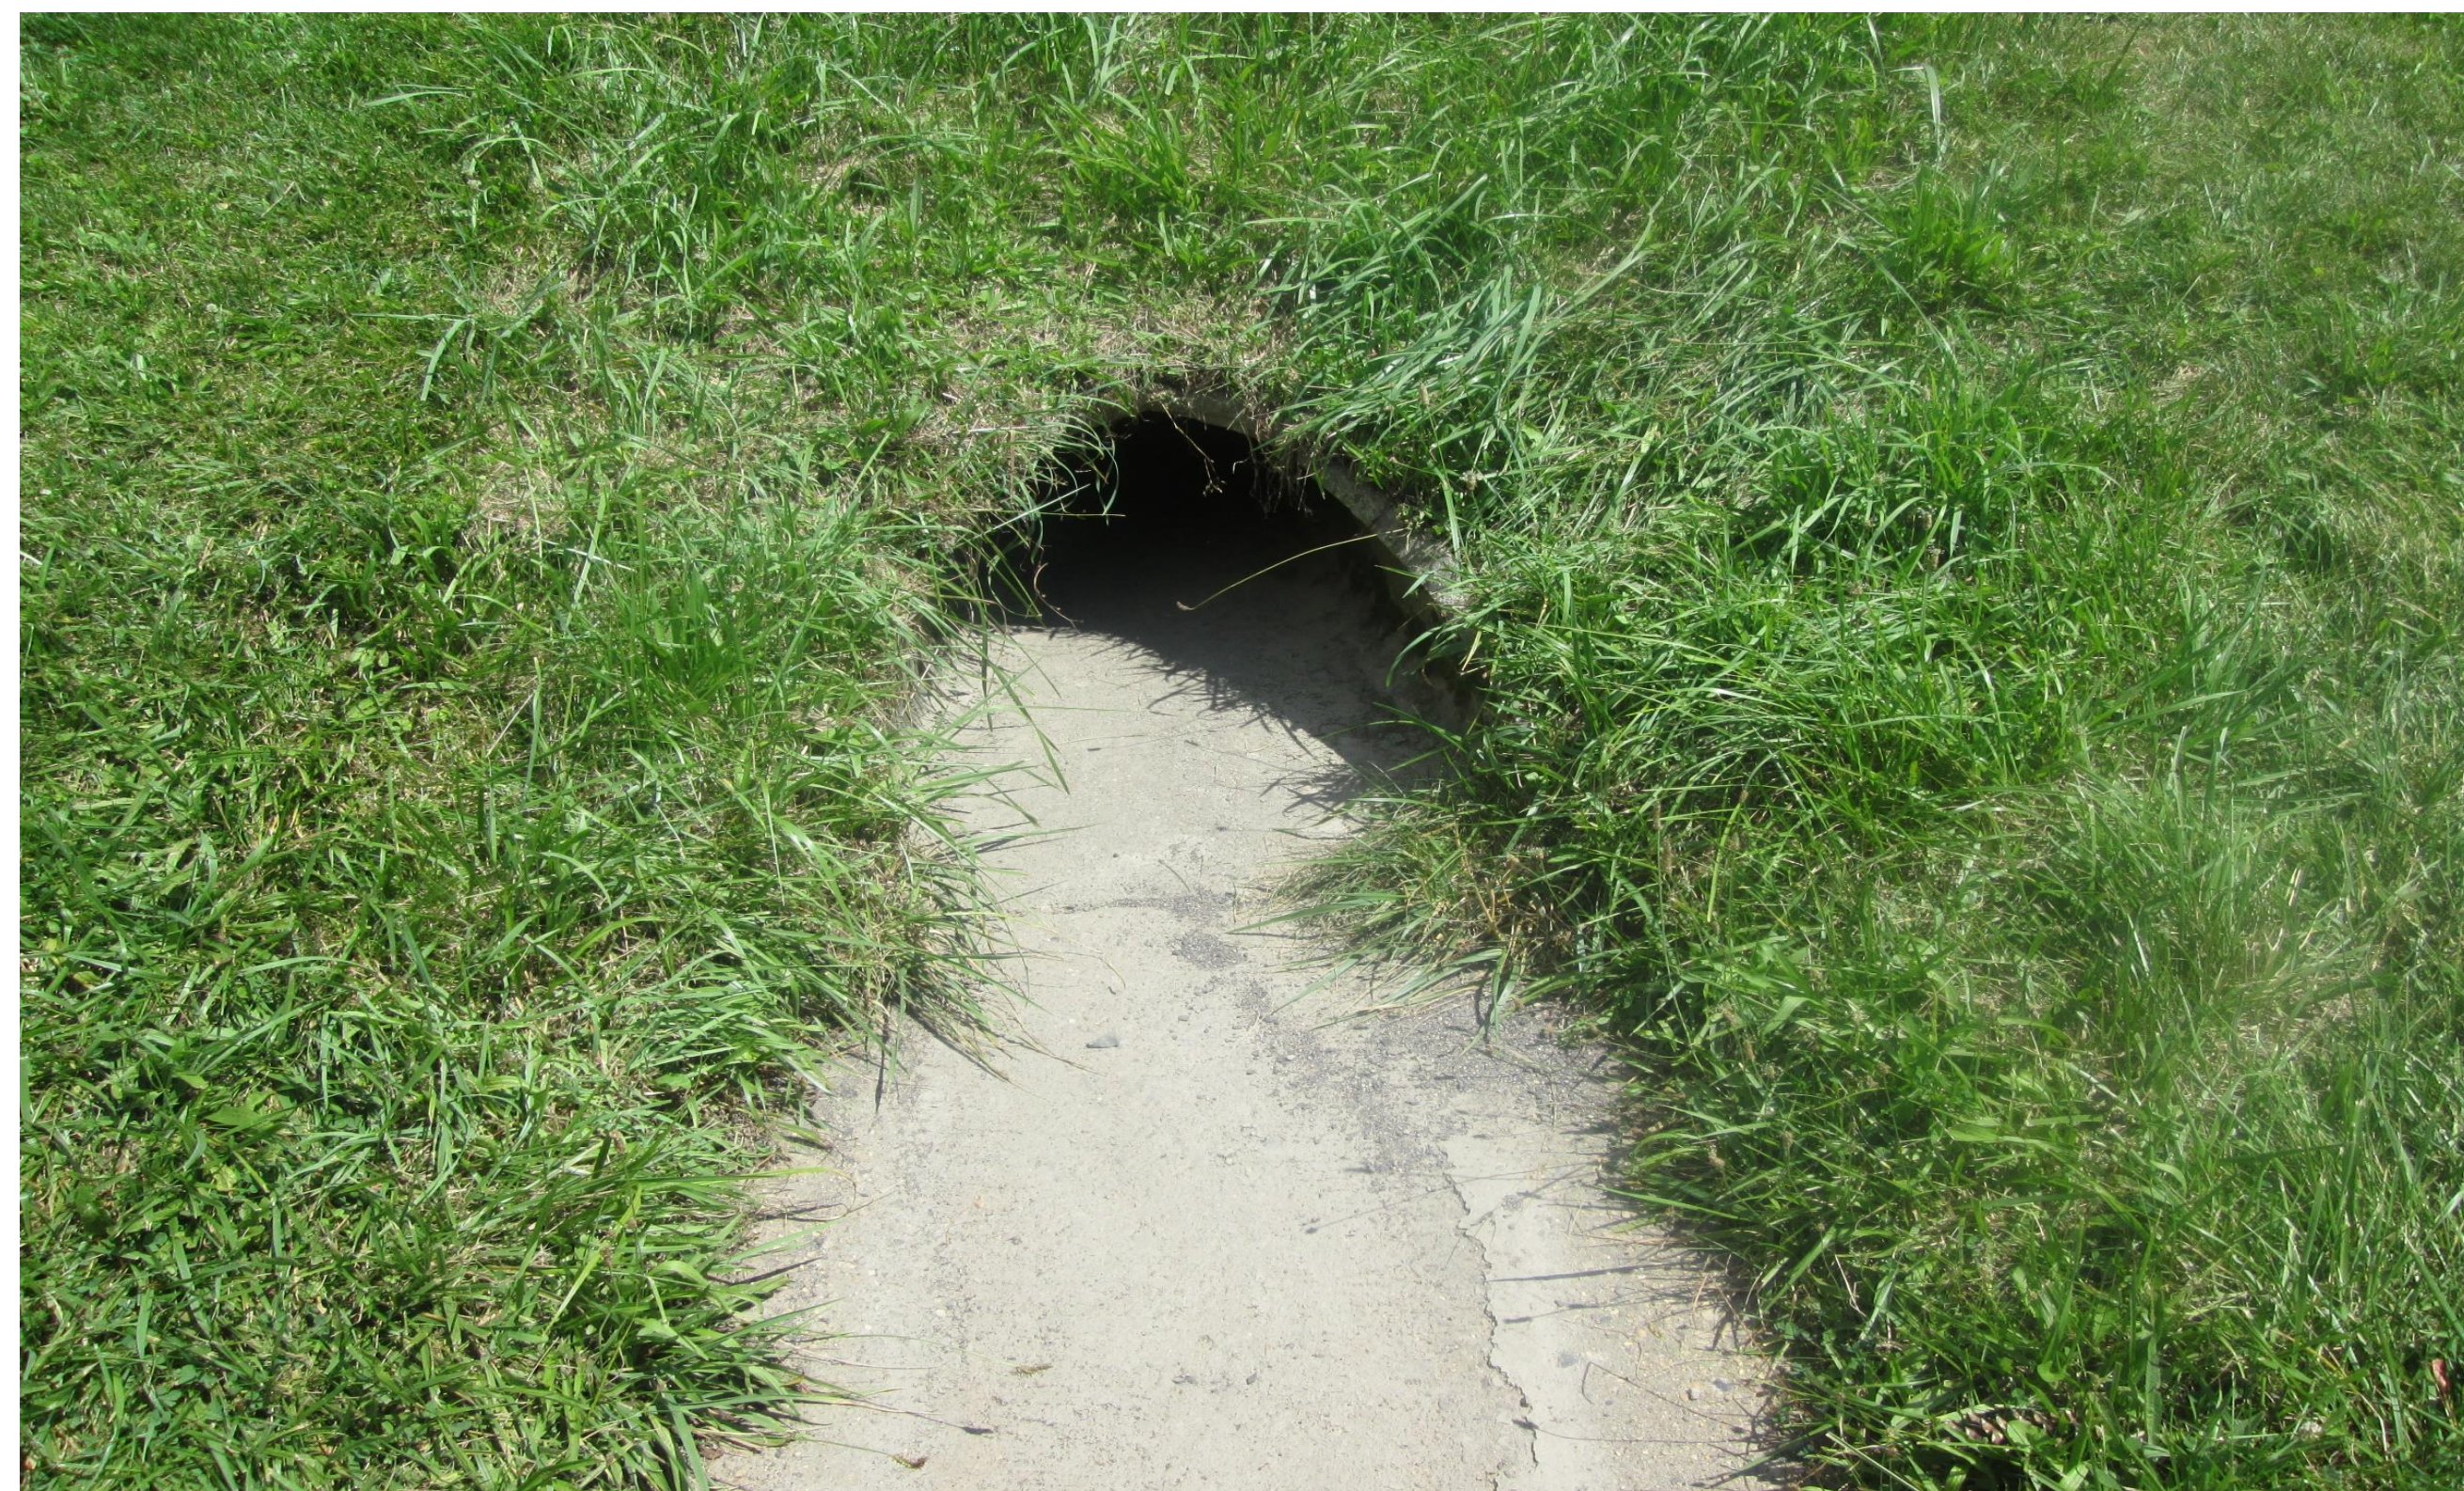
Inlet

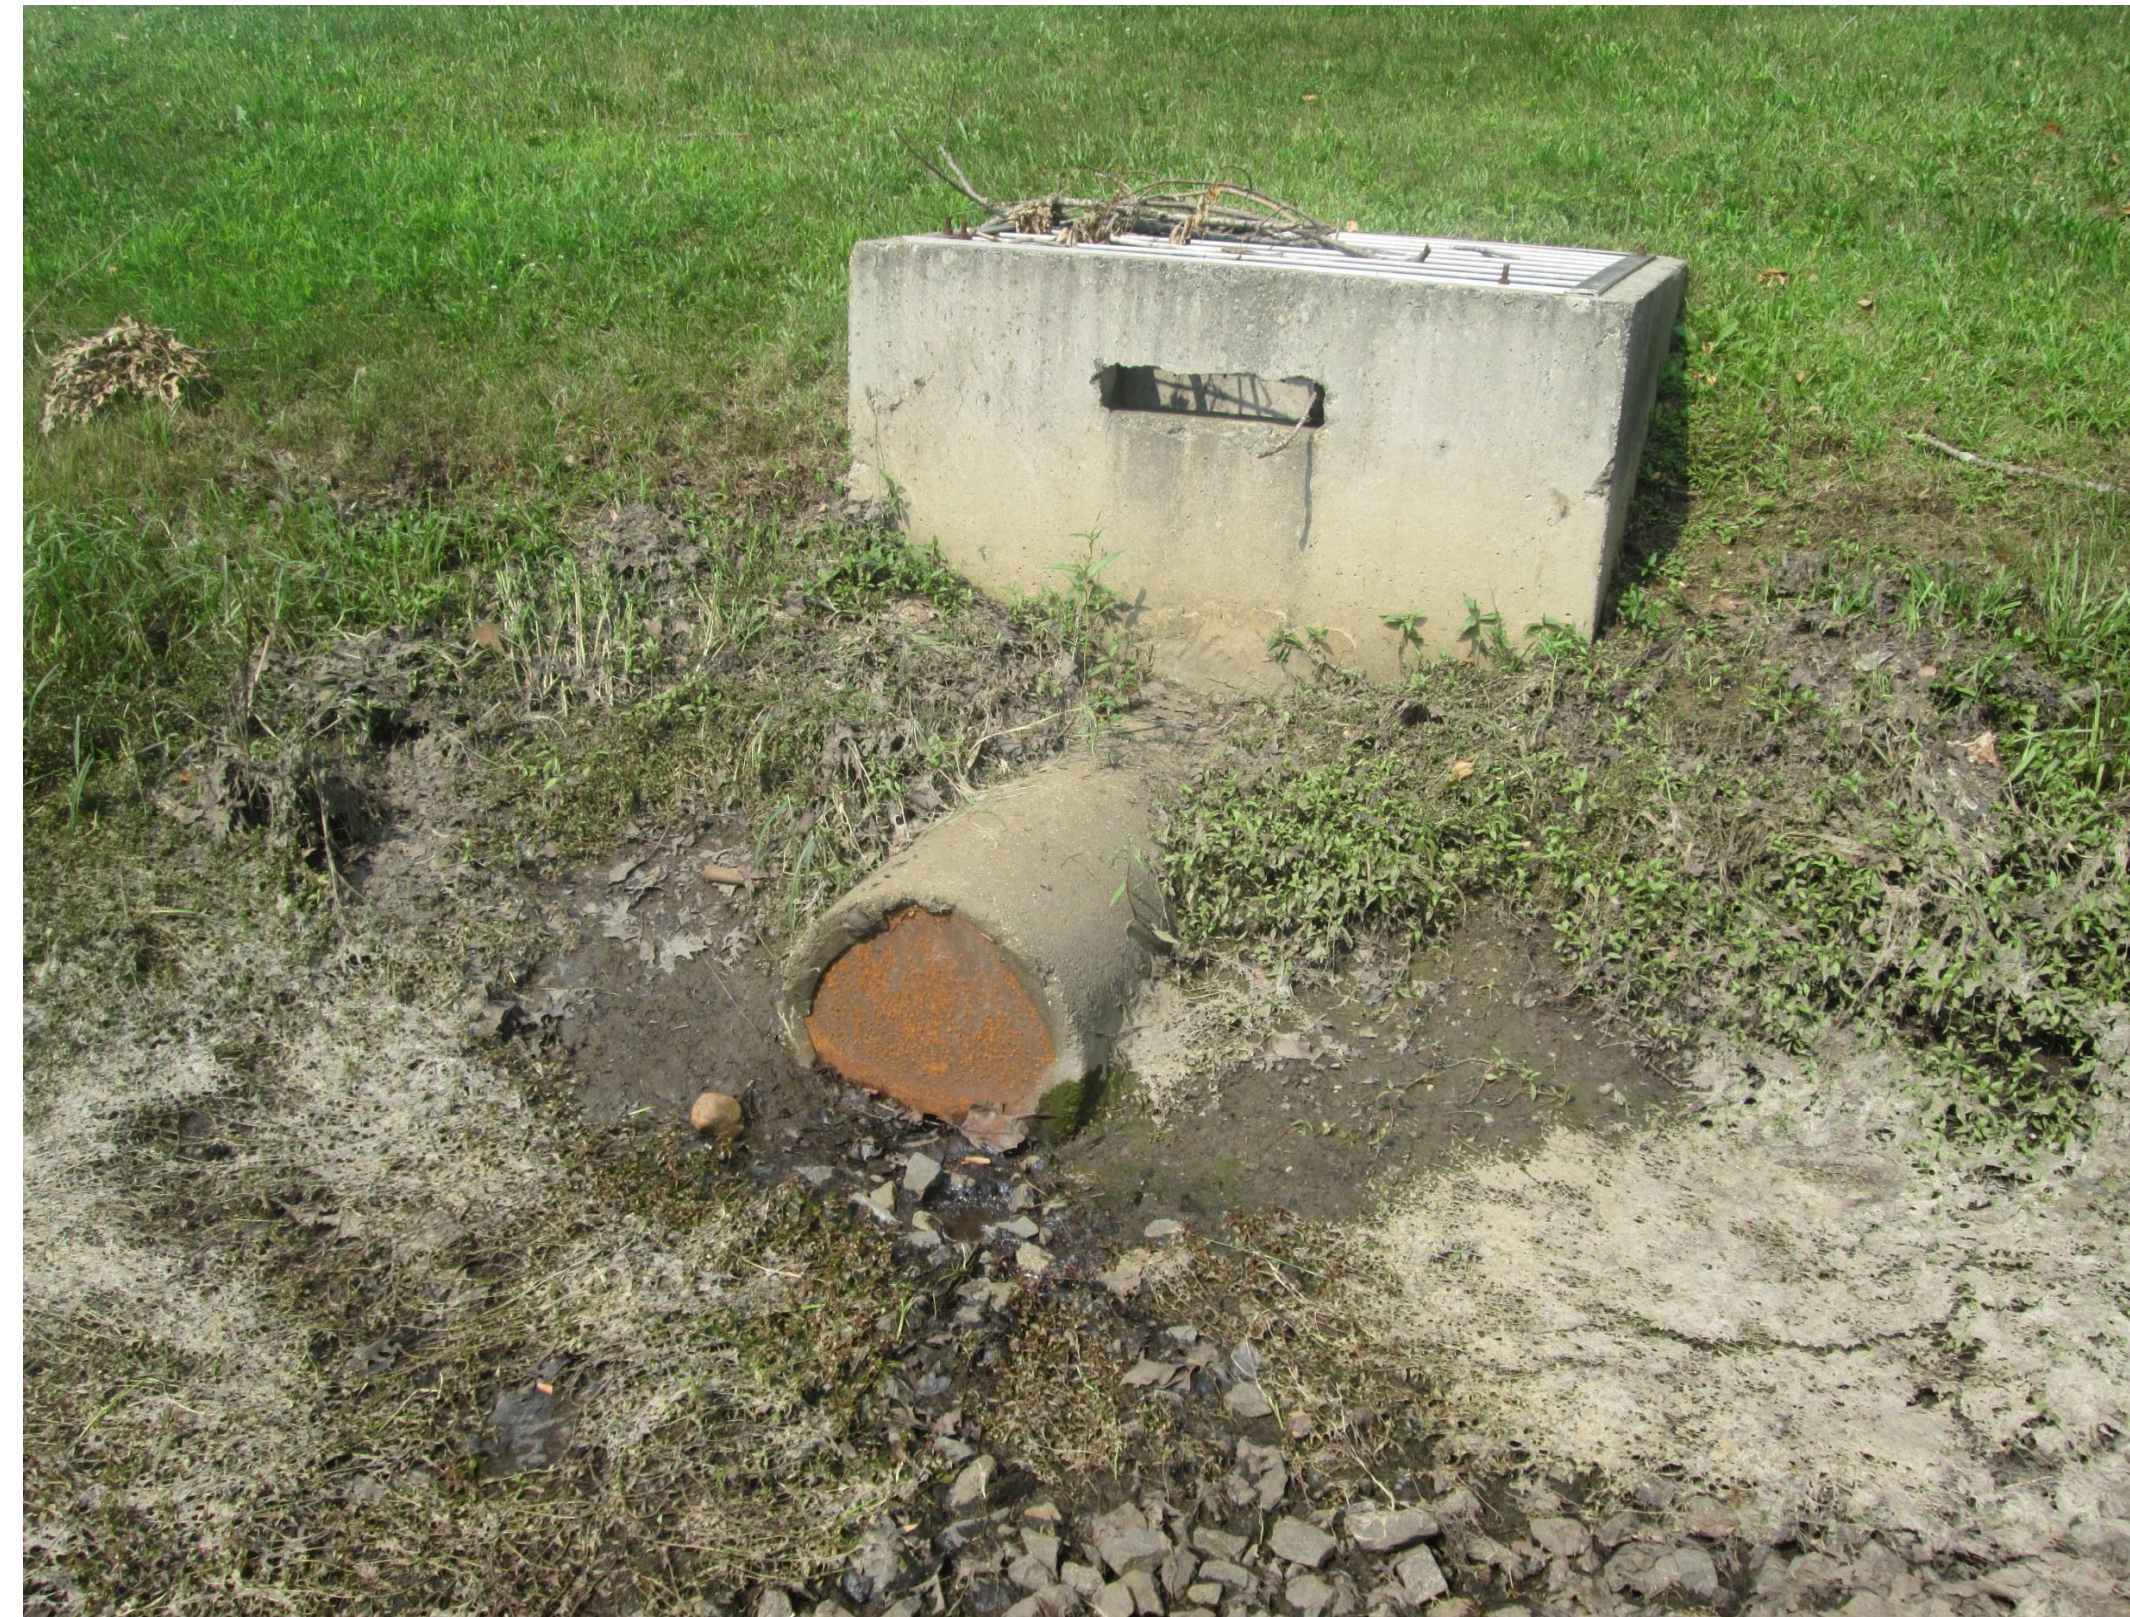
Outlet

- One common pipe conveys stormwater from eastern basin to western basin
- Standing water noted in basin bottom
- Invasive weeds and excessive sediment accumulation in basin bottom
- Eroding outlet pipe
- Emergency spillway leads to a vegetated swale

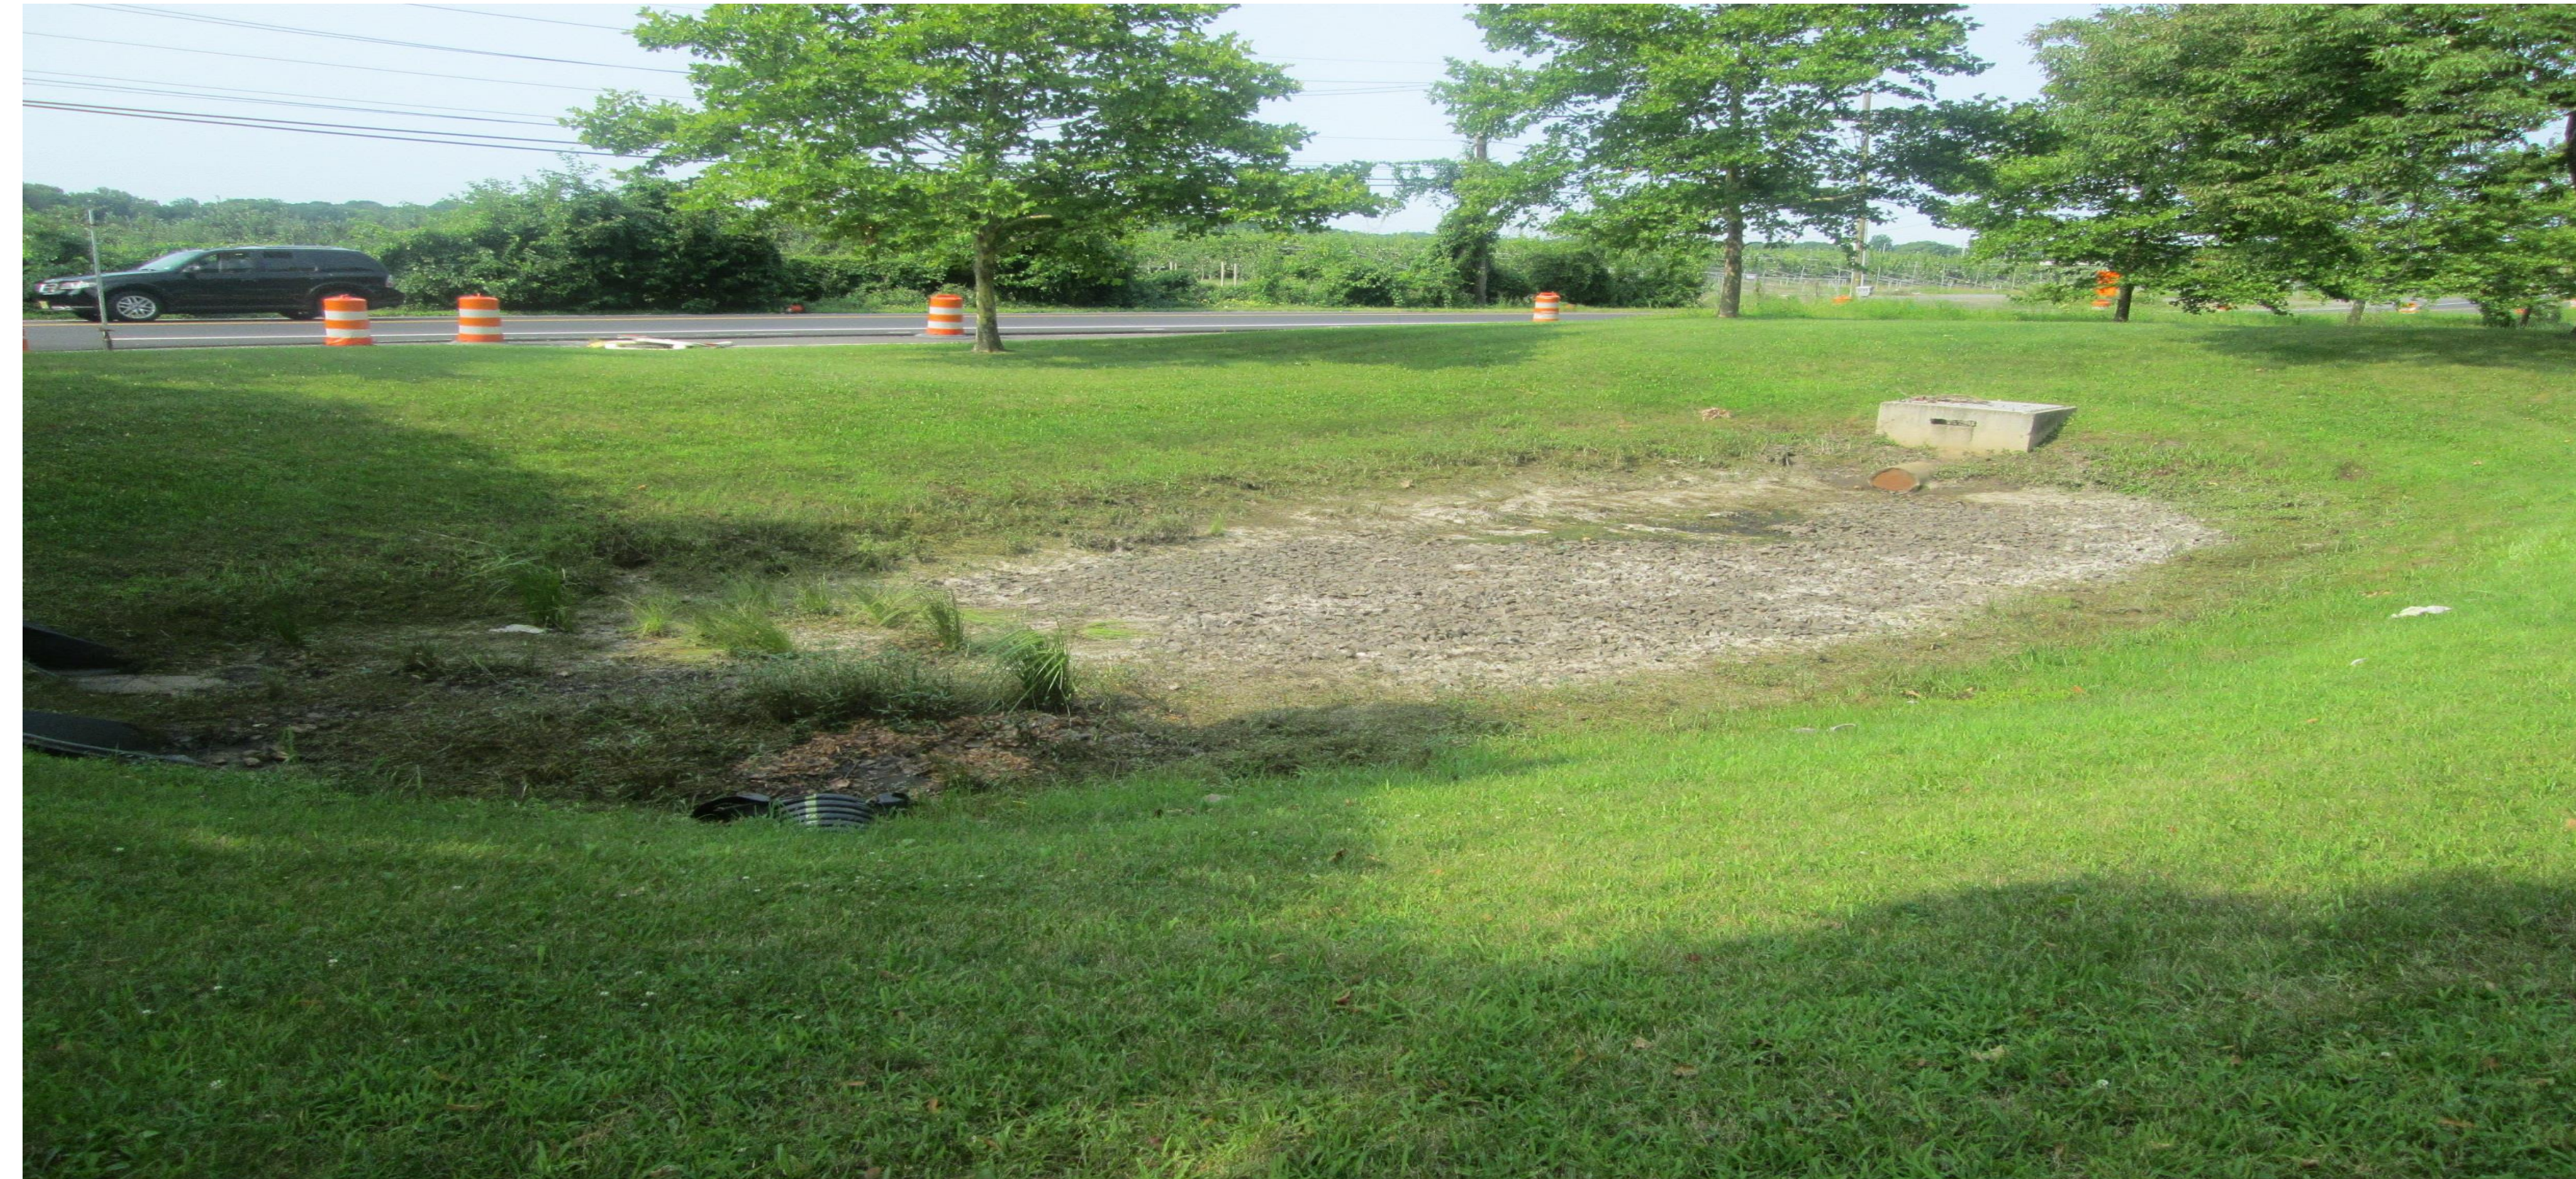
Overview of basin

- Looks like someone took the steps to retrofit this into an infiltration basin since the low flow outlet pipe is sealed
- Naturalized with herbaceous and woody vegetation recently compared to aerial
- Basin in good condition and naturalized, no recommendations

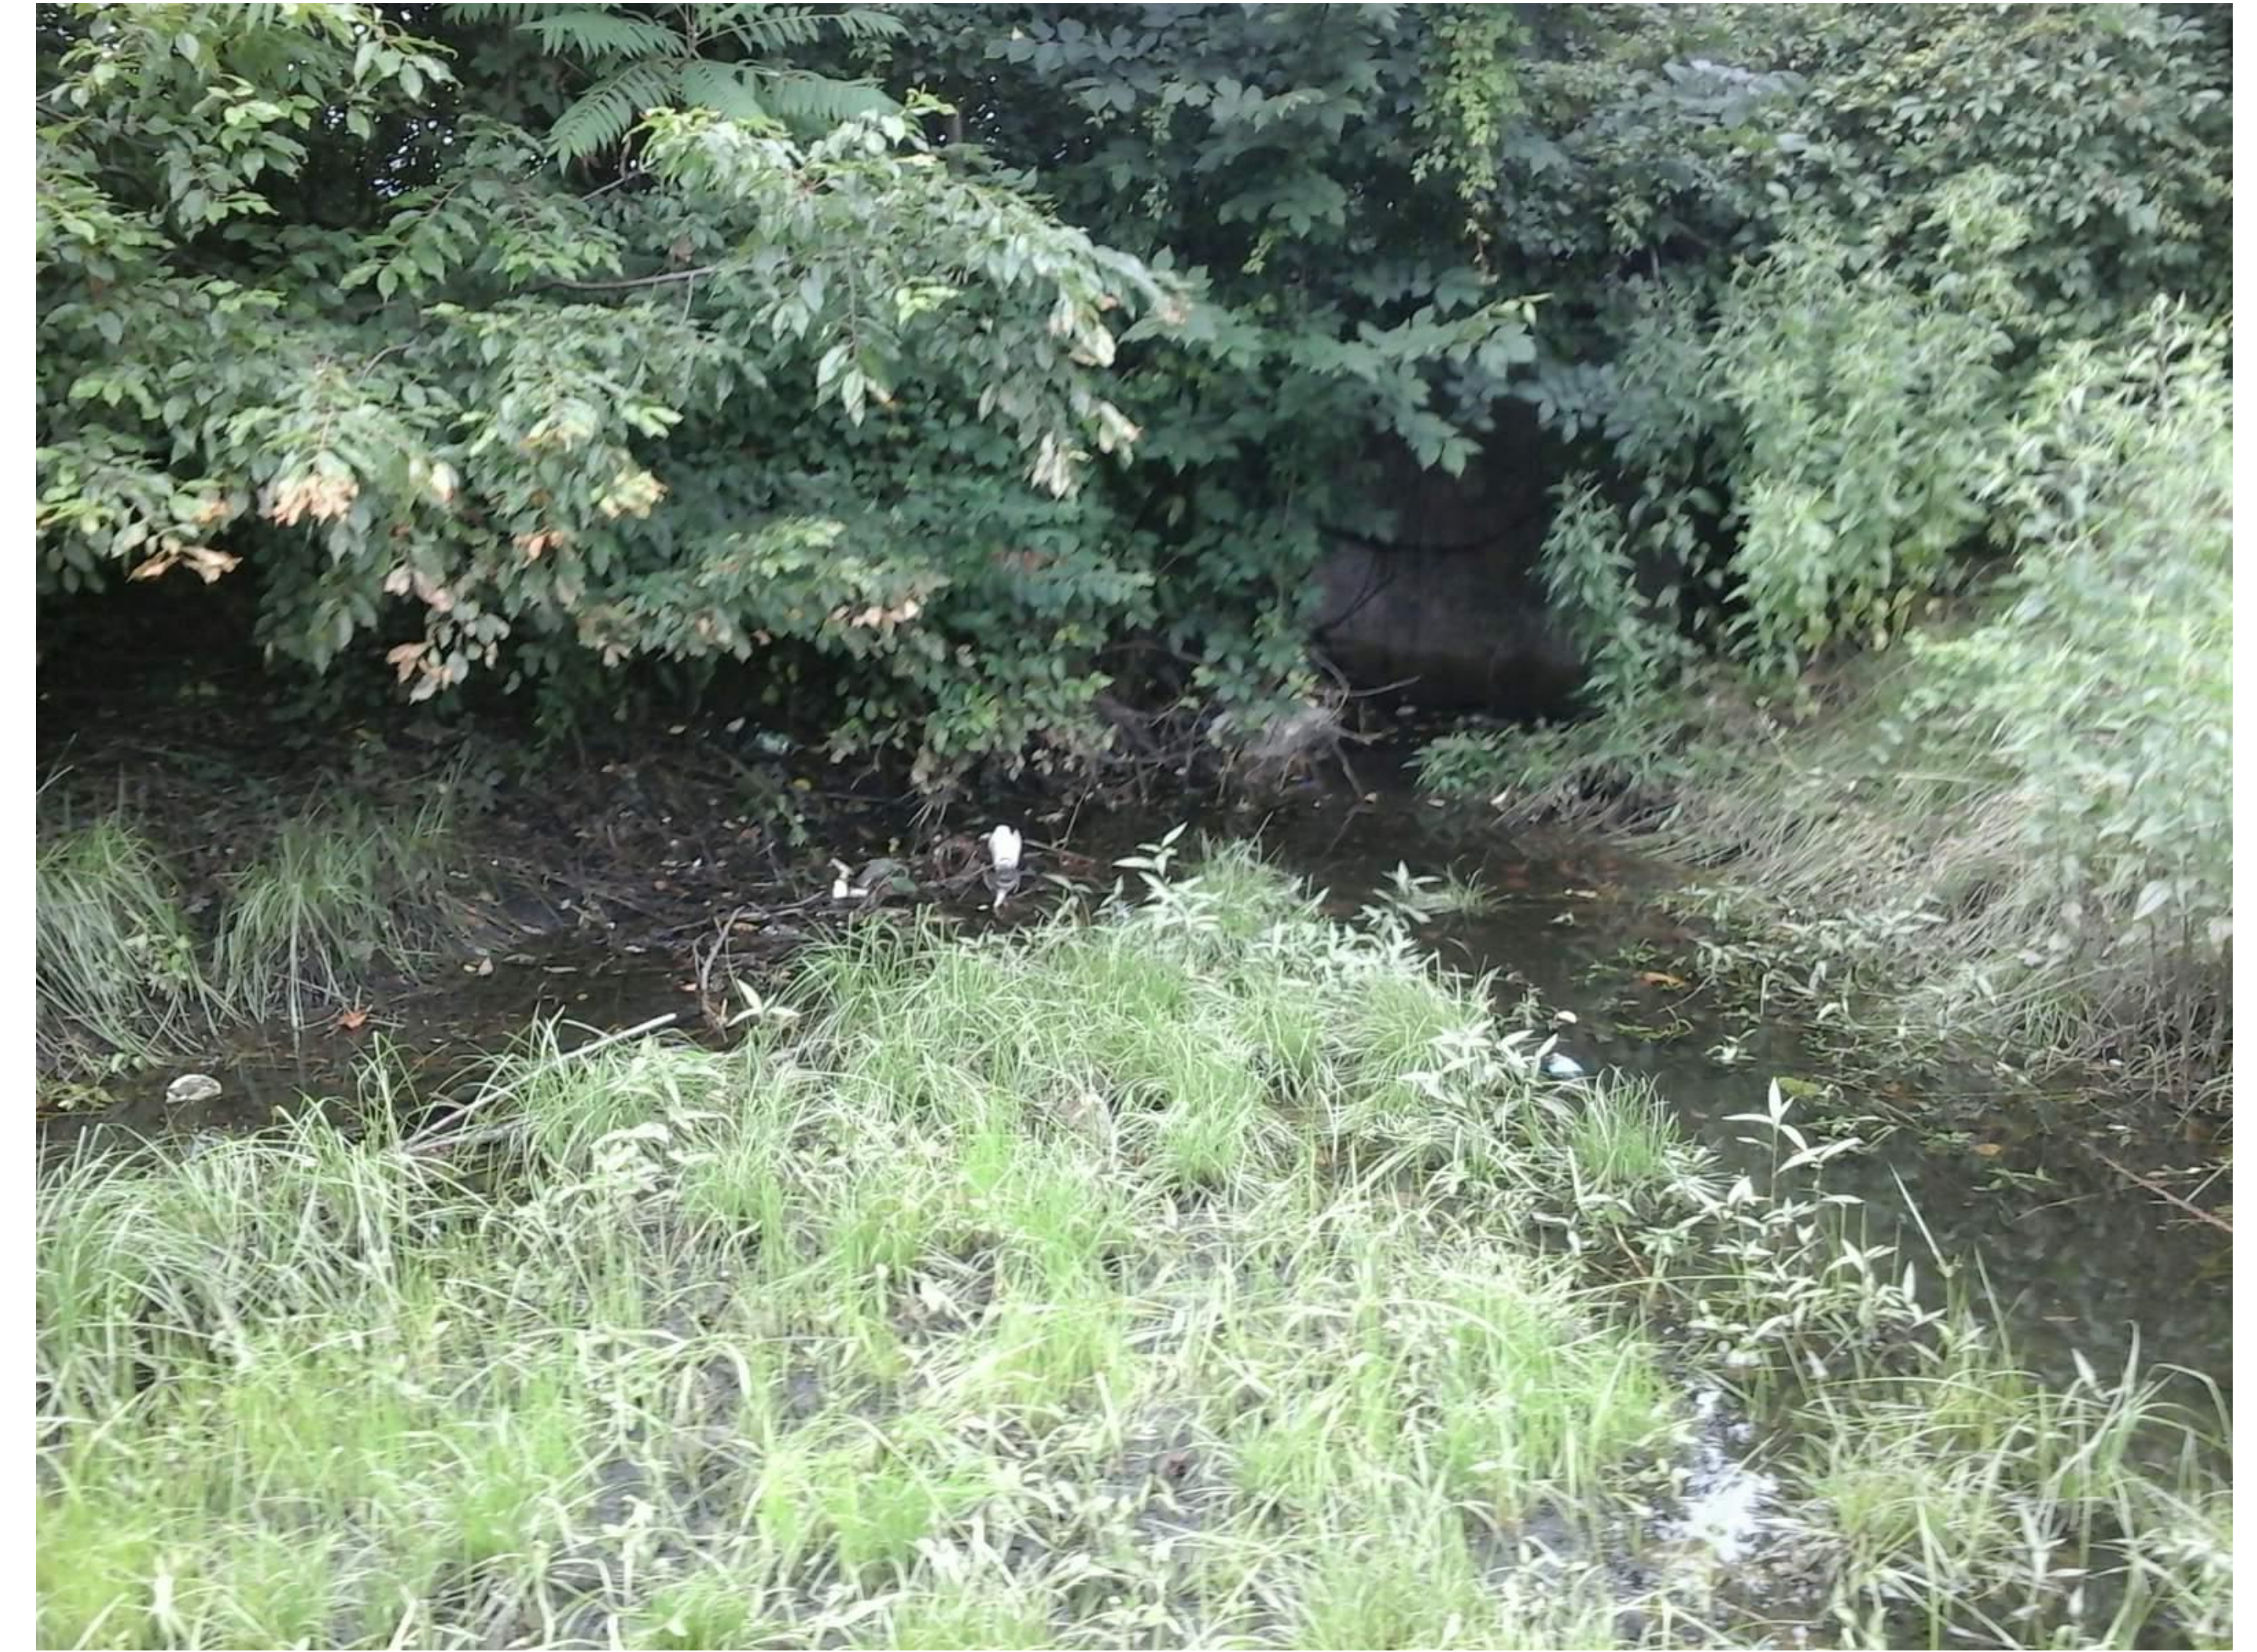
Outlet

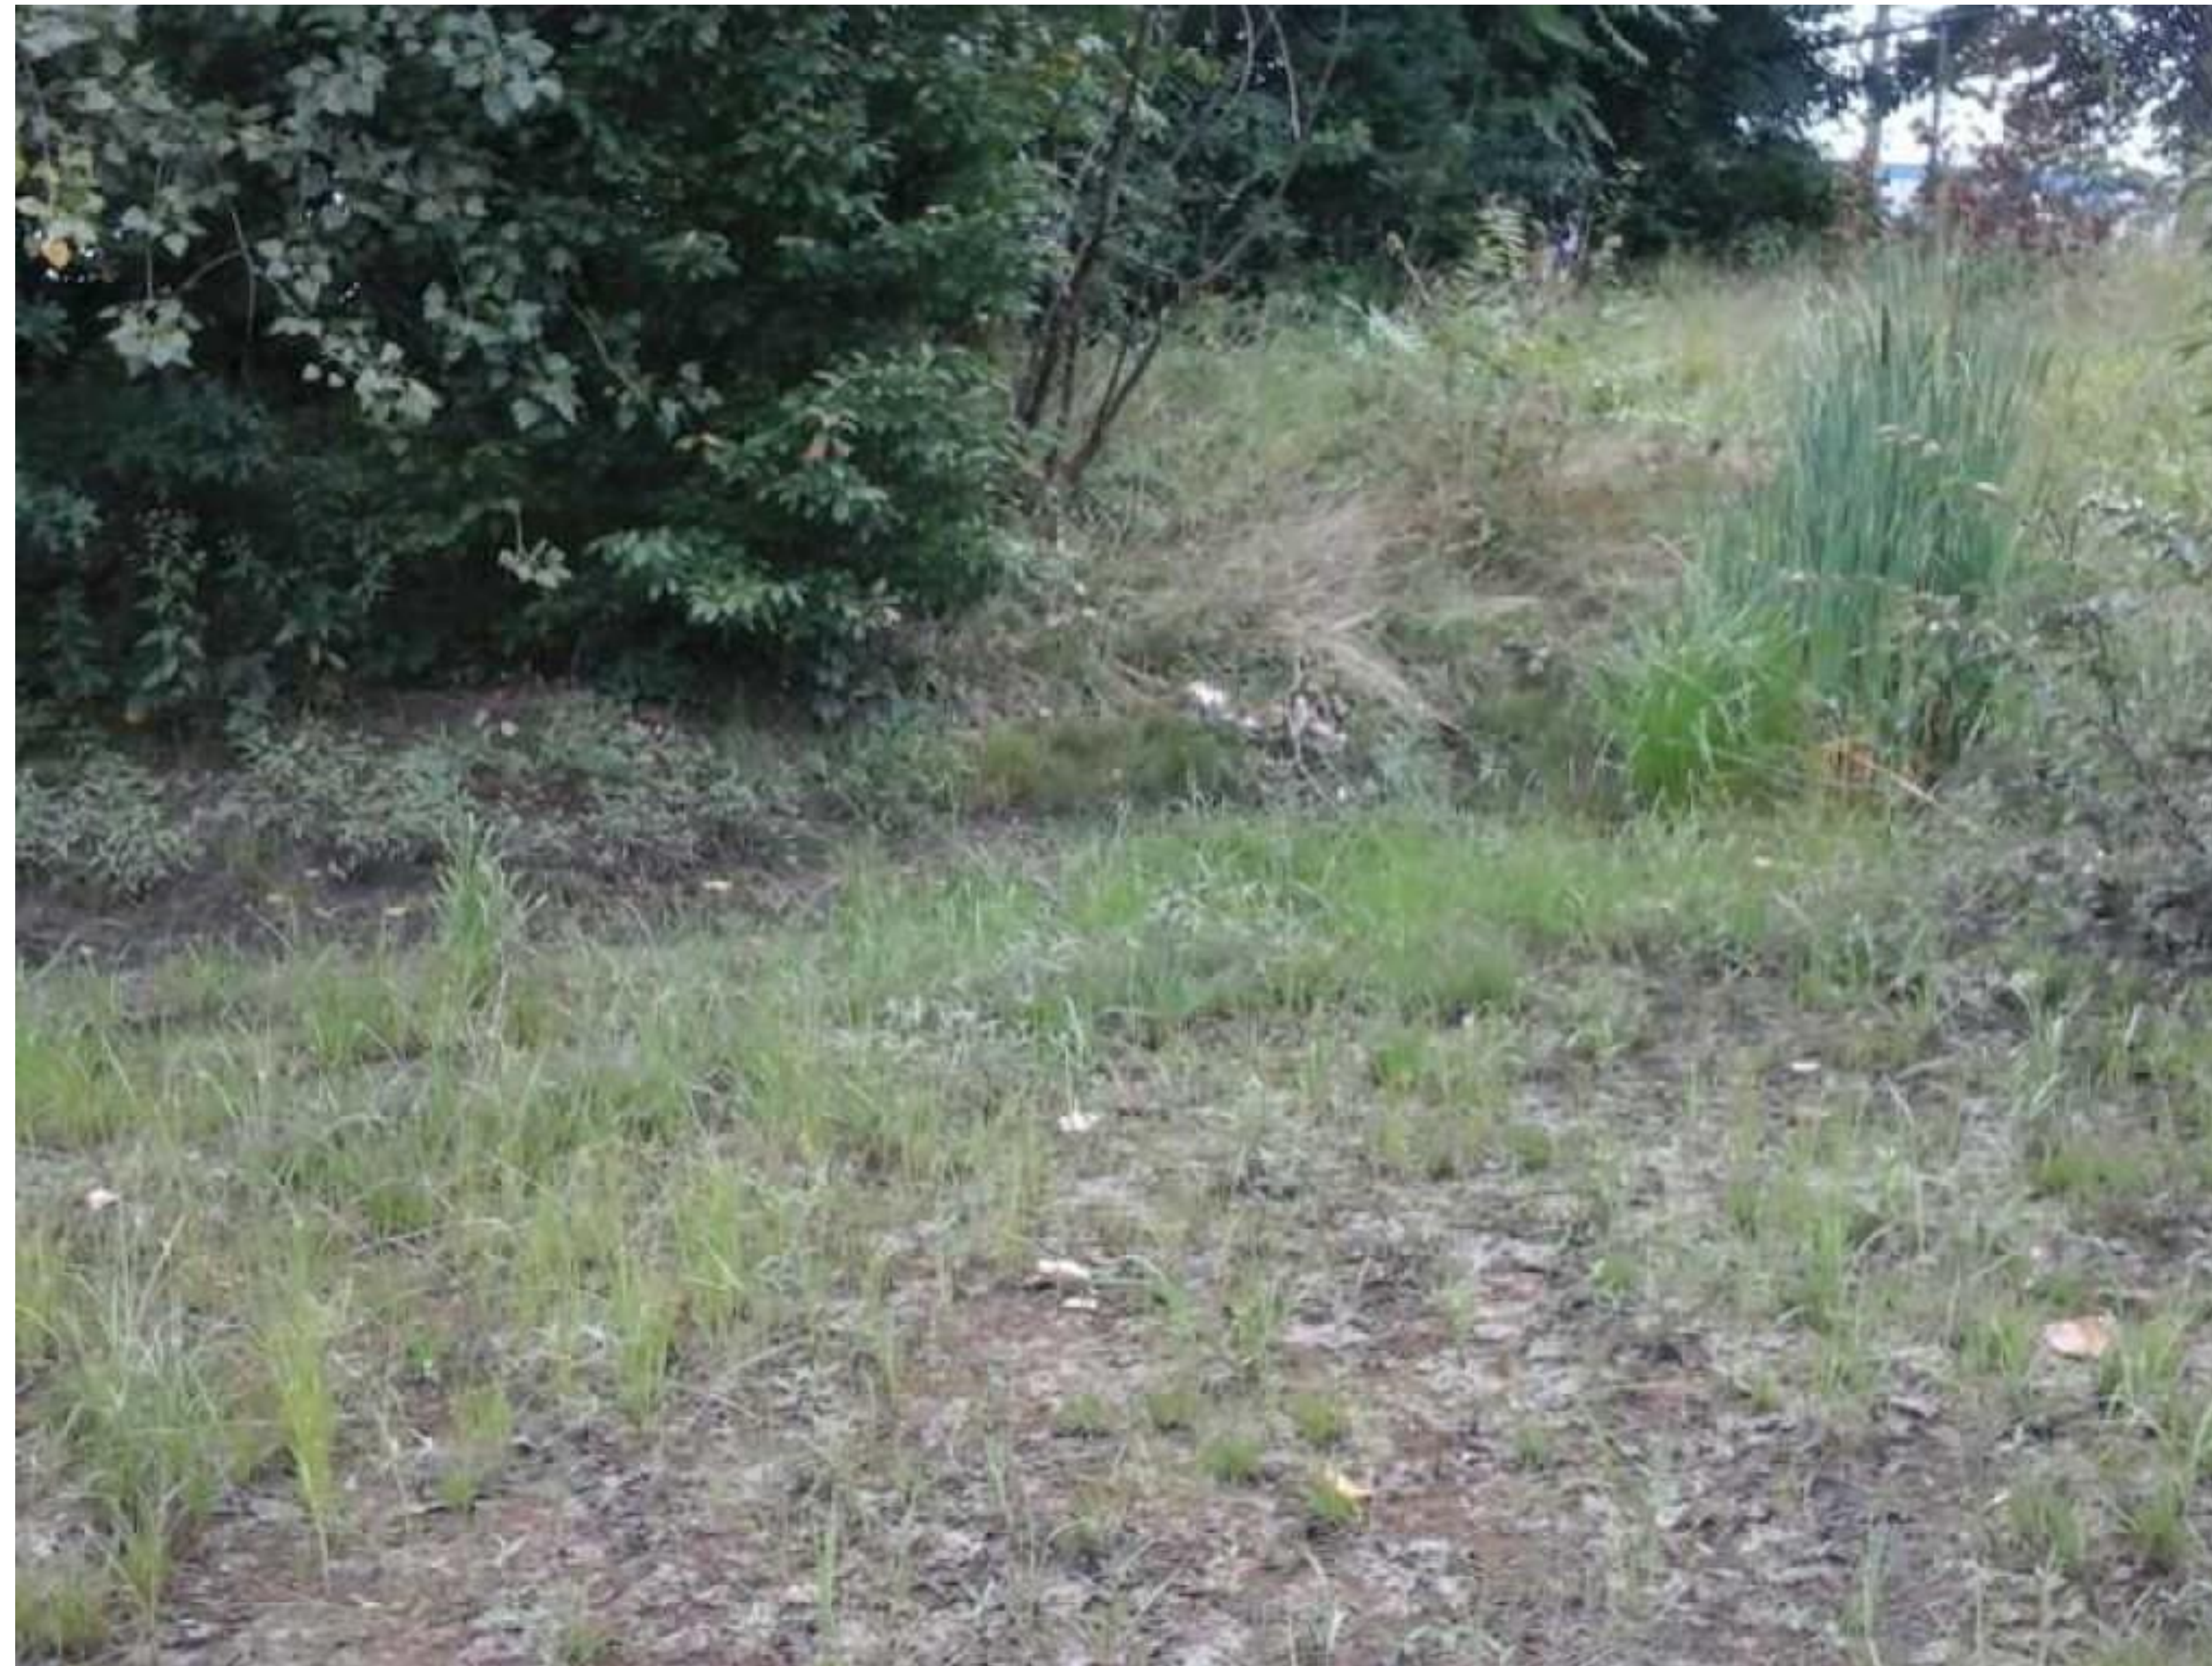
- Basin is not well maintained, lots of trash
- Make sure inlets and outlets are clear of vegetation
- Low flow channel has sediment accumulation and sign of standing water
- Replace low flow channel with stone channel to allow more infiltration

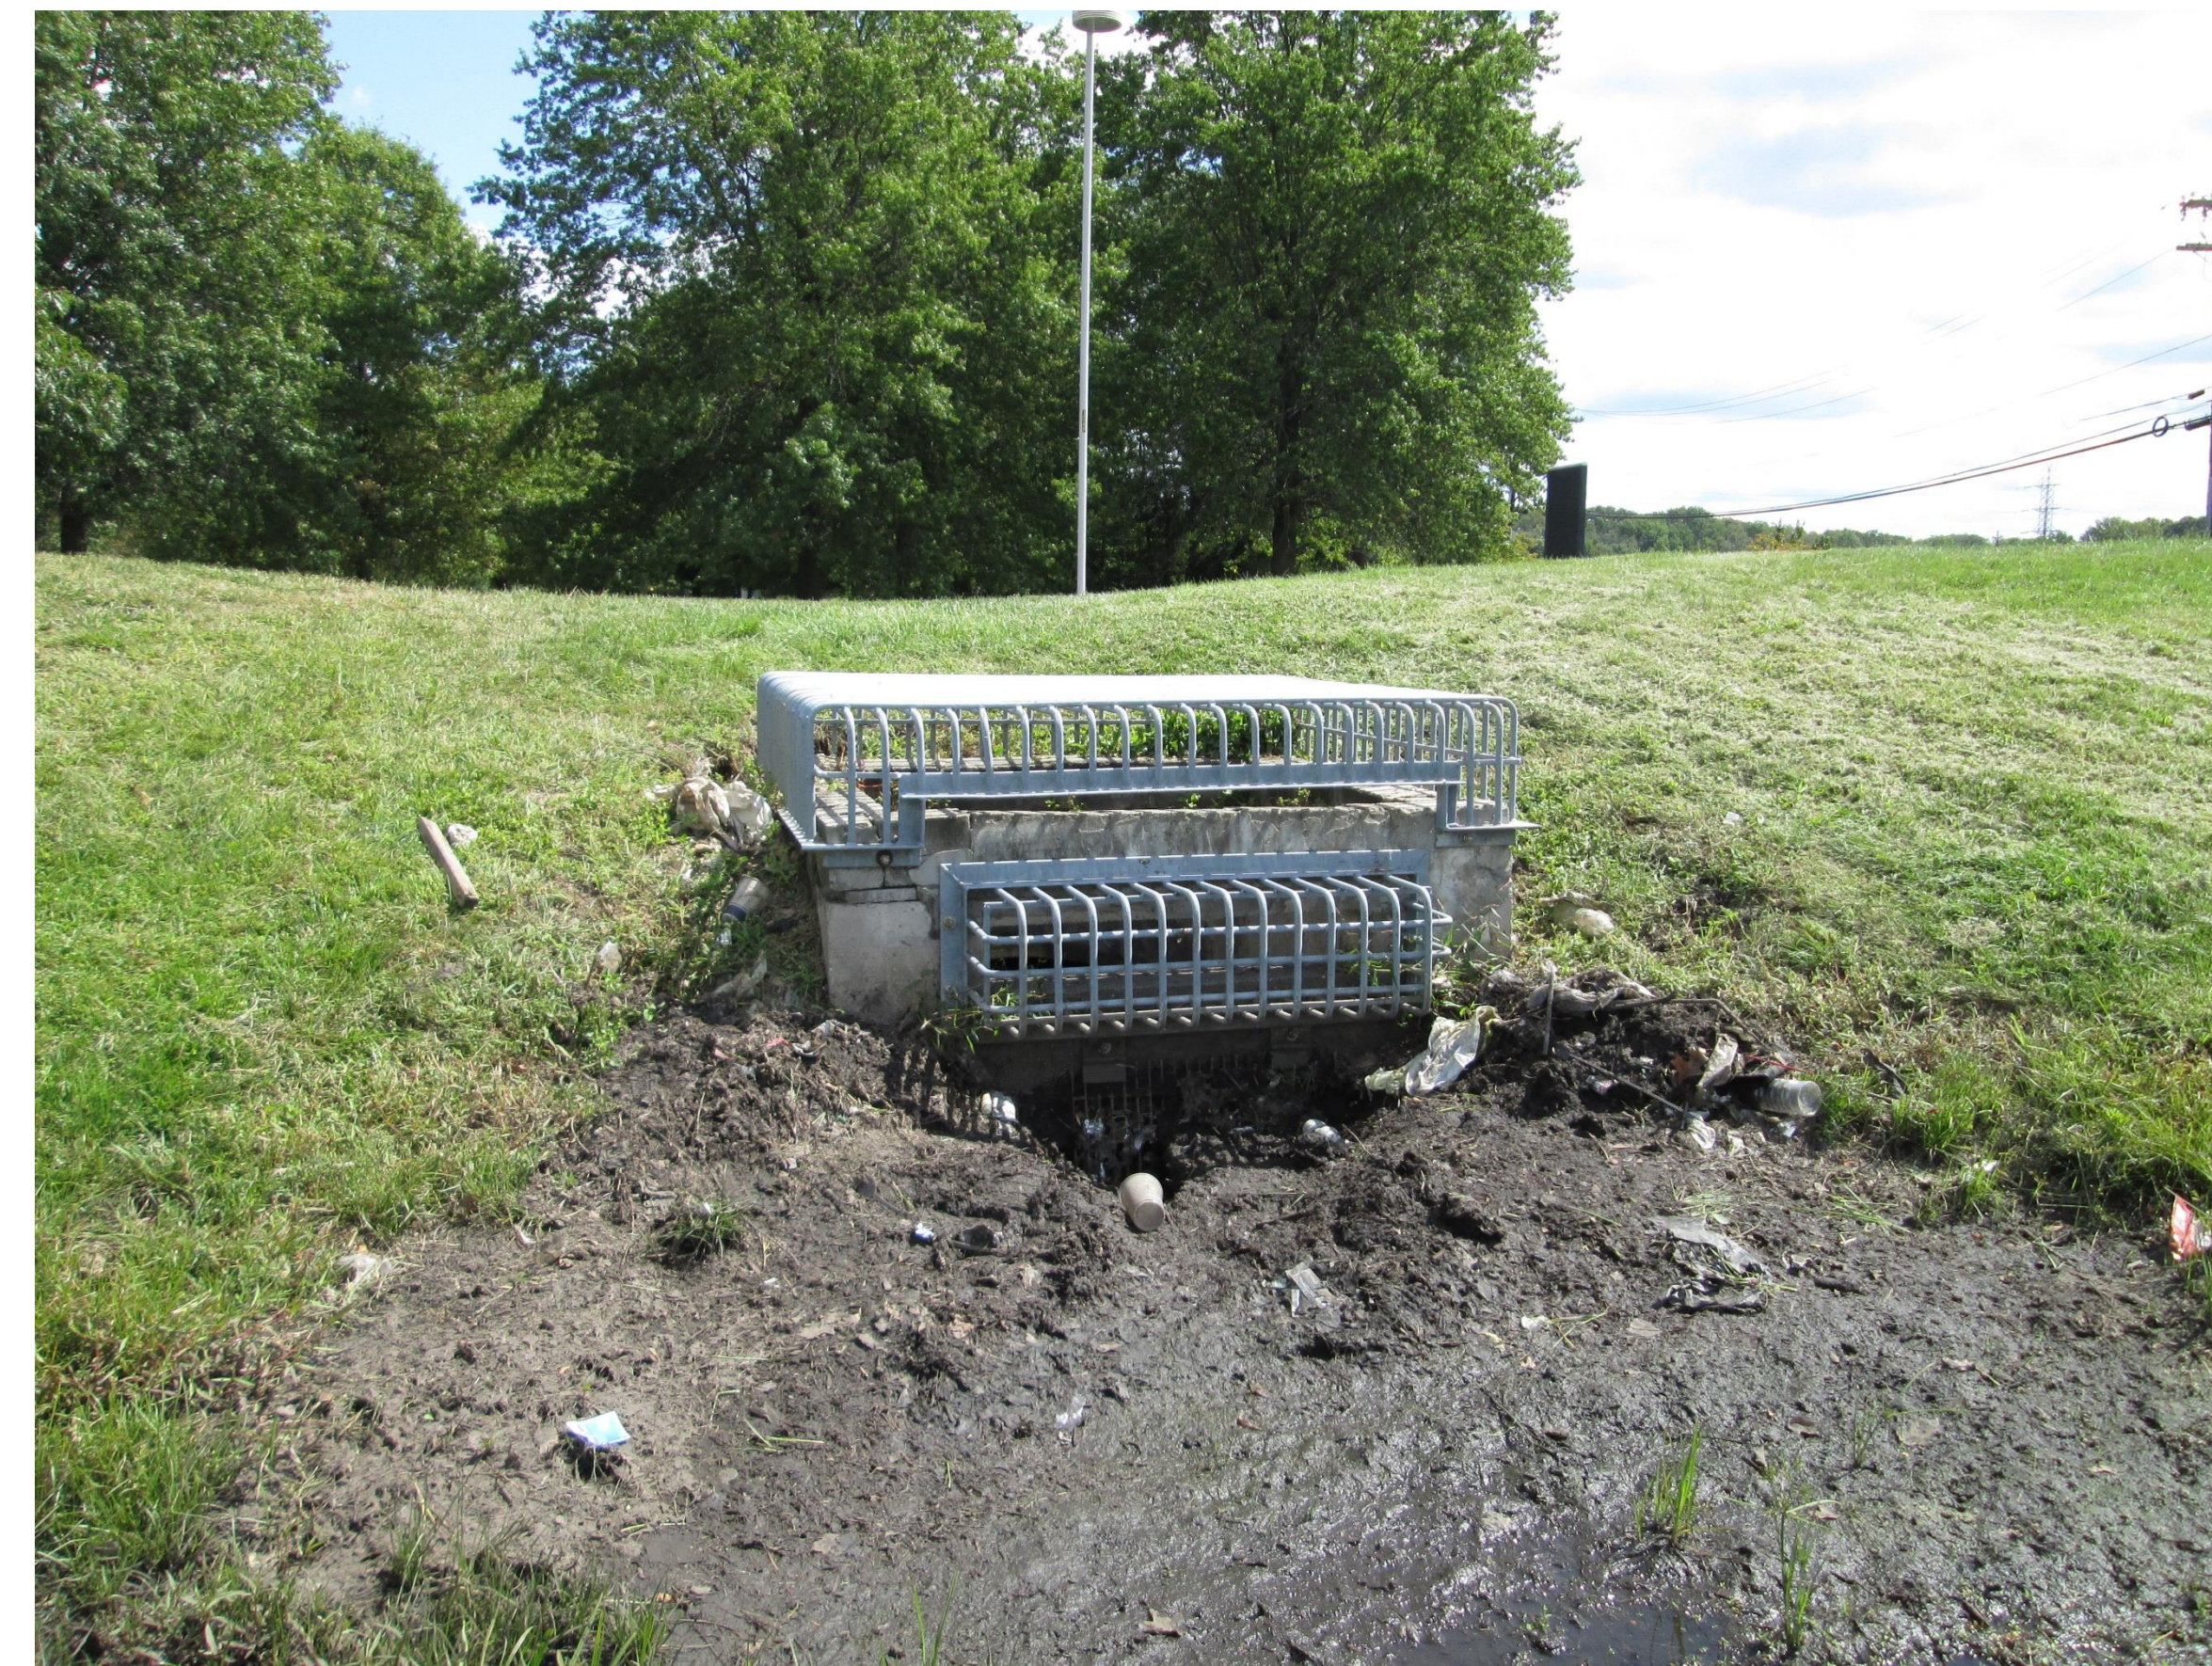
Outlet

- Sediment and litter inside and surrounding outlet
- Erosion of all inlet structures
- Retrofit low flow channels with stone channels and reduce mowing to allow for better infiltration
