**Hamilton Township (Mercer County)
Stormwater Basin Assessment Summary
Past Priority Addendum (Year 5B)**

Developed by the Rutgers Cooperative Extension Water Resources Program
Funded by Hamilton Township, Mercer County, New Jersey

November 27, 2019

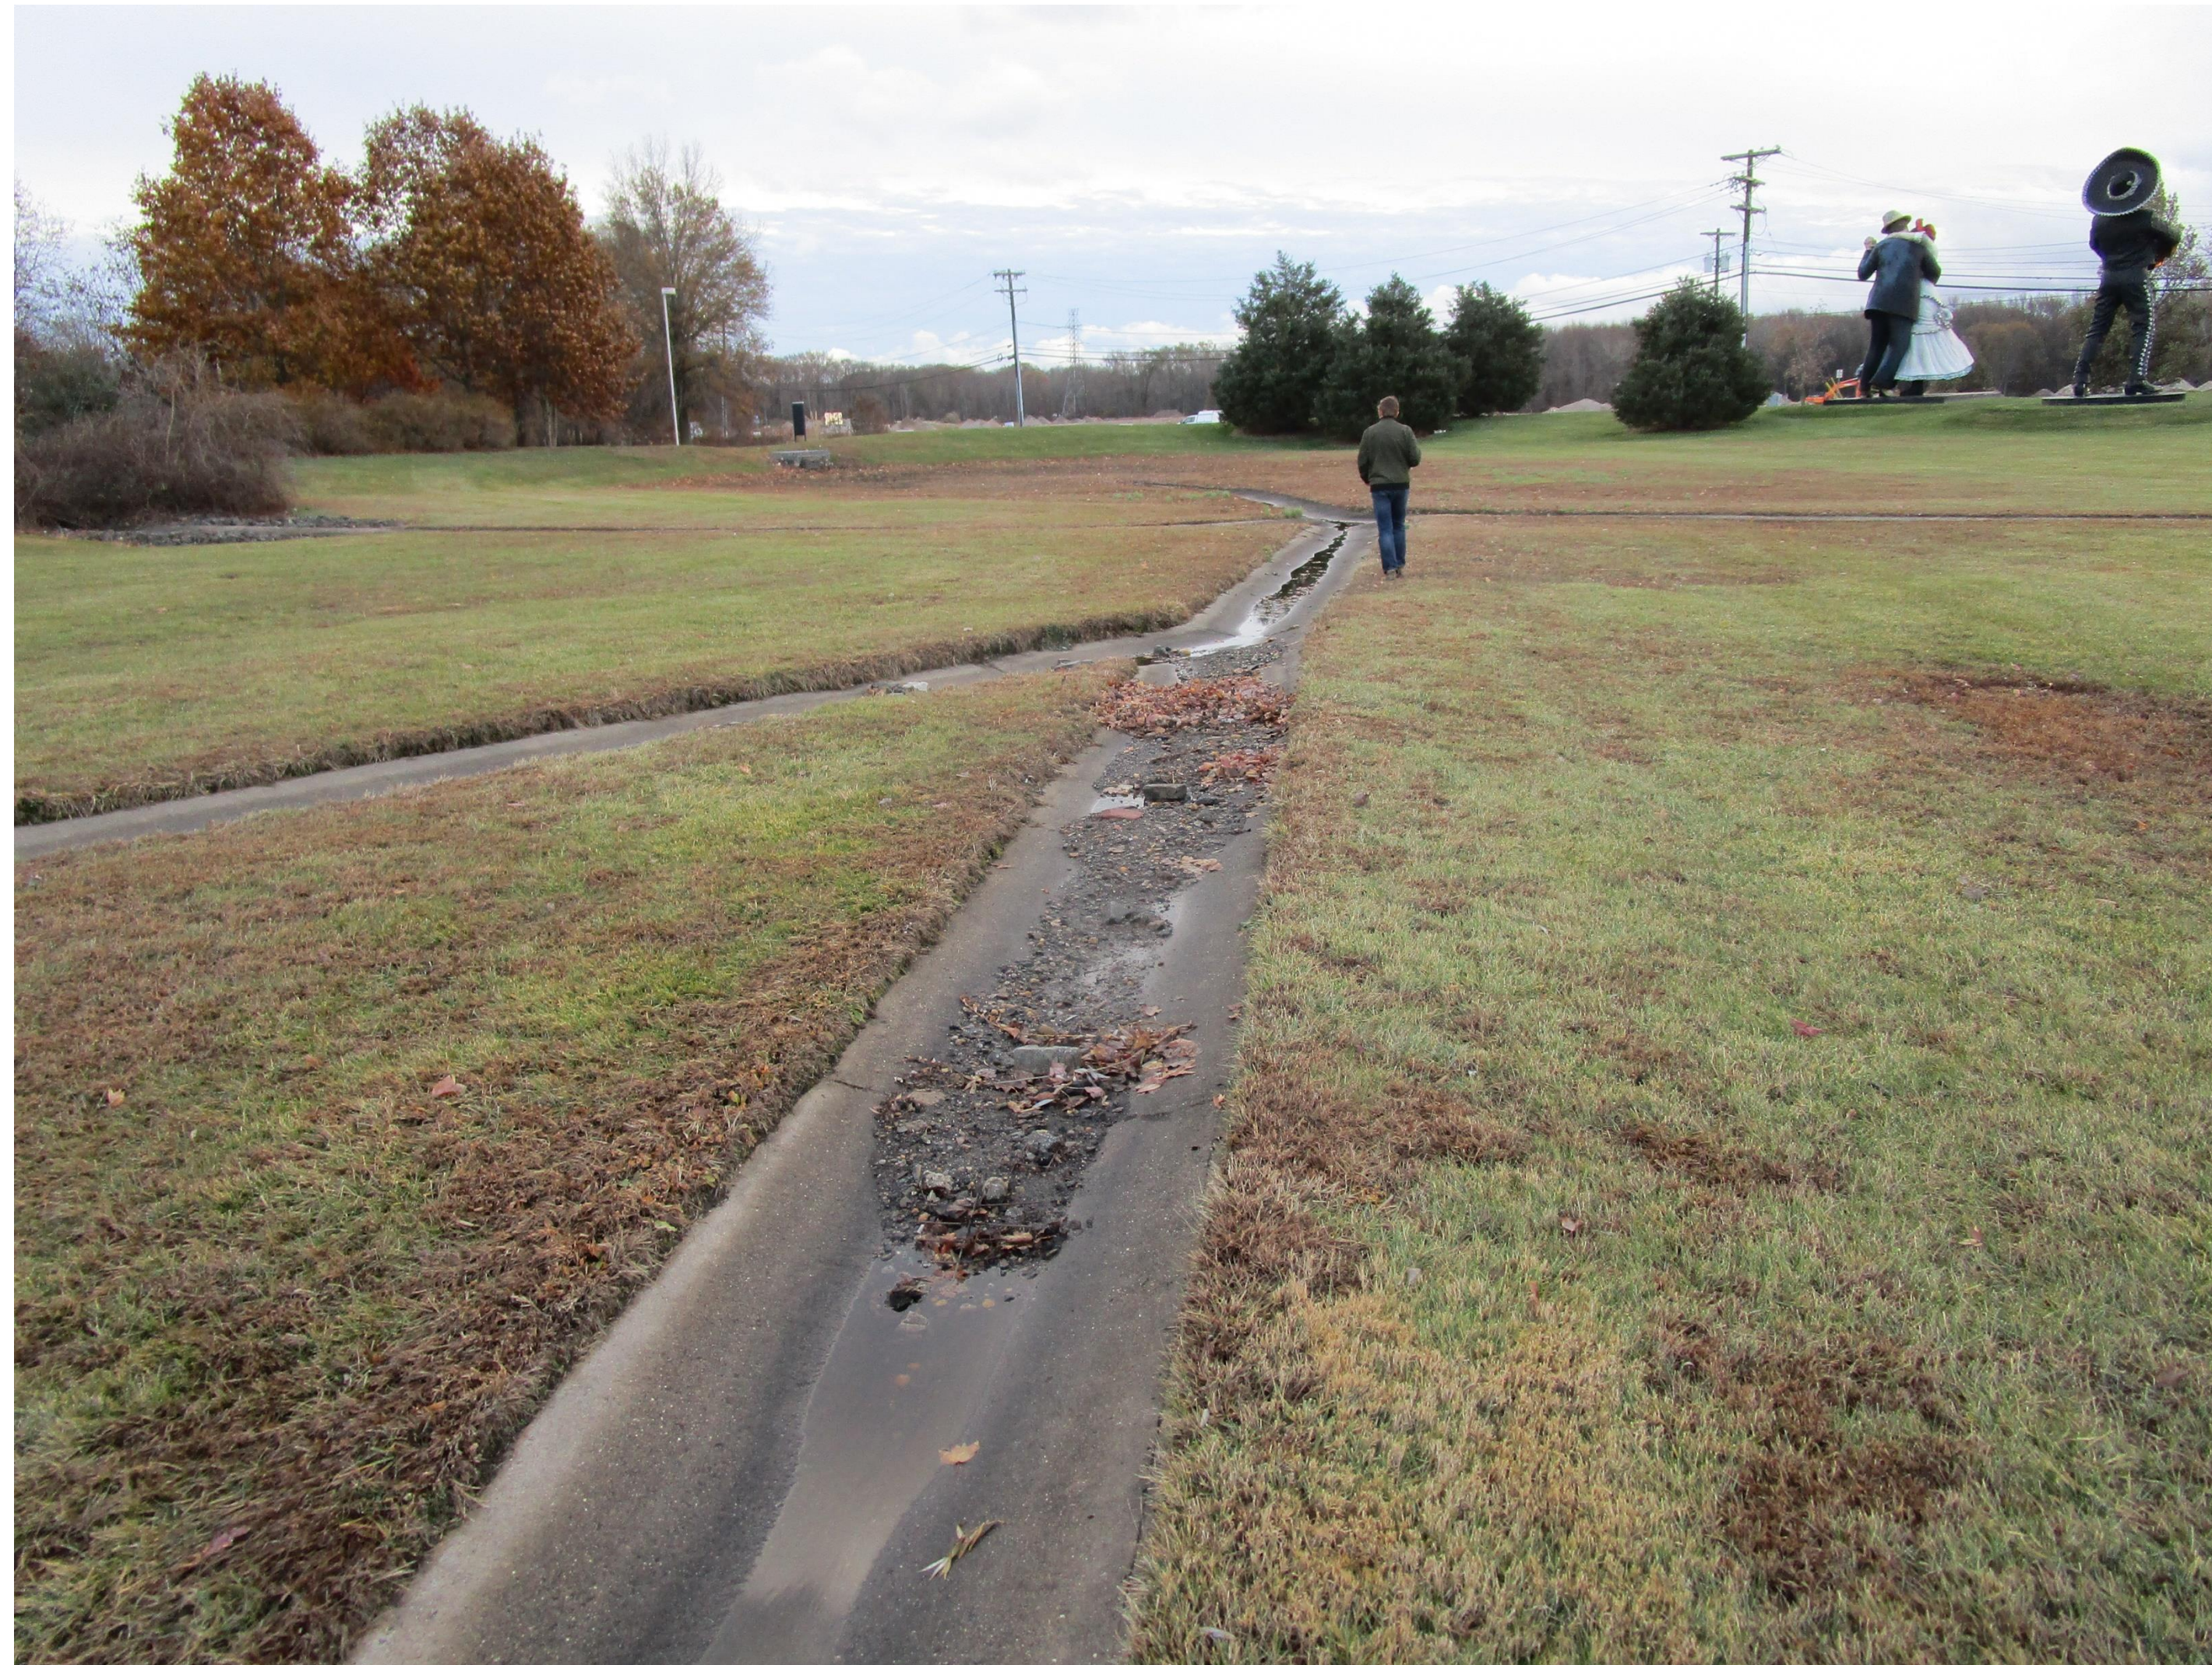
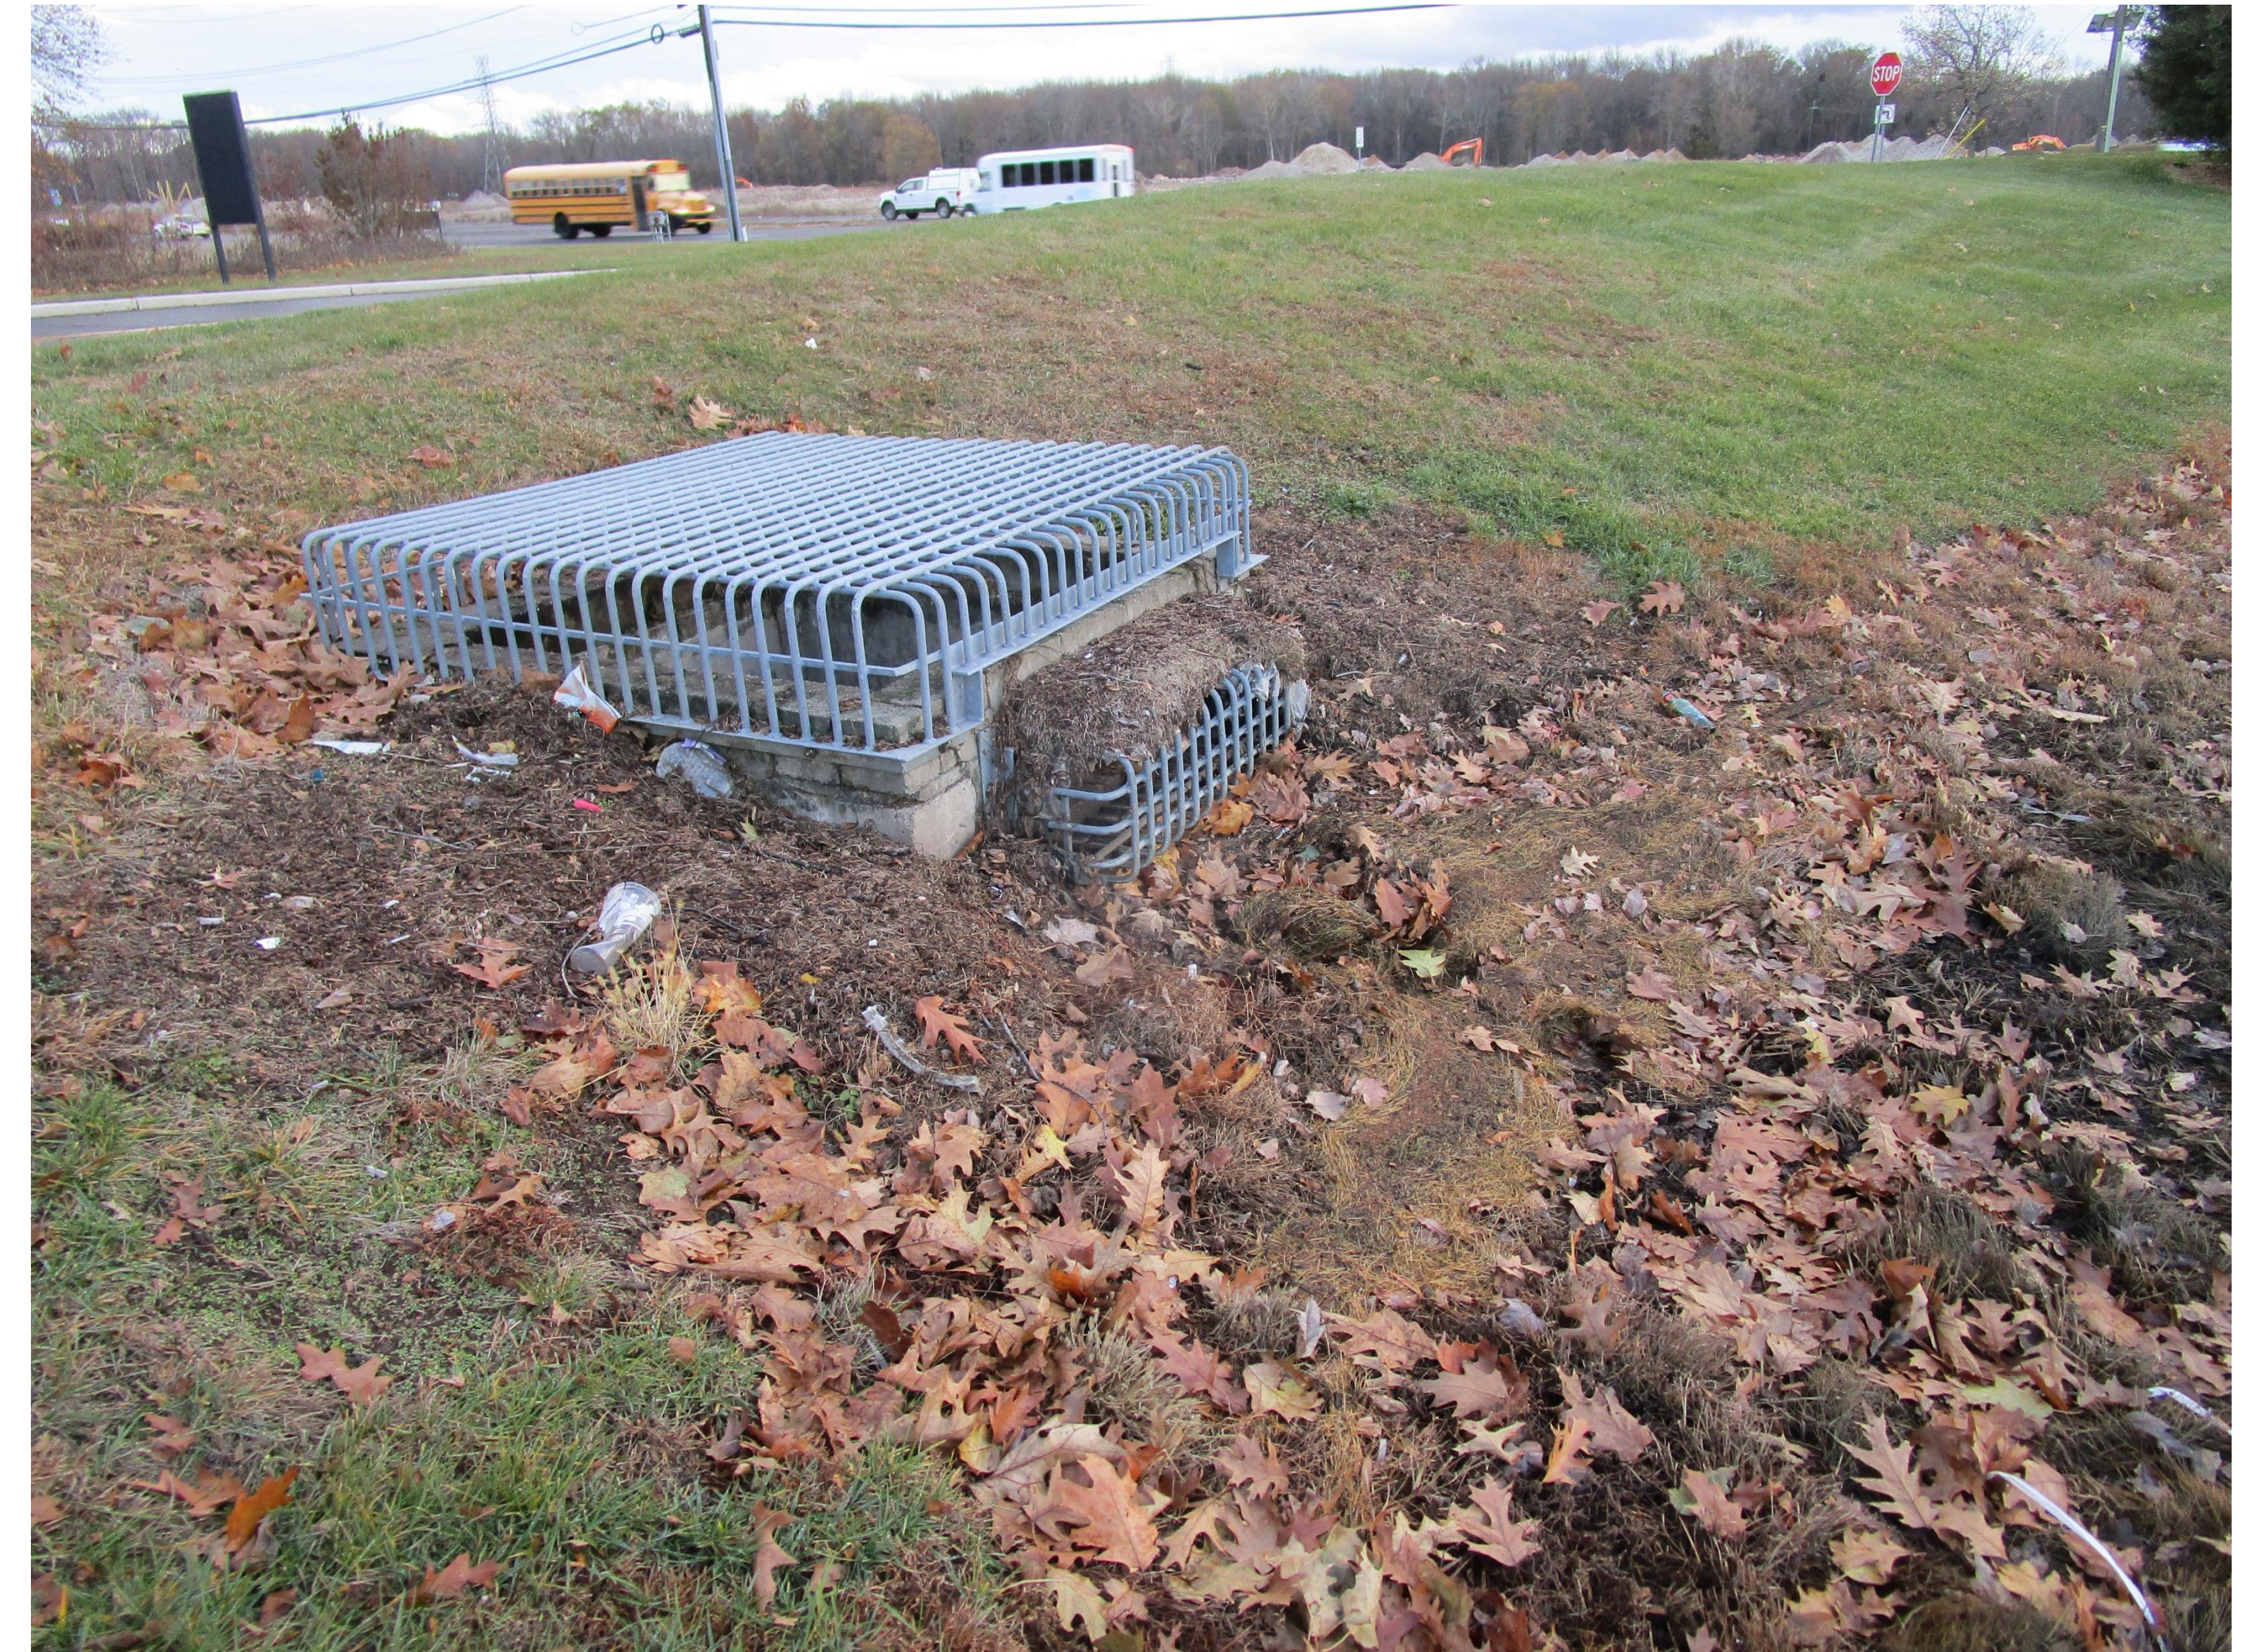
Hamilton Township
Stormwater Basin Assessment
320. Hamilton Train Station Basin

- Basin inlets have significant erosion to concrete structure as seen in previous assessment
- Outlet severely clogged with grass and sediment
- Low end of basin appears to have significant sediment accumulation
- Maintenance and repair suggested to address issues
- Potential retrofit by removing low flow channels with stone channels to promote infiltration

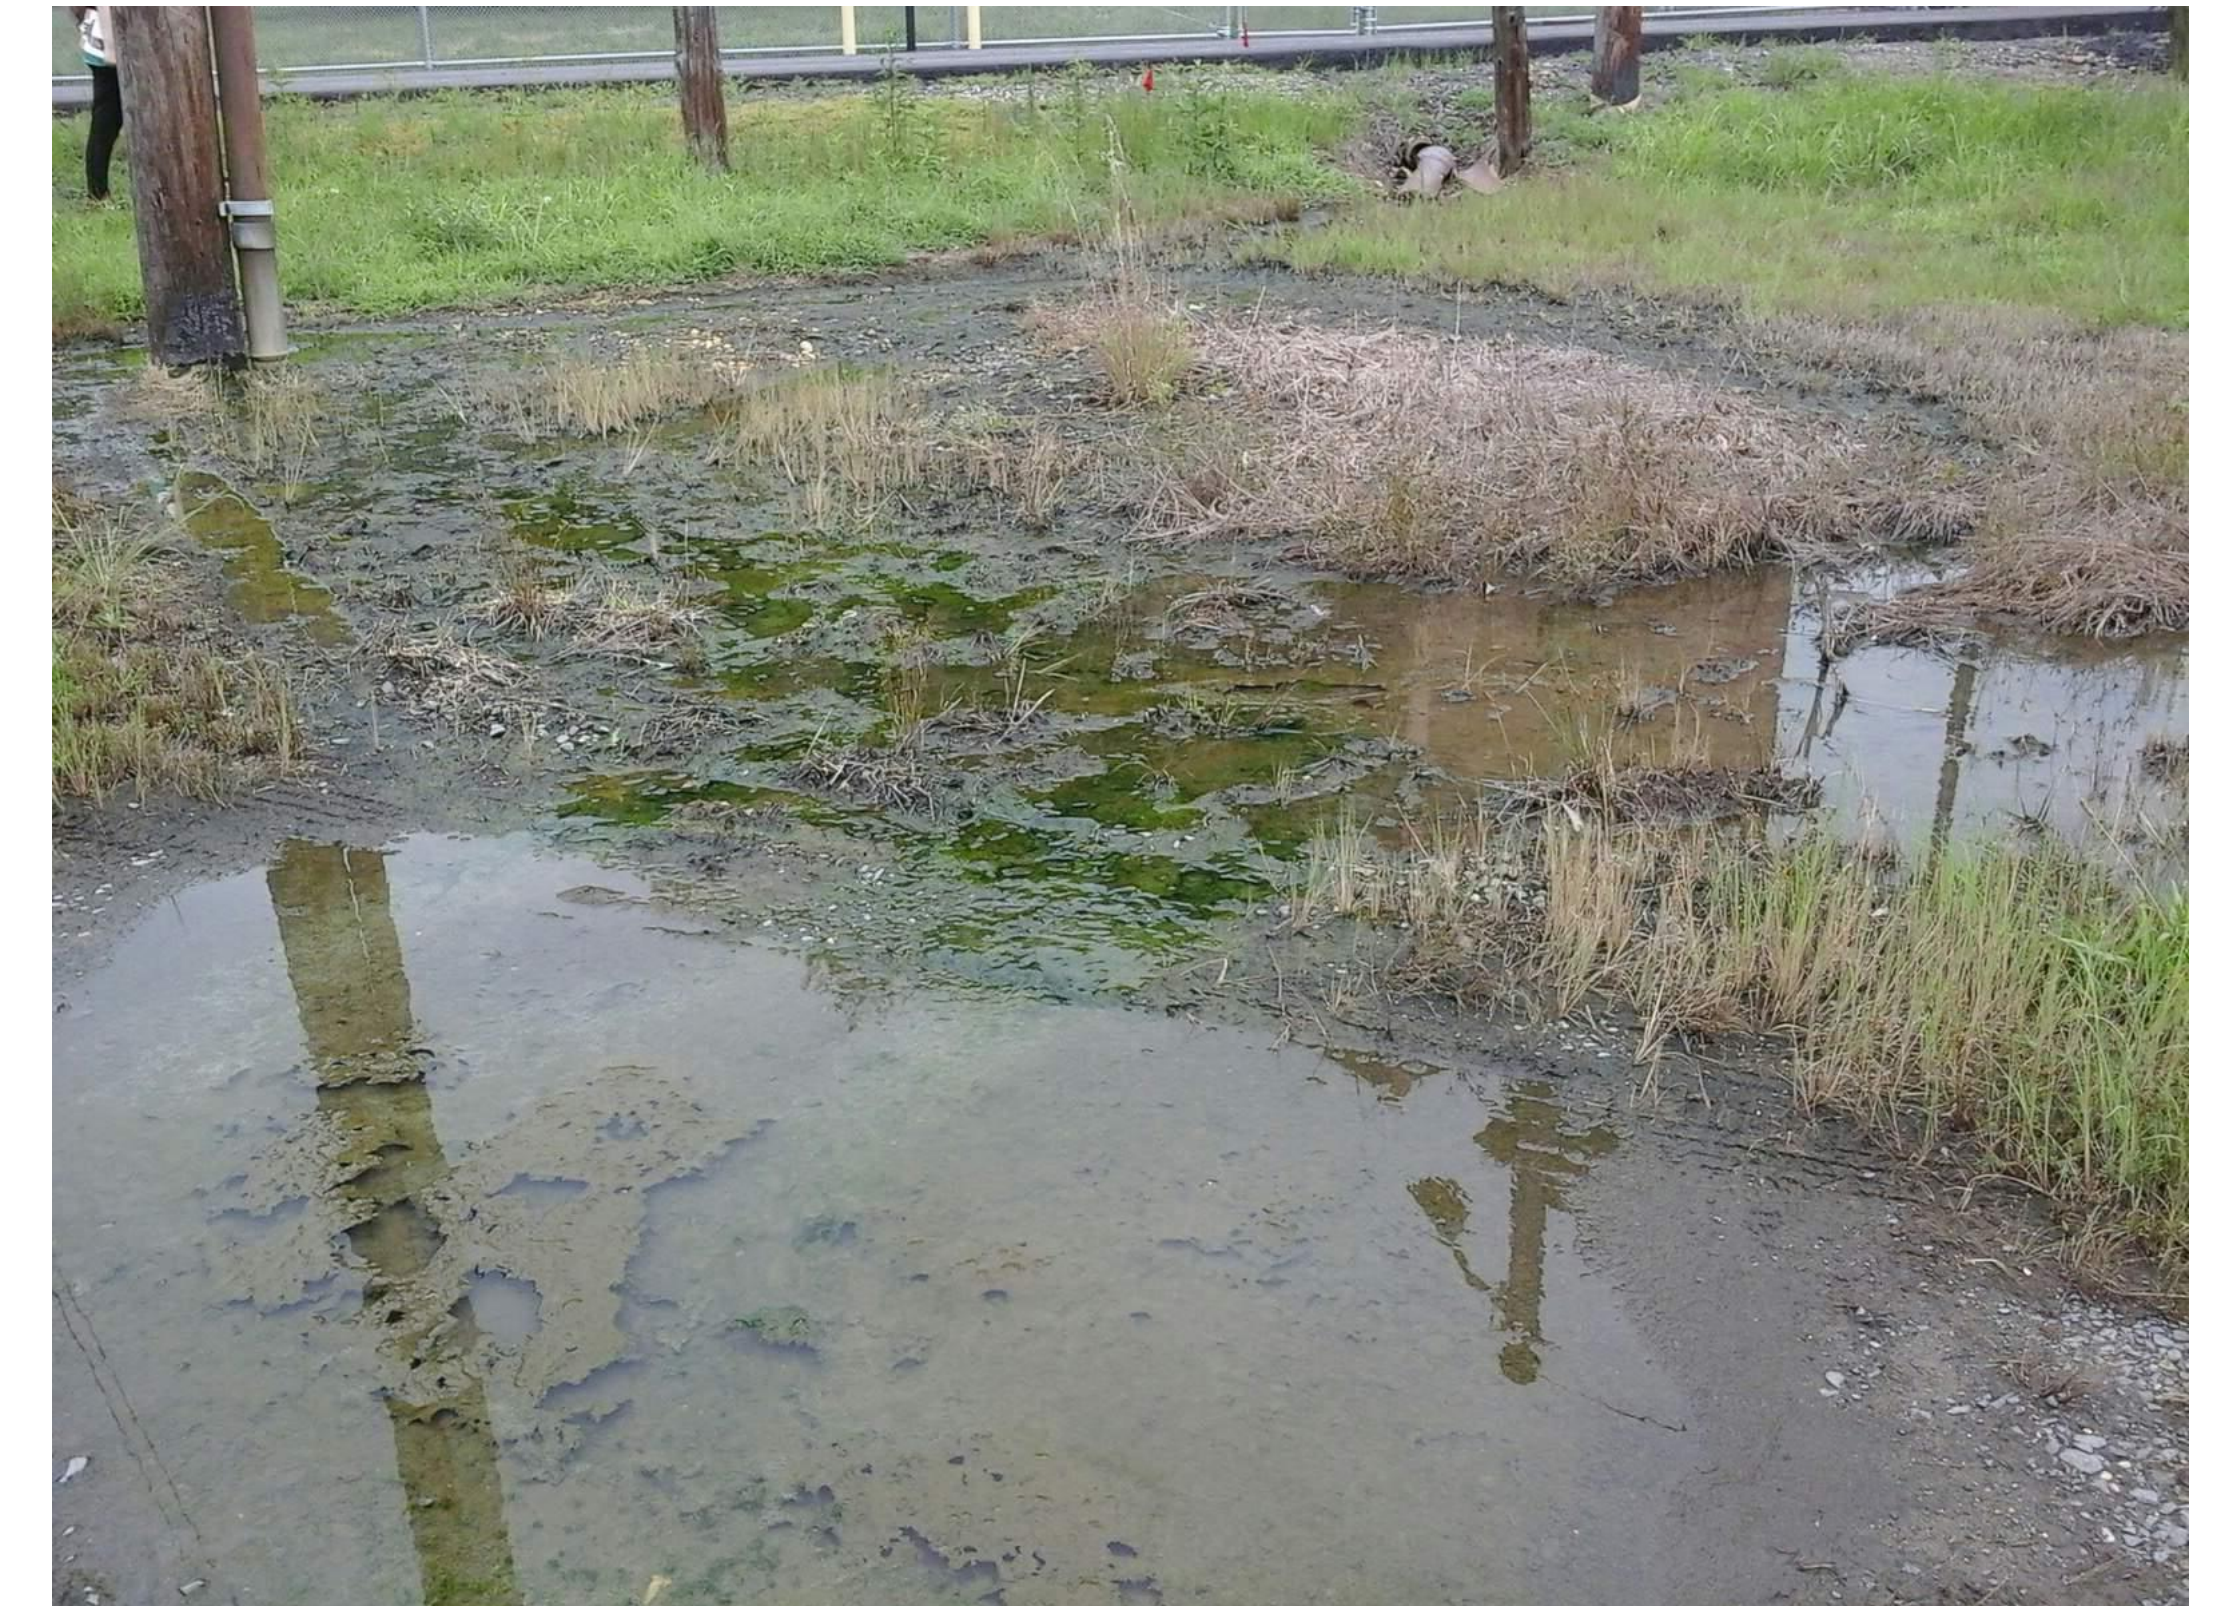
Standing water

- Standing water present
- Basin near environmental clean up site
- Amend soil to improve infiltration and reduce standing water
- Plant with woody vegetation to improve infiltration
