## Hamilton Township (Mercer County)

# REVIEW AND EVALUATION OF TOTAL MAXIMUM DAILY LOADS (TMDLs)

Developed by the Rutgers Cooperative Extension Water Resources Program  
Funded by Hamilton Township, Mercer County, New Jersey

December 5, 2019

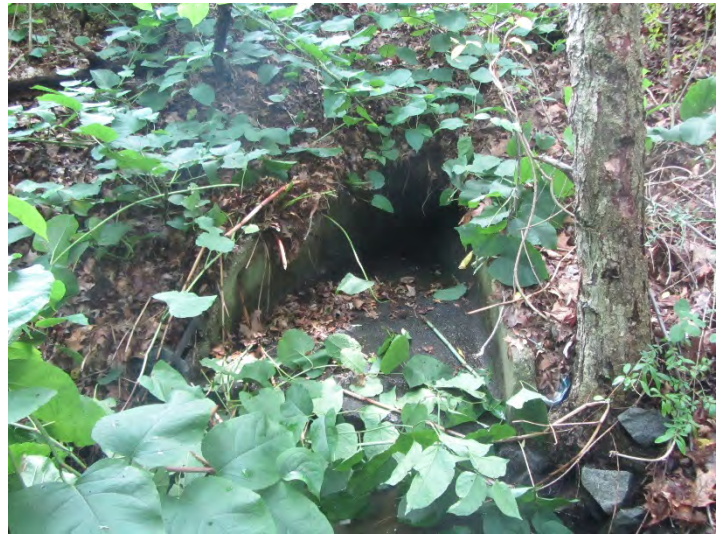
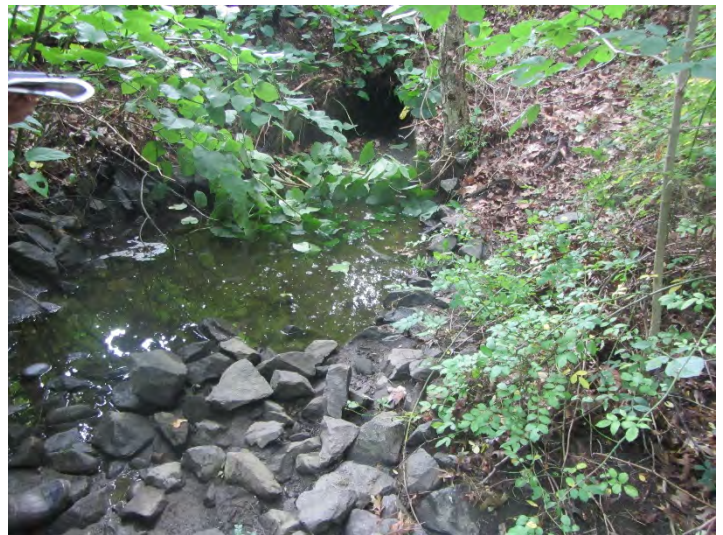
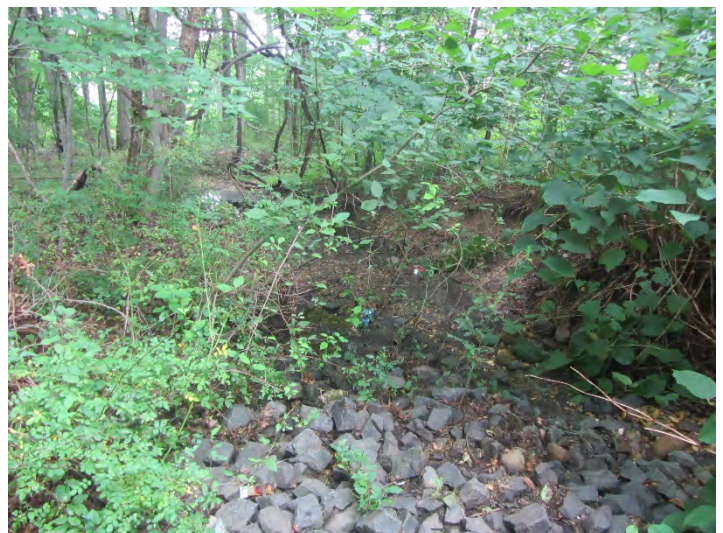
- 24" diameter concrete pipe
- Known commercial discharges
- Cloudy, brown water
- Sediment deposits
- Moderate erosion has been caused by the outfall

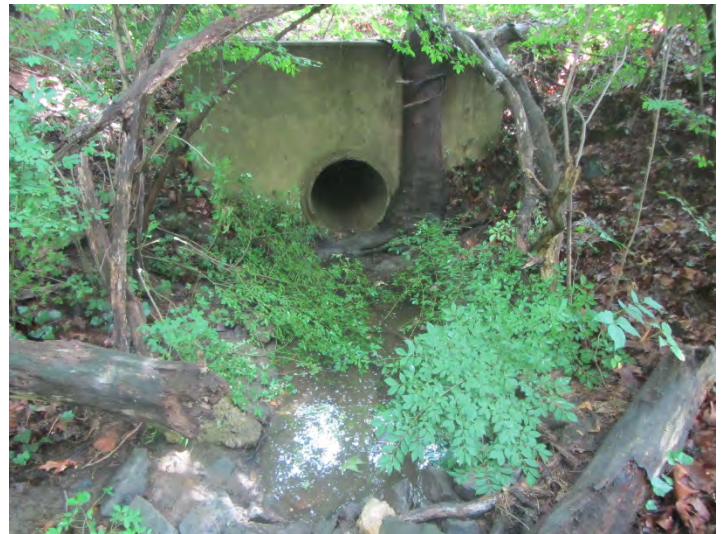
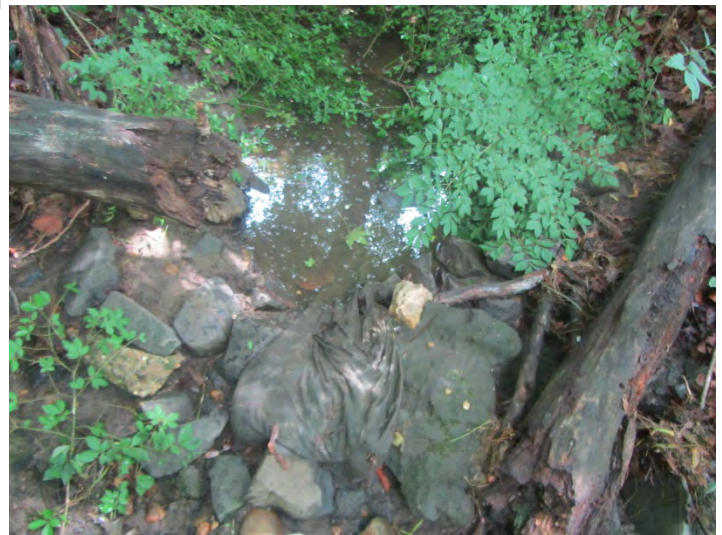
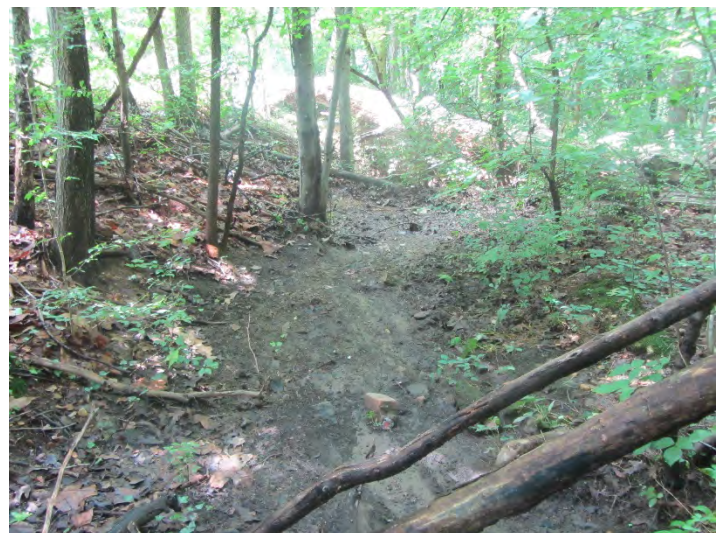
- 21" diameter concrete pipe
- Cloudy, grey water
- Sediment deposits
- Erosion has undermined outfall stability
- Moderate erosion has been caused by the outfall

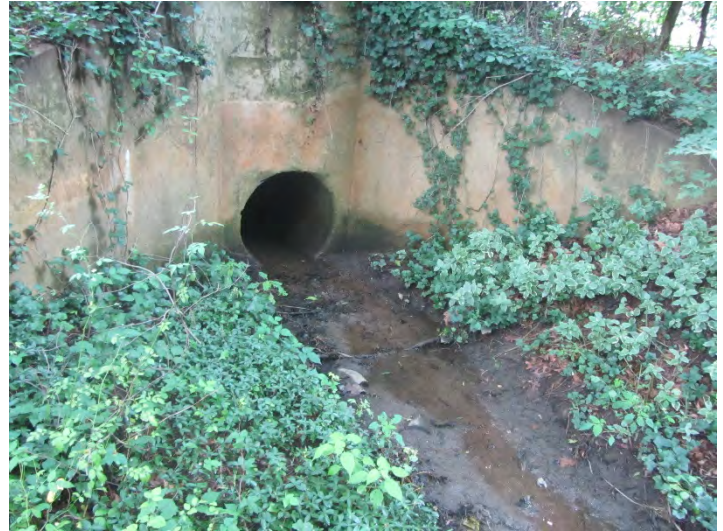
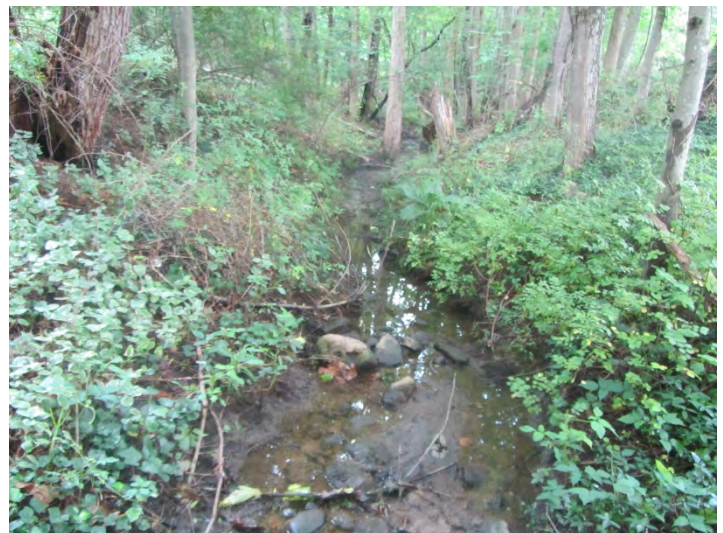
- 36" diameter concrete pipe
- Cloudy, brown water
- Sediment deposits
- Minor erosion has been caused by the outfall

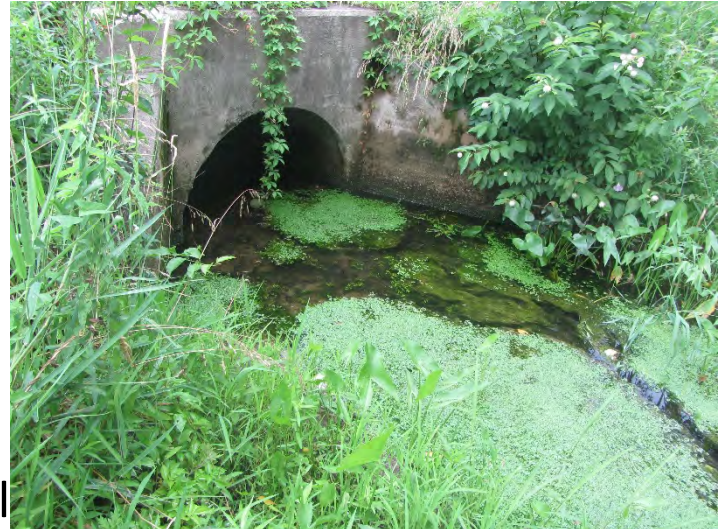
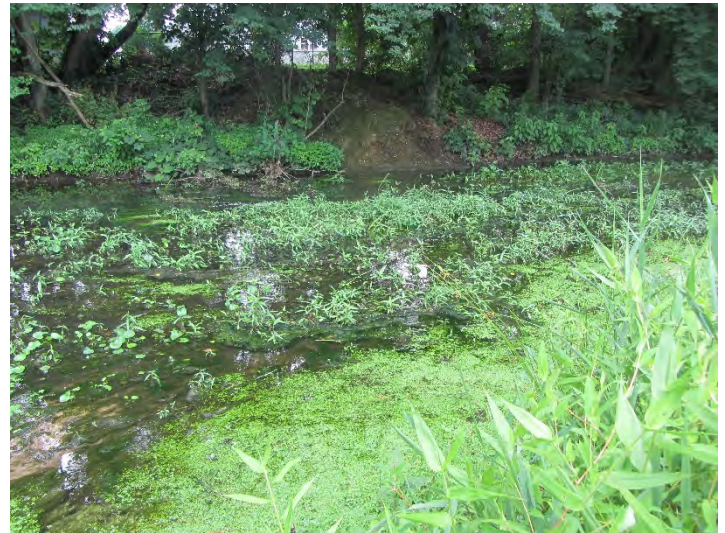
- 36" diameter concrete pipe
- Cloudy, grey water
- Sediment deposits
- Erosion has undermined outfall stability
- Moderate erosion has been caused by the outfall

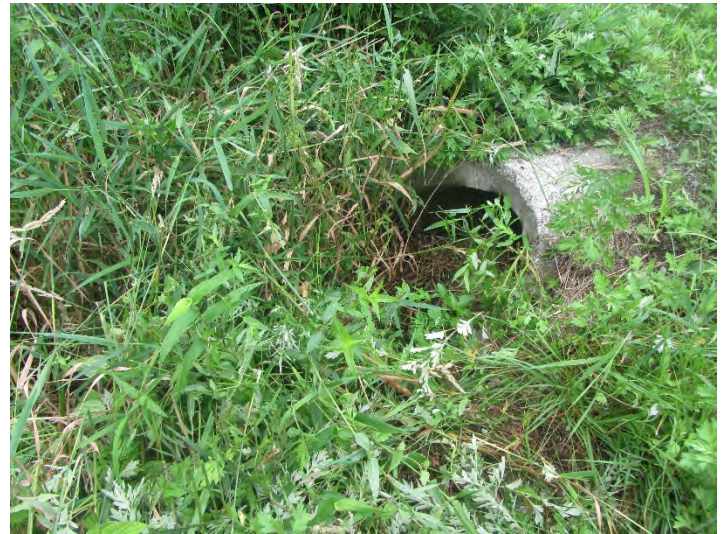
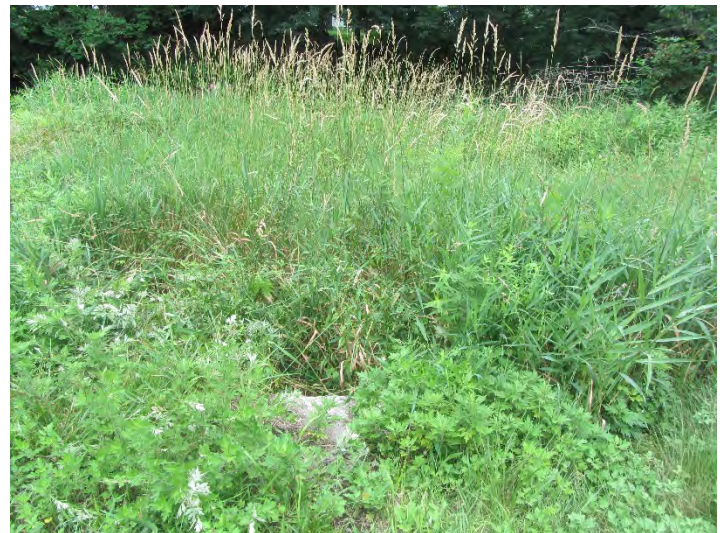
- 24" diameter concrete pipe
- Sediment deposits

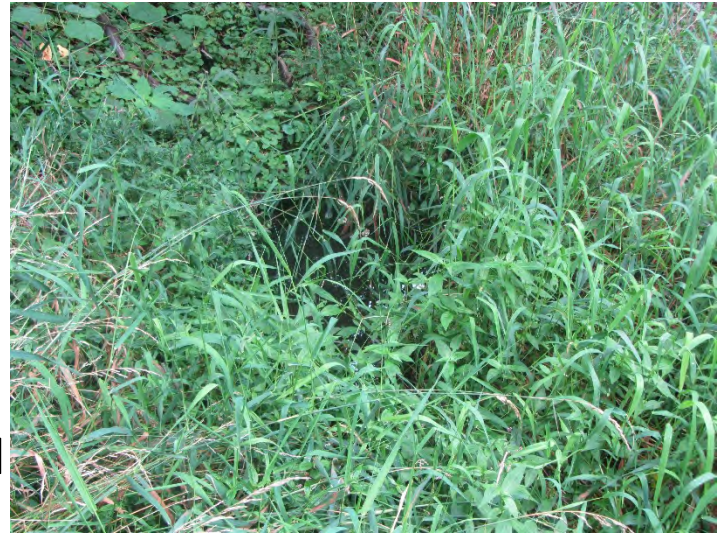
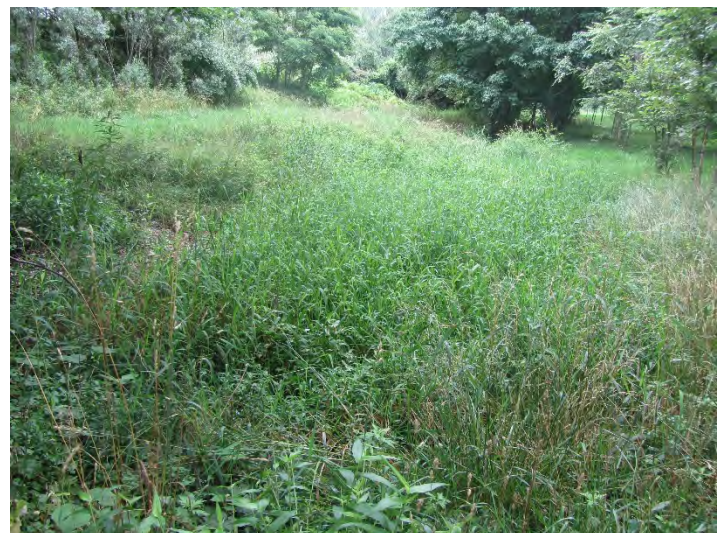
- 24" diameter concrete pipe
- Known commercial discharges
- Cloudy, grey water
- Sediment deposits and floatable trash
- Erosion has undermined outfall stability
- Moderate erosion has been caused by the outfall

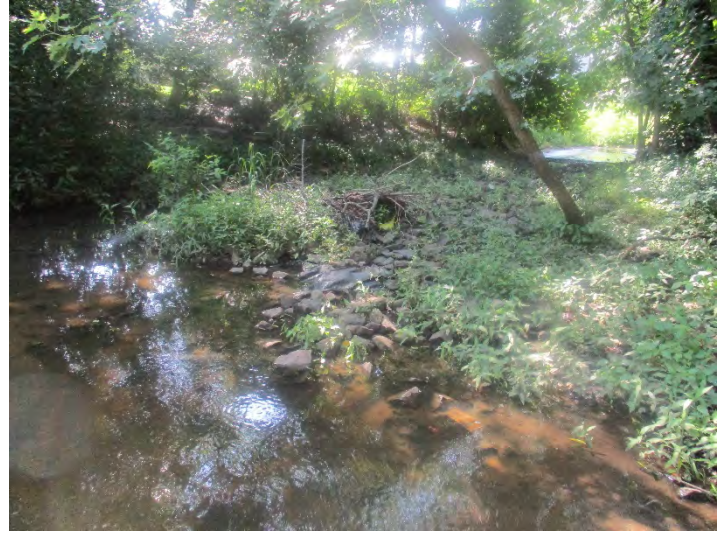
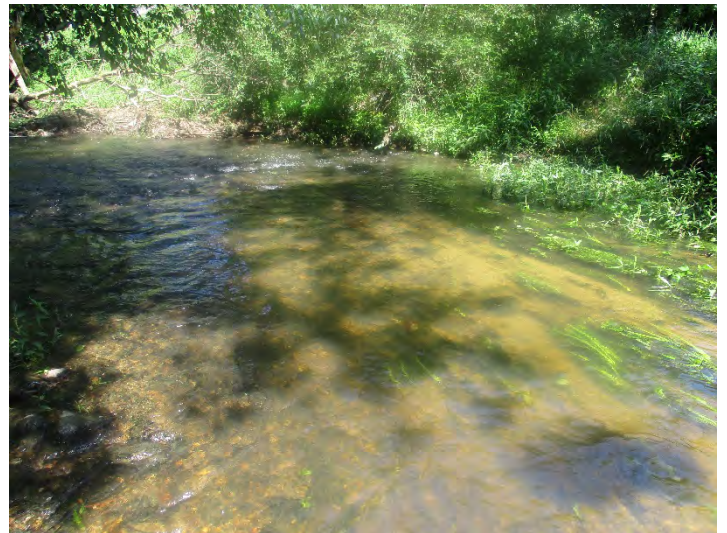
- Controlled flow channel
- No outfall pipe was found
- Minor erosion has been caused by the outfall

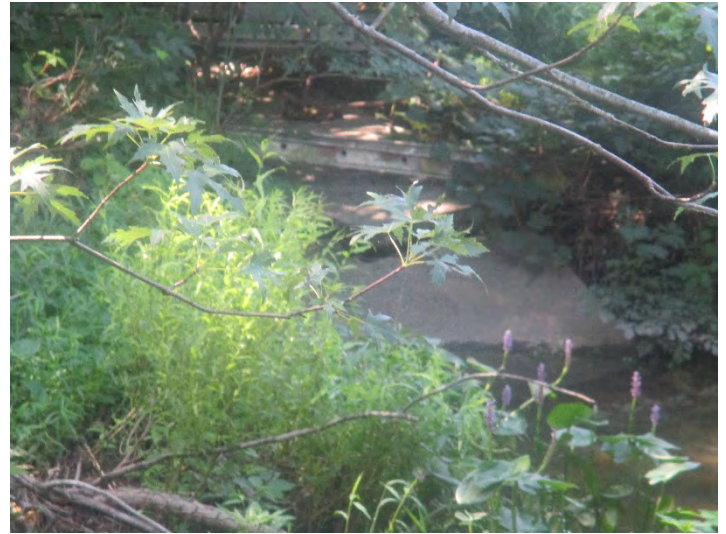
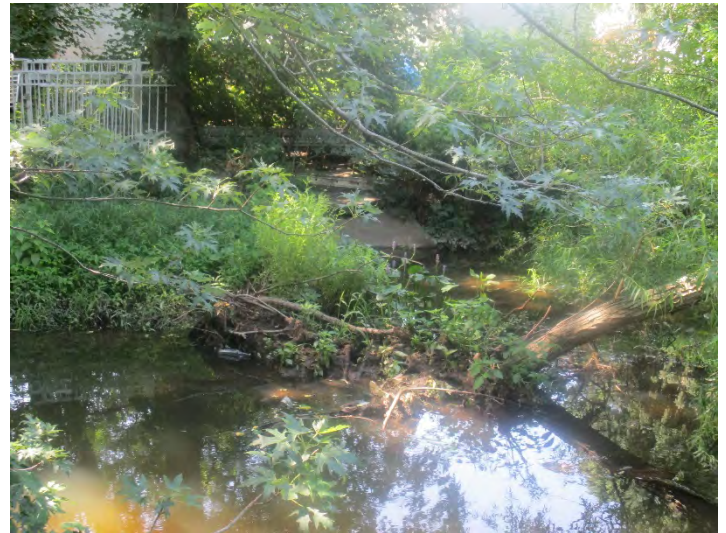
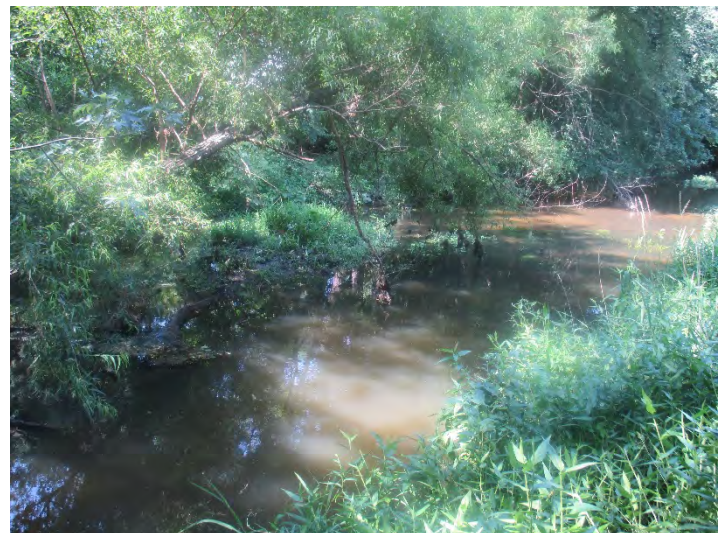
- Outfall pipe is not visible due to head wall collapse
- Reinforced concrete pipe
- Cloudy, grey water
- Sediment deposits
- Erosion has undermined outfall stability
- Moderate erosion has been caused by the outfall

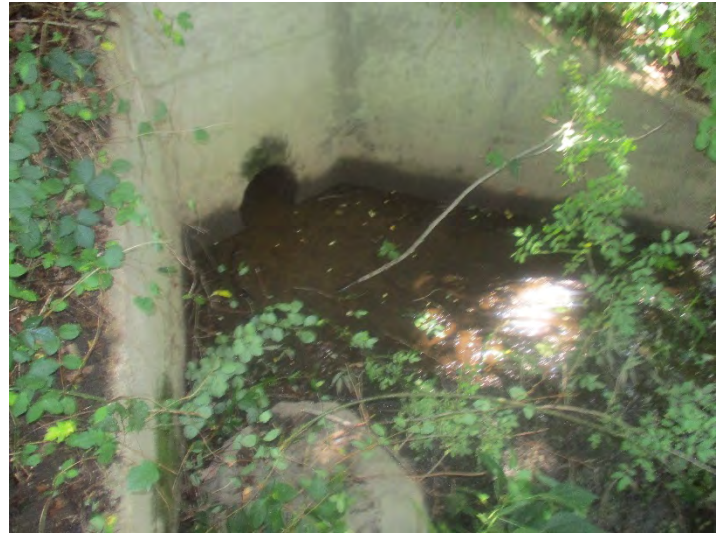
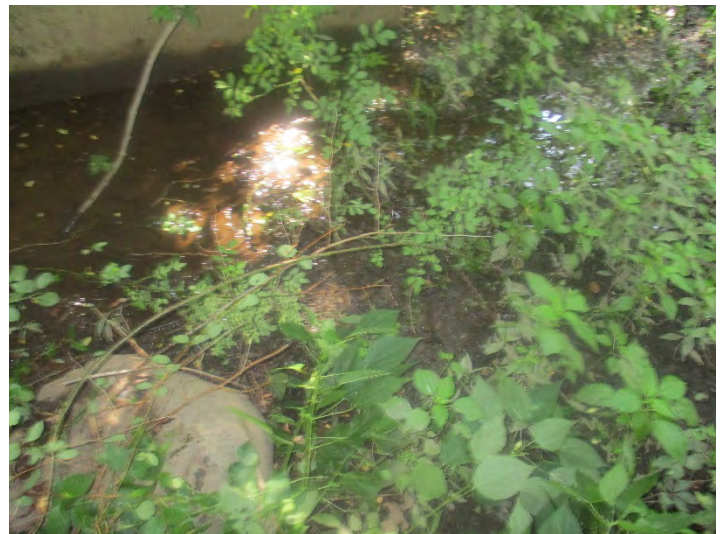
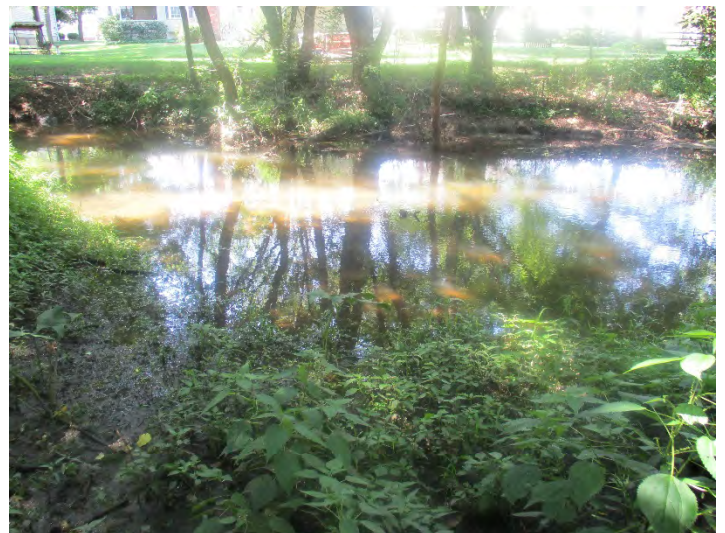
- 12" diameter concrete pipe
- Grey water
- Known commercial discharges
- Sediment deposits
- Outfall has excessive sediment accumulation

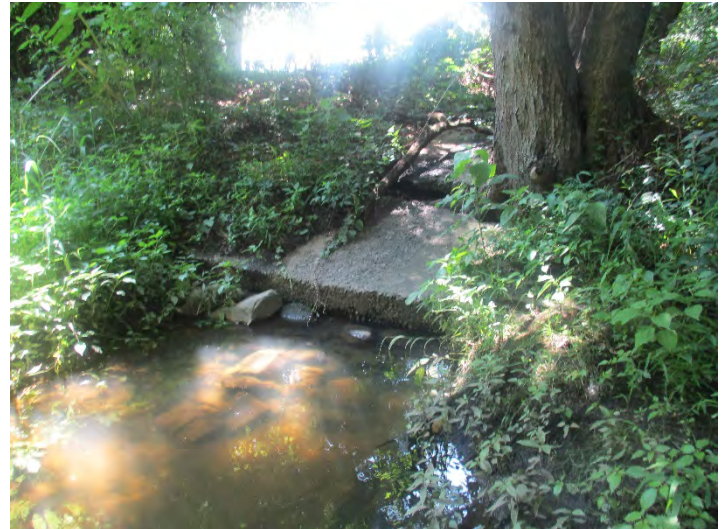
- Controlled flow channel
- No outfall pipe was found
- Erosion has undermined outfall stability
- Minor erosion has been caused by the outfall
- Excessive tree root growth is restricting the flow of water

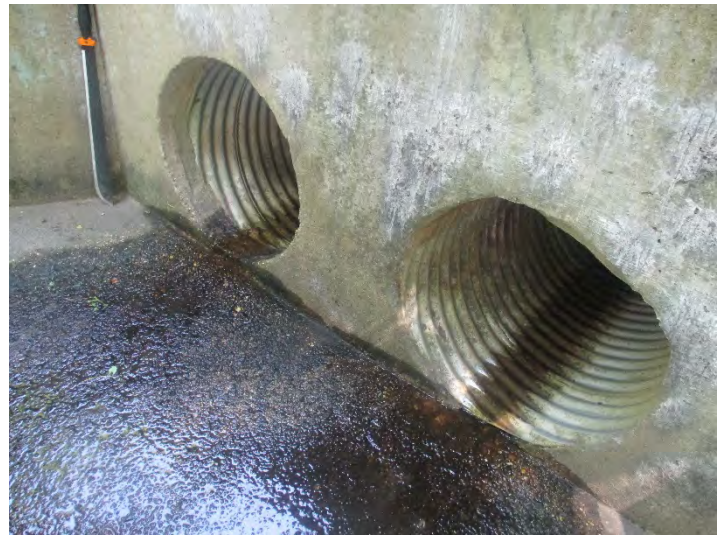
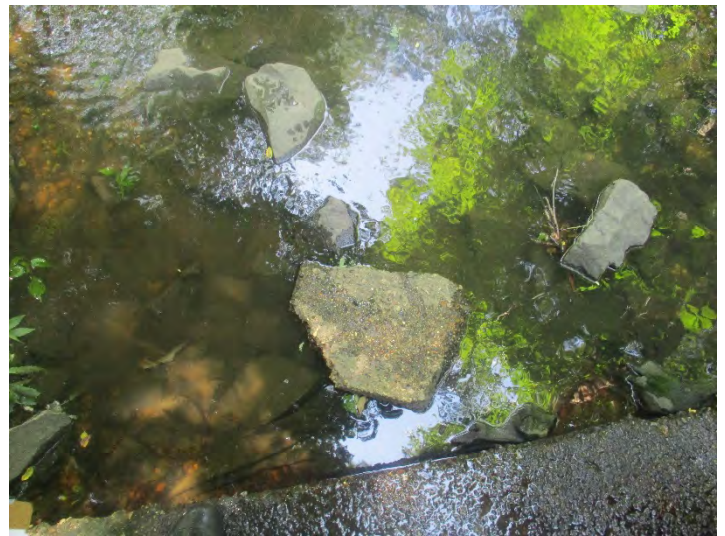
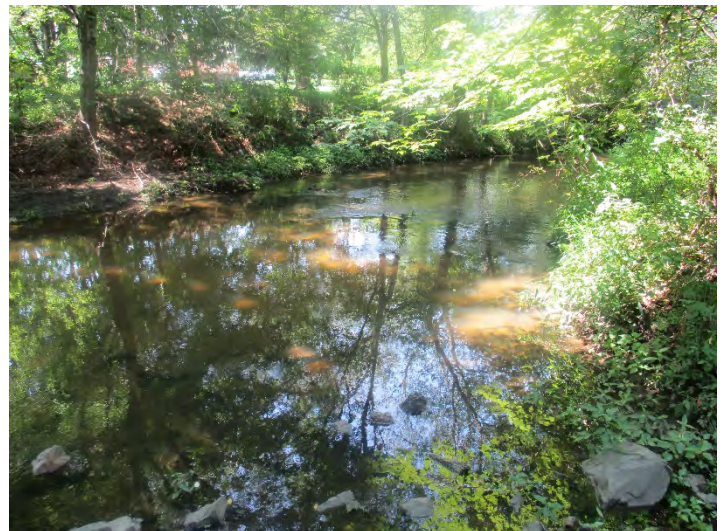
- 24" diameter metal pipe
- Grey water
- Excessive trash and sediment visible inside the pipe is restricting water flow

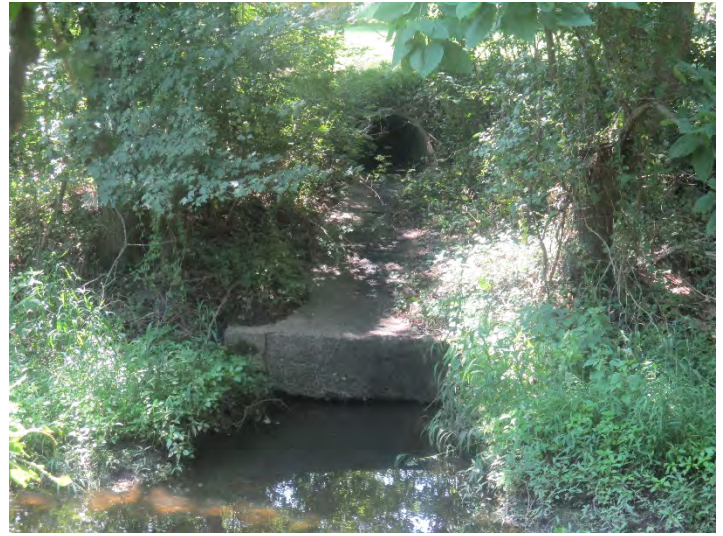
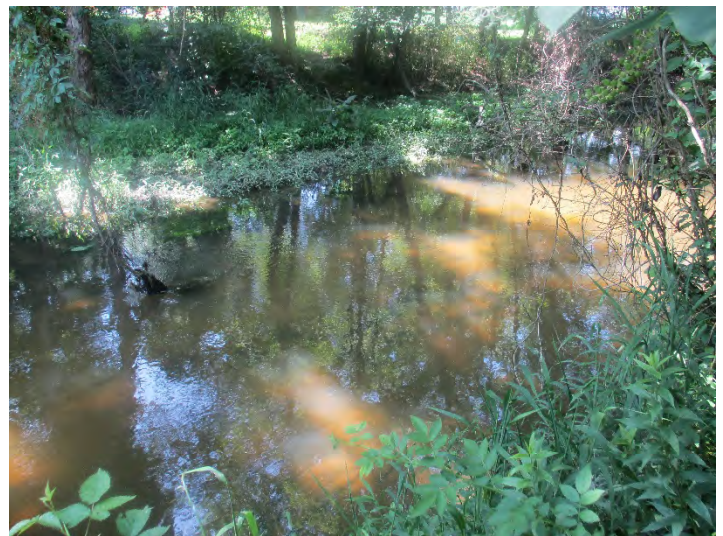
- 26" diameter concrete pipe
- Cloudy, grey water
- Known commercial discharges
- Sediment deposits
- Erosion and tree roots have undermined outfall stability
- Minor erosion has been caused by the outfall

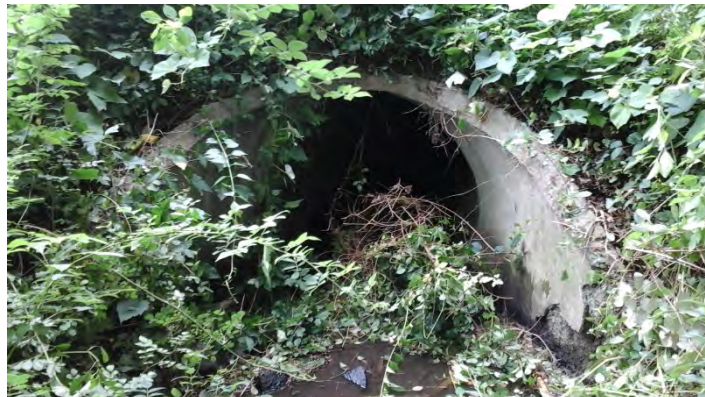
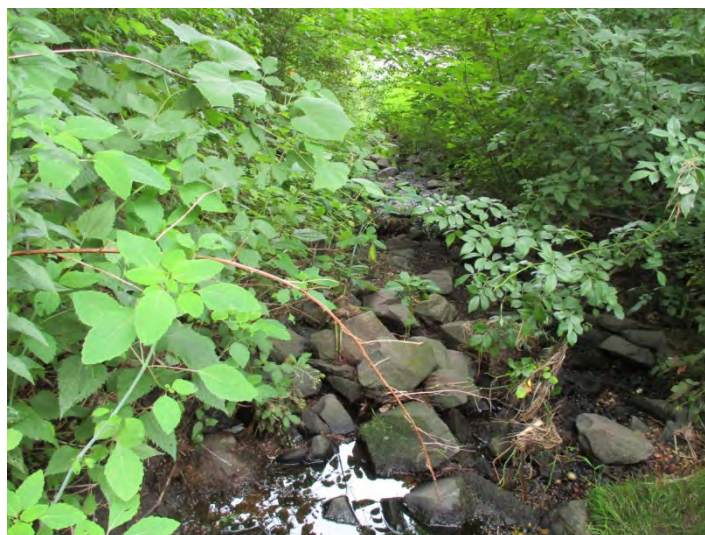
- 53" diameter concrete pipe
- Sediment deposits
- Brown water

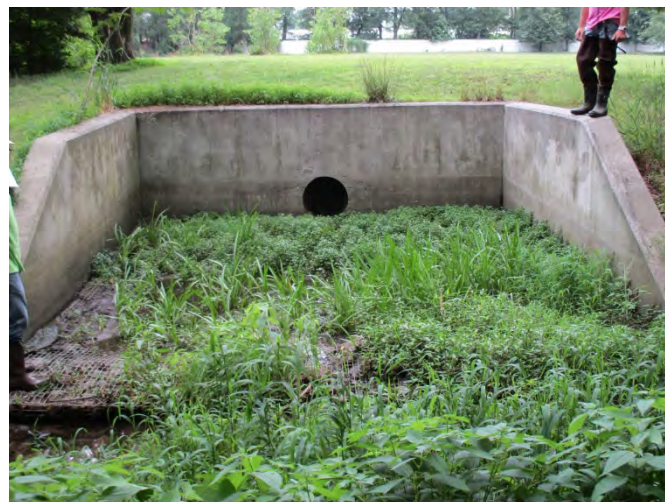
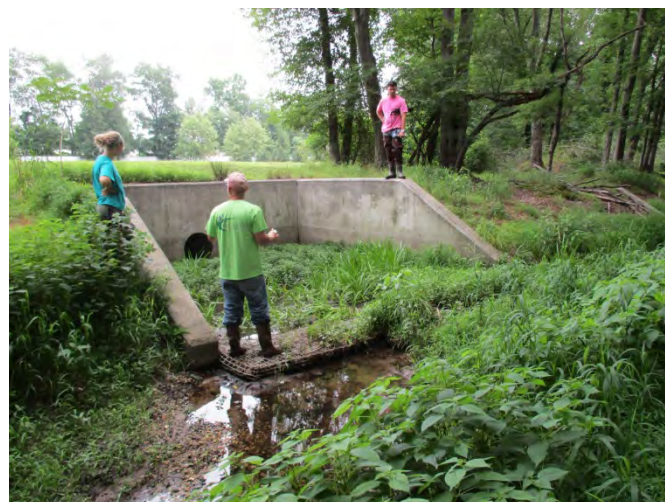
- 24" diameter concrete pipe
- Sediment deposits
- Outfall has excessive sediment accumulation (1.5' deep)

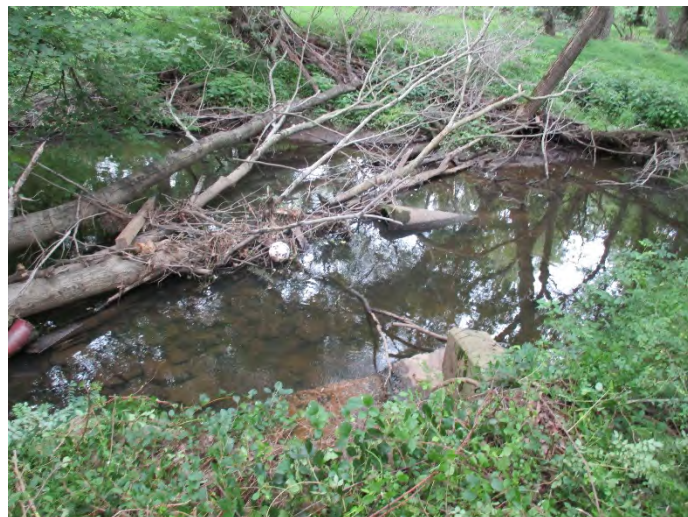
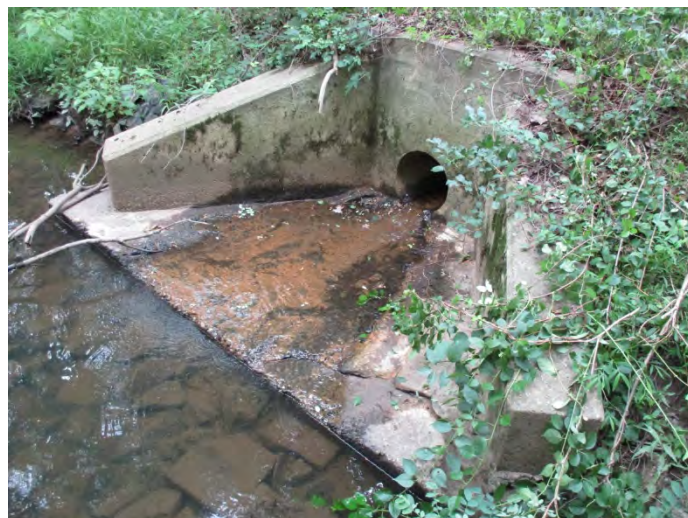
- 14" diameter concrete pipe
- Outfall structure is spalling
- Cloudy, grey water
- Sewage odor
- Floatable trash

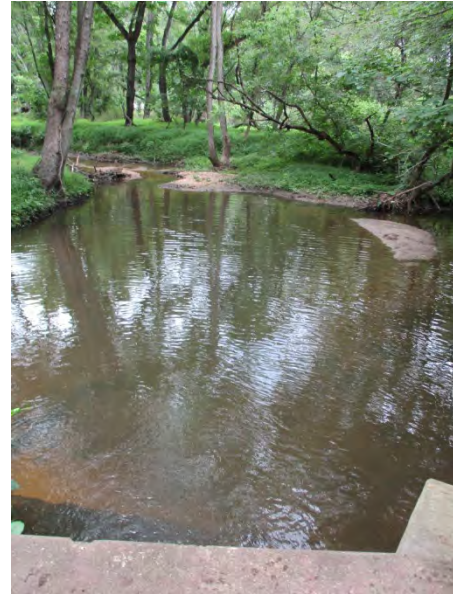
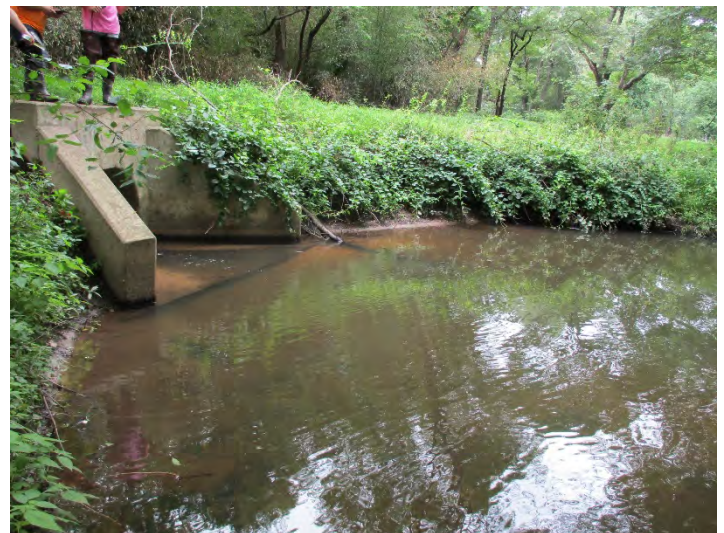
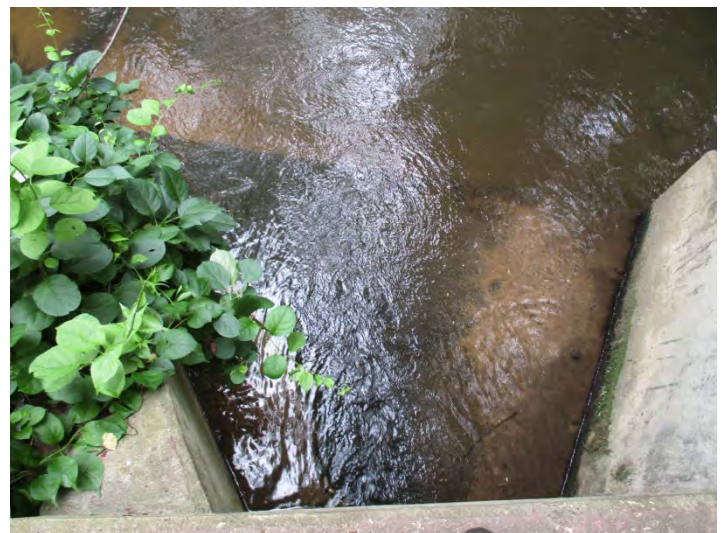
- 40" diameter concrete pipe
- Cloudy, grey water

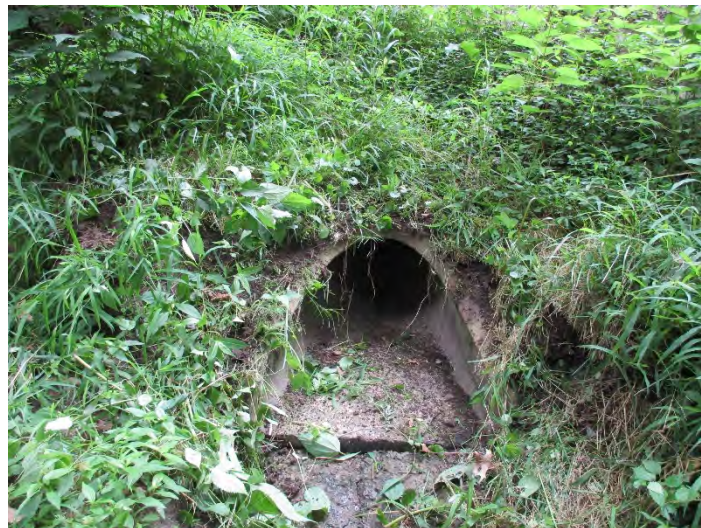
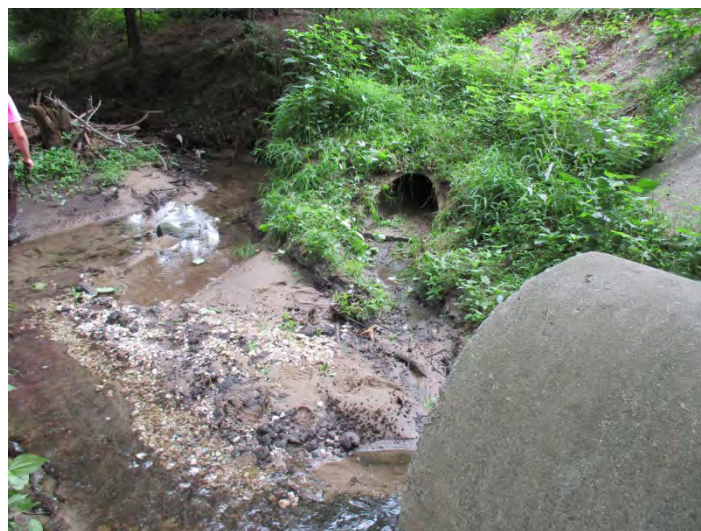
- 14" diameter concrete pipe
- Sediment deposits and oily sheen
- Sediment is restricting flow of water
- Cloudy, grey water

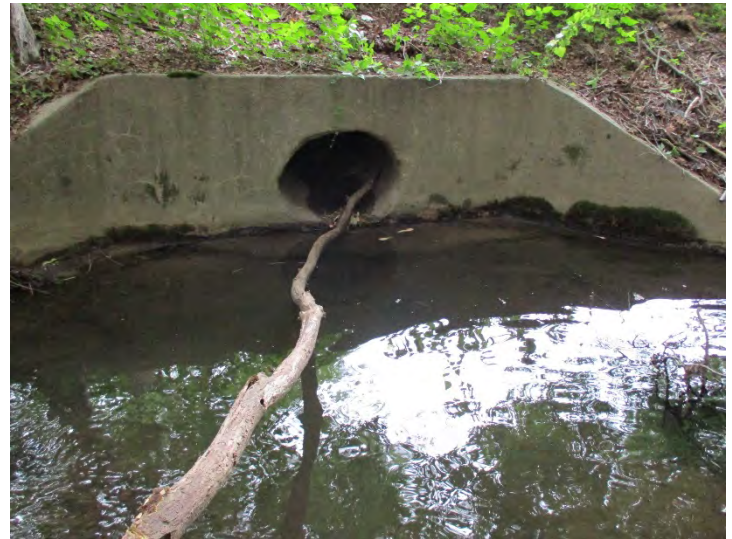
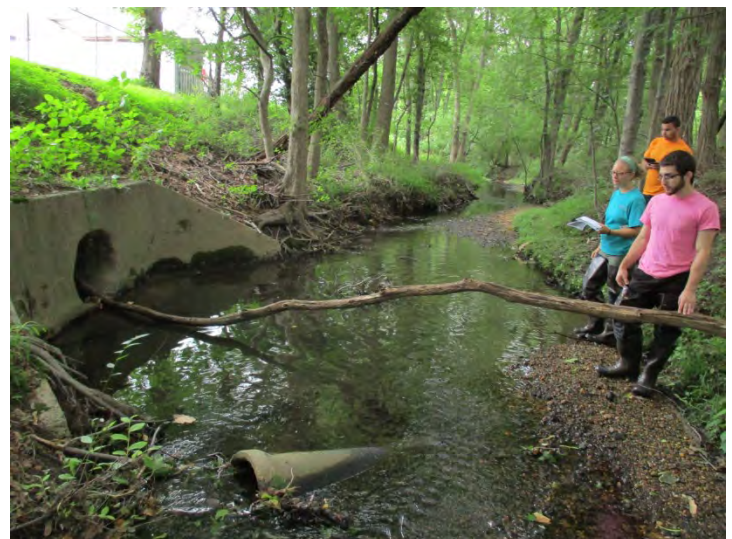
- Outfall pipe is 26" tall and 35" wide (elliptical pipe)
- Reinforced concrete pipe
- Cloudy, grey water
- Sewage odor
- Sediment deposits
- Moderate erosion has been caused by the outfall
- Nearby residential property is eroding along stream

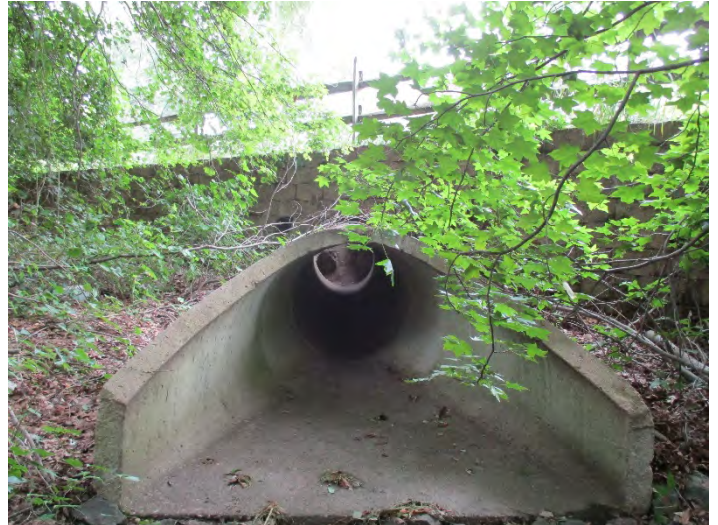
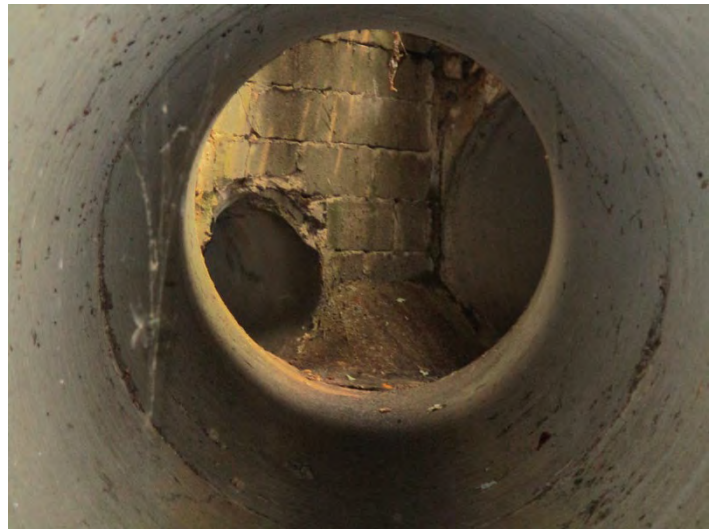
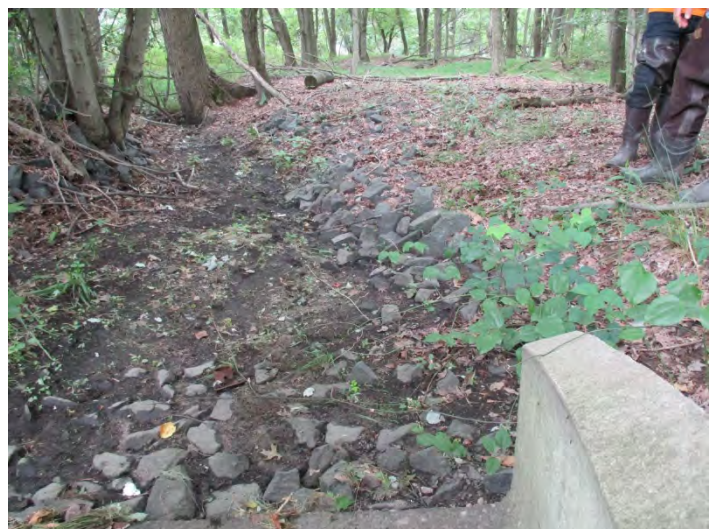
- 34" diameter concrete pipe
- Sediment deposits and floatable trash

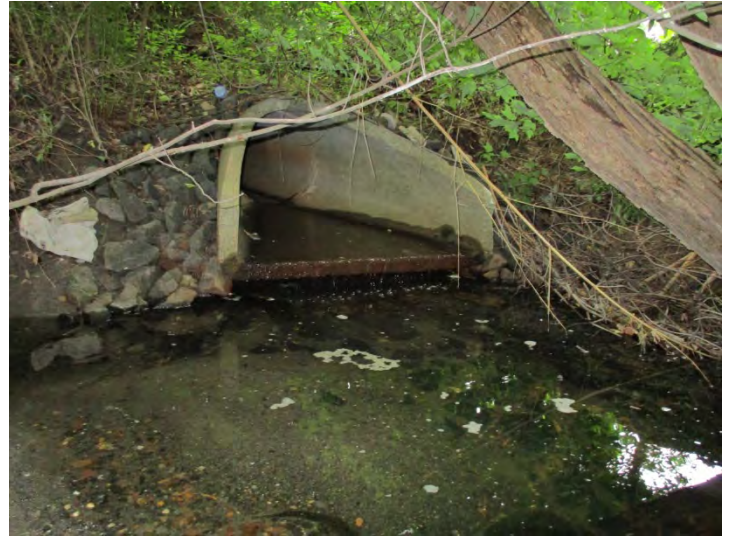
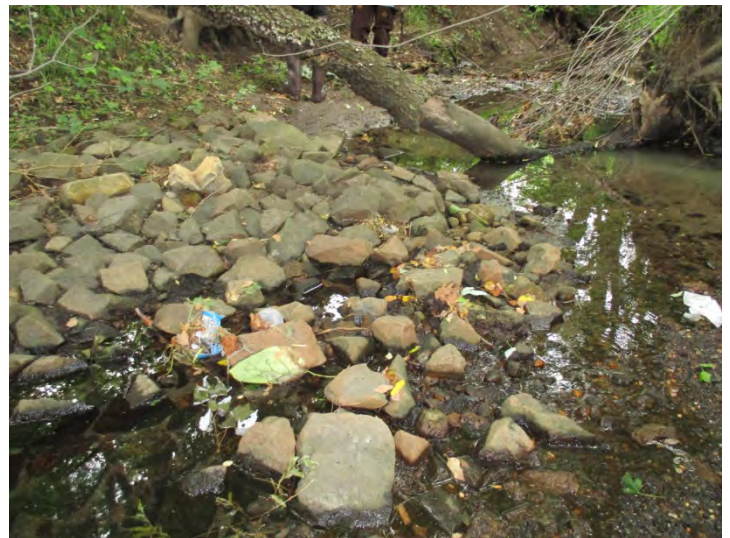
- 28" diameter concrete pipe
- Cloudy, grey water
- Sewage odor
- Sediment deposits and floatable trash
- Significant erosion has been caused by the outfall
- Erosion has undermined outfall stability

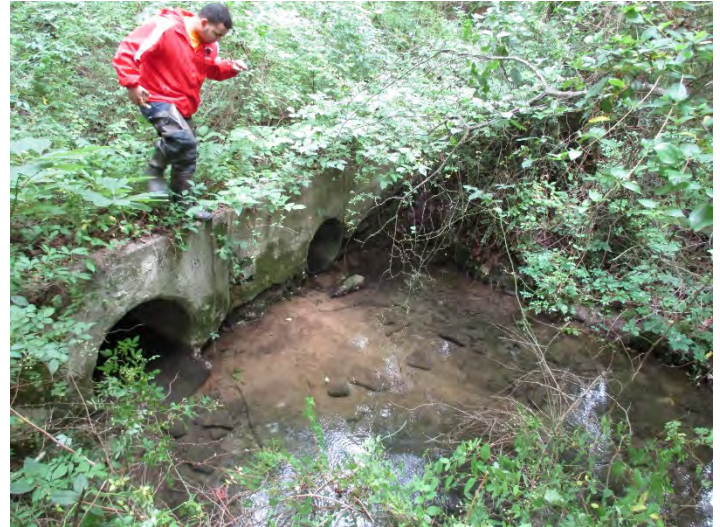
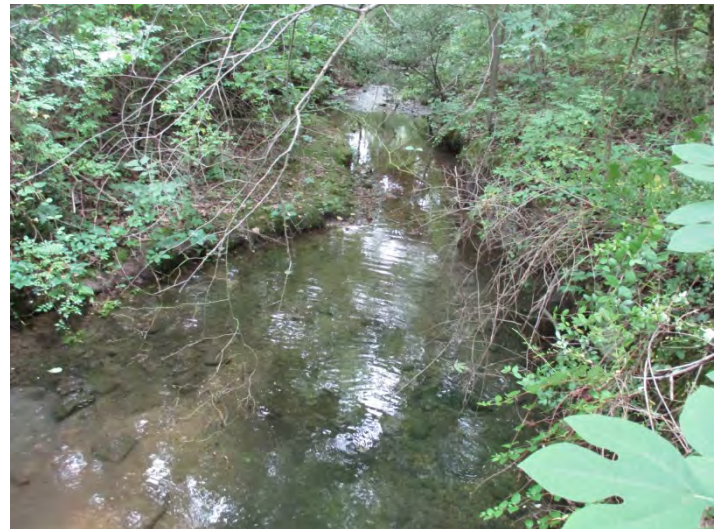
- Both outfall pipes are approximately 30" in diameter
- Reinforced concrete pipe
- Sediment deposits
- Outfall structure is cracking
- Moderate erosion has been caused by the outfall

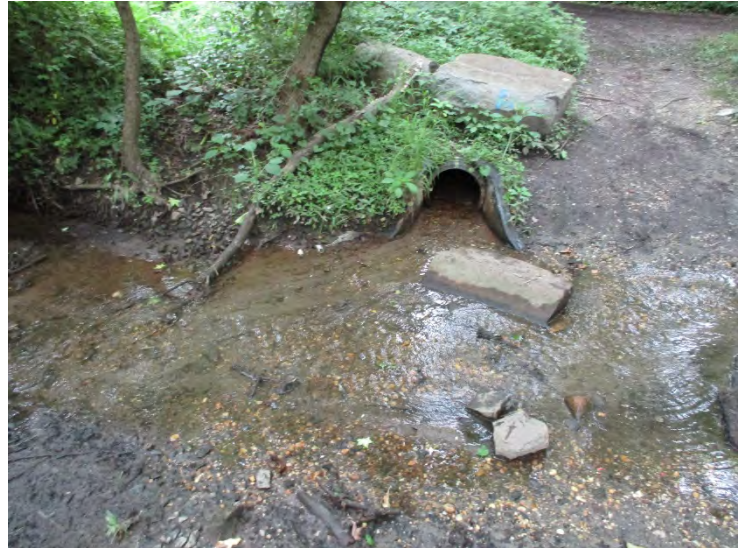
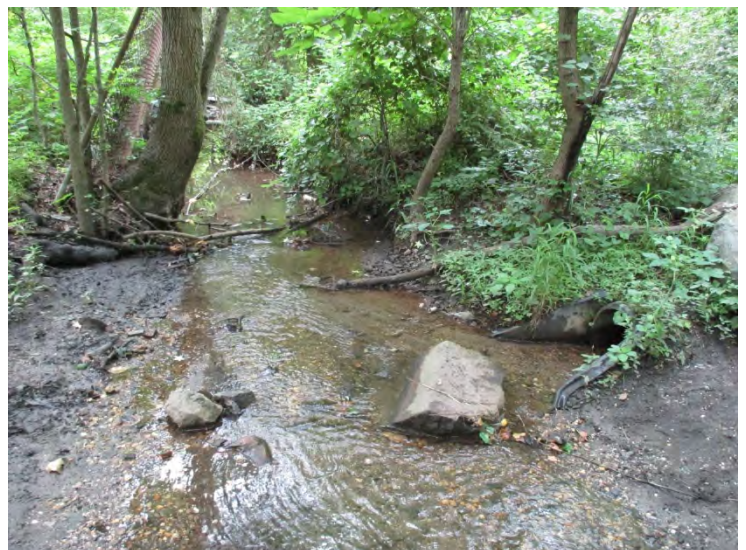
- 14" diameter plastic pipe
- Sewage odor
- Sediment deposits

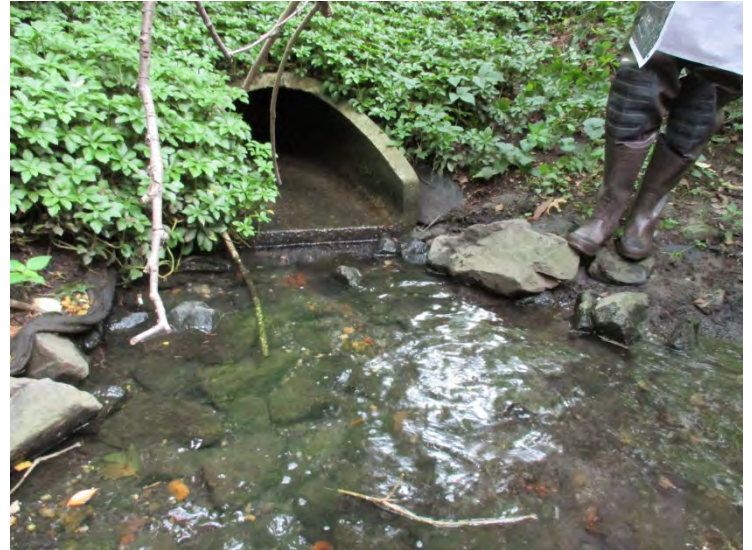
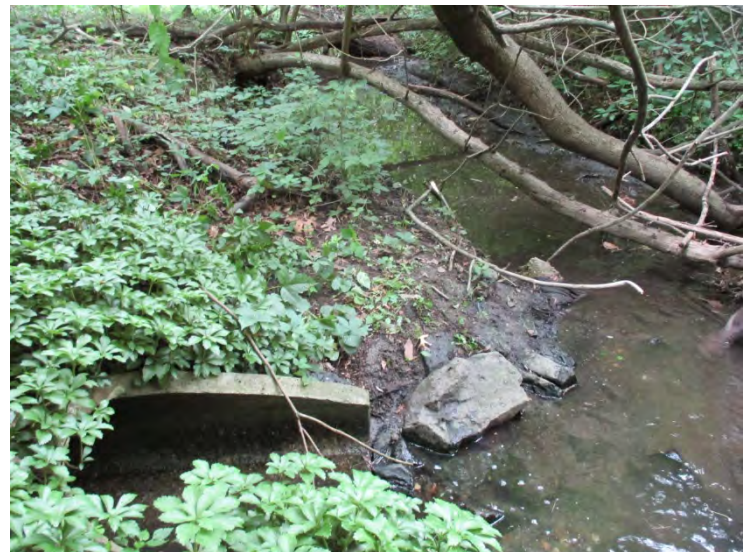
- 26" diameter concrete pipe
- Sediment deposits

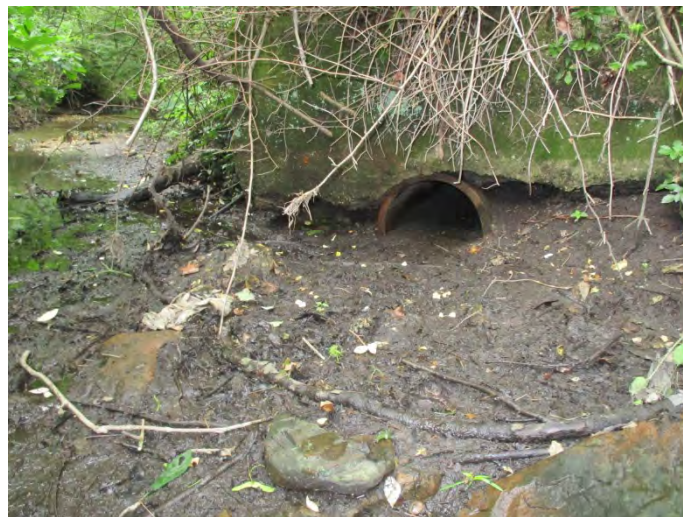
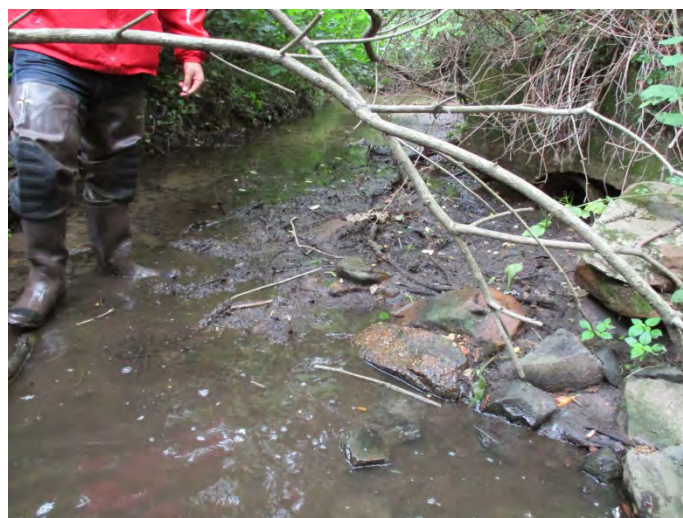
- 14" diameter metal pipe
- Headwall is broken
- Sediment deposits
- Sediment is blocking the outfall pipe
- Minor erosion has been caused by the outfall

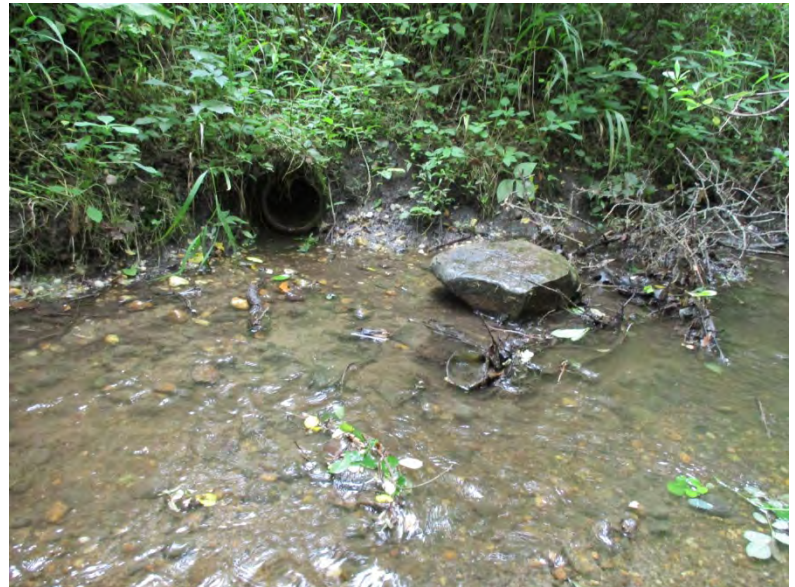
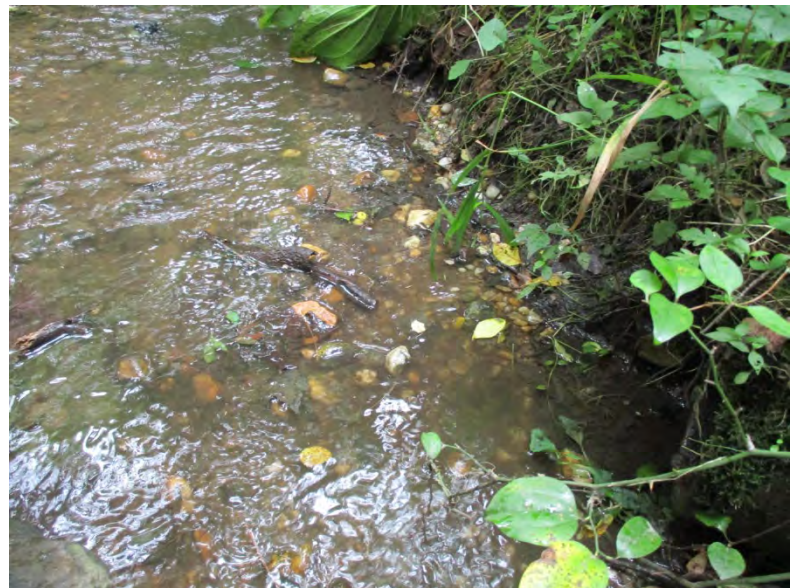
- 6" diameter metal pipe
