## Hamilton Township (Mercer County)

# REVIEW AND EVALUATION OF TOTAL MAXIMUM DAILY LOADS (TMDLs)

Developed by the Rutgers Cooperative Extension Water Resources Program  
Funded by Hamilton Township, Mercer County, New Jersey

December 5, 2019

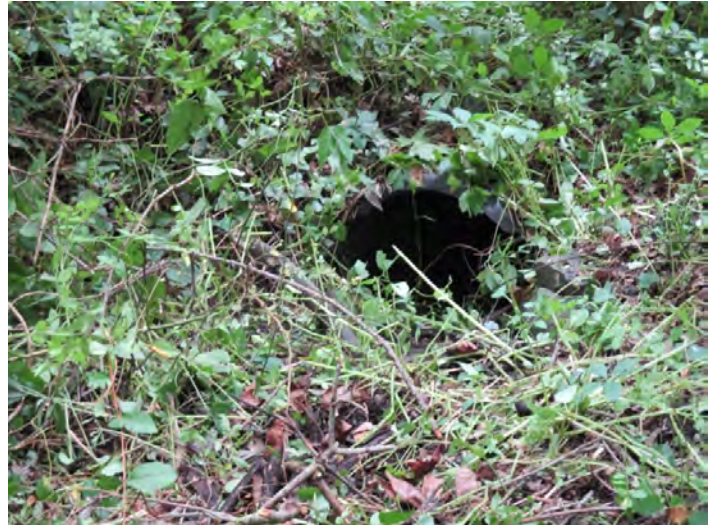
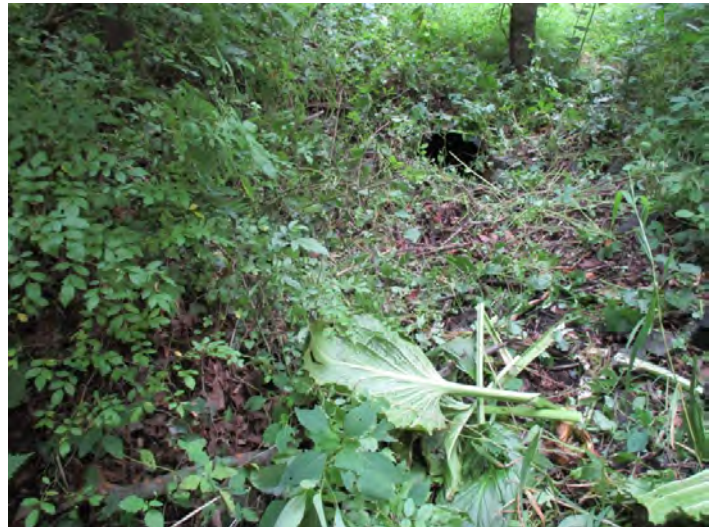
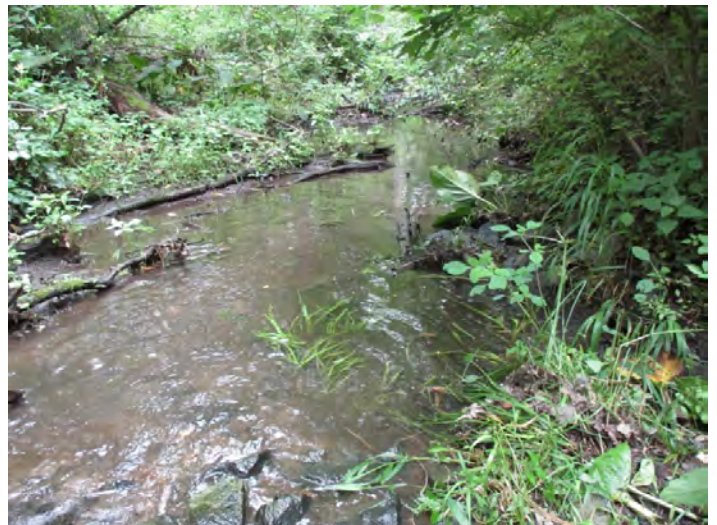
- 16" diameter plastic pipe
- Sewage odor
- Sediment deposits, oil deposits, and floatable trash
- Excessive vegetation growth

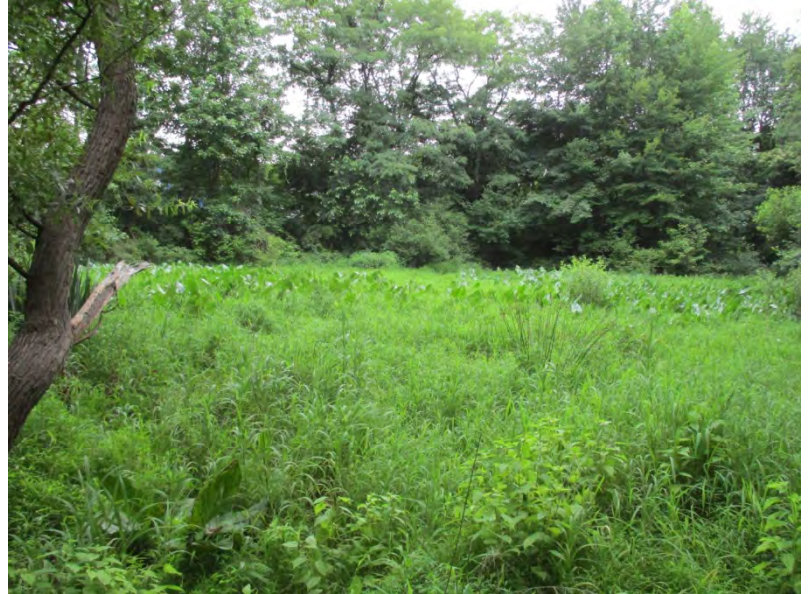
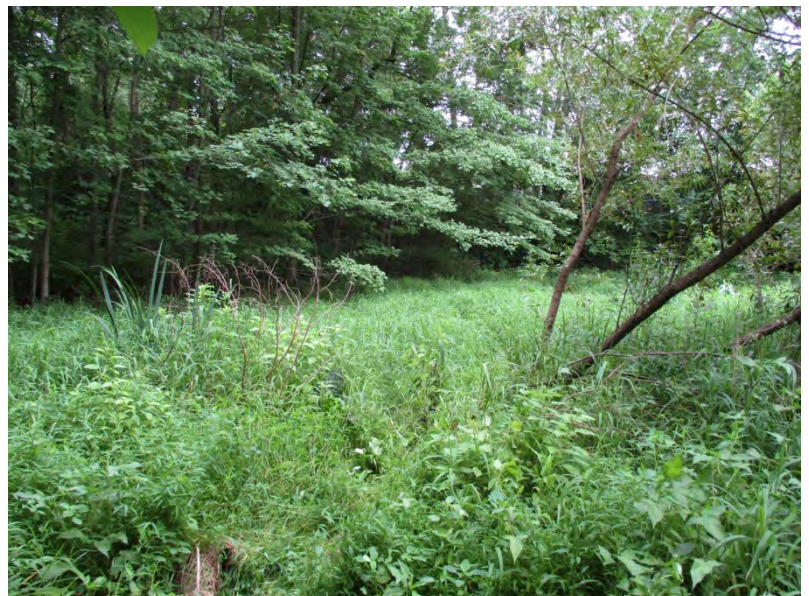
- Outfall could not be found
- Wetland area

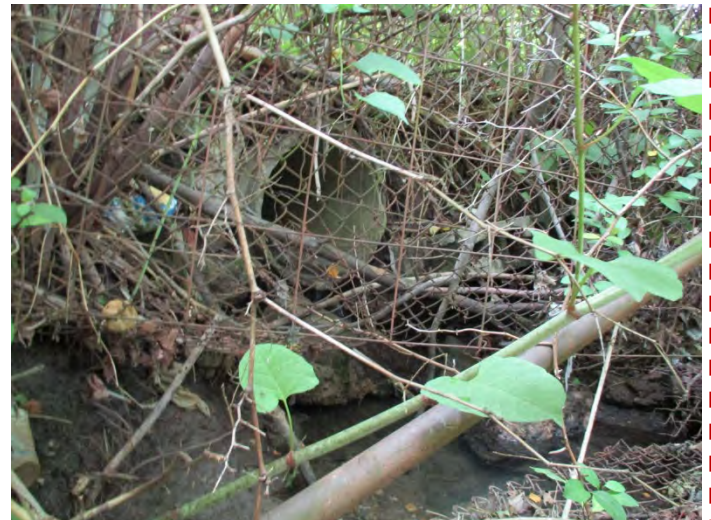
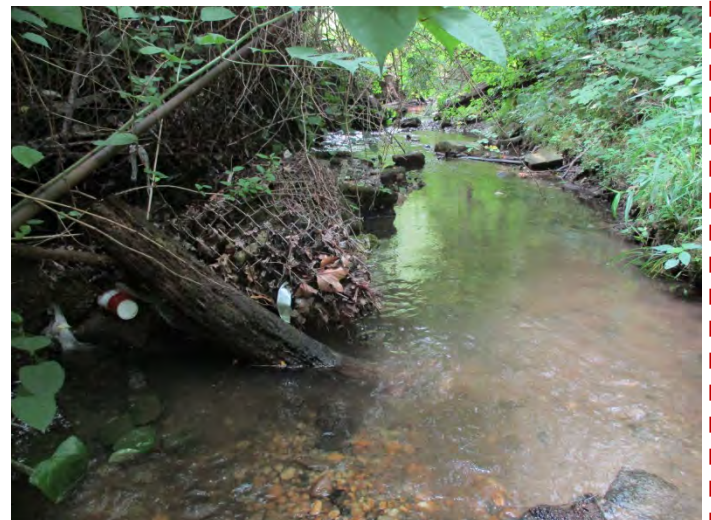
- Outfall pipe is estimated to be 26" in diameter
- Reinforced concrete pipe
- Sediment deposits and floatable trash
- Excessive vegetation growth
- Pipe headwall has fallen into the creek
- Berm upstream has failed
- Significant erosion has been caused by the outfall

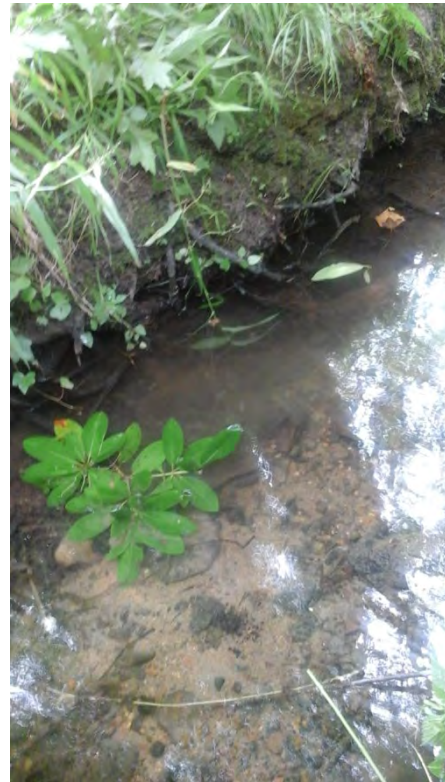
- 9" diameter clay pipe
- Sediment deposits
- Excessive vegetation growth
- Pipe has deteriorated and broken
- Moderate erosion has been caused by the outfall

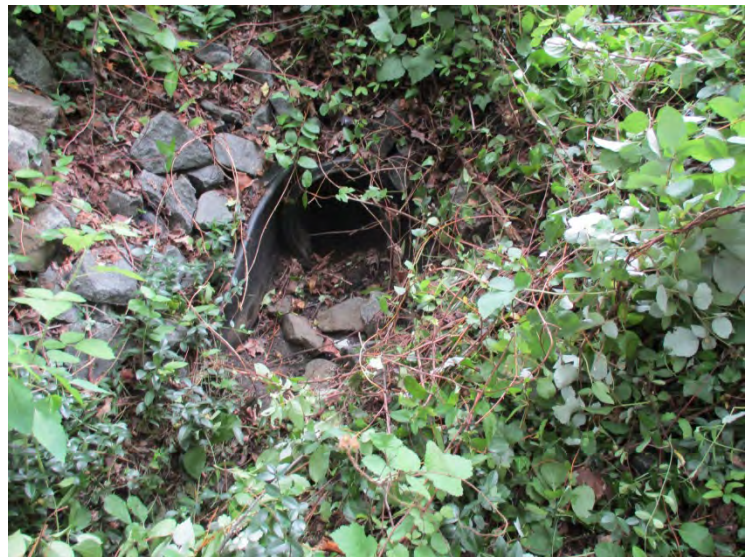
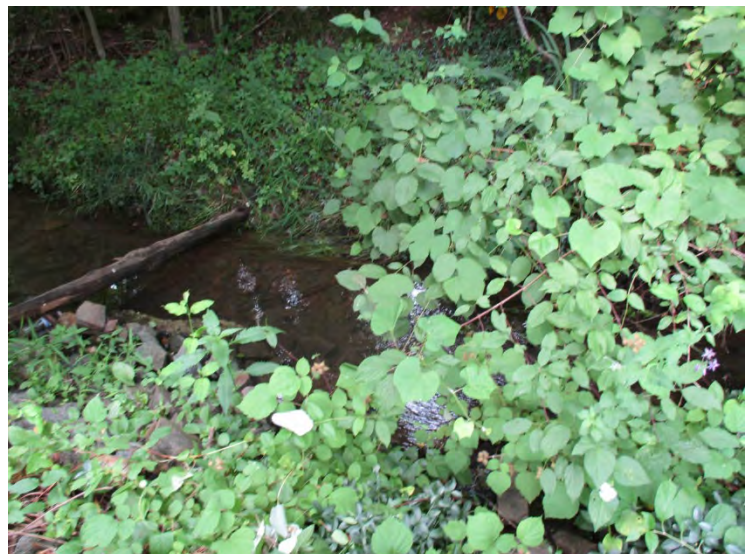
- 14" diameter plastic pipe
- Cloudy, grey water
- Sediment deposits

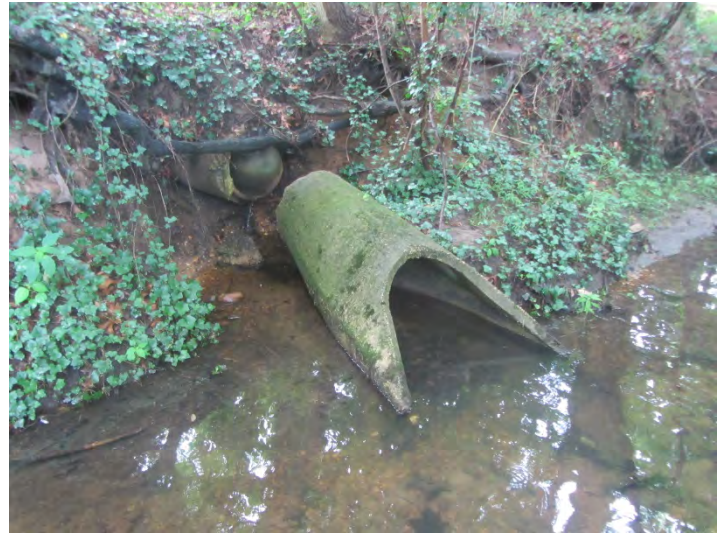
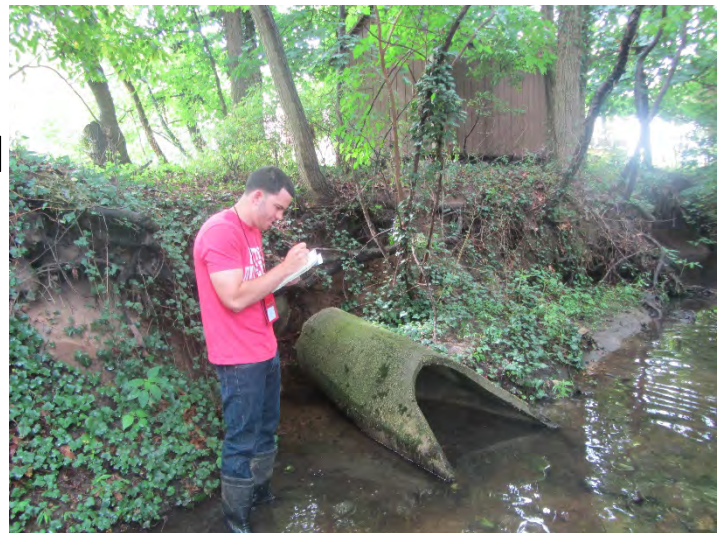
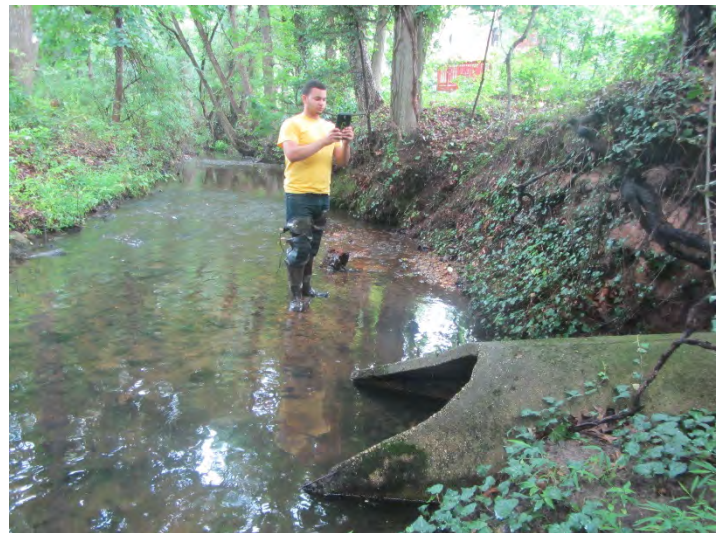
- 18" diameter concrete pipe
- Known commercial discharges
- Sediment deposits
- Significant erosion has been caused by the outfall
- Erosion has undermined outfall stability
- The flared end section of pipe has detached and fallen into stream

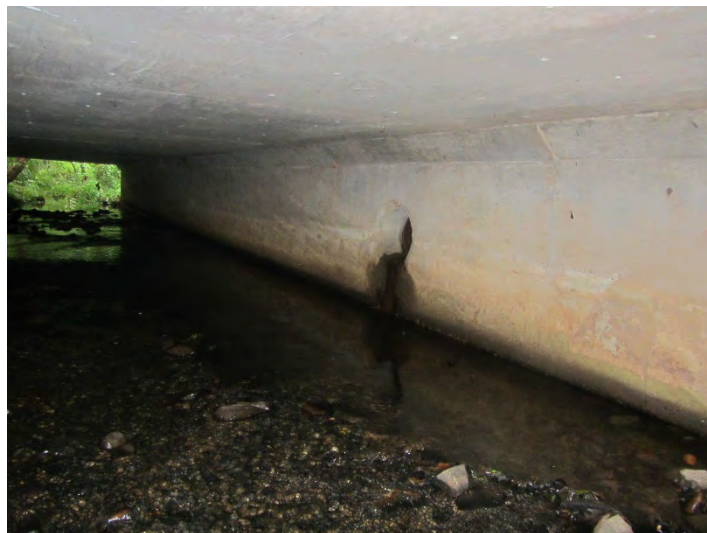
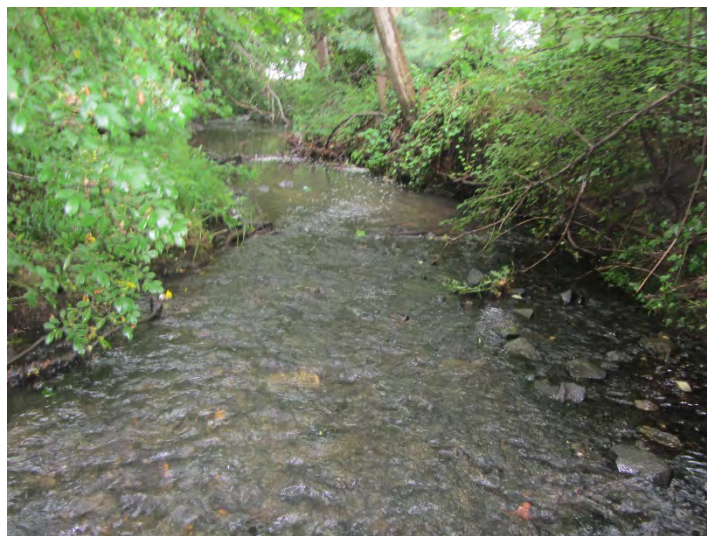
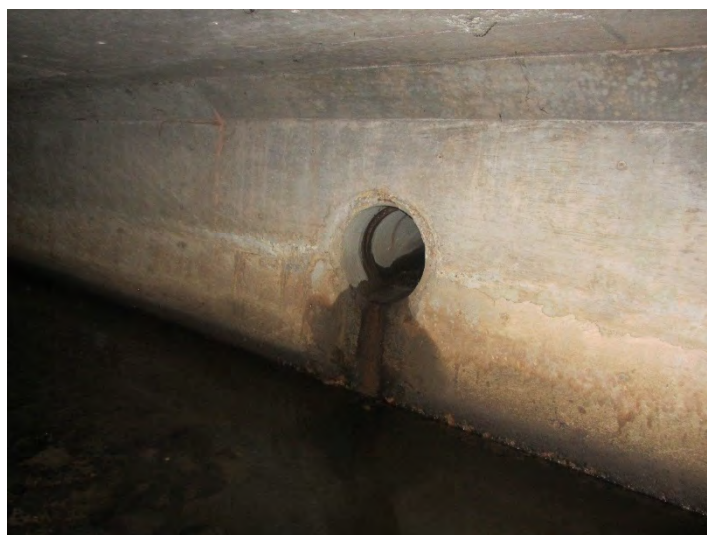
- 18" diameter concrete pipe
- Known commercial discharges
- Grey water

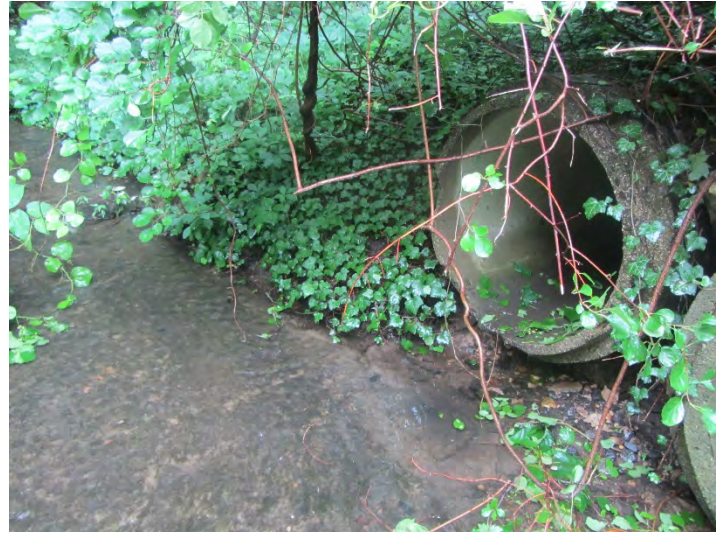
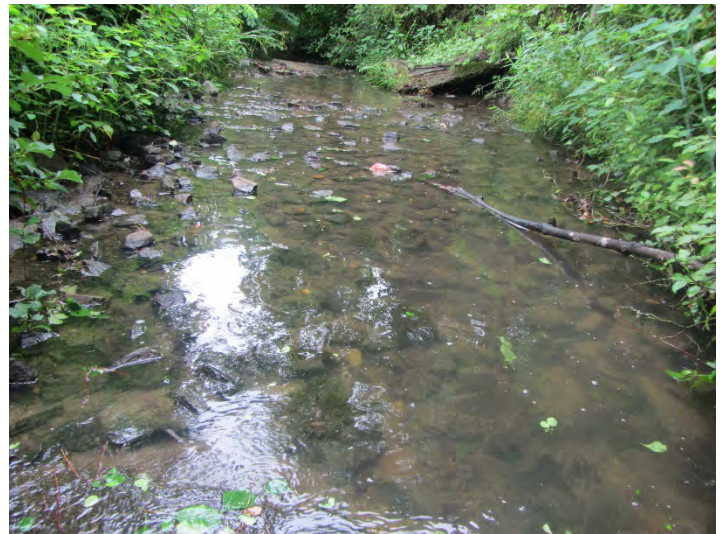
- 30" diameter concrete pipe
- Grey water
- Known commercial discharges
- Pipe is spalling

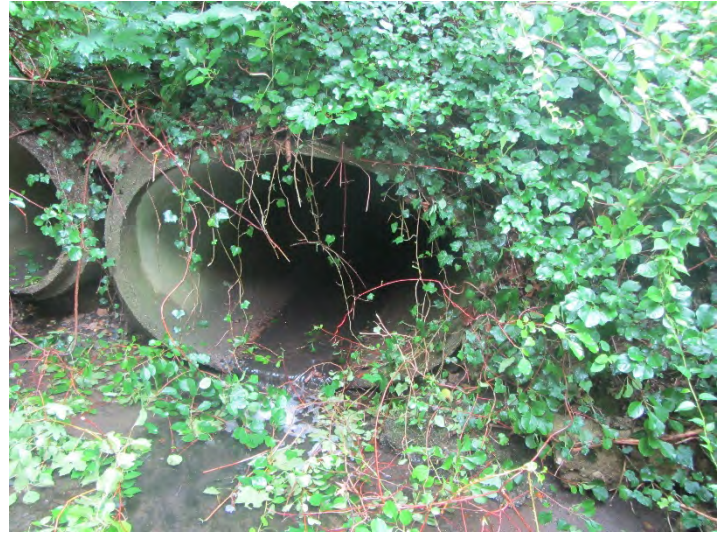
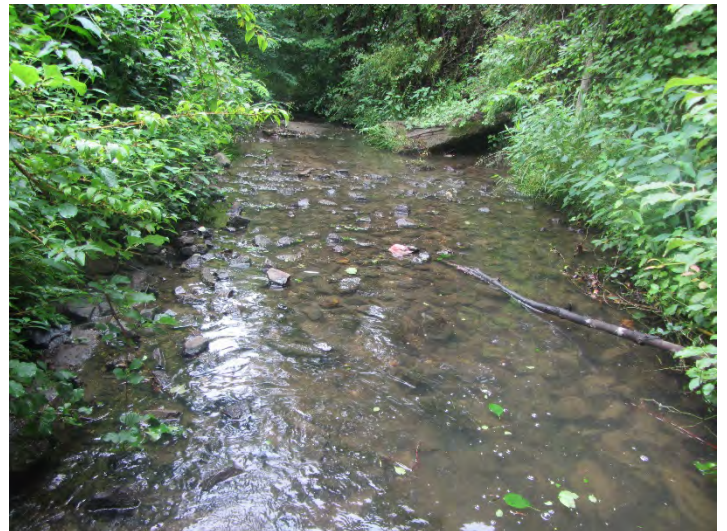
- 40" diameter concrete pipe
- Known commercial discharges
- Grey water
- Sediment deposits
- Pipe is spalling

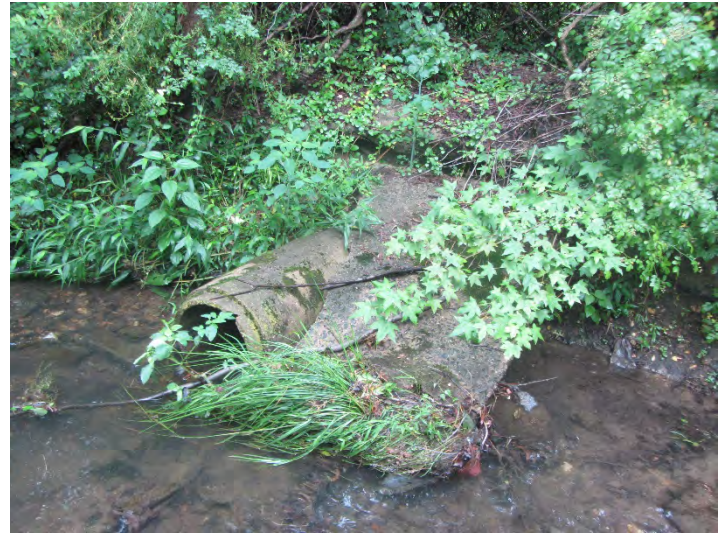
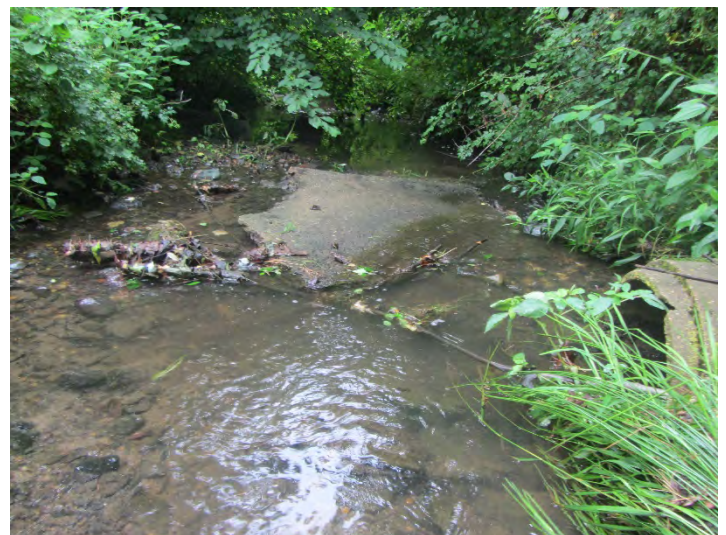
- 15" diameter concrete pipe
- Sediment deposits
- Grey water
- Known commercial discharges
- Significant erosion has been caused by the outfall
- Erosion has undermined outfall stability
- Pipe is unstable and broken
- Outfall structure is obstructing the flow of water
- Head wall is nonexistent

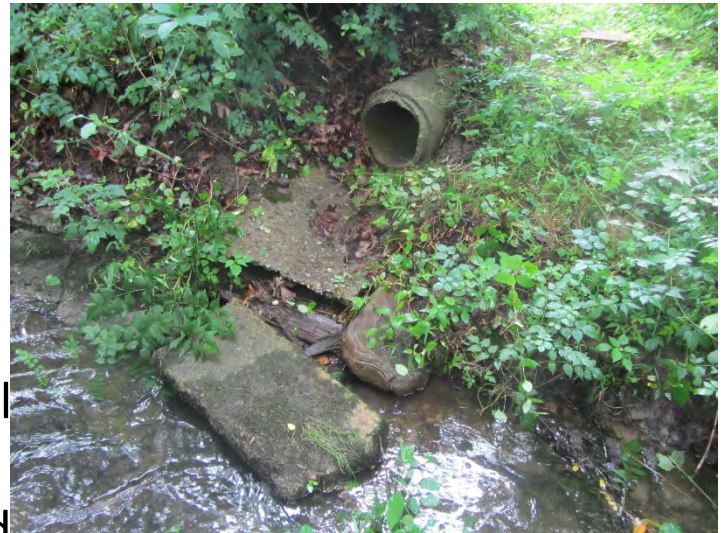
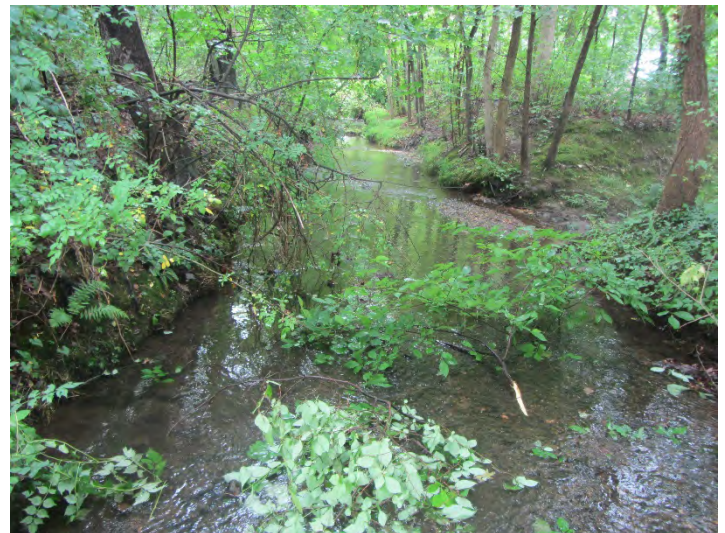
- 12" diameter concrete pipe
- Grey water
- Sediment deposits
- Erosion has undermined outfall stability
- Minor erosion has been caused by the outfall

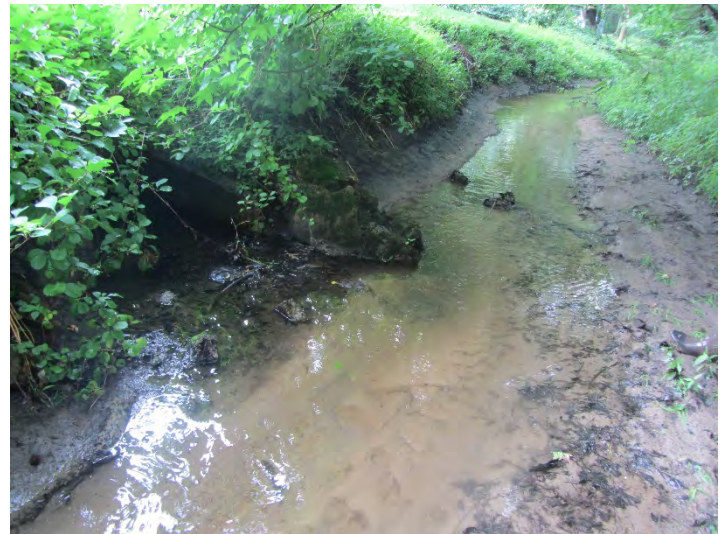
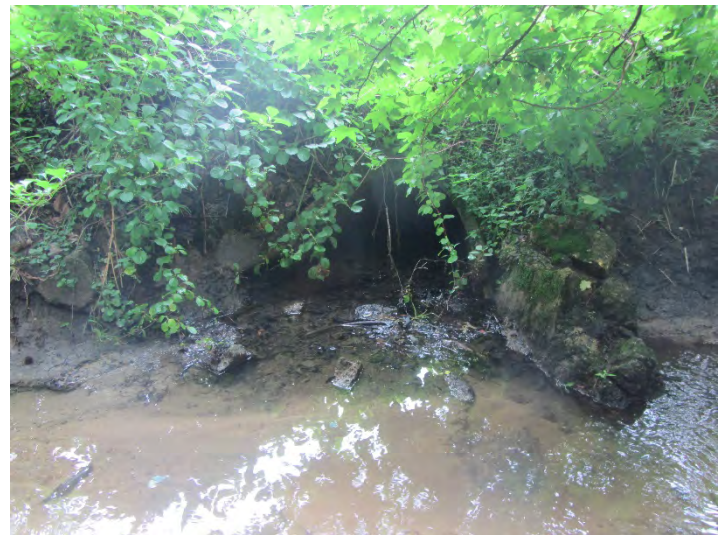
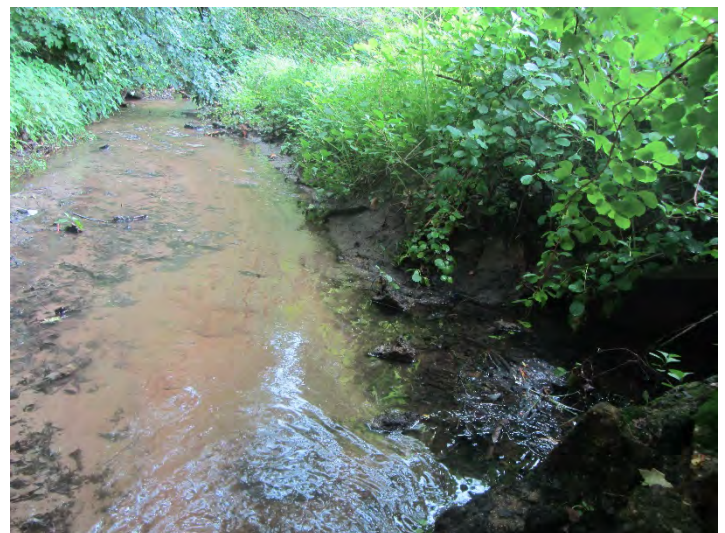
- 24" diameter concrete pipe
- Known commercial discharges
- Grey water
- Sewage odor
- Sediment deposits
- Erosion has undermined outfall stability
- Moderate erosion has been caused by the outfall
- Flared end section is cracked and detached

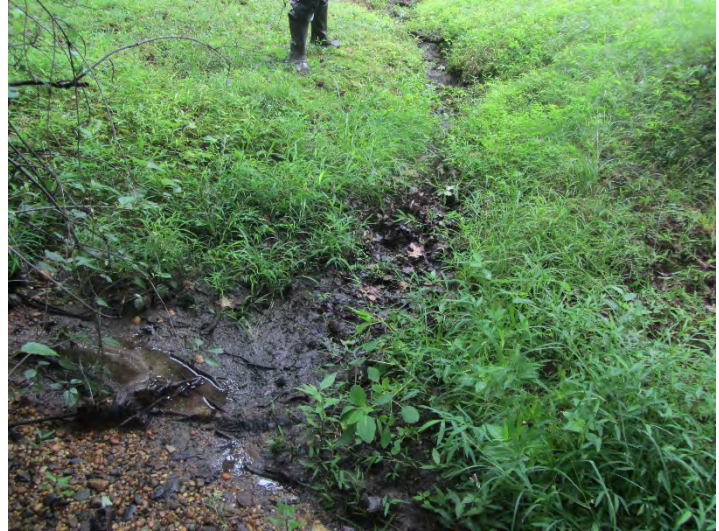
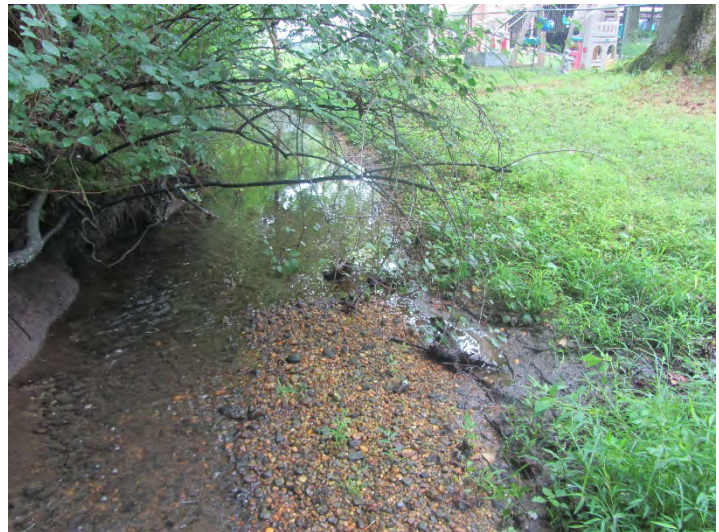
- Controlled flow channel
- No outfall pipe was found
- Minor erosion has been caused by the outfall

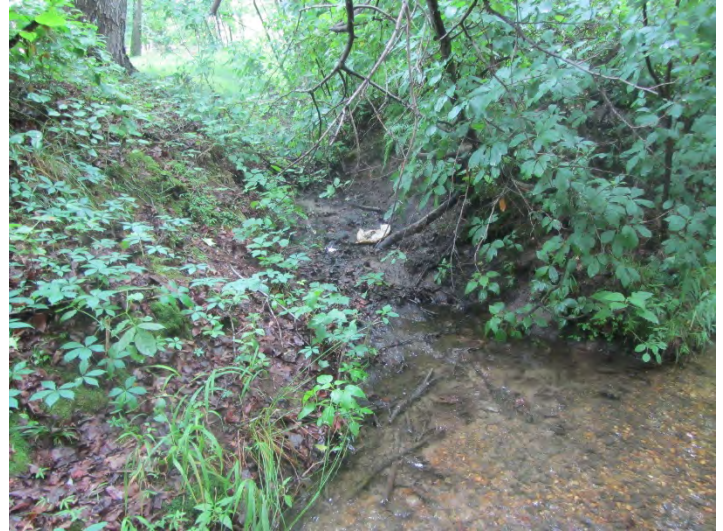
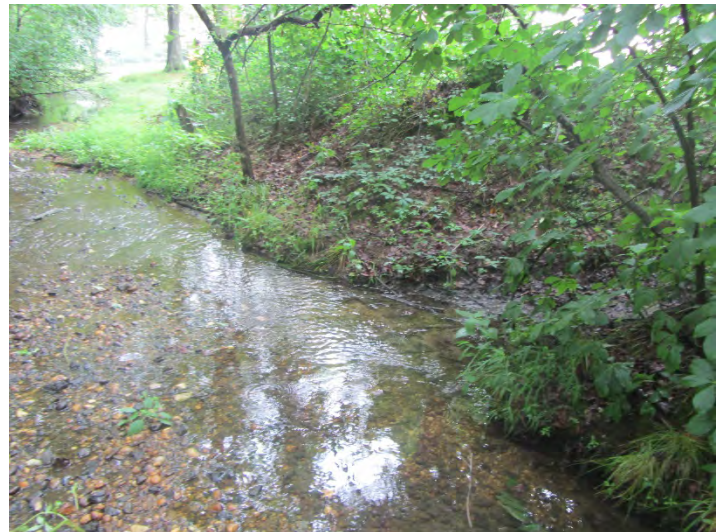
- Controlled flow channel
- No outfall pipe was found
- Sediment deposits
- Moderate erosion has been caused by the outfall

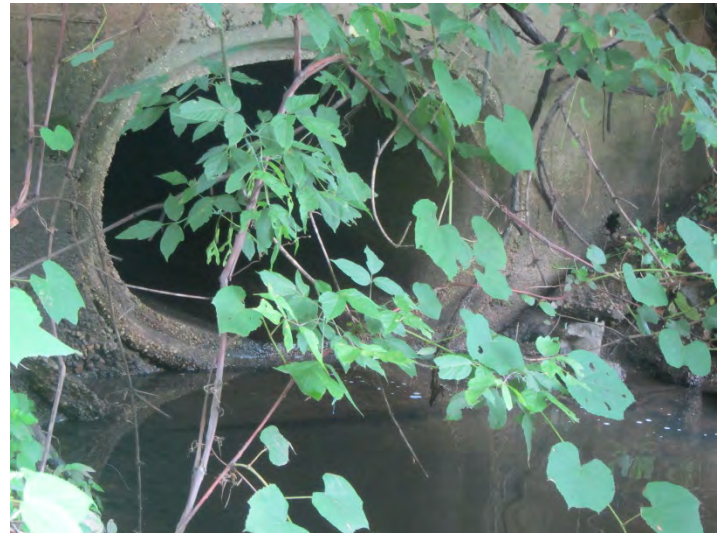
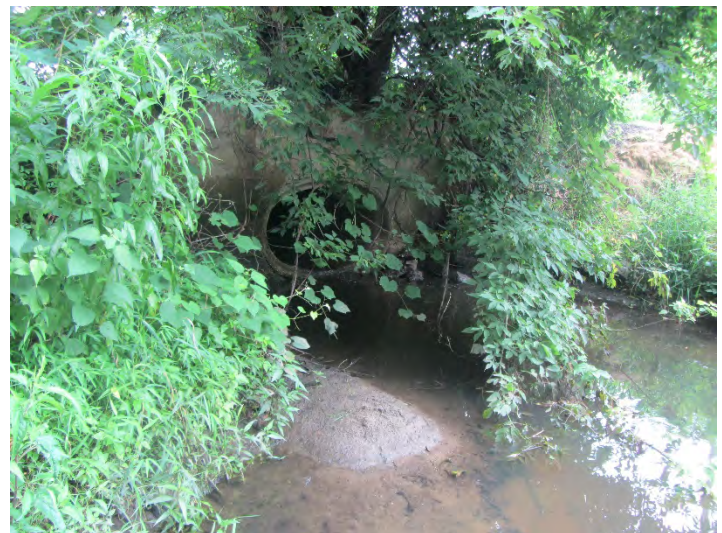
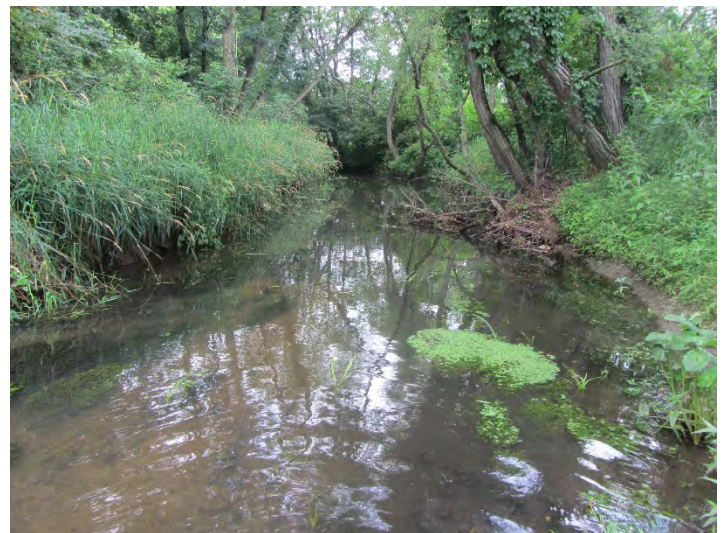
- 36" diameter concrete pipe
- Cloudy, grey water
- Sewage odor
- Sediment deposits
- Pipe is spalling
- Moderate erosion has been caused by the outfall

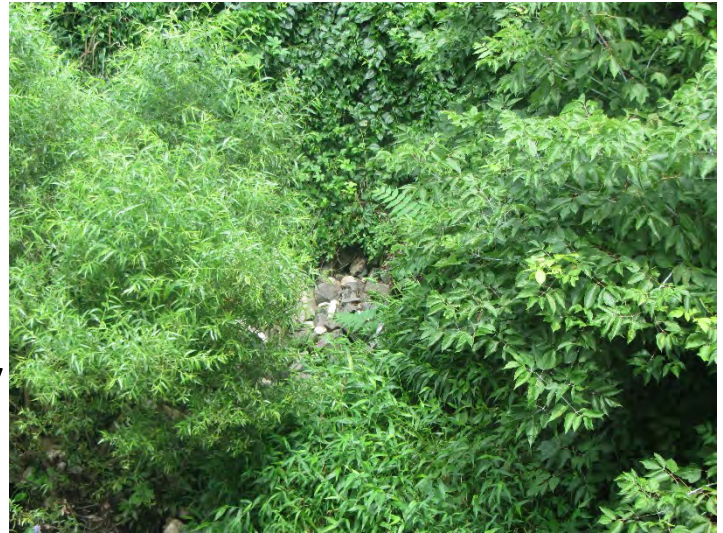
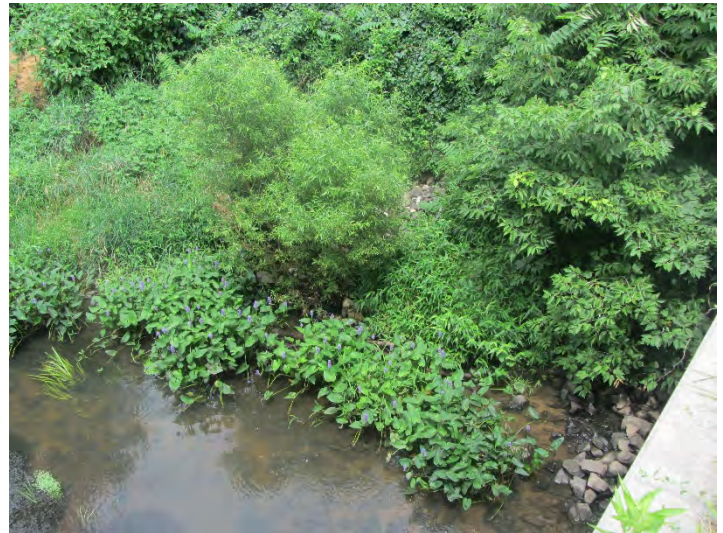
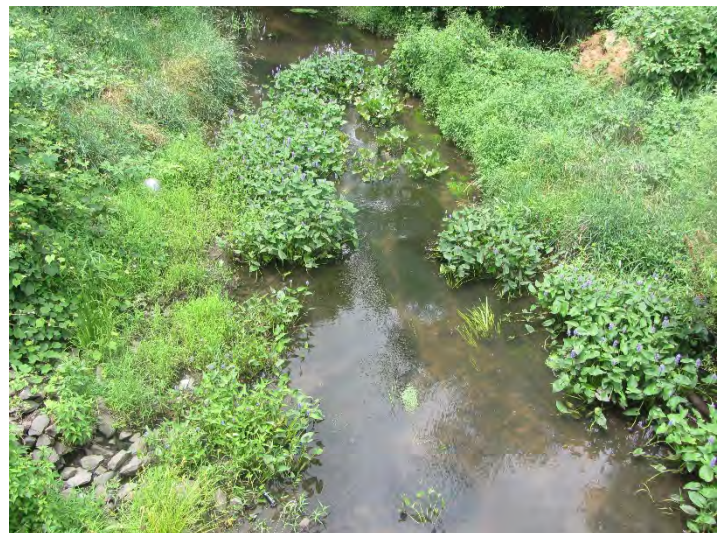
- Outfall pipe is not accessible by foot
- Reinforced concrete pipe
- Cloudy, grey water
- Sediment deposits
- Sewage odor

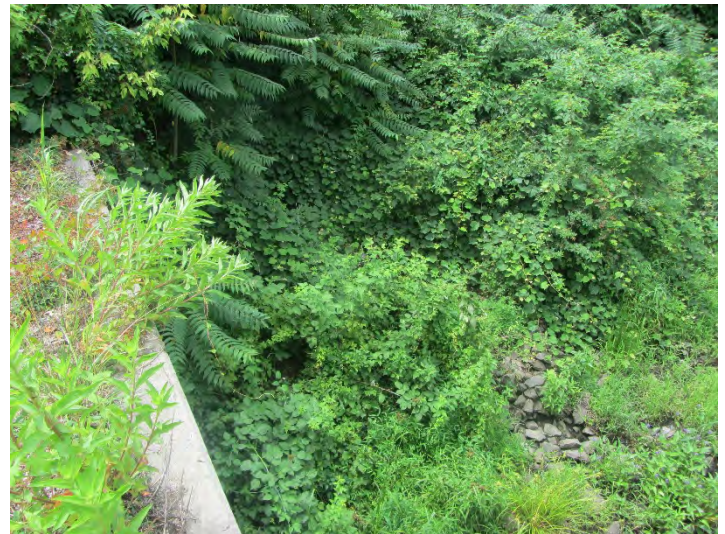
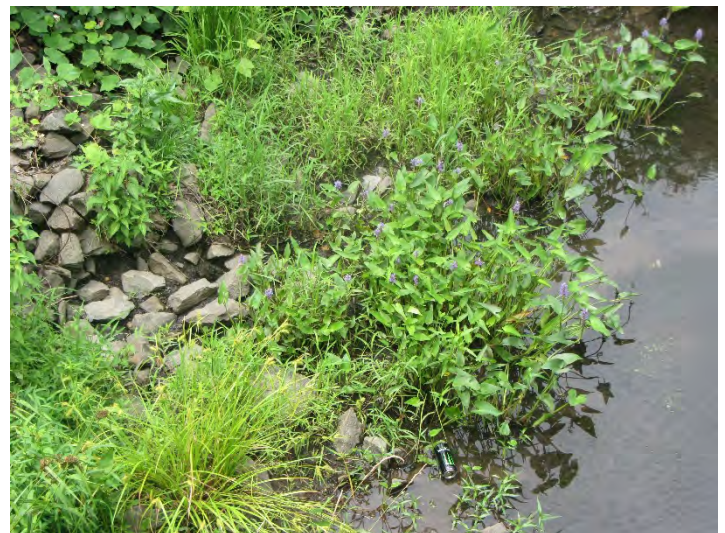
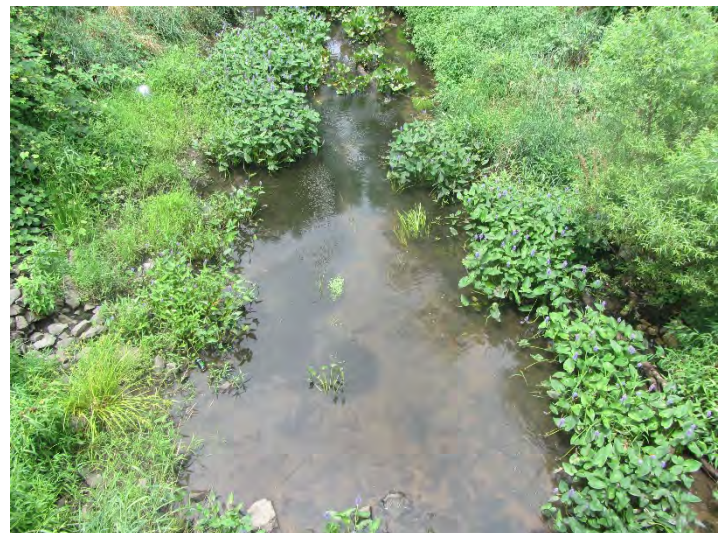
- Pipe not accessible by foot
- Reinforced concrete pipe
- Sewage odor

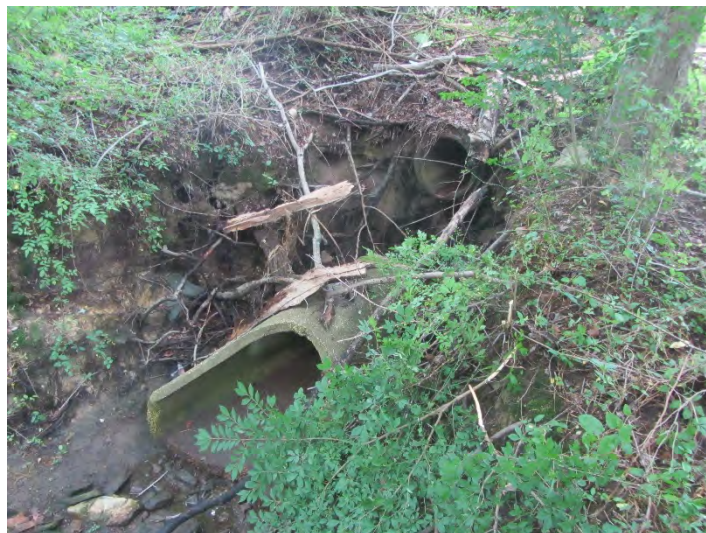
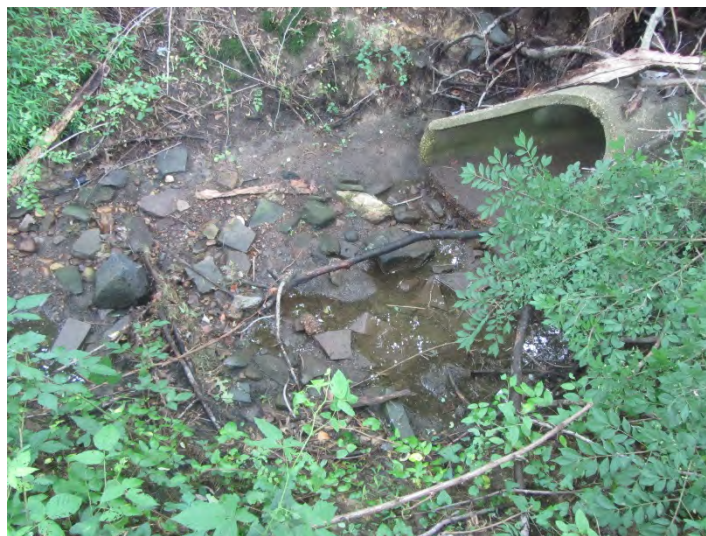
- 24" diameter concrete pipe
- Known commercial discharges
- Cloudy, grey water
- Sediment deposits
- Significant erosion has been caused by the outfall
- Erosion has undermined outfall stability
- Flared end section has detached and fallen into stream

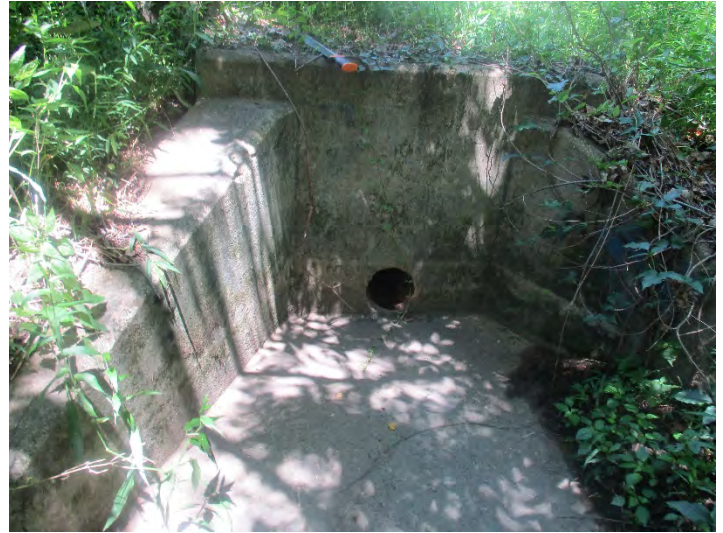
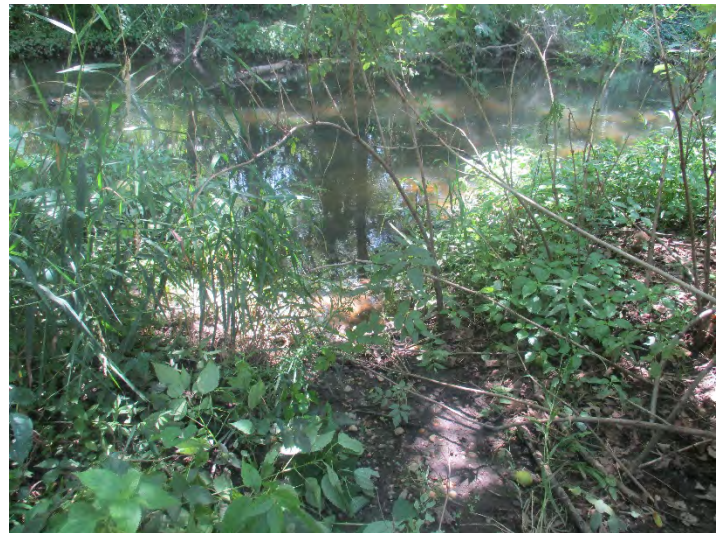
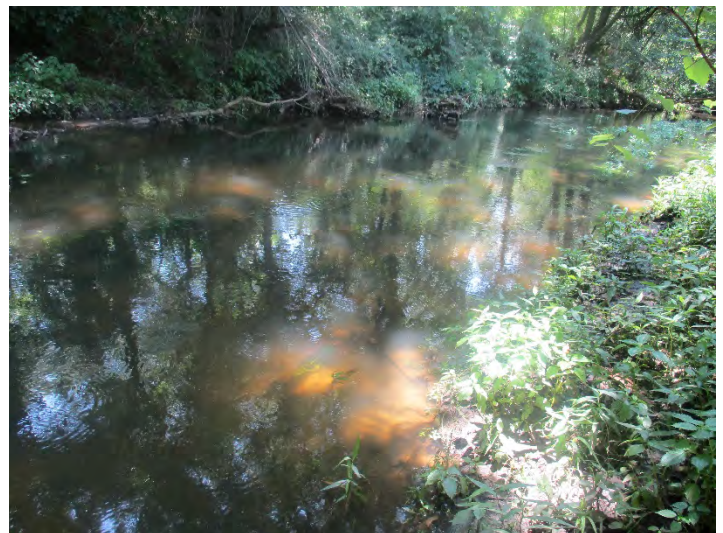
- 8" diameter metal pipe
- Known commercial discharges
- Cloudy, grey water

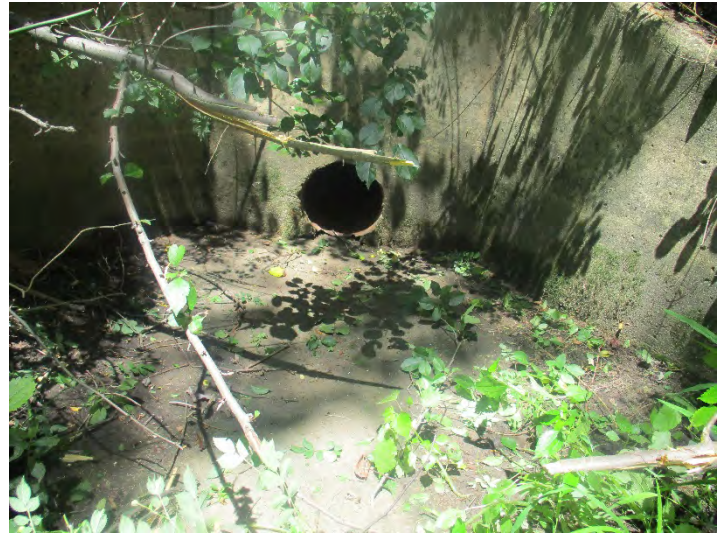
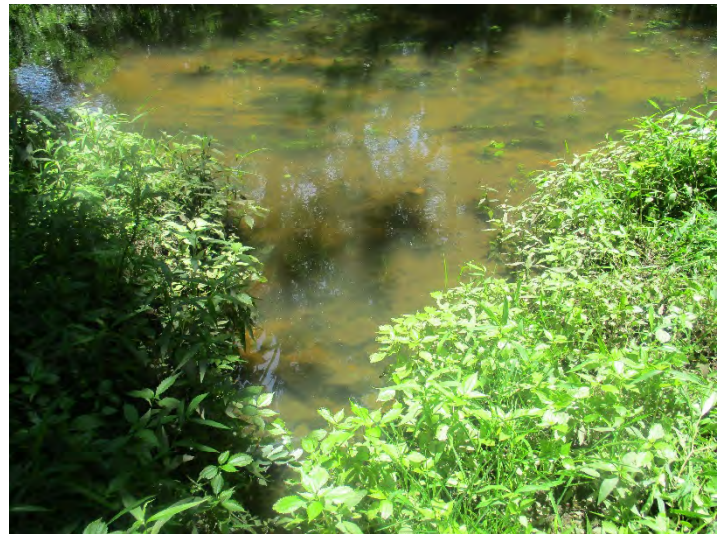
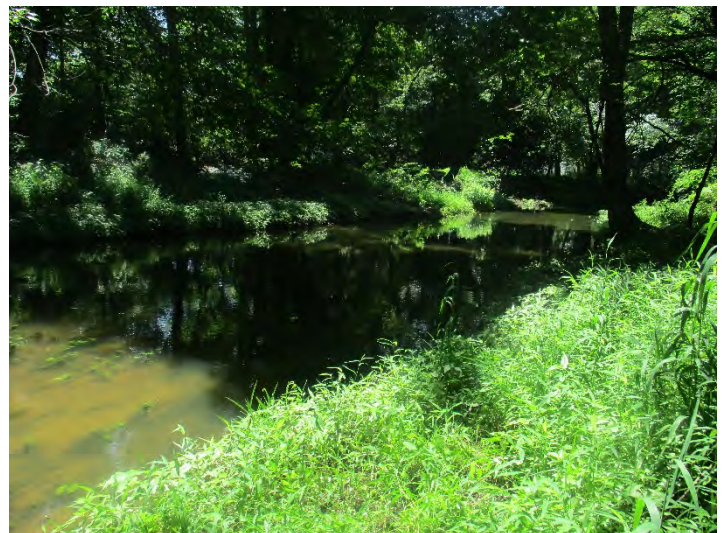
- 10" diameter metal pipe
- Known commercial discharges
- Grey water
- Sediment deposits

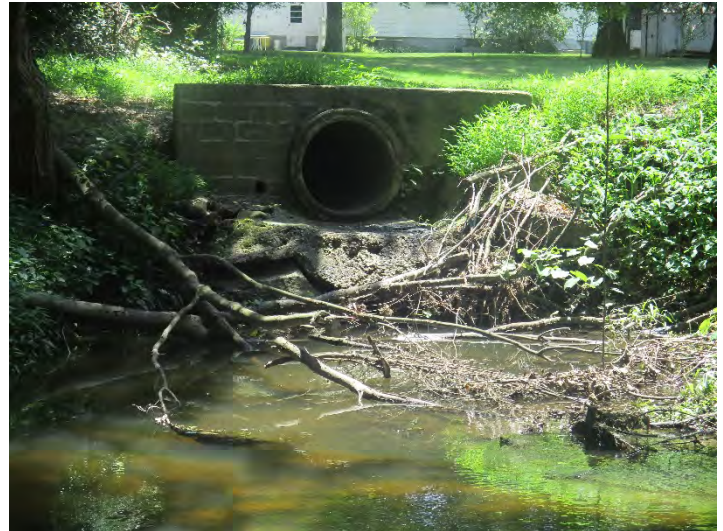
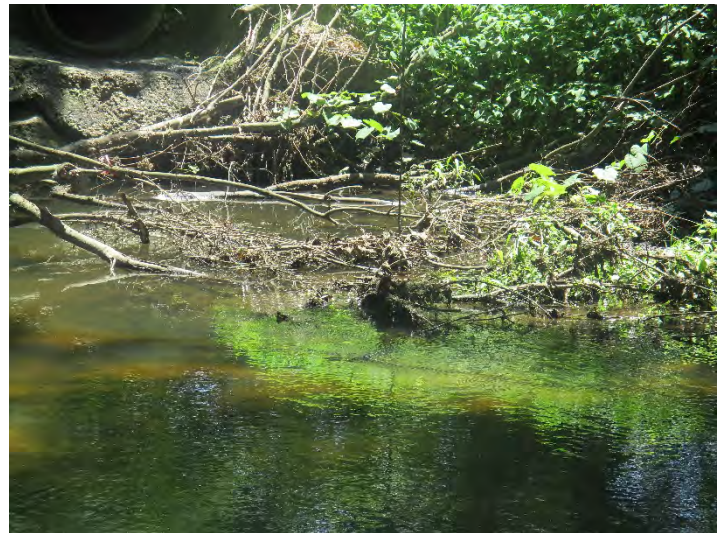
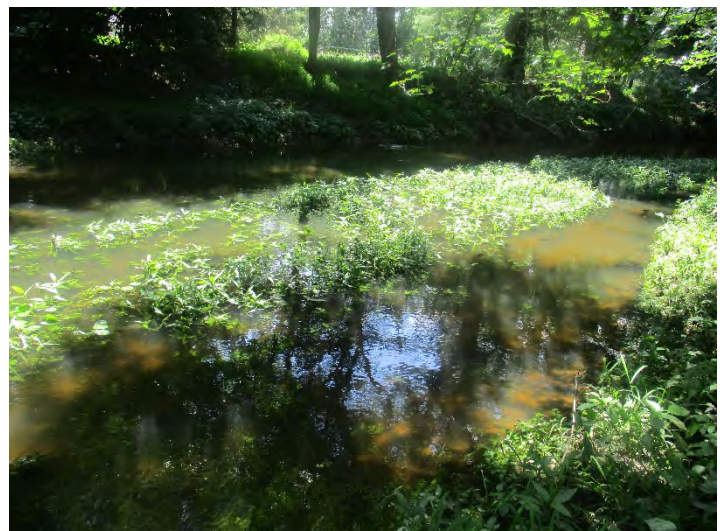
- 36" diameter concrete pipe
- Known commercial discharges
- Cloudy, grey water
- Sediment deposits
- Erosion has undermined outfall stability
- Minor erosion has been caused by the outfall
- Minor cracking in pipe
- Supporting structure is being damaged by tree roots

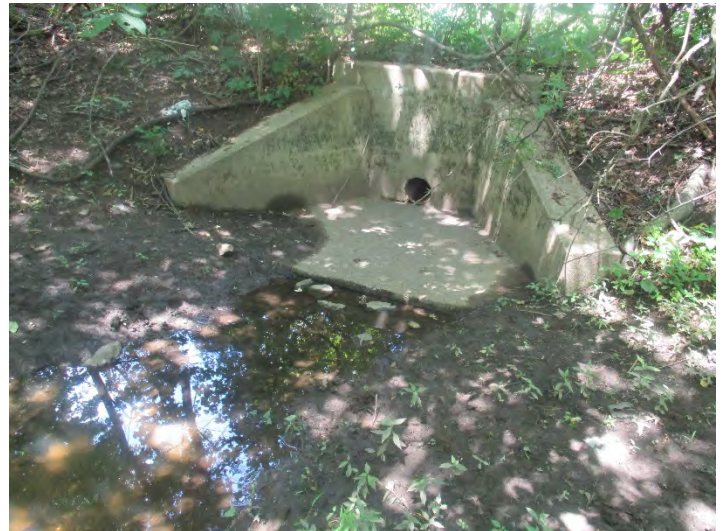
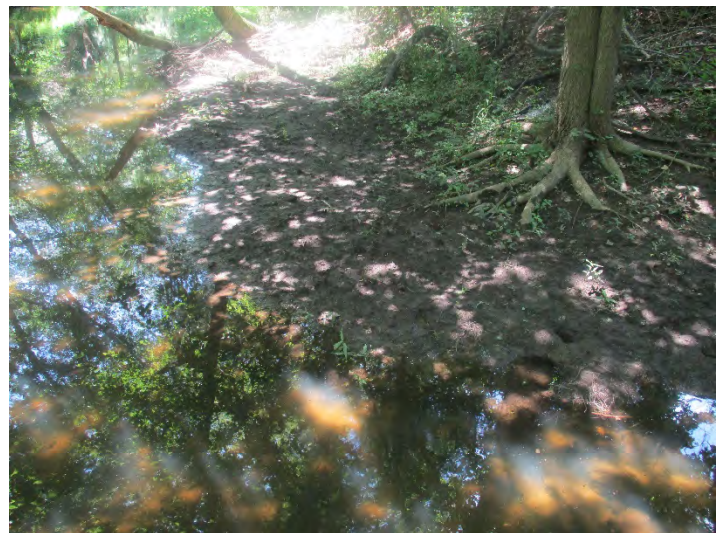
- 8" diameter metal pipe
- Known commercial discharges
- Cloudy, grey water
- Sediment deposits

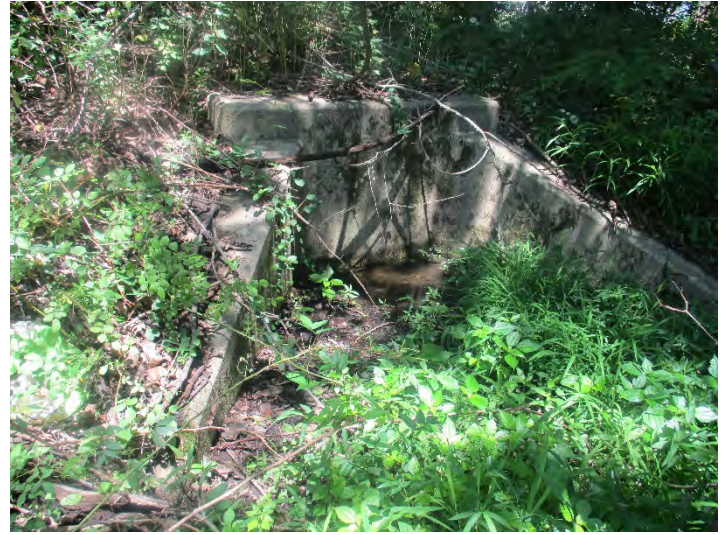
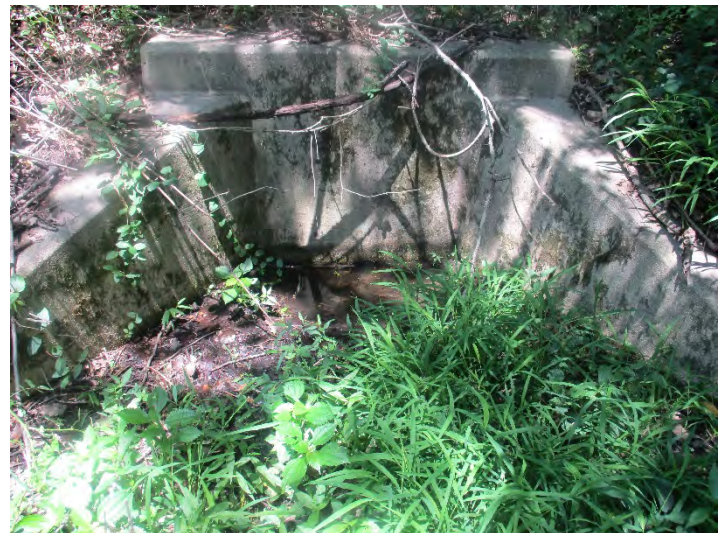
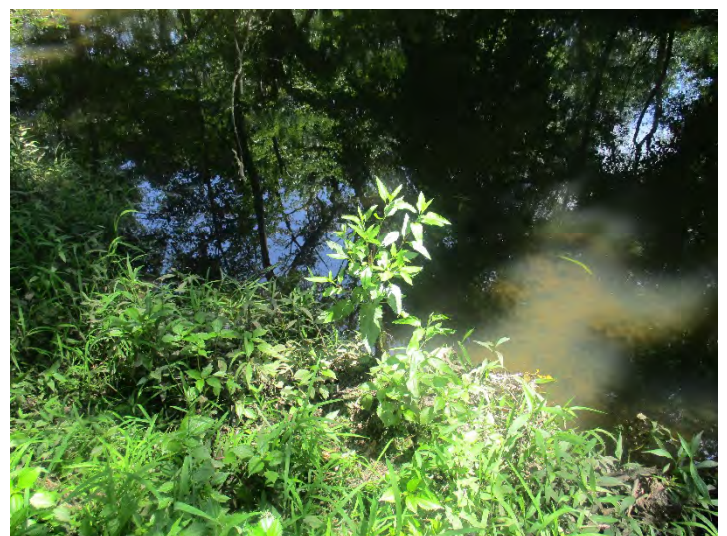
- 10" diameter metal pipe
- Grey water
- Sediment deposits
- Outfall has excessive sediment accumulation
