## Hamilton Township (Mercer County)

# REVIEW AND EVALUATION OF TOTAL MAXIMUM DAILY LOADS (TMDLs)

Developed by the Rutgers Cooperative Extension Water Resources Program  
Funded by Hamilton Township, Mercer County, New Jersey

December 5, 2019

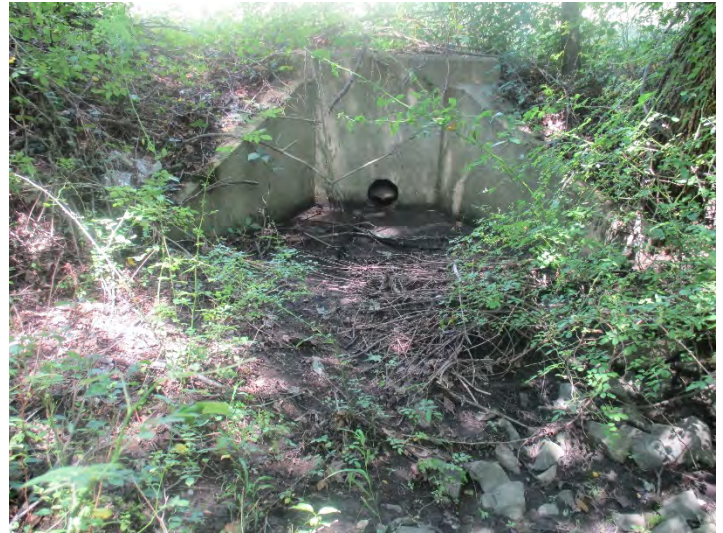
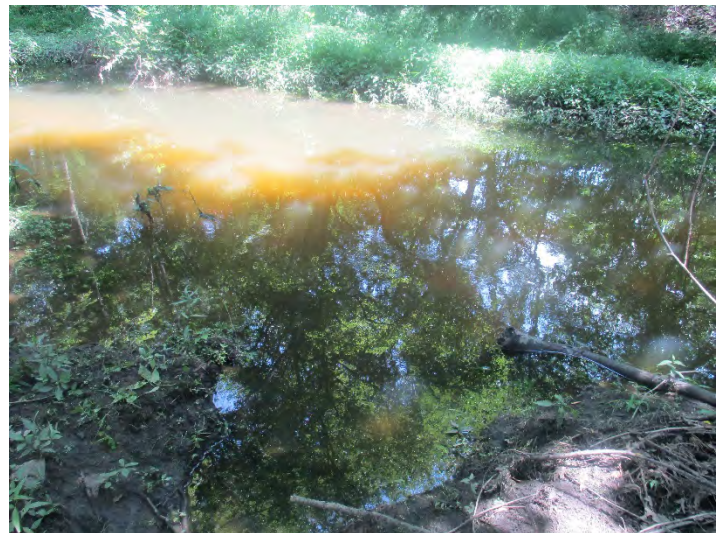
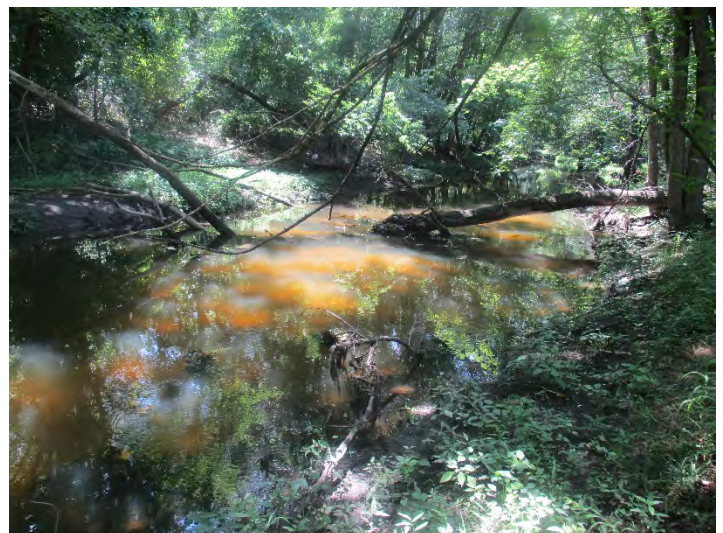
- 10" diameter metal pipe
- Known commercial discharges
- Sediment deposits

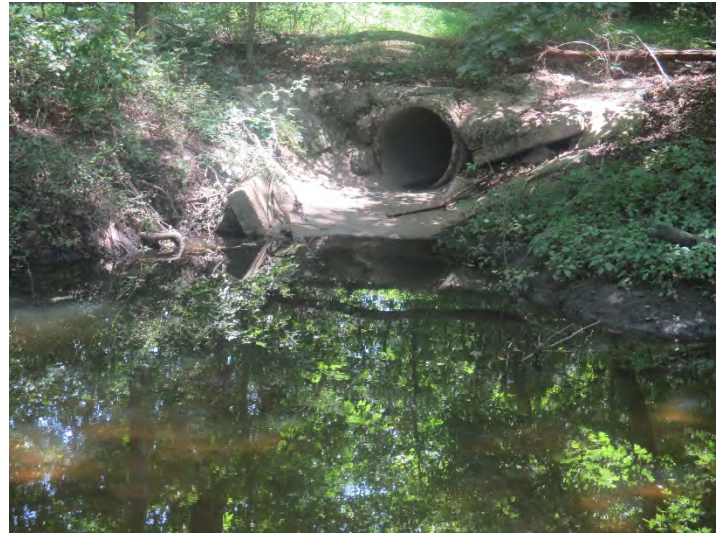
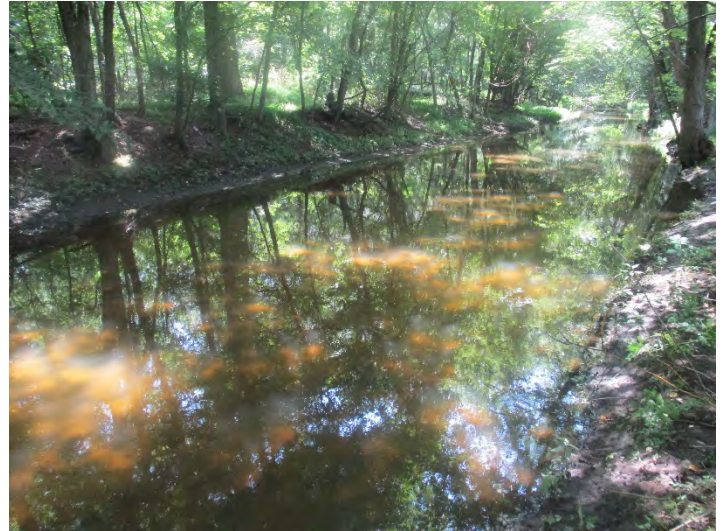
- Outfall pipe is approximately 36" in diameter
- Reinforced concrete pipe
- Cloudy, grey water
- Sediment deposits
- Minor erosion has been caused by the outfall
- Pipe was not accessible

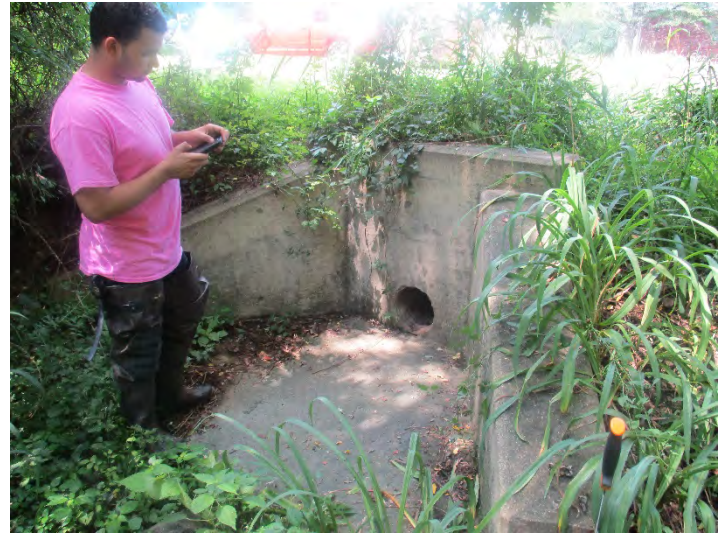
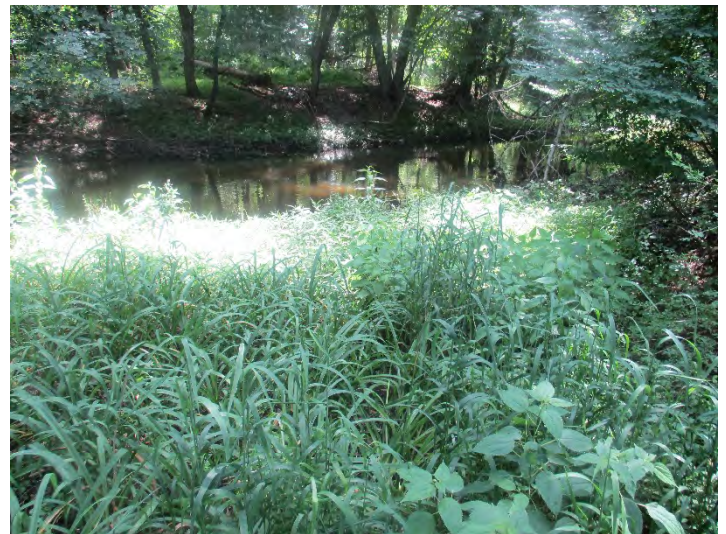
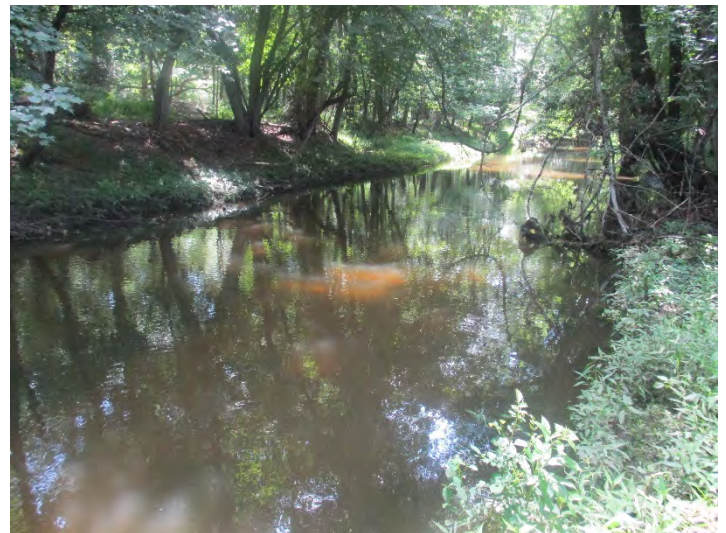
- 12" diameter metal pipe
- Known commercial discharges
- Cloudy, grey water
- Sediment deposits

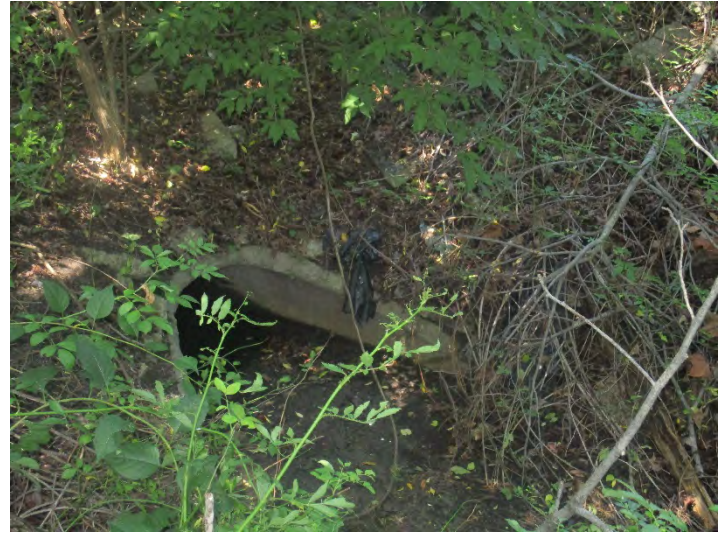
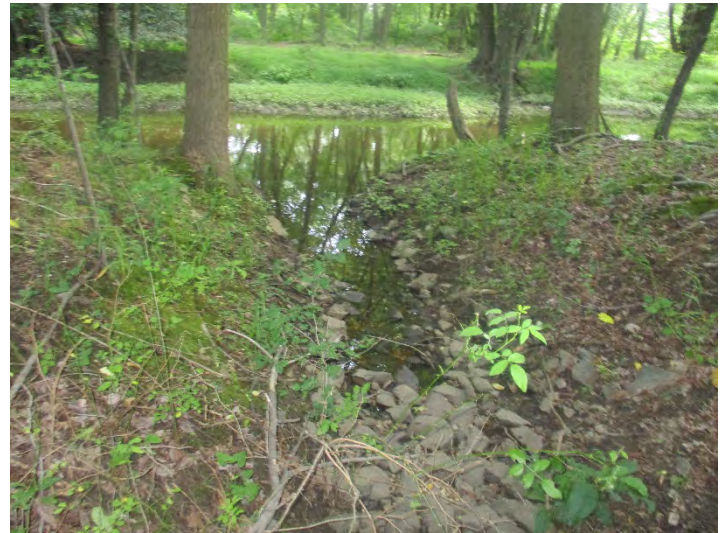
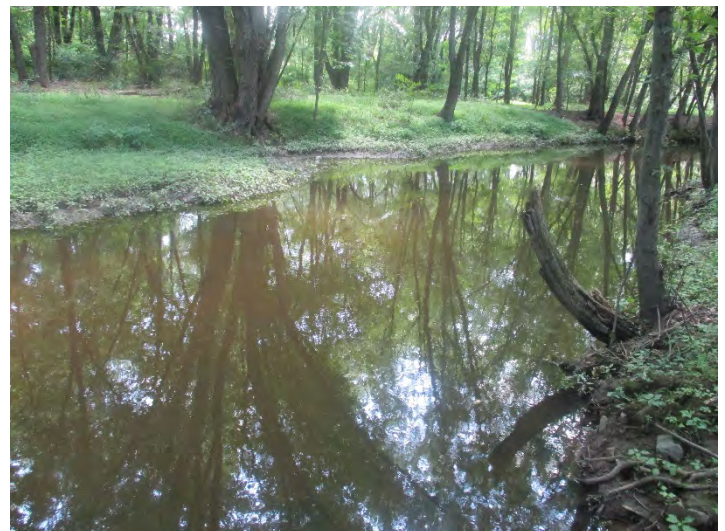
- 24" diameter concrete pipe
- Known commercial discharges
- Cloudy, brown water
- Sediment deposits

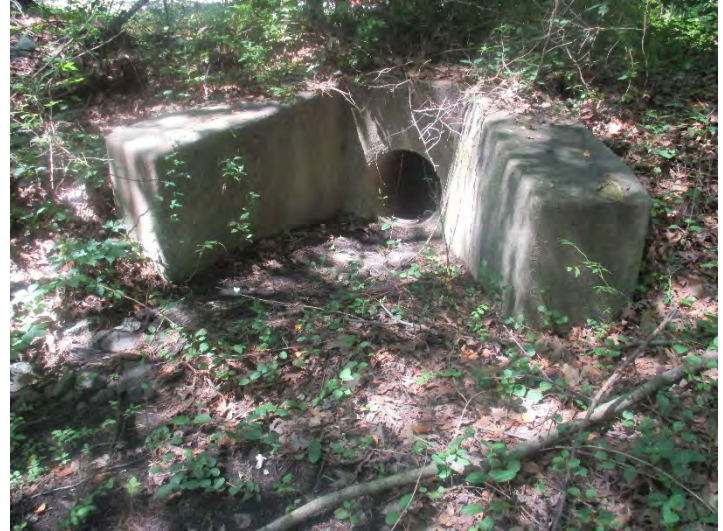
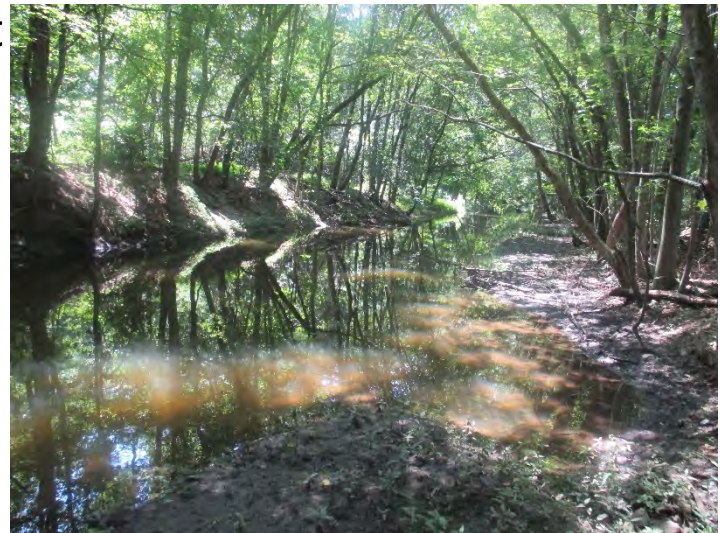
- 18" diameter concrete pipe
- Known commercial discharges
- Cloudy, grey water
- Sediment deposits
- Moderate erosion has been caused by outfall
- Outfall has excessive sediment accumulation

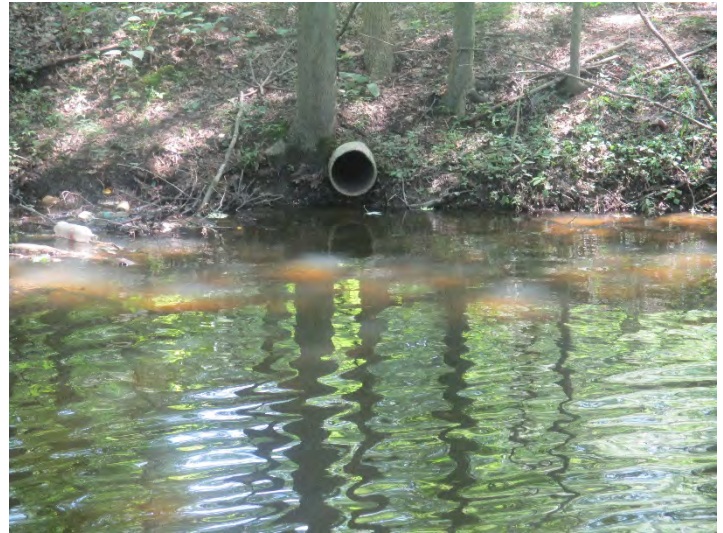
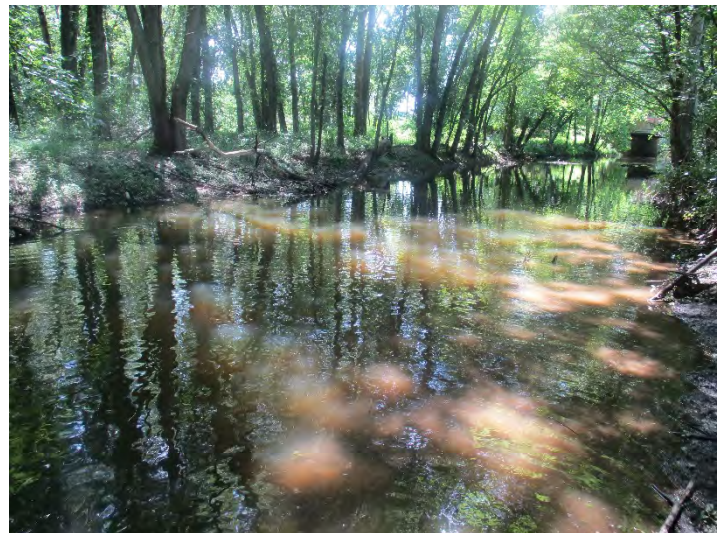
- 14" diameter concrete pipe
- Cloudy, grey water
- Sediment deposits

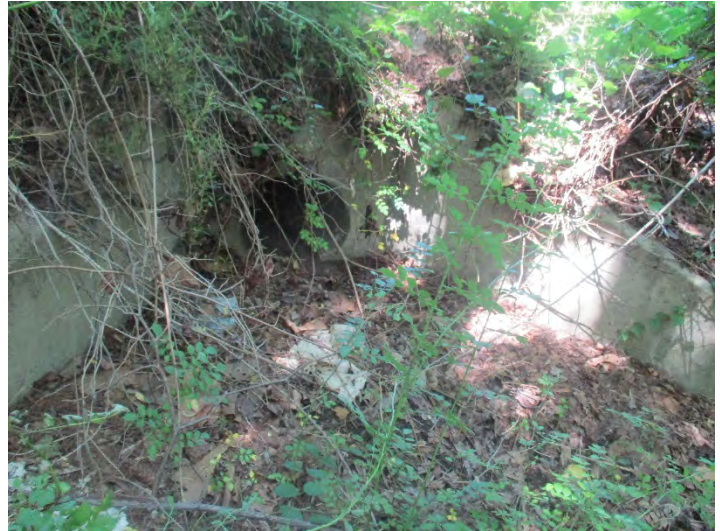
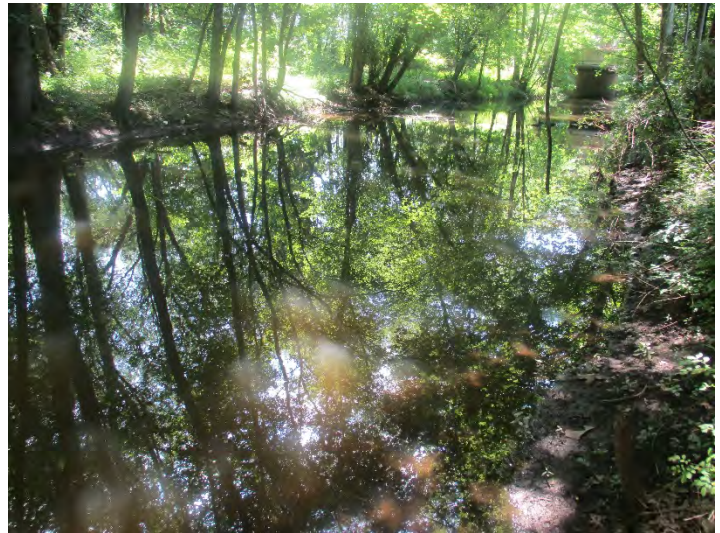
- 18" diameter concrete pipe
- Known commercial discharges
- Cloudy, grey water
- Sediment deposits
- Outfall has excessive sediment accumulation

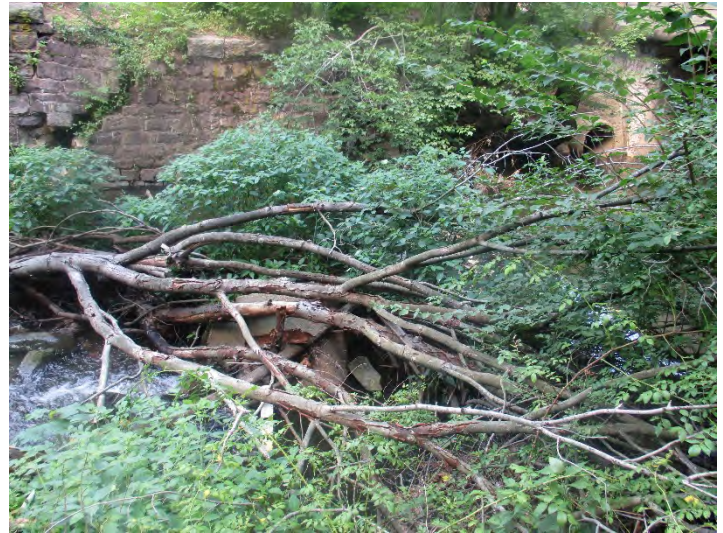
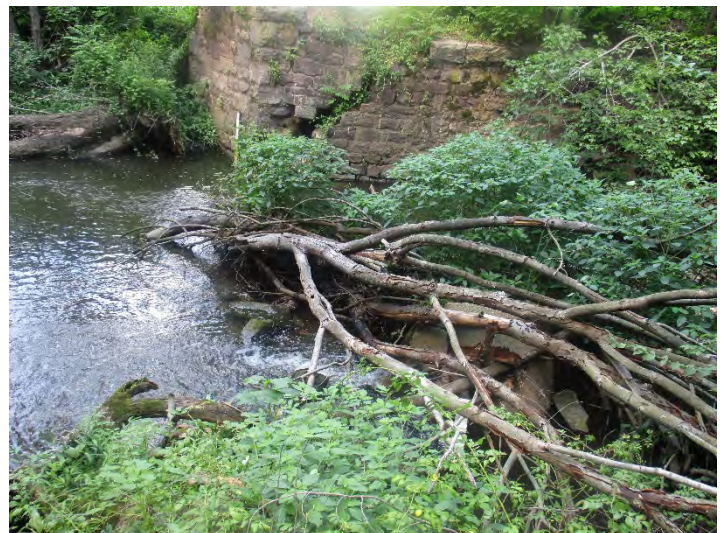
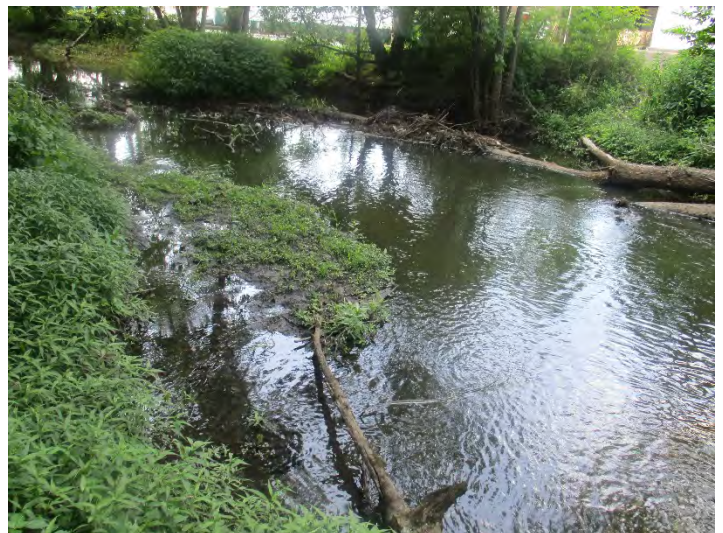
- 36" diameter concrete pipe
- Grey water
- Sediment deposits
- Erosion has undermined outfall stability
- Significant erosion has been caused by the outfall
- Outfall structure has completely deteriorated
- Outfall pipe has fell into the creek and is obstructing the flow of water

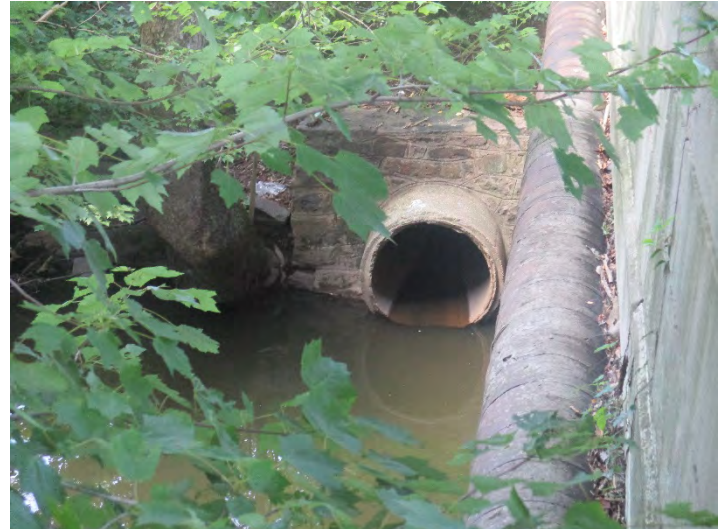
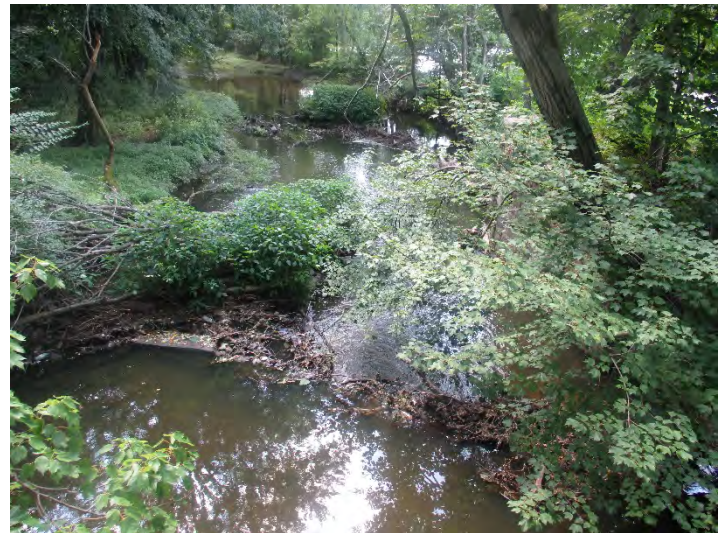
- 48" diameter concrete pipe
- Known commercial discharges
- Grey color
- Pipe is spalling
- Tree roots have undermined the outfall stability

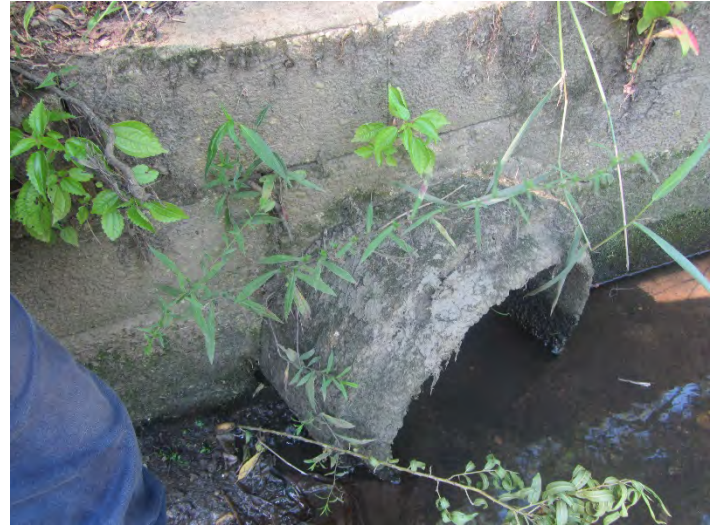
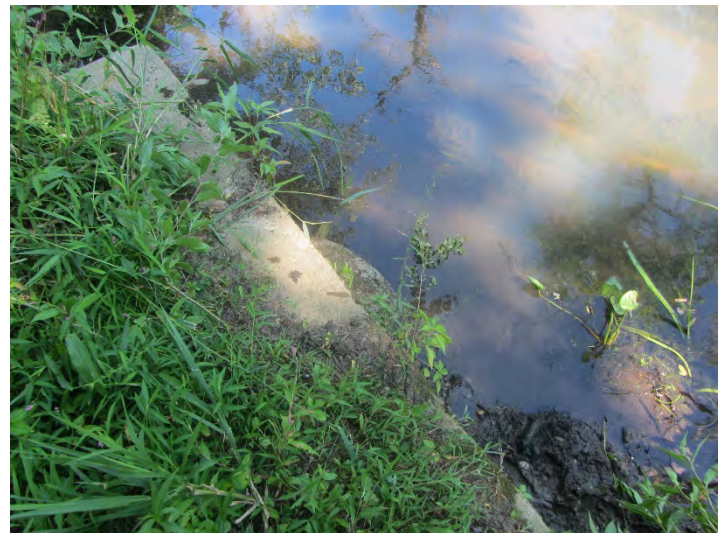
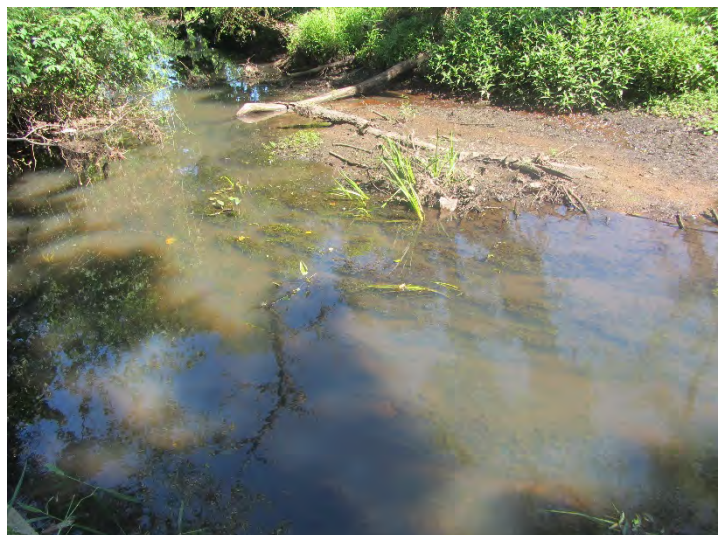
- 14" diameter concrete pipe
- Known commercial discharges
- Cloudy, grey water
- Sediment deposits
- Outfall has excessive sediment accumulation

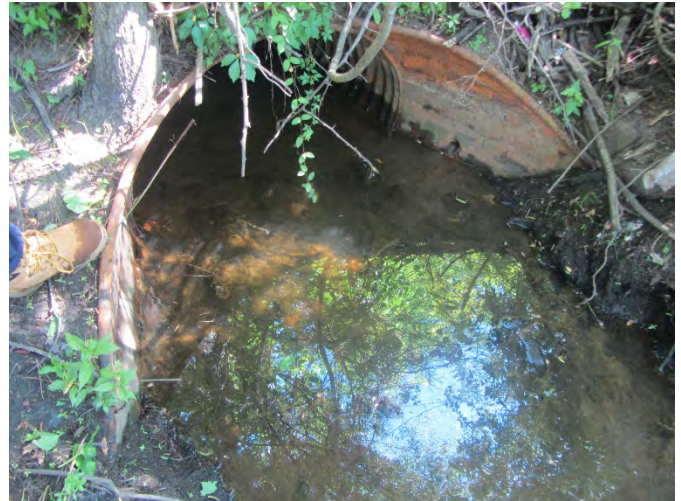
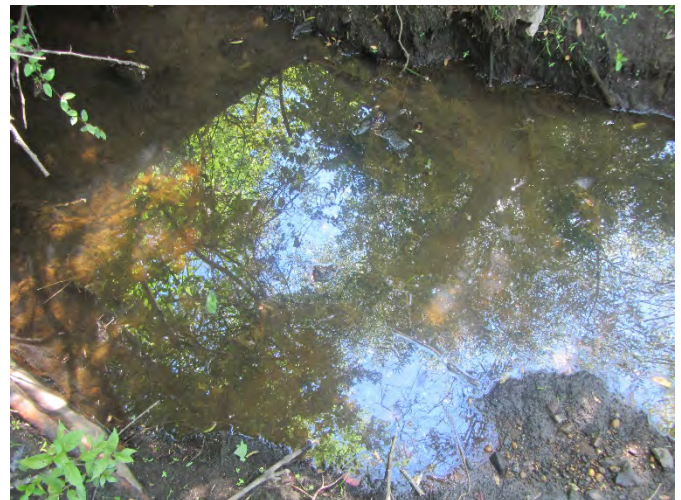
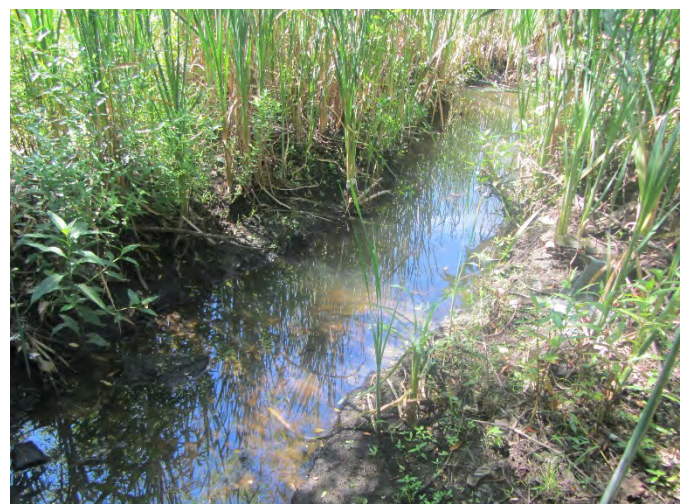
- 38" diameter metal pipe
- Known commercial discharges
- Cloudy, grey water
- Sediment and oil deposits
- Outfall pipe is corroding
- Moderate erosion has been caused by the outfall
- Nearby tree growth is contributing to erosion

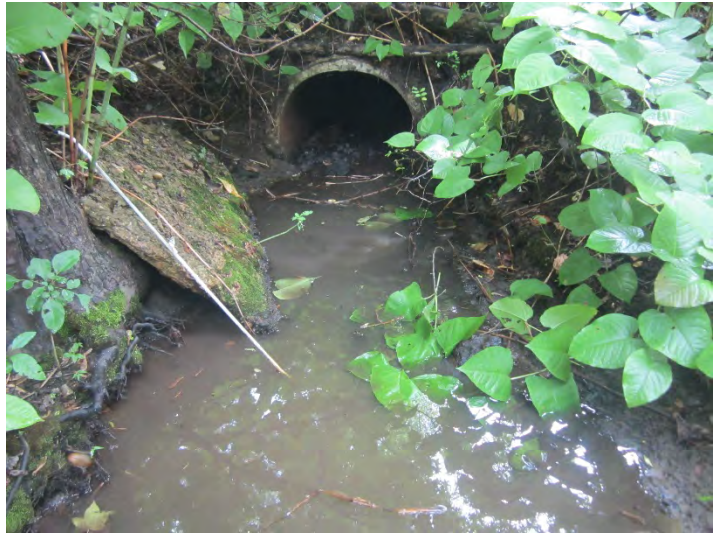
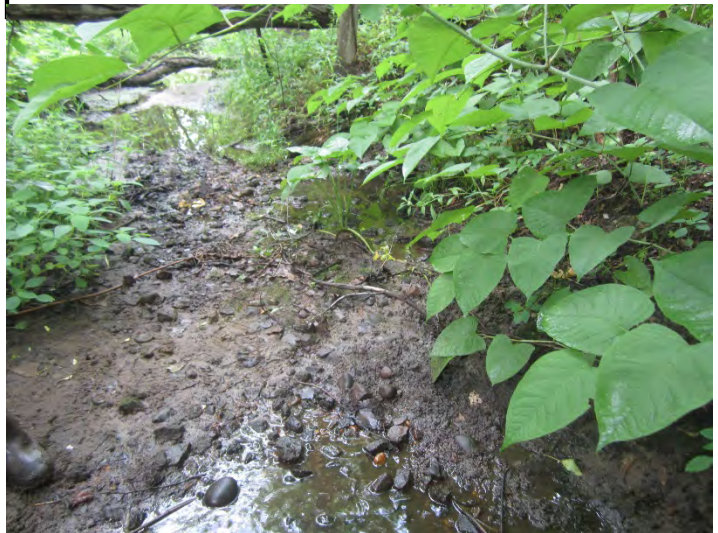
- Outfall pipe is 36" tall and 24" wide
- Reinforced Concrete Pipe
- Grey water
- Sediment deposits
- Excessive plant growth
- Erosion has undermined outfall stability
- Pipe appears to be crushed
- Outfall structure has deteriorated

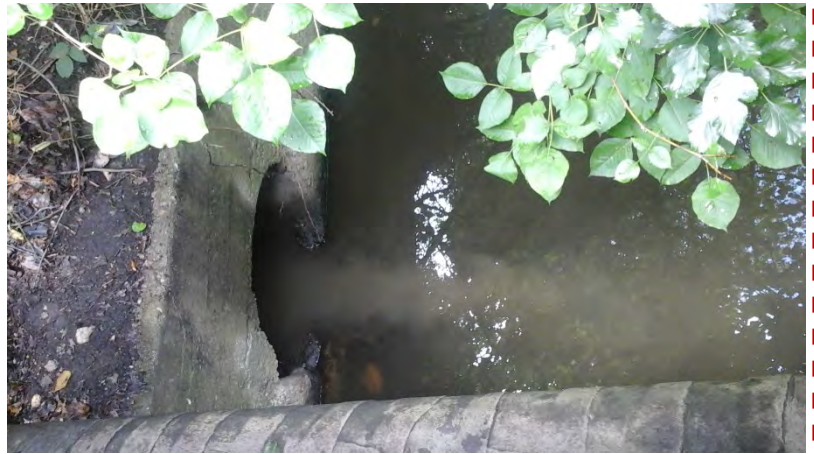
- 32" diameter concrete Pipe
- Cloudy, grey water
- Excessive growth
- Pipe was difficult to reach

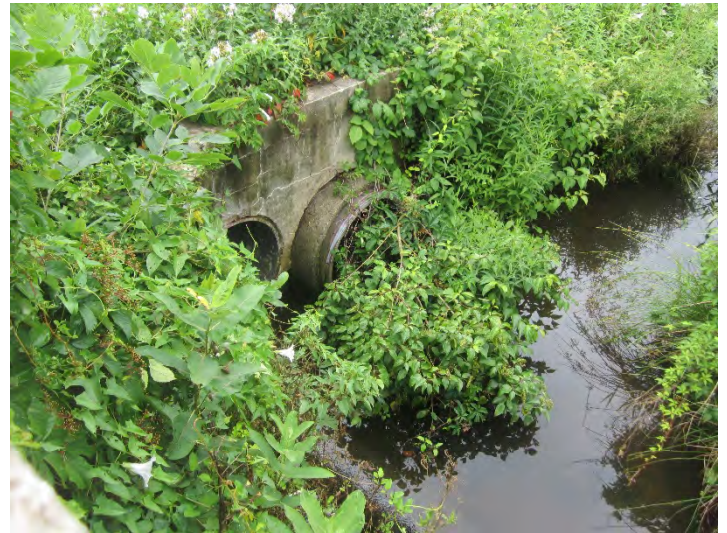
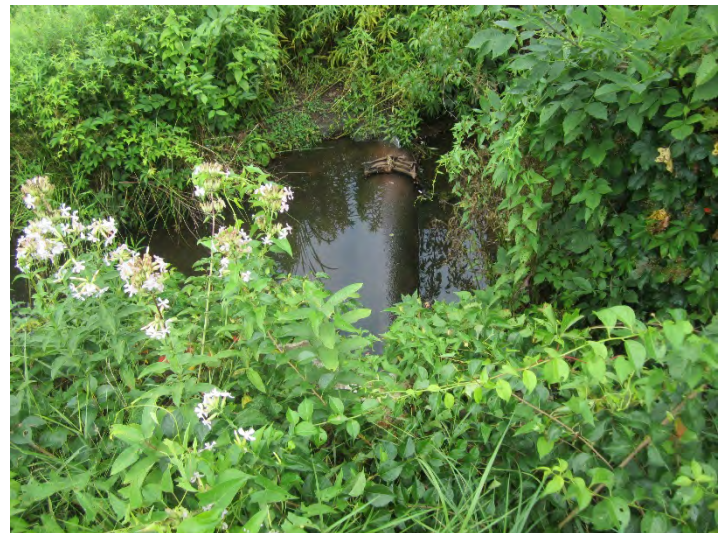
- 28" diameter metal pipe
- Cloudy, brown water
- Oily sheen
- Excessive vegetation growth
- Headwall is cracking

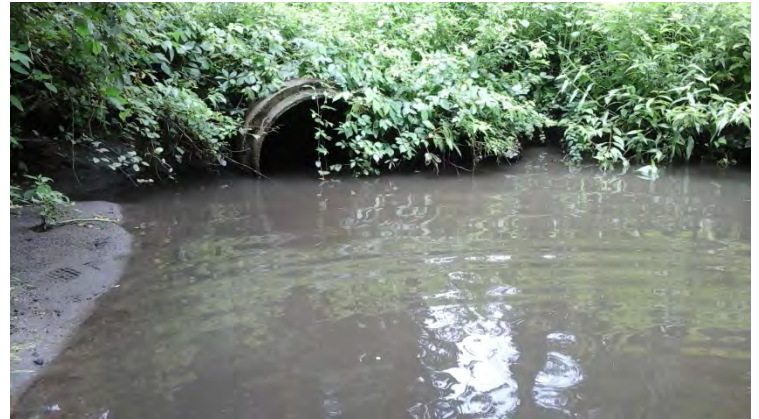
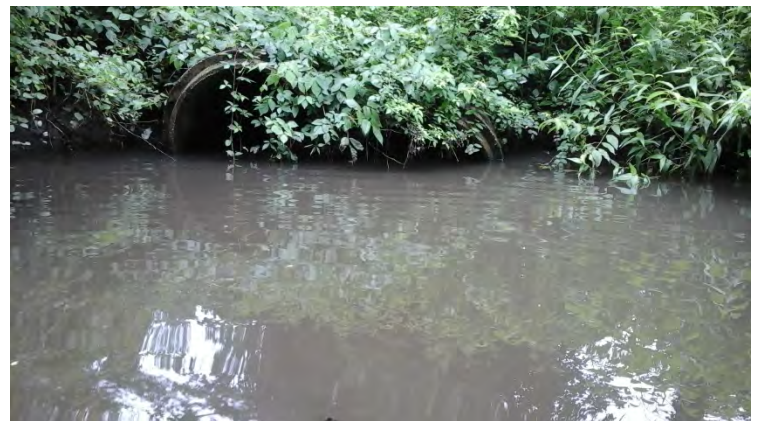
- 32" diameter concrete pipe
- Cloudy, brown water
- Sediment deposits, oily sheen, and floatable trash
- Erosion has undermined outfall stability
- Minor erosion has been caused by the outfall

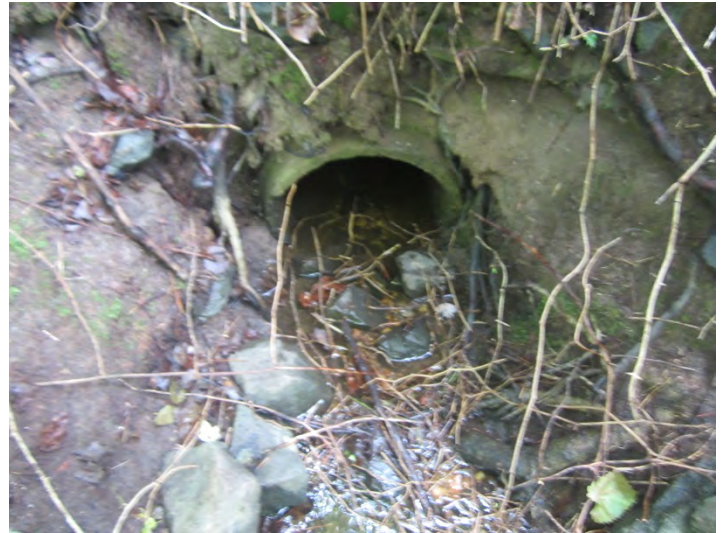
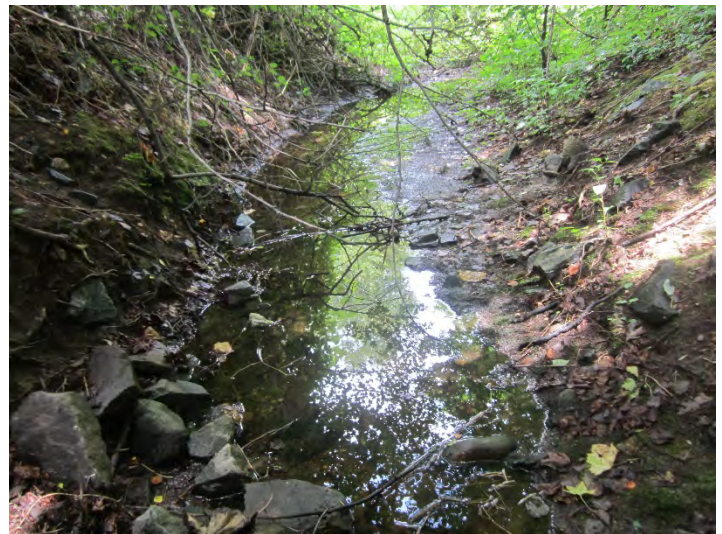
- 14" diameter concrete pipe
- Known commercial discharges
- Outfall pipe is cracking
- Minor erosion has been caused by the outfall

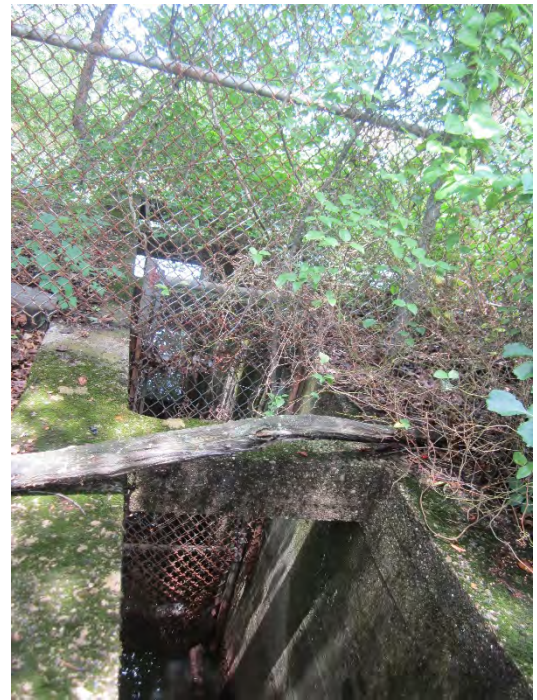
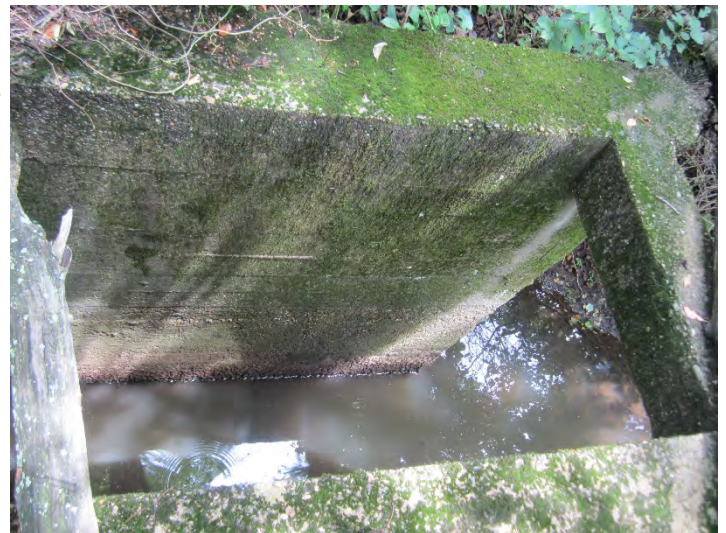
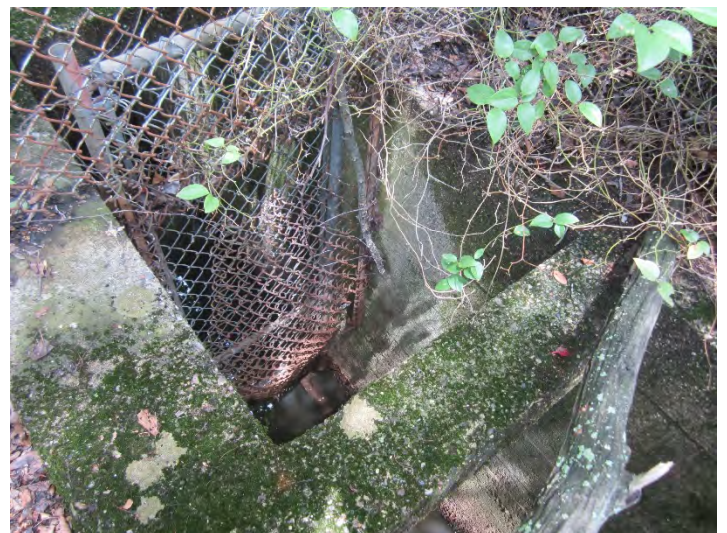
- Outfall structure from pond (not a pipe)
- Outfall is made of concrete
- Known commercial uses
- Opaque, cloudy water
- Sediment deposits and floatable trash
- Minor erosion has been caused by the outfall

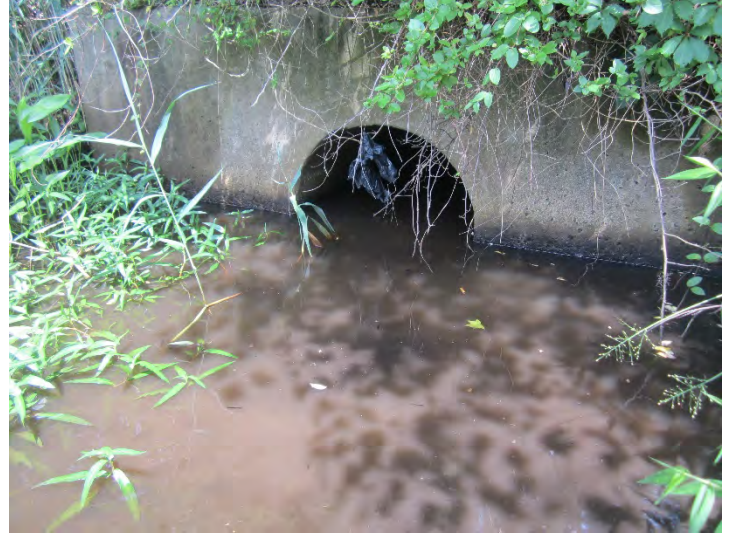
- 30" diameter concrete pipe
- Sour odor
- Opaque, brown water
- Sediment deposits
- Excessive vegetation growth

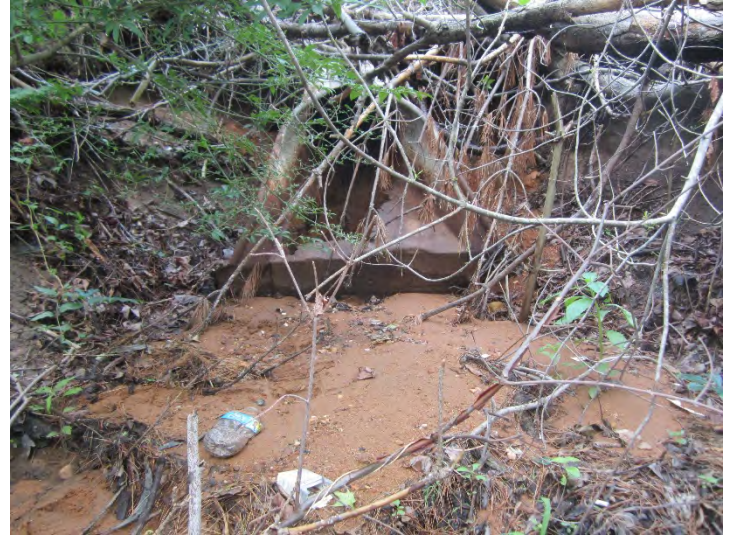
- 14" diameter metal pipe
- Sediment deposits
- Excessive vegetation growth
- Significant erosion has been caused by the outfall
- Pipe has been damaged by large tree falling and creating a large hole in pipe

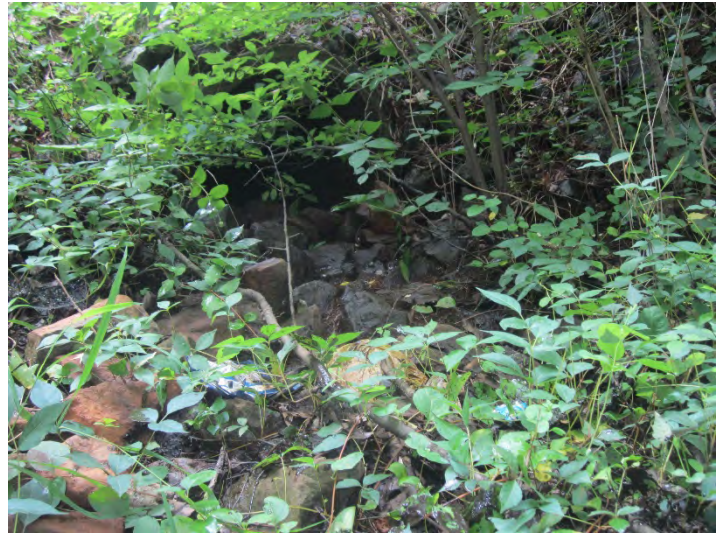
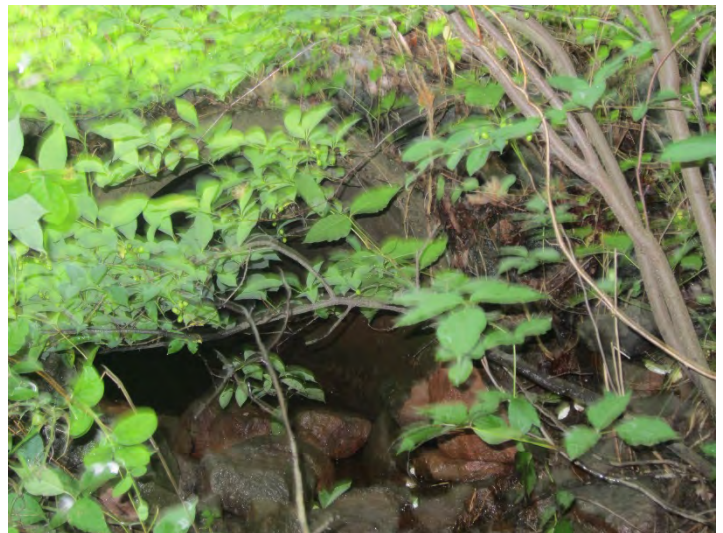
- 25" diameter concrete pipe
- Cloudy, grey water
- Sediment deposits and floatable trash
- Excessive vegetation growth
- Minor erosion has been caused by the outfall

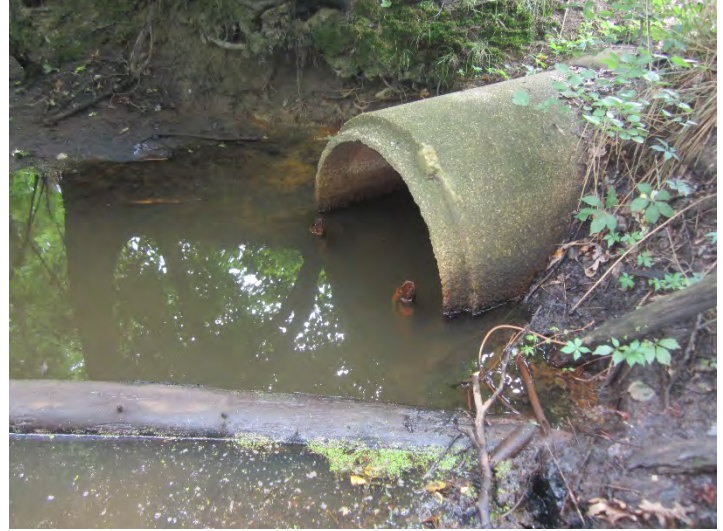
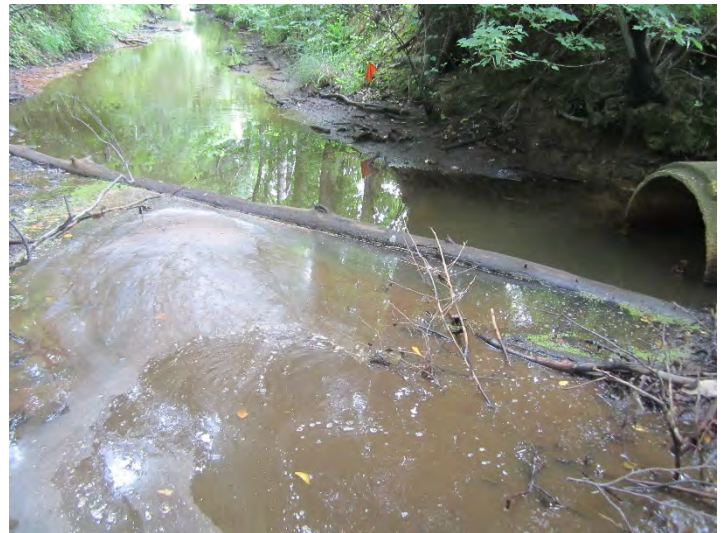
- 30" diameter concrete pipe
- Sewage odor
- Opaque, brown water
- Sediment deposits and oily sheen

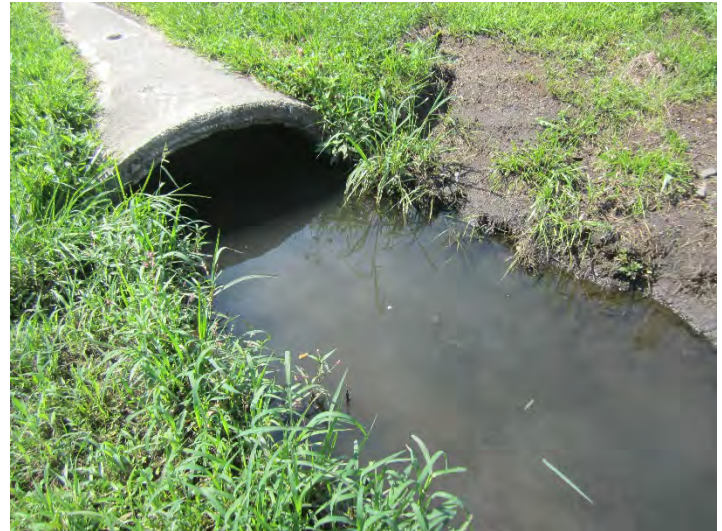
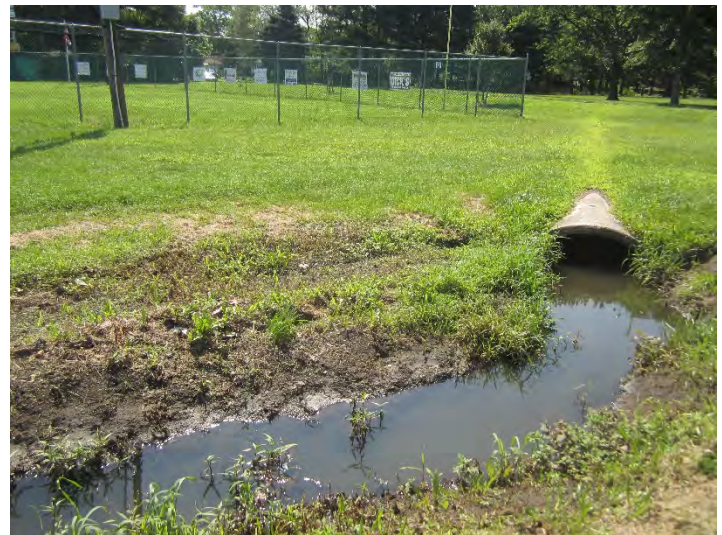
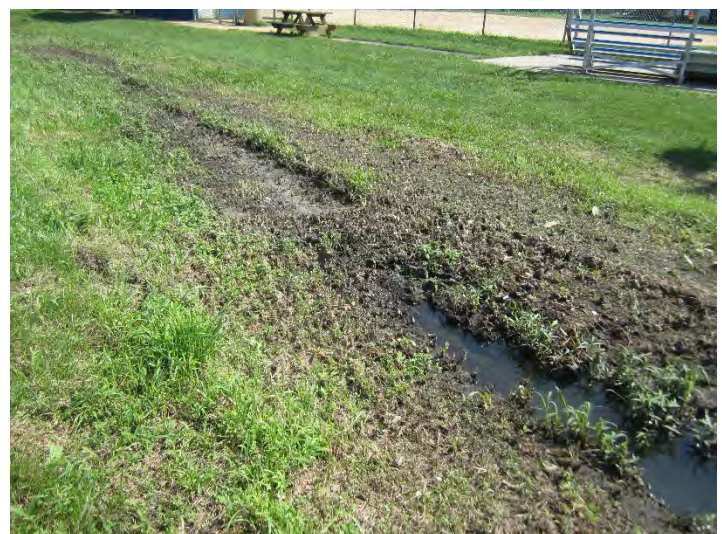
- 38" diameter concrete pipe
- Cloudy, brown water
- Sediment deposits and floatable trash
- Outfall pipe is corroding

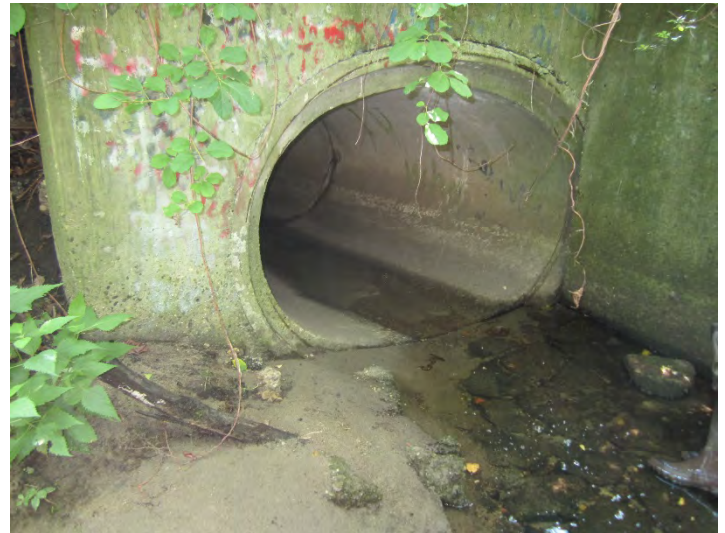
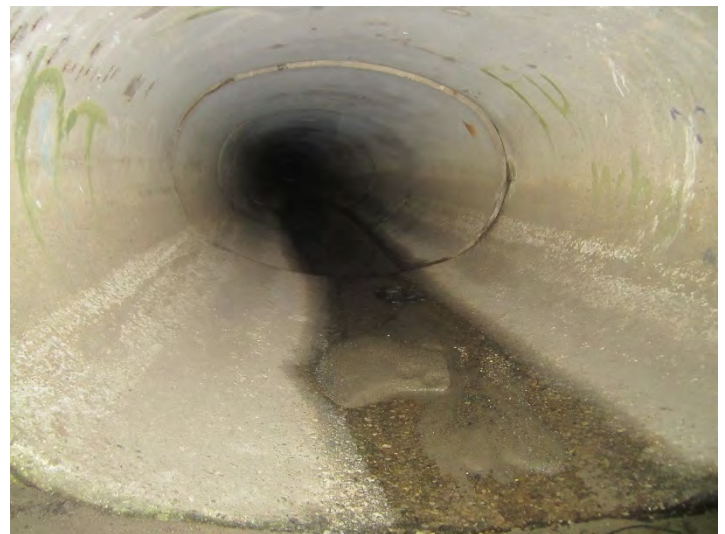
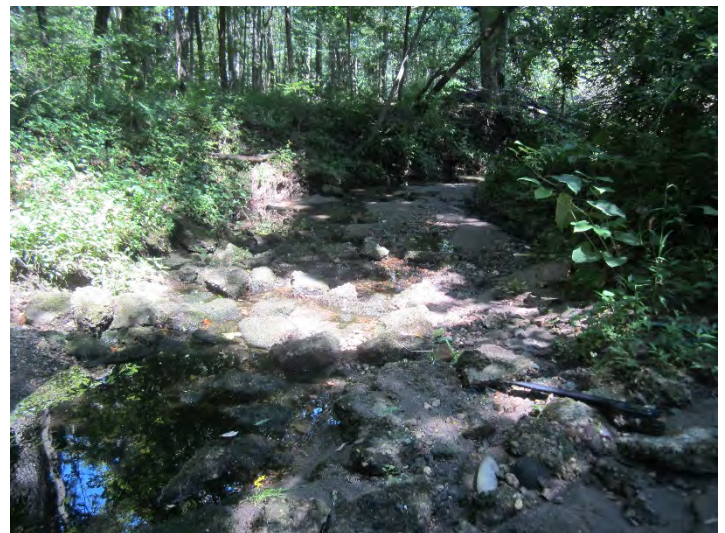
- Outfall pipe is 78" wide and 48" tall (elliptical)
- Reinforced concrete pipe
- Sediment deposits
- Outfall pipe has begun to crack
- Minor erosion has been caused by the outfall

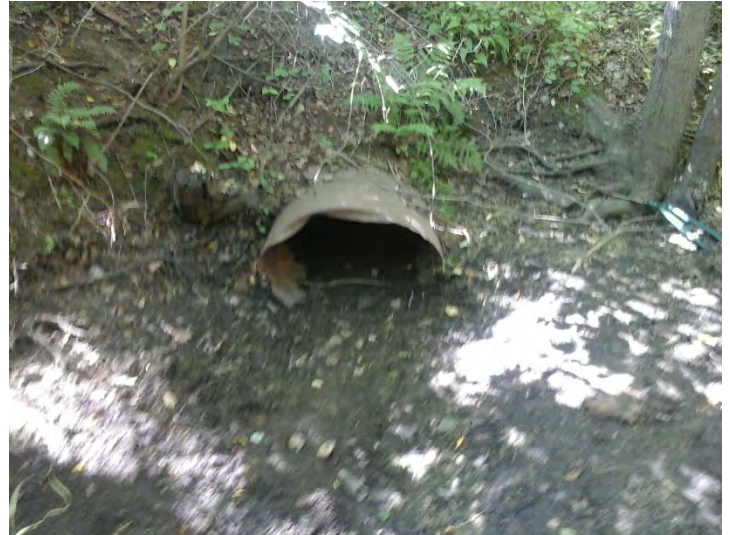
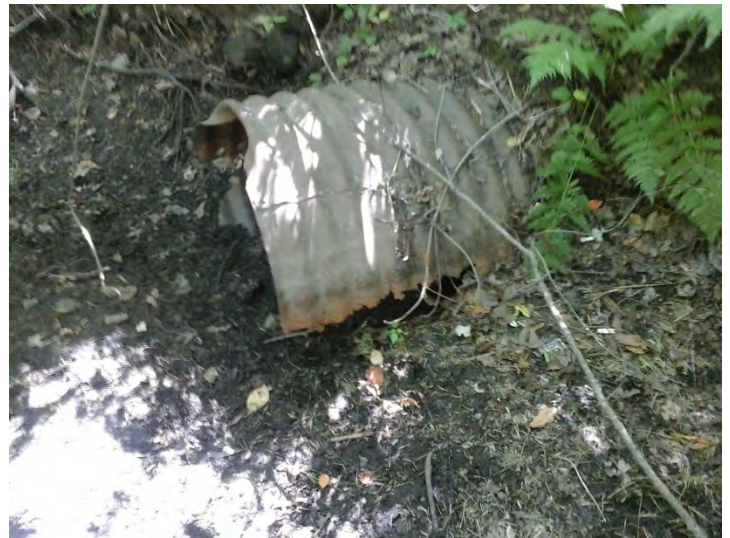
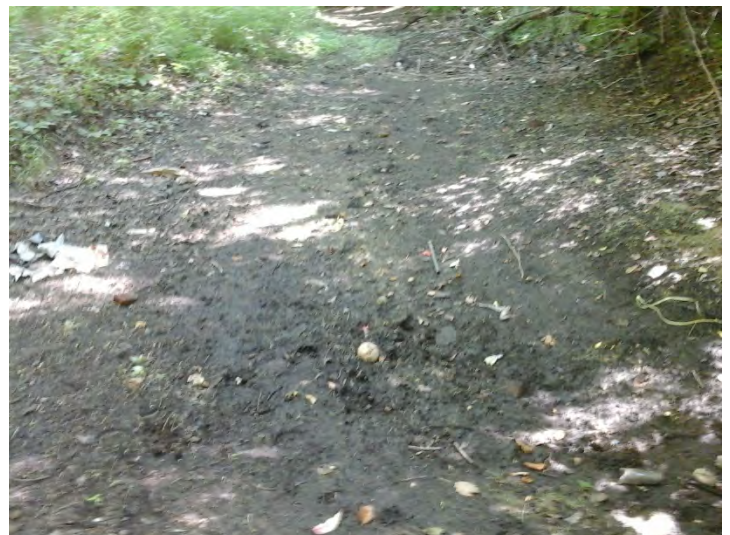
- Outfall pipe is 16" tall and 29" wide (elliptical)
- Metal pipe
- Cracking in pipe
- Outfall pipe is being crushed by sediment

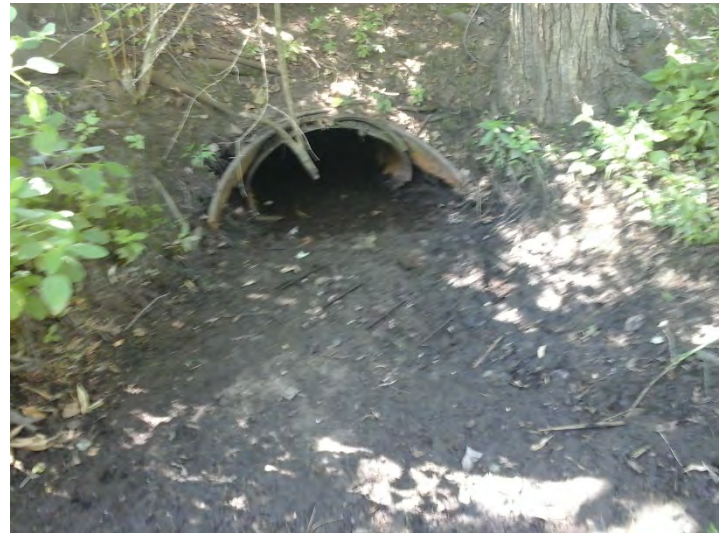
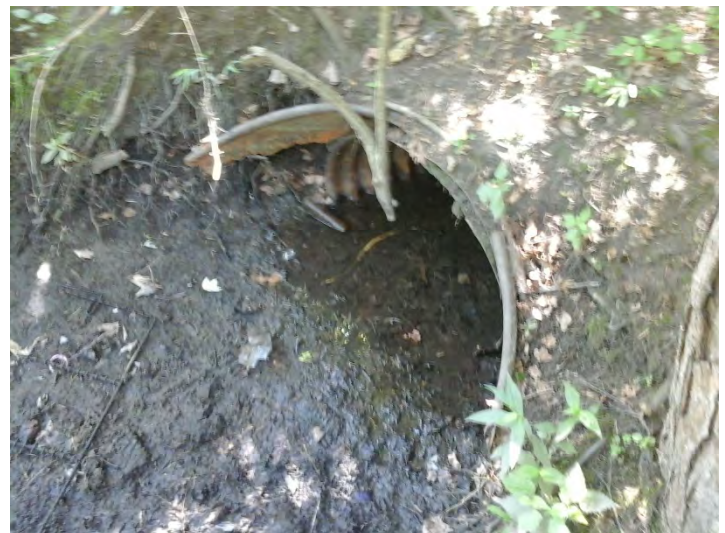
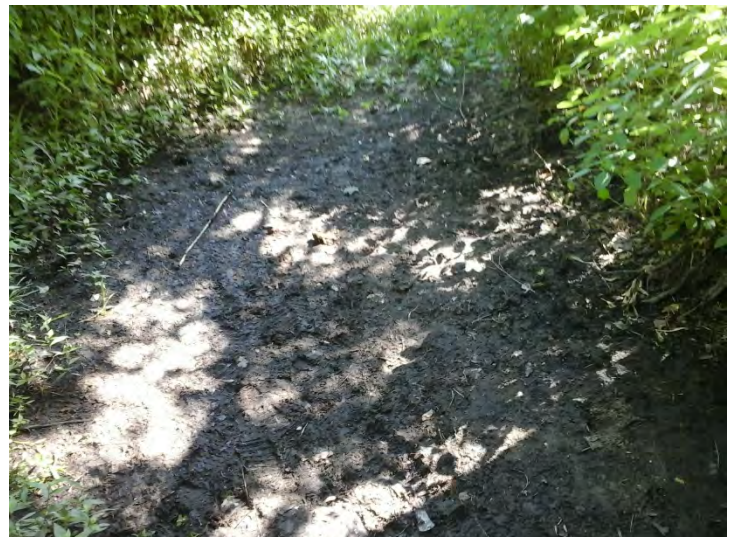
- Outfall pipe is 16" tall and 22" wide (elliptical)
- Metal pipe
- Outfall pipe is being crushed
- Flared-end section is corroding
