## Hamilton Township (Mercer County)

# REVIEW AND EVALUATION OF TOTAL MAXIMUM DAILY LOADS (TMDLs)

Developed by the Rutgers Cooperative Extension Water Resources Program  
Funded by Hamilton Township, Mercer County, New Jersey

December 5, 2019

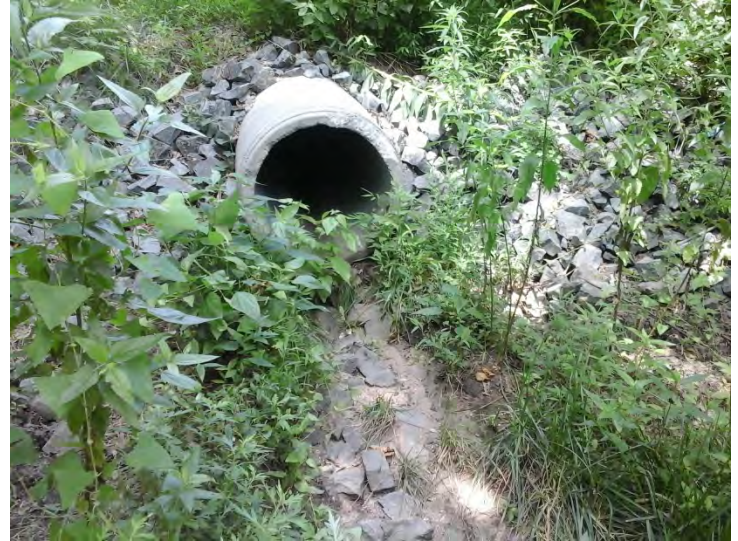
- 25" diameter concrete pipe
- Sediment deposits
- Outfall has excessive sediment accumulation
- Outfall pipe is cracking

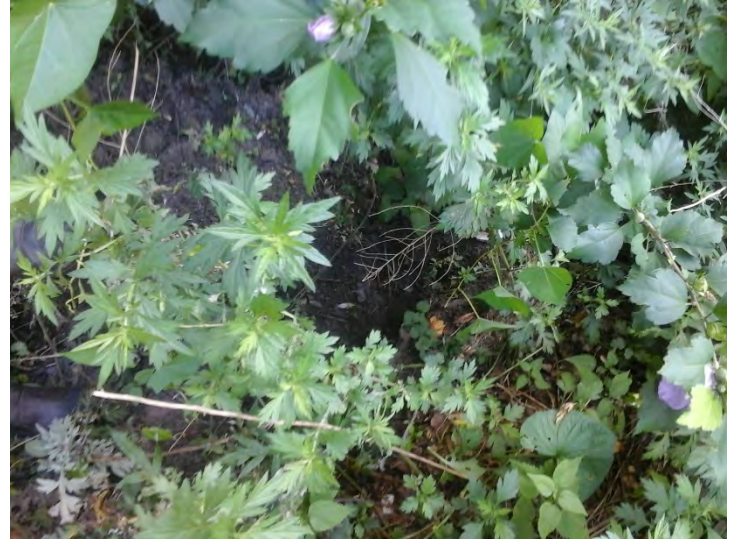
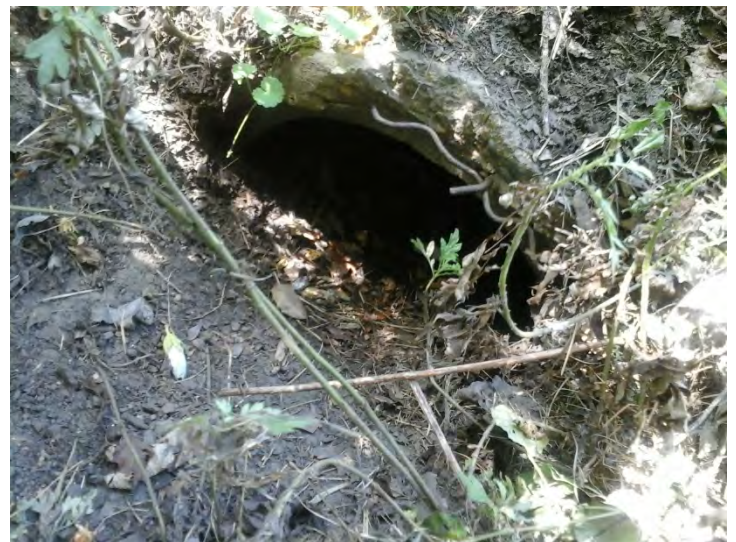
- 12" diameter concrete pipe
- Sediment deposits
- Excessive sediment is blocking outfall pipe
- Excessive vegetation growth
- Outfall pipe is corroding and revealed metal wire

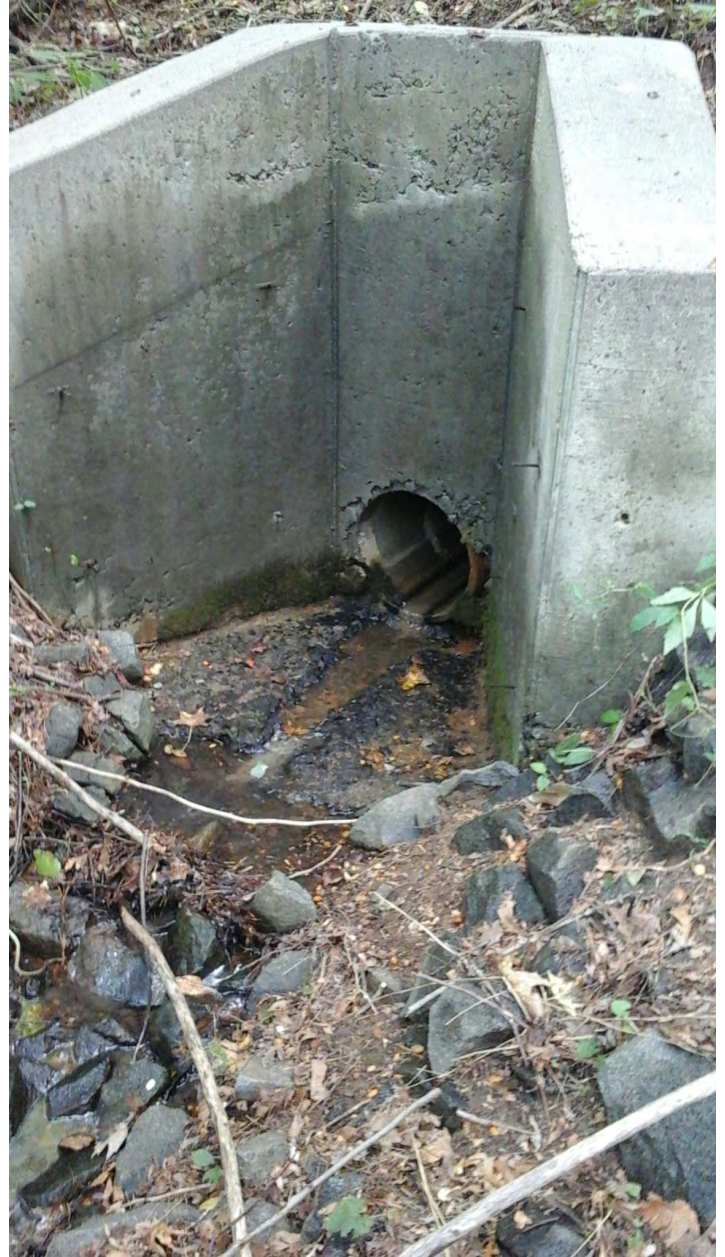
- 15" diameter concrete pipe
- No erosion identified
- Brown, clear water

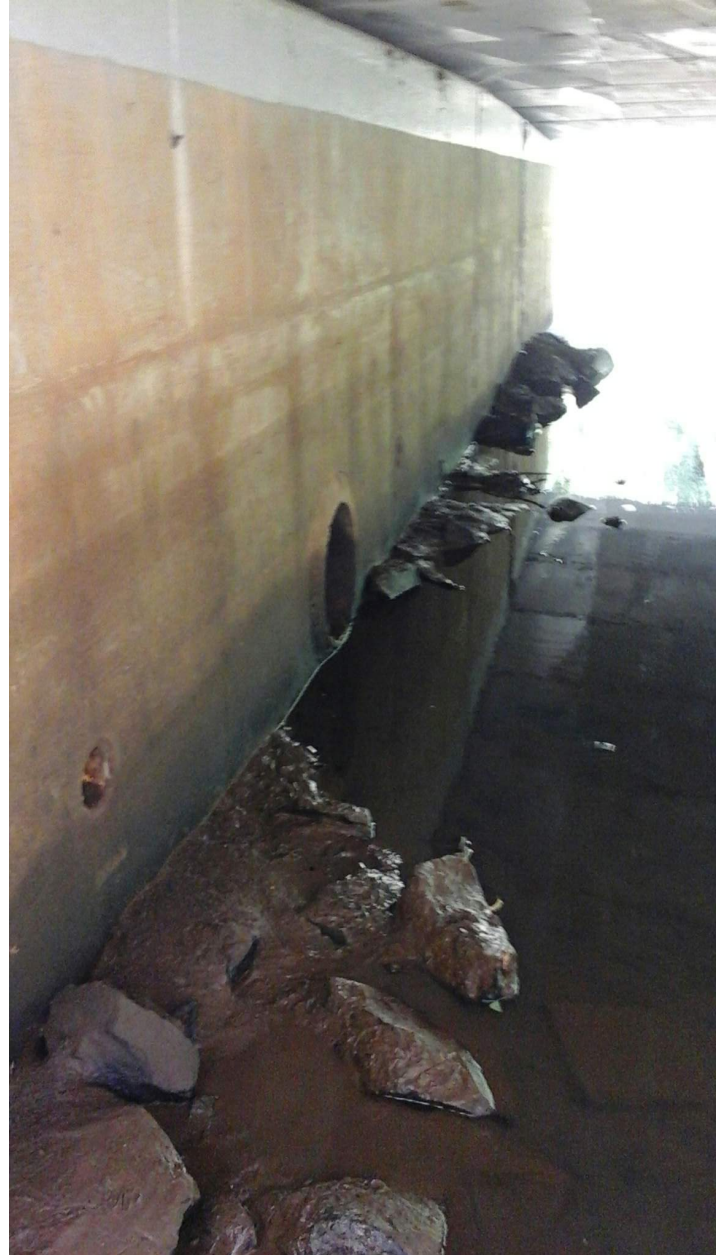
- 15" diameter concrete pipe
- No erosion identified
- Under roadway bridge
- Brown, clear water

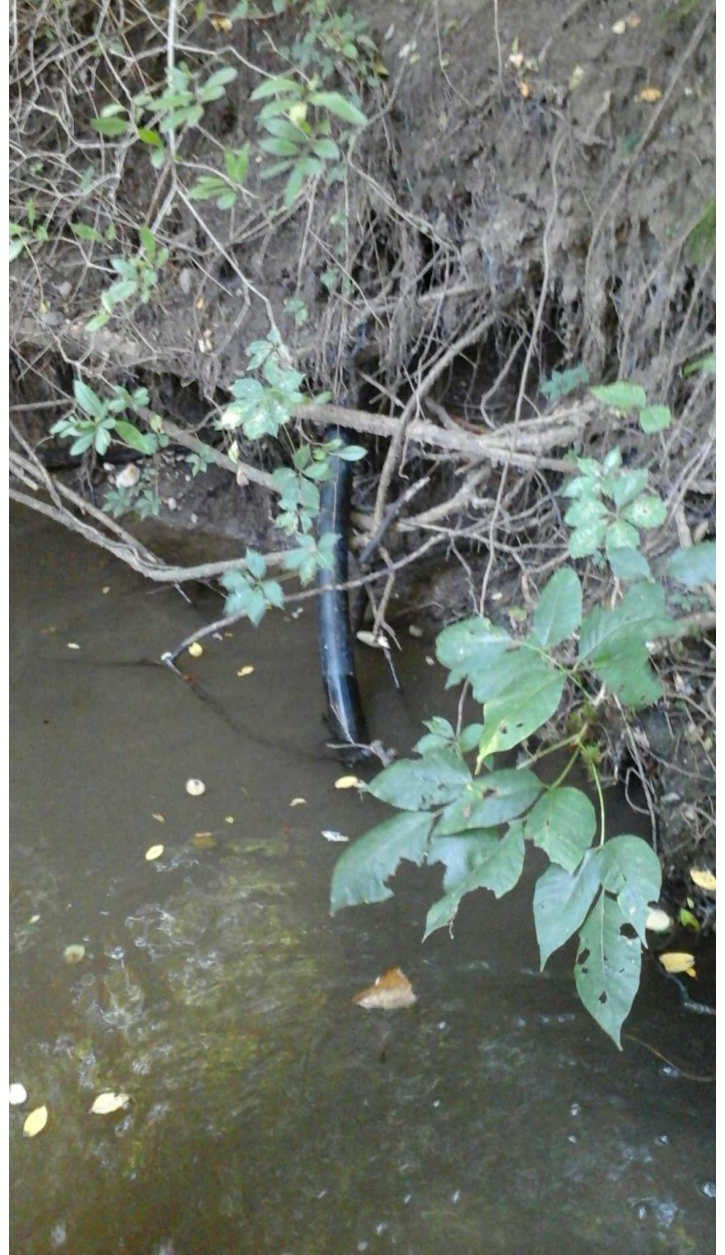
- 2" diameter plastic pipe
- No erosion identified
- Brown, cloudy water

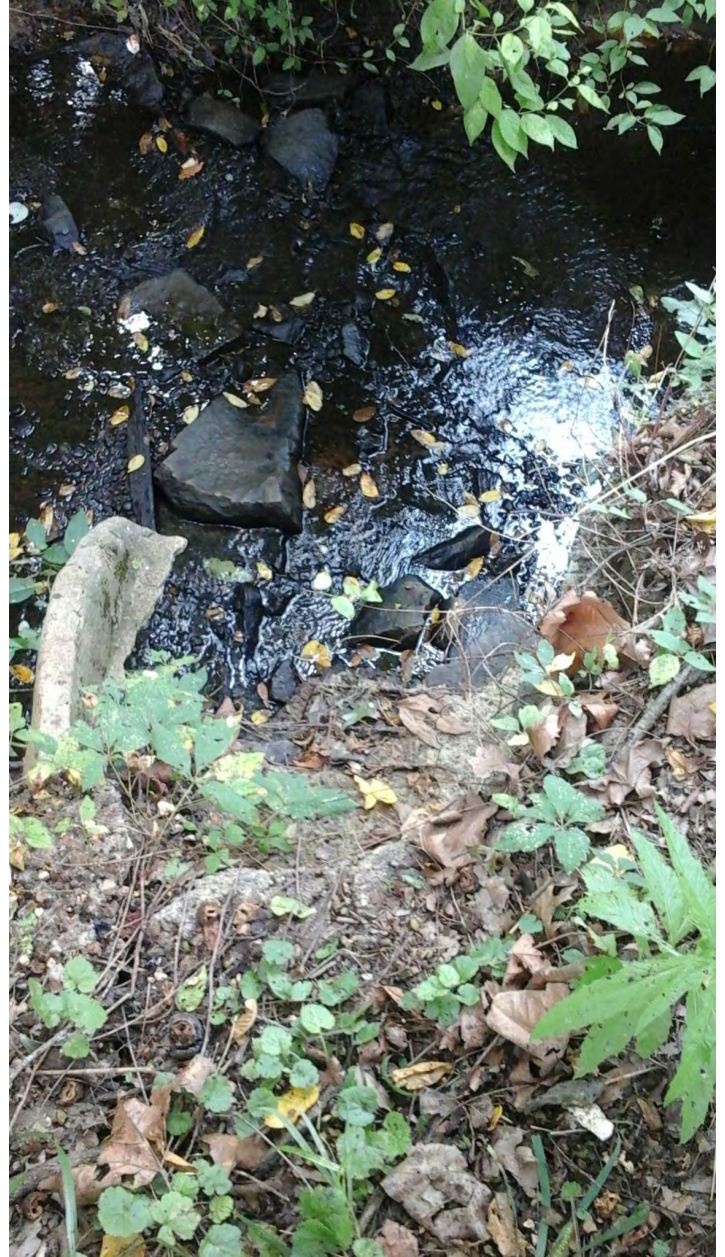
- 18" diameter concrete pipe
- No erosion identified
- Brown, clear water
- Sediment deposits partly clogging pipe

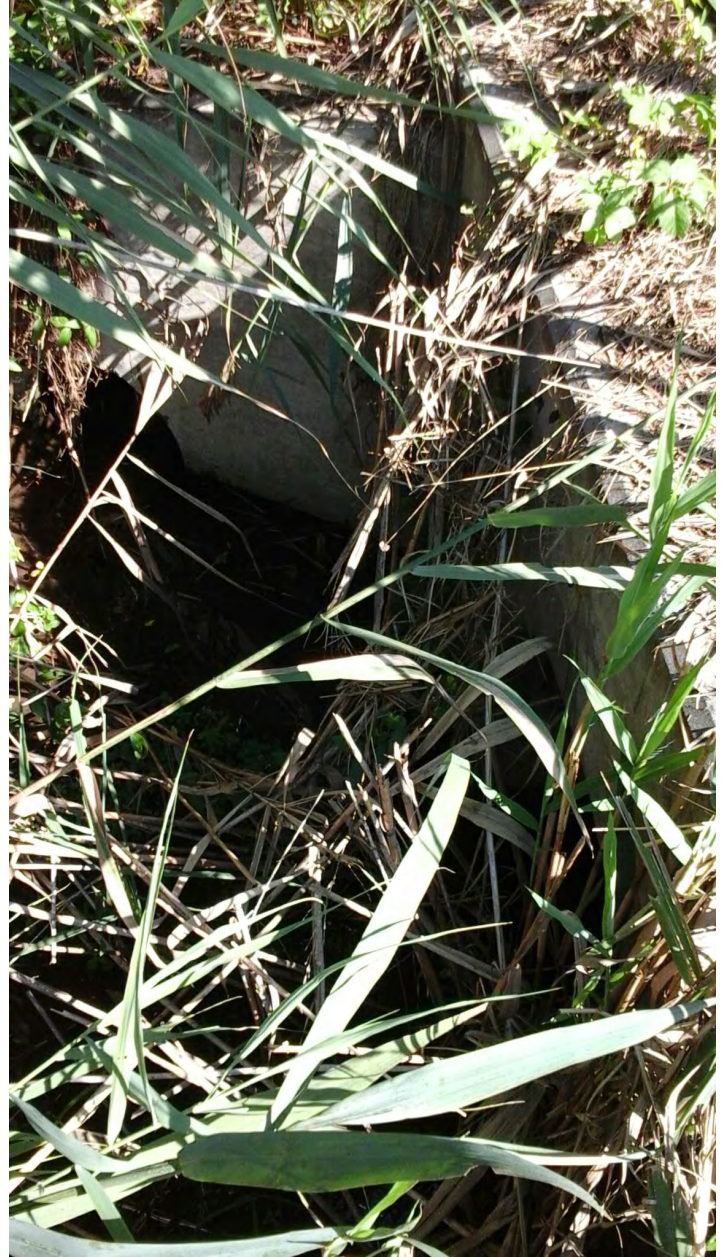
- 30" and 16" diameter concrete pipes
- No erosion identified
- Brown, cloudy water
- Excessive vegetative growth

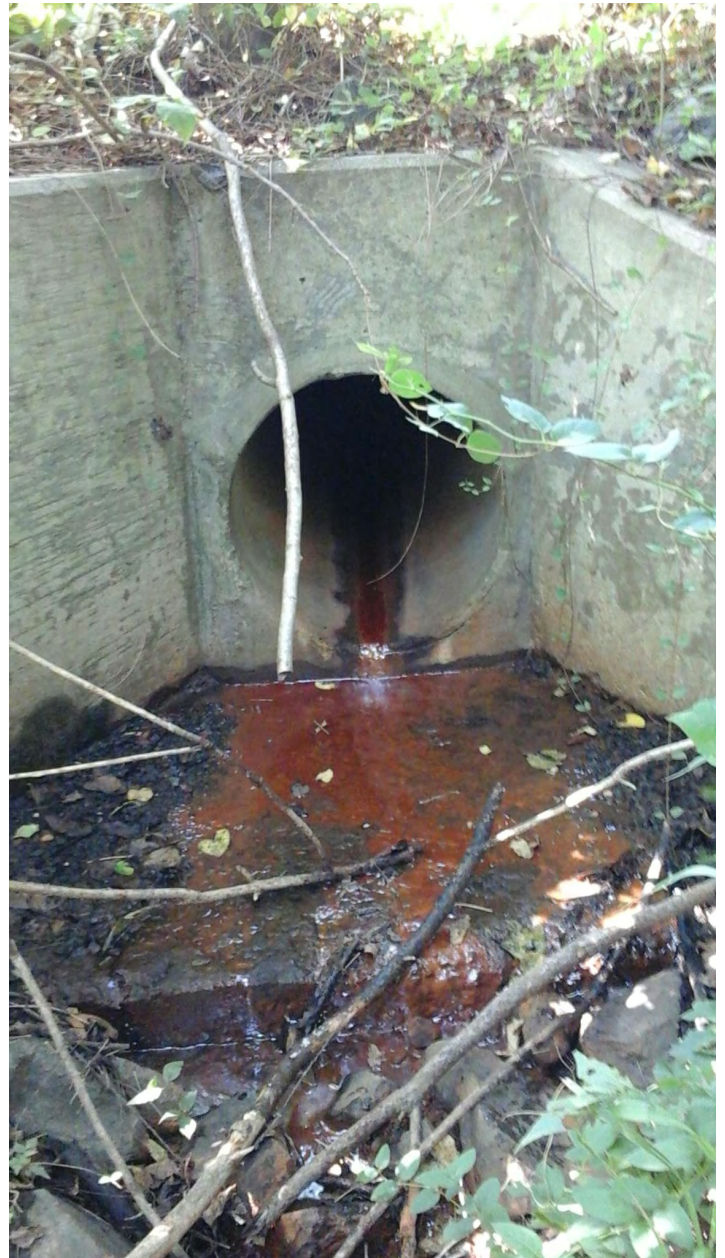
- 27" diameter concrete pipe
- No erosion identified
- Red-brown, cloudy water

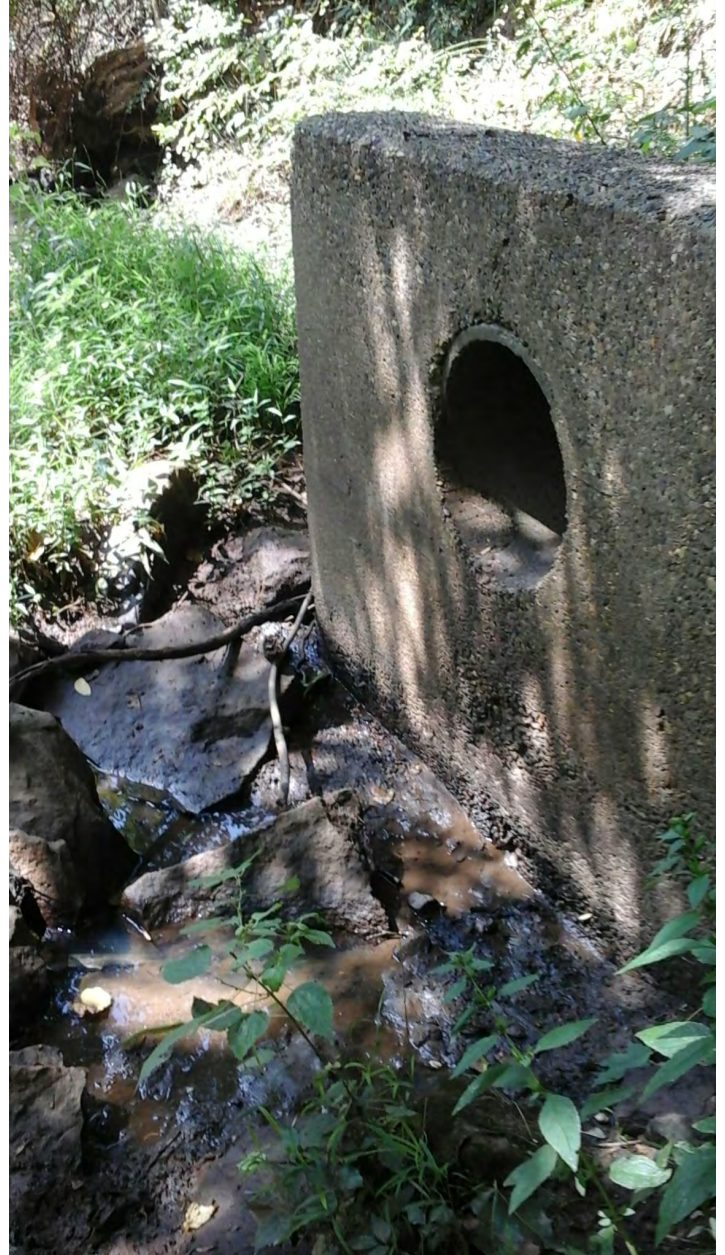
- 18" diameter concrete pipe
- No erosion identified
- Brown, clear water

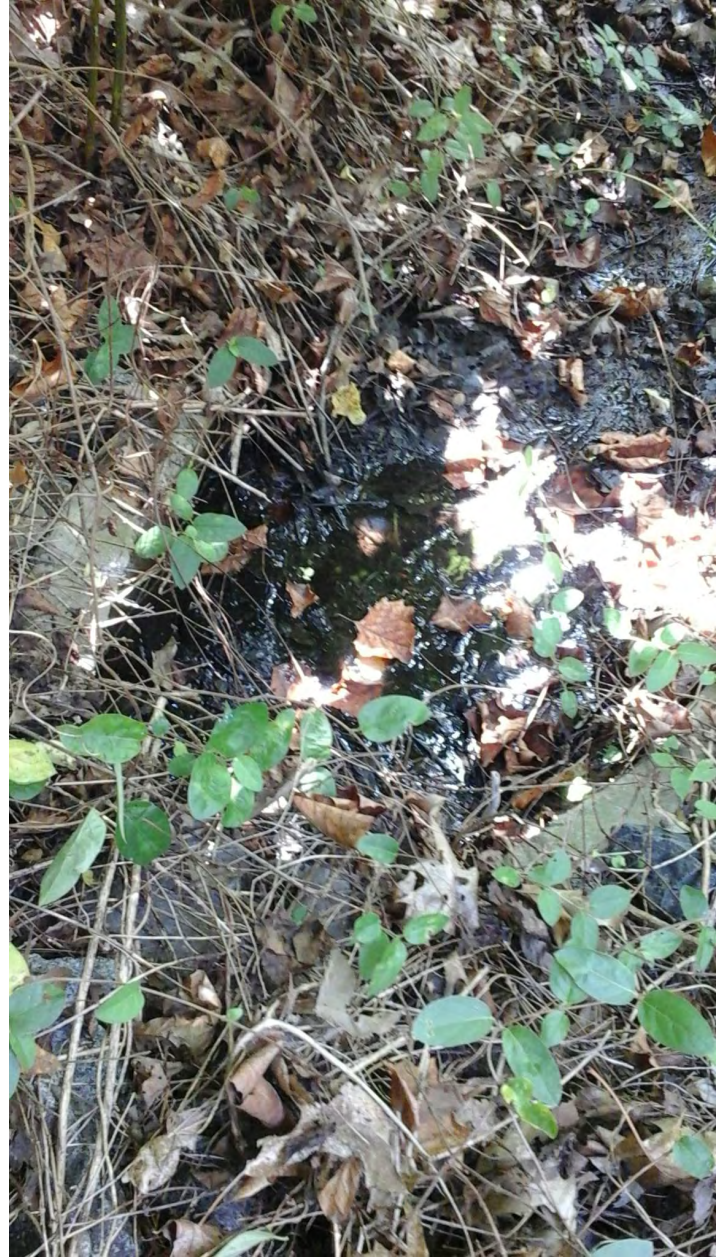
- 16" diameter concrete pipe
- No erosion identified
- Brown, cloudy water
- Sediment deposits
- Excessive vegetative growth

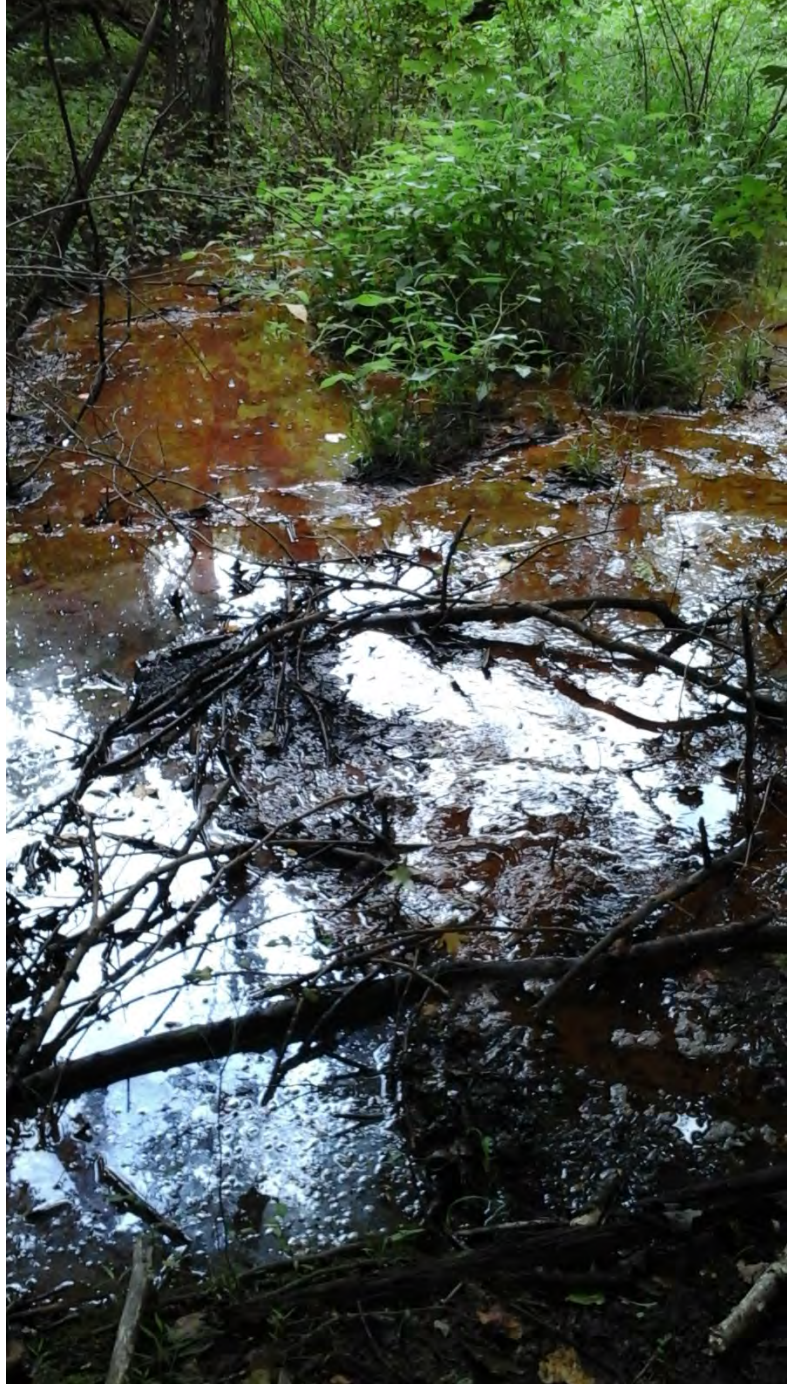
- Pipe is fully submerged
- Rancid smelling, opaque receiving water with oil slicks
- Water is flowing from pipe during dry weather

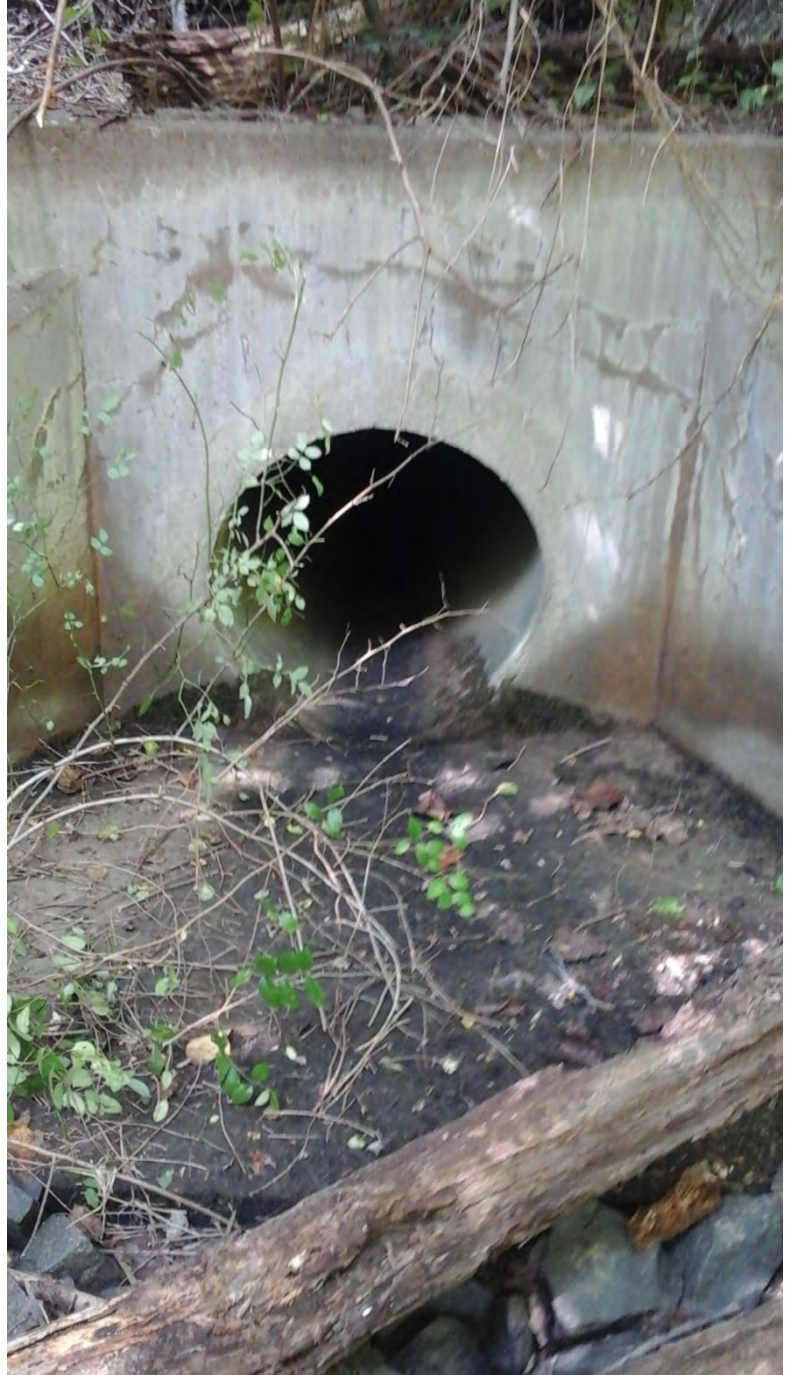
- 30" concrete pipe
- Overall in good condition

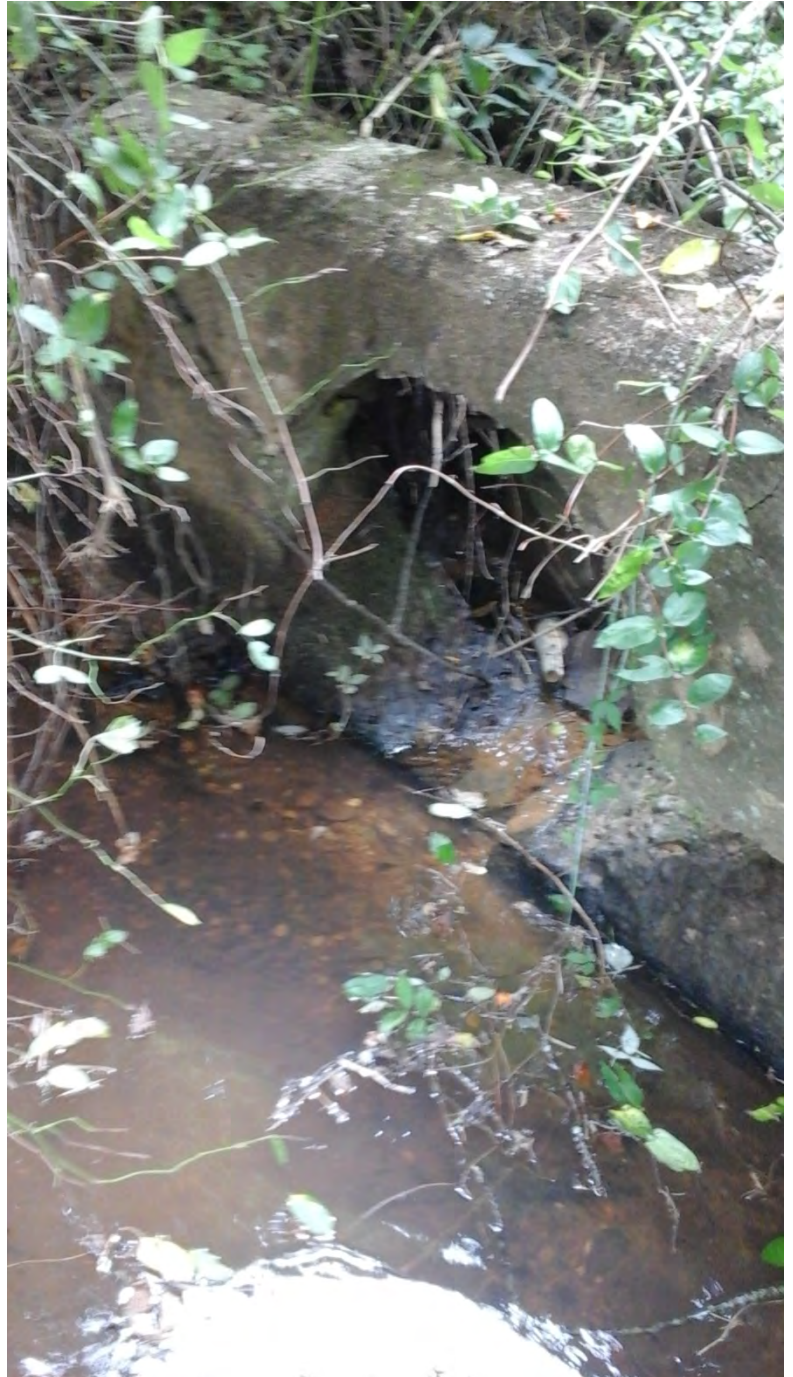
- 24" concrete pipe
- Brown, cloudy water
- Trash and sediment accumulations

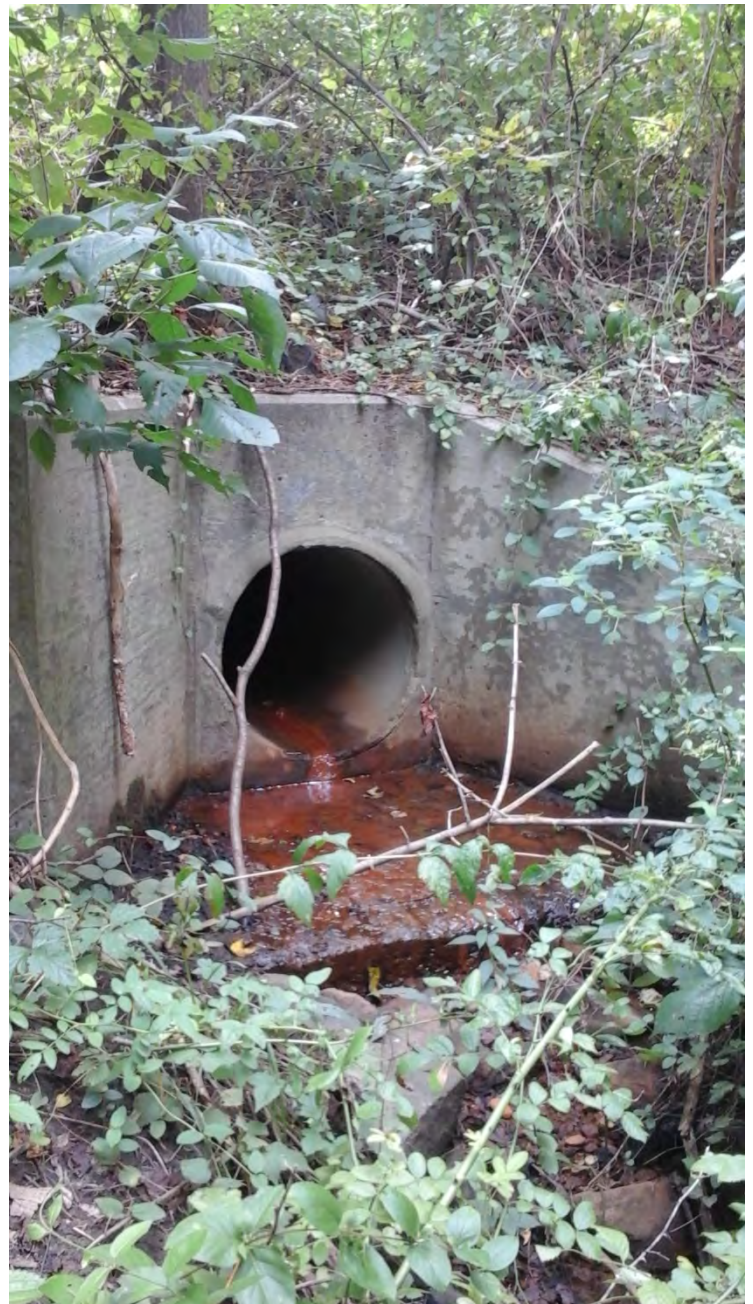
- 24" diameter concrete pipe
- Cloudy, brown water
- Sediment deposits

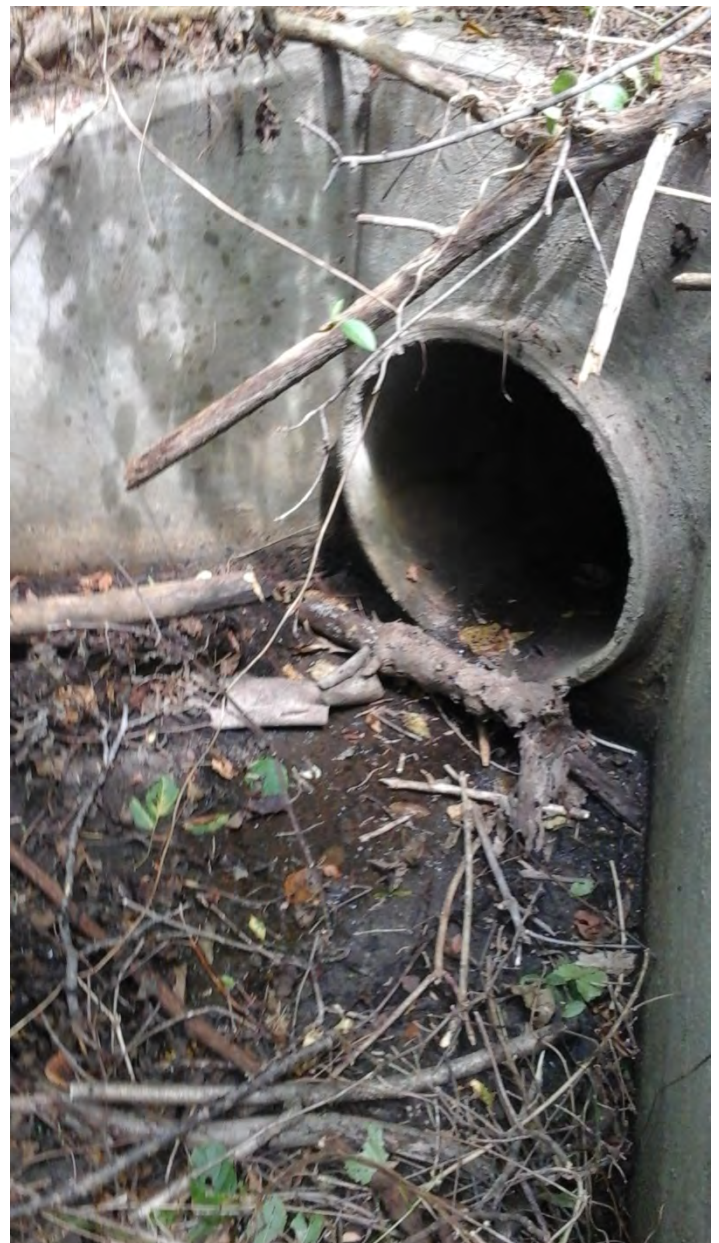
- 24" diameter concrete pipe
- Sediment deposits
- Excessive vegetation growth
- Small pool of stagnant water

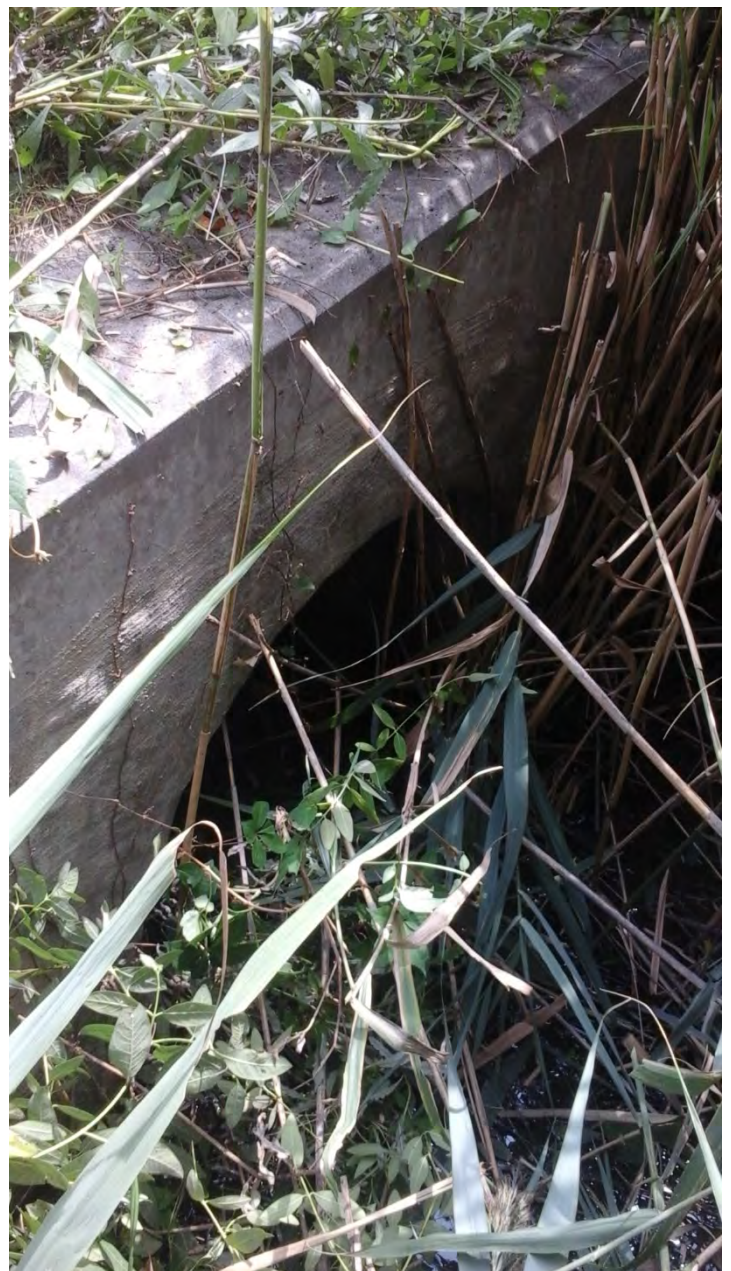
- 37" diameter concrete pipe
- Trash present
- Sediment deposits
- Excessive vegetation growth

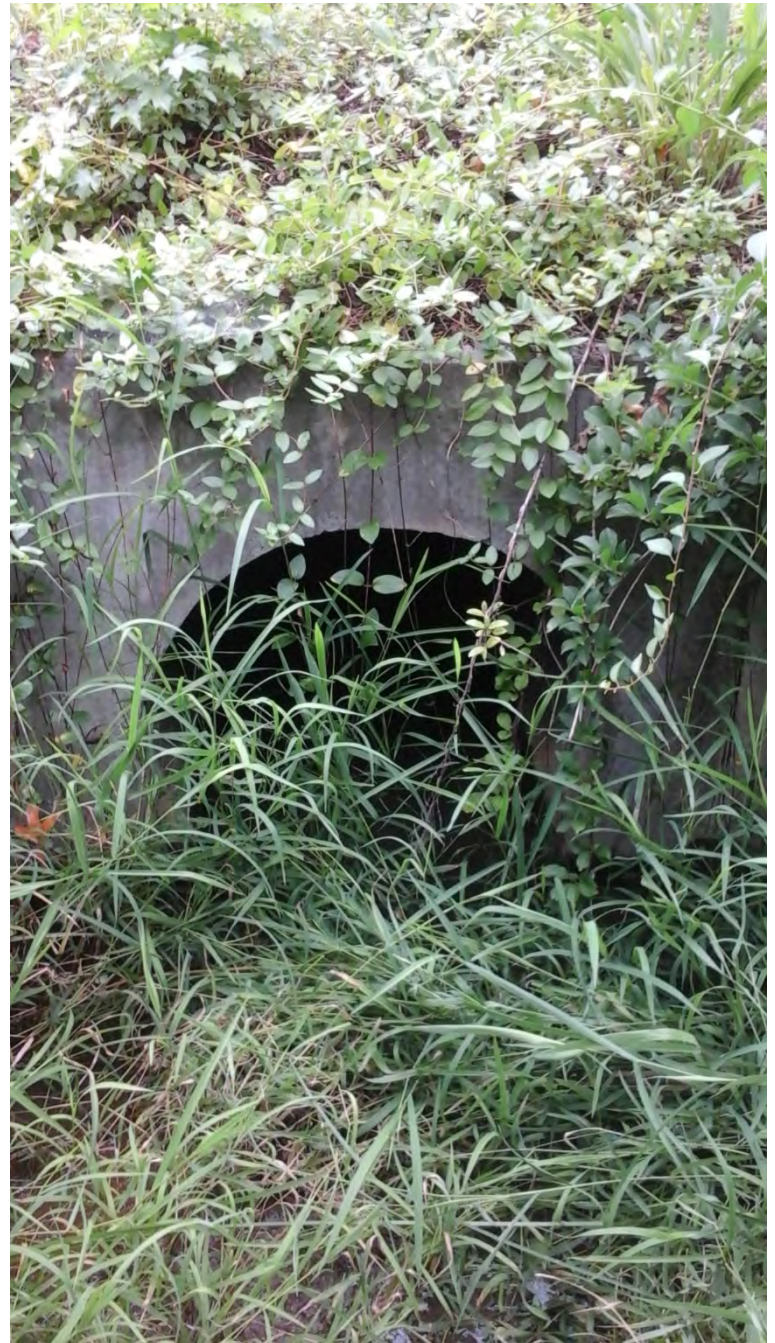
- 37" diameter concrete pipe
- Opaque, brown water
- Excessive vegetation growth
- Stagnant water in outflow

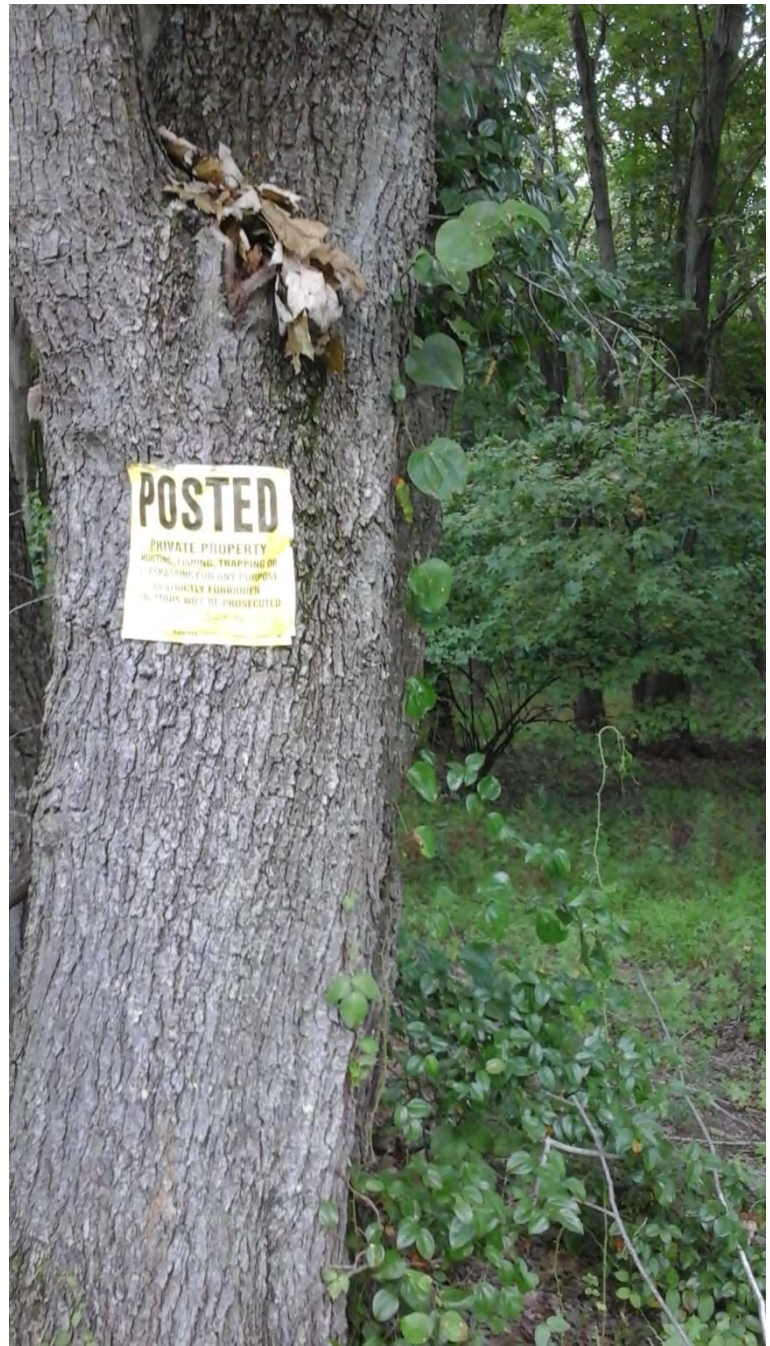
- Not accessible

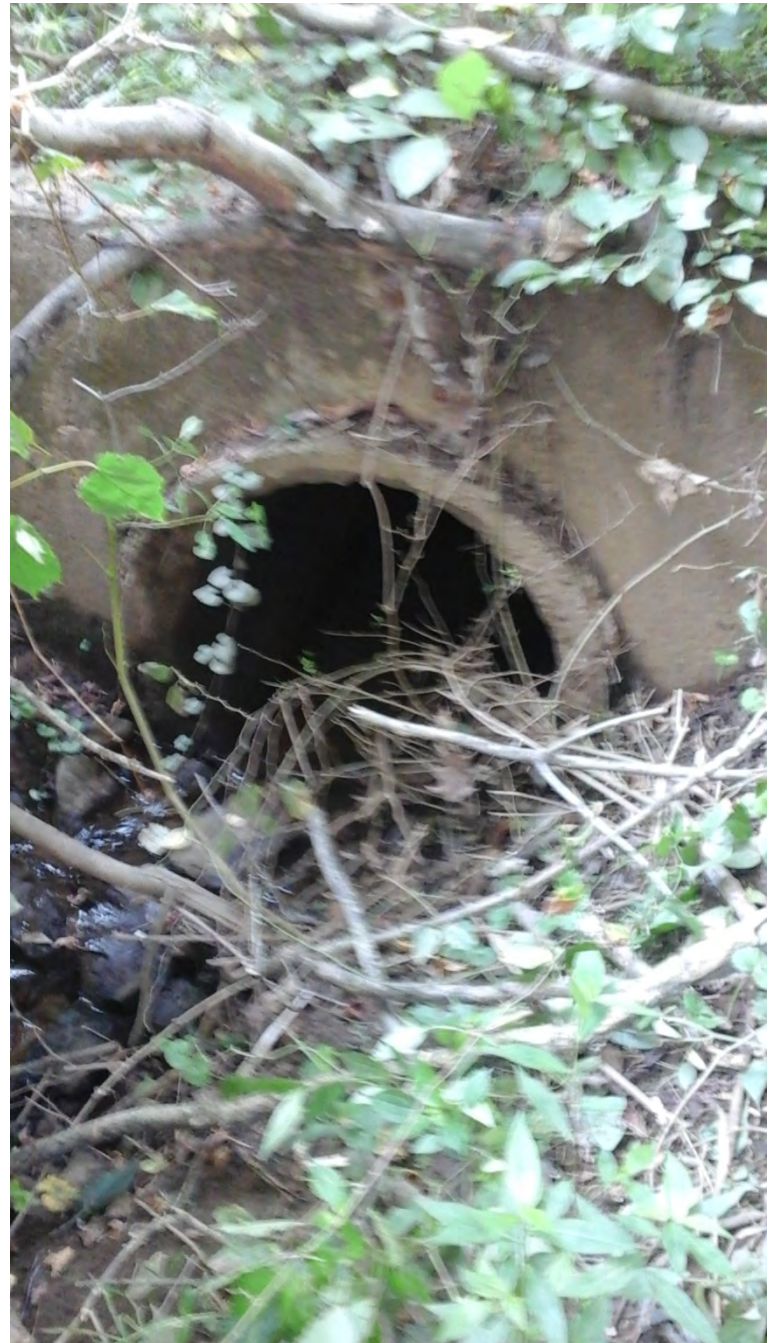
- 30" diameter concrete pipe
- Flowing during dry weather
- Excessive vegetation growth

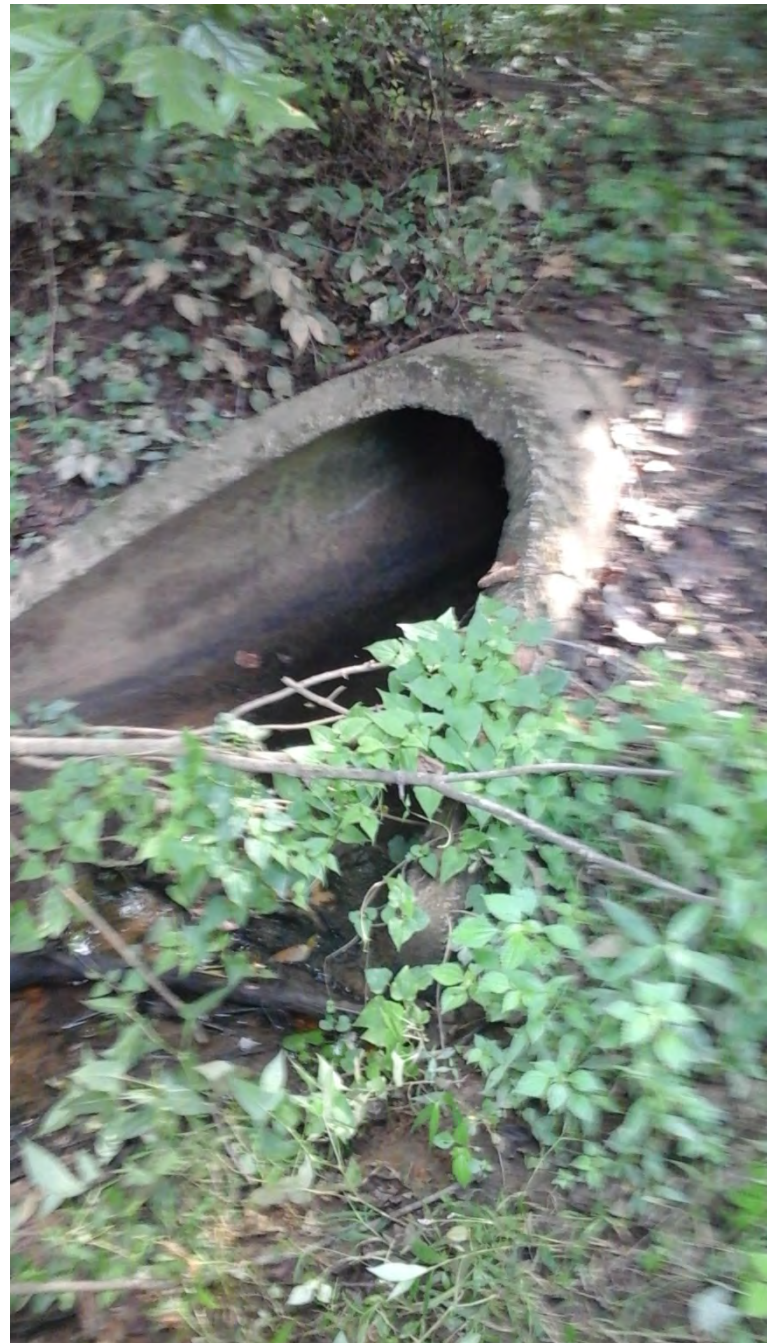
- 48" diameter concrete pipe
- Flowing during dry weather
- Raccoon tracks going in and out of outfall

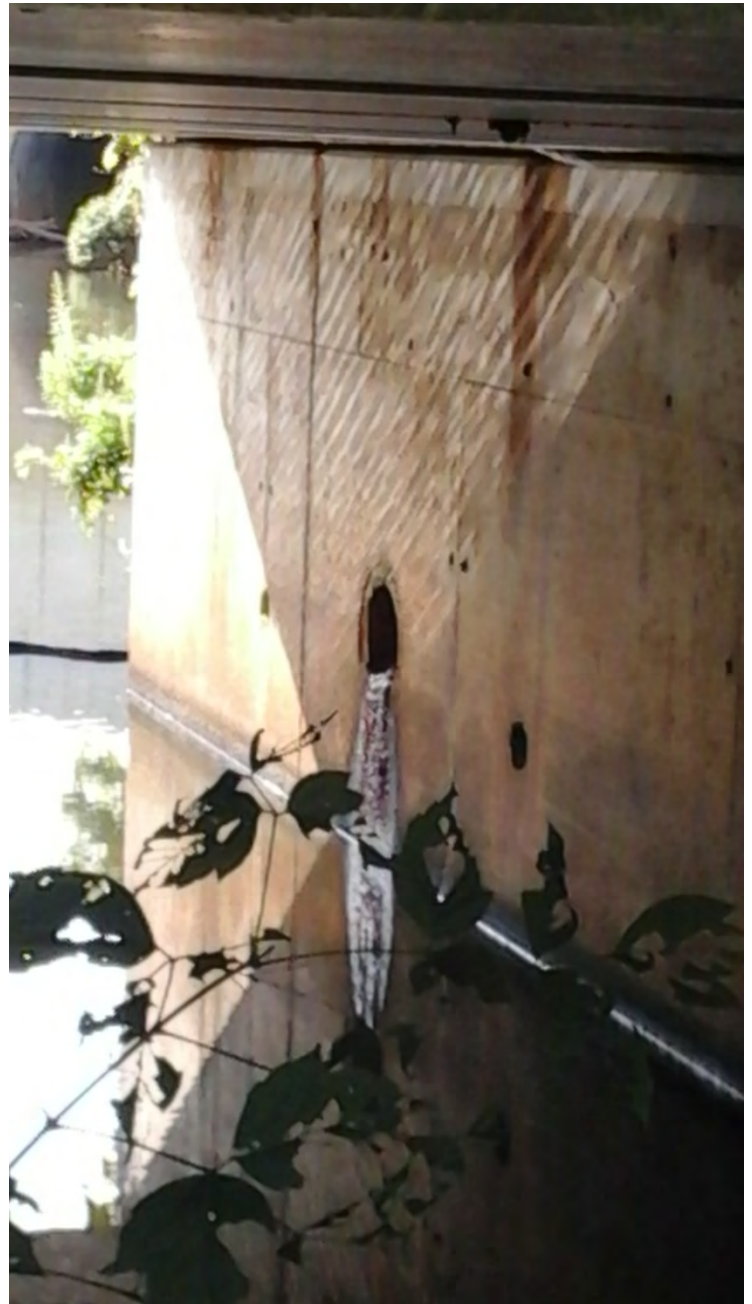
- 24" diameter concrete pipe
- Cloudy, yellow water
- Vegetation growing inside pipe

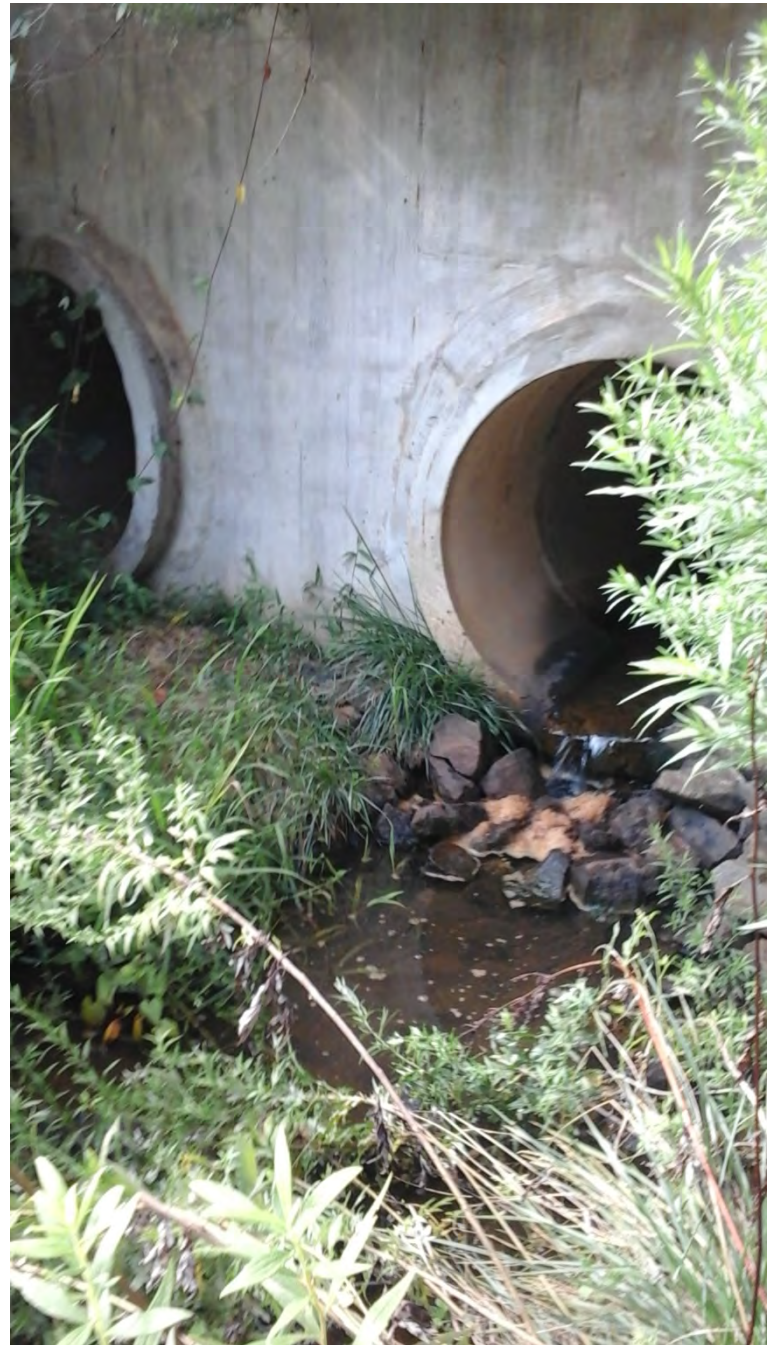
- 36" diameter concrete pipe
- Rancid/sour odor
- Cloudy, brown water
- Flowing during dry weather
- Excessive vegetation growth

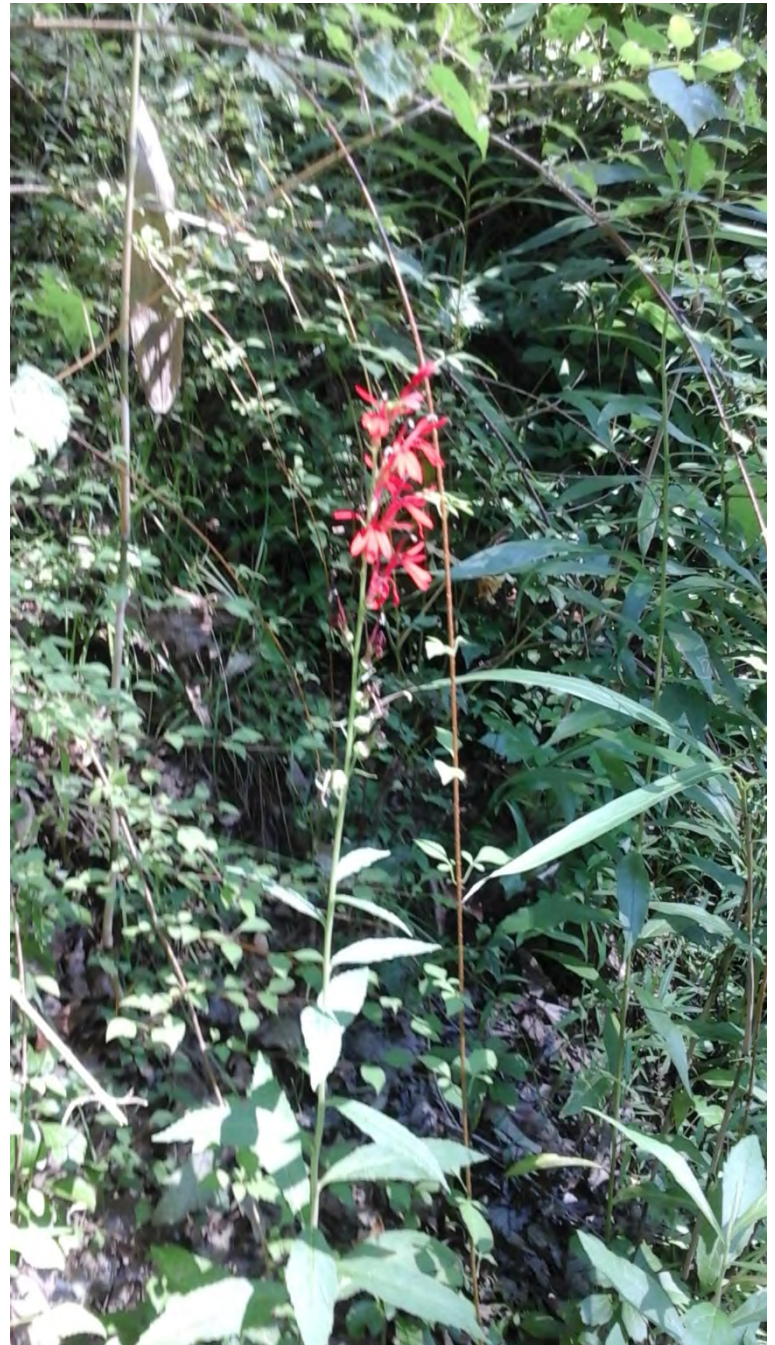
- Not accessible due to excessive vegetation growth
