## Hamilton Township (Mercer County)

# REVIEW AND EVALUATION OF TOTAL MAXIMUM DAILY LOADS (TMDLs)

Developed by the Rutgers Cooperative Extension Water Resources Program  
Funded by Hamilton Township, Mercer County, New Jersey

December 5, 2019

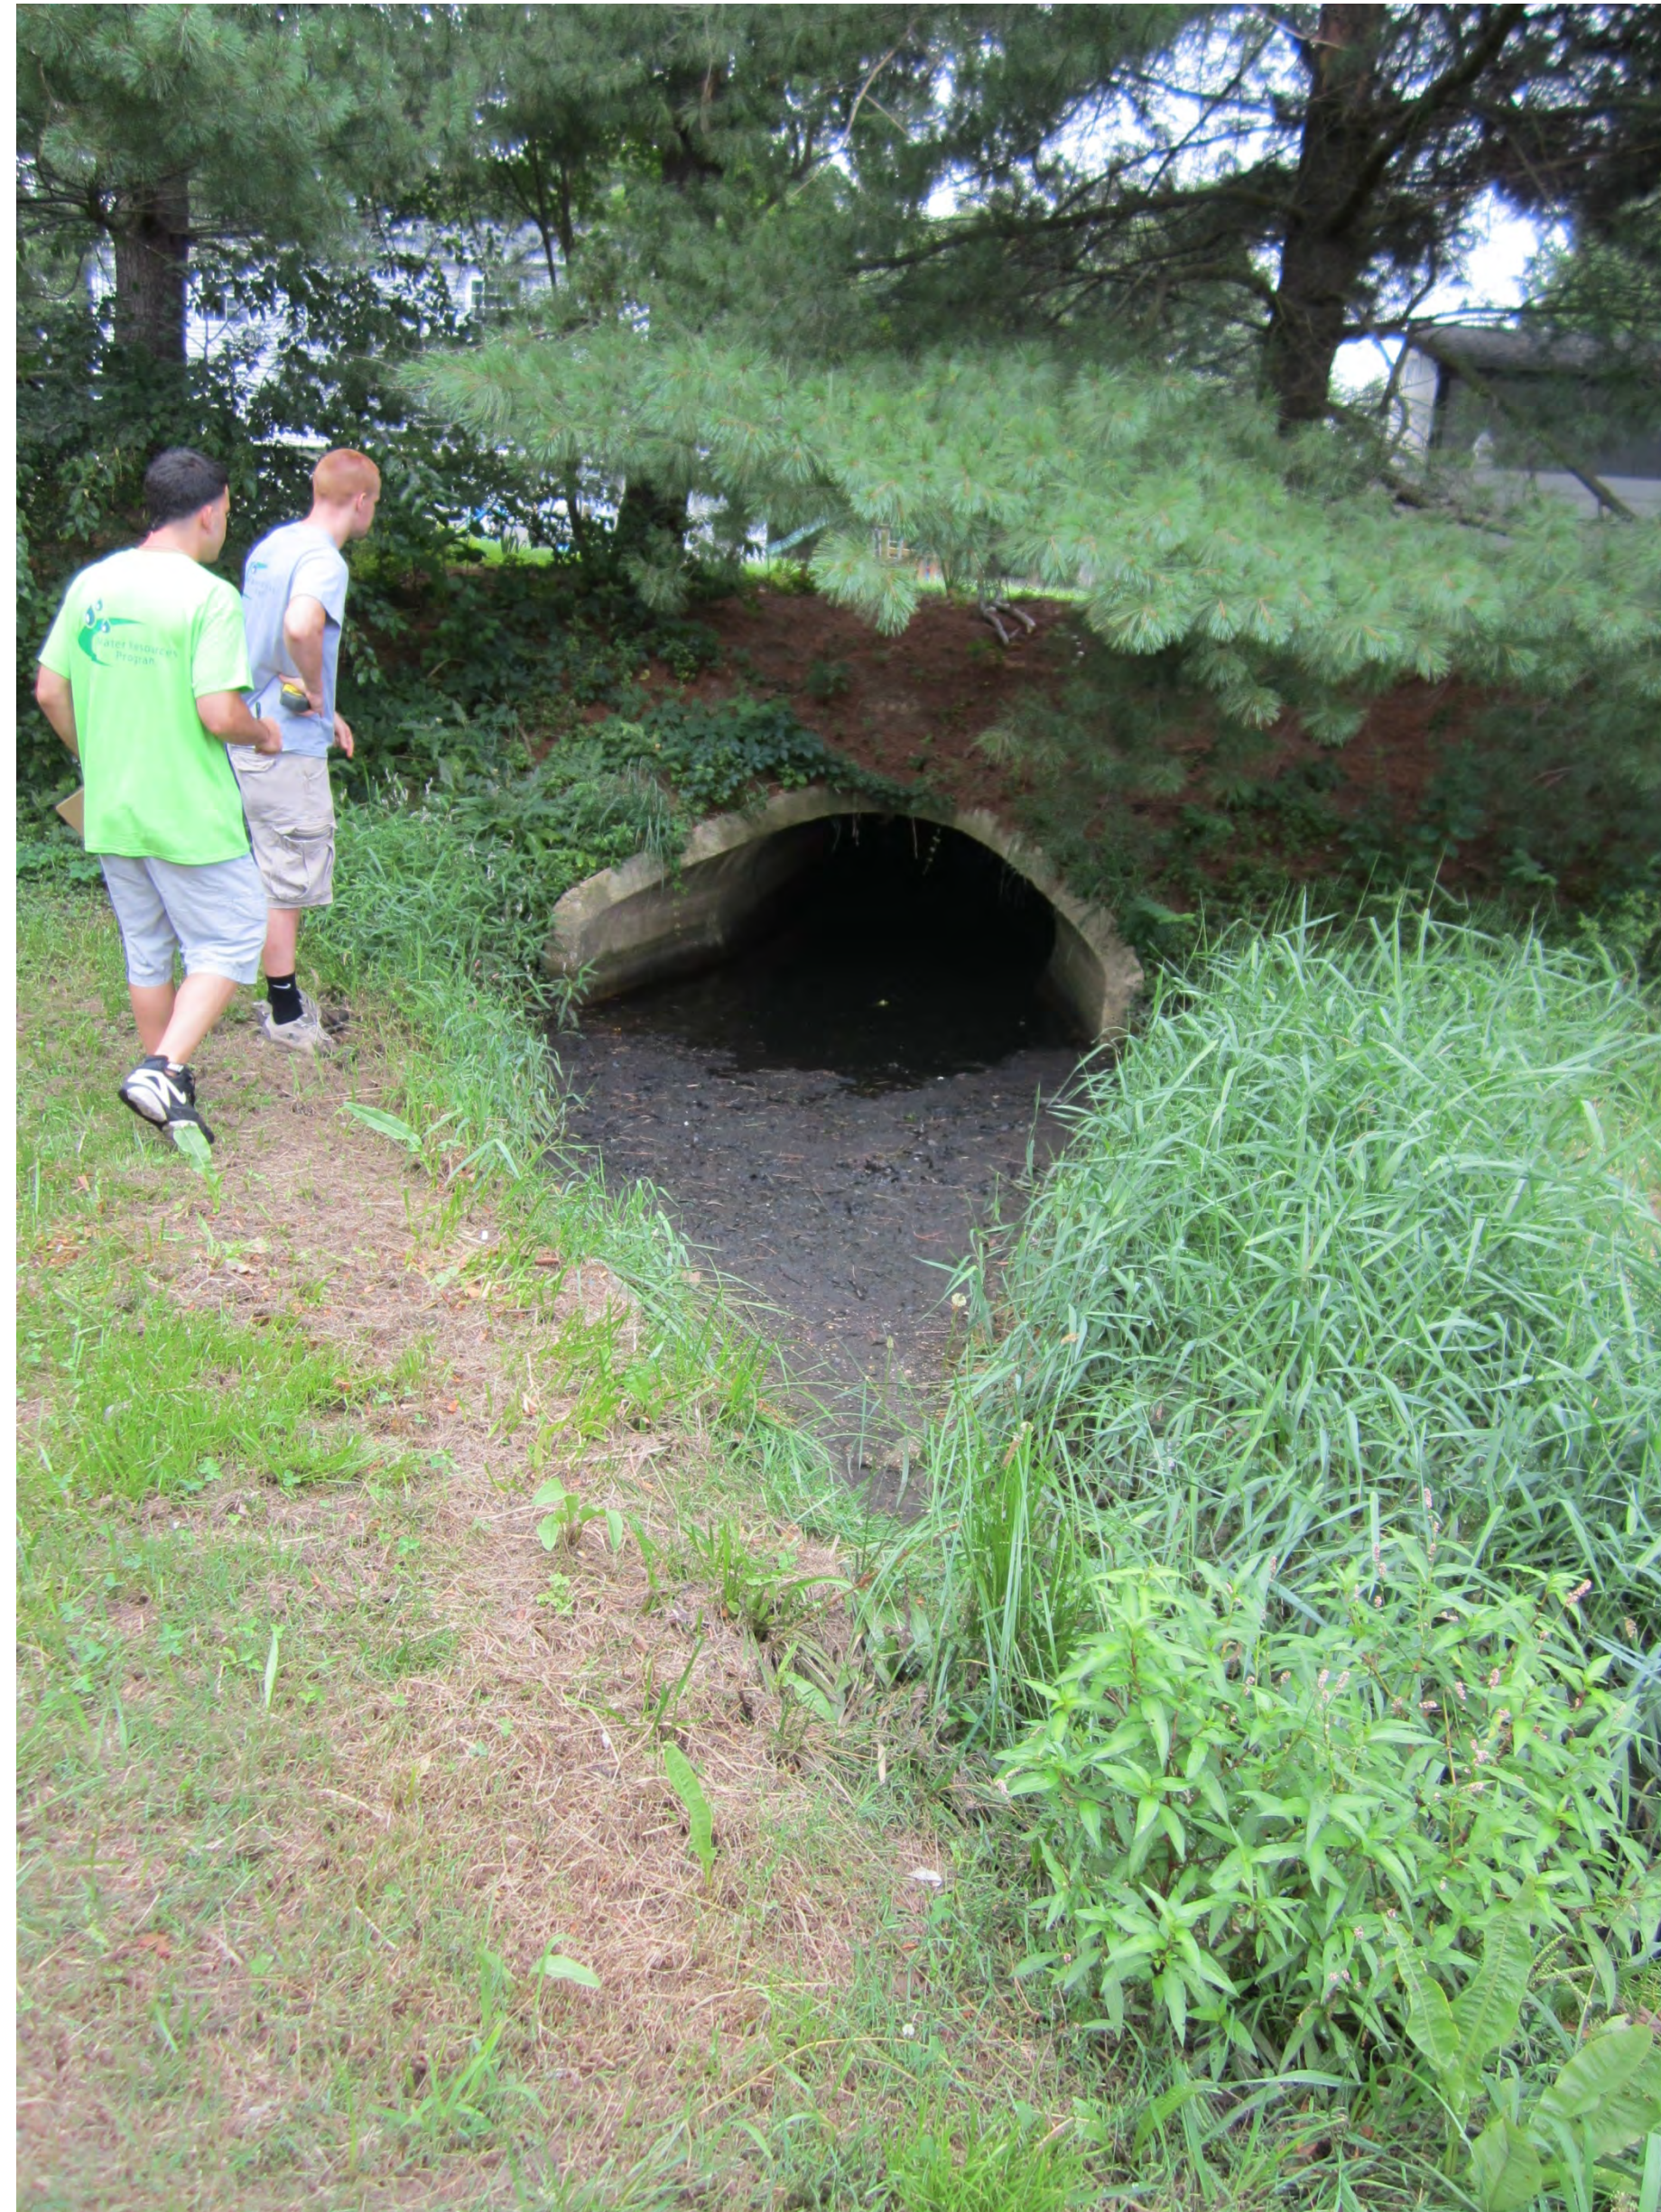
Clogged inlet.

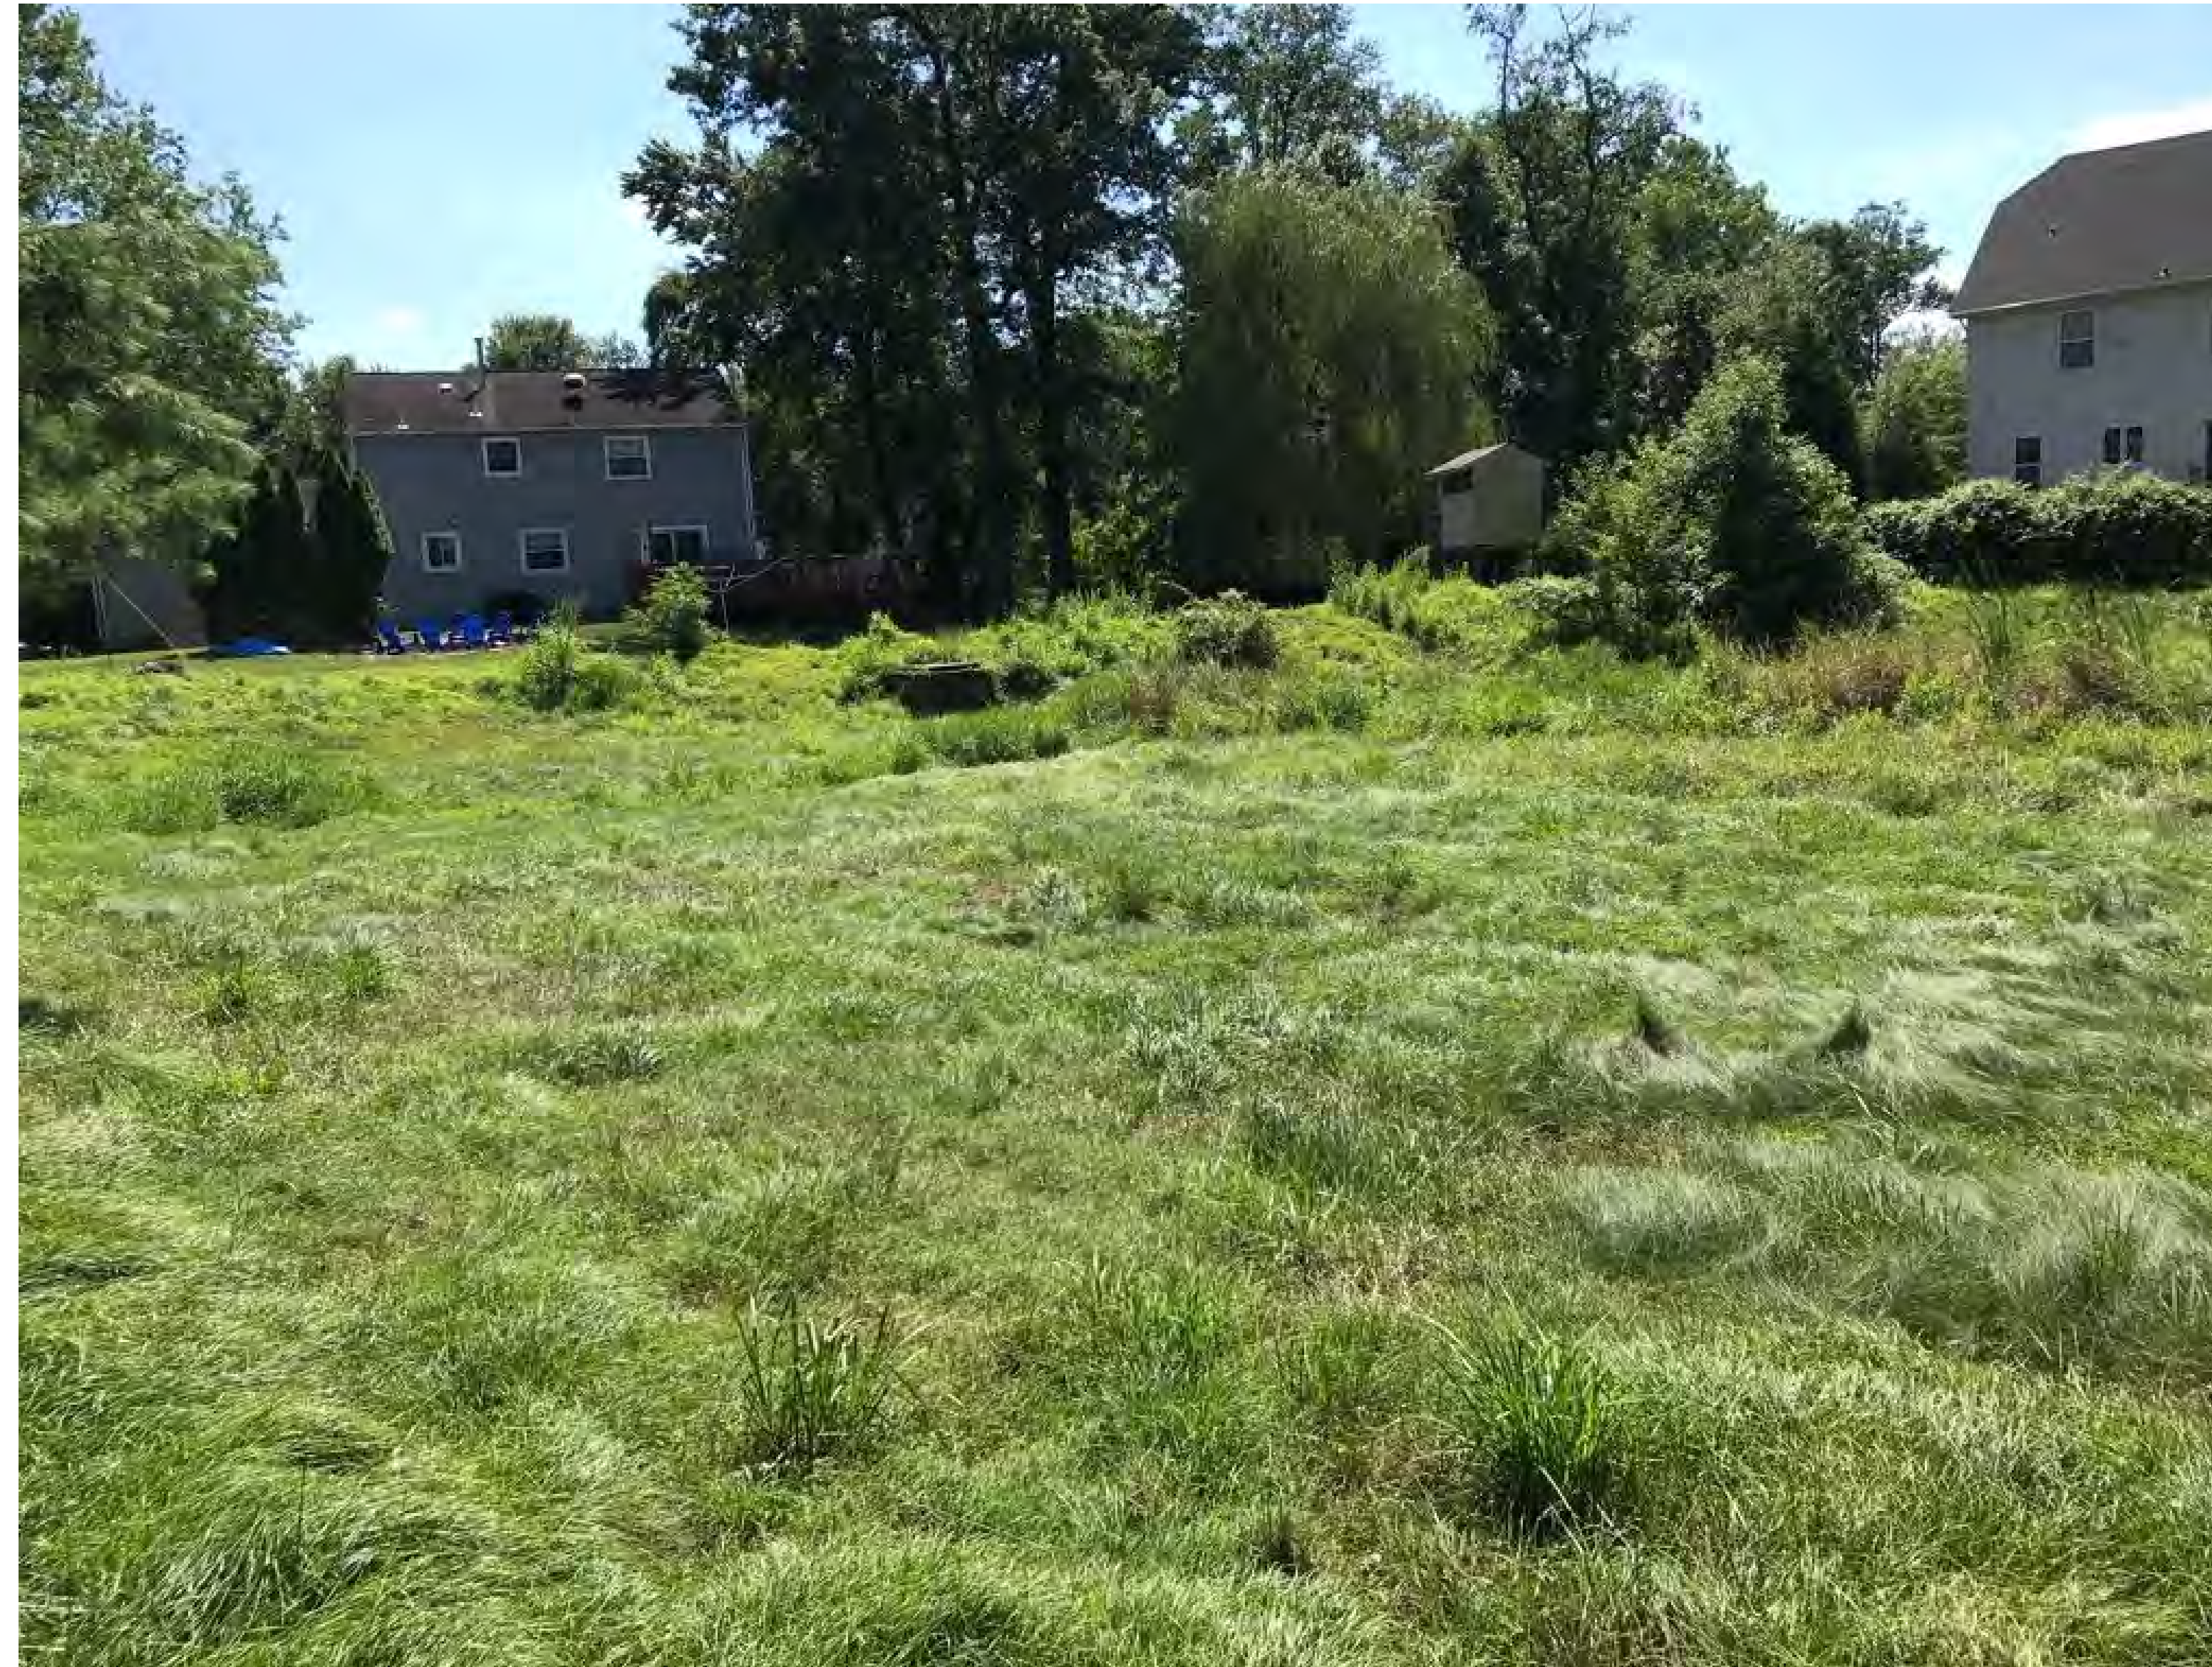
## *1. Dogwood Lane Residential Detention Basin*

- Channel overgrown with vegetation and sediment leading to restricted flow
- Basin has not improved from previous assessment
- Suggest maintenance to clear out channels

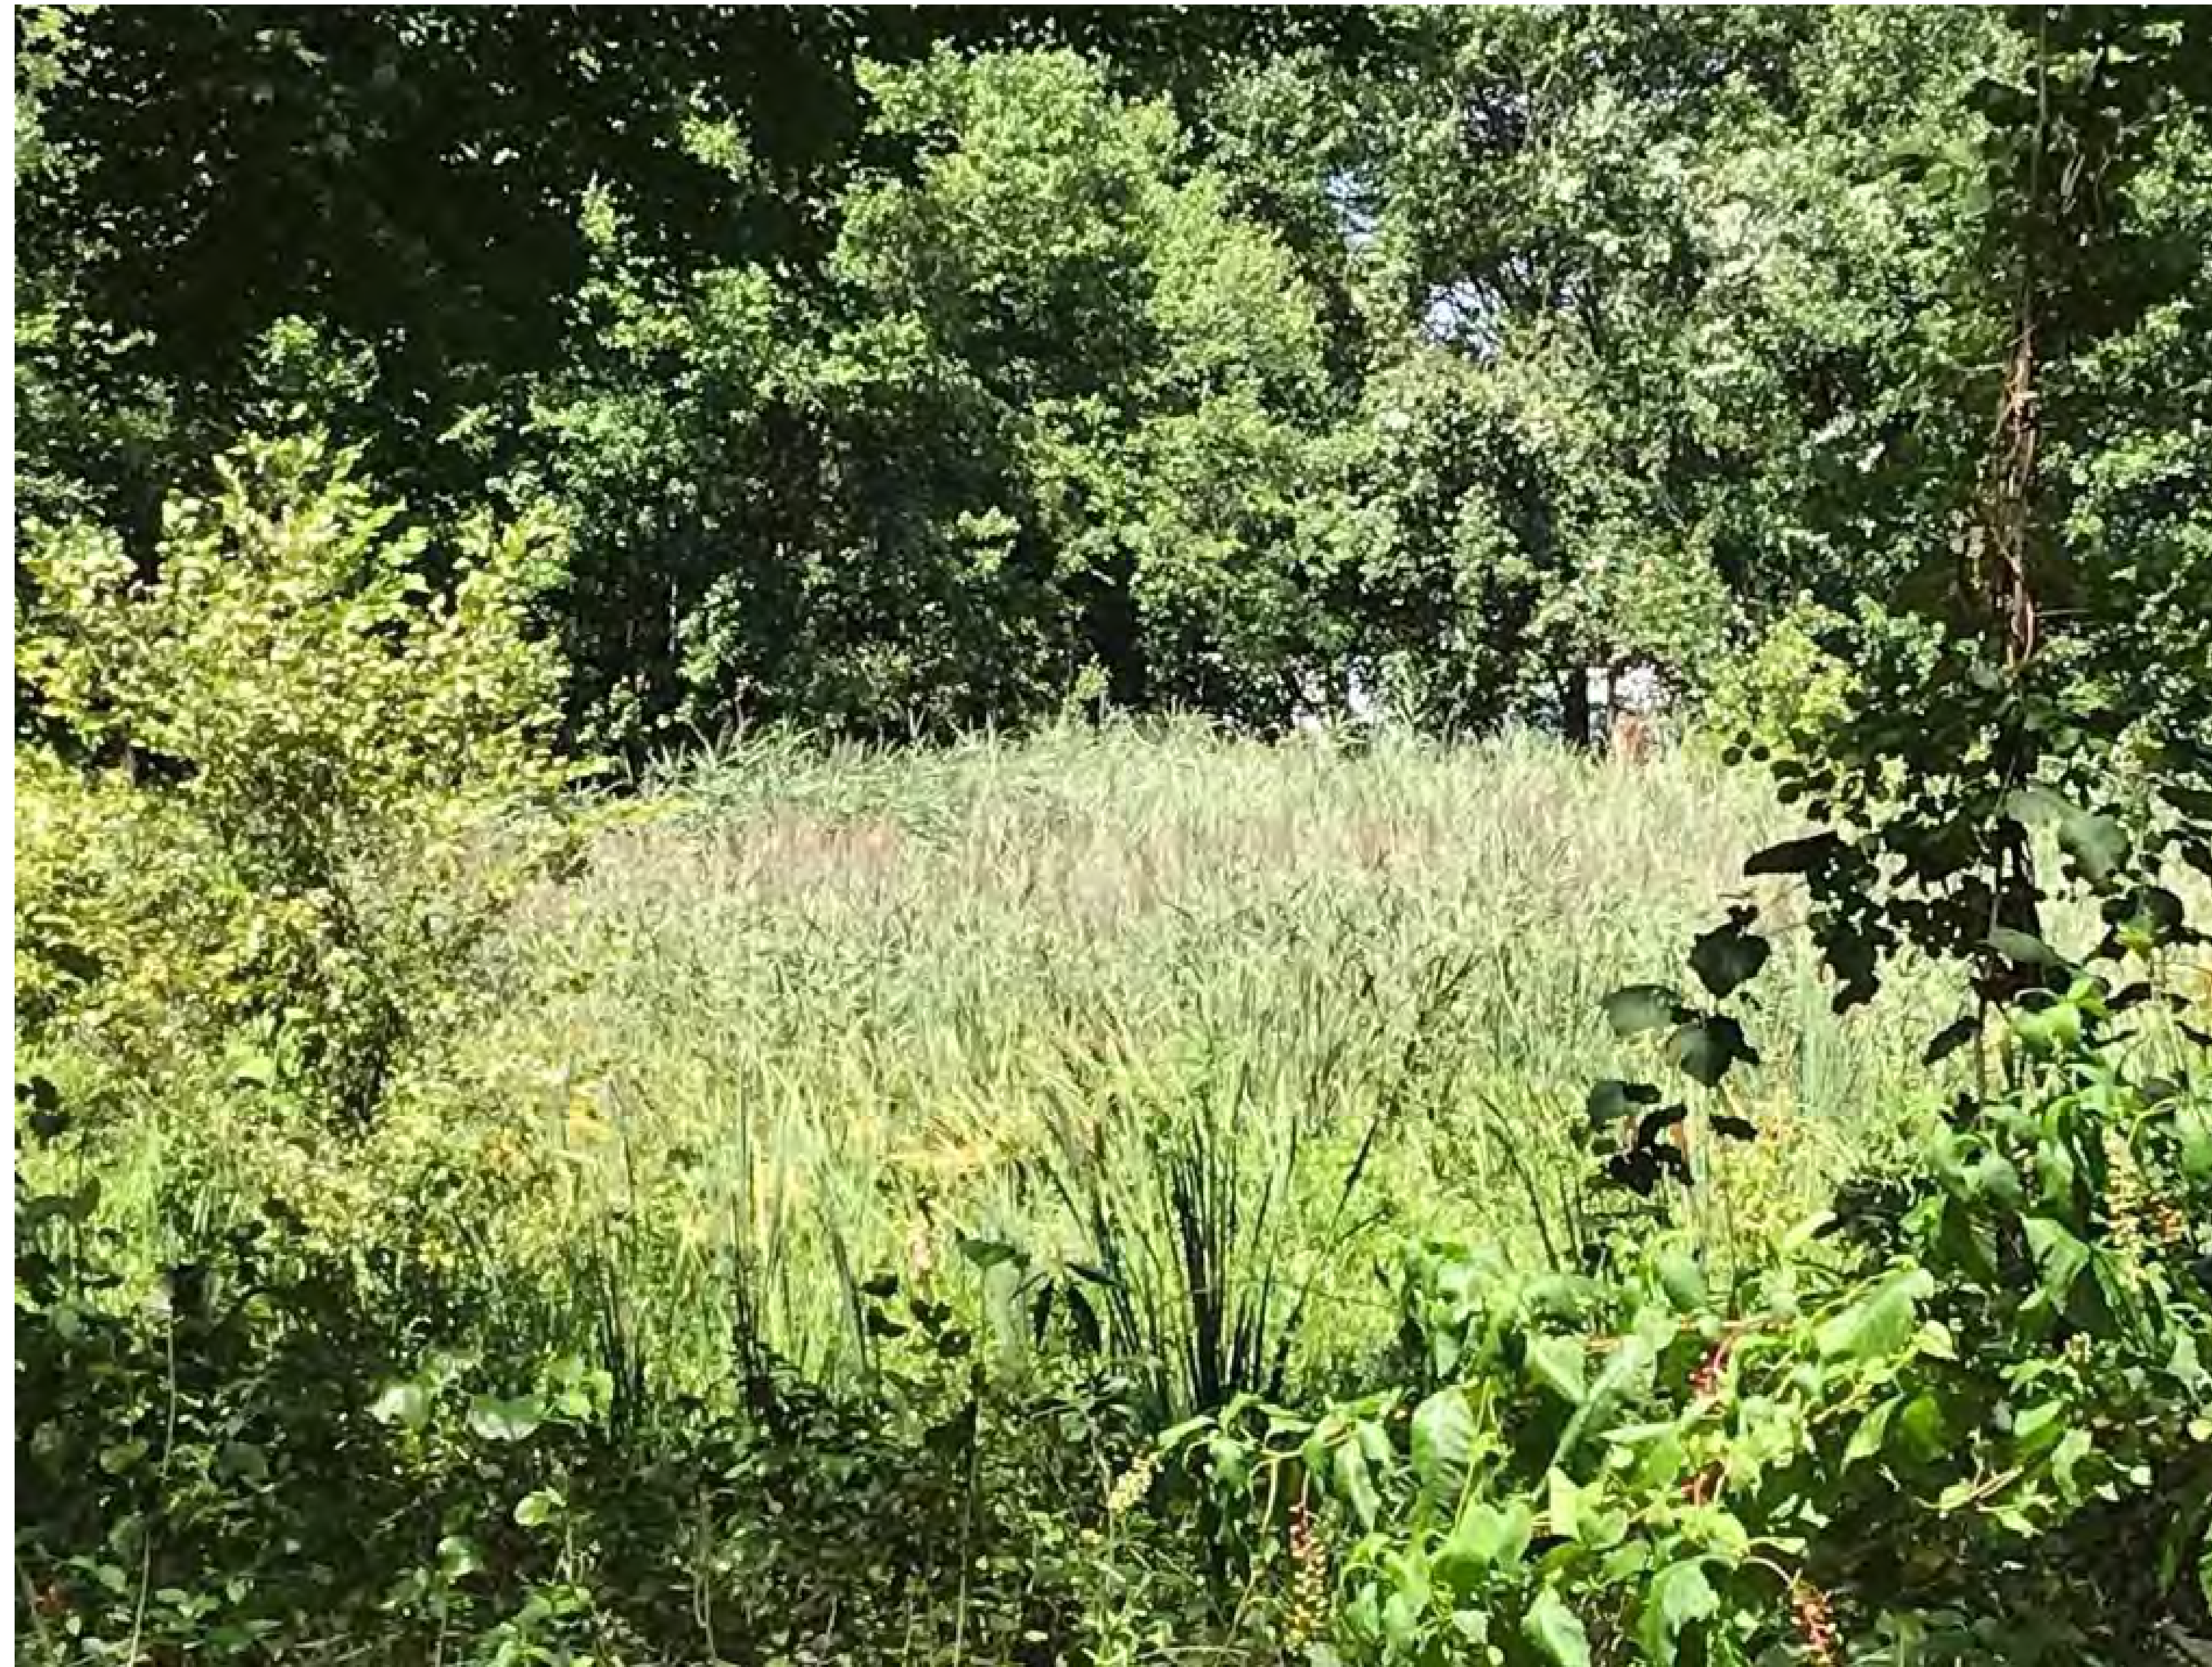
- Basin is inaccessible due to over grown vegetation
- Maintenance suggested to have access to basin and outlet structures

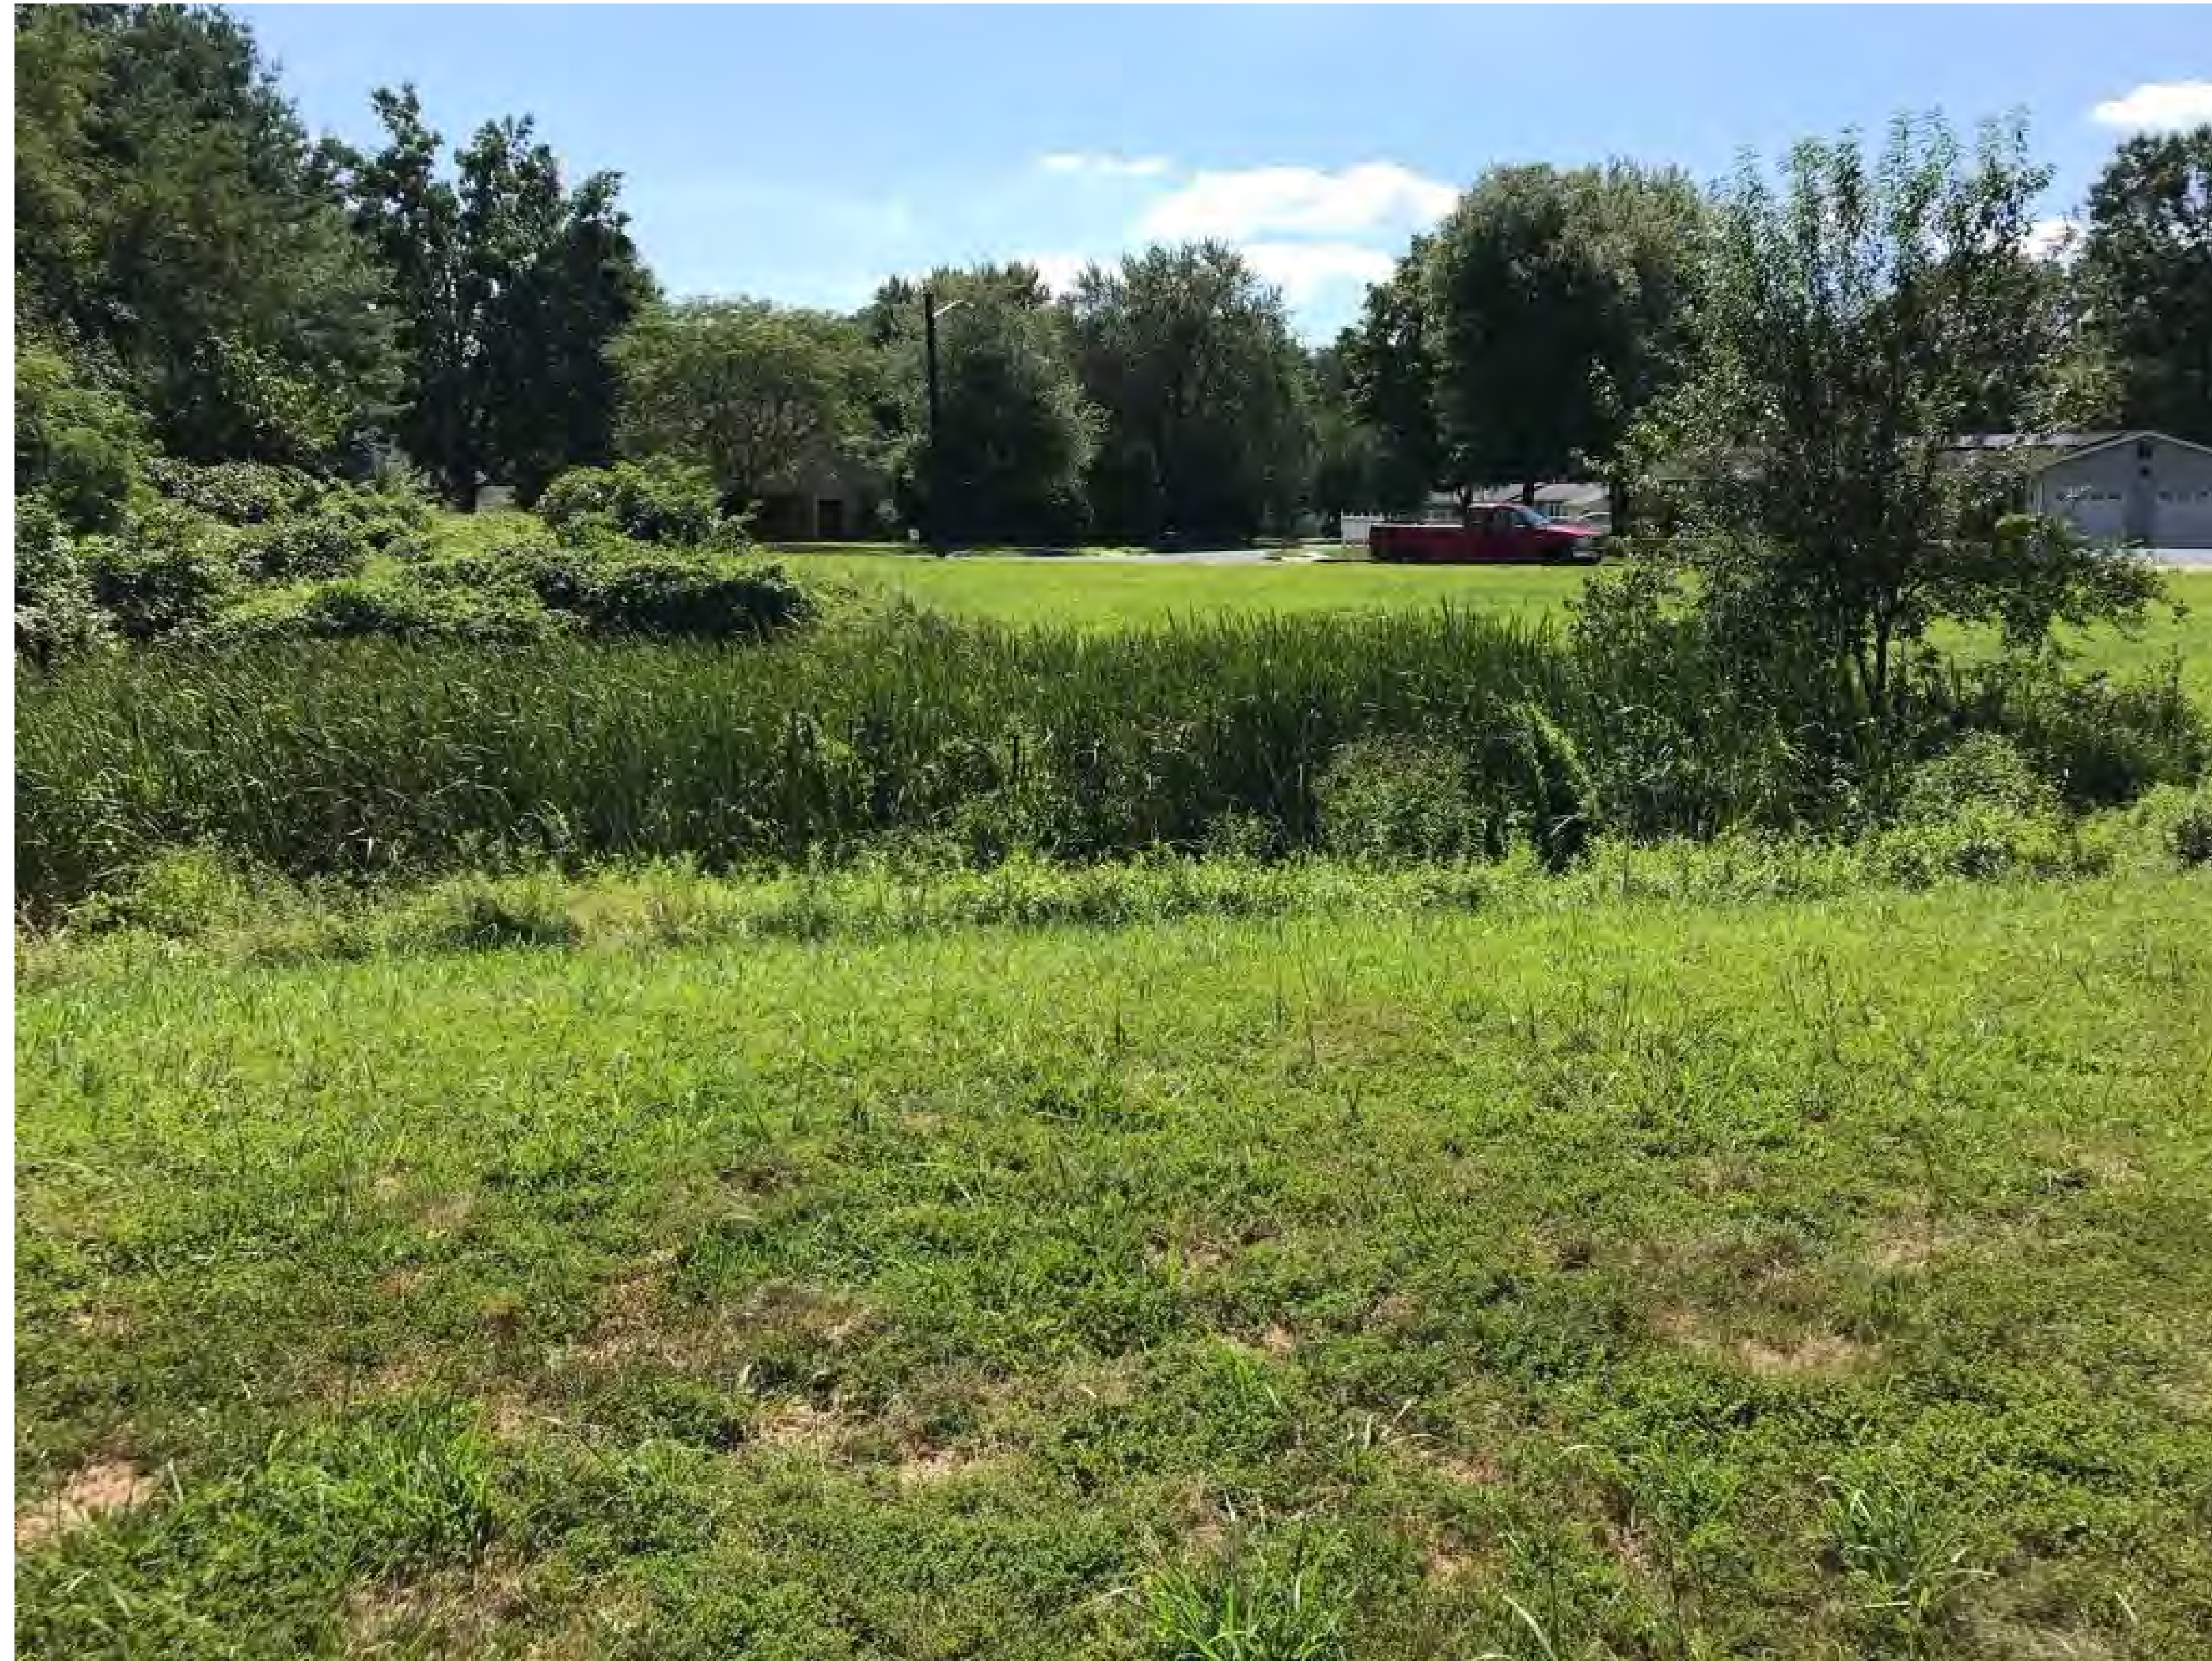
- Heavy vegetation in the basin
- No clear outlet identified

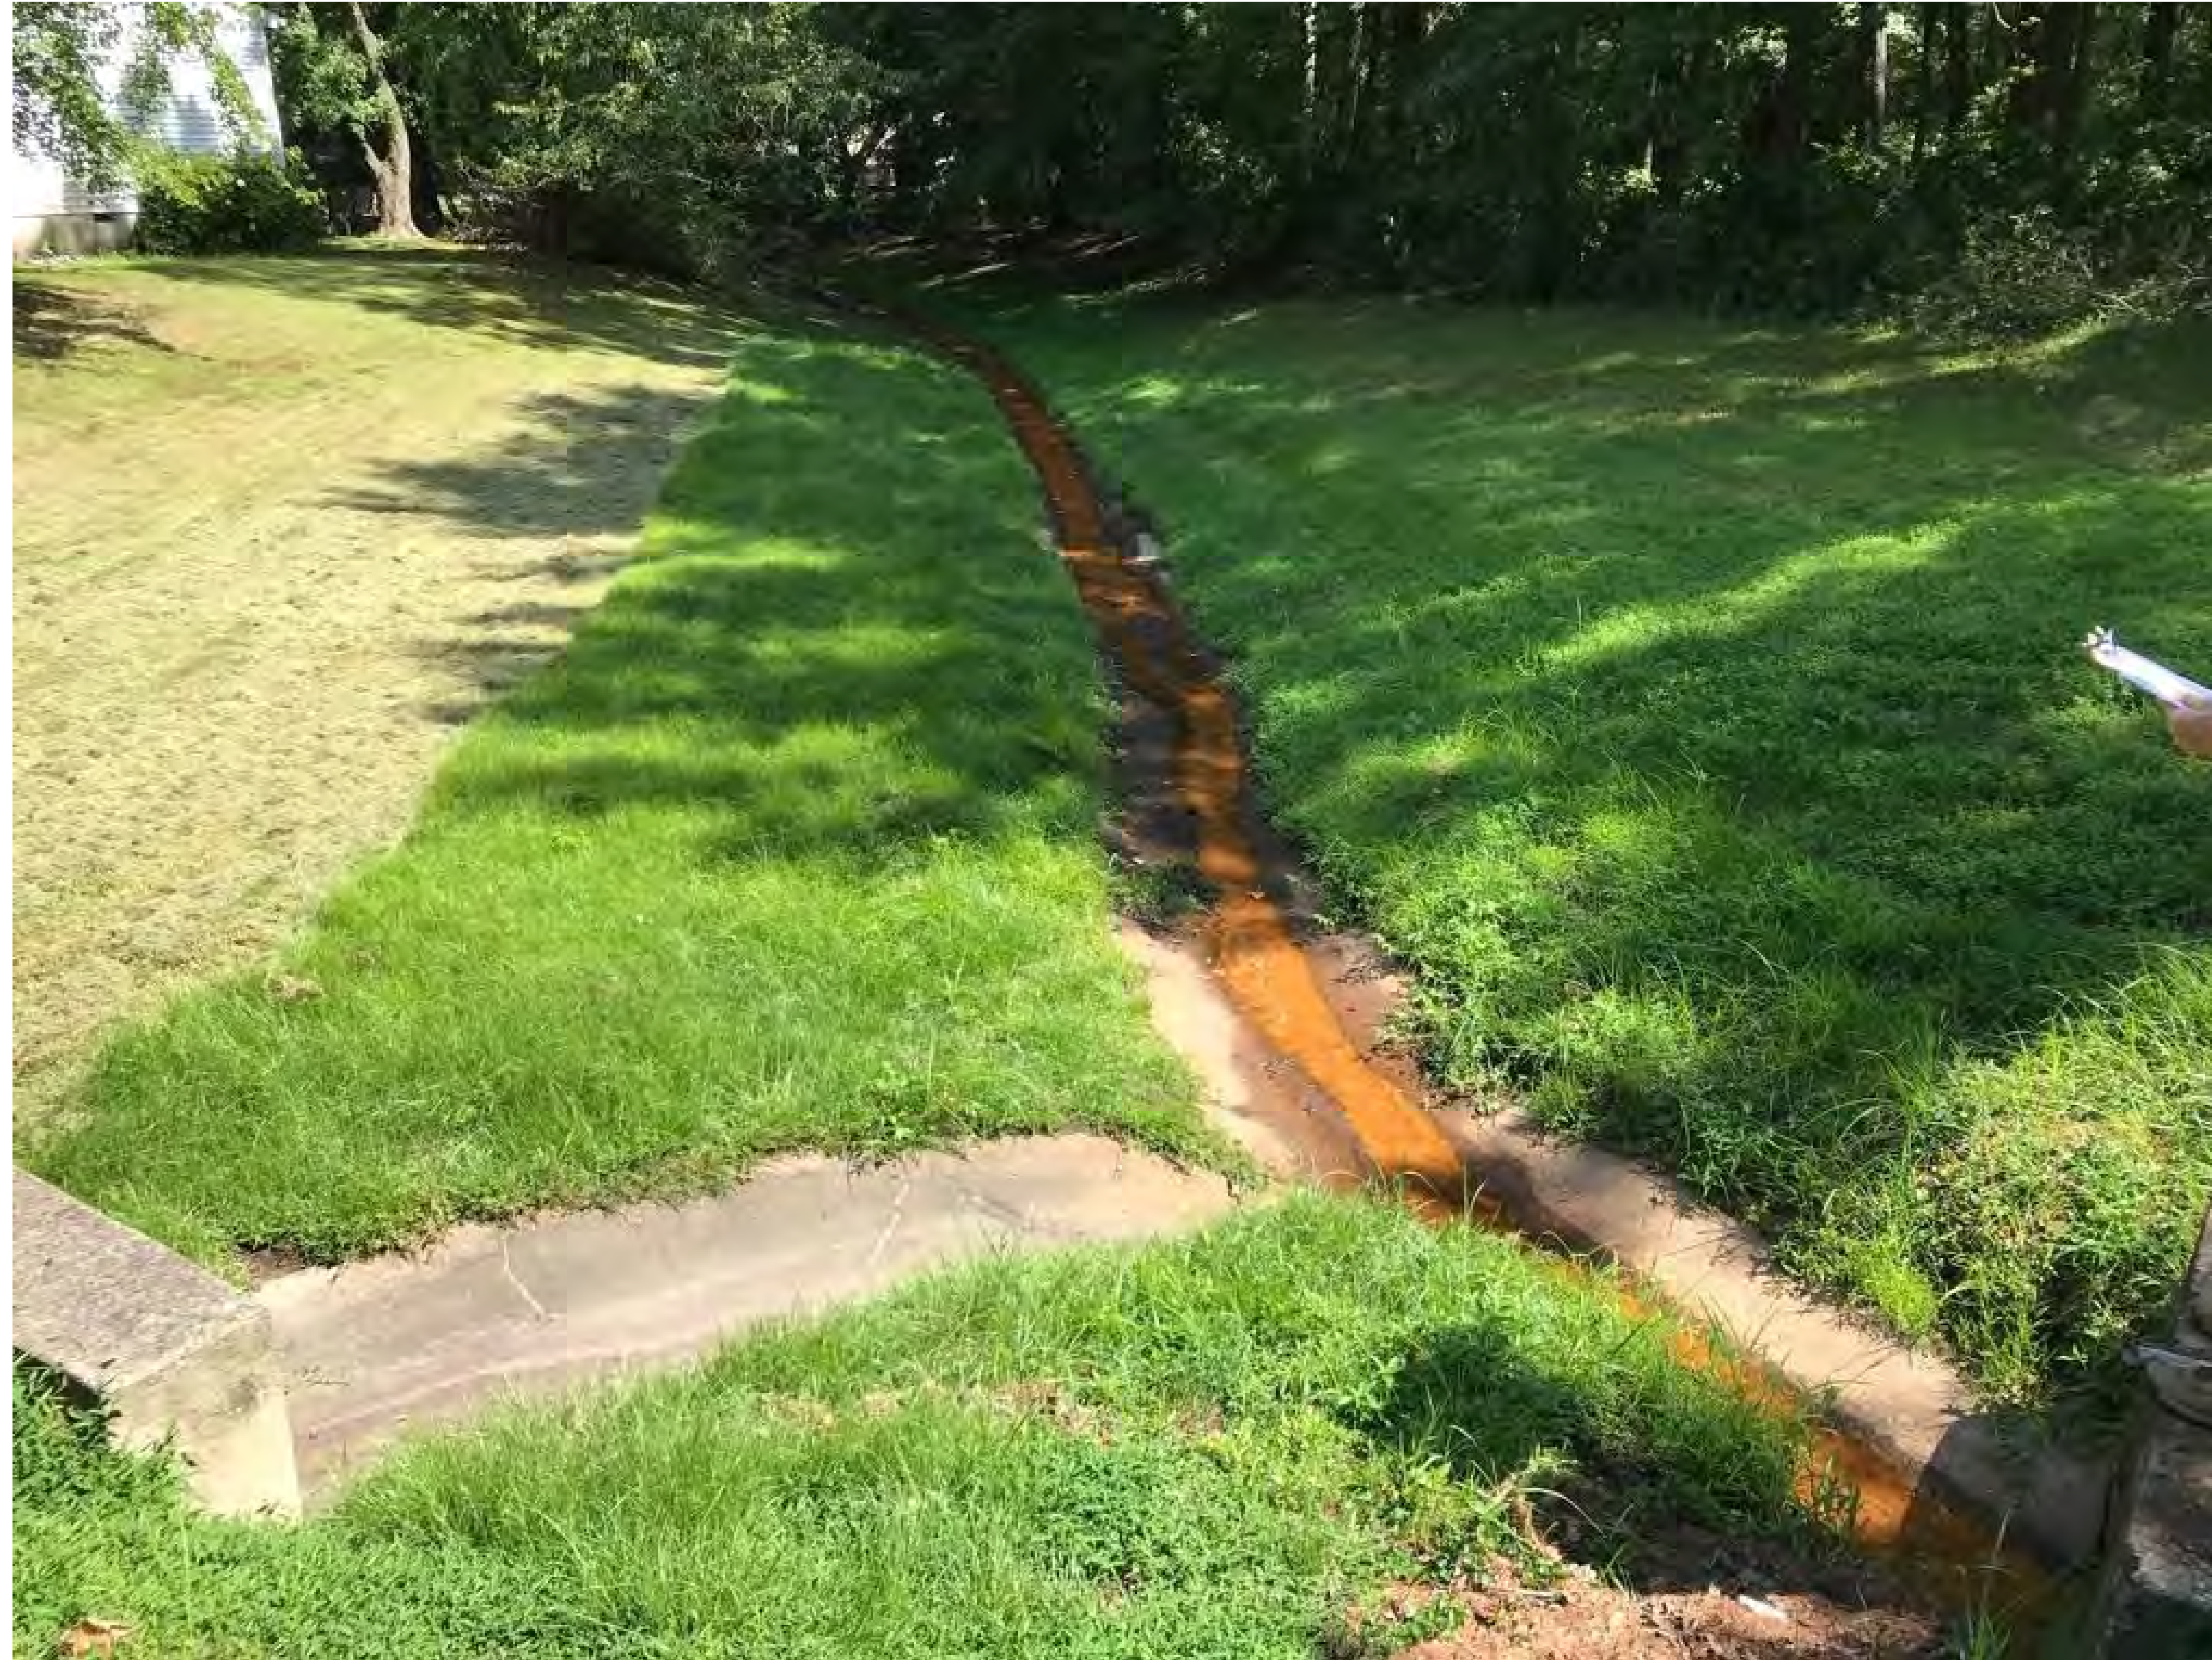
- Long detention basin with two inlets and an outlet
- Standing water present in low flow channel
- Clear sign of erosion occurring upstream from color of water in low flow channel

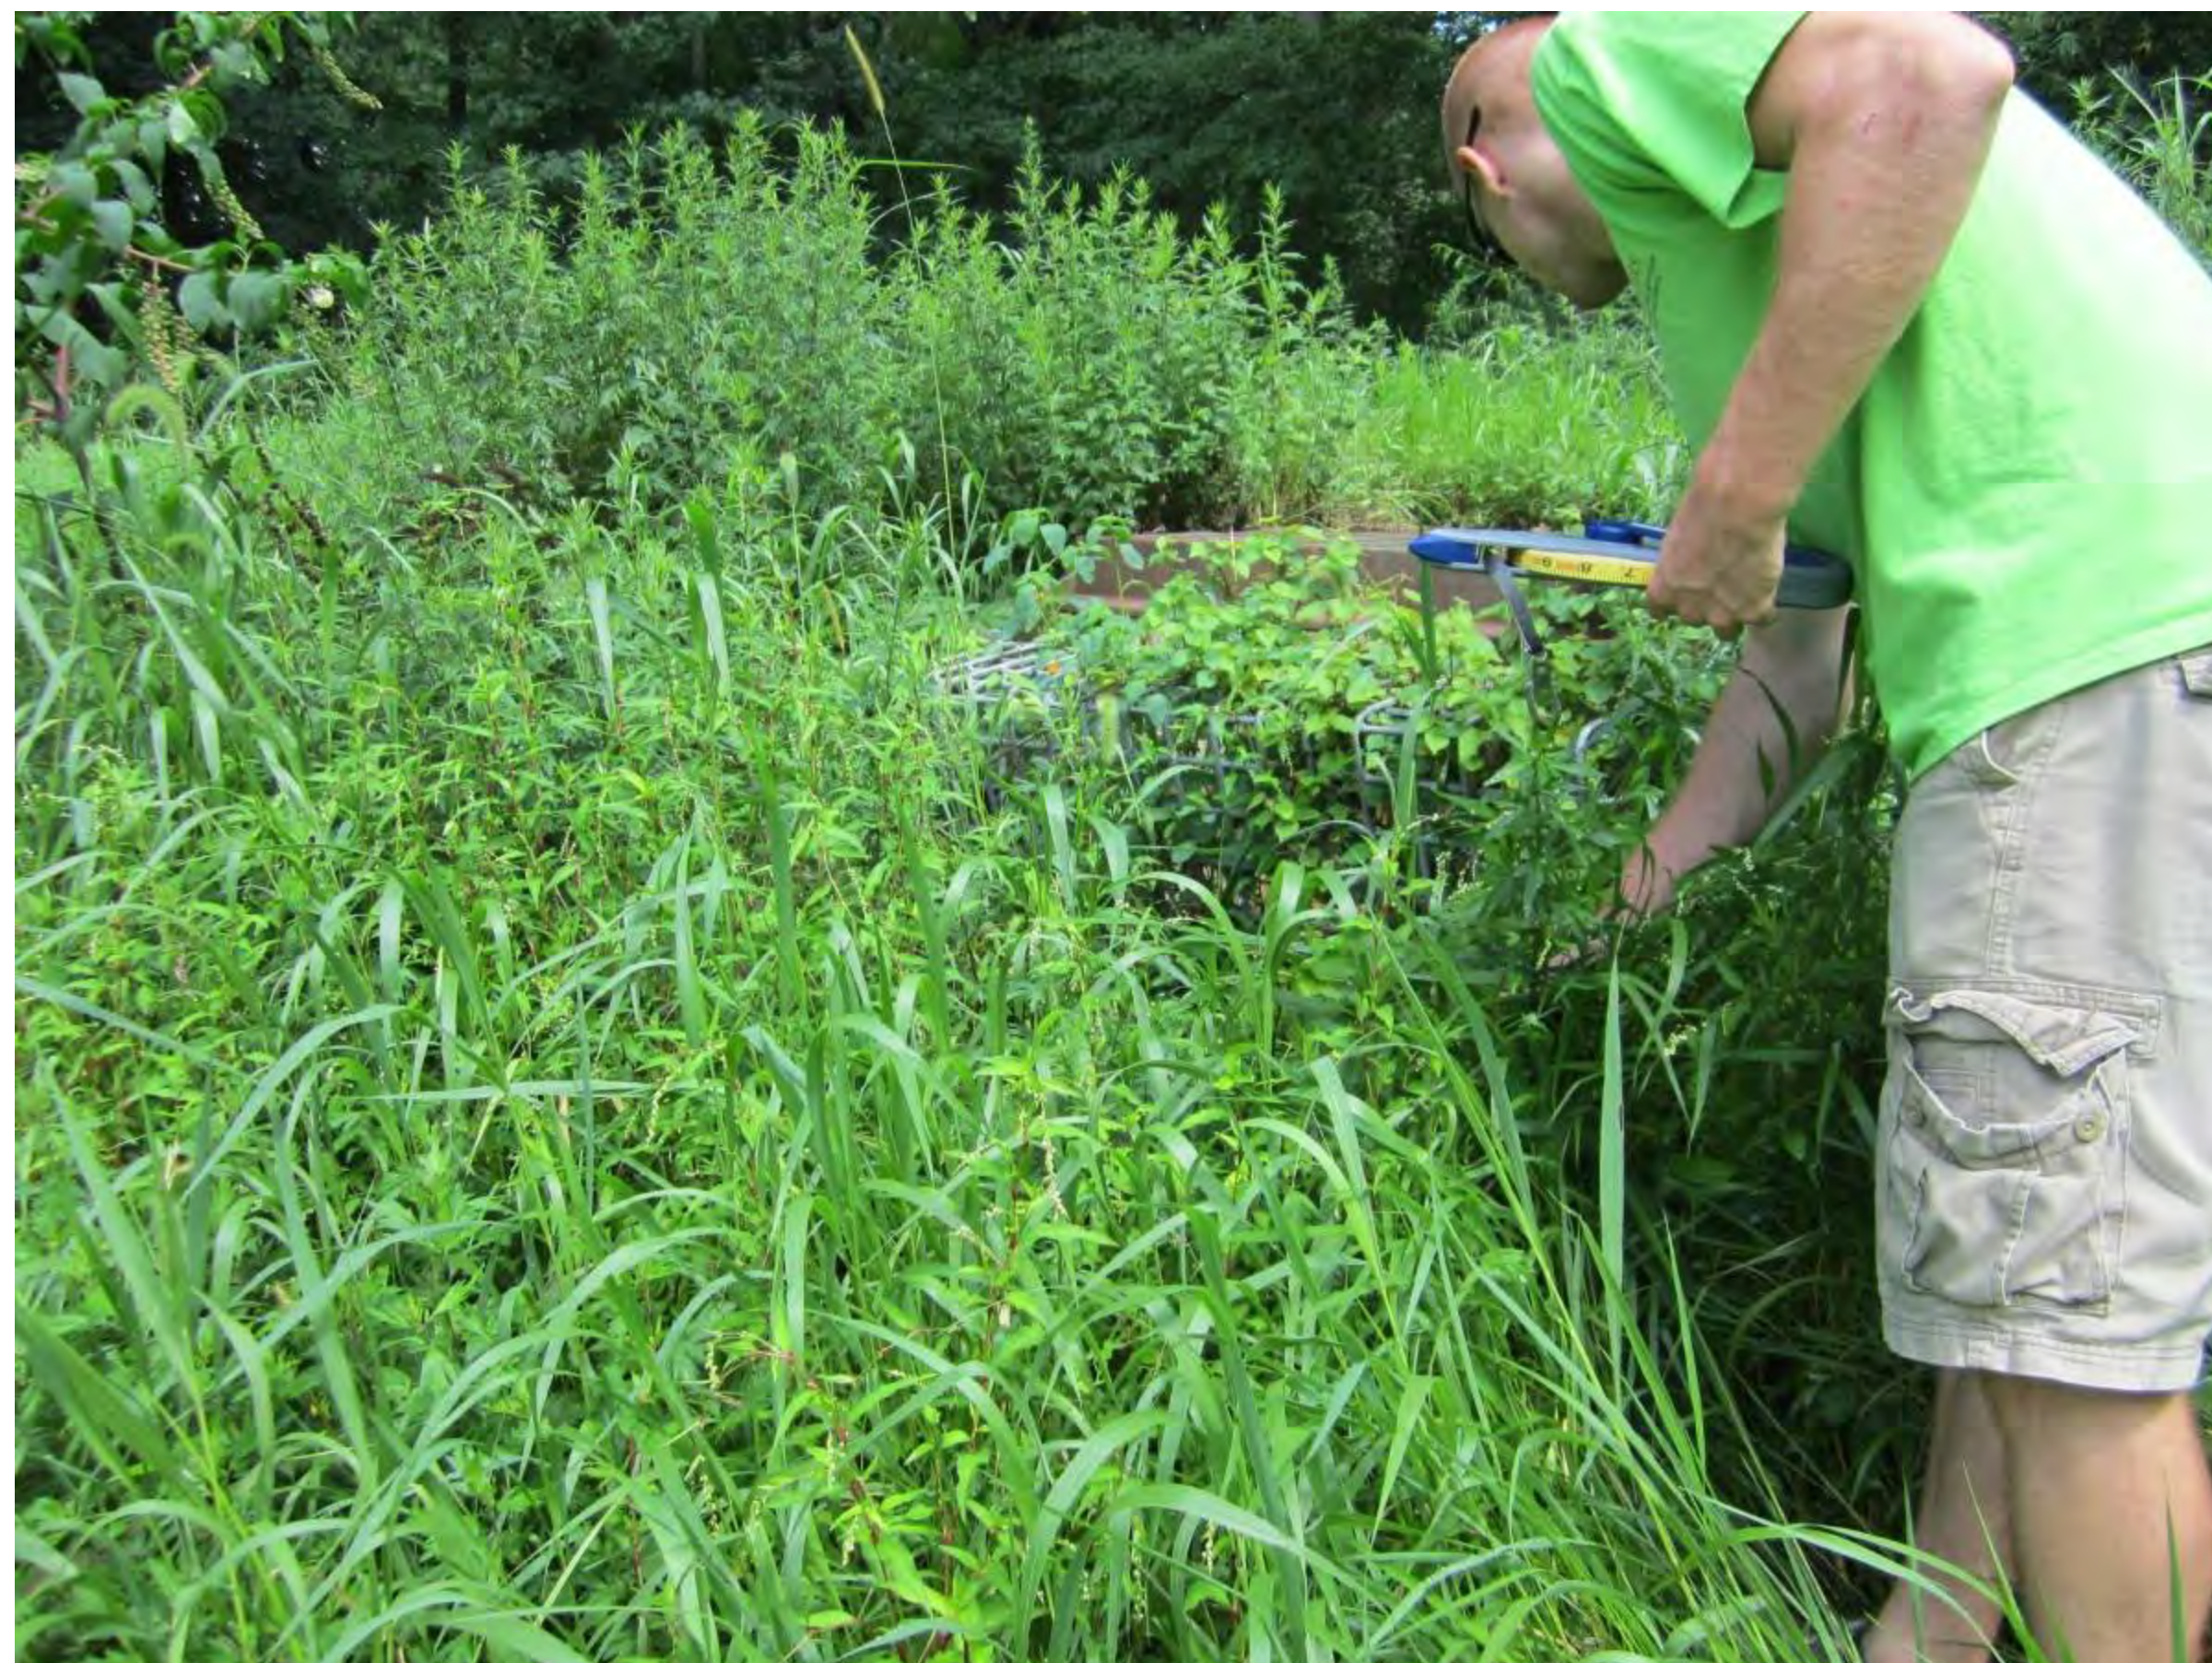
Overgrown outlet

- Standing water present in the low flow channel, and large amounts of vegetation around basin
- Low flow channel could be removed to promote infiltration instead of the standing water that is present.
