## Hamilton Township (Mercer County)

# REVIEW AND EVALUATION OF TOTAL MAXIMUM DAILY LOADS (TMDLs)

Developed by the Rutgers Cooperative Extension Water Resources Program  
Funded by Hamilton Township, Mercer County, New Jersey

December 5, 2019

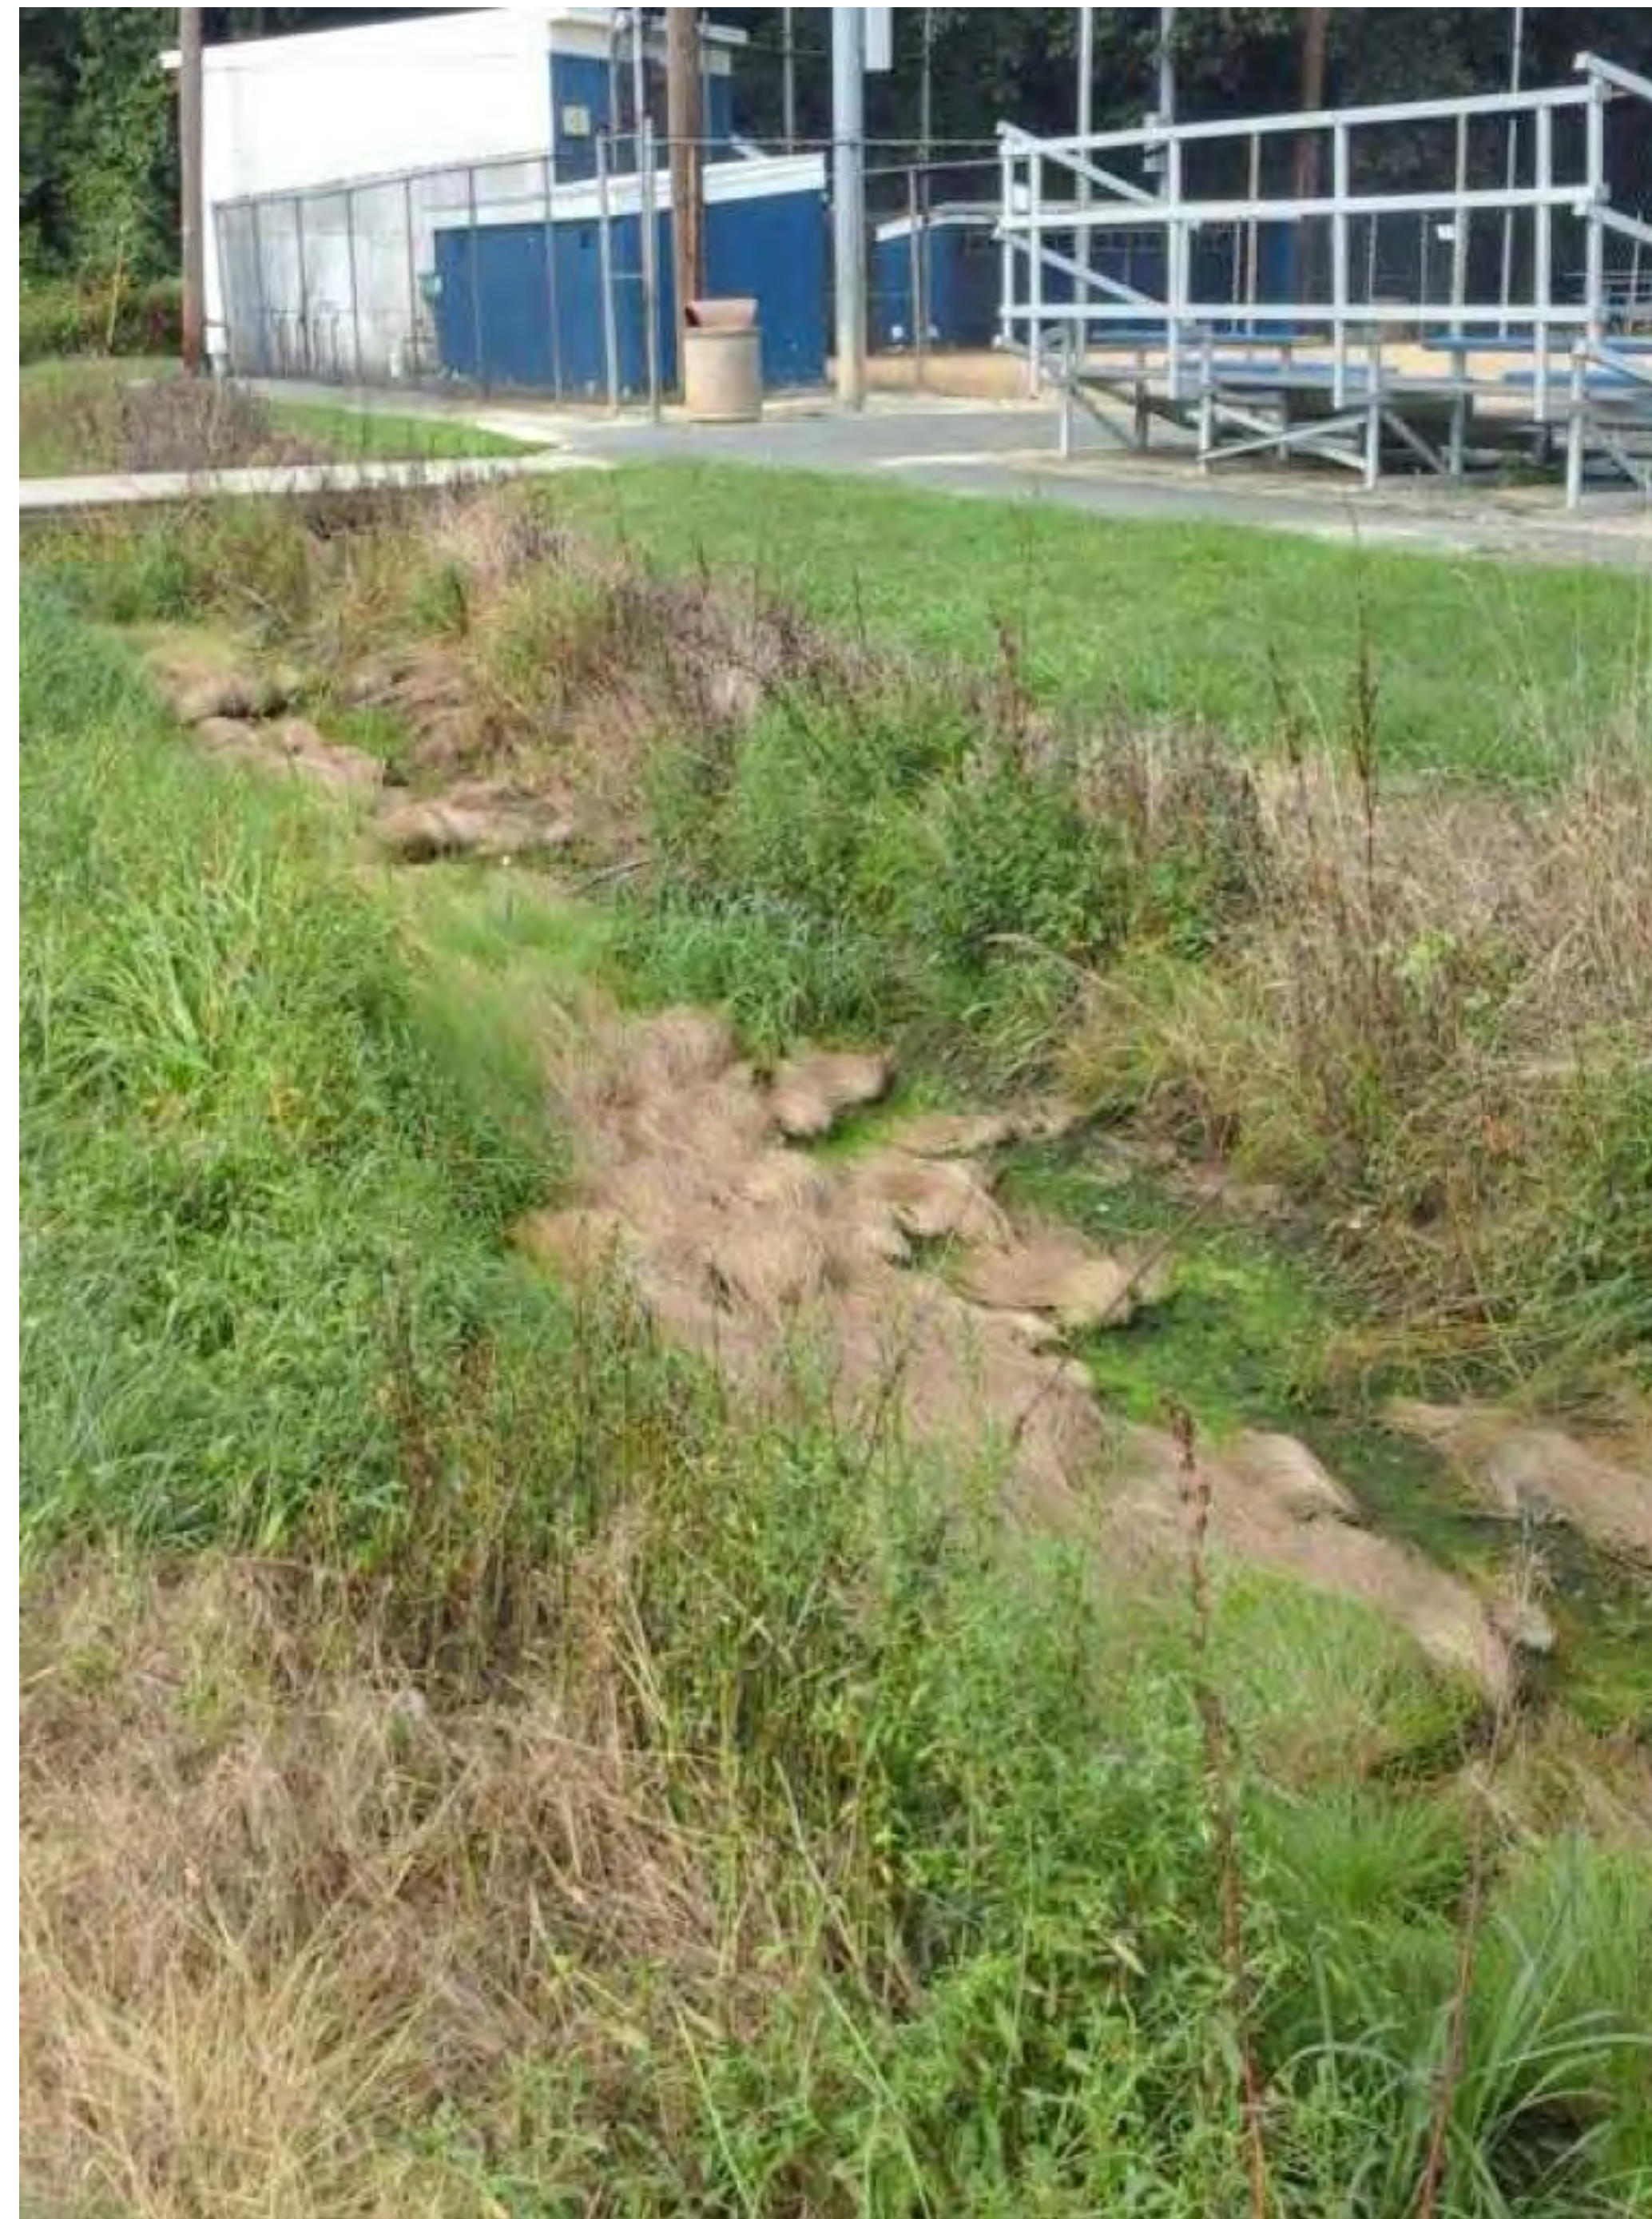
Hamilton Township  
Stormwater Basin Assessment  
*39. George Dick Field Basin*

- Appears to be a vegetated swale with check dams, not a true stormwater basin
- Bottom has some algae growth and lots of trash in it, appears to have high water flow with some erosion present
- Add stone to the bottom to help slow down the water and reduce erosion

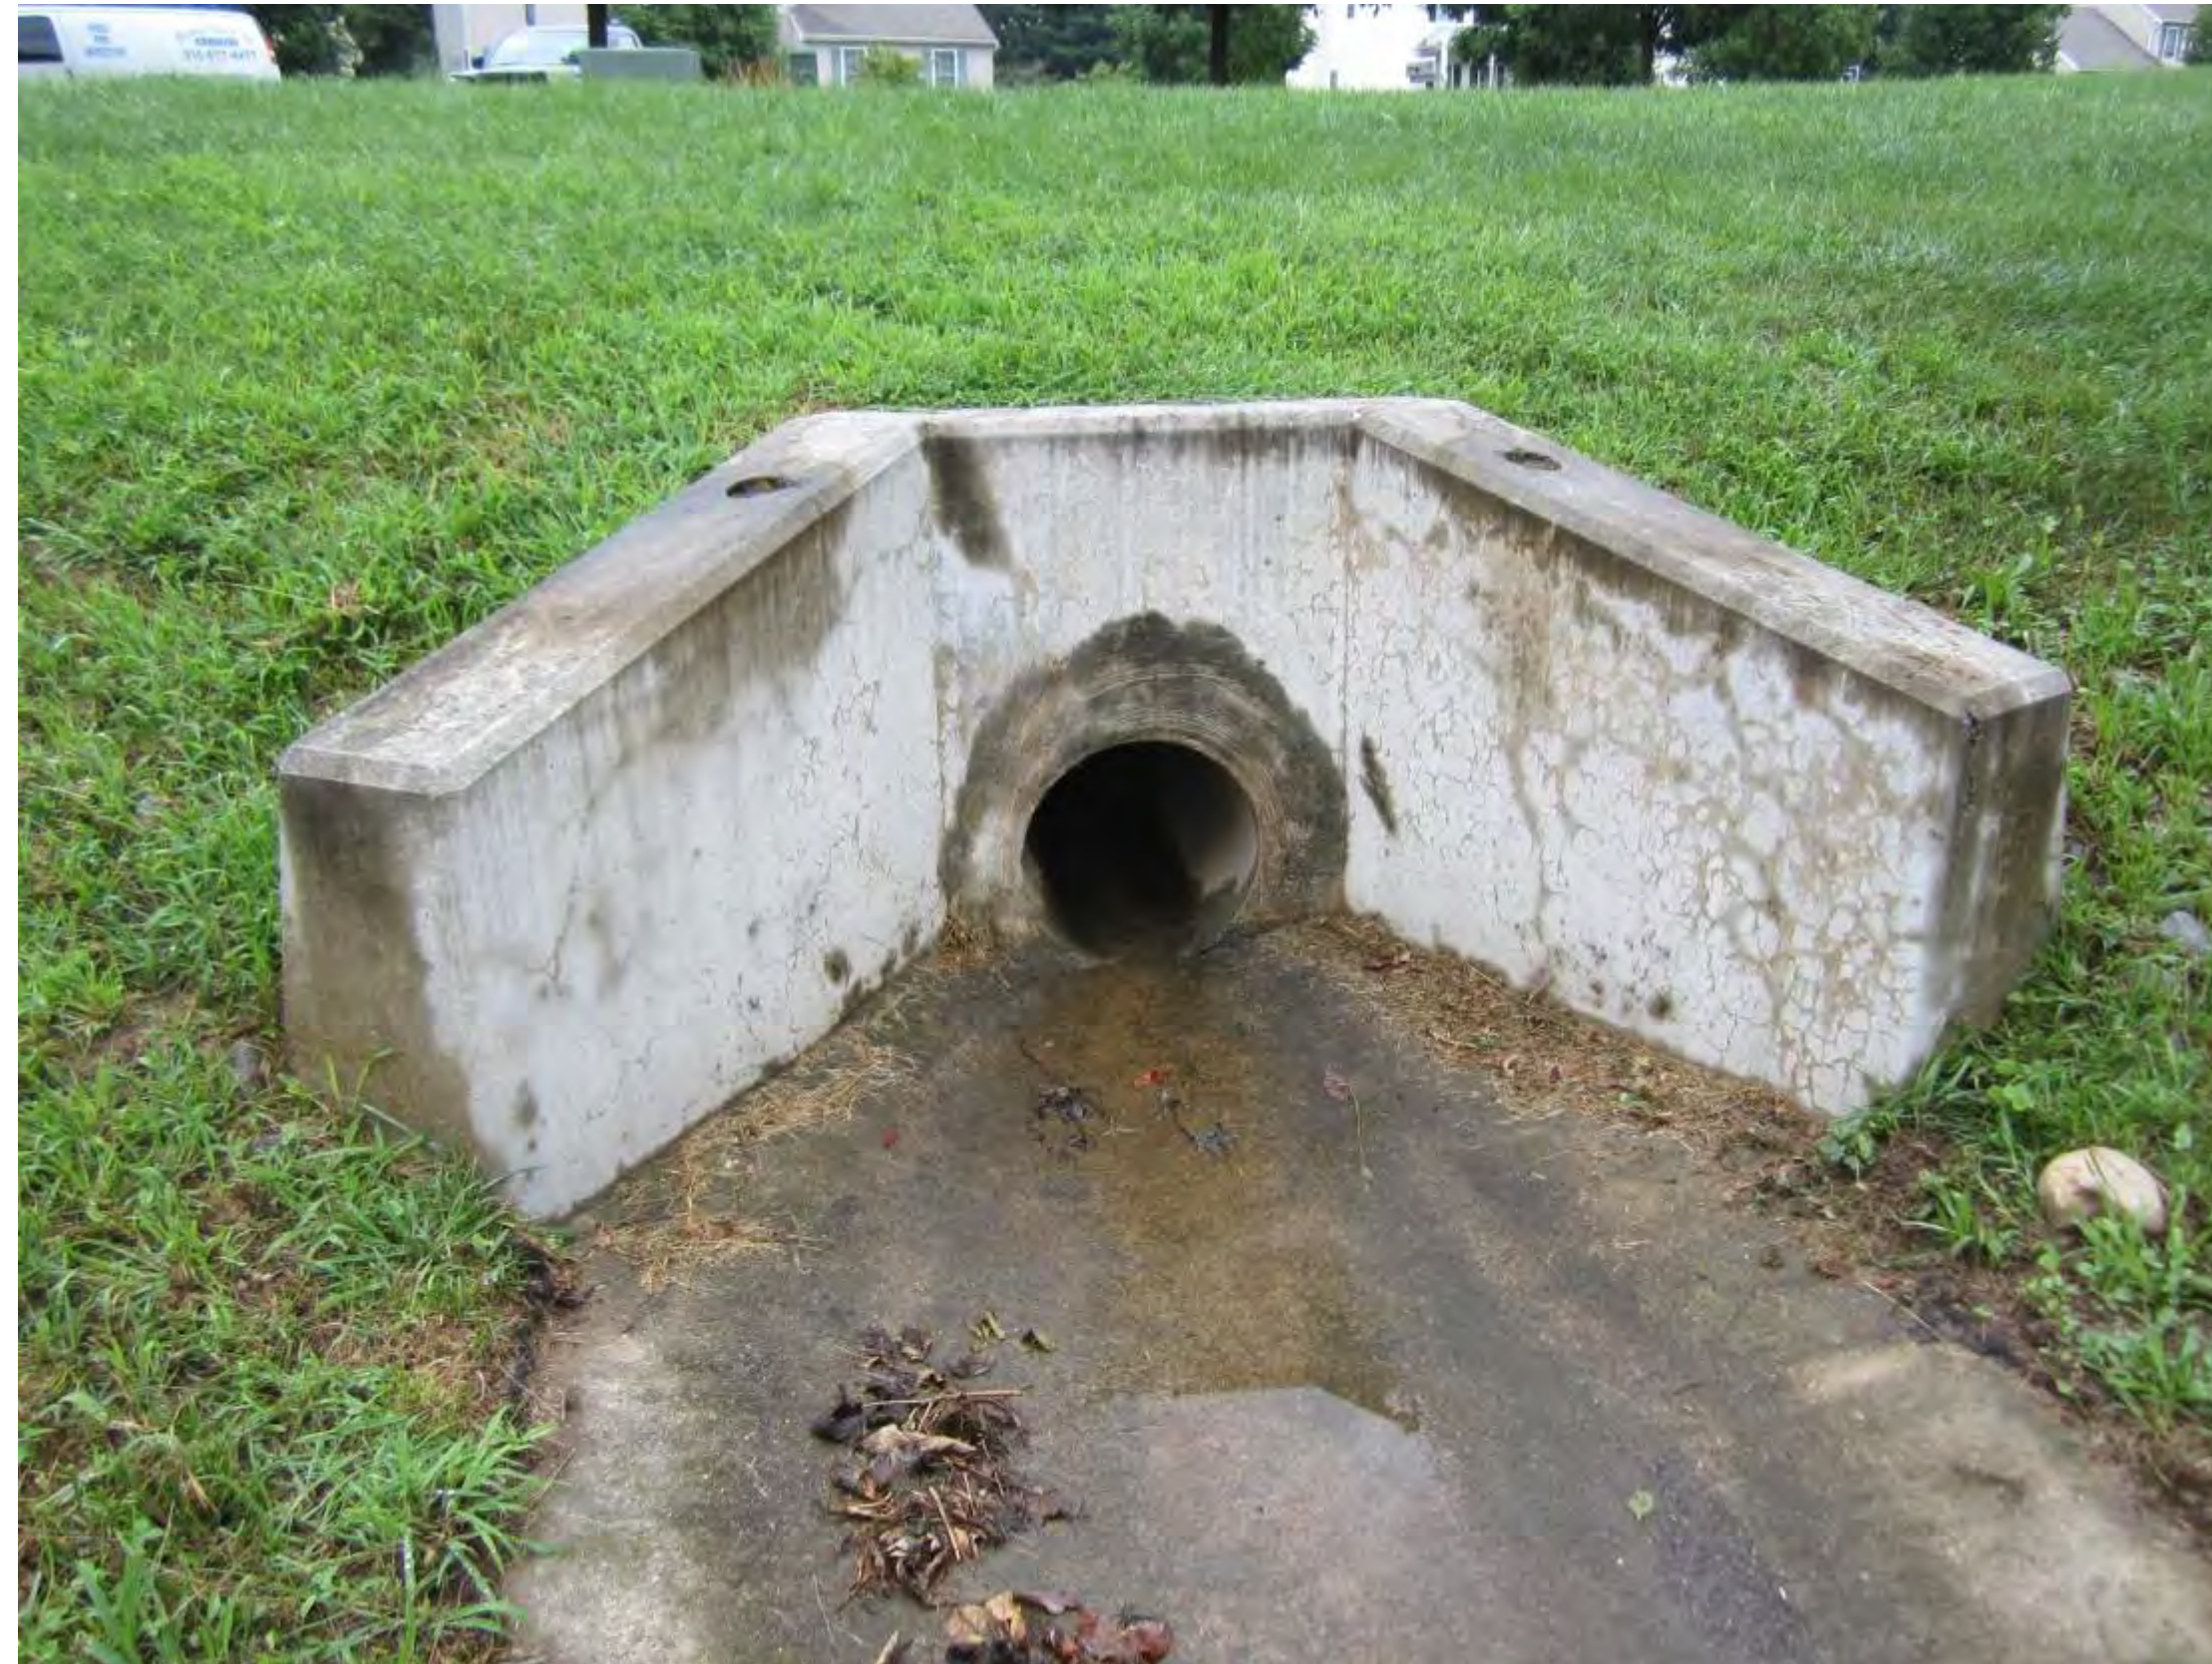
Inlet

- Standing water in low flow channel
- Outlet has structural damage and trash rack is clogged with sediment/debris

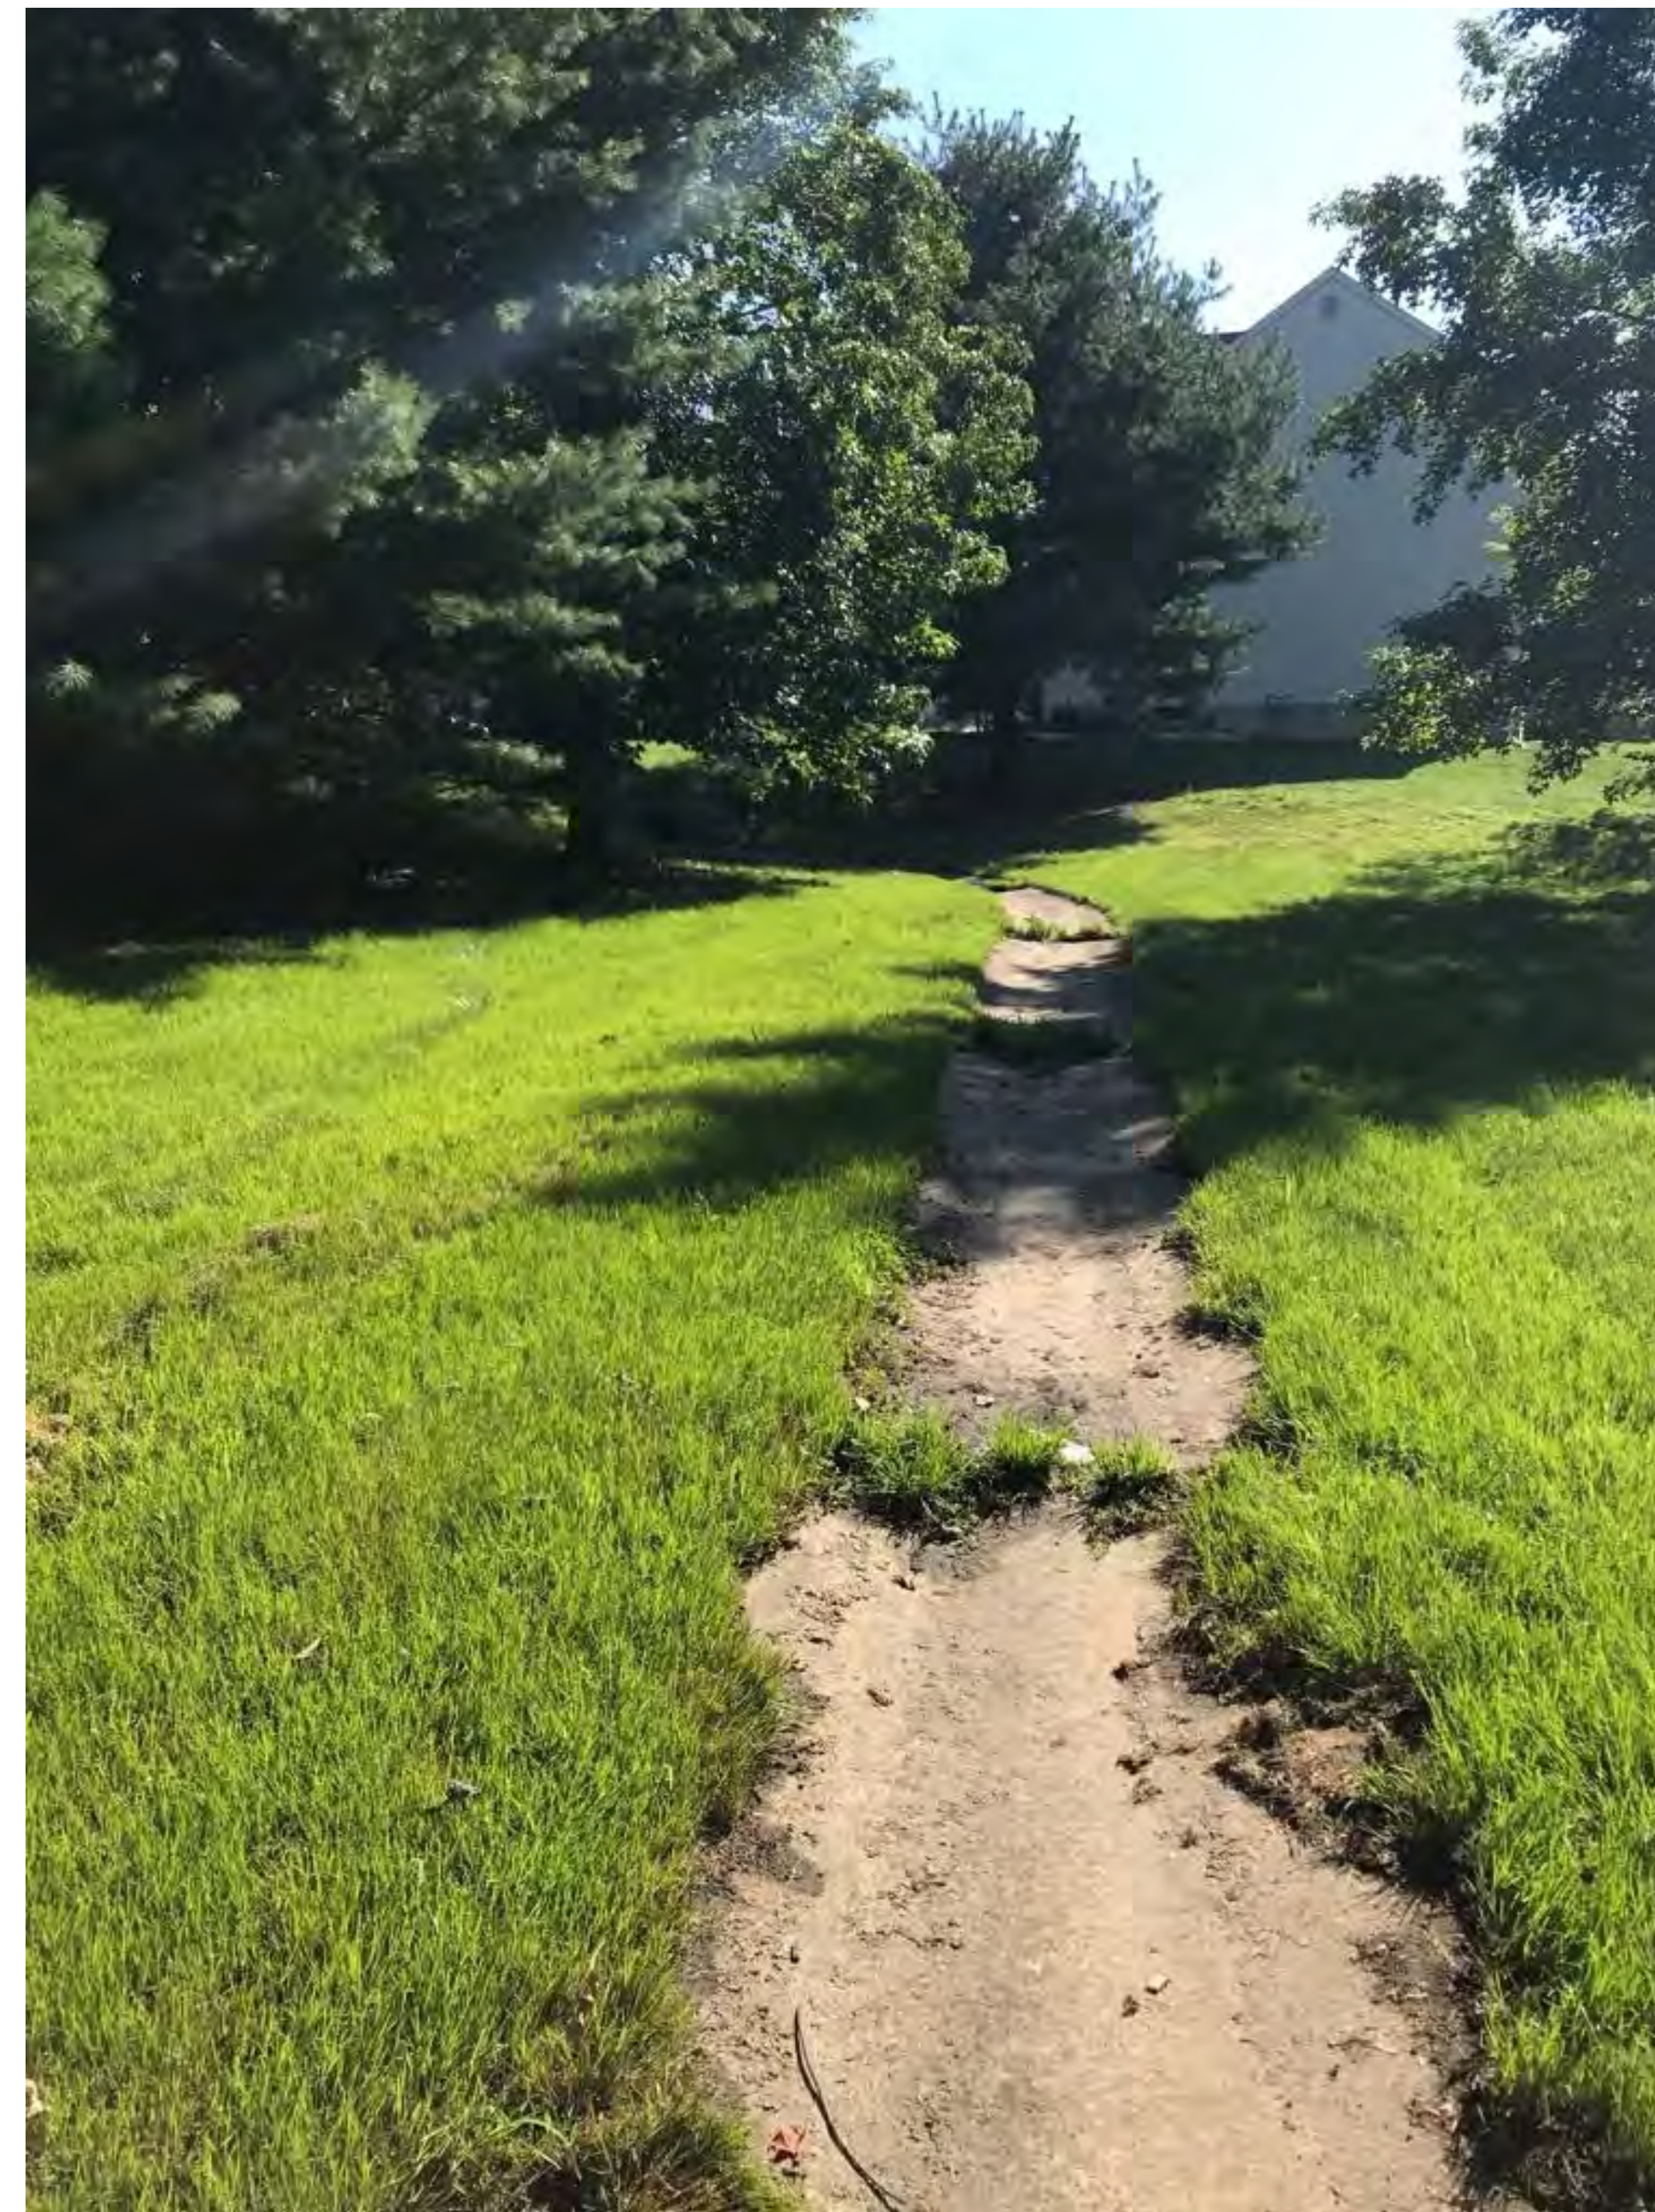
Hamilton Township  
Stormwater Basin Assessment  
*56. Colton Ct Residential Basin*

- Low flow channel blocked by organic debris and sediment
- Remove sediment and clearing of obstructions to outflow
- Opportunity to remove concrete channels and add rock flow channels with vegetation

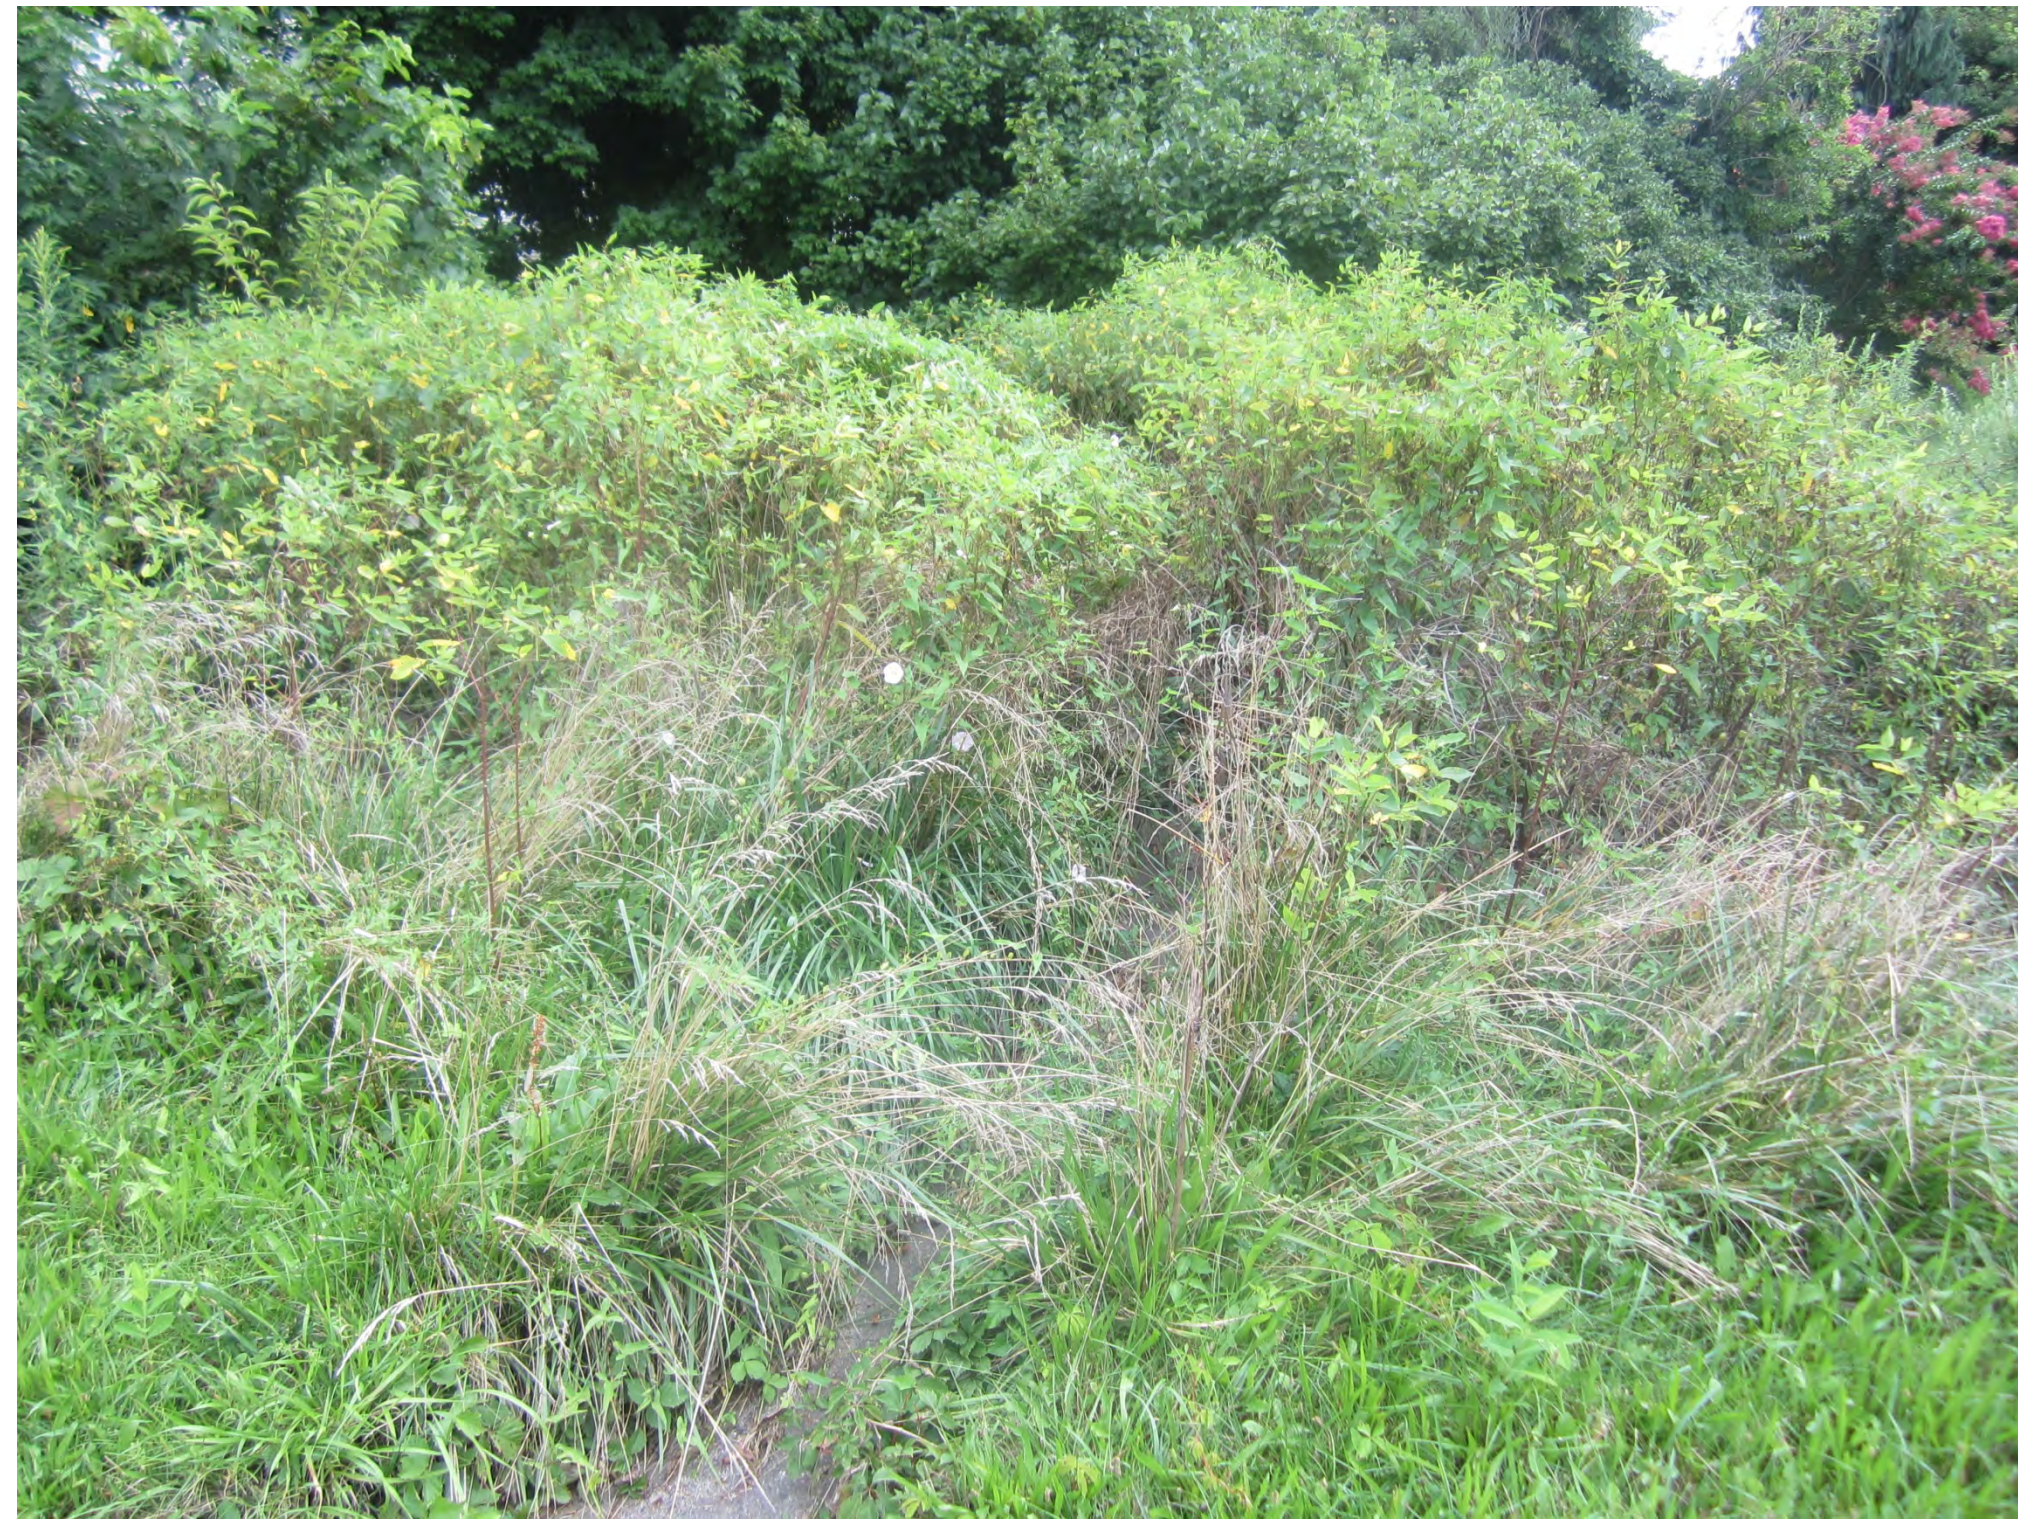
Overgrown inlet

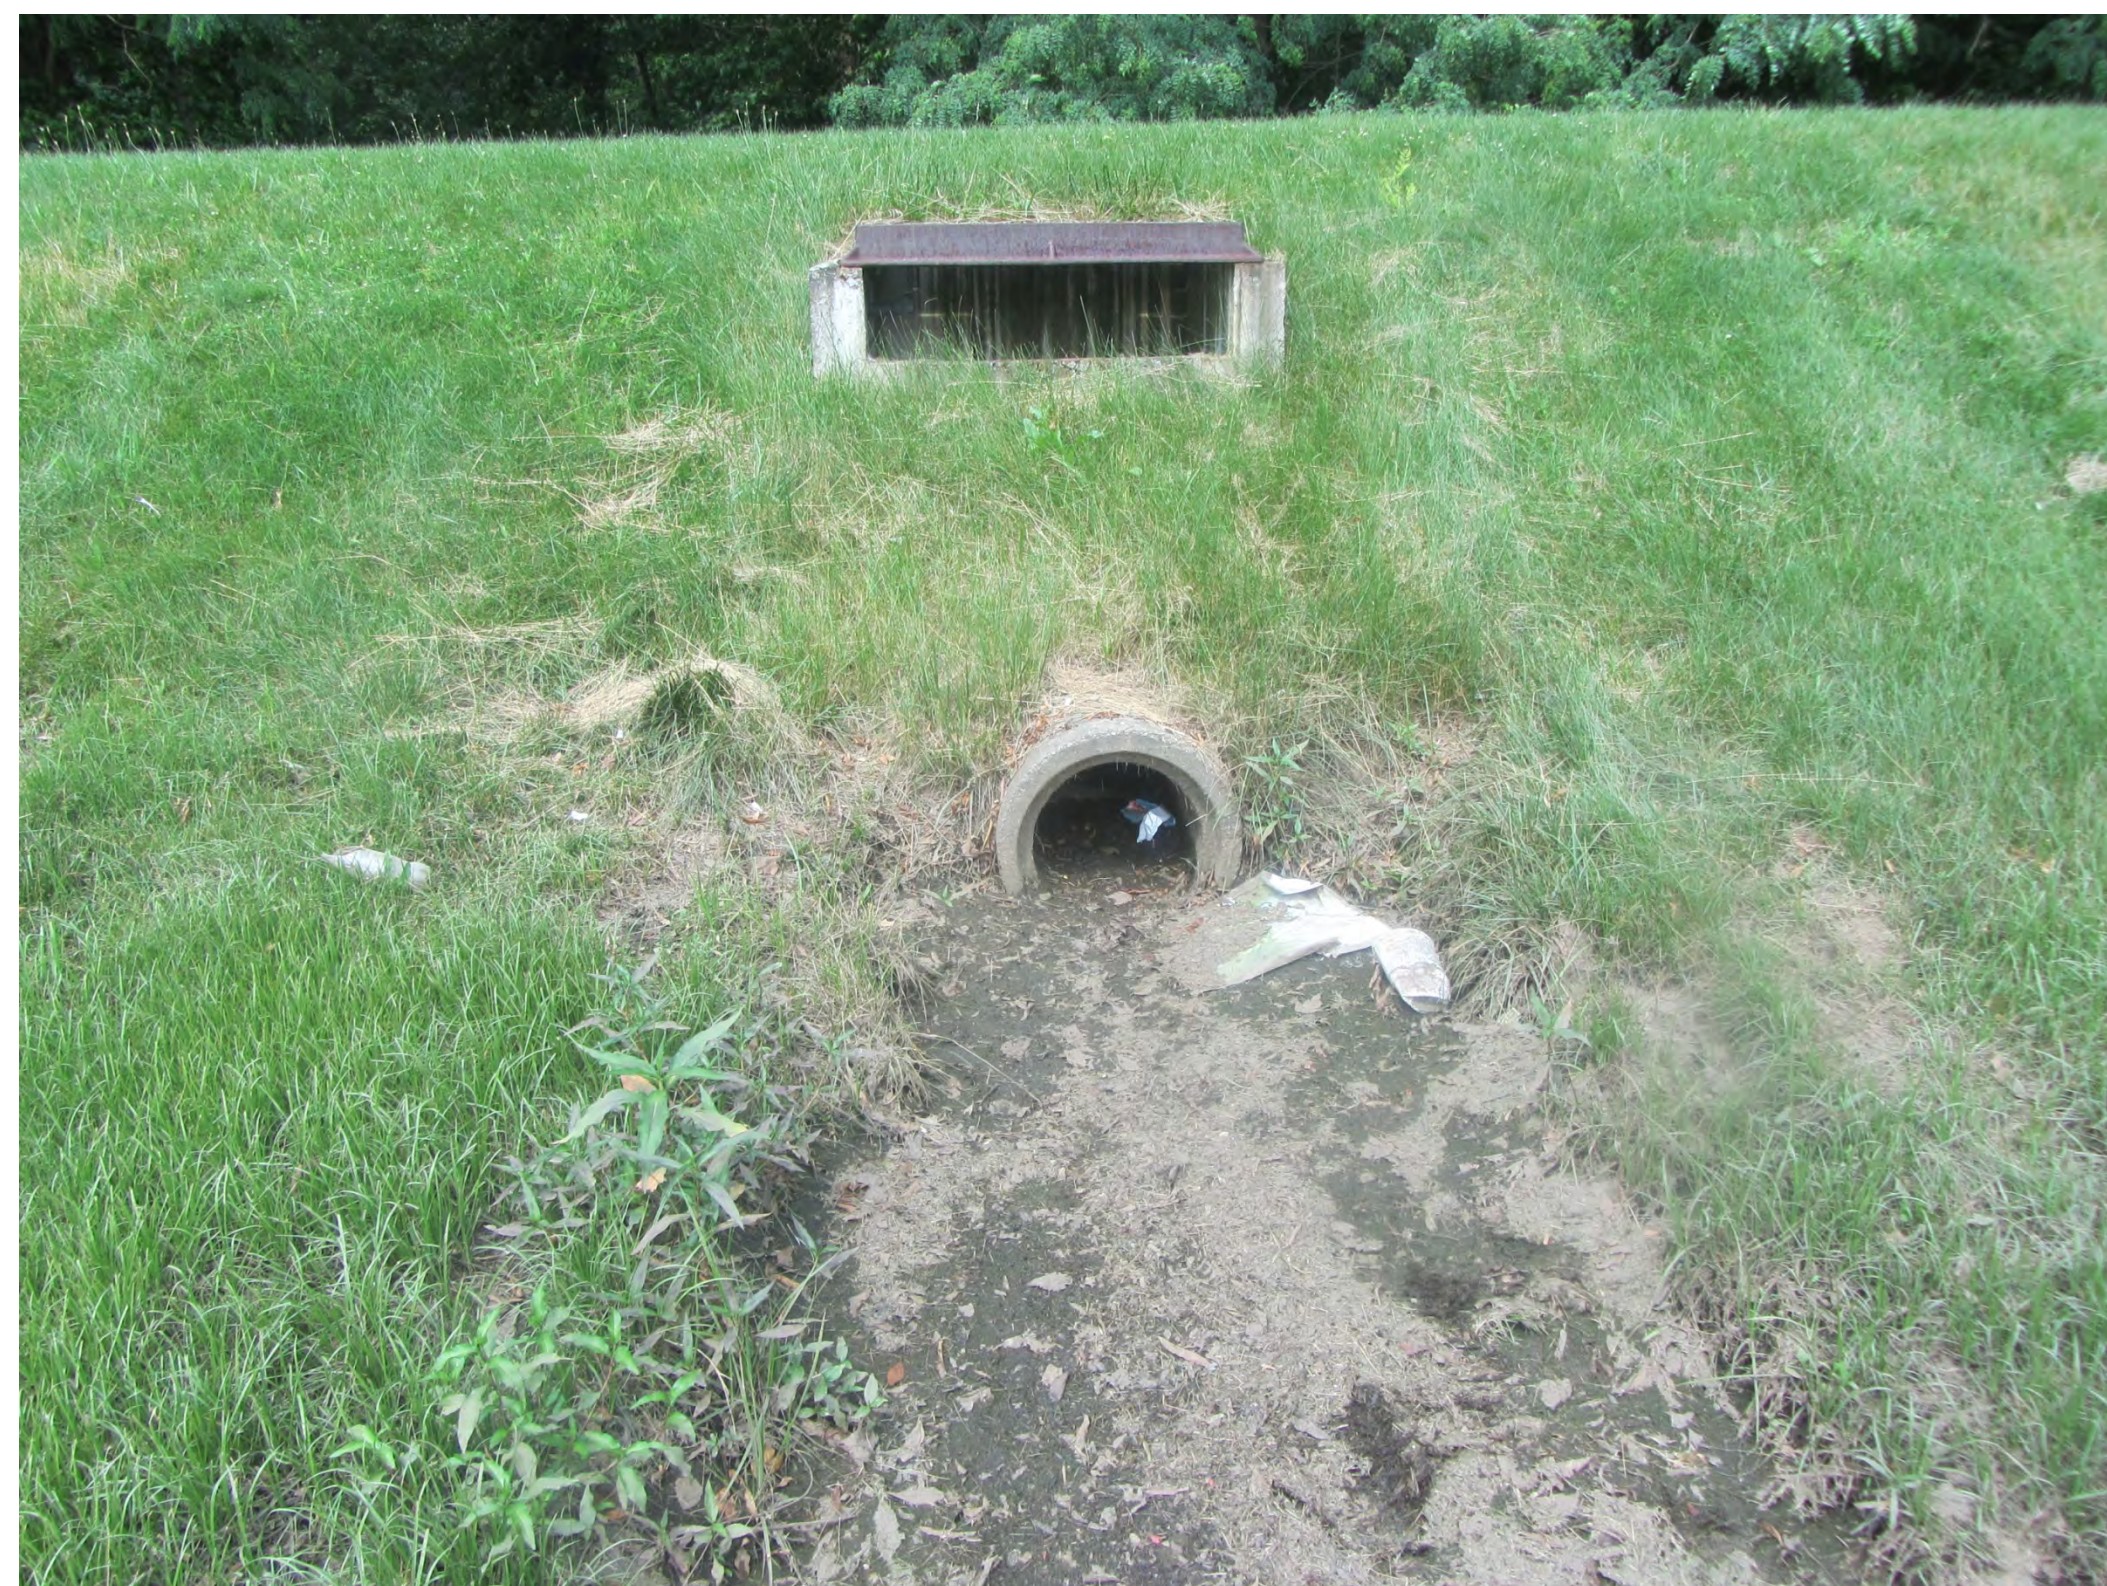
Outlet structure

- Excessive sediment build up in front of outlet structure, grass growing over low flow channel
- Excess sediment and litter should be removed
- Opportunity to replace low flow channel with a stone channel to promote infiltration

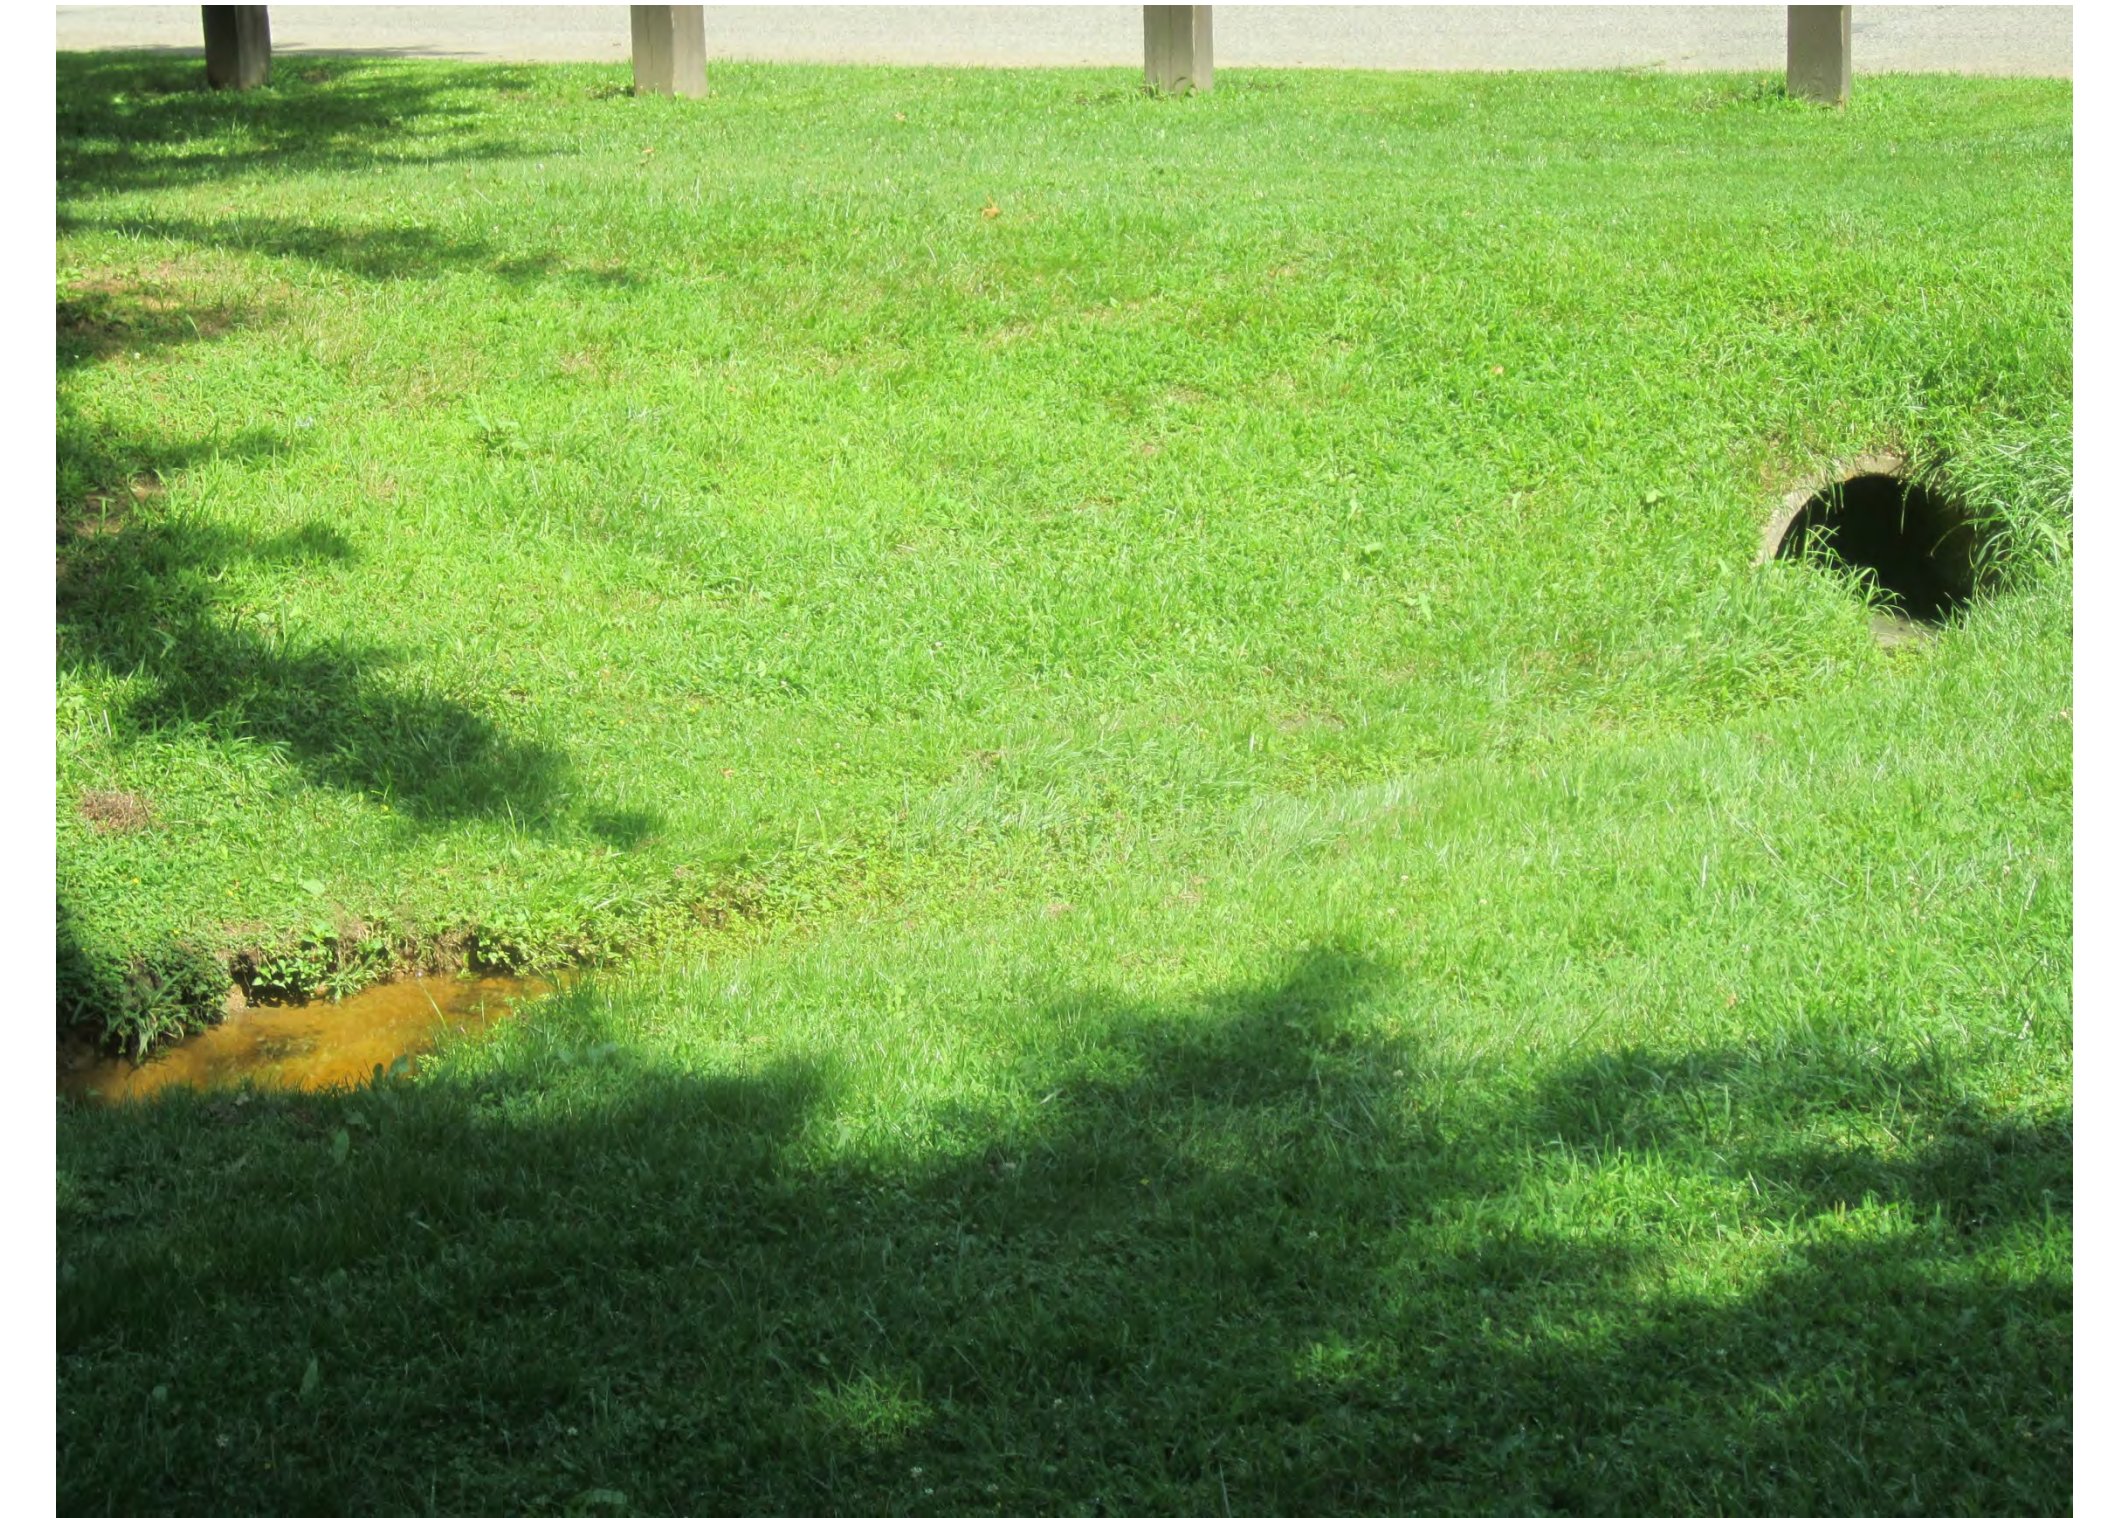
Outlet structure and gully

- The southern inlet is about halfway filled with sediment
- The northeastern inlet is in need of replacement
- The basin bottom has many gullies throughout and excess sediment accumulation
- There is standing water and erosion in front of the outlet
