## Hamilton Township (Mercer County)

# REVIEW AND EVALUATION OF TOTAL MAXIMUM DAILY LOADS (TMDLs)

Developed by the Rutgers Cooperative Extension Water Resources Program  
Funded by Hamilton Township, Mercer County, New Jersey

December 5, 2019

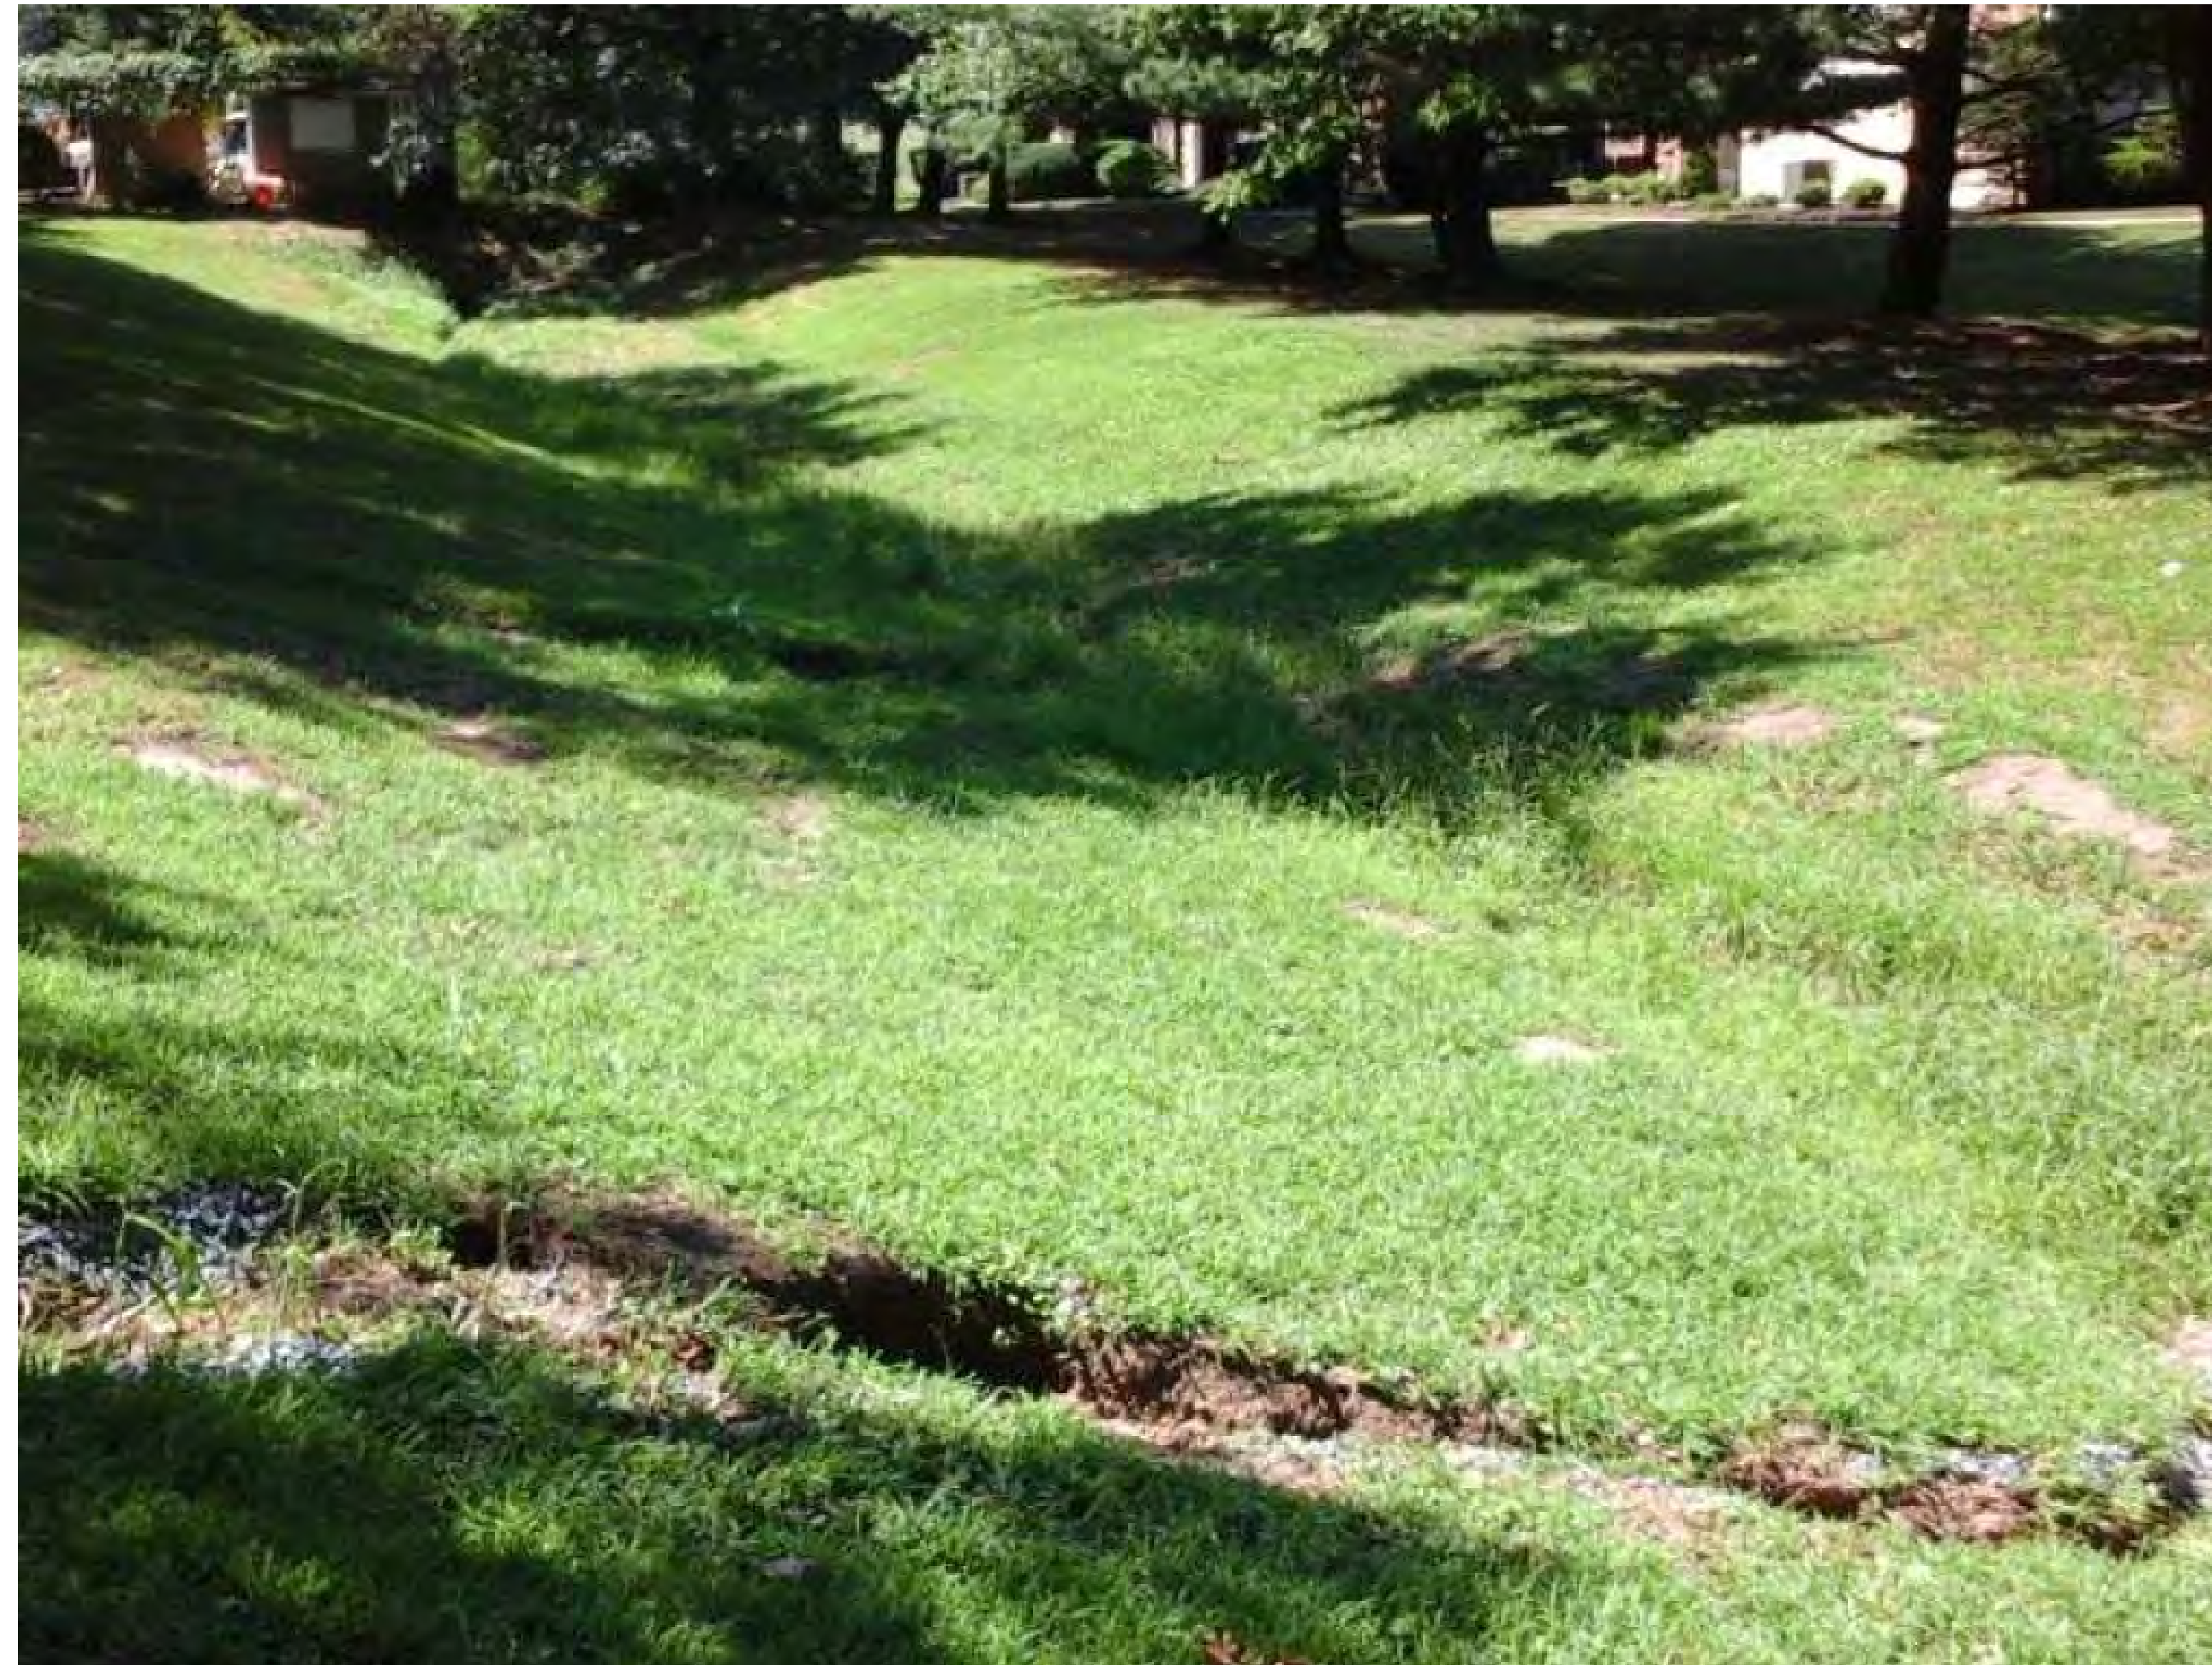
*158. Hamilton Veterans Park Detention Basin (a)*

- Area appears to be more of a swale than a basin
- Severe erosion issue near inlet that needs to be remediated
- Naturalize base with herbaceous plants

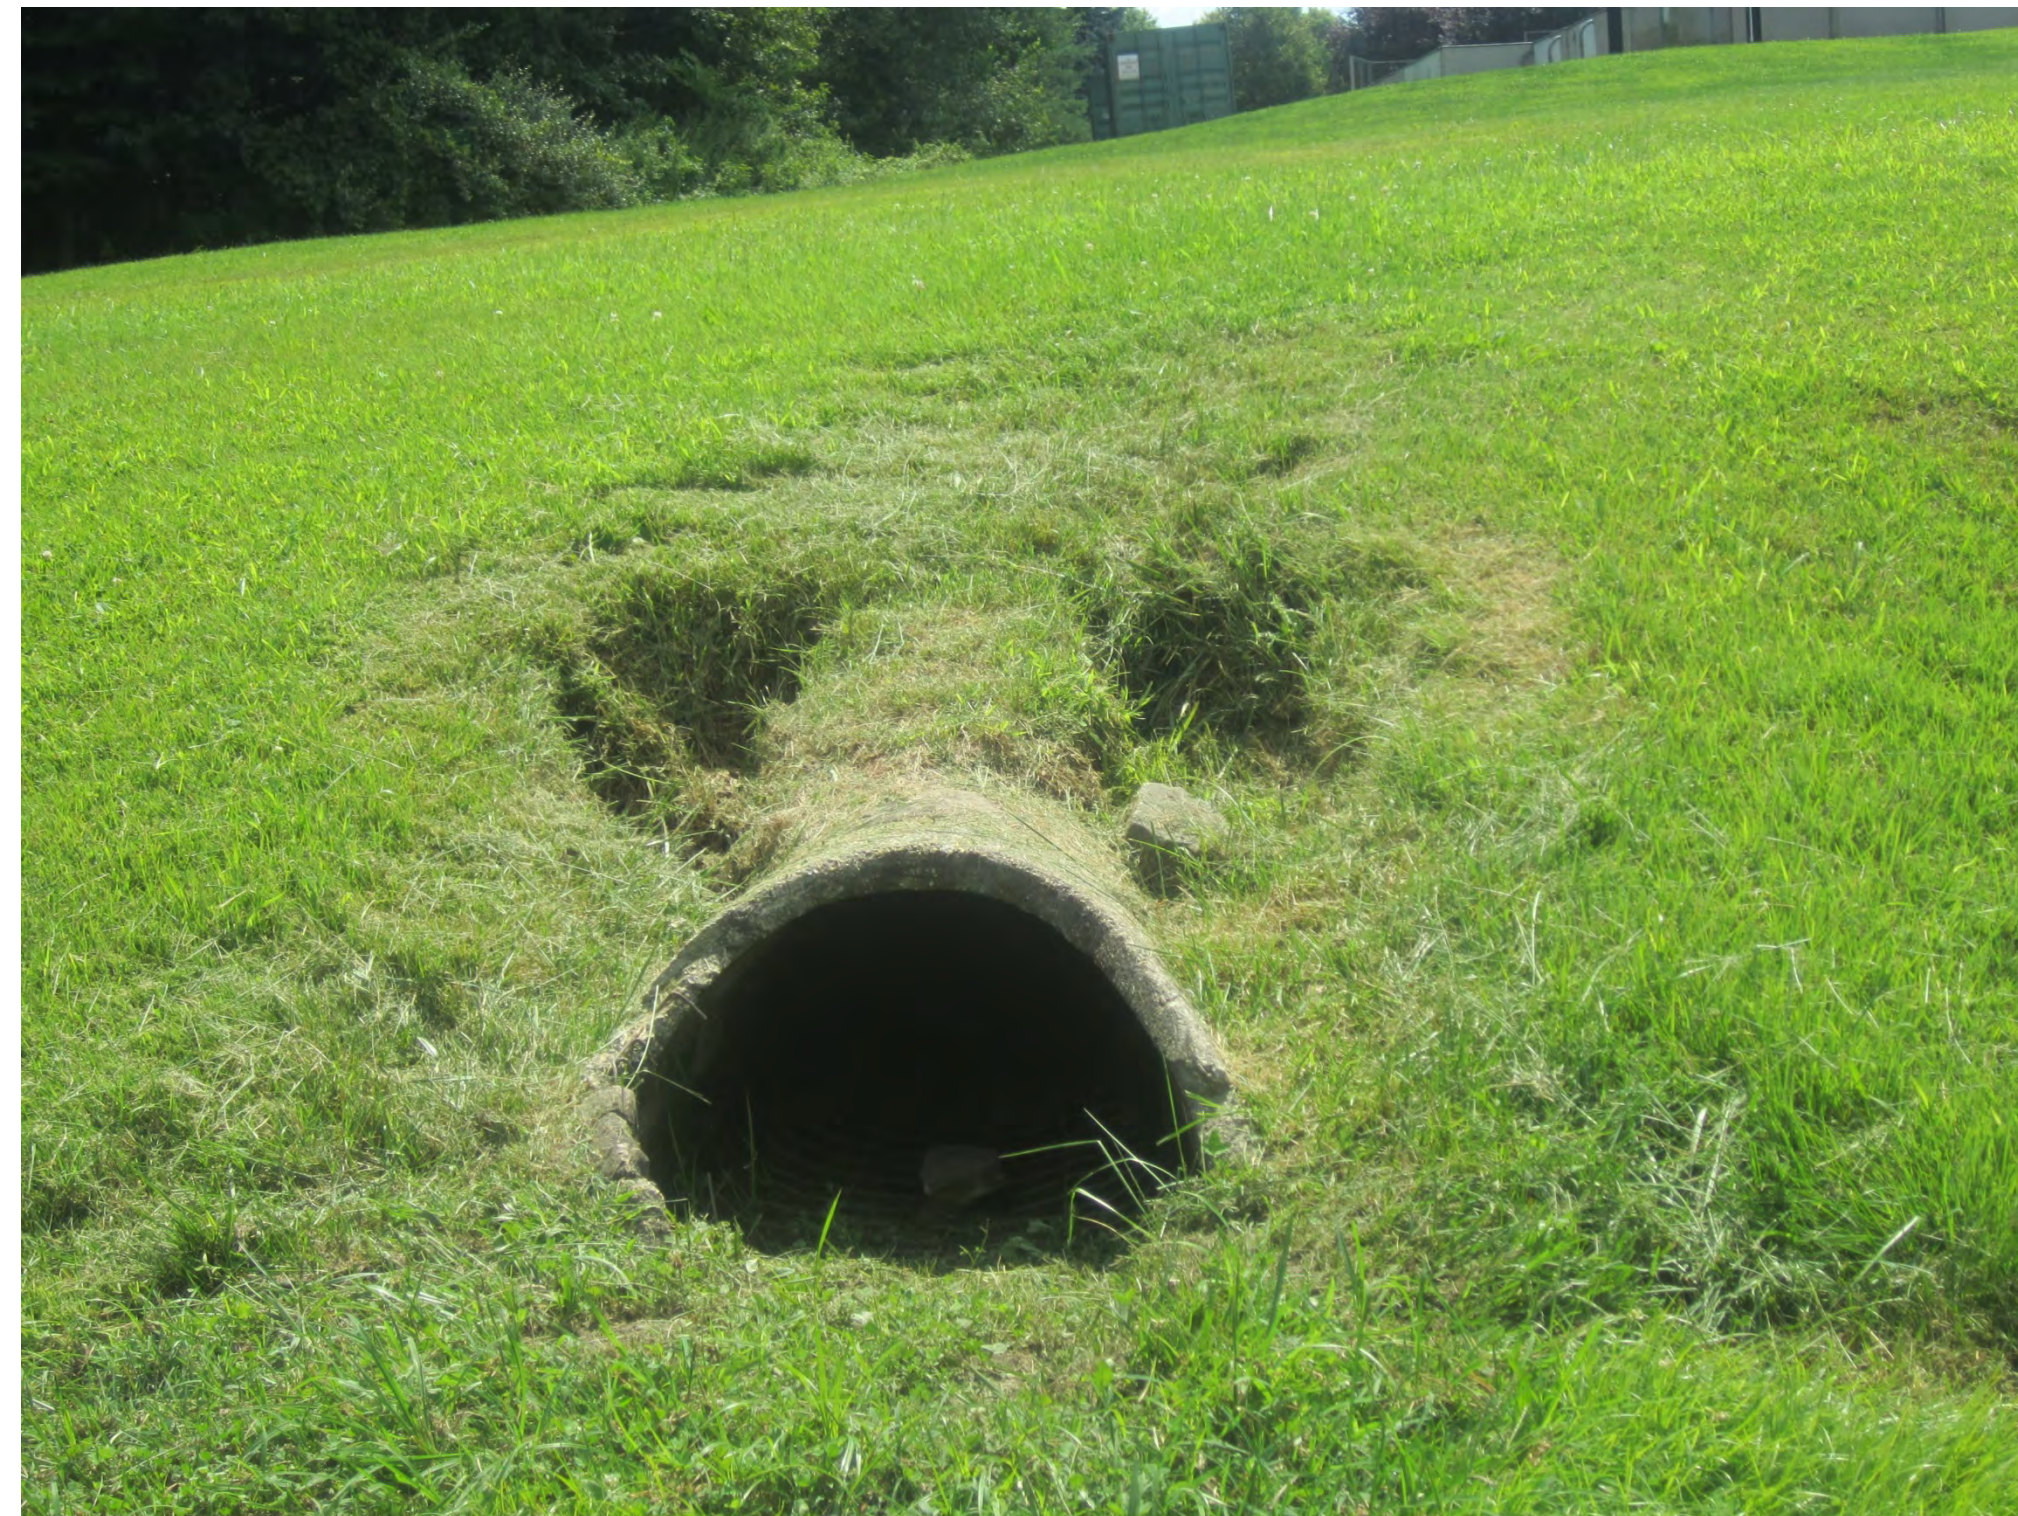
Northeastern inlet

- There is a swale that collects runoff from the nearby parking lots which conveys the water into the basin
- The basin has 5 total inlets
- The northeastern inlet is in need of replacement
- The northwestern inlet is clogged with sediment that is restricting the flow of water
- The outlet has a large low flow orifice that could use a restrictor plate
- The basin bottom has areas of gullying and tread marks

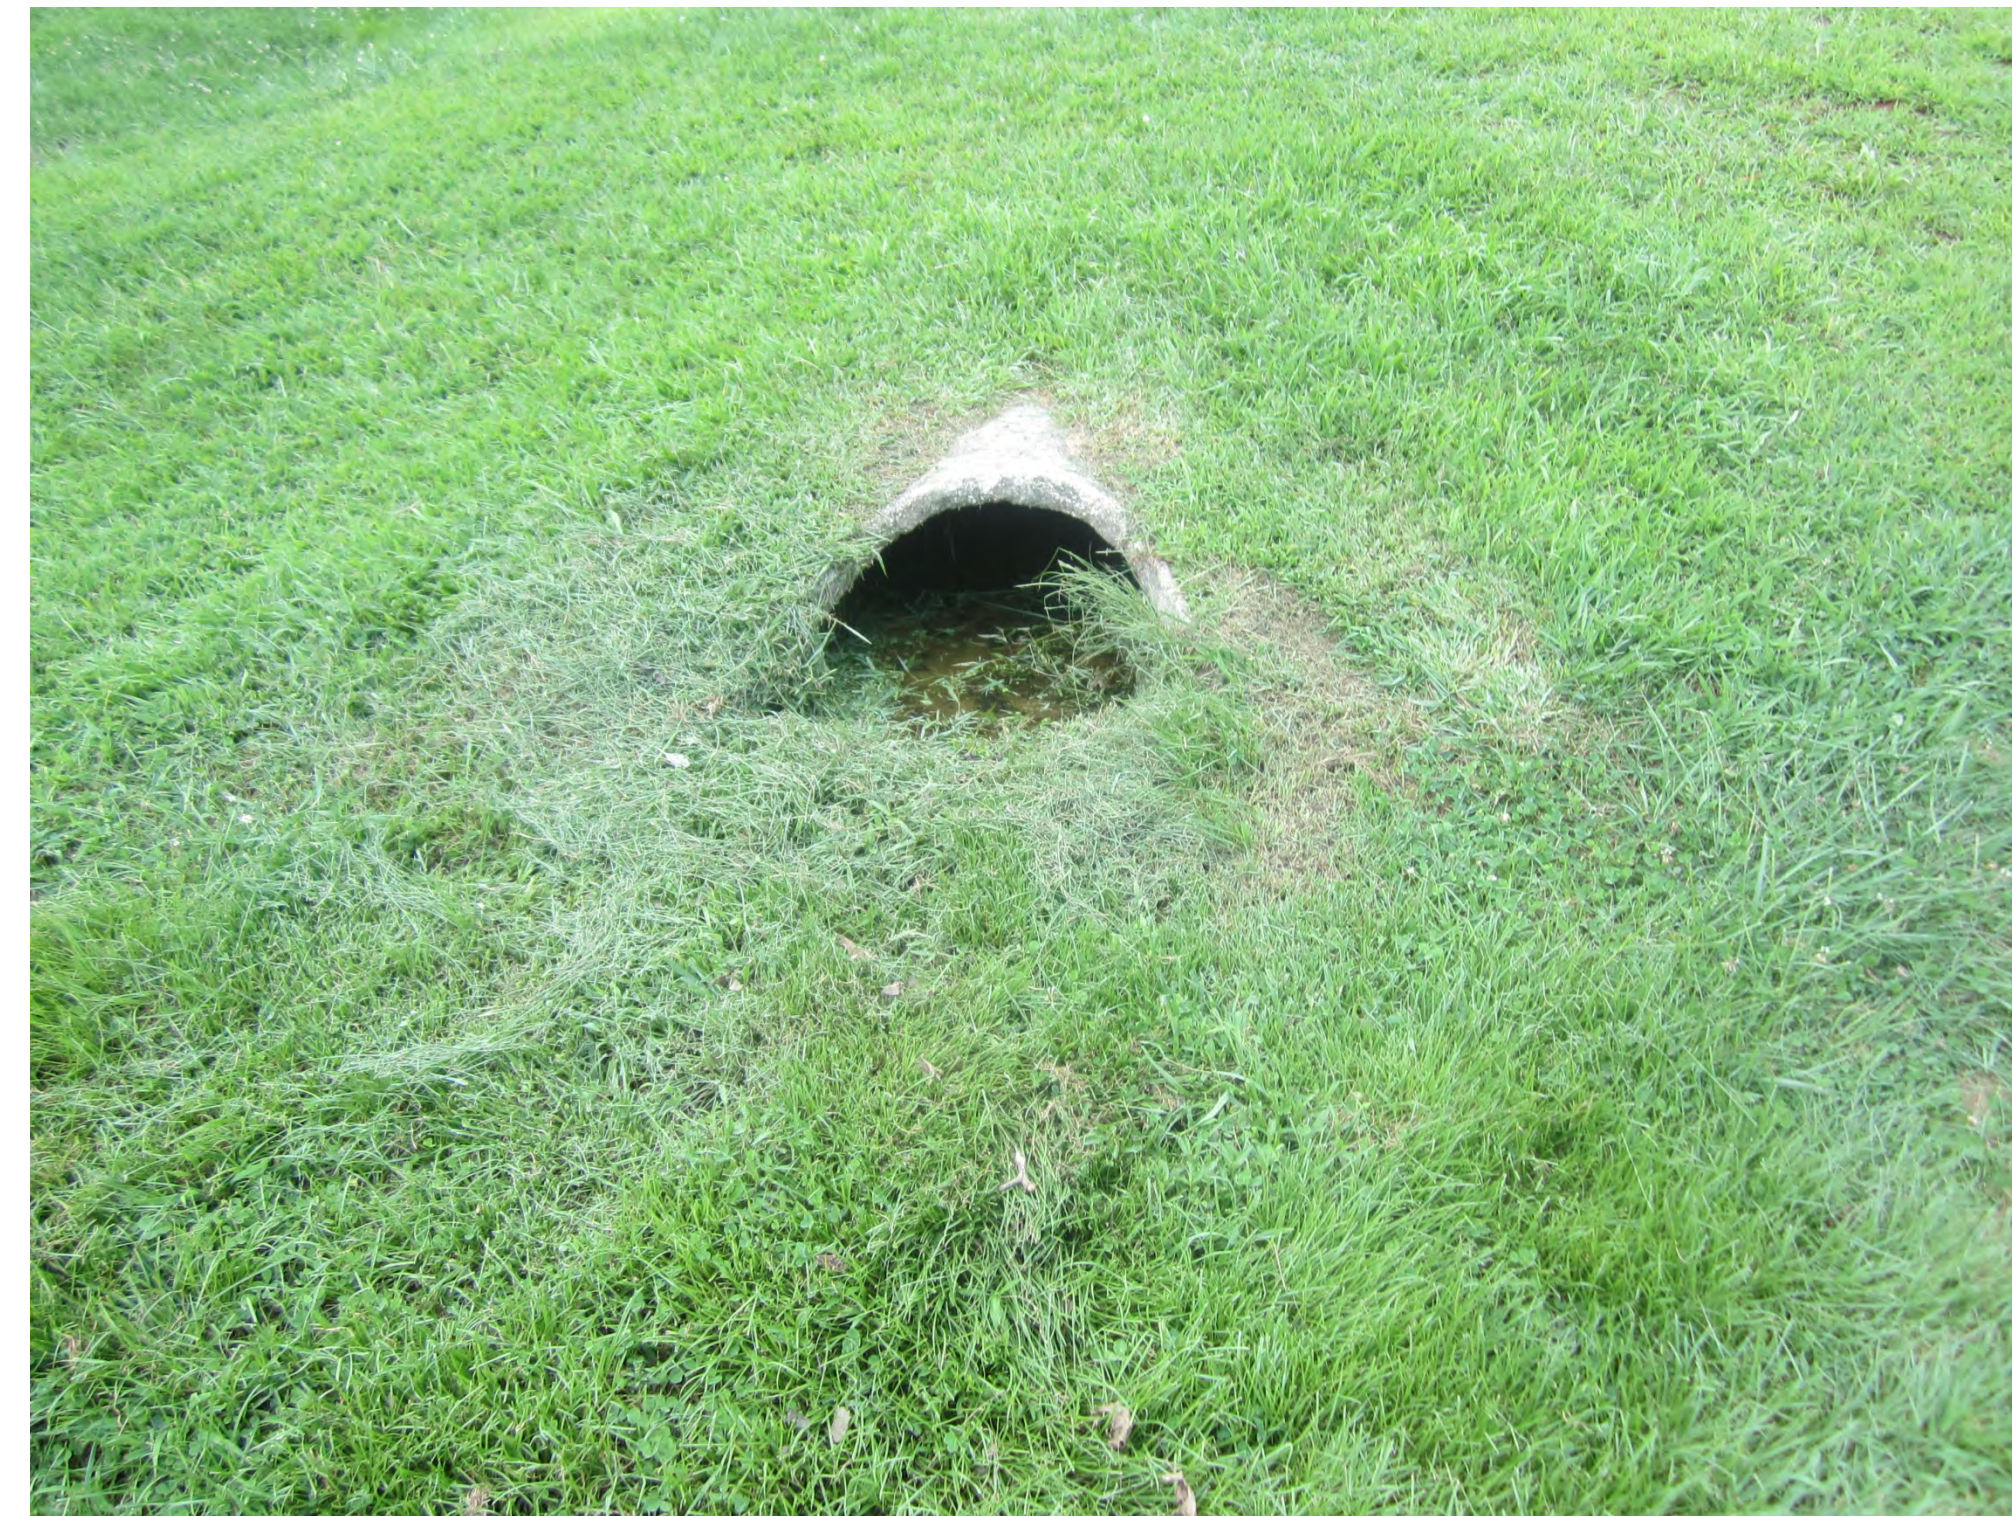
Northwestern inlet

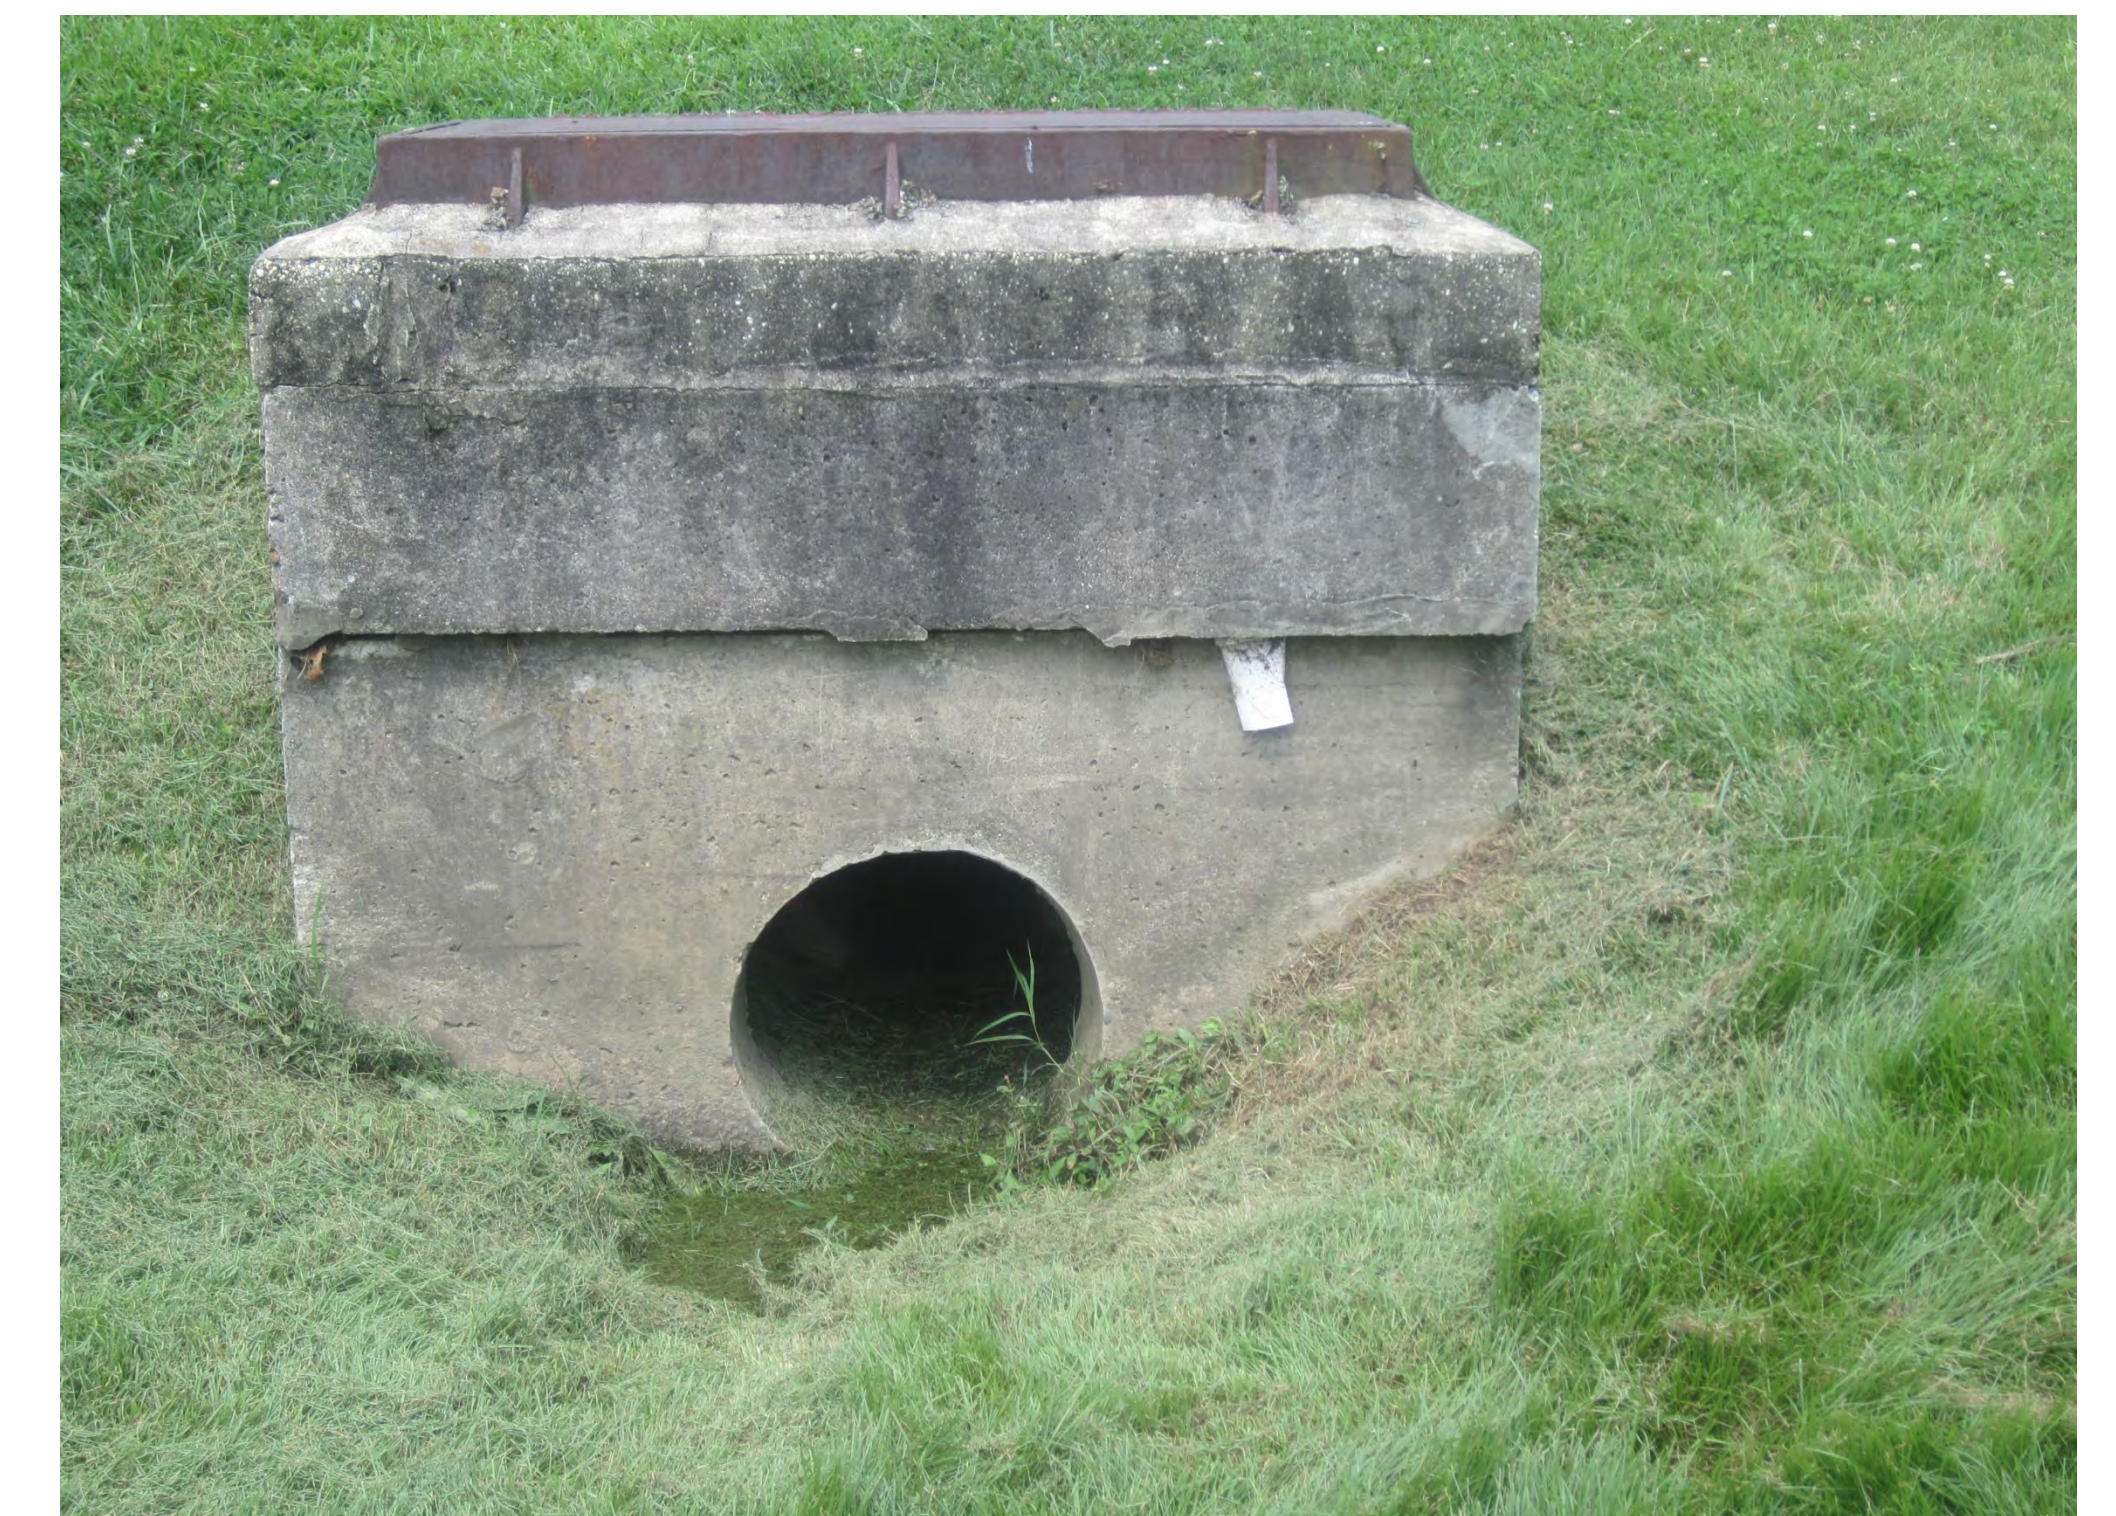
Outlet structure

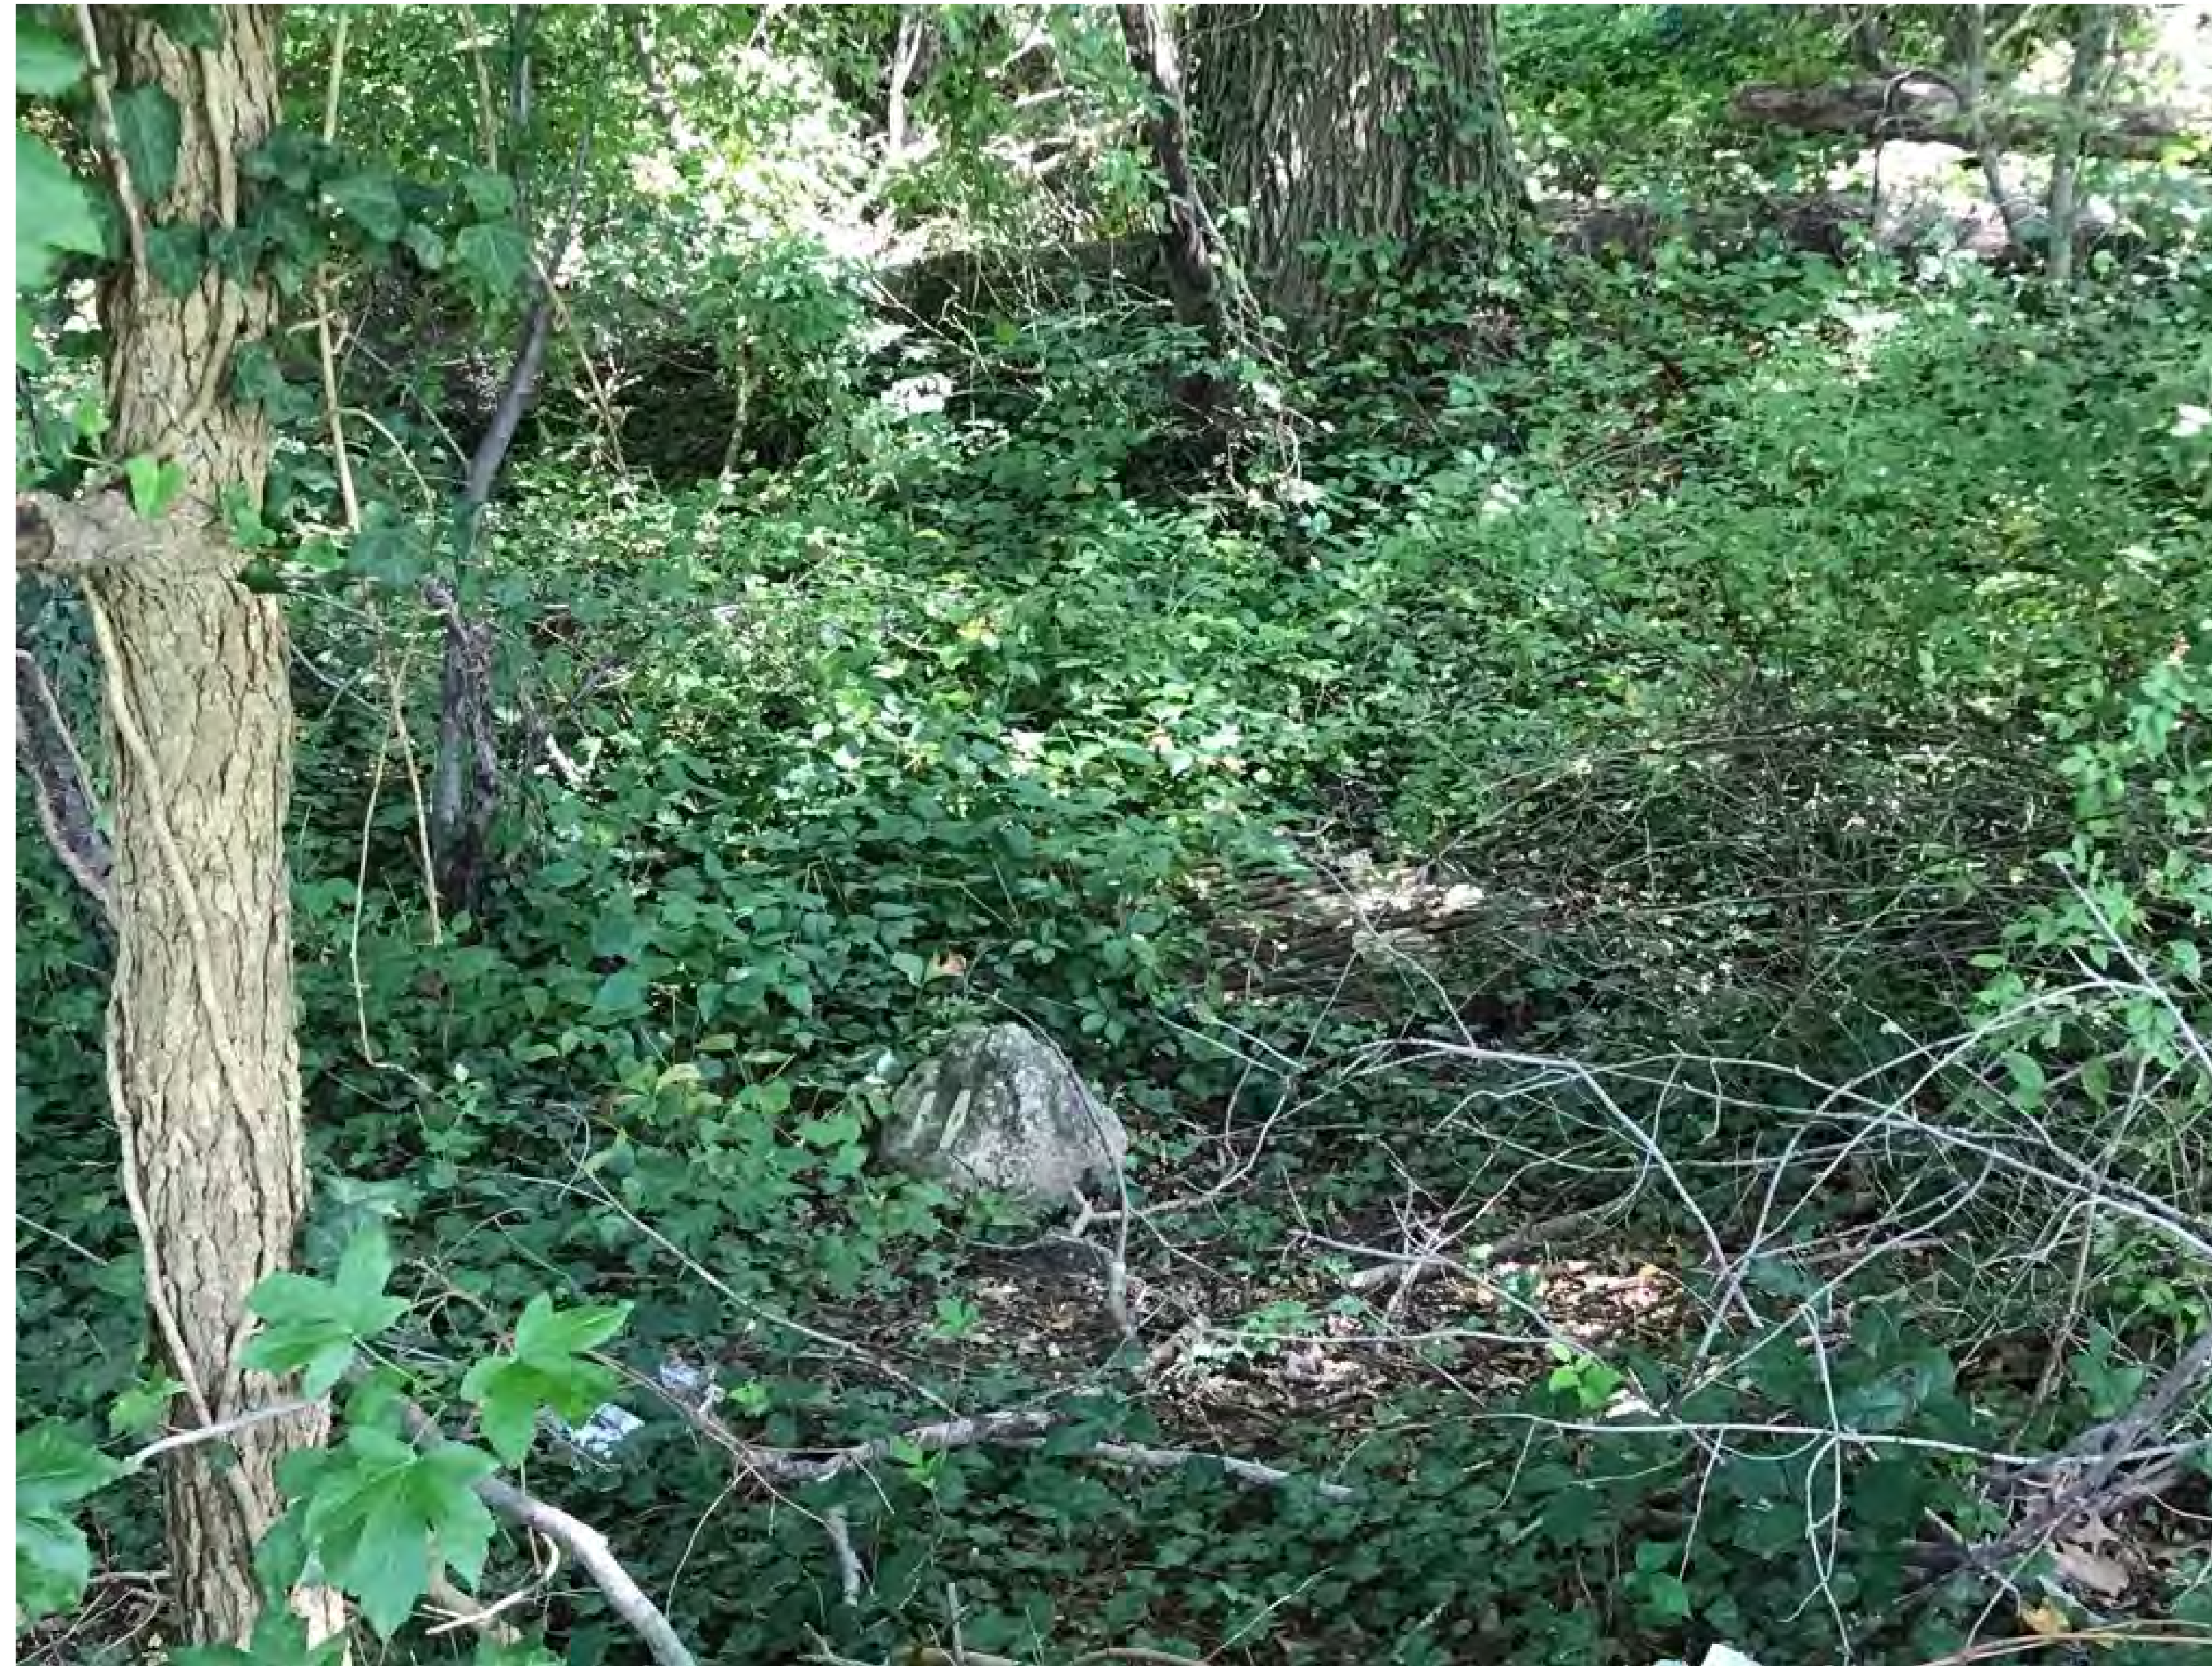
- Note assessed in 2013 due to inaccessibility
- Appears to just be a catch basin in a forested area

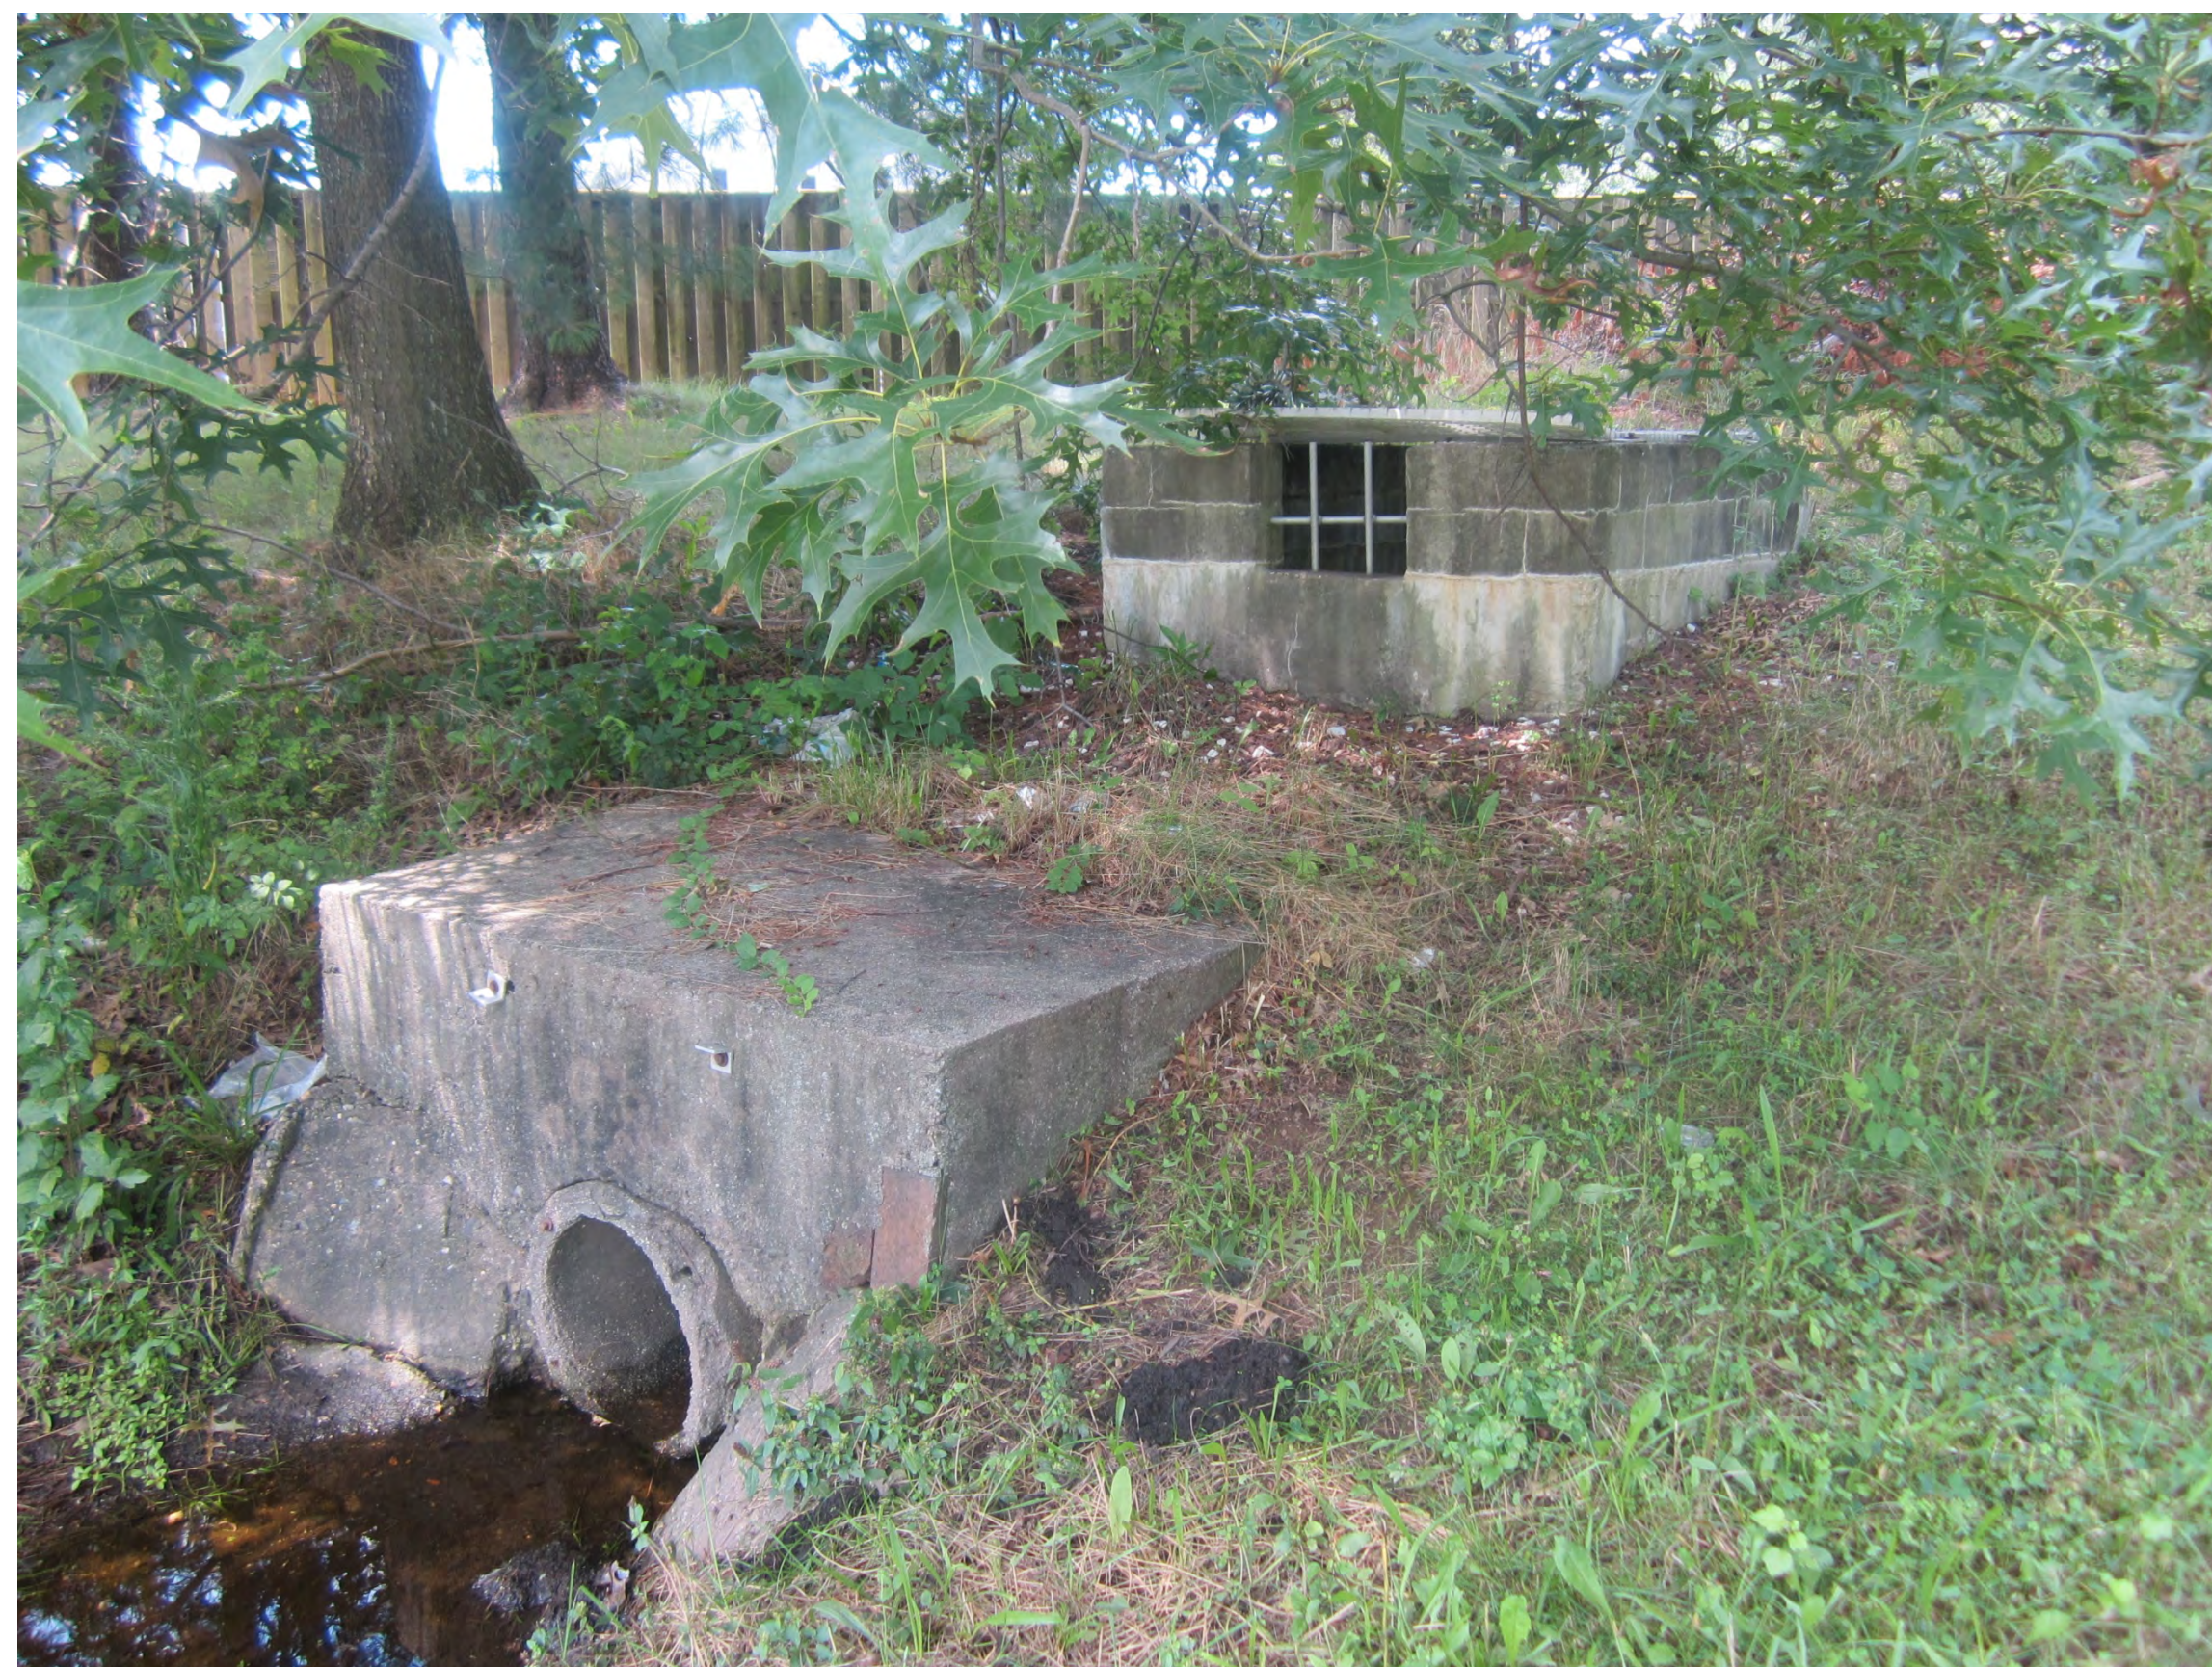
Outlet structure
