## Hamilton Township (Mercer County)

# REVIEW AND EVALUATION OF TOTAL MAXIMUM DAILY LOADS (TMDLs)

Developed by the Rutgers Cooperative Extension Water Resources Program  
Funded by Hamilton Township, Mercer County, New Jersey

December 5, 2019

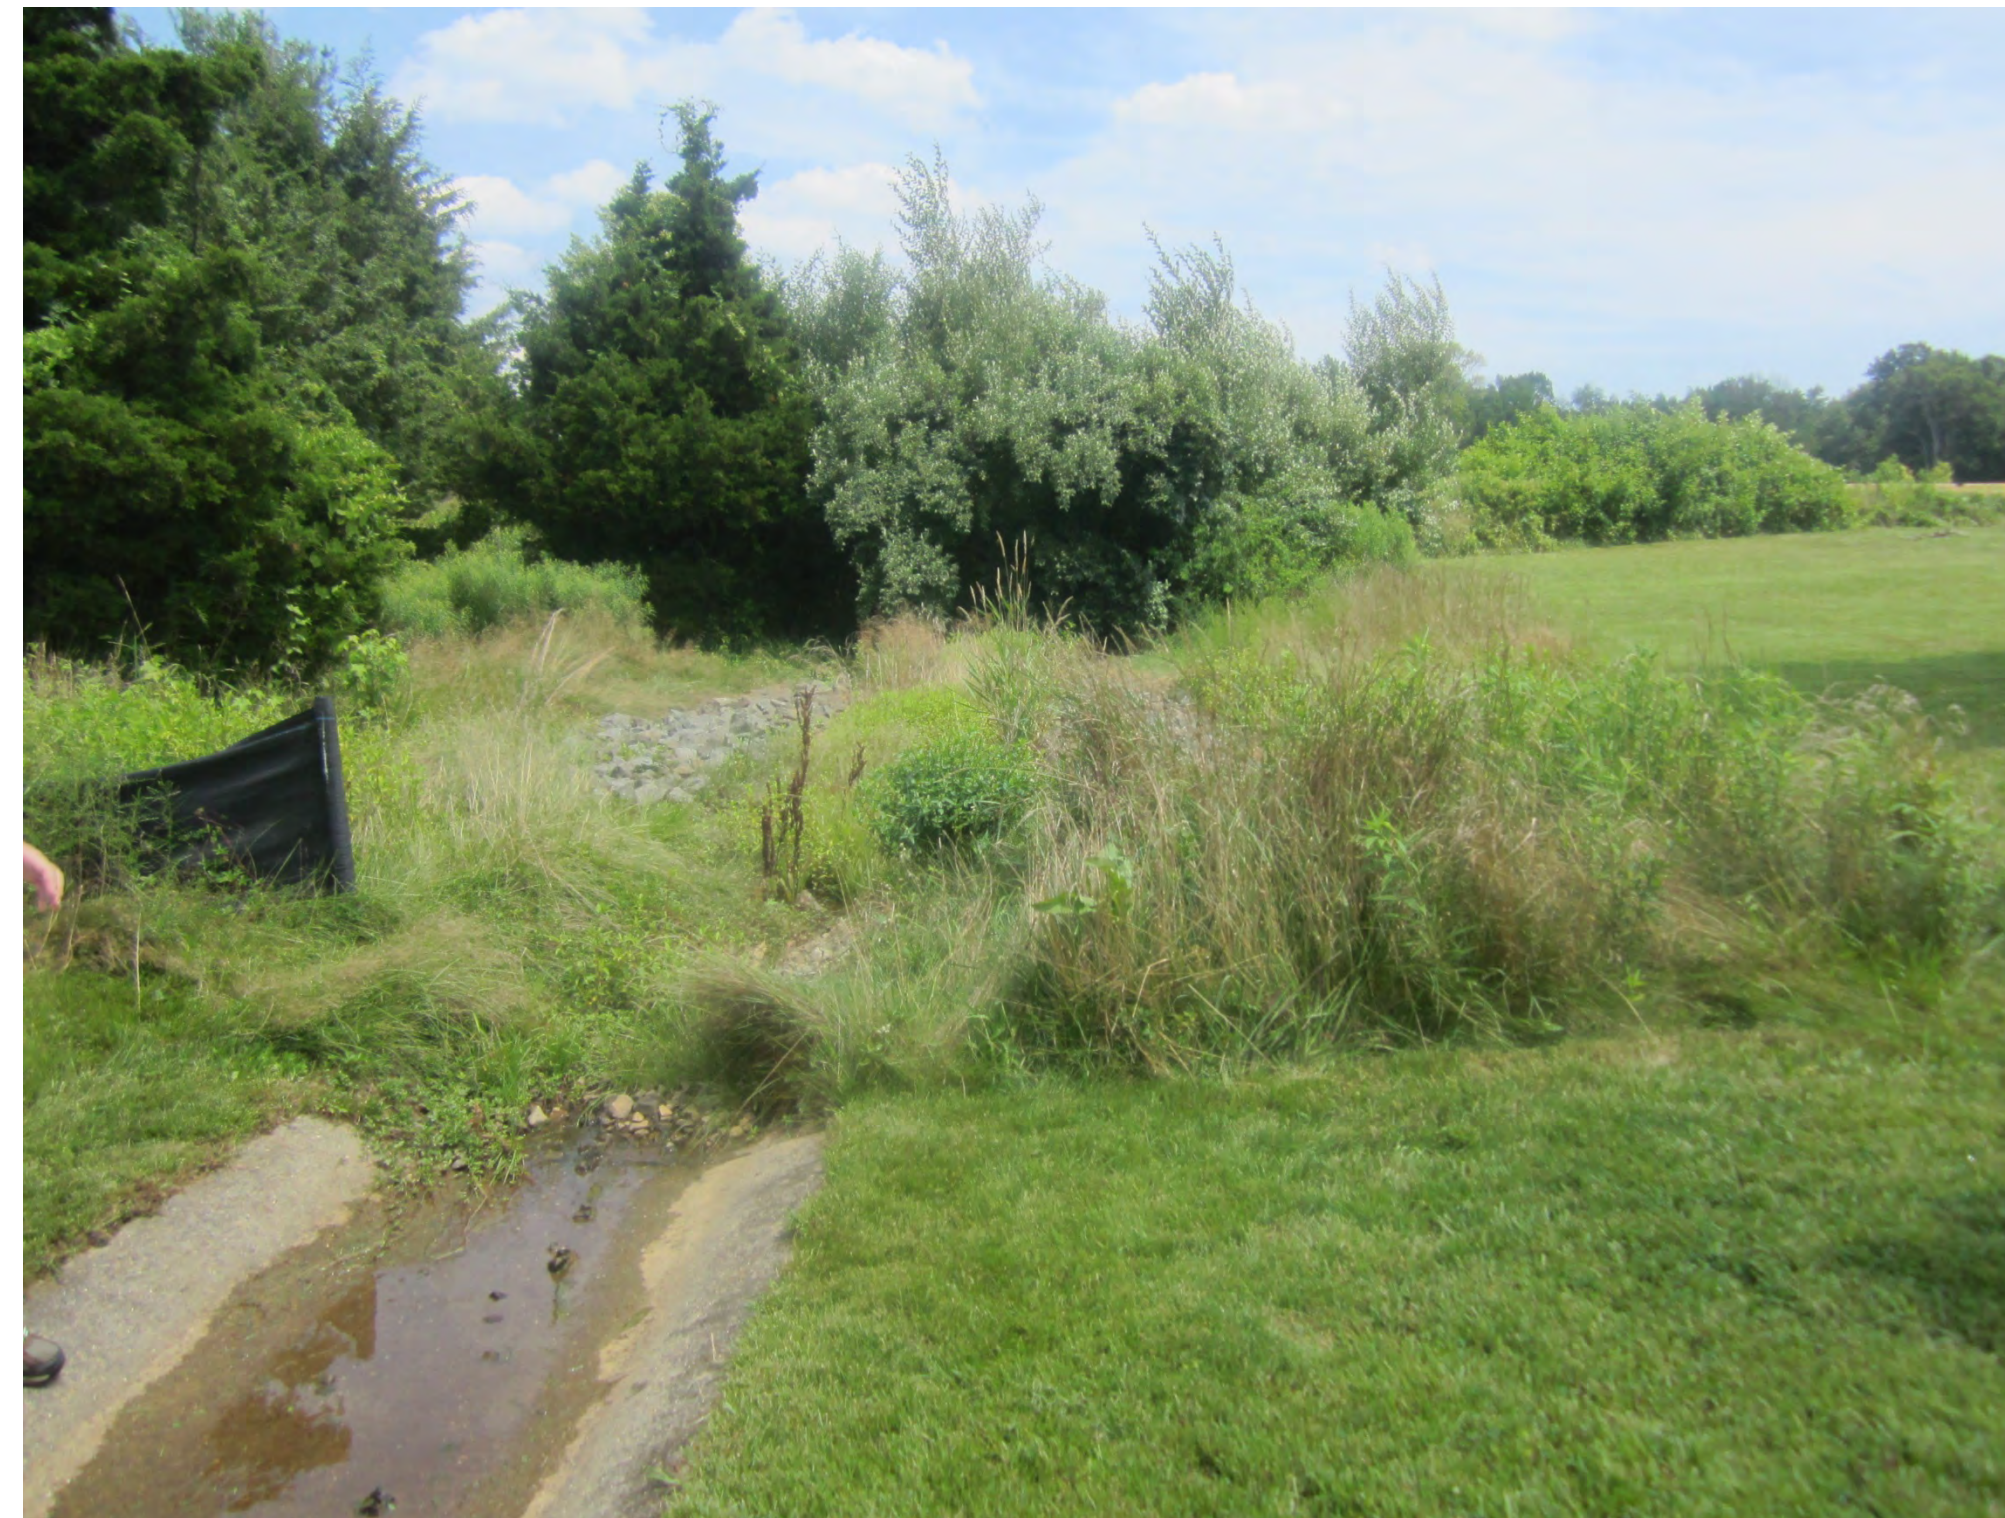
Overgrown eastern inlet

- There is excess sediment accumulated and standing water in the low flow channel
- The eastern and western inlets both have excess sediment accumulation and are overgrown with various types of vegetation
- The outlet structure has cracks in parging, the trash rack is broken, and the water is not discharging from the outlet causing the entire basin to back up

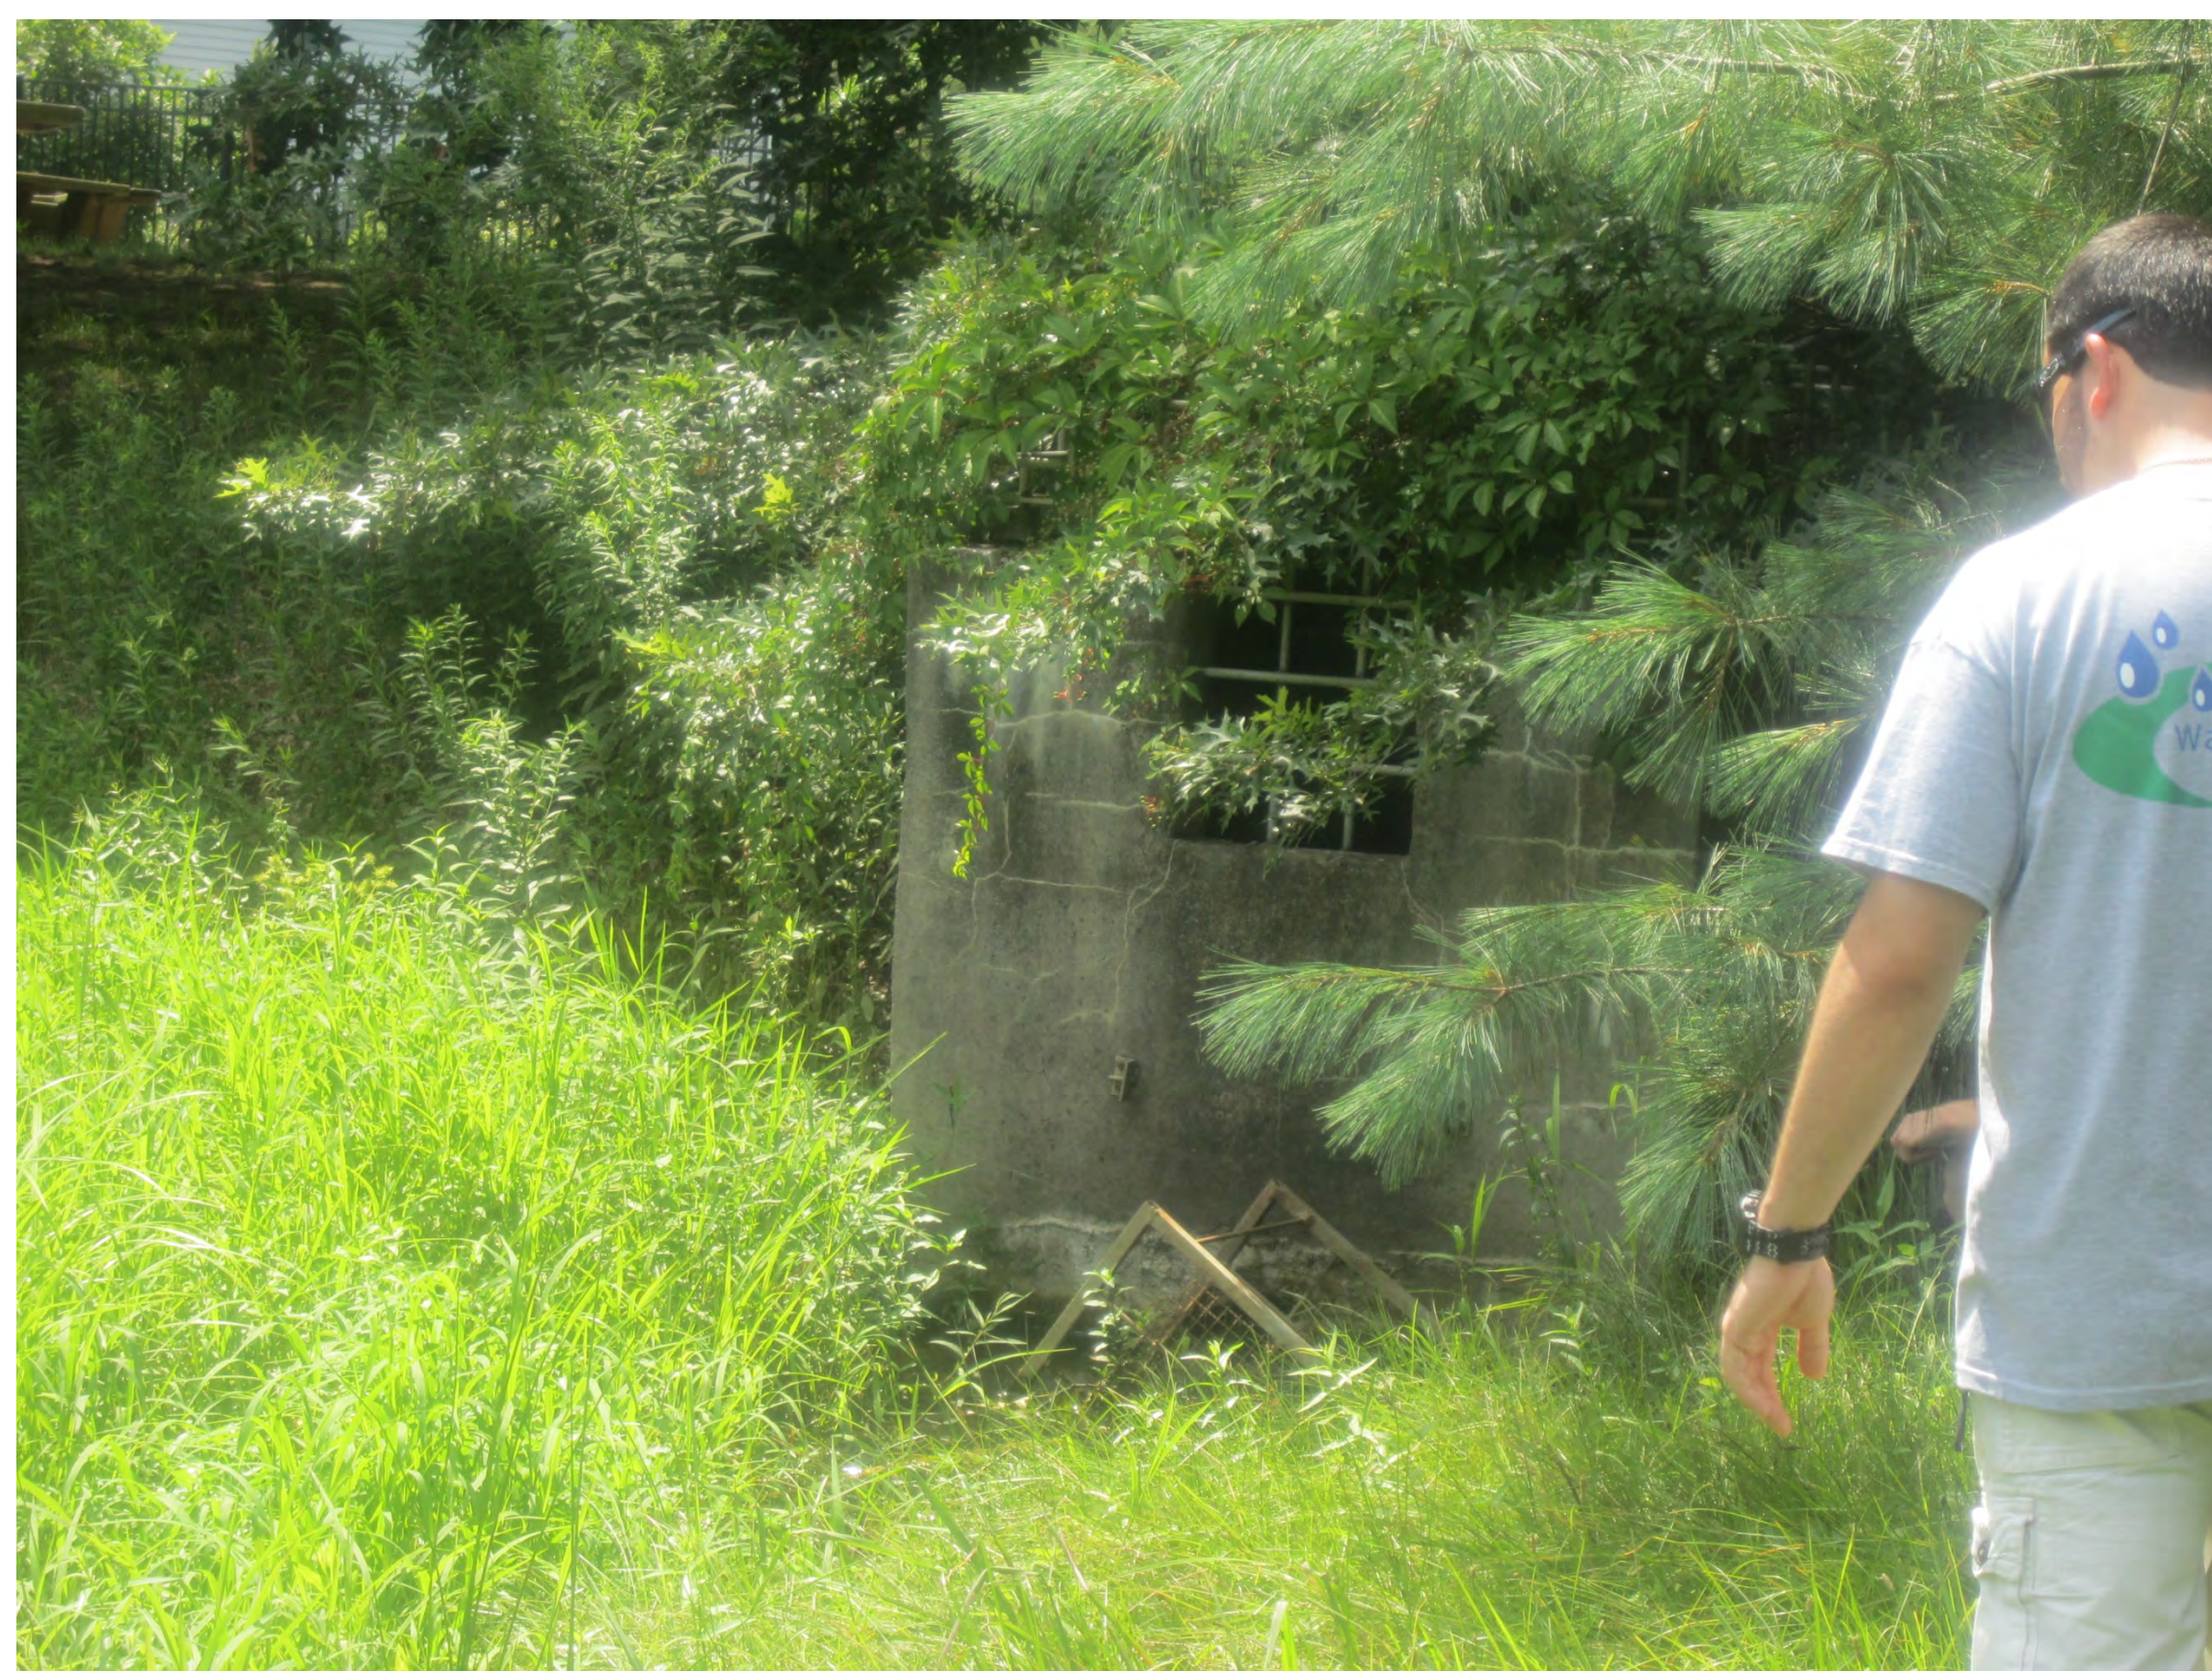
Outlet structure

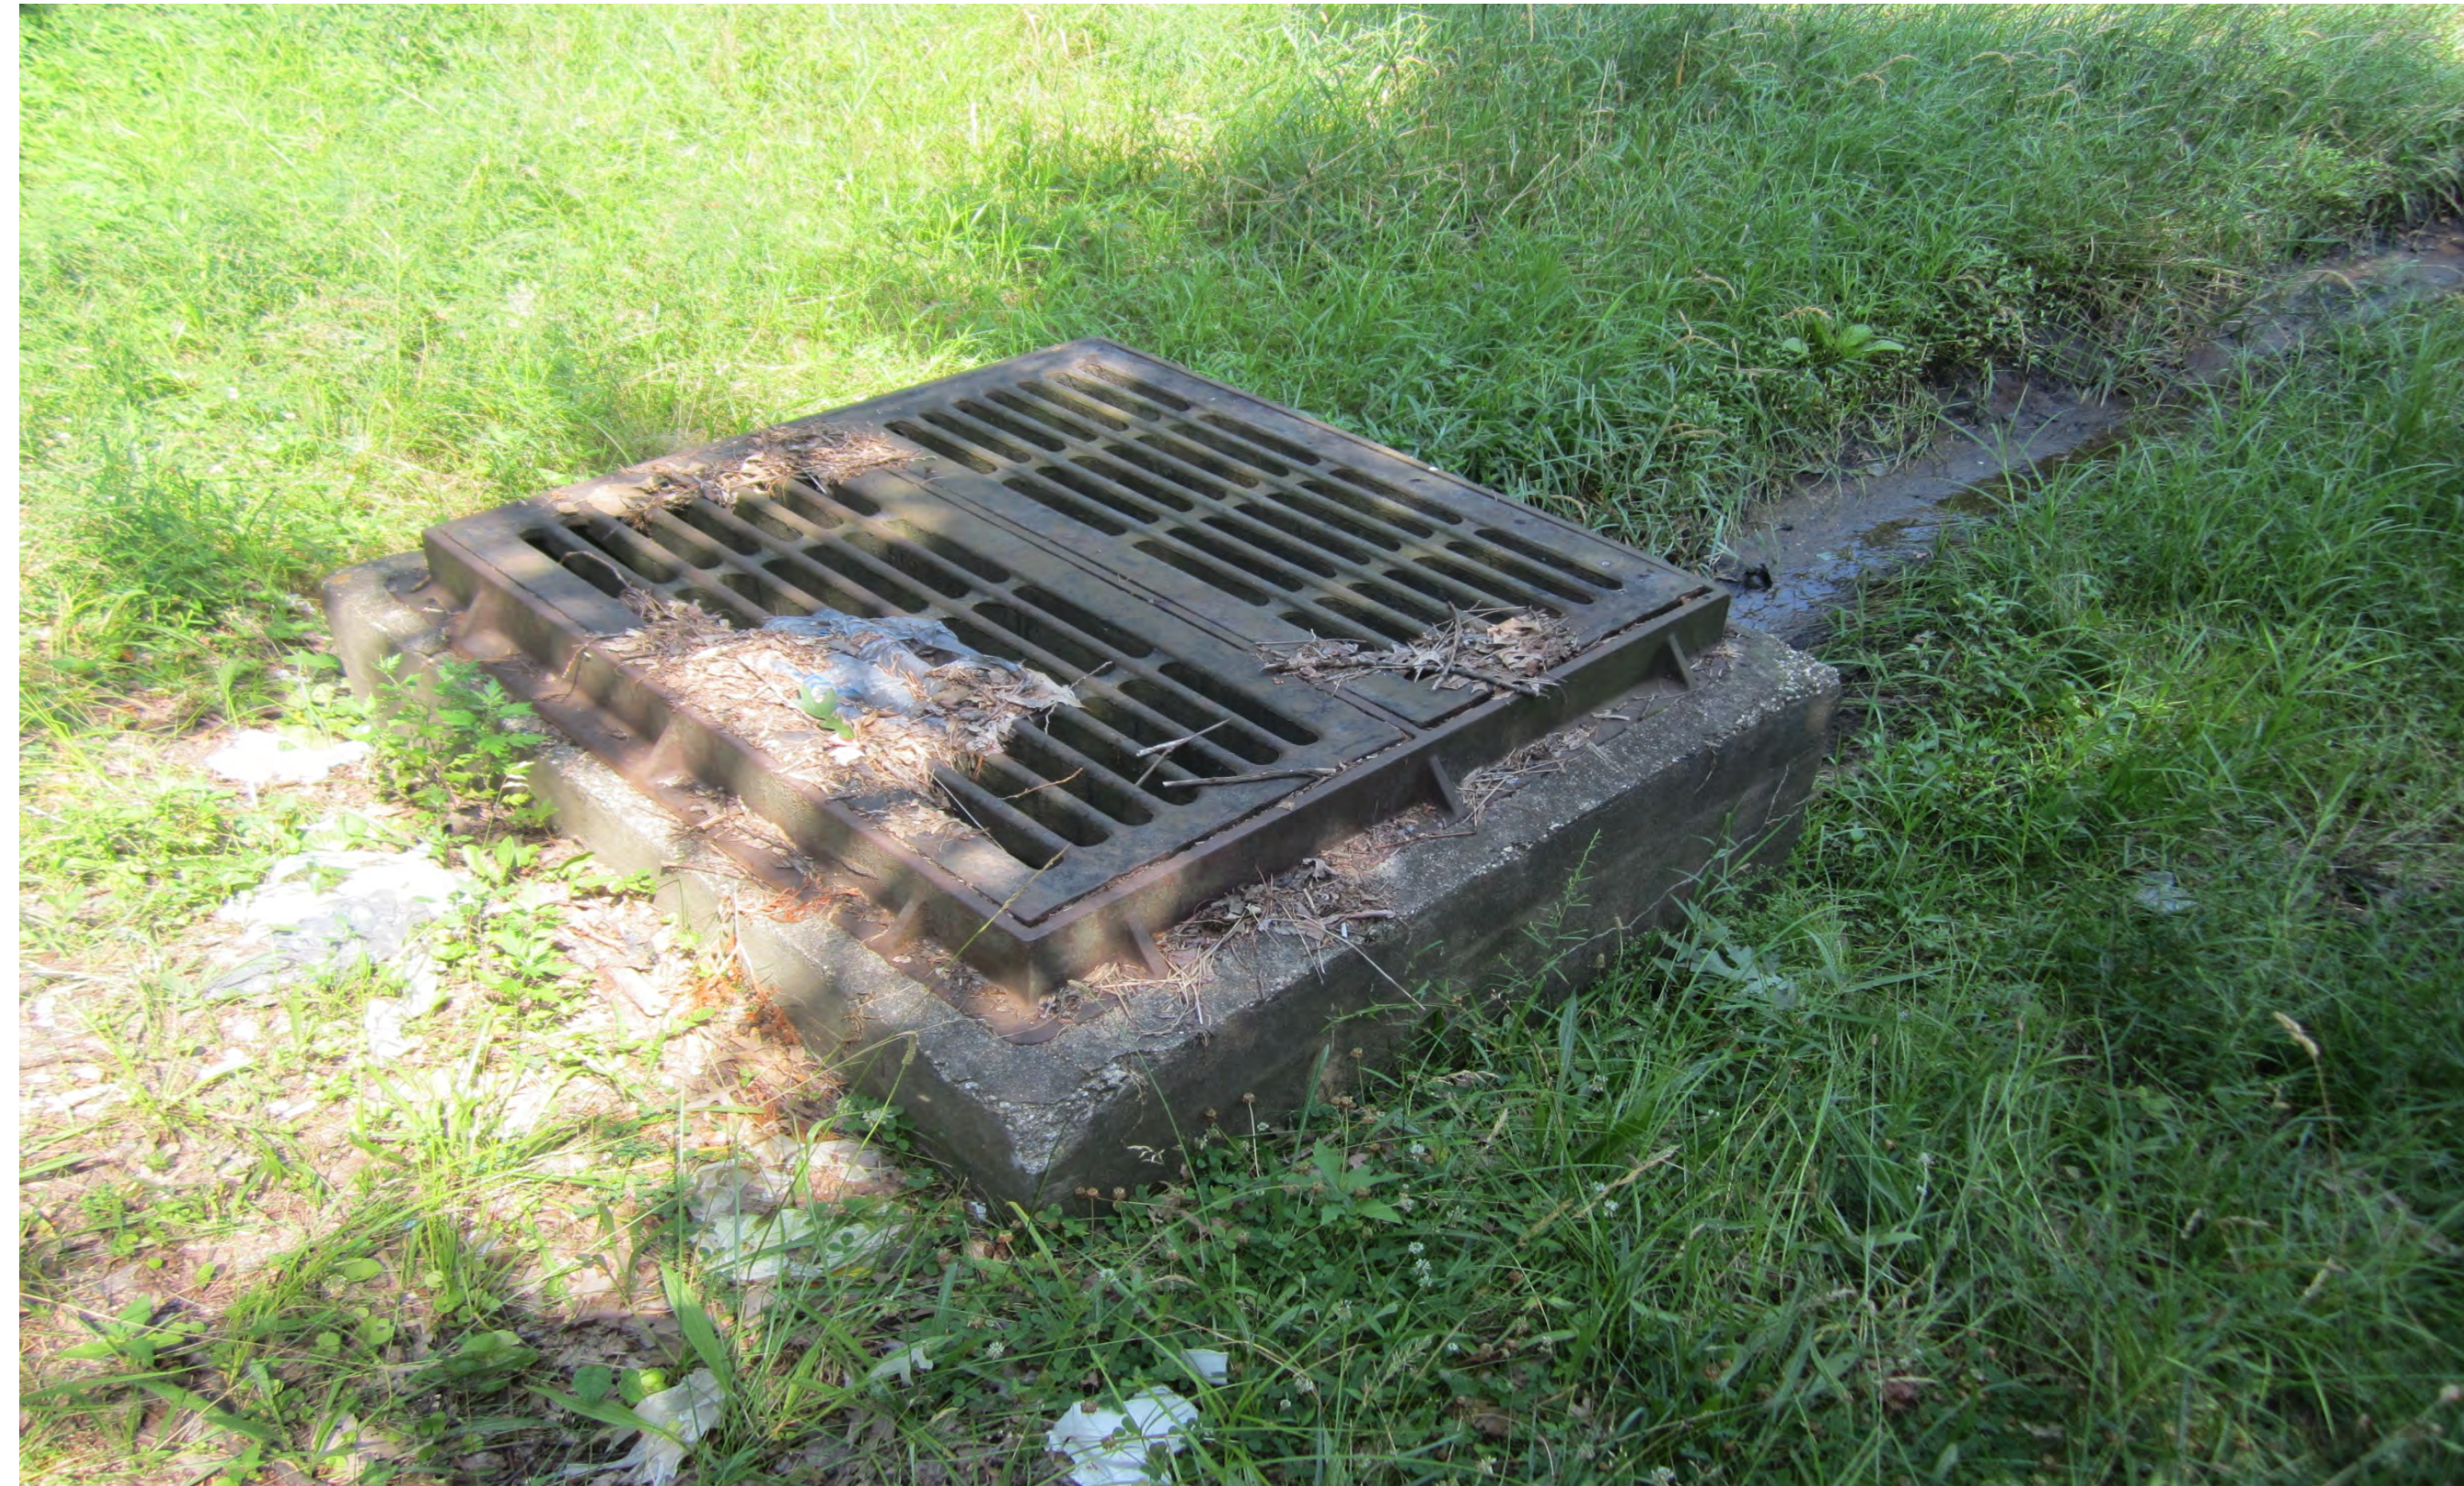
Outlet

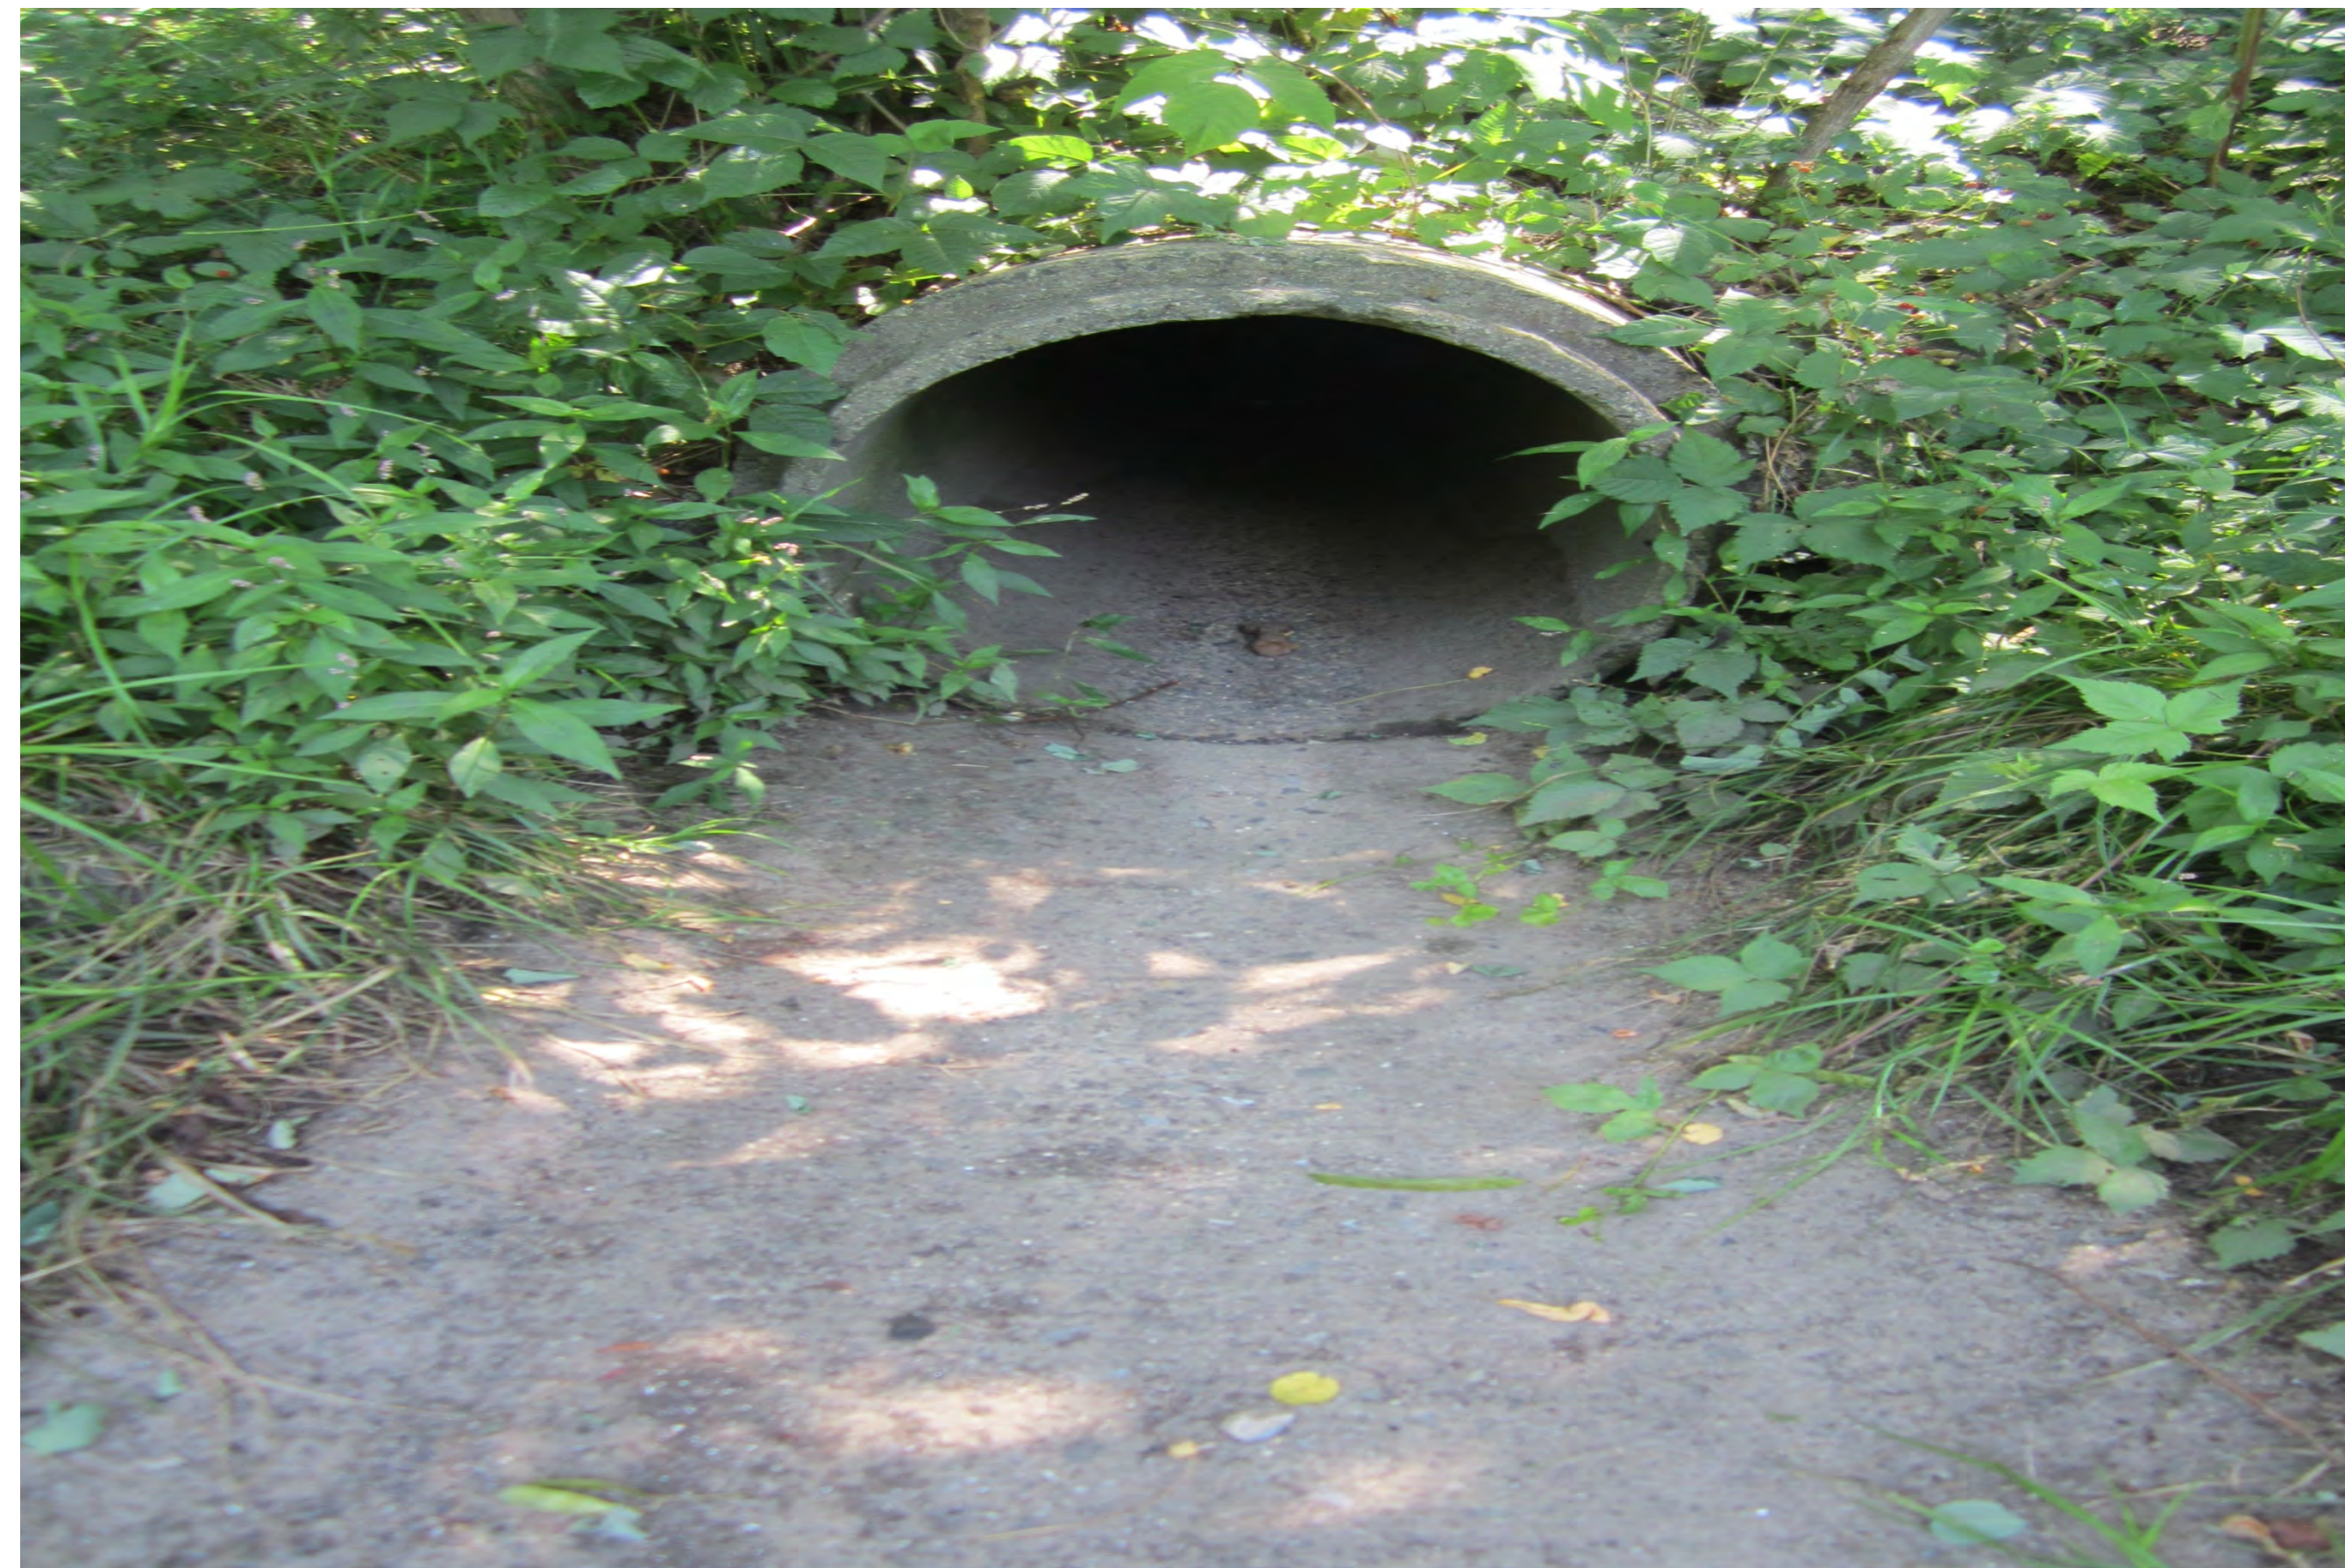
Inlet

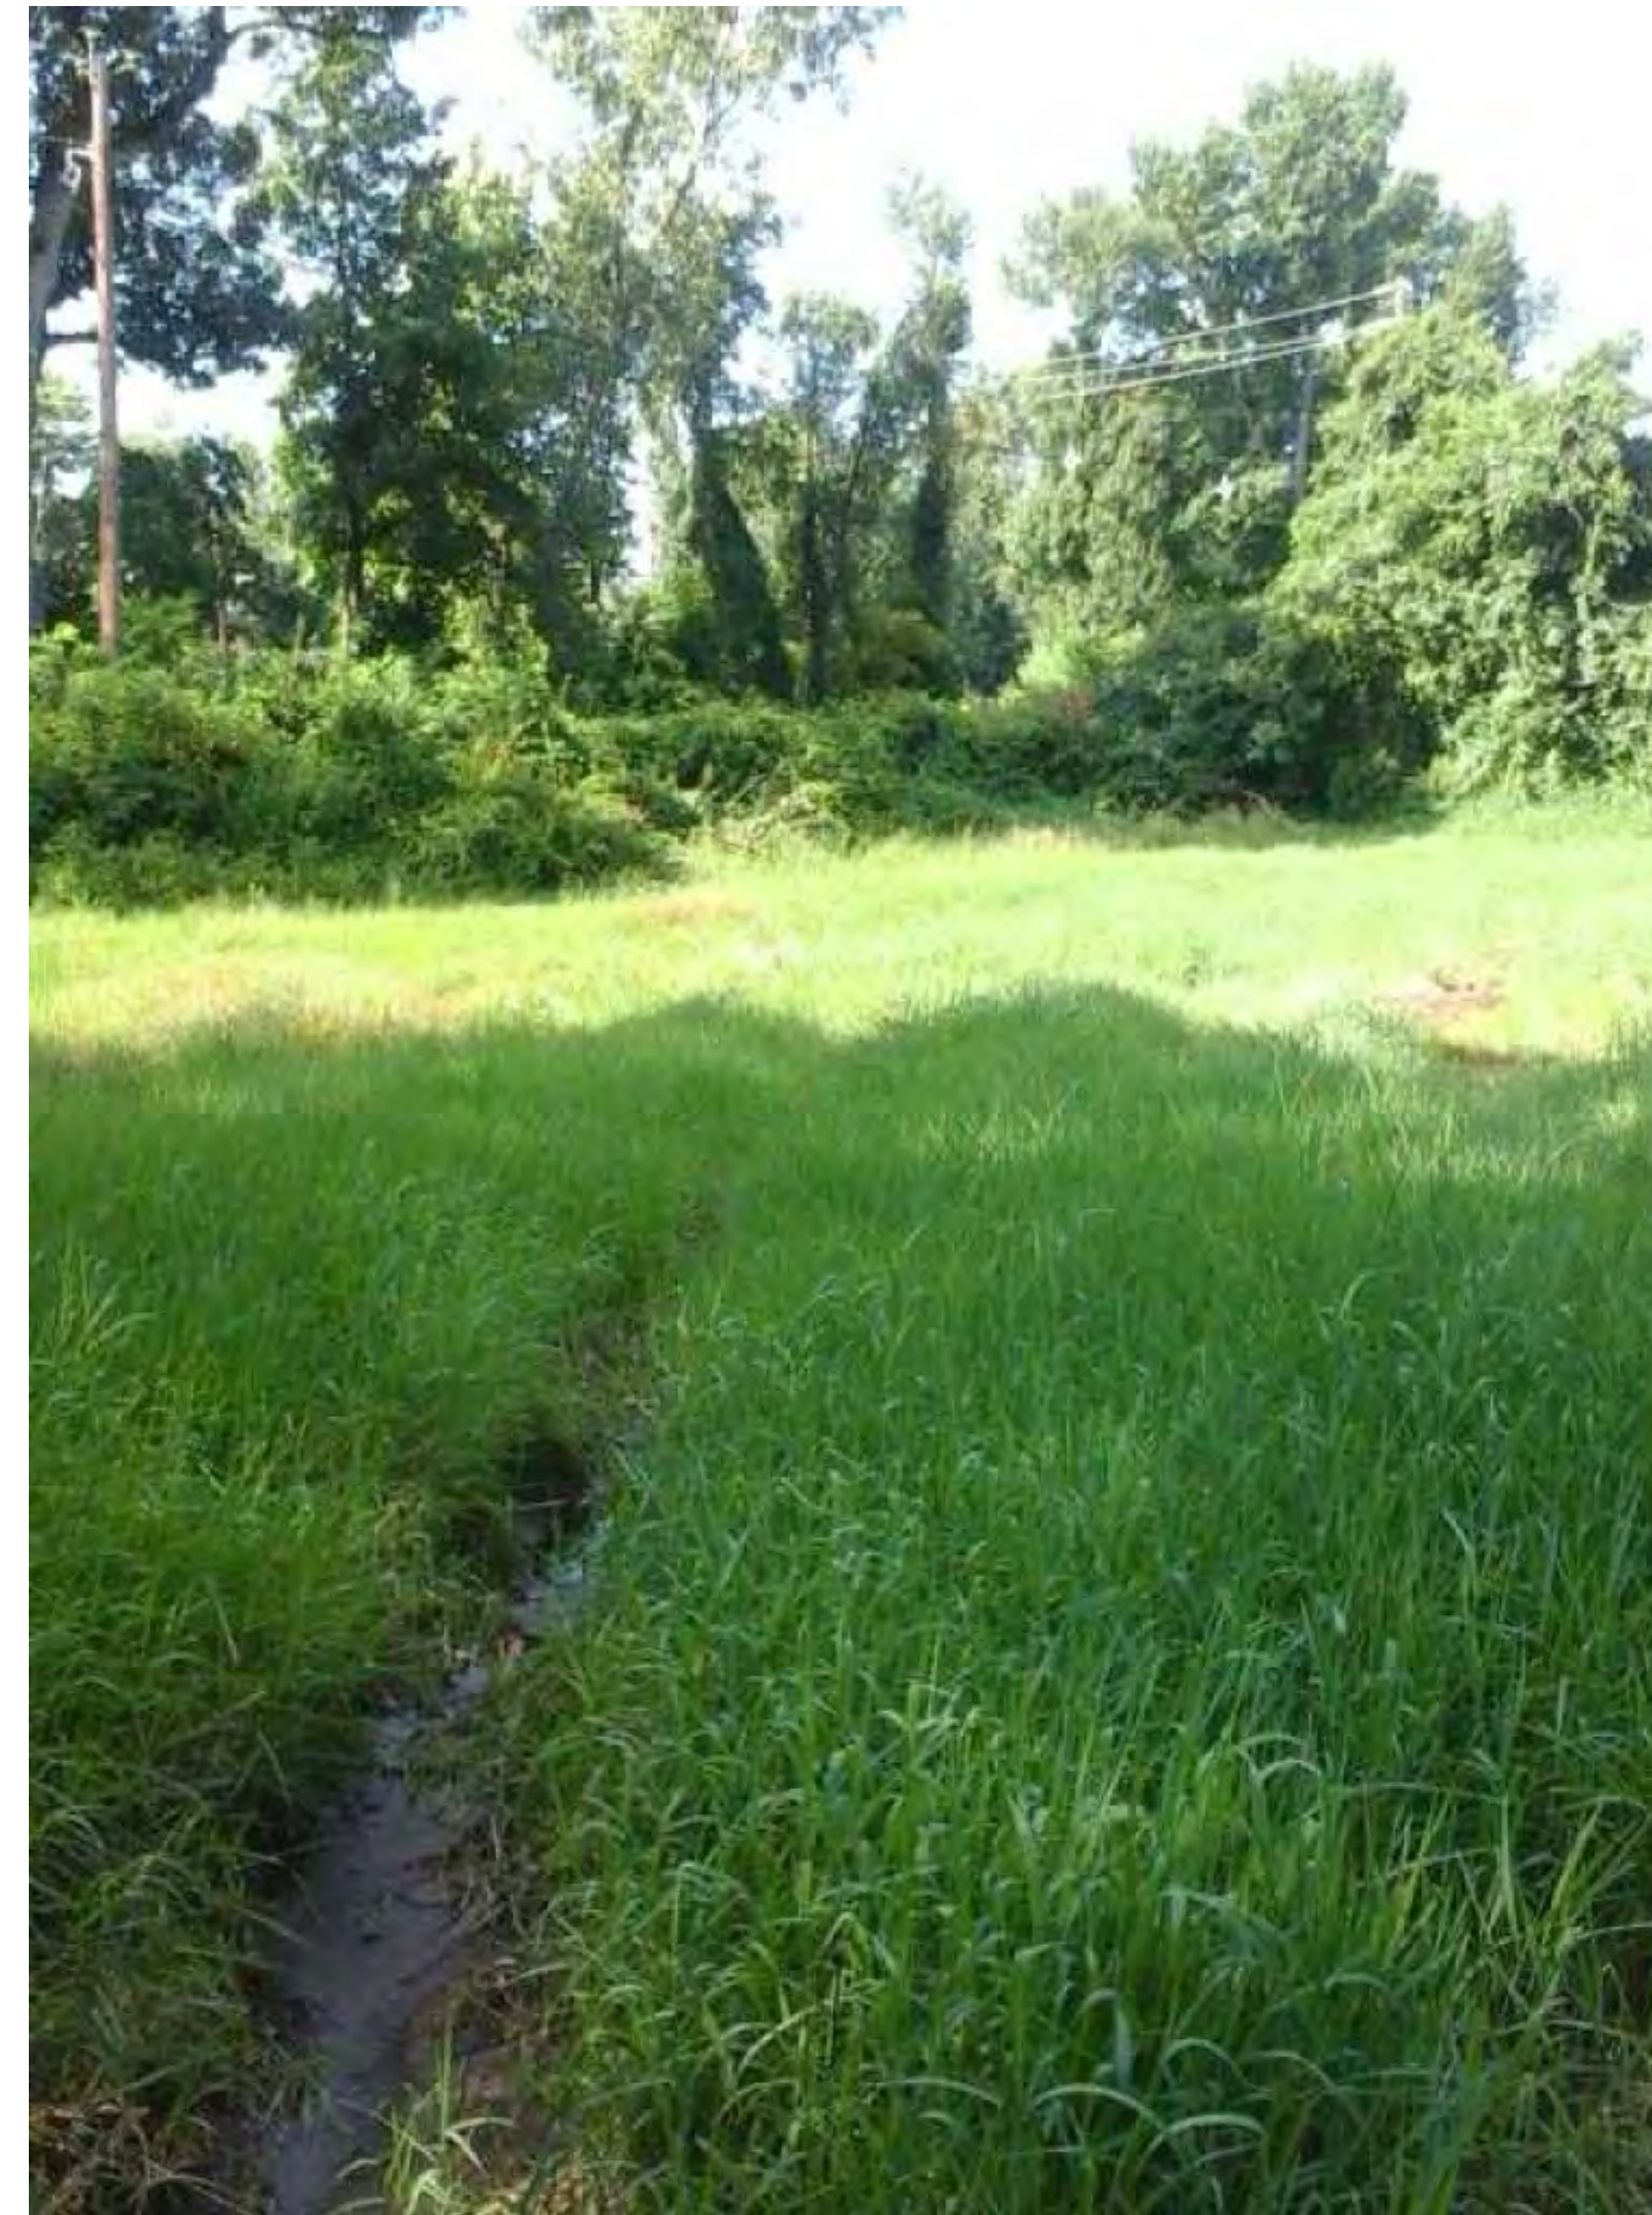
- A lot of sediment buildup in basin
- Clear out sediment in low flow channel to be sure basin is working as designed. Appears low flow orifice is completely clogged
- Allow basin to continue to naturalize, but plant or seed with native herbaceous species

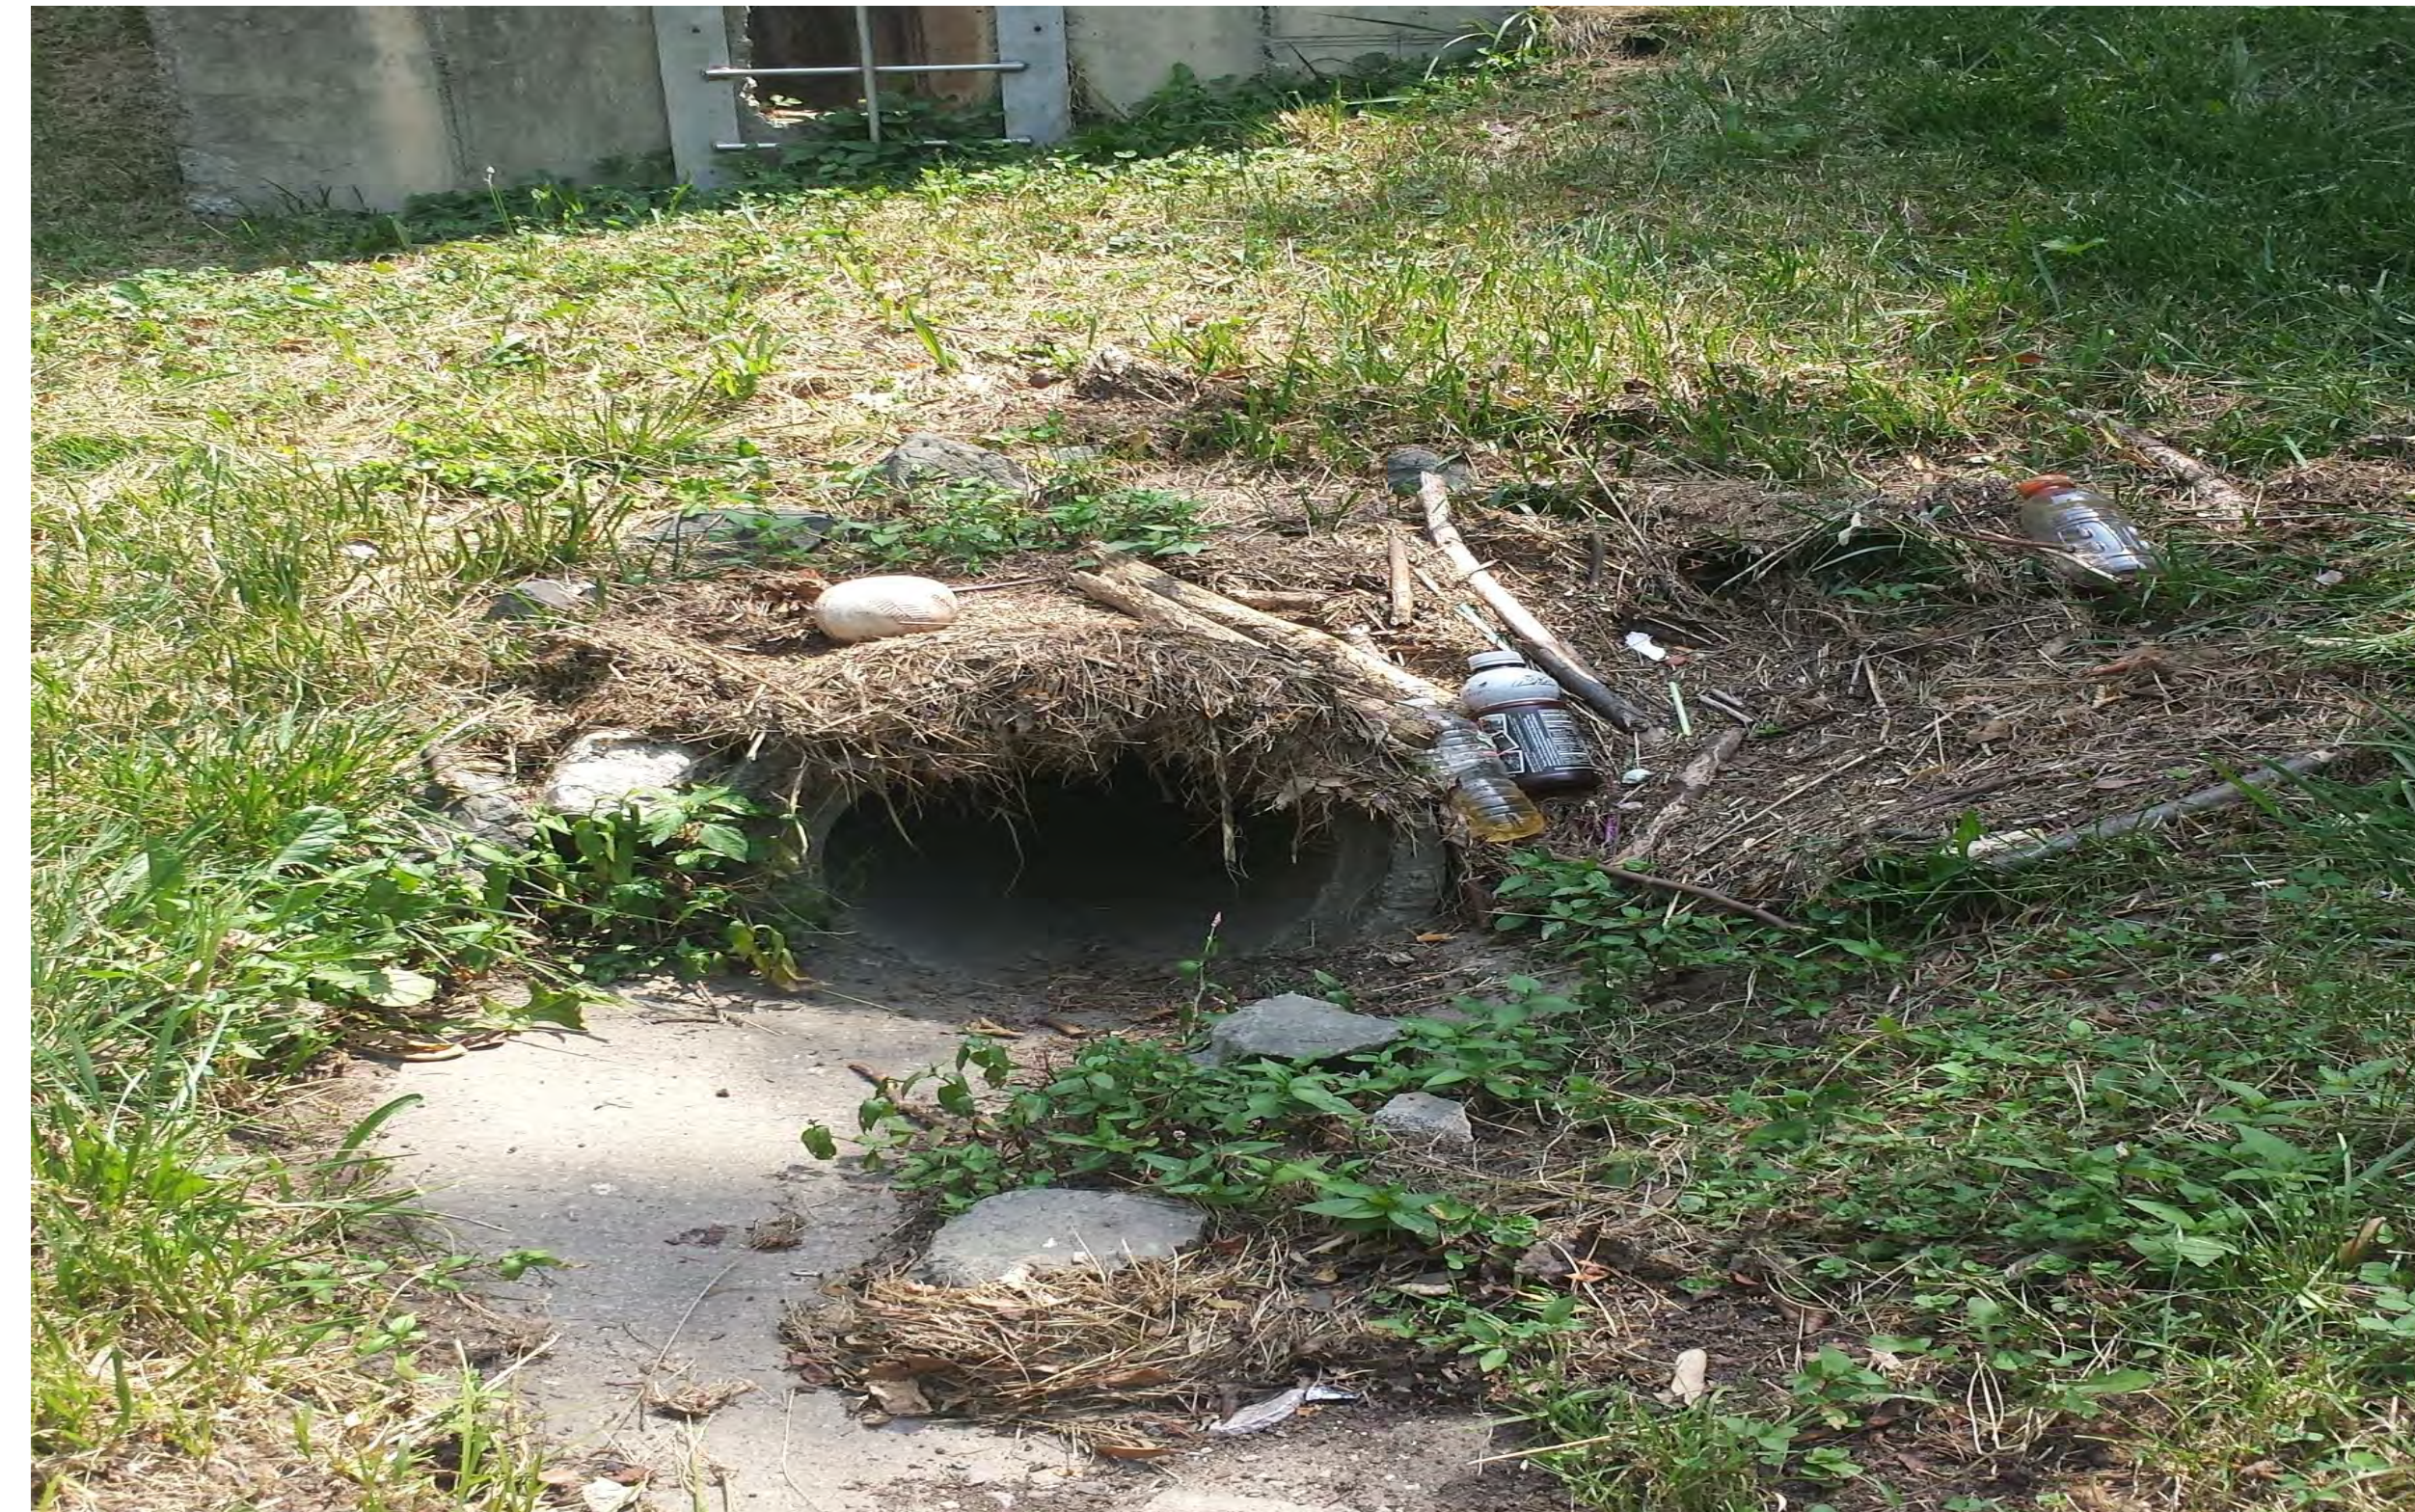
Outlet
