## Hamilton Township (Mercer County)

# REVIEW AND EVALUATION OF TOTAL MAXIMUM DAILY LOADS (TMDLs)

Developed by the Rutgers Cooperative Extension Water Resources Program  
Funded by Hamilton Township, Mercer County, New Jersey

December 5, 2019

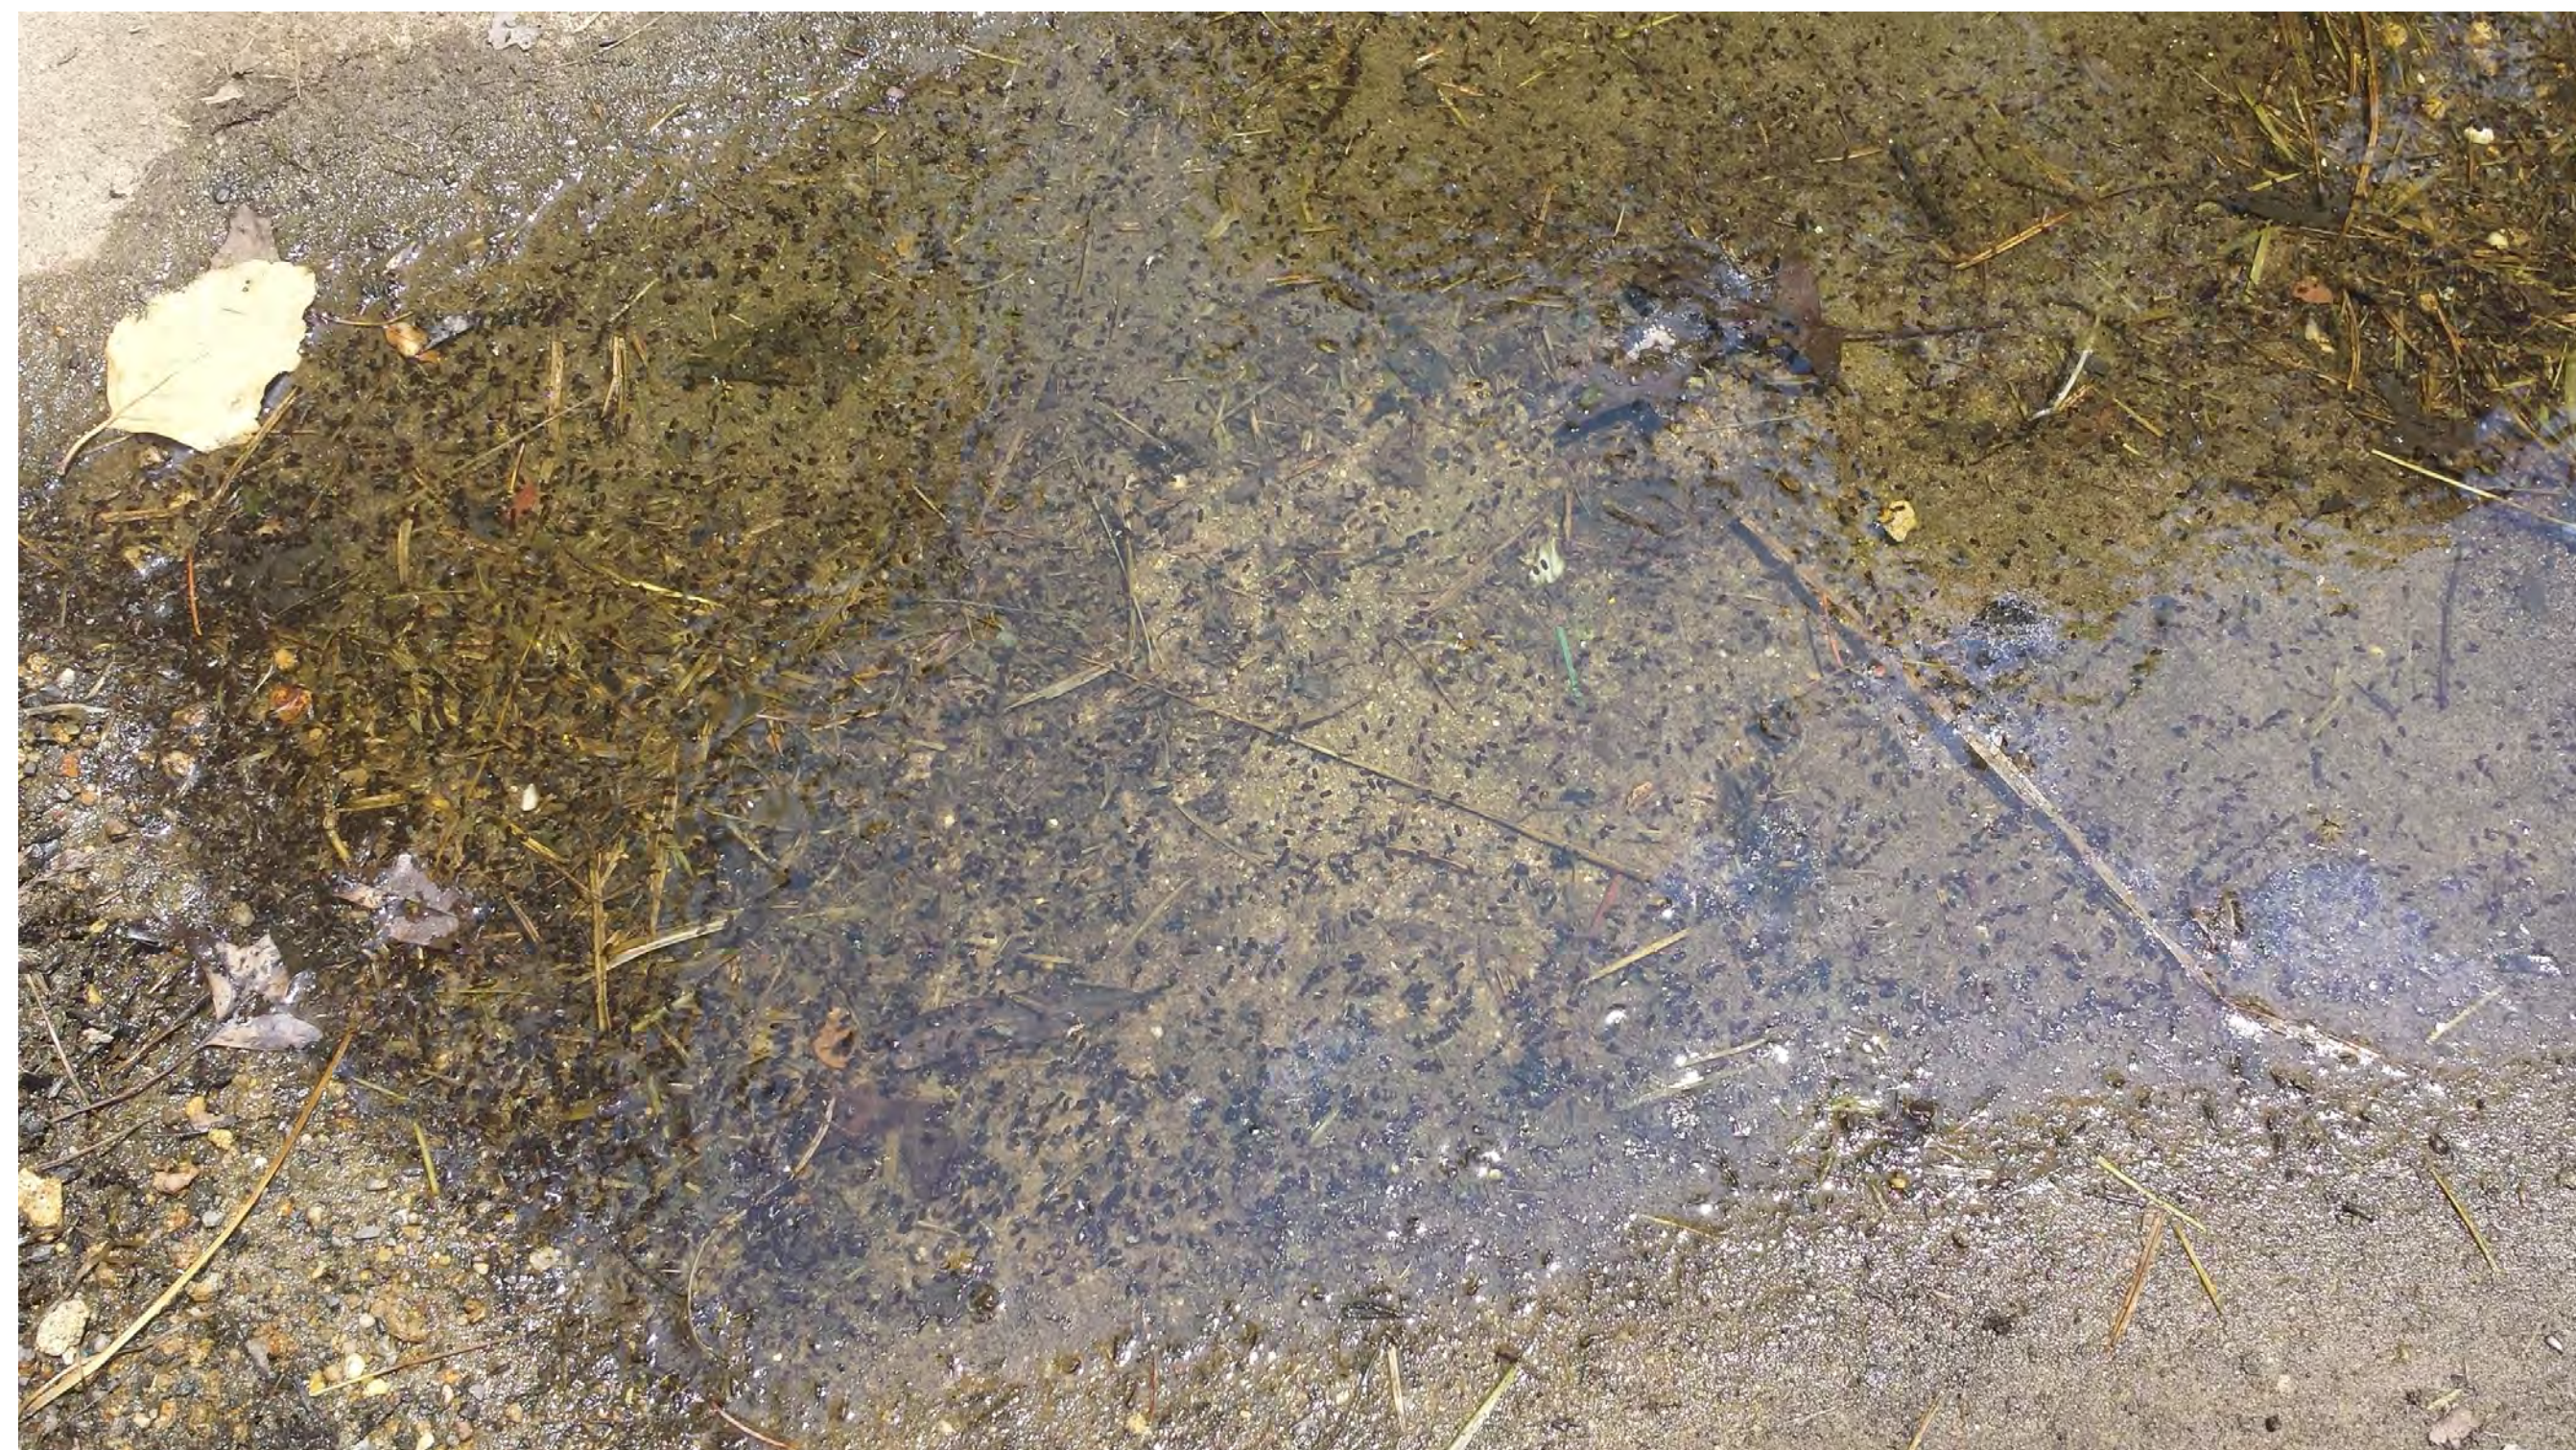
Mosquito larvae in low flow channel

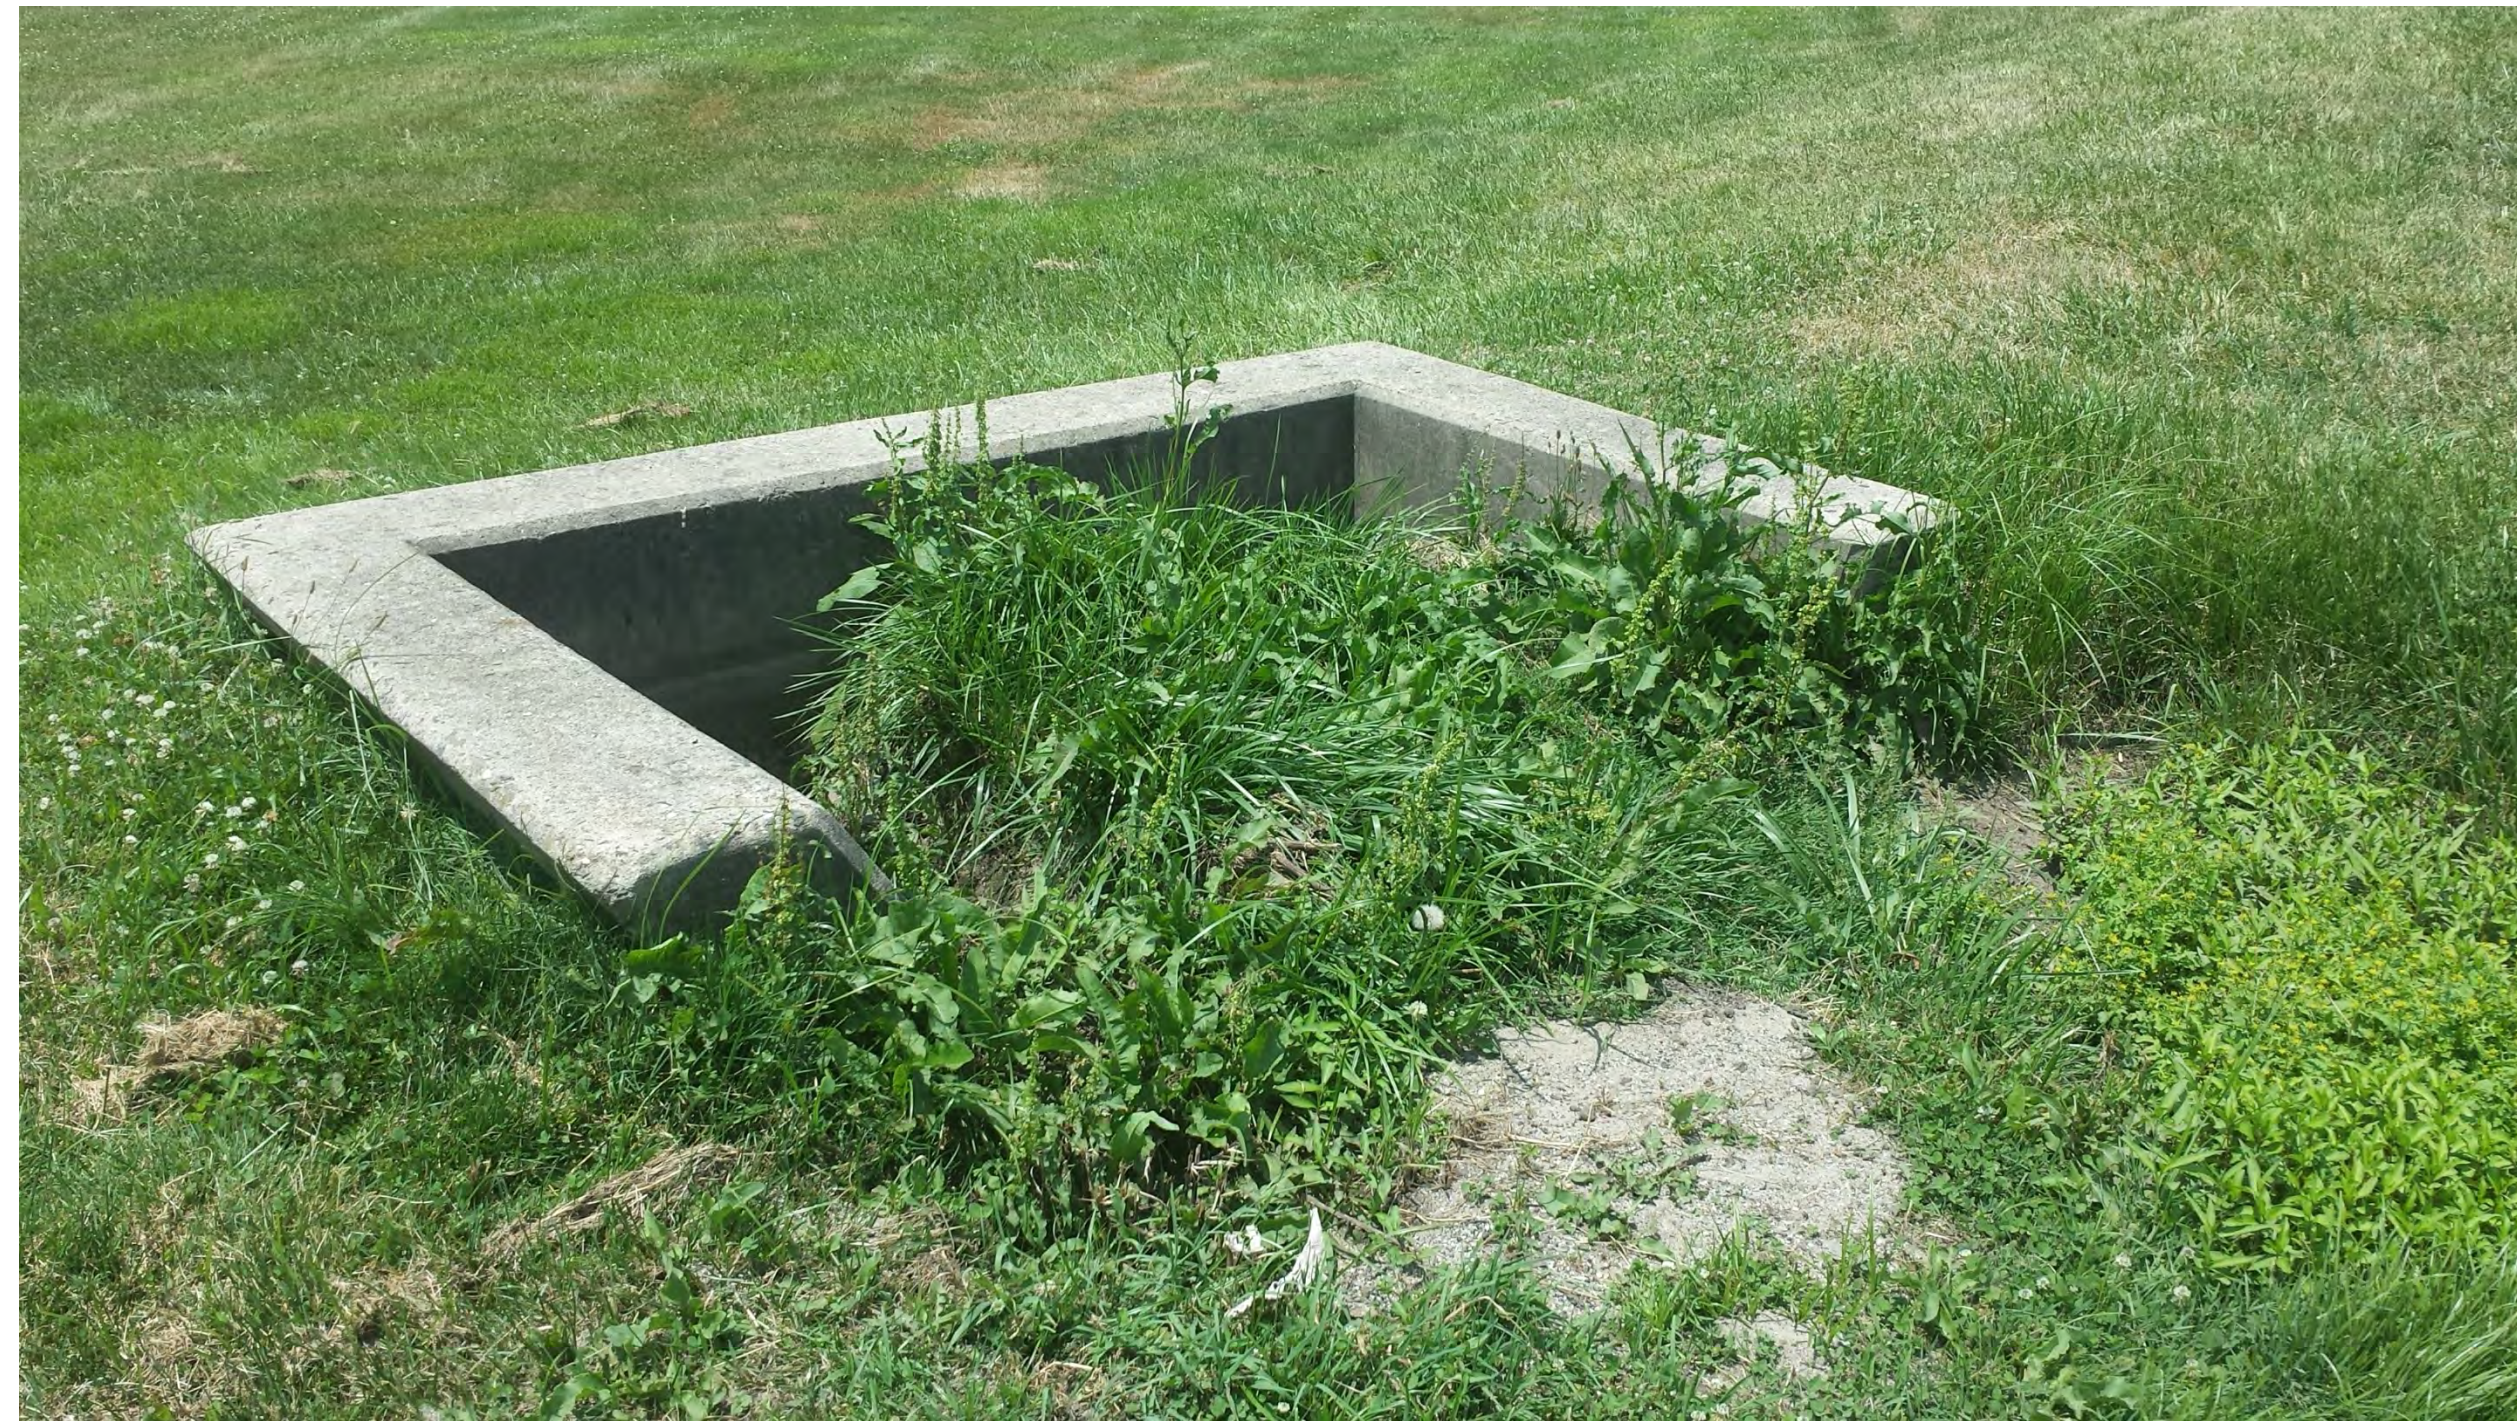
- Inlet has grass and plants restricting water flow
- Water flows to a maintained garden
- Minimal erosion caused by running water
- No outlets apparent
- Emergency spillway leads to depressed area near basin center
- Swale receives water from northern parking lot

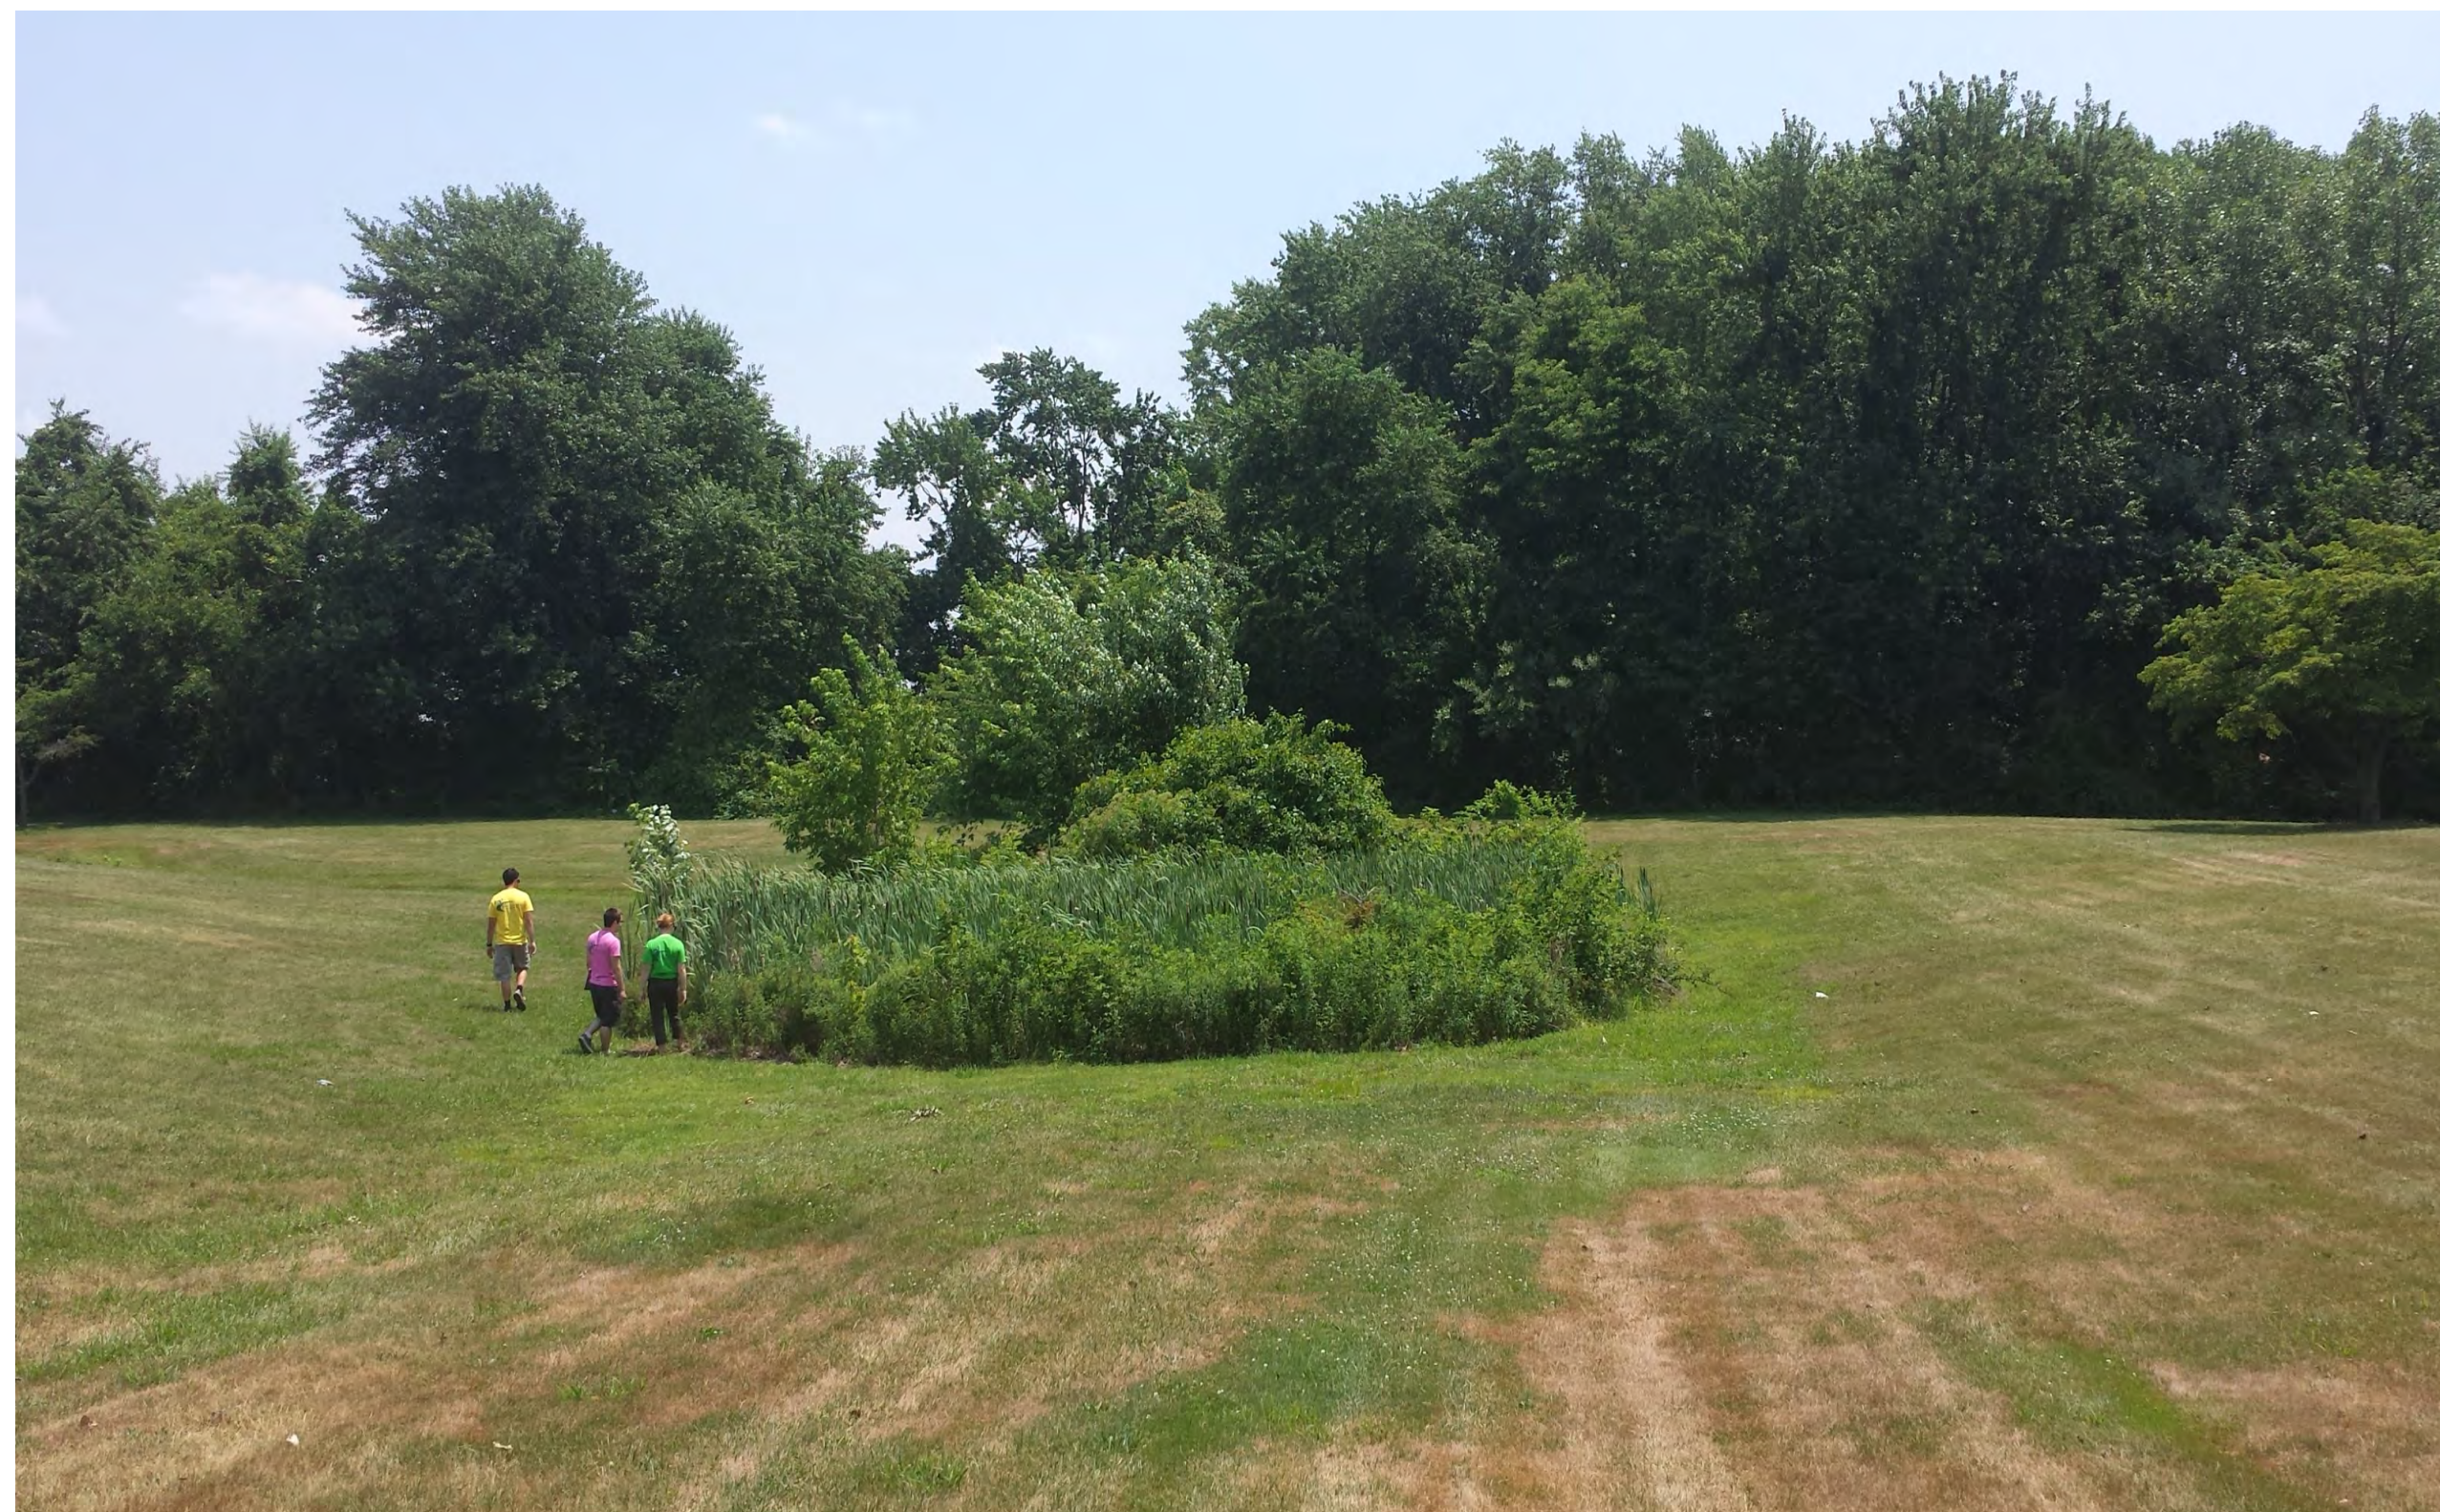
Garden at end of swail

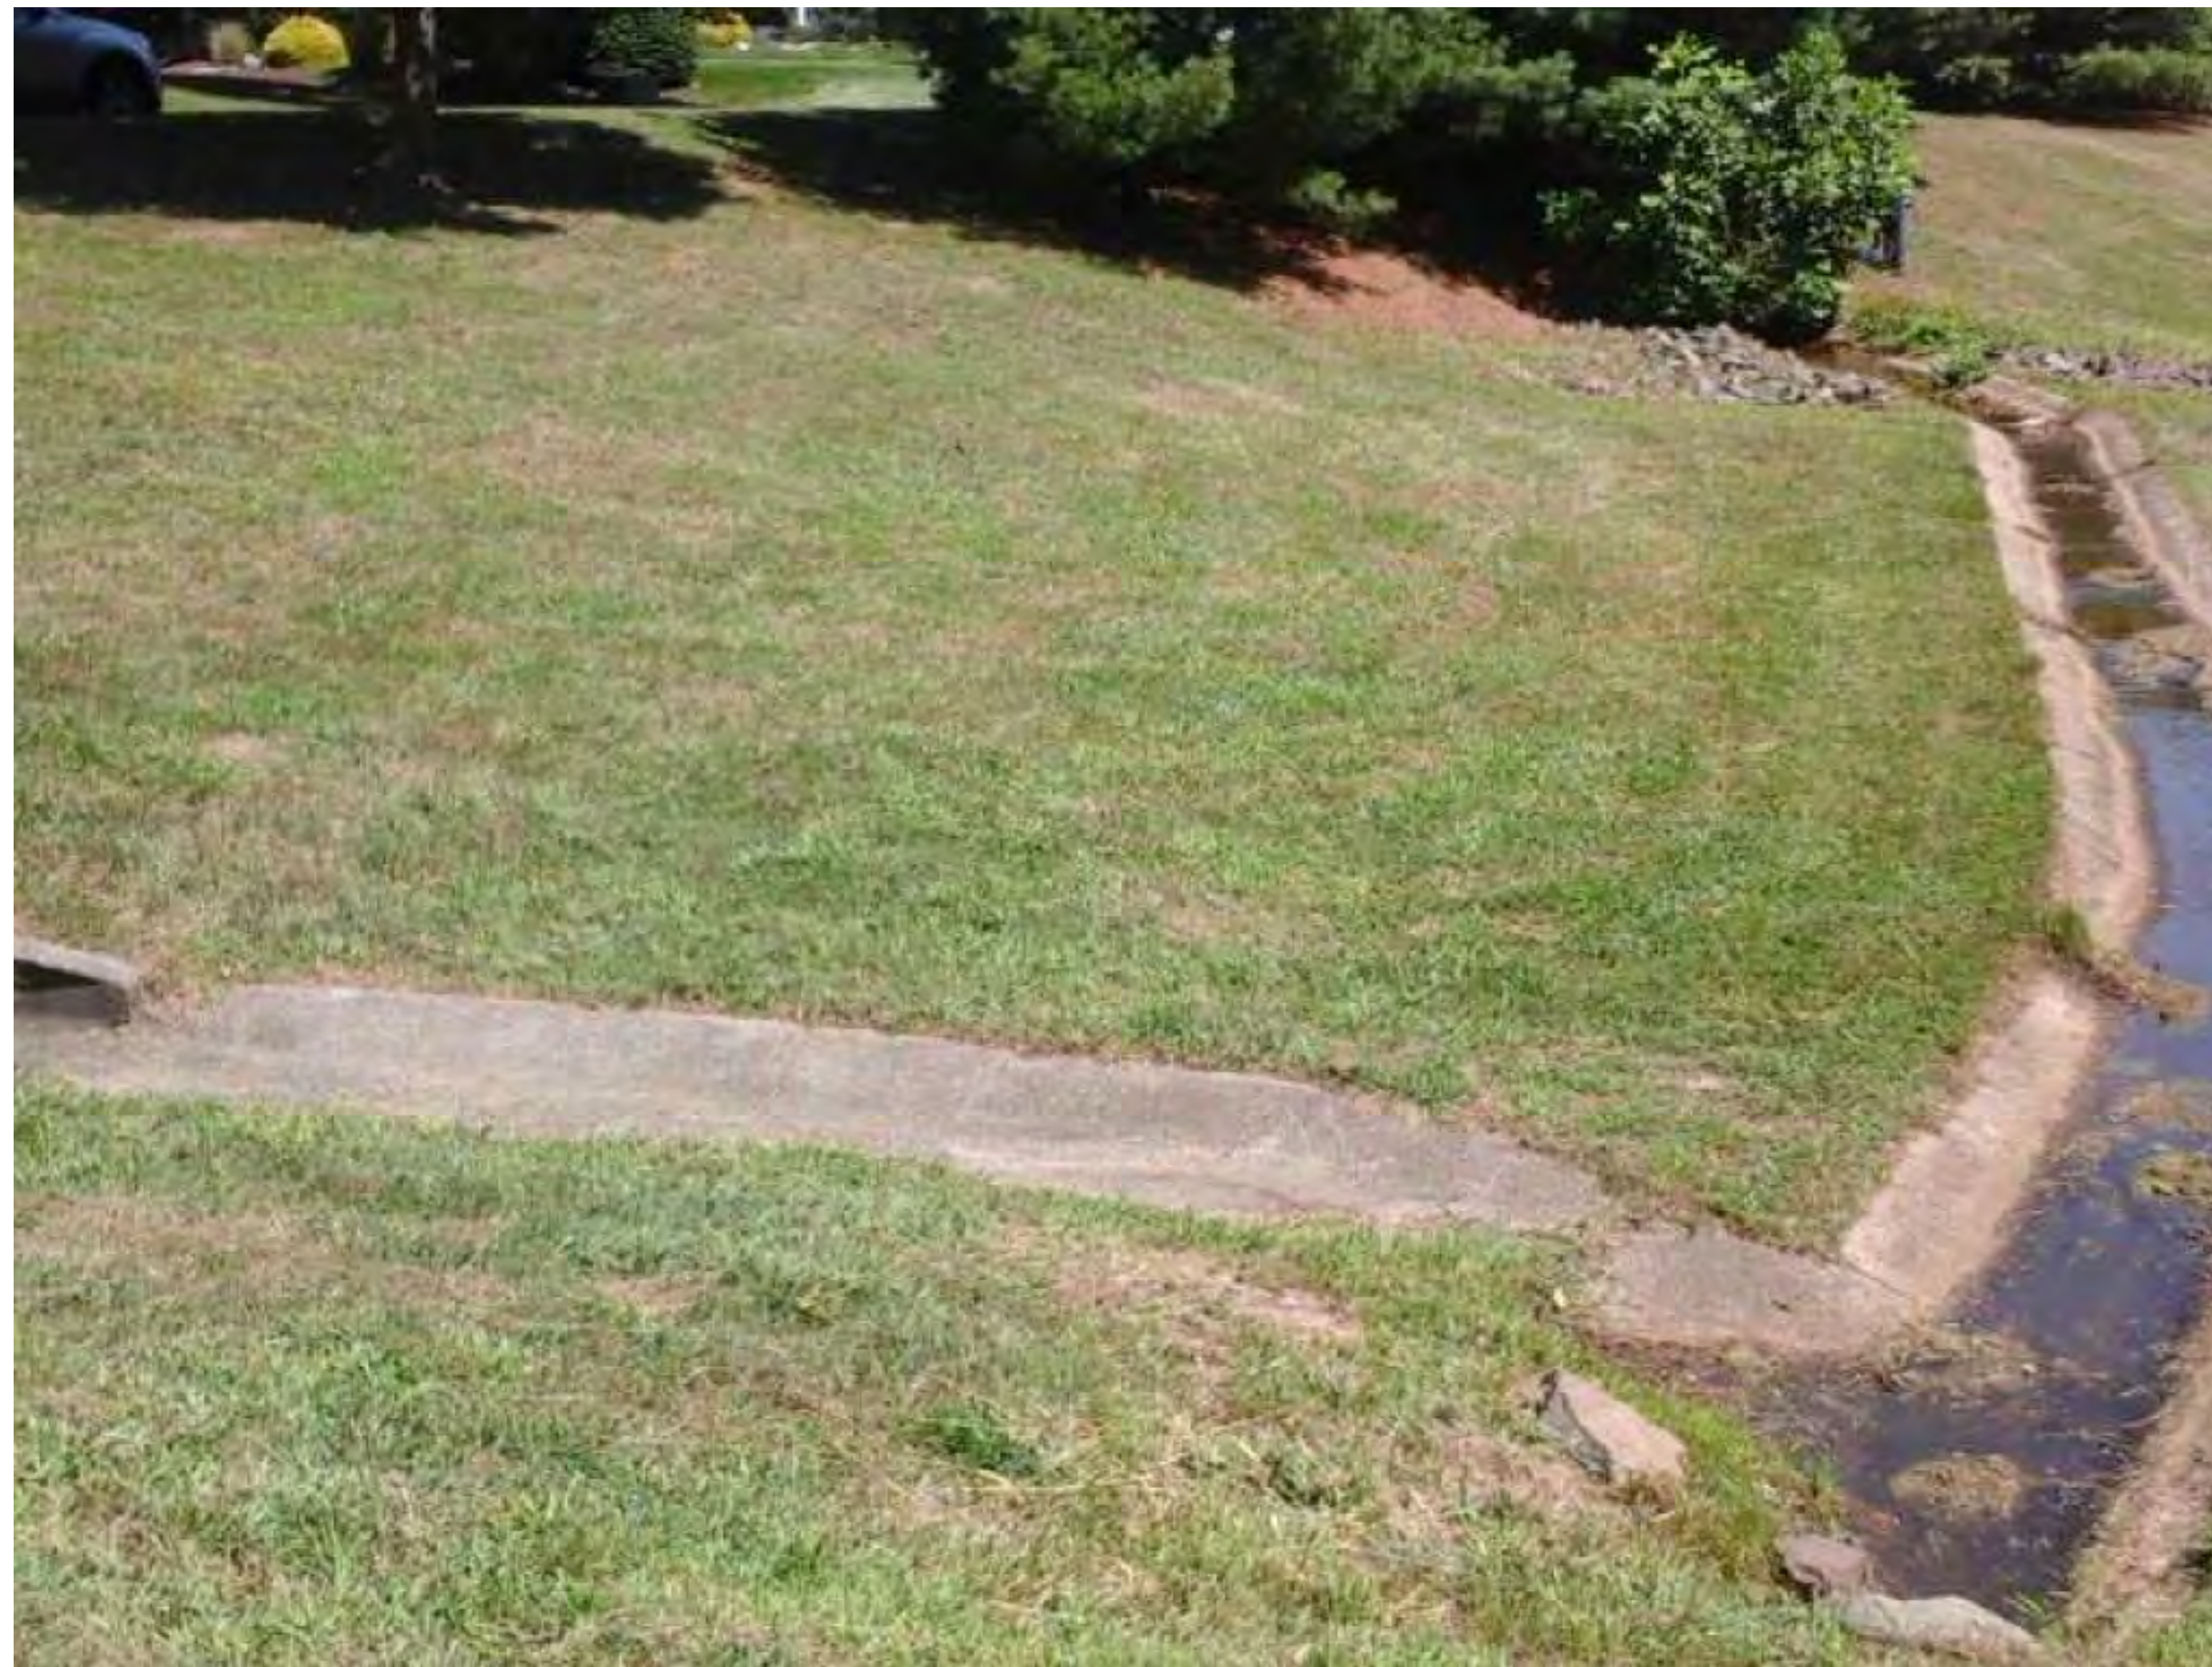
- Basin #233 low flow channel has some grass clippings and some standing water
- Retrofit plants for infiltration
- Tall grass, located in between houses
- Both basins can have stone channels implemented in place of low flow channels, and herbaceous plant can be used to naturalize the basins

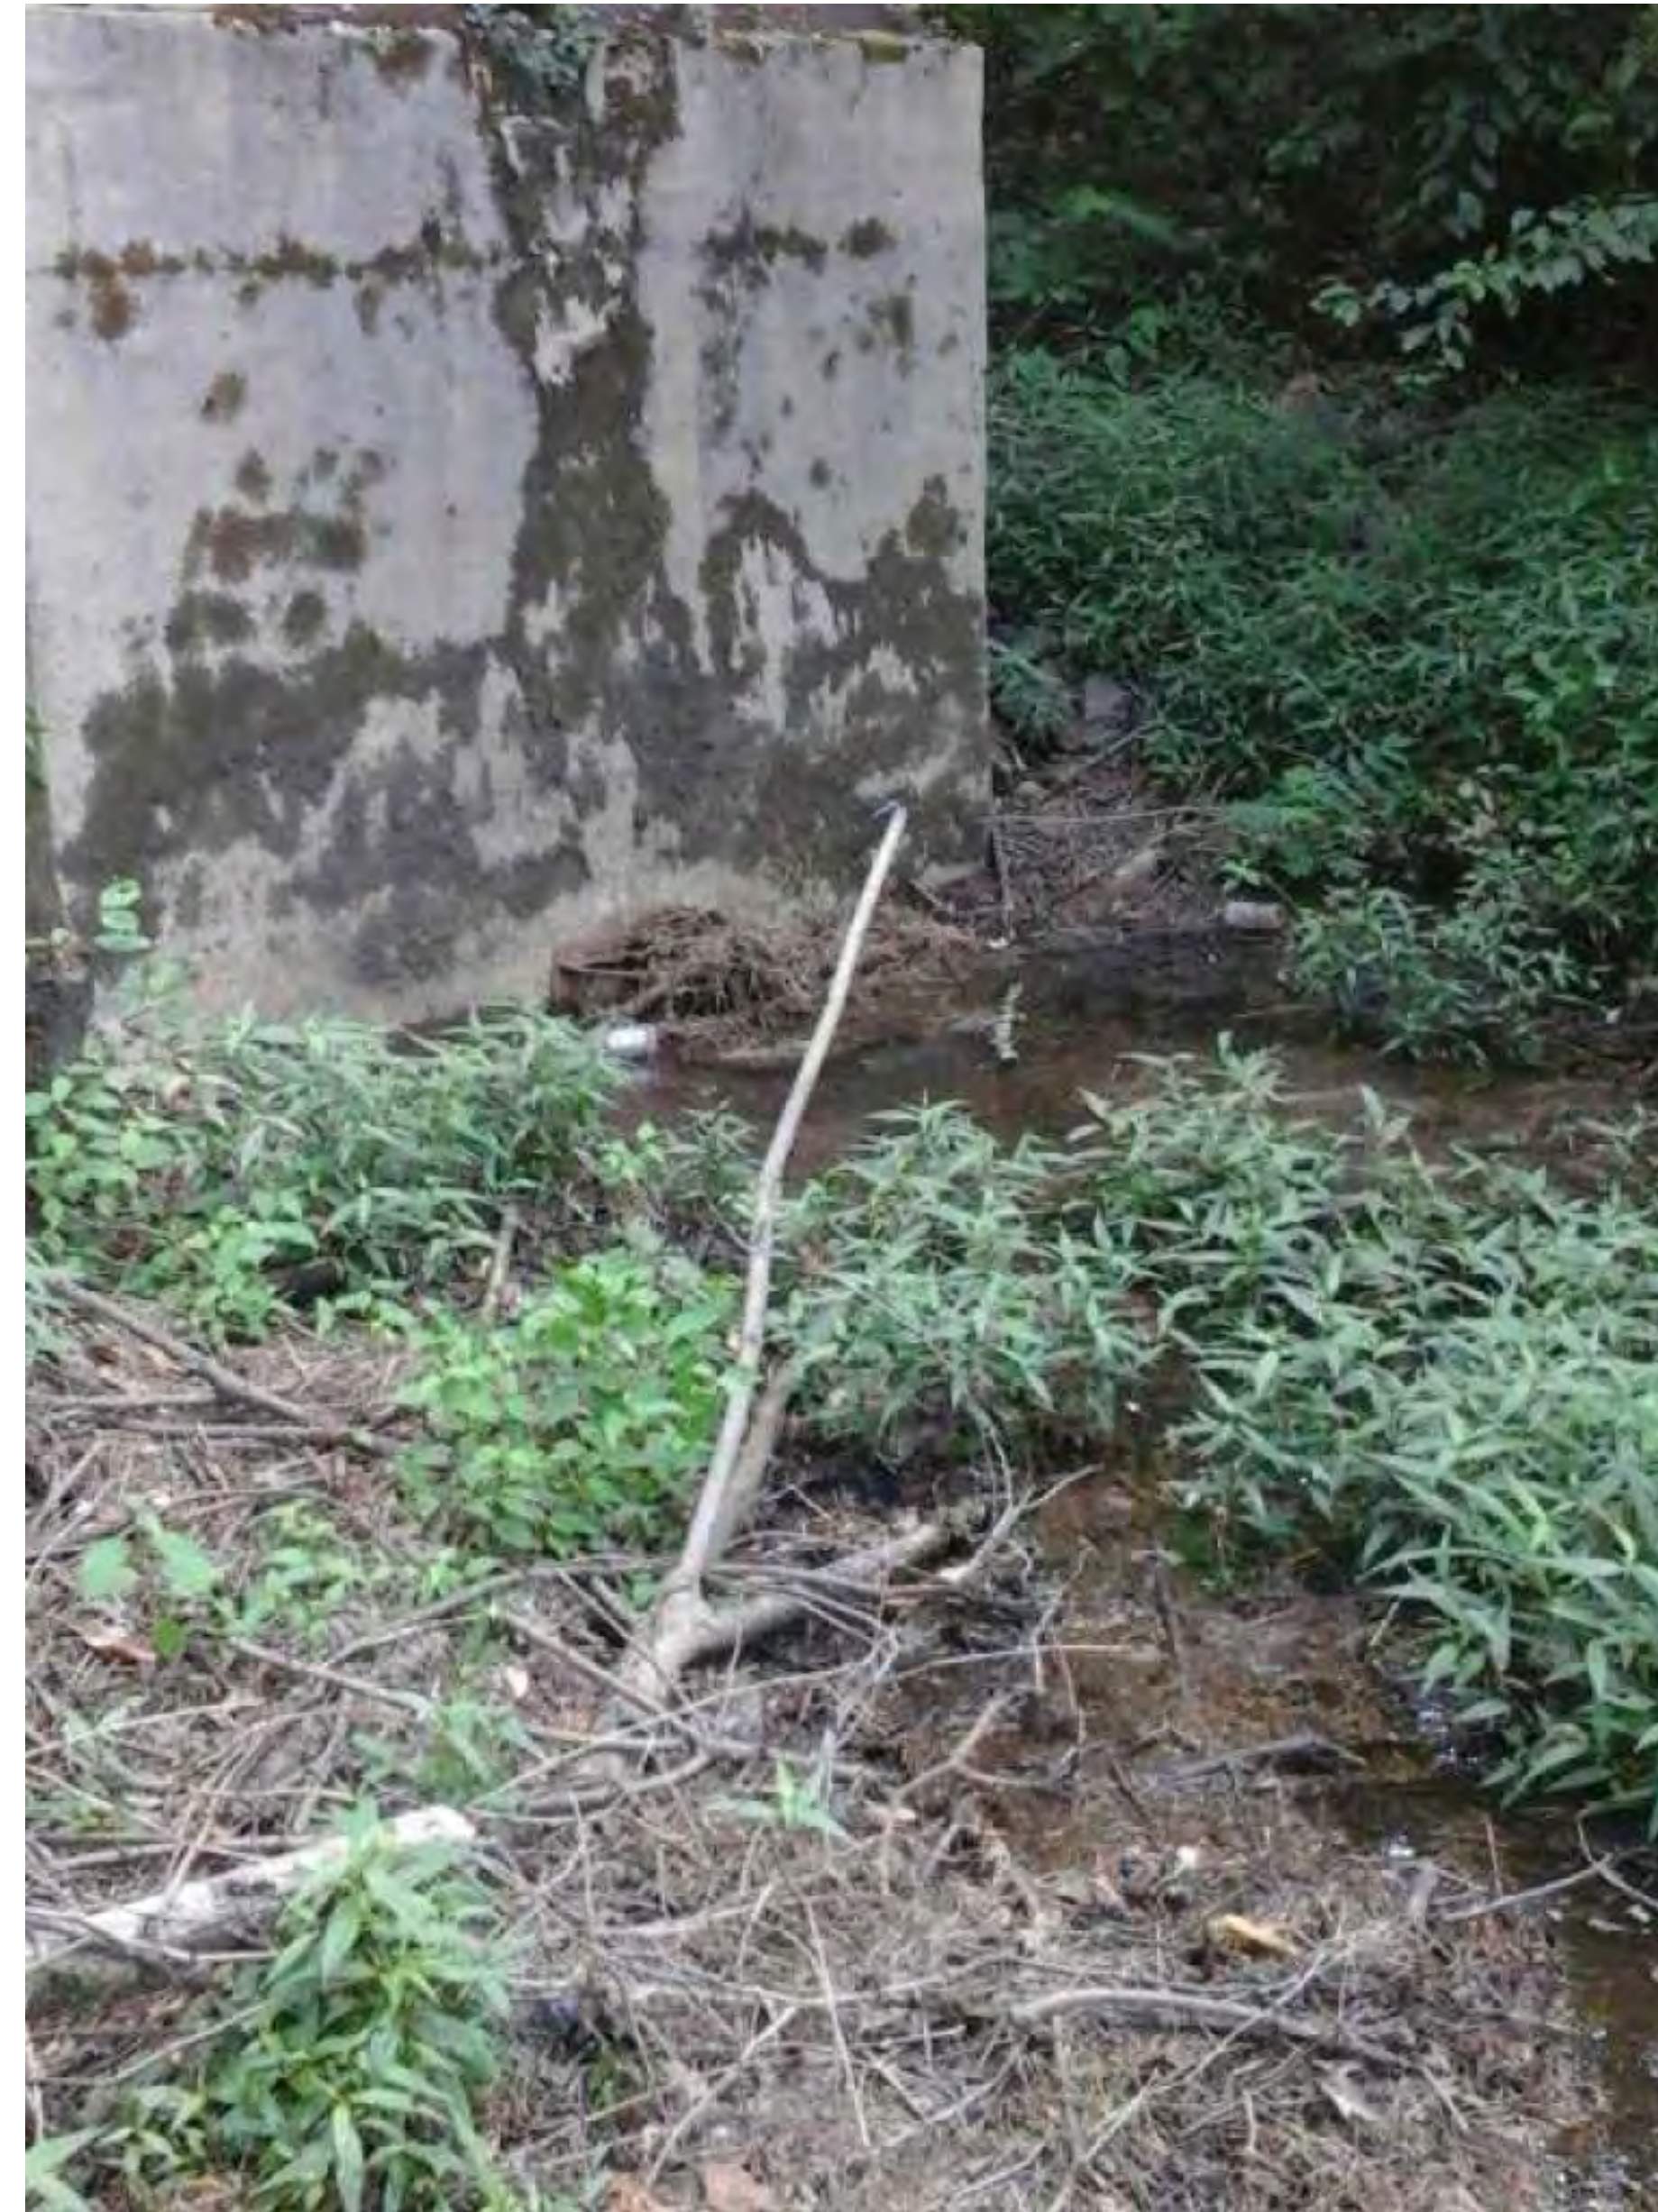
- Both basin suffer from similar problems with Basin #236 being worse
- Water flowing through has a red is color, channel is overgrown, due to overgrowth and excess sediment, the outlet is blocked and water is backing up
- Replace channel with rocks, clear out unwanted vegetation, clean outlet and excess sediment
- Replace low flow channel with rock channel

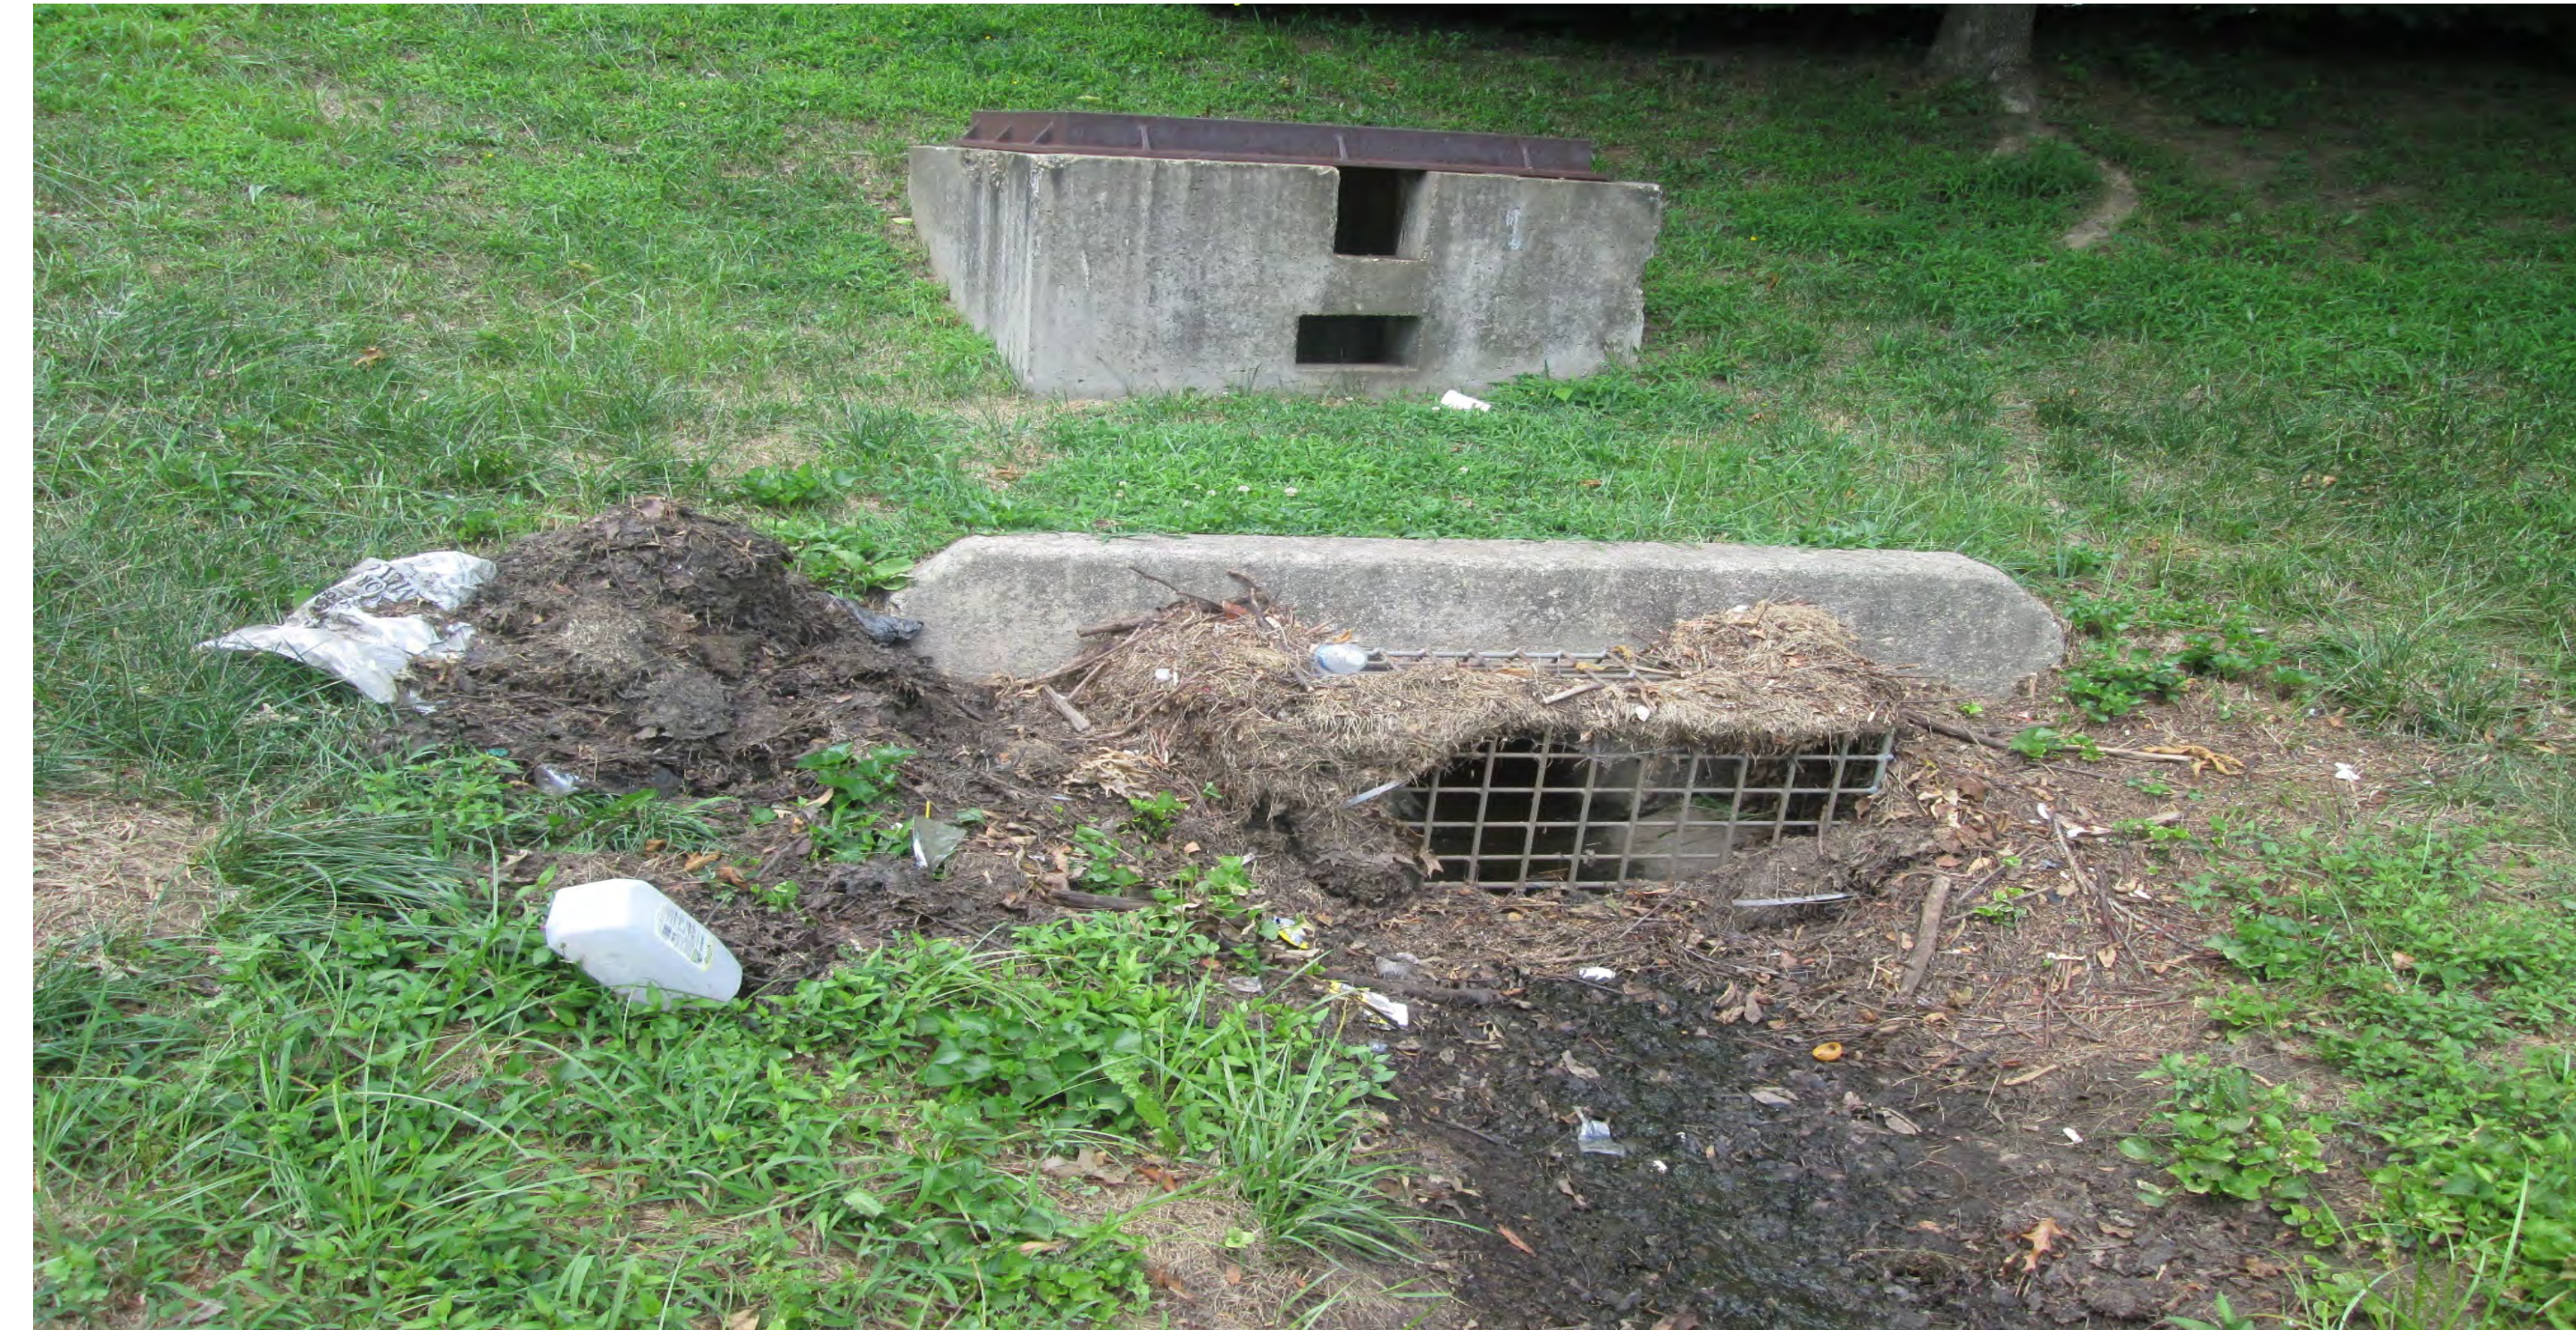
- Outlet has excessive sediment accumulation clogging low flow orifice
- Remove low flow channel and replace with a rock-lined channel to allow infiltration
- Naturalize with herbaceous plants
