## Hamilton Township (Mercer County)

# REVIEW AND EVALUATION OF TOTAL MAXIMUM DAILY LOADS (TMDLs)

Developed by the Rutgers Cooperative Extension Water Resources Program  
Funded by Hamilton Township, Mercer County, New Jersey

December 5, 2019

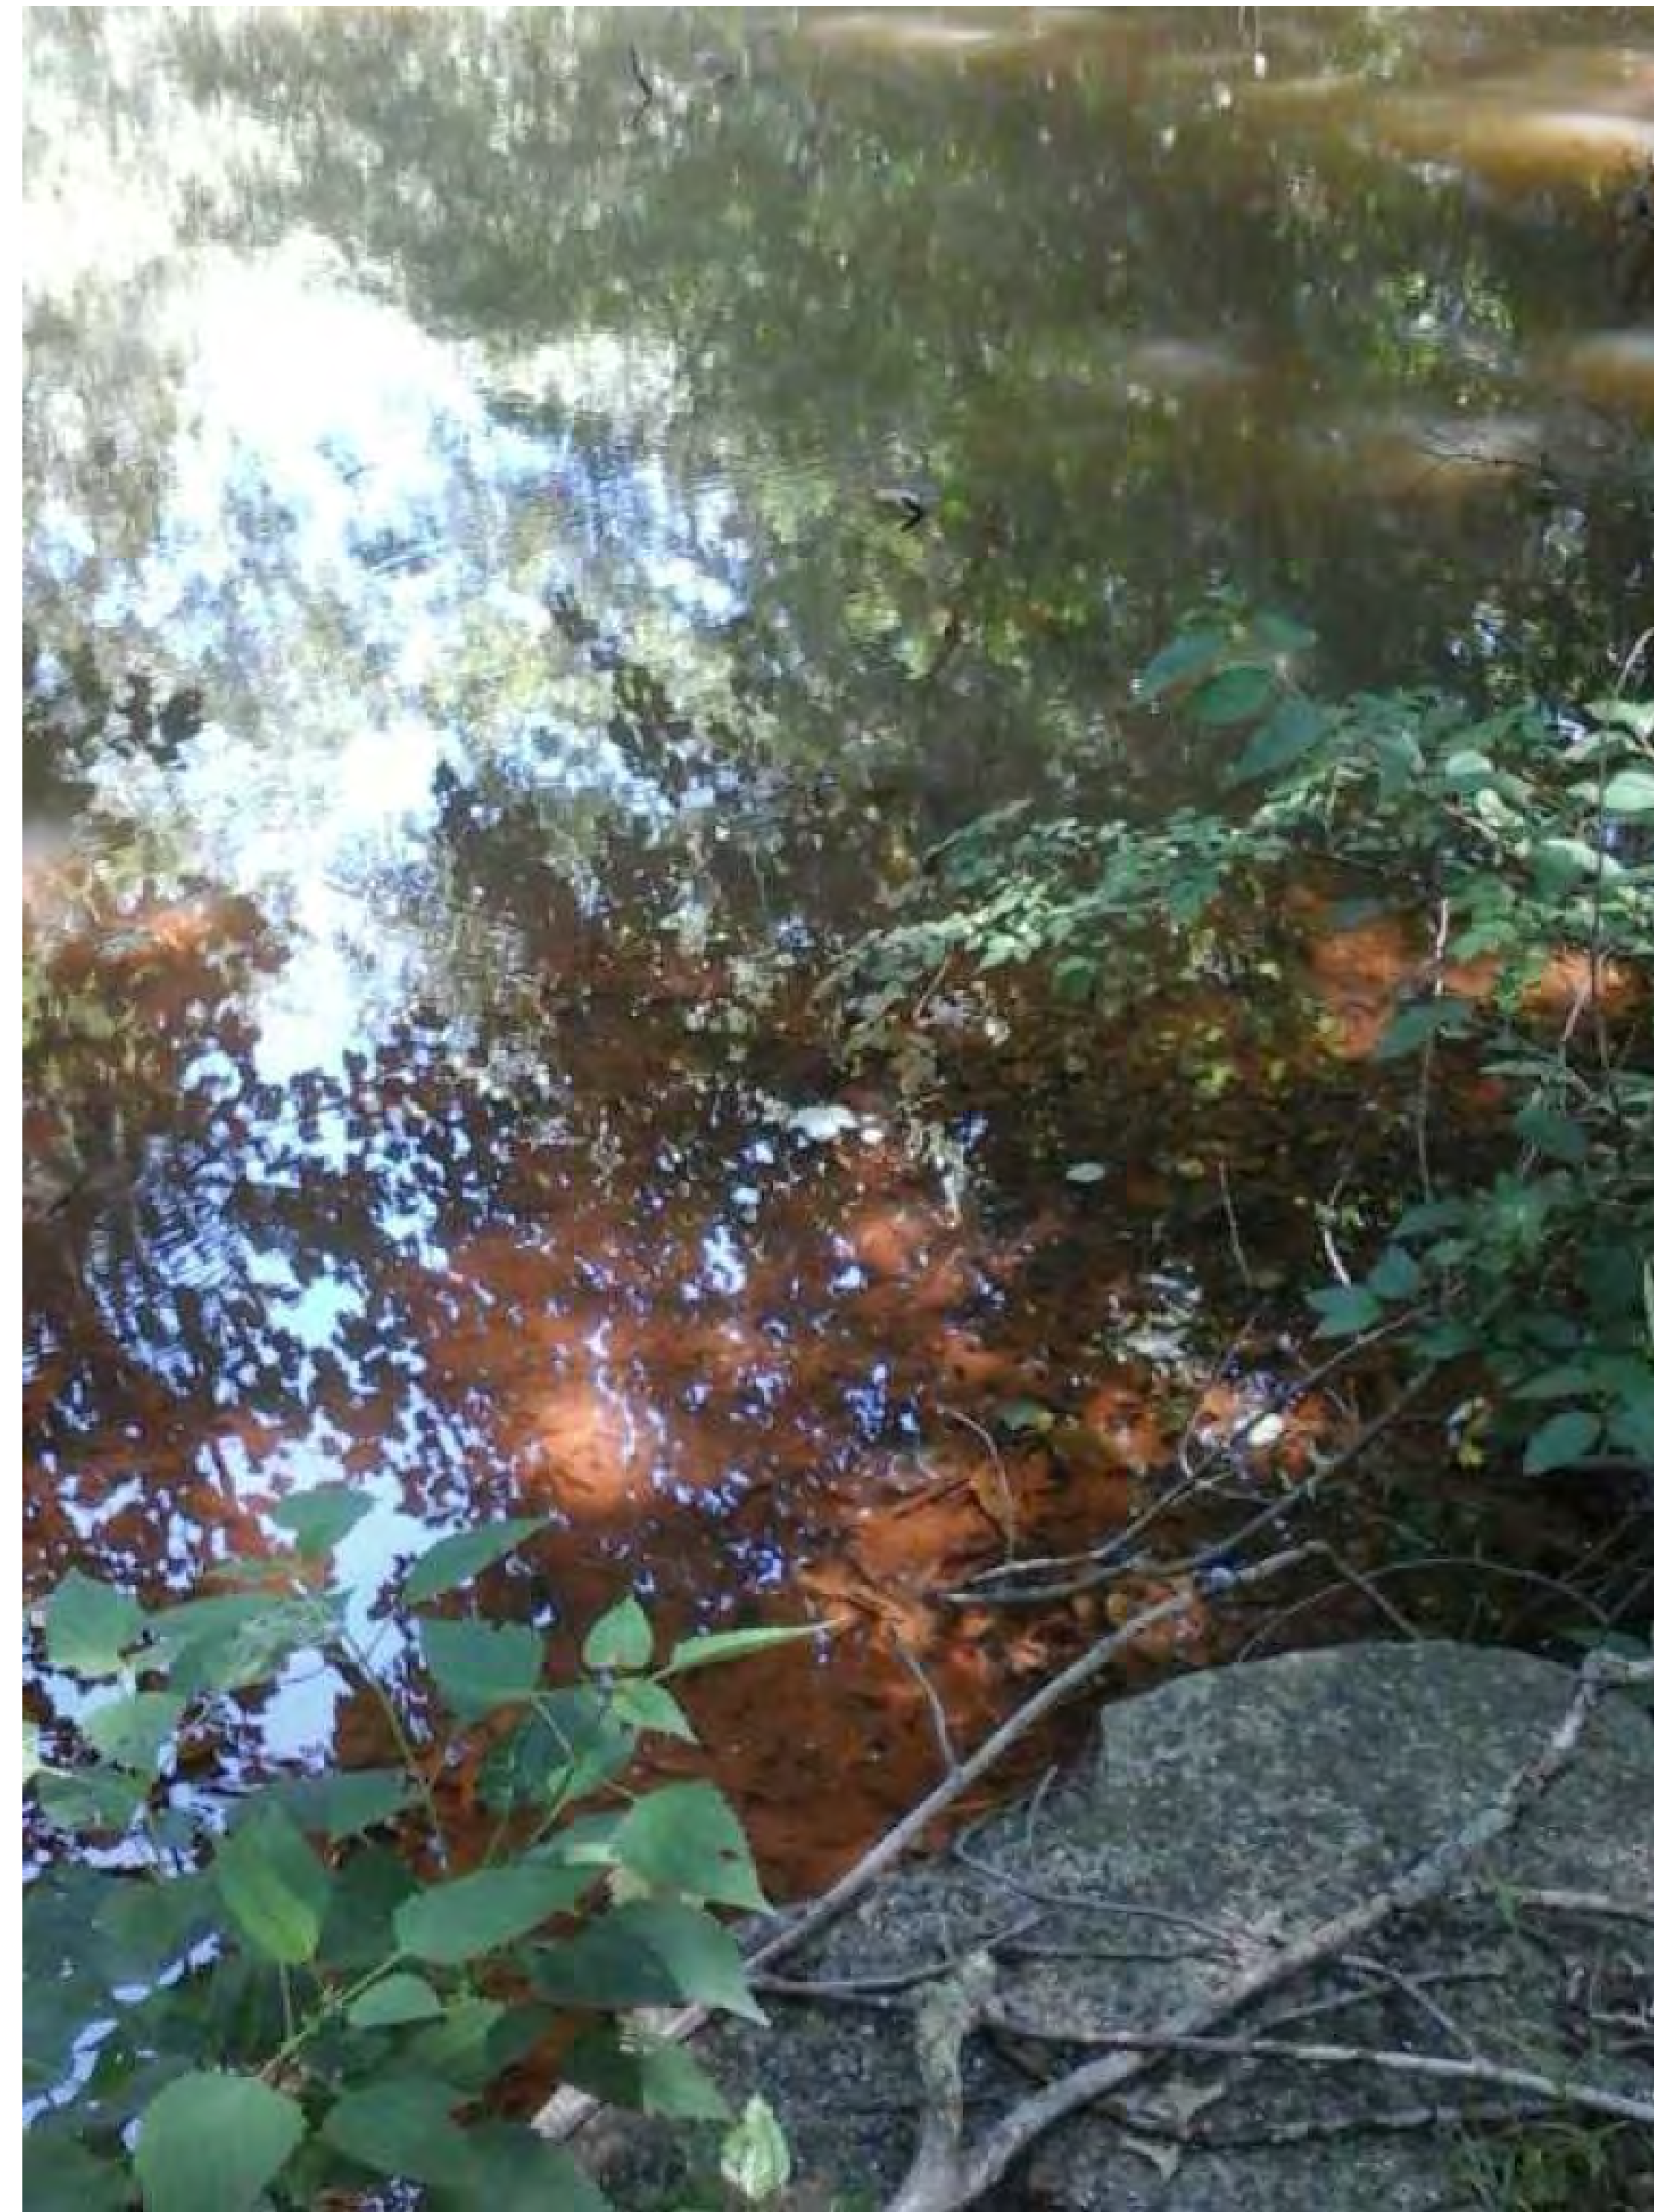
- No notes from 2014 report
- Appears to just be a pond, not a basin

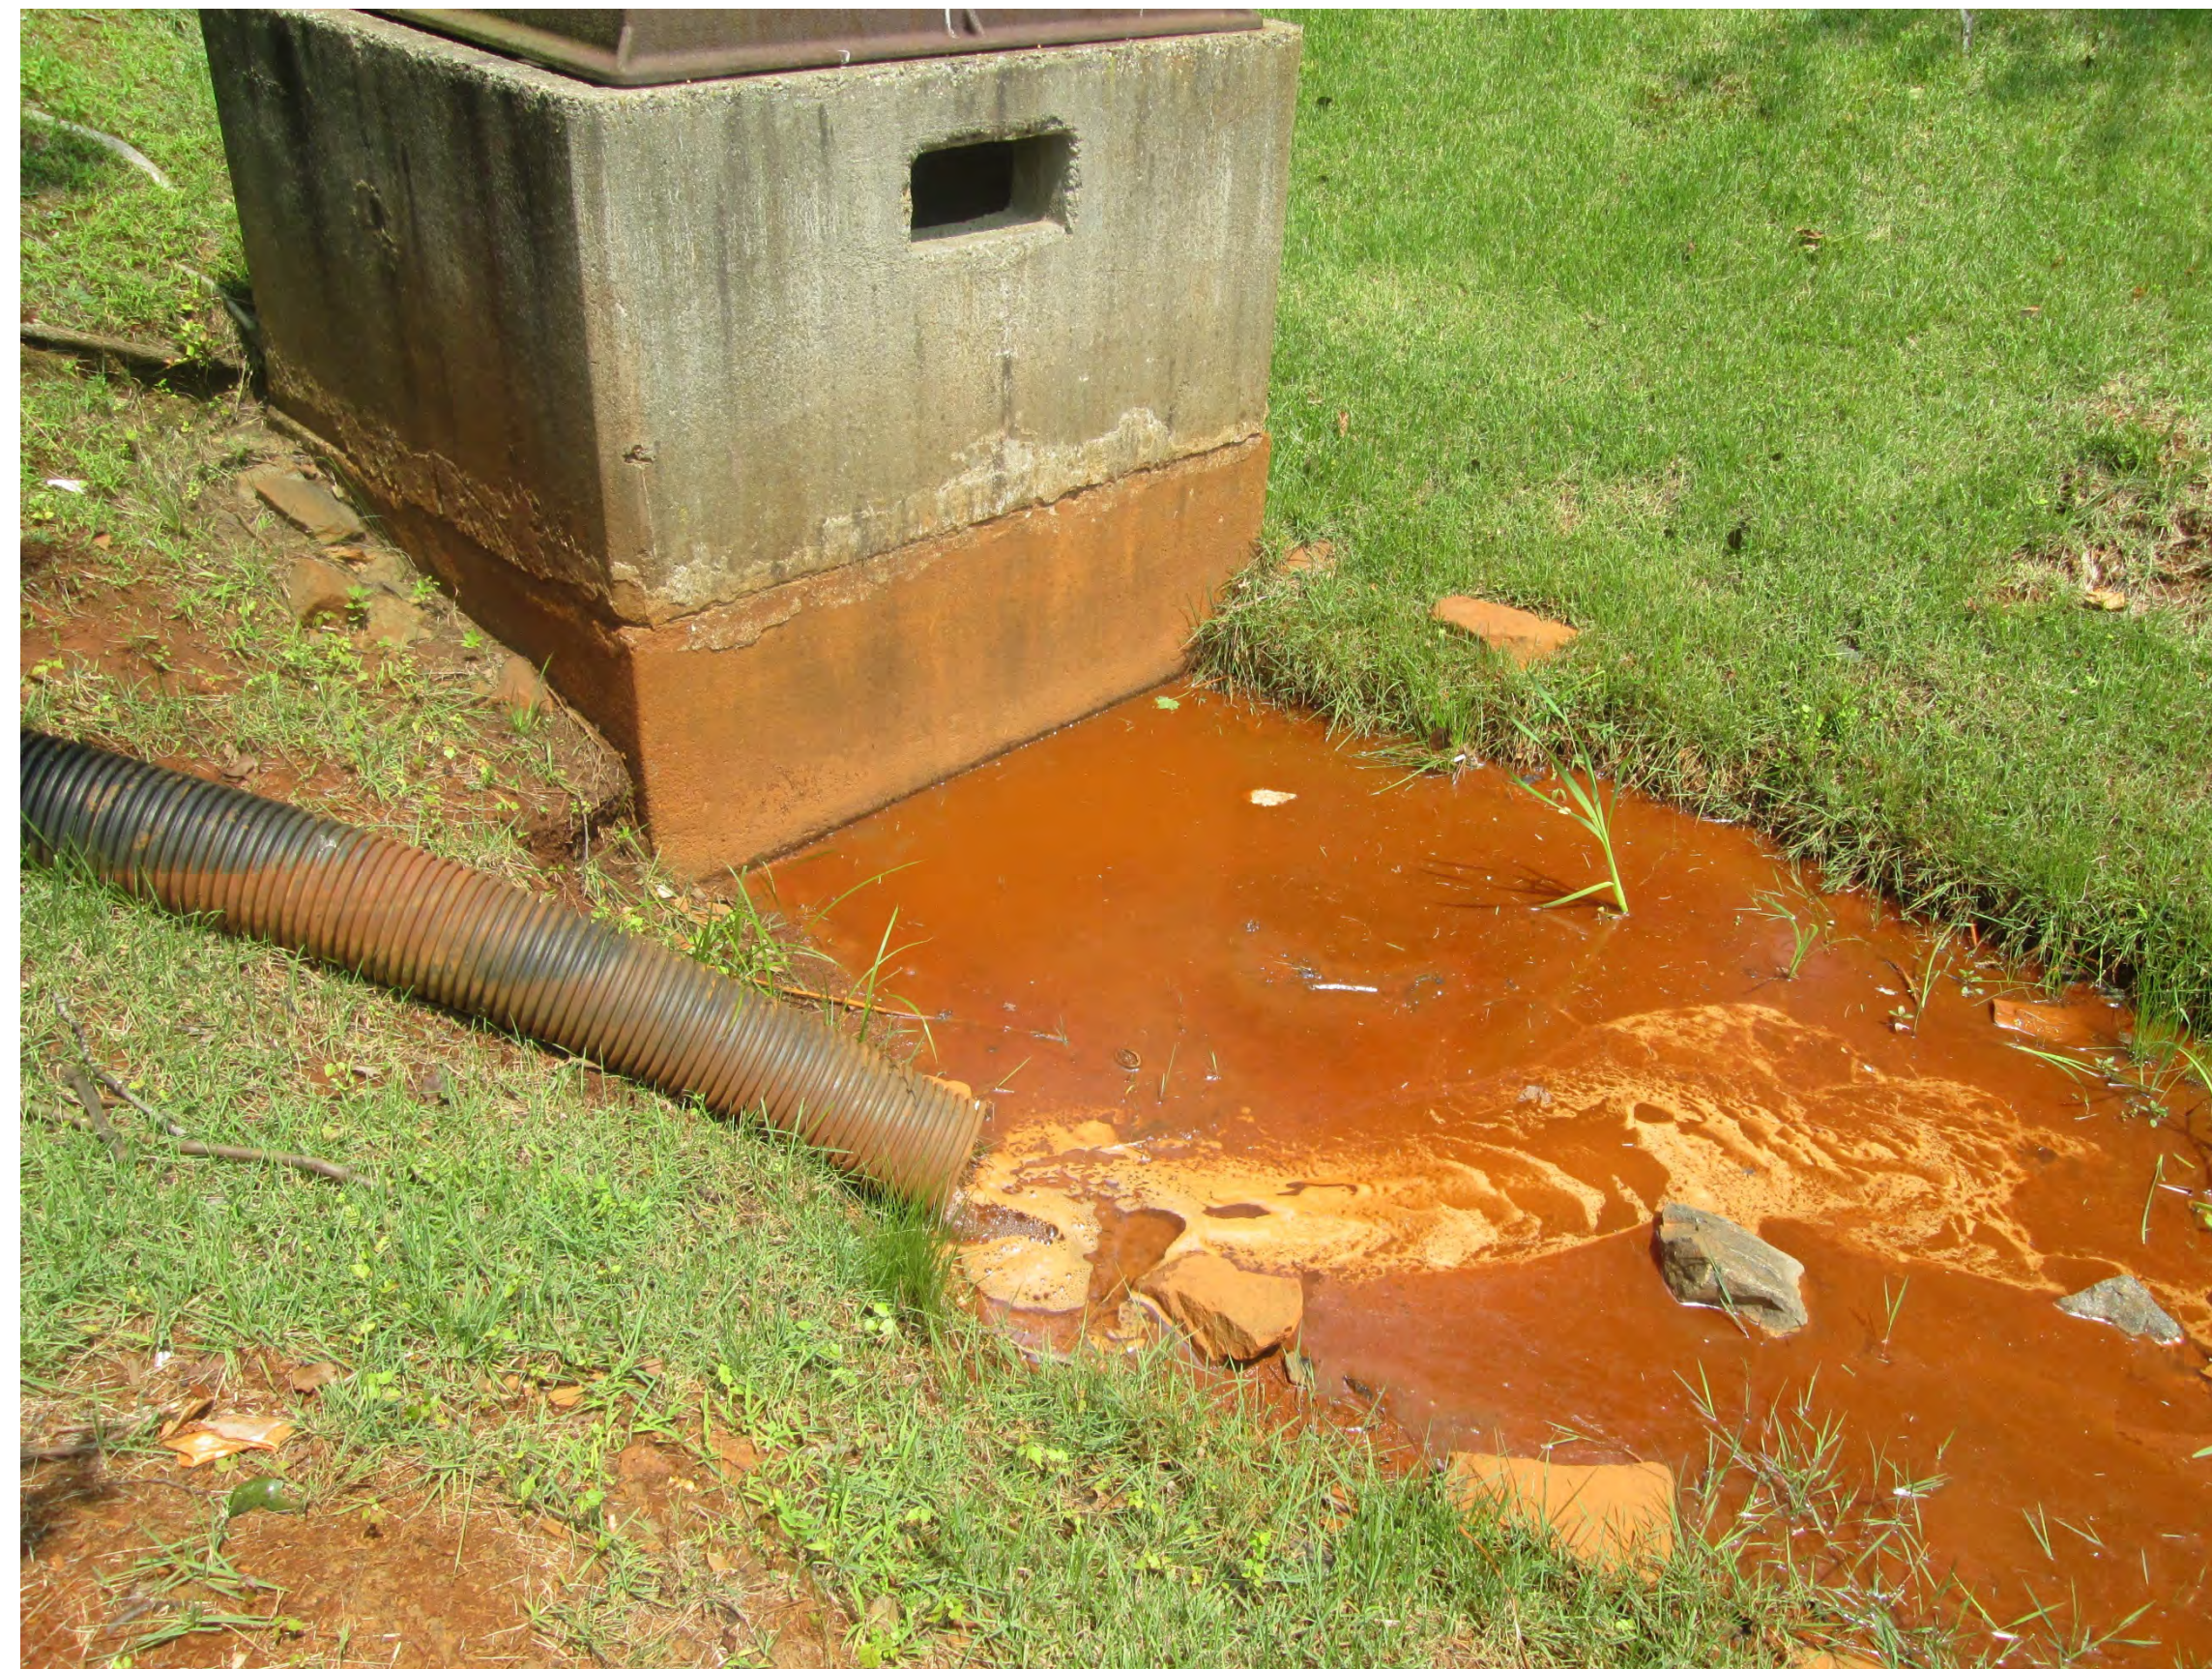
Outlet

- The low flow outlet appears to be clogged leading to significant standing water in low flow channel
- Heavy erosion caused by small inlet pipe should be remediated
- Low flow channel can be replaced with a stone channel to provide better infiltration in smaller storm events

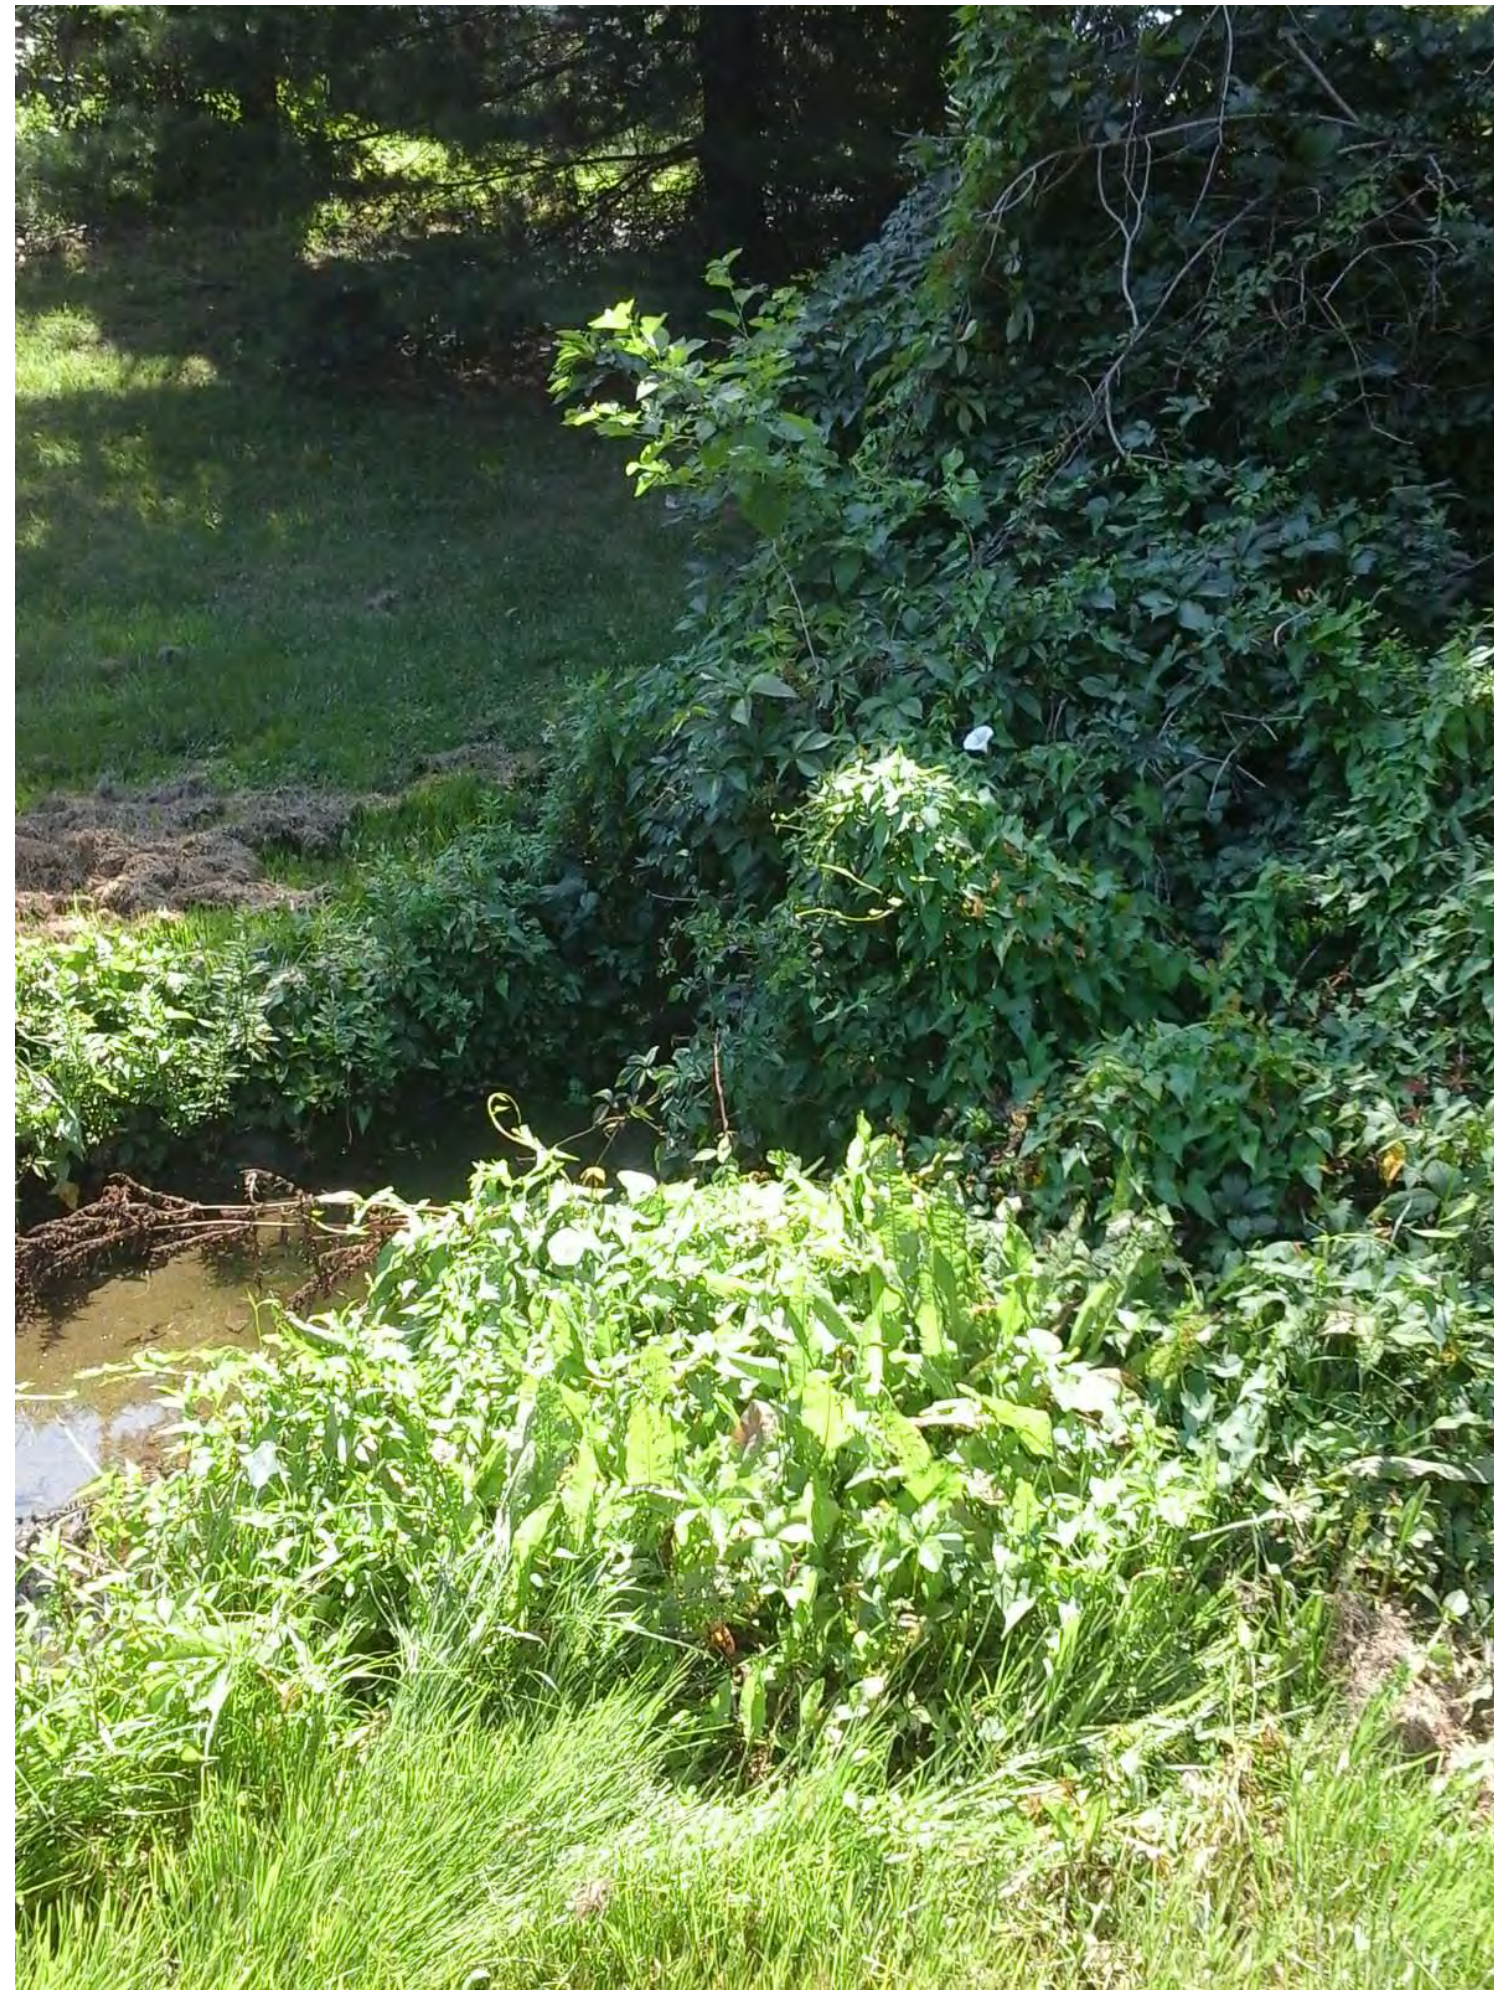
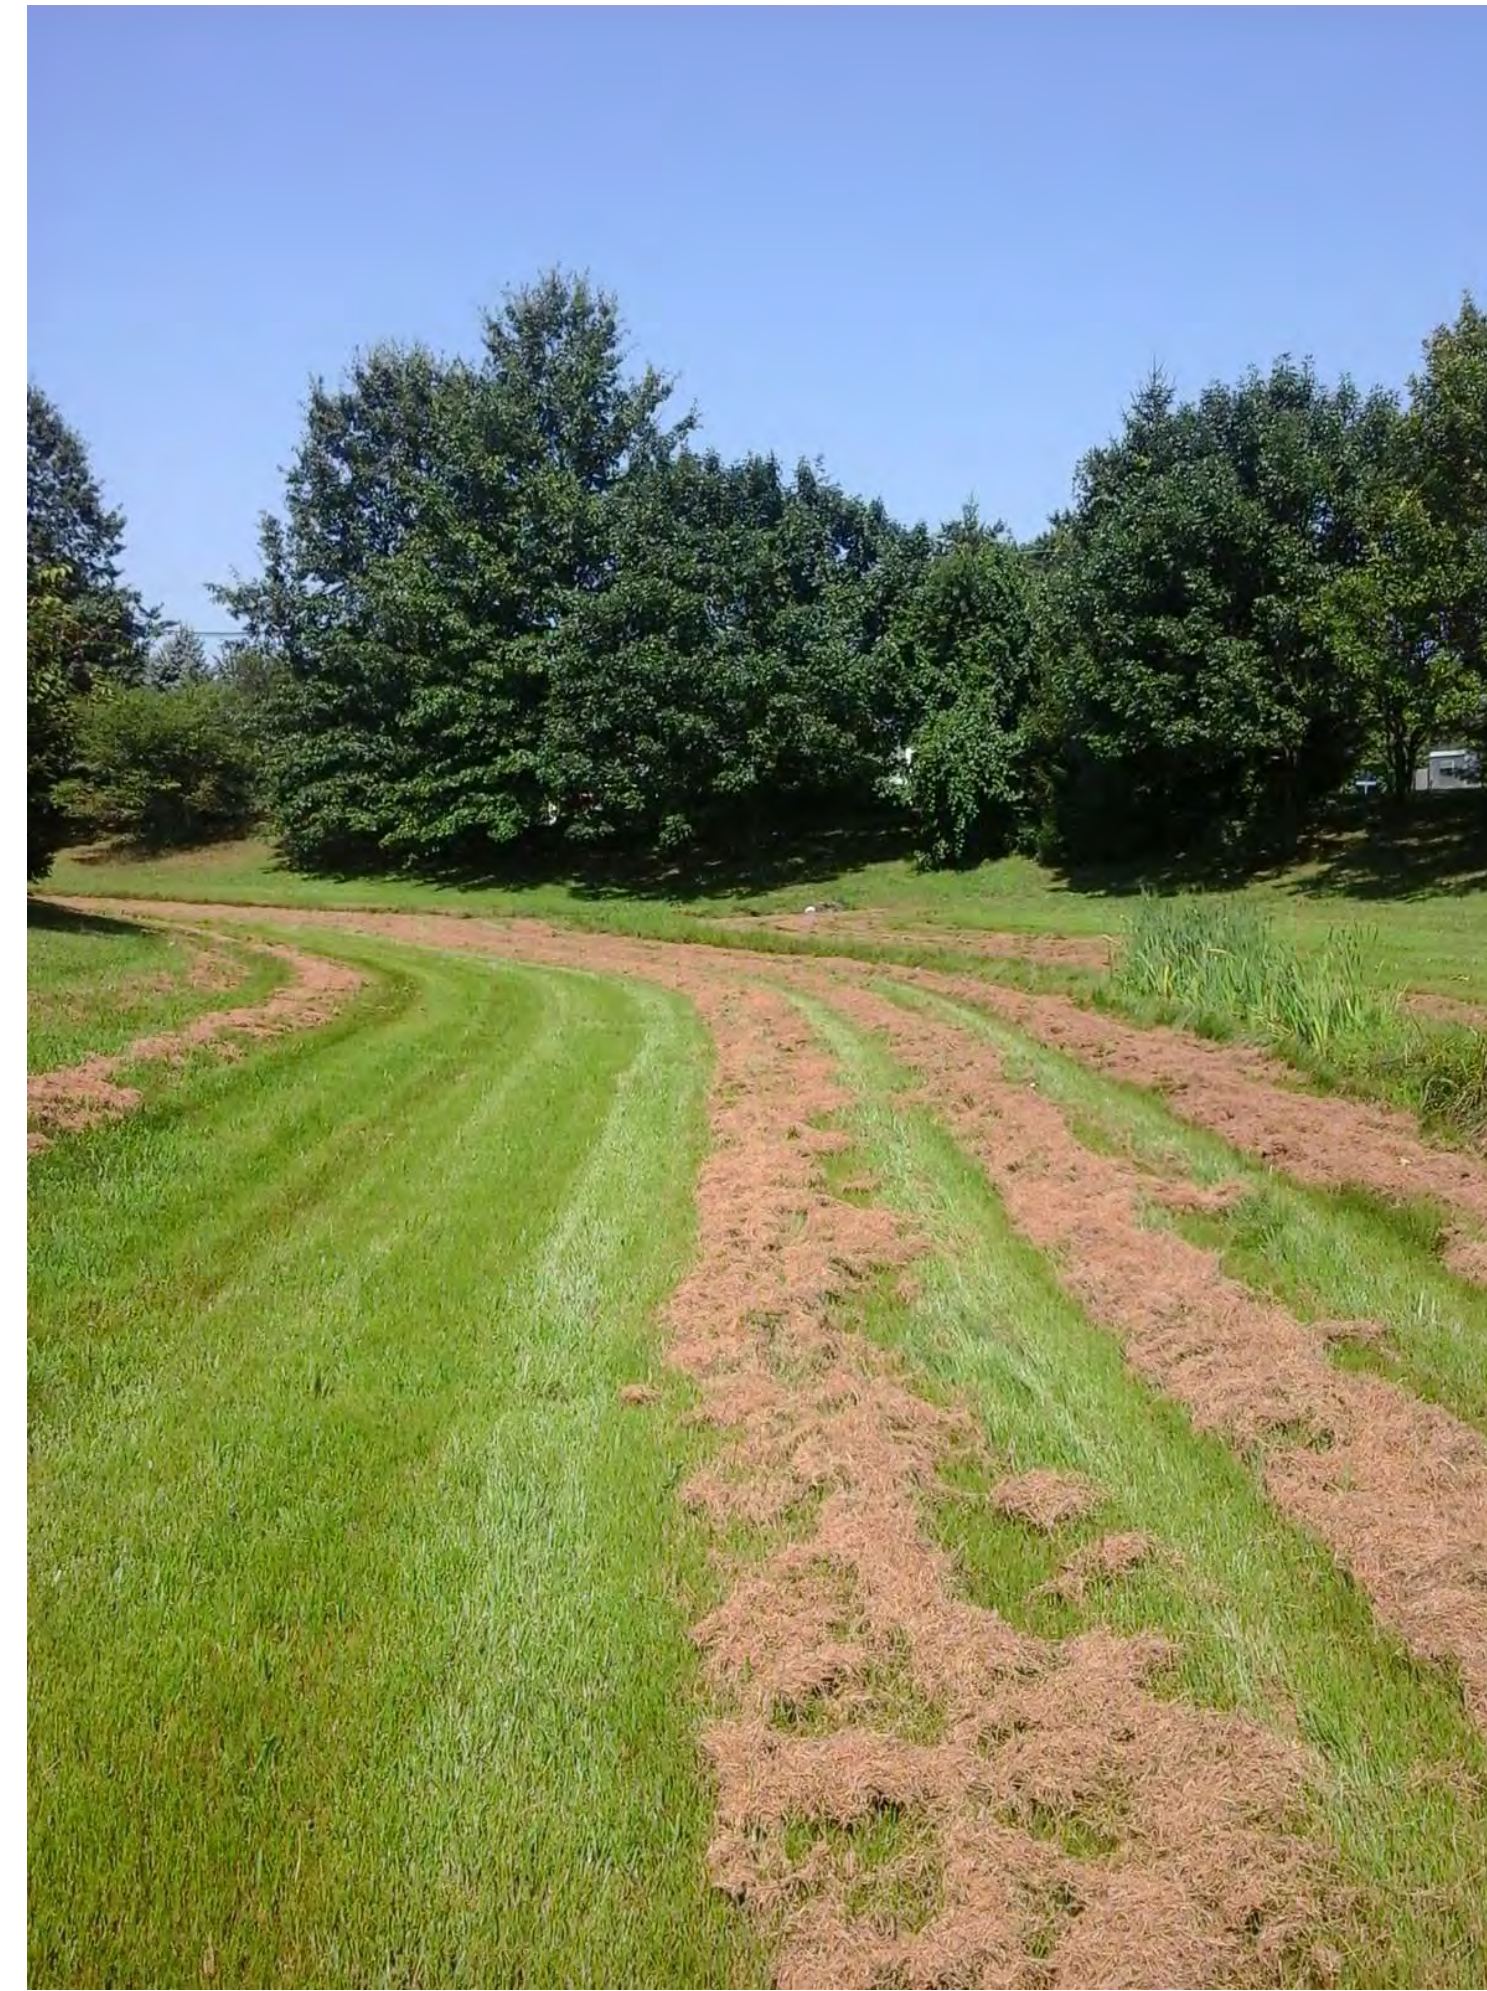
Inlet vegetation and overview of Basin #329

- Sediment accumulation at outlets and in low flow channels for both basins
- Vegetation overgrowth at Basin #329
- Reduce mowing and establish meadows to improve infiltration

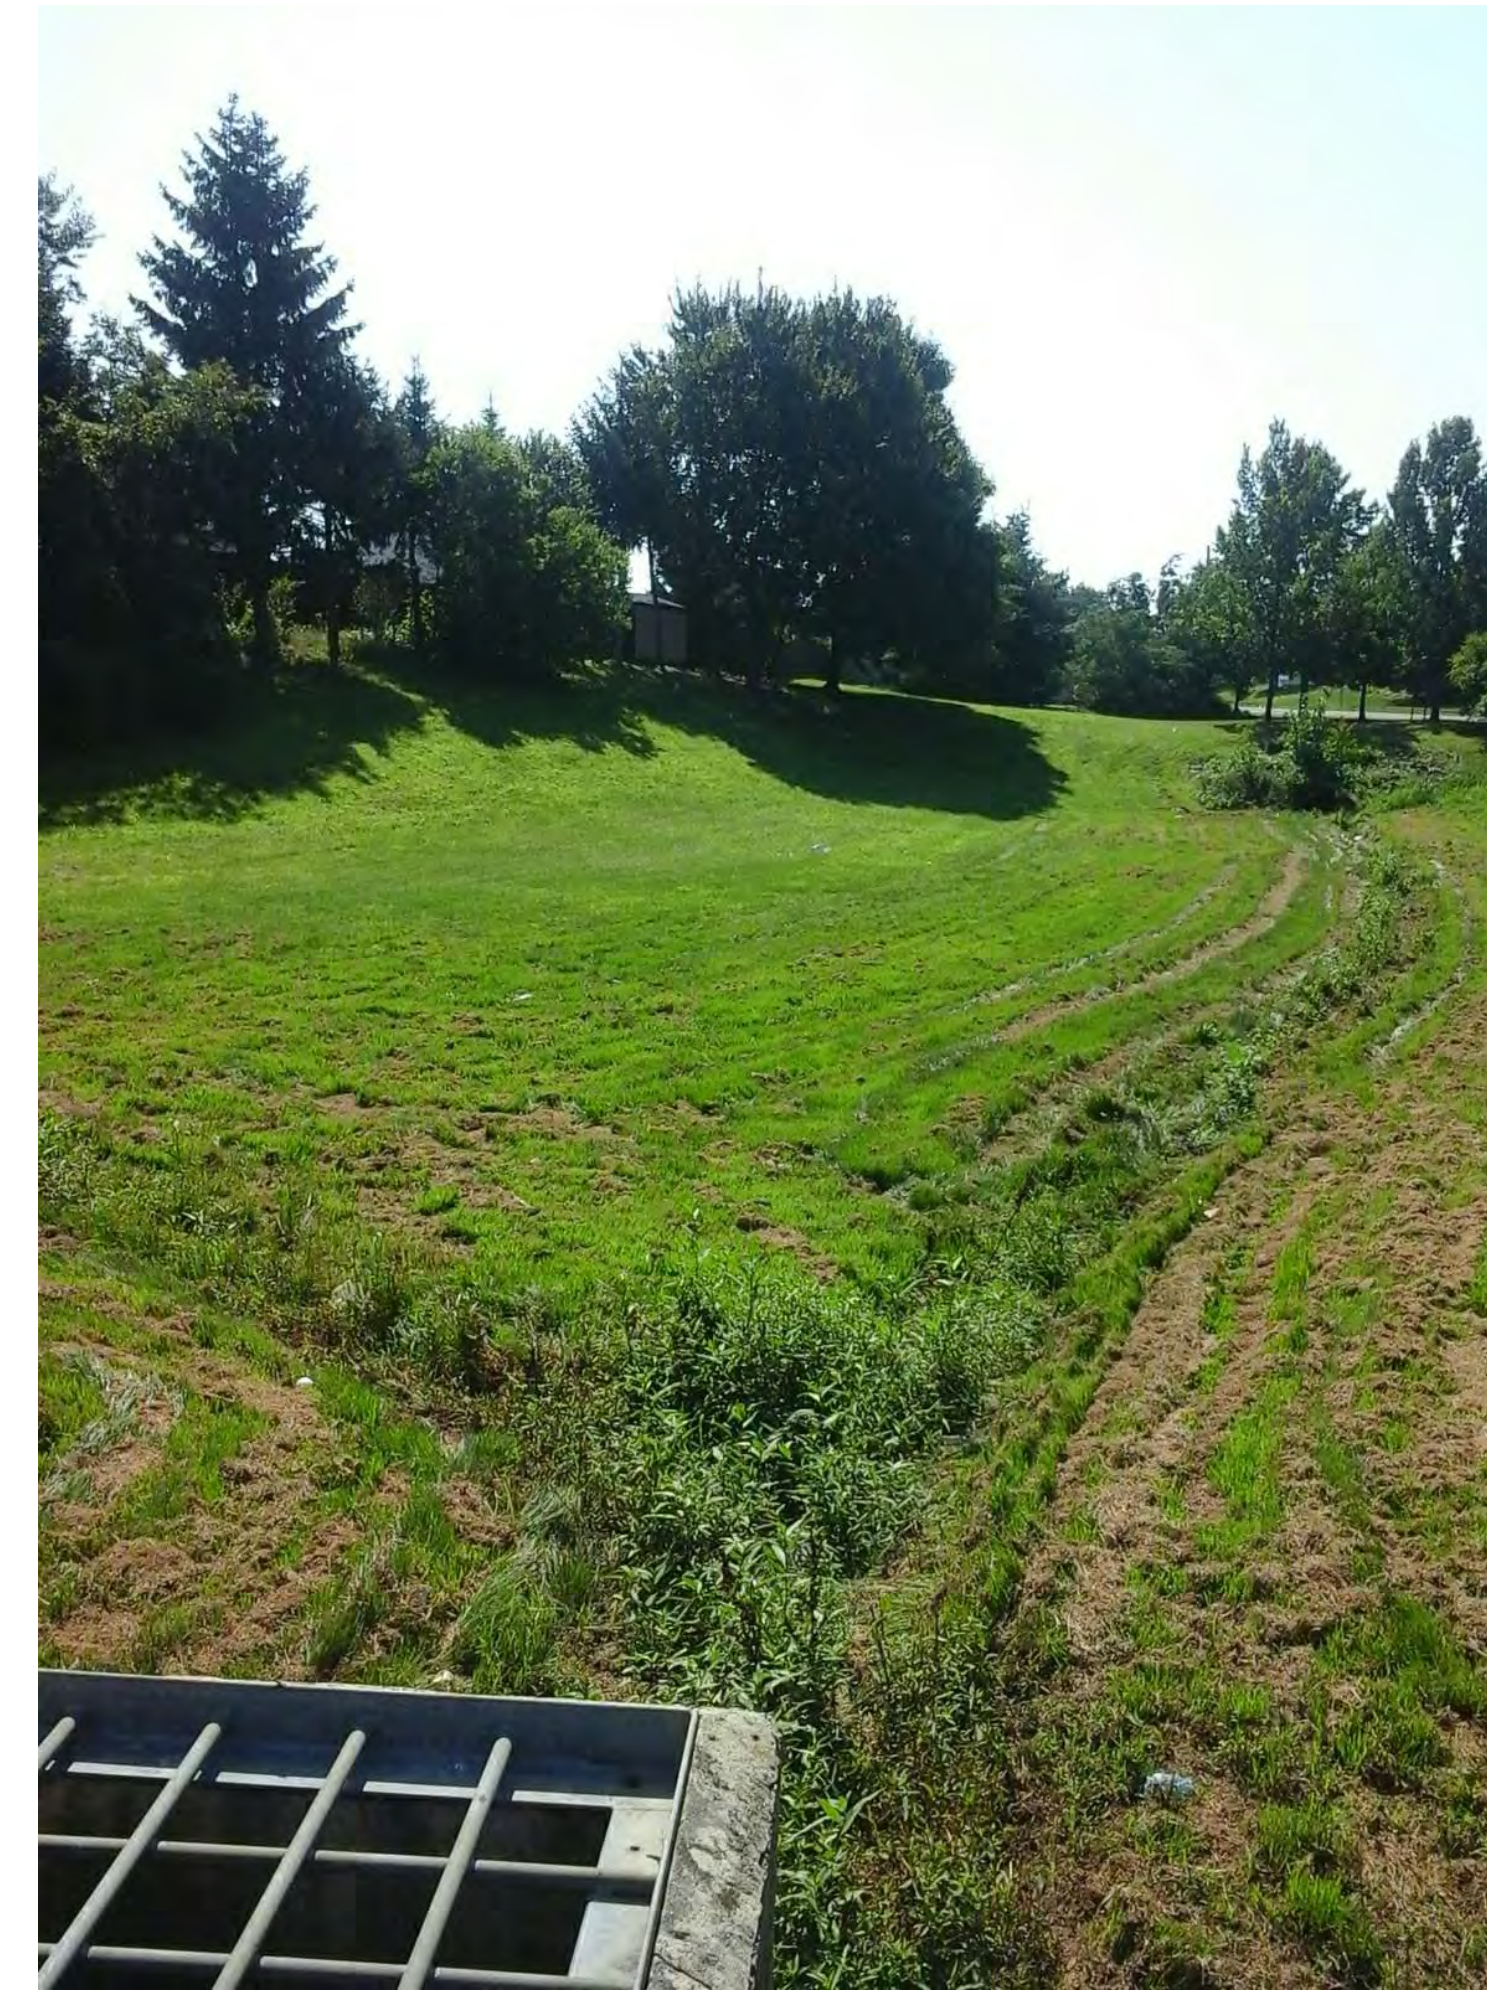
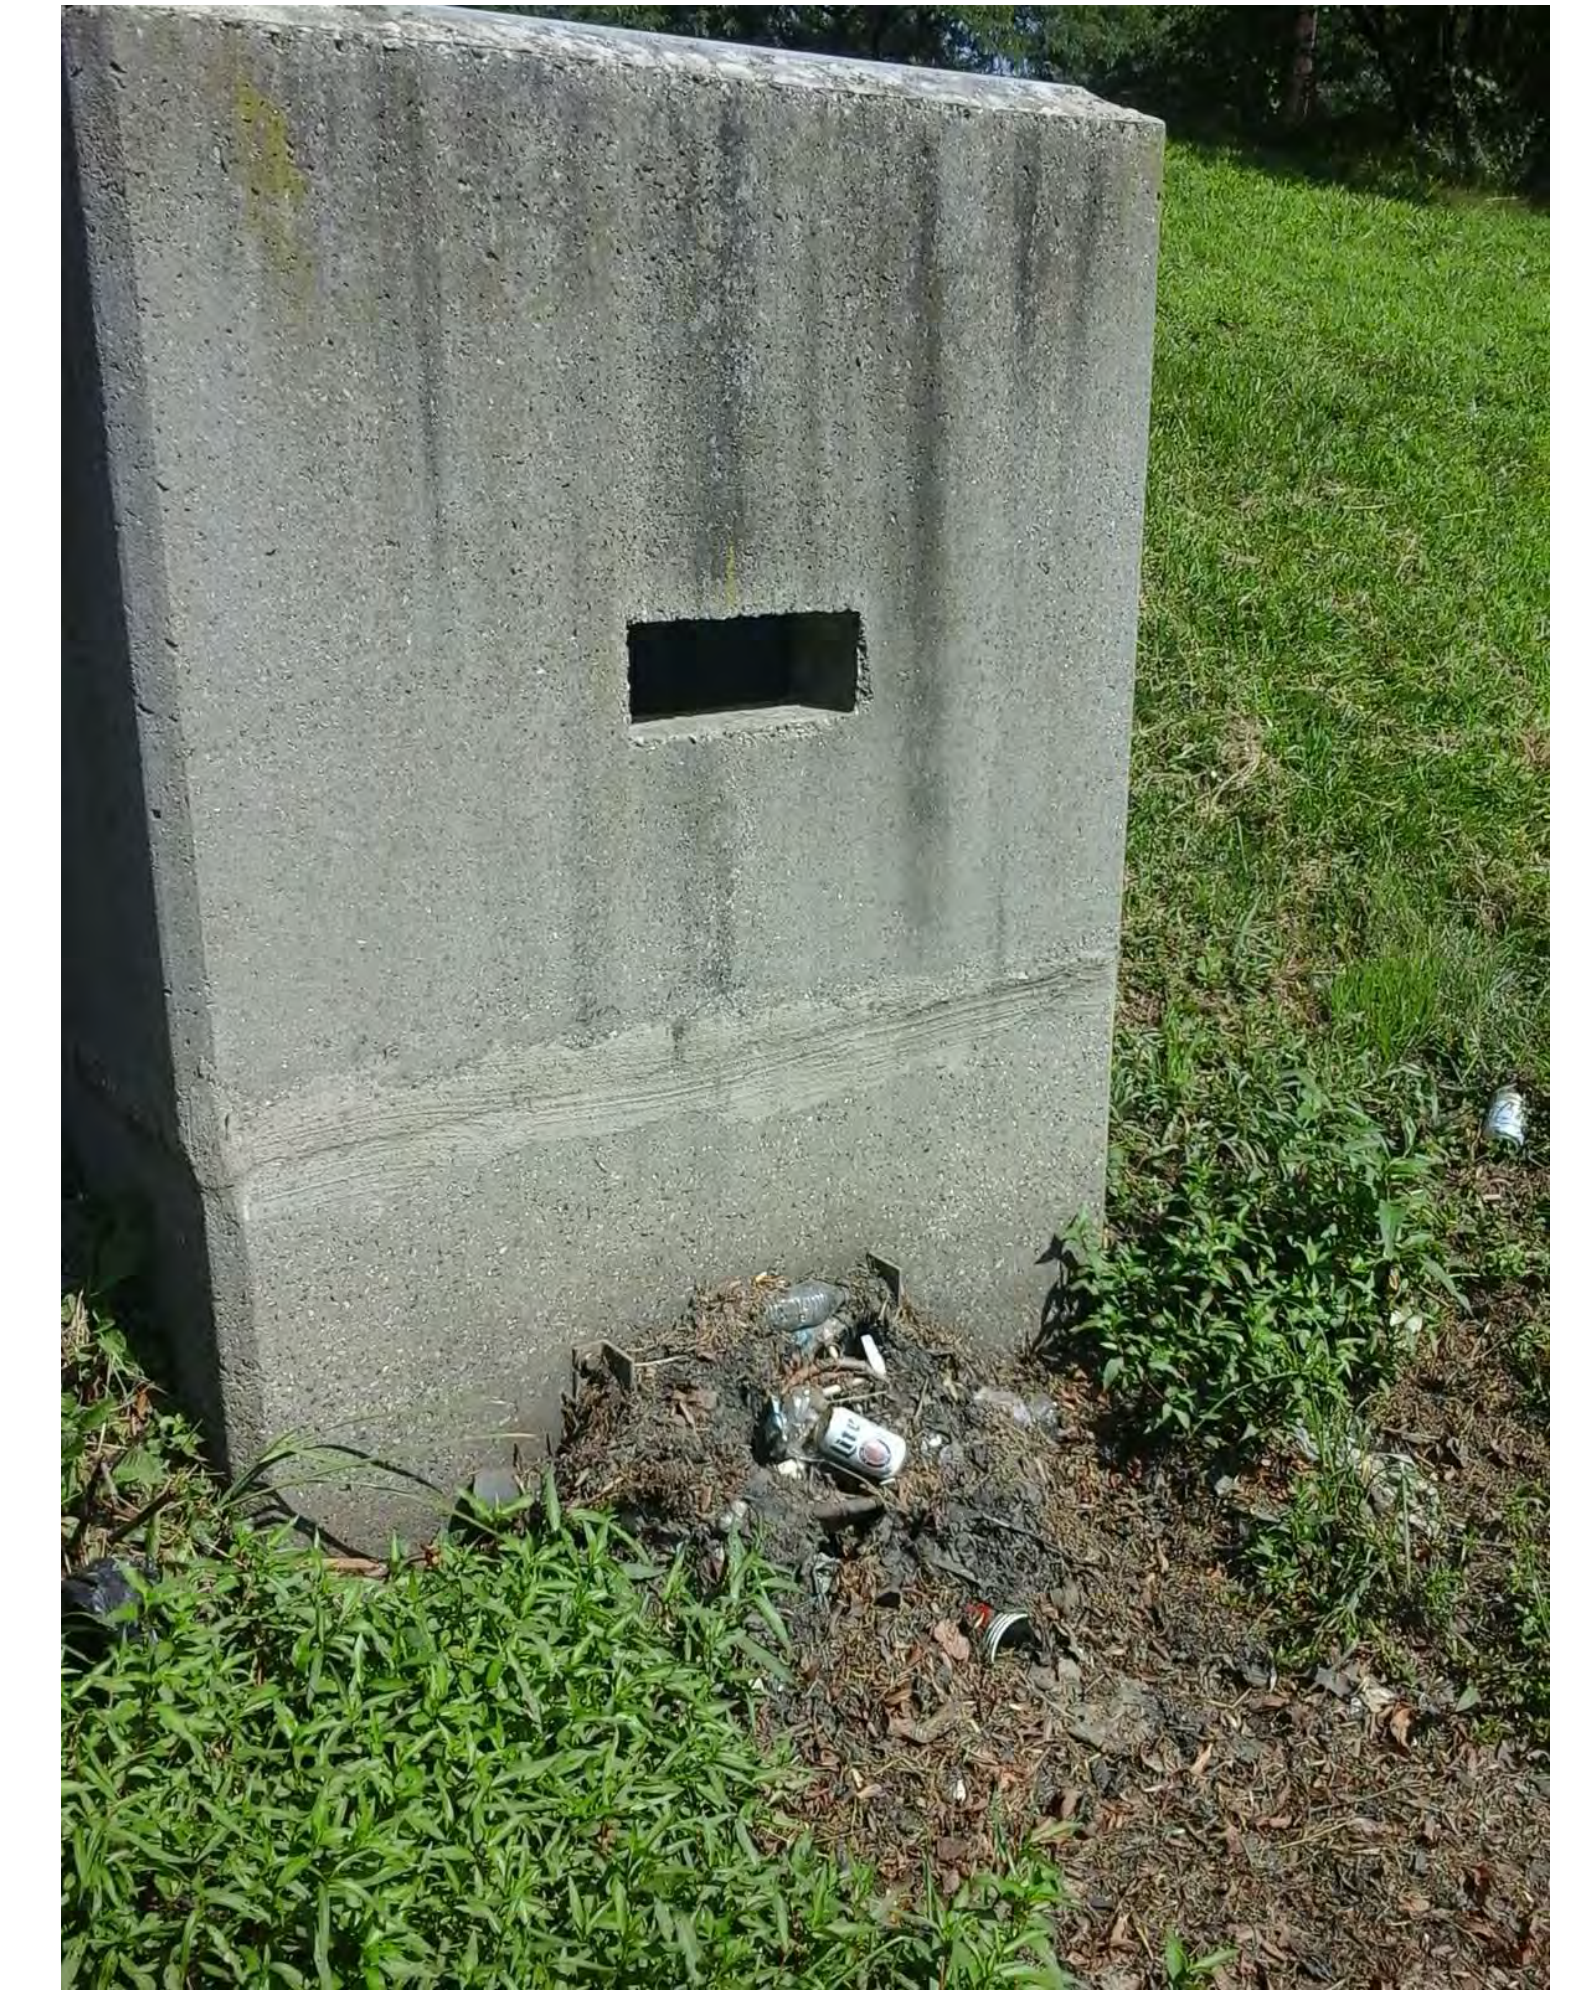
Overview of Basin #330 and basin outlet
