## Hamilton Township (Mercer County)

# REVIEW AND EVALUATION OF TOTAL MAXIMUM DAILY LOADS (TMDLs)

Developed by the Rutgers Cooperative Extension Water Resources Program  
Funded by Hamilton Township, Mercer County, New Jersey

December 5, 2019

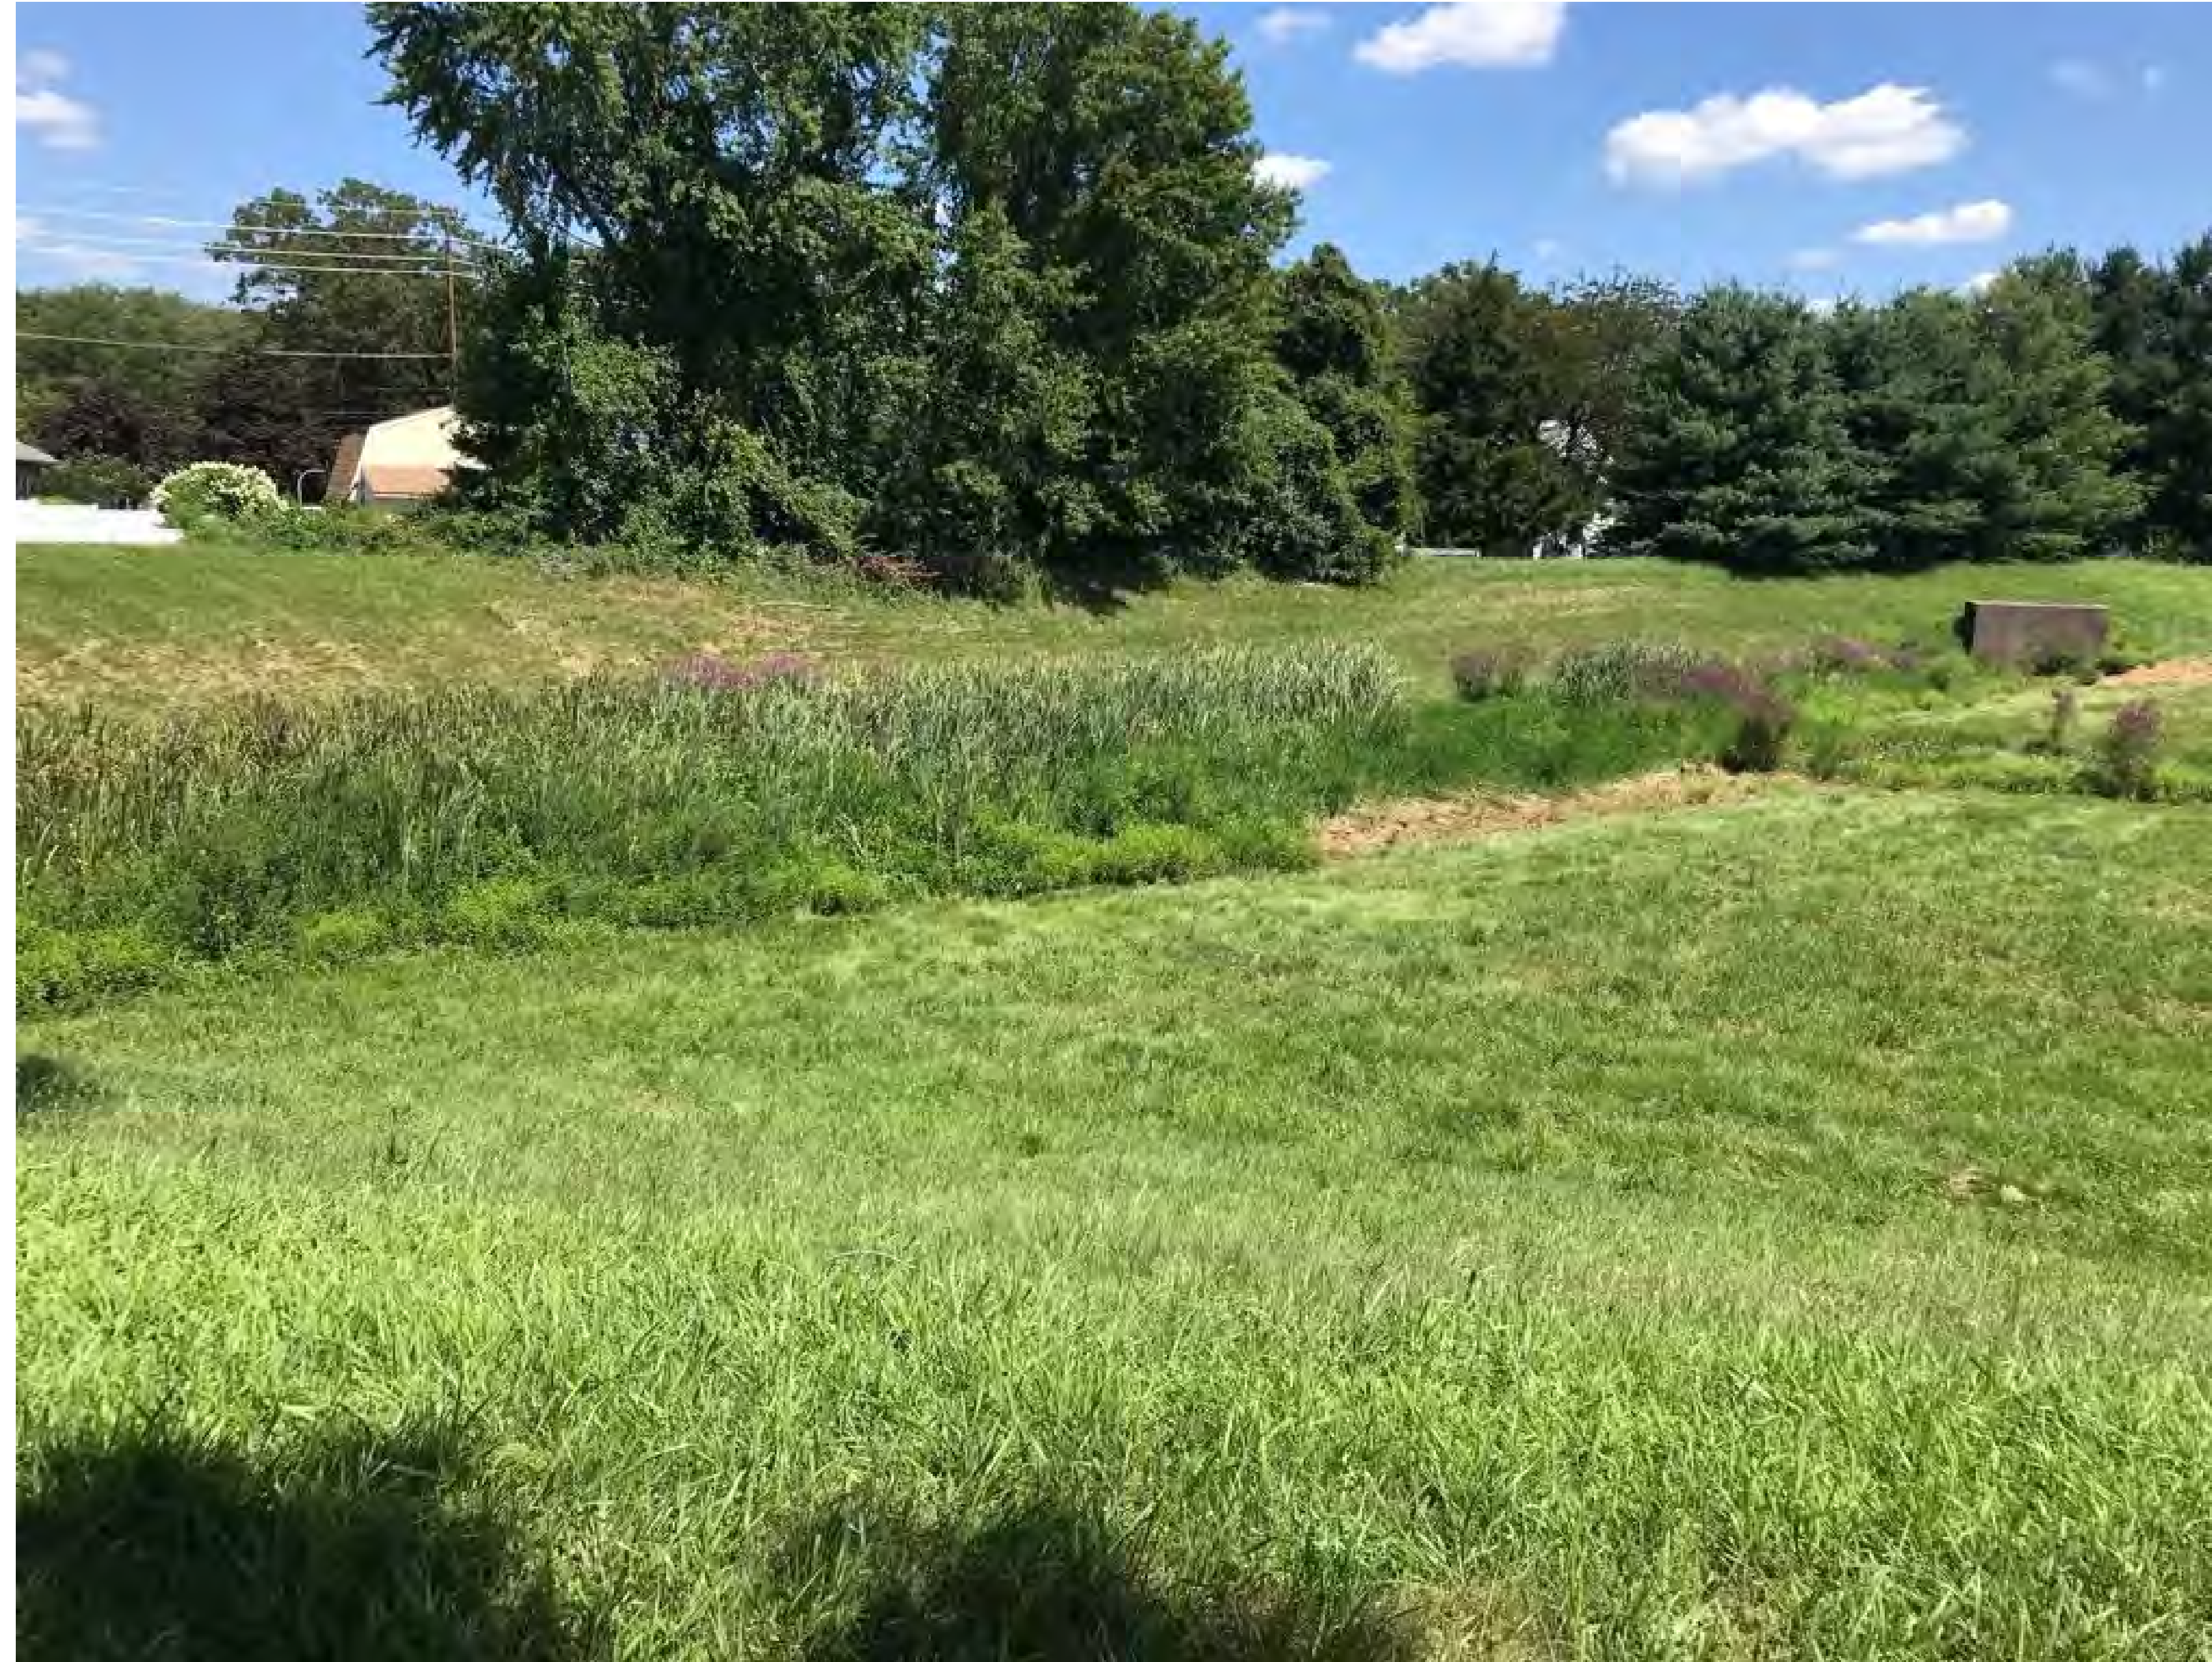
- Large vegetation growth around the channels. Large plants such as cat tails and lavender
- Make sure inflow and outflow areas are not too restricted by vegetation
- Low flow channel should be removed for proper naturalization to allow water to infiltrate
- Allow rest of basin to naturalize by converting to meadow by reducing mowing

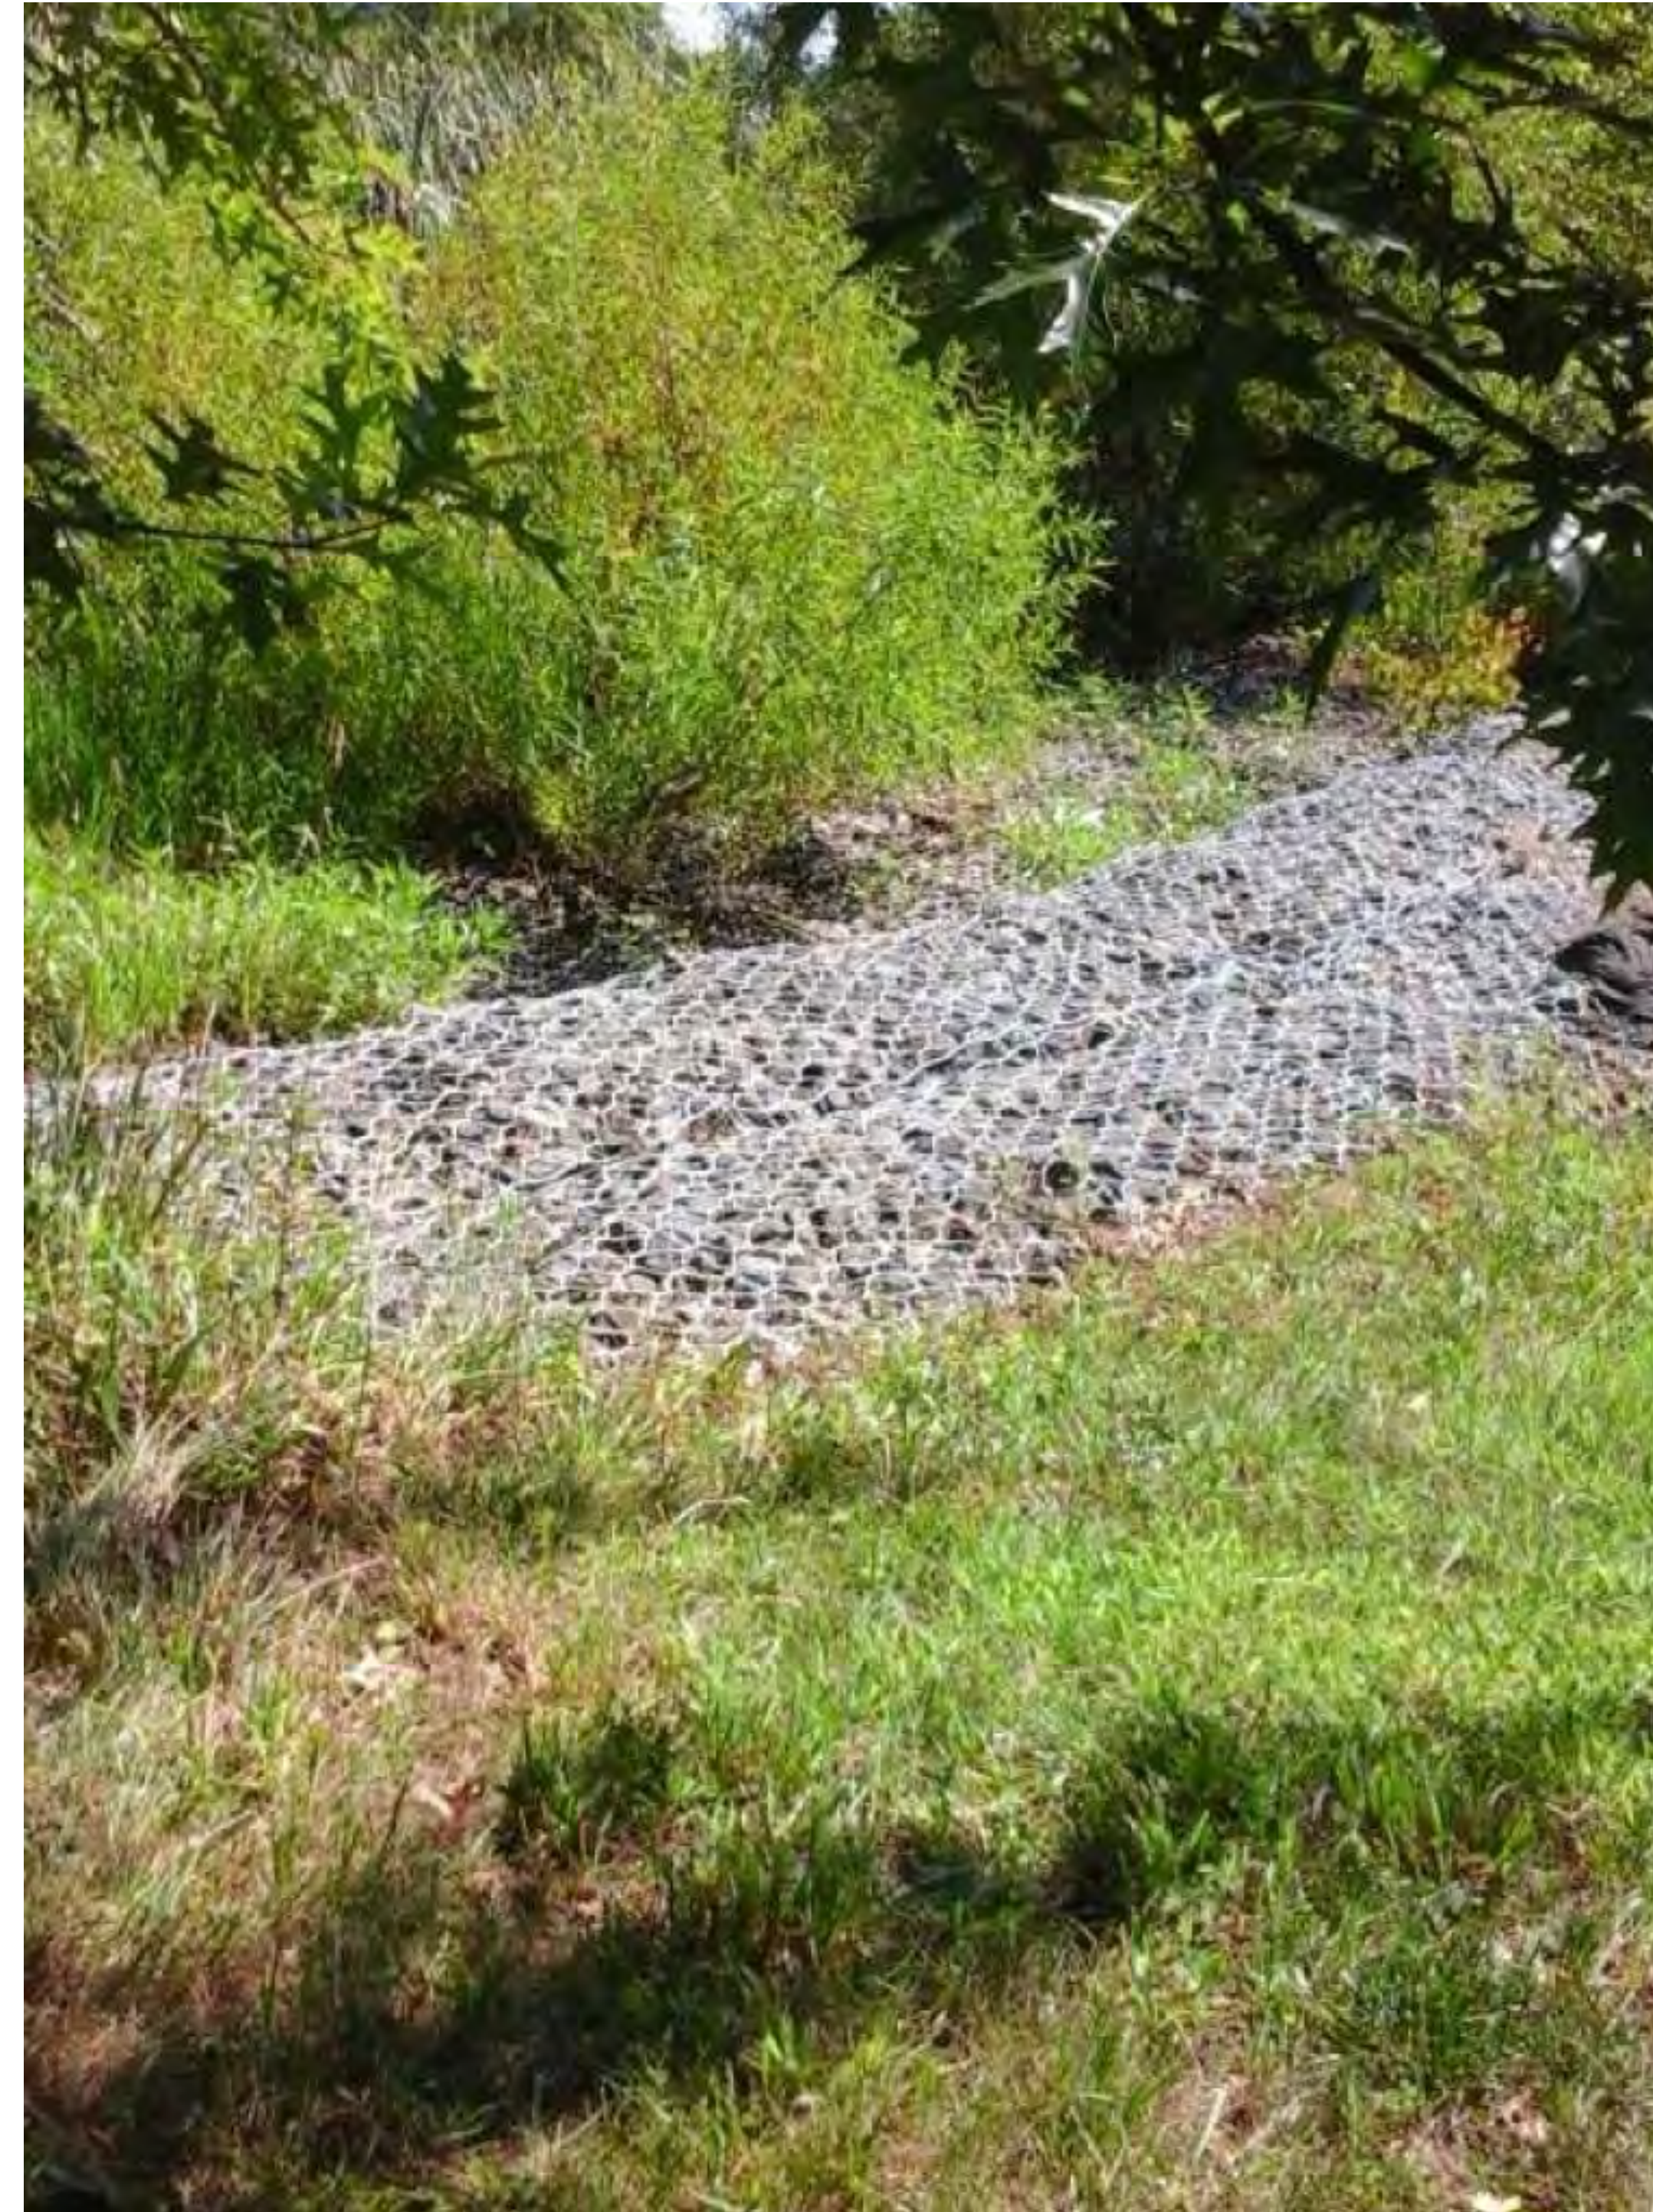
- Well establish retention basin with a fountain
- Maintain adequate mowing (up to property lines, had a complaint township is not mowing from nearby home owners )

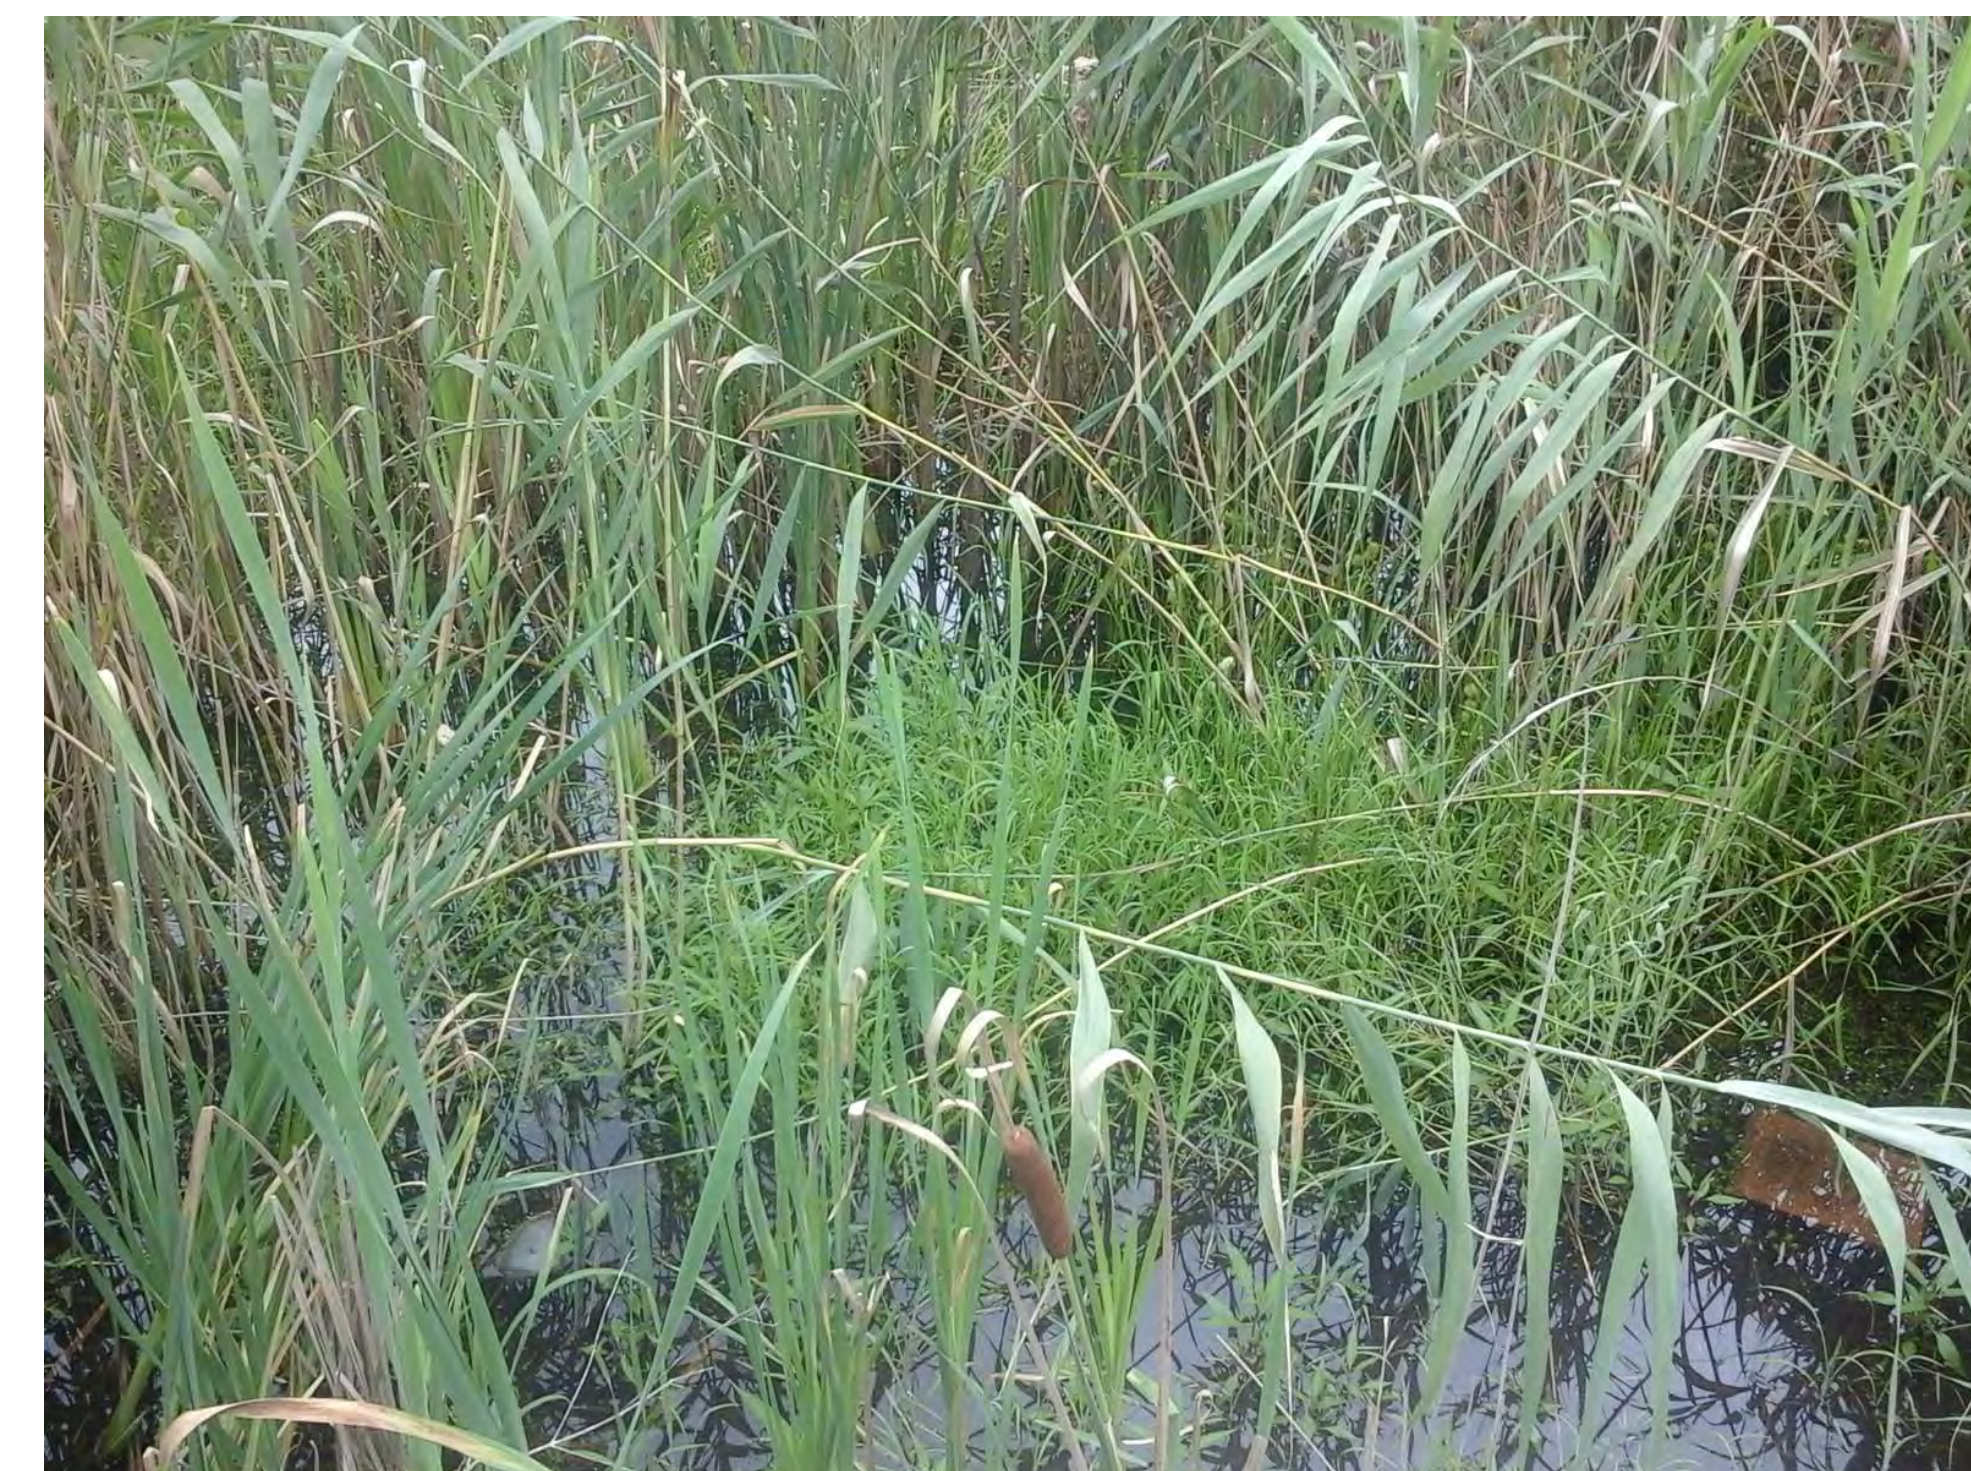
- Invasive phragmites growing in retention pond
- Otherwise well maintained

Invasive vegetation growth

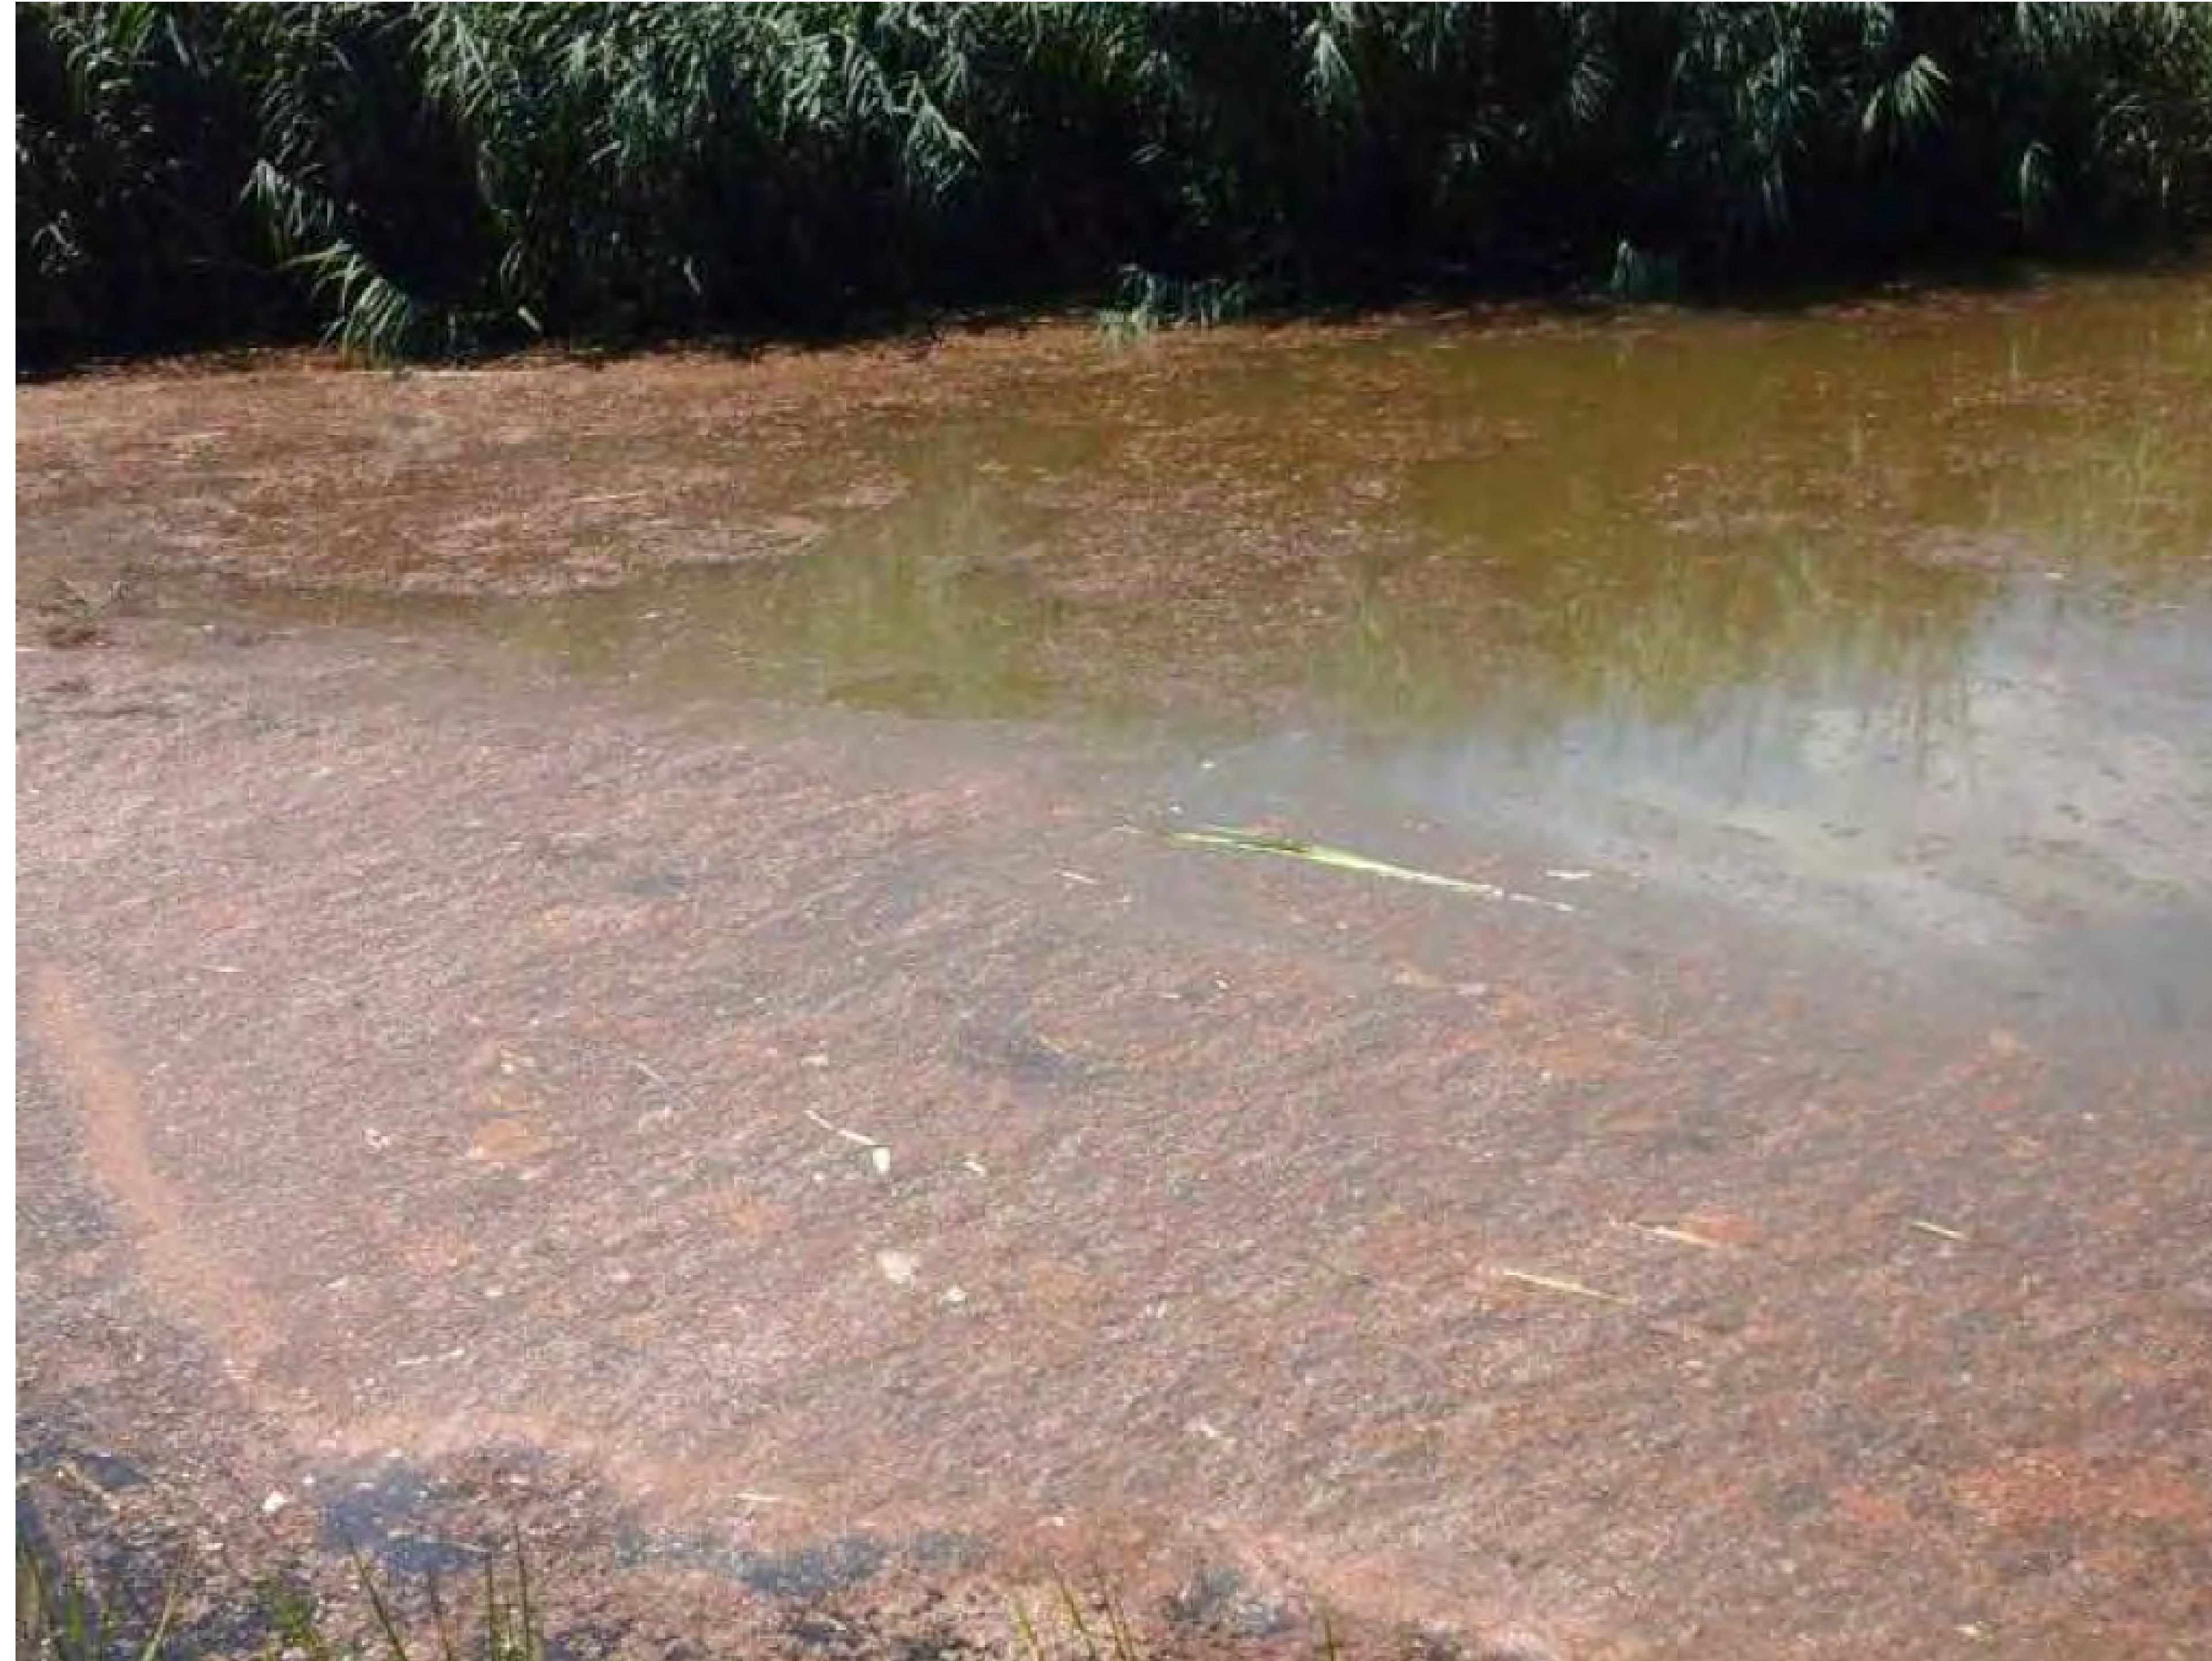
- Well established retention basin, water seems fairly stagnant
- Fountain could be installed to help with stagnant water issue
- Maintain adequate mowing around basins

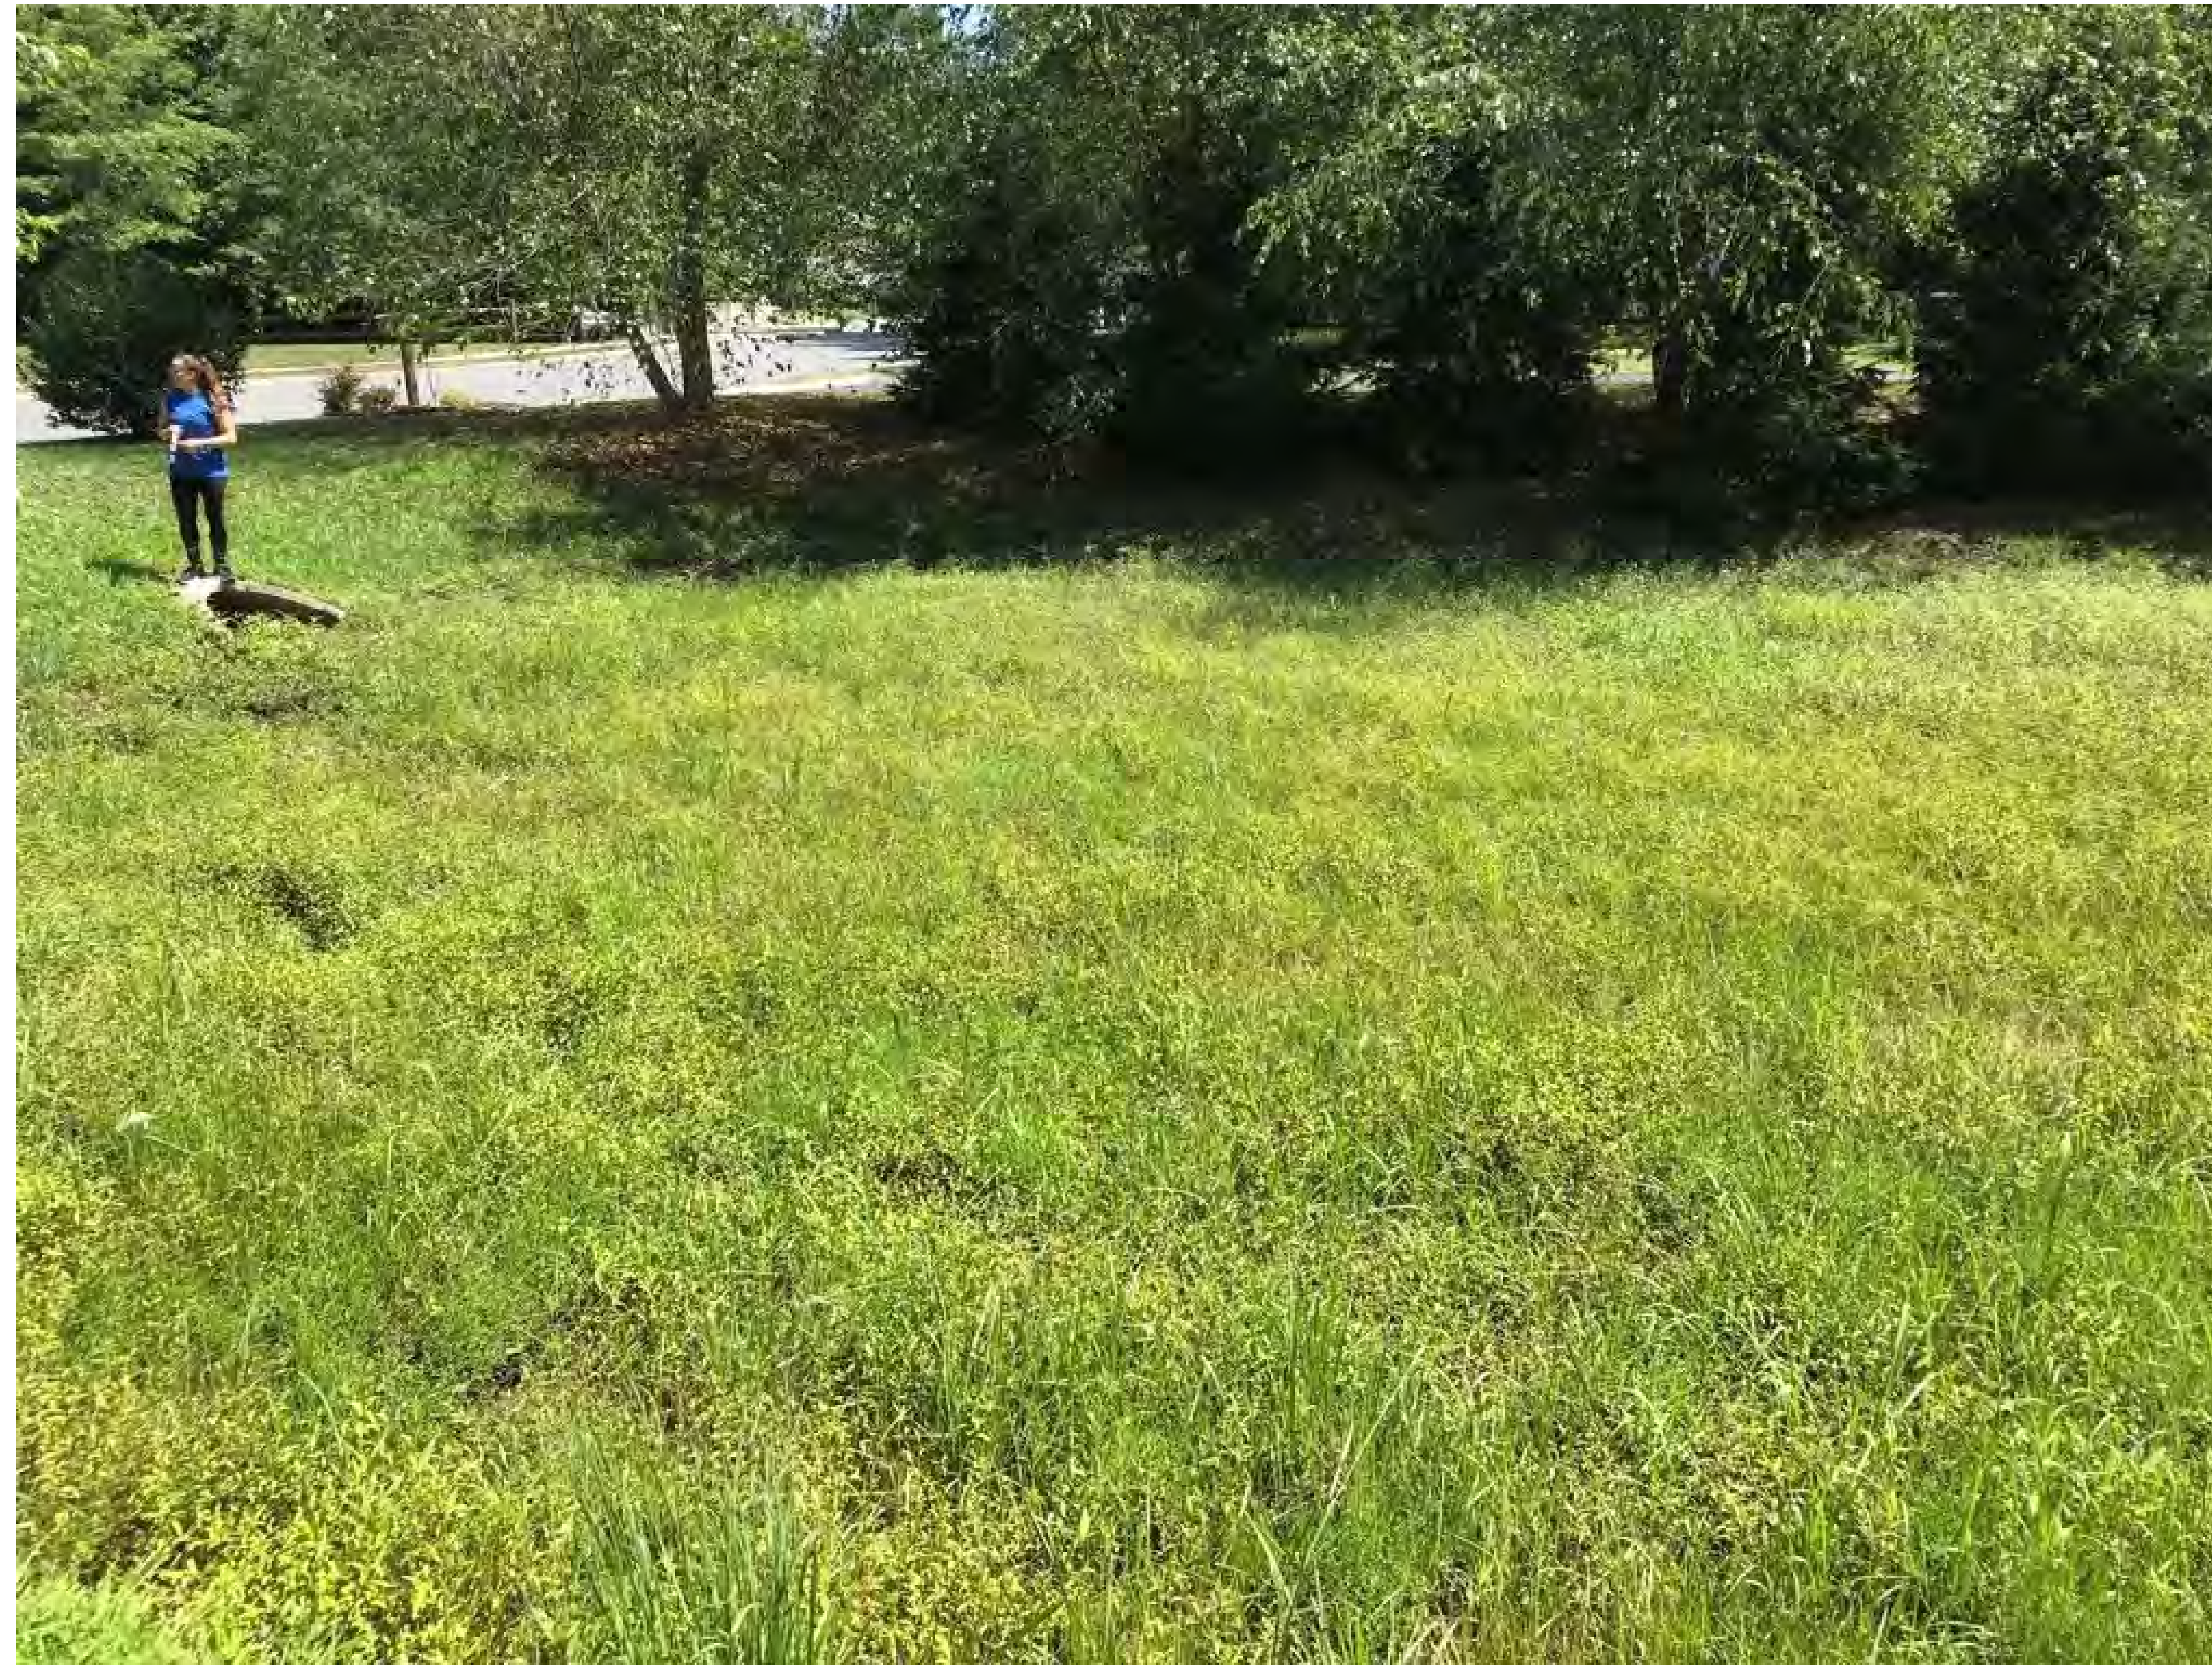
- Infiltration basin forebay with spillway into detention basin for larger storms
- Both basins could be naturalized with herbaceous plants

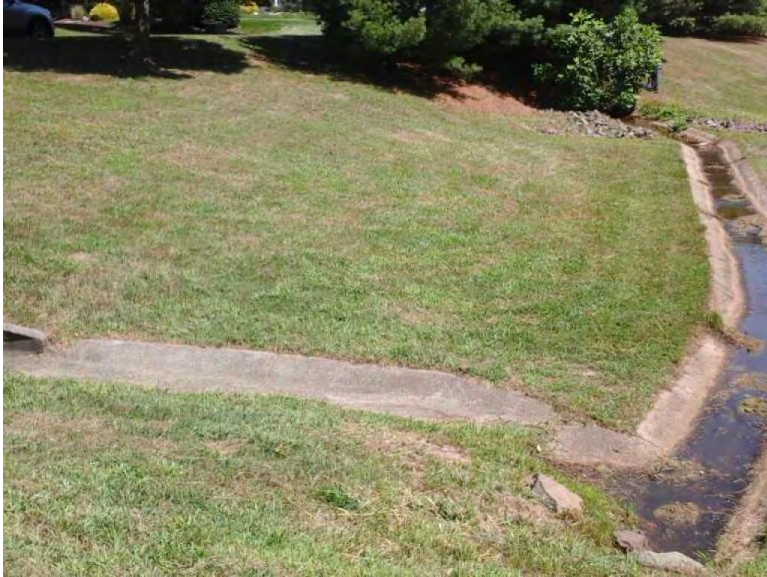
- Basin #233 low flow channel has some grass clippings and some standing water
- Retrofit plants for infiltration
- Tall grass, located in between houses
- Both basins can have stone channels implemented in place of low flow channels, and herbaceous plant can be used to naturalize the basins

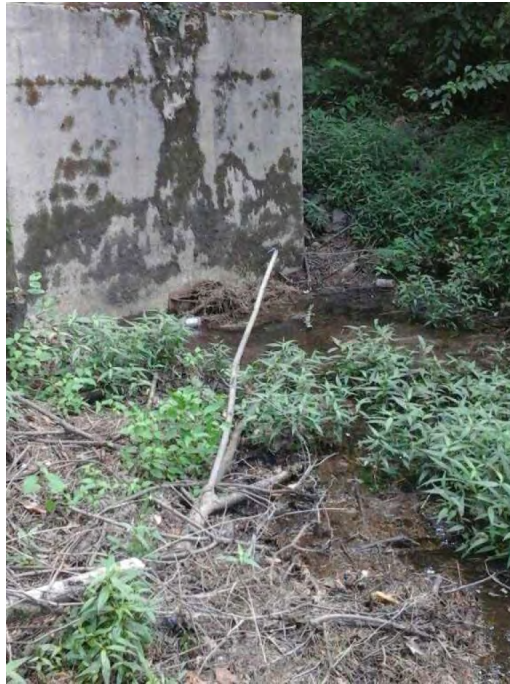
- Both basin suffer from similar problems with Basin #236 being worse
- Water flowing through has a red is color, channel is overgrown, due to overgrowth and excess sediment, the outlet is blocked and water is backing up
- Replace channel with rocks, clear out unwanted vegetation, clean outlet and excess sediment
- Replace low flow channel with rock channel

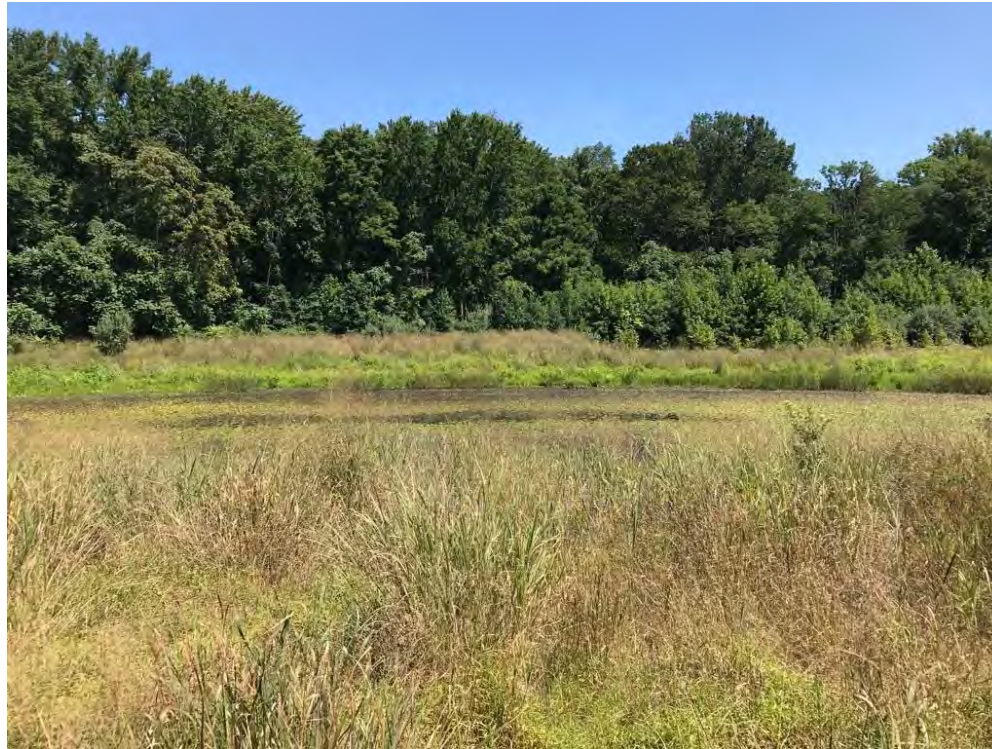
- 2014 report did not include notes for this basin as retention basins were not being fully assessed at the time
- Massive retention basin surrounded by thick vegetation
- Appears in good condition, no recommendation

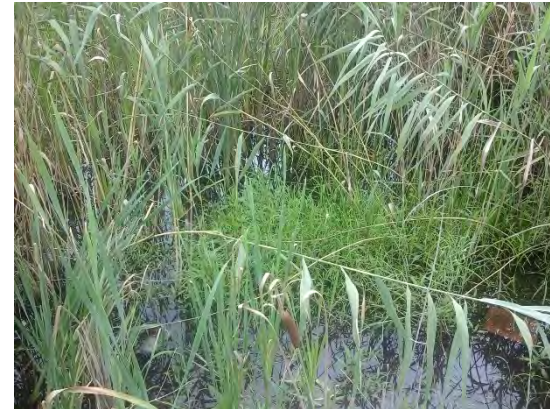
- Invasive phragmites growing in retention pond
- Otherwise well maintained

Invasive vegetation  
growth

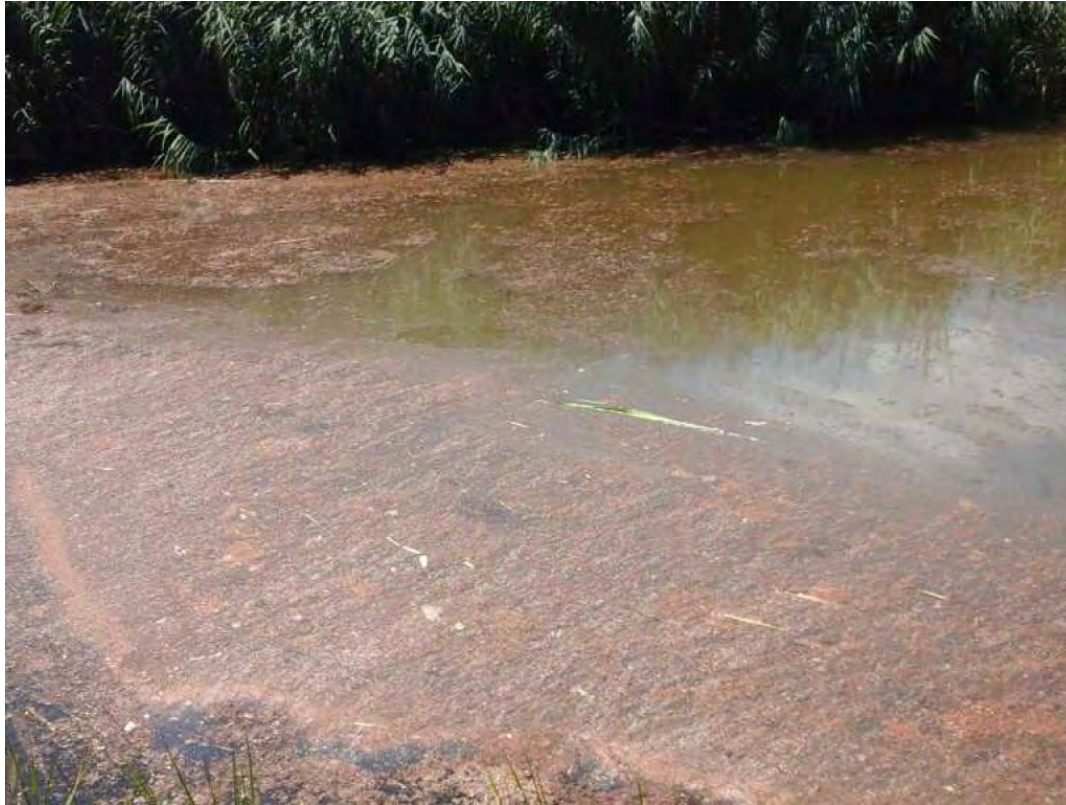
- Well established retention basin, water seems fairly stagnant
- Fountain could be installed to help with stagnant water issue
- Maintain adequate mowing around basins
