Hamilton Township (Mercer County) Stormwater Basin Assessment Summary (Year 1)

Developed by the Rutgers Cooperative Extension Water Resources Program
Funded by Hamilton Township, Mercer County, New Jersey

December 6, 2012

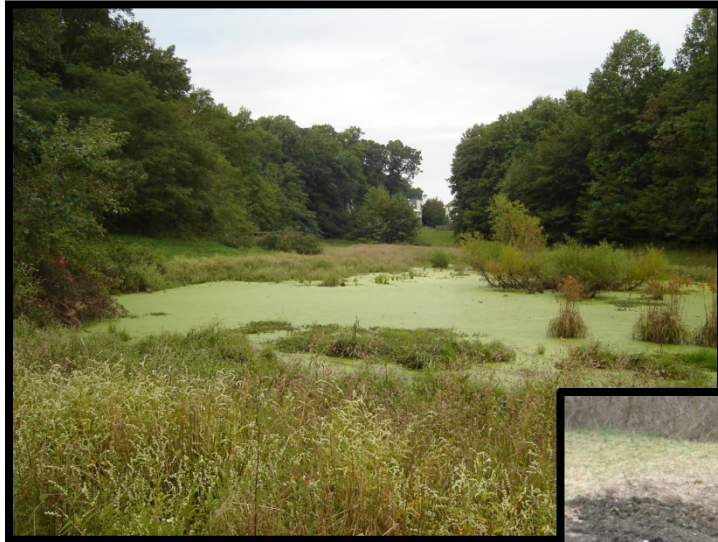
Kristopher Drive Basin Prior to Cleaning (2011)

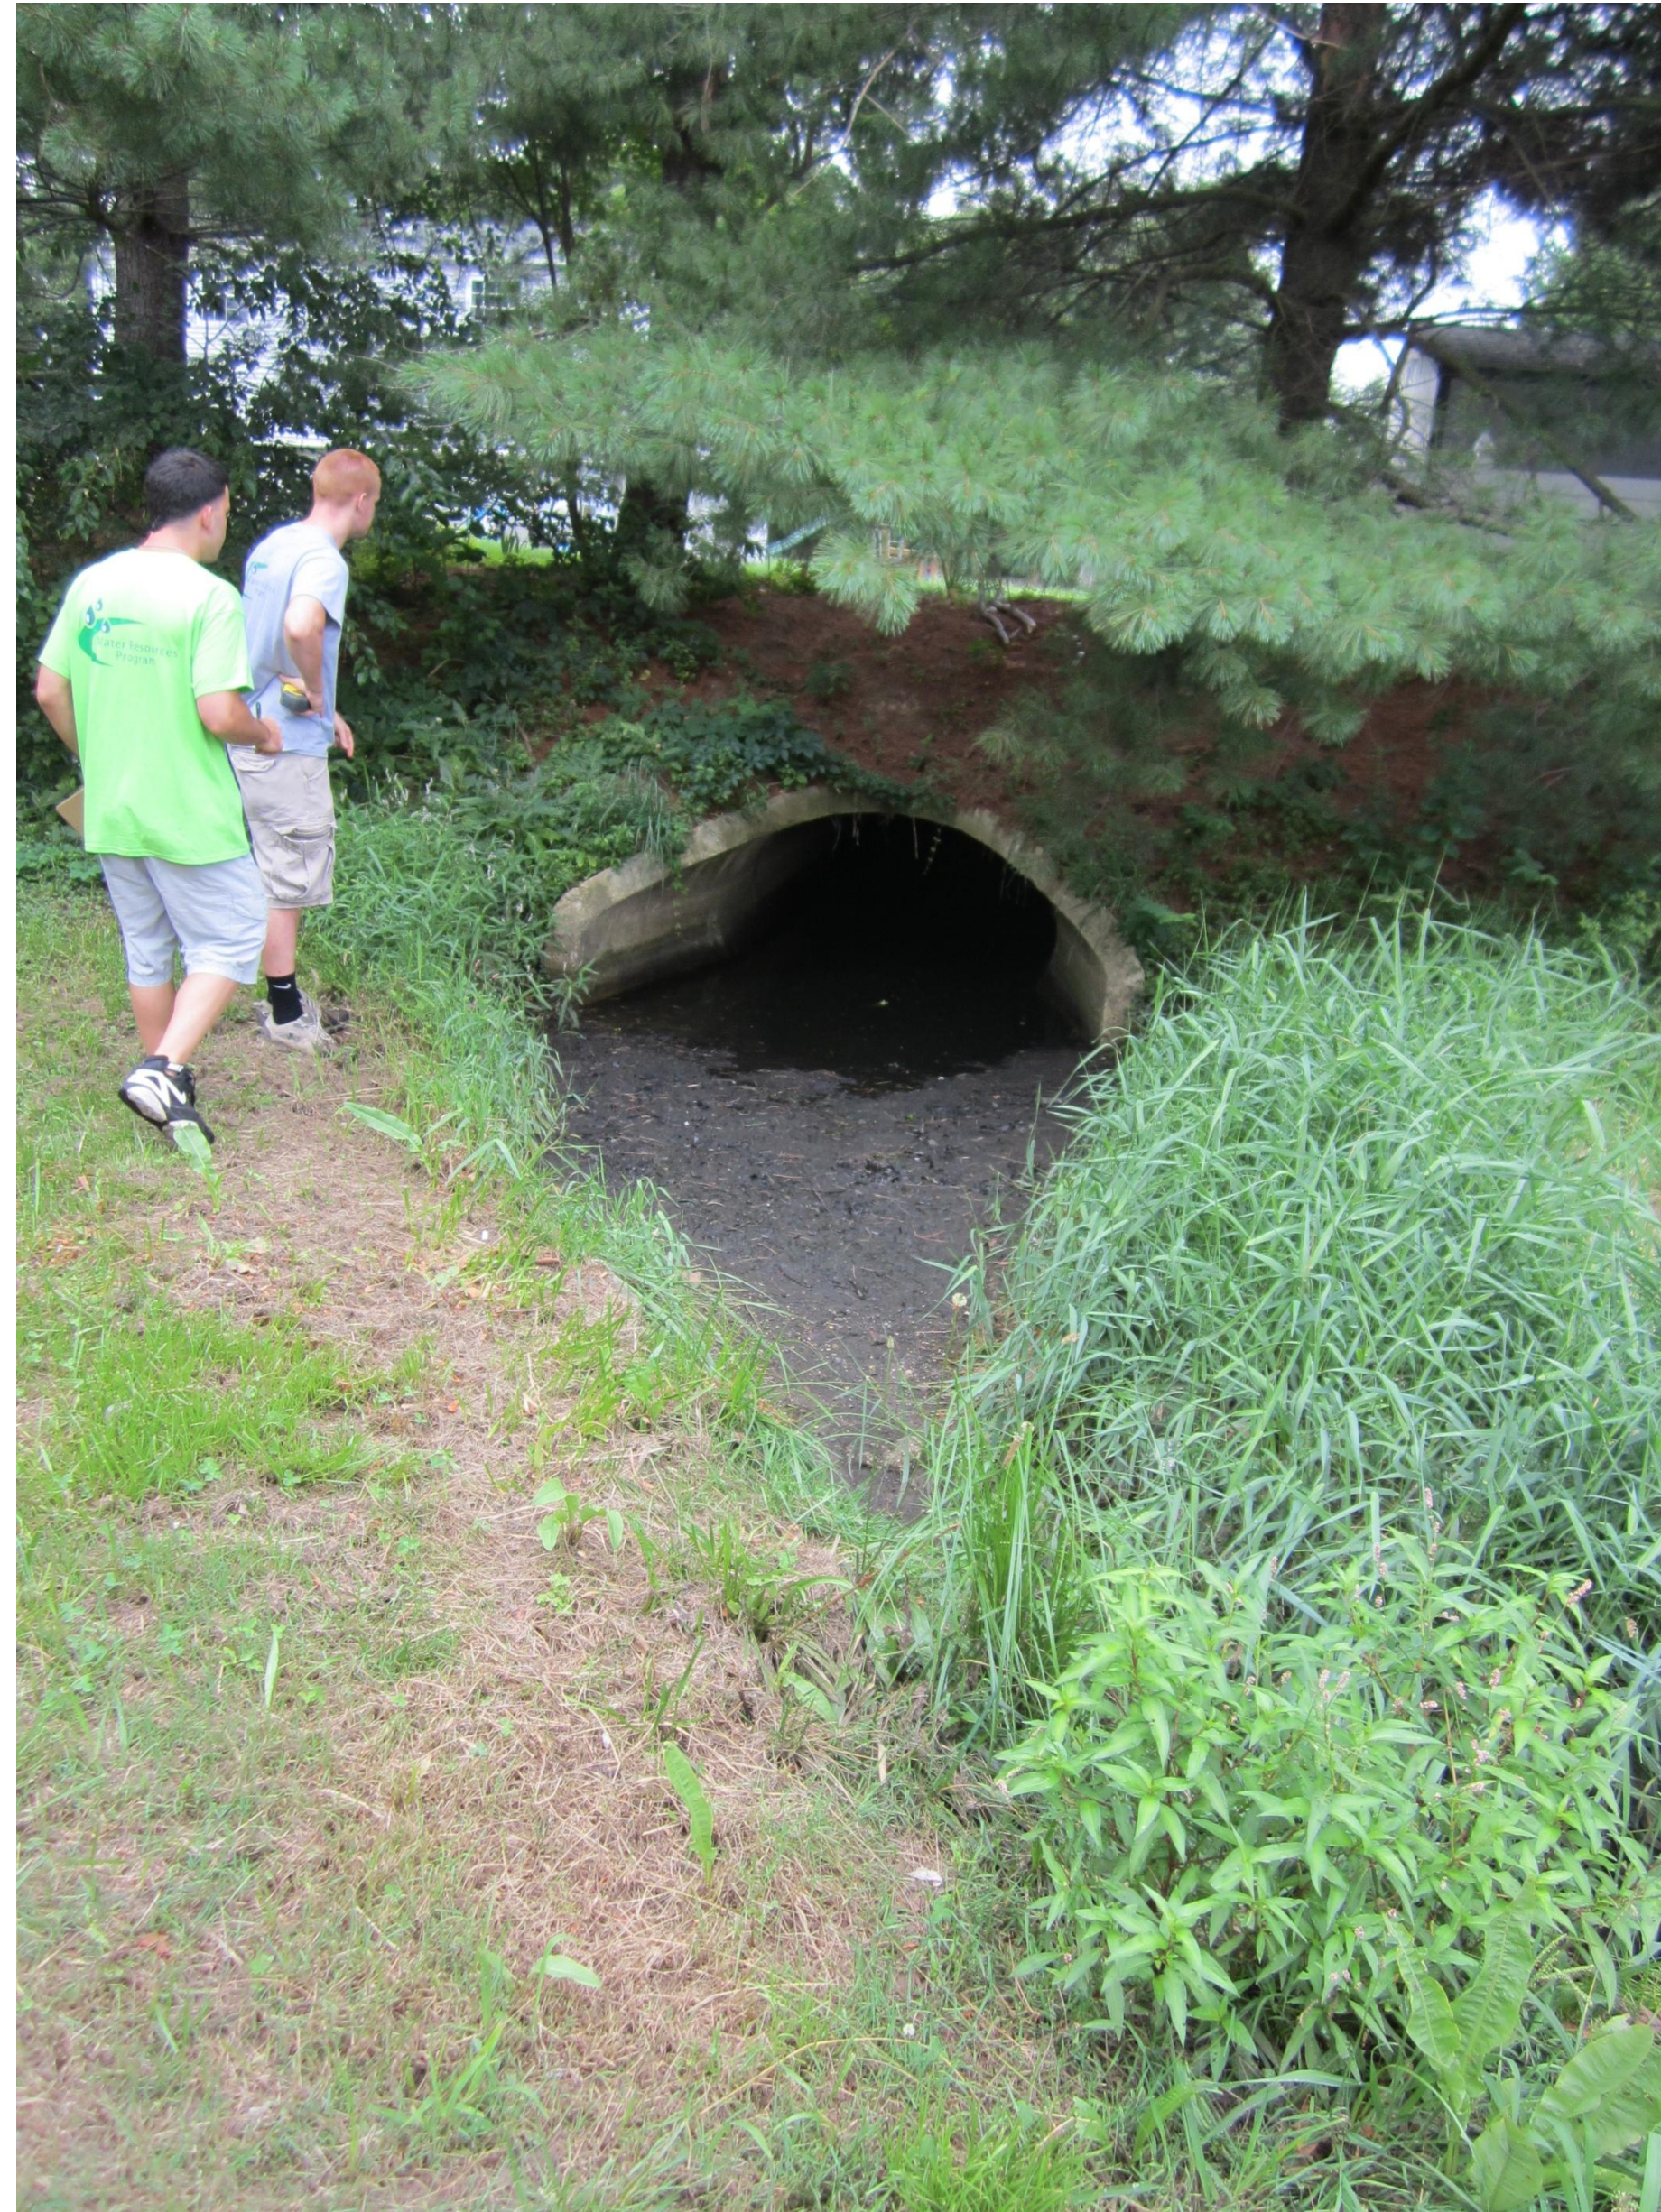
Clogged inlet.

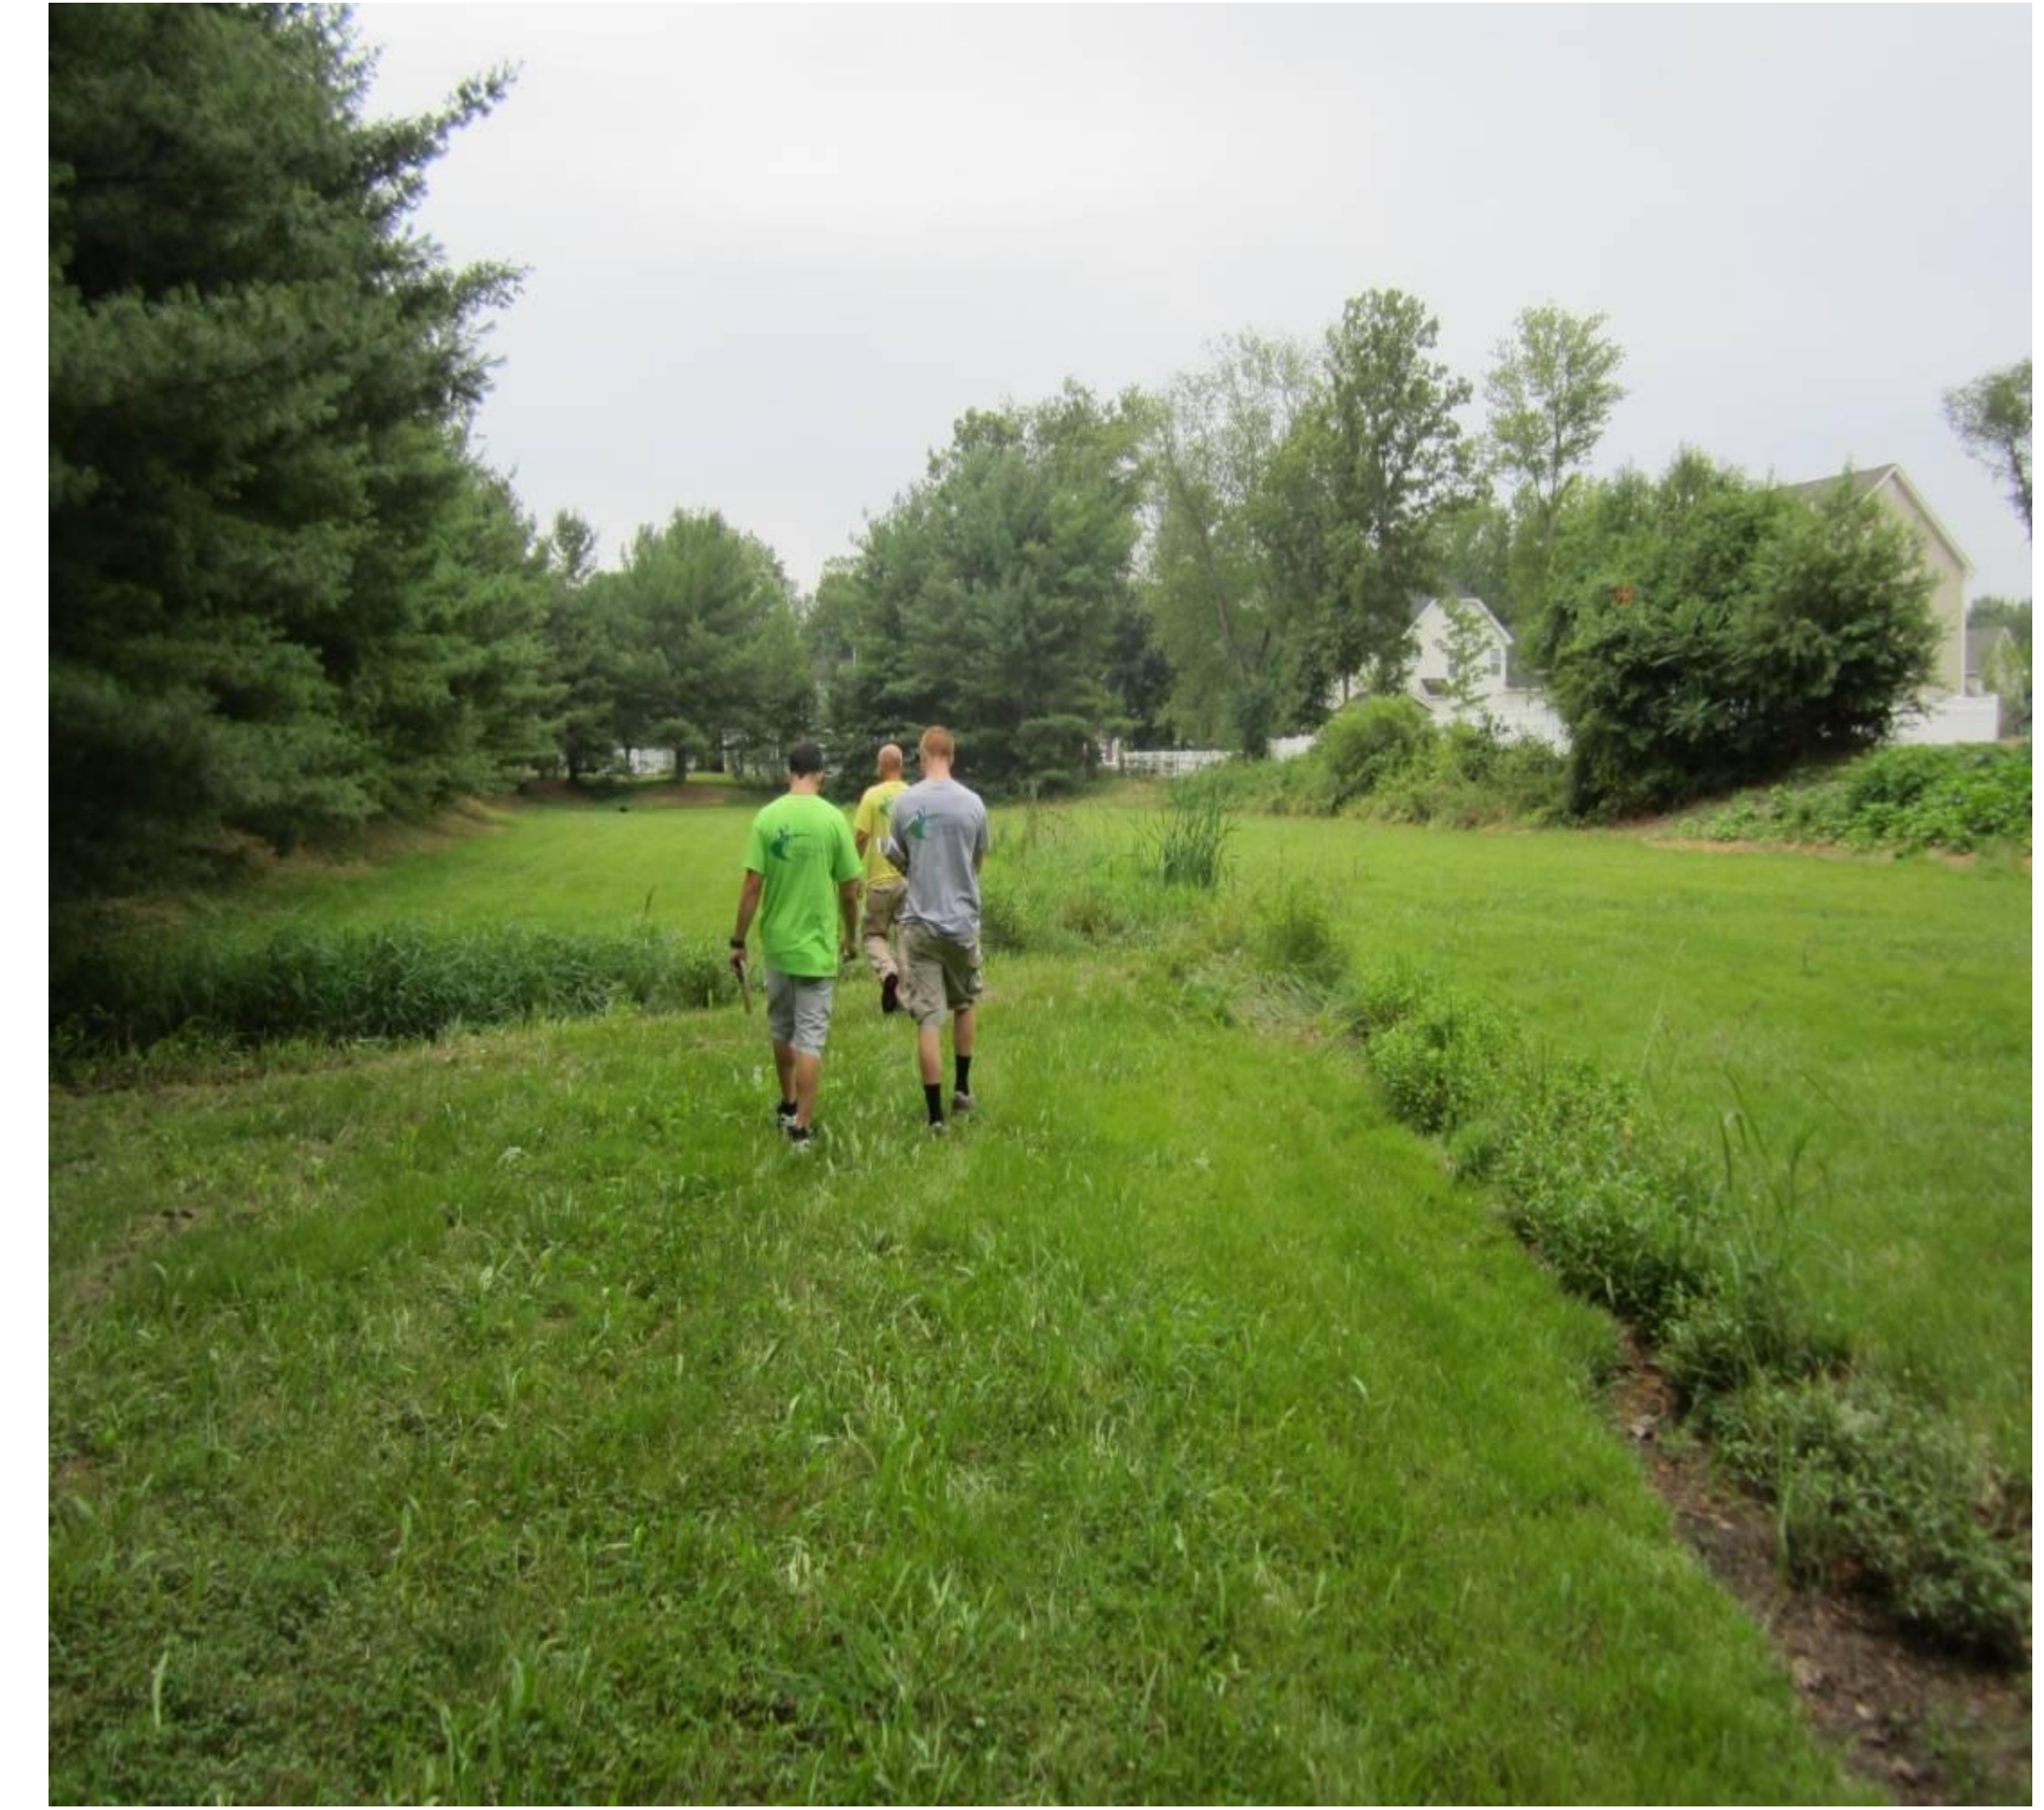
Looking south from basin bottom.

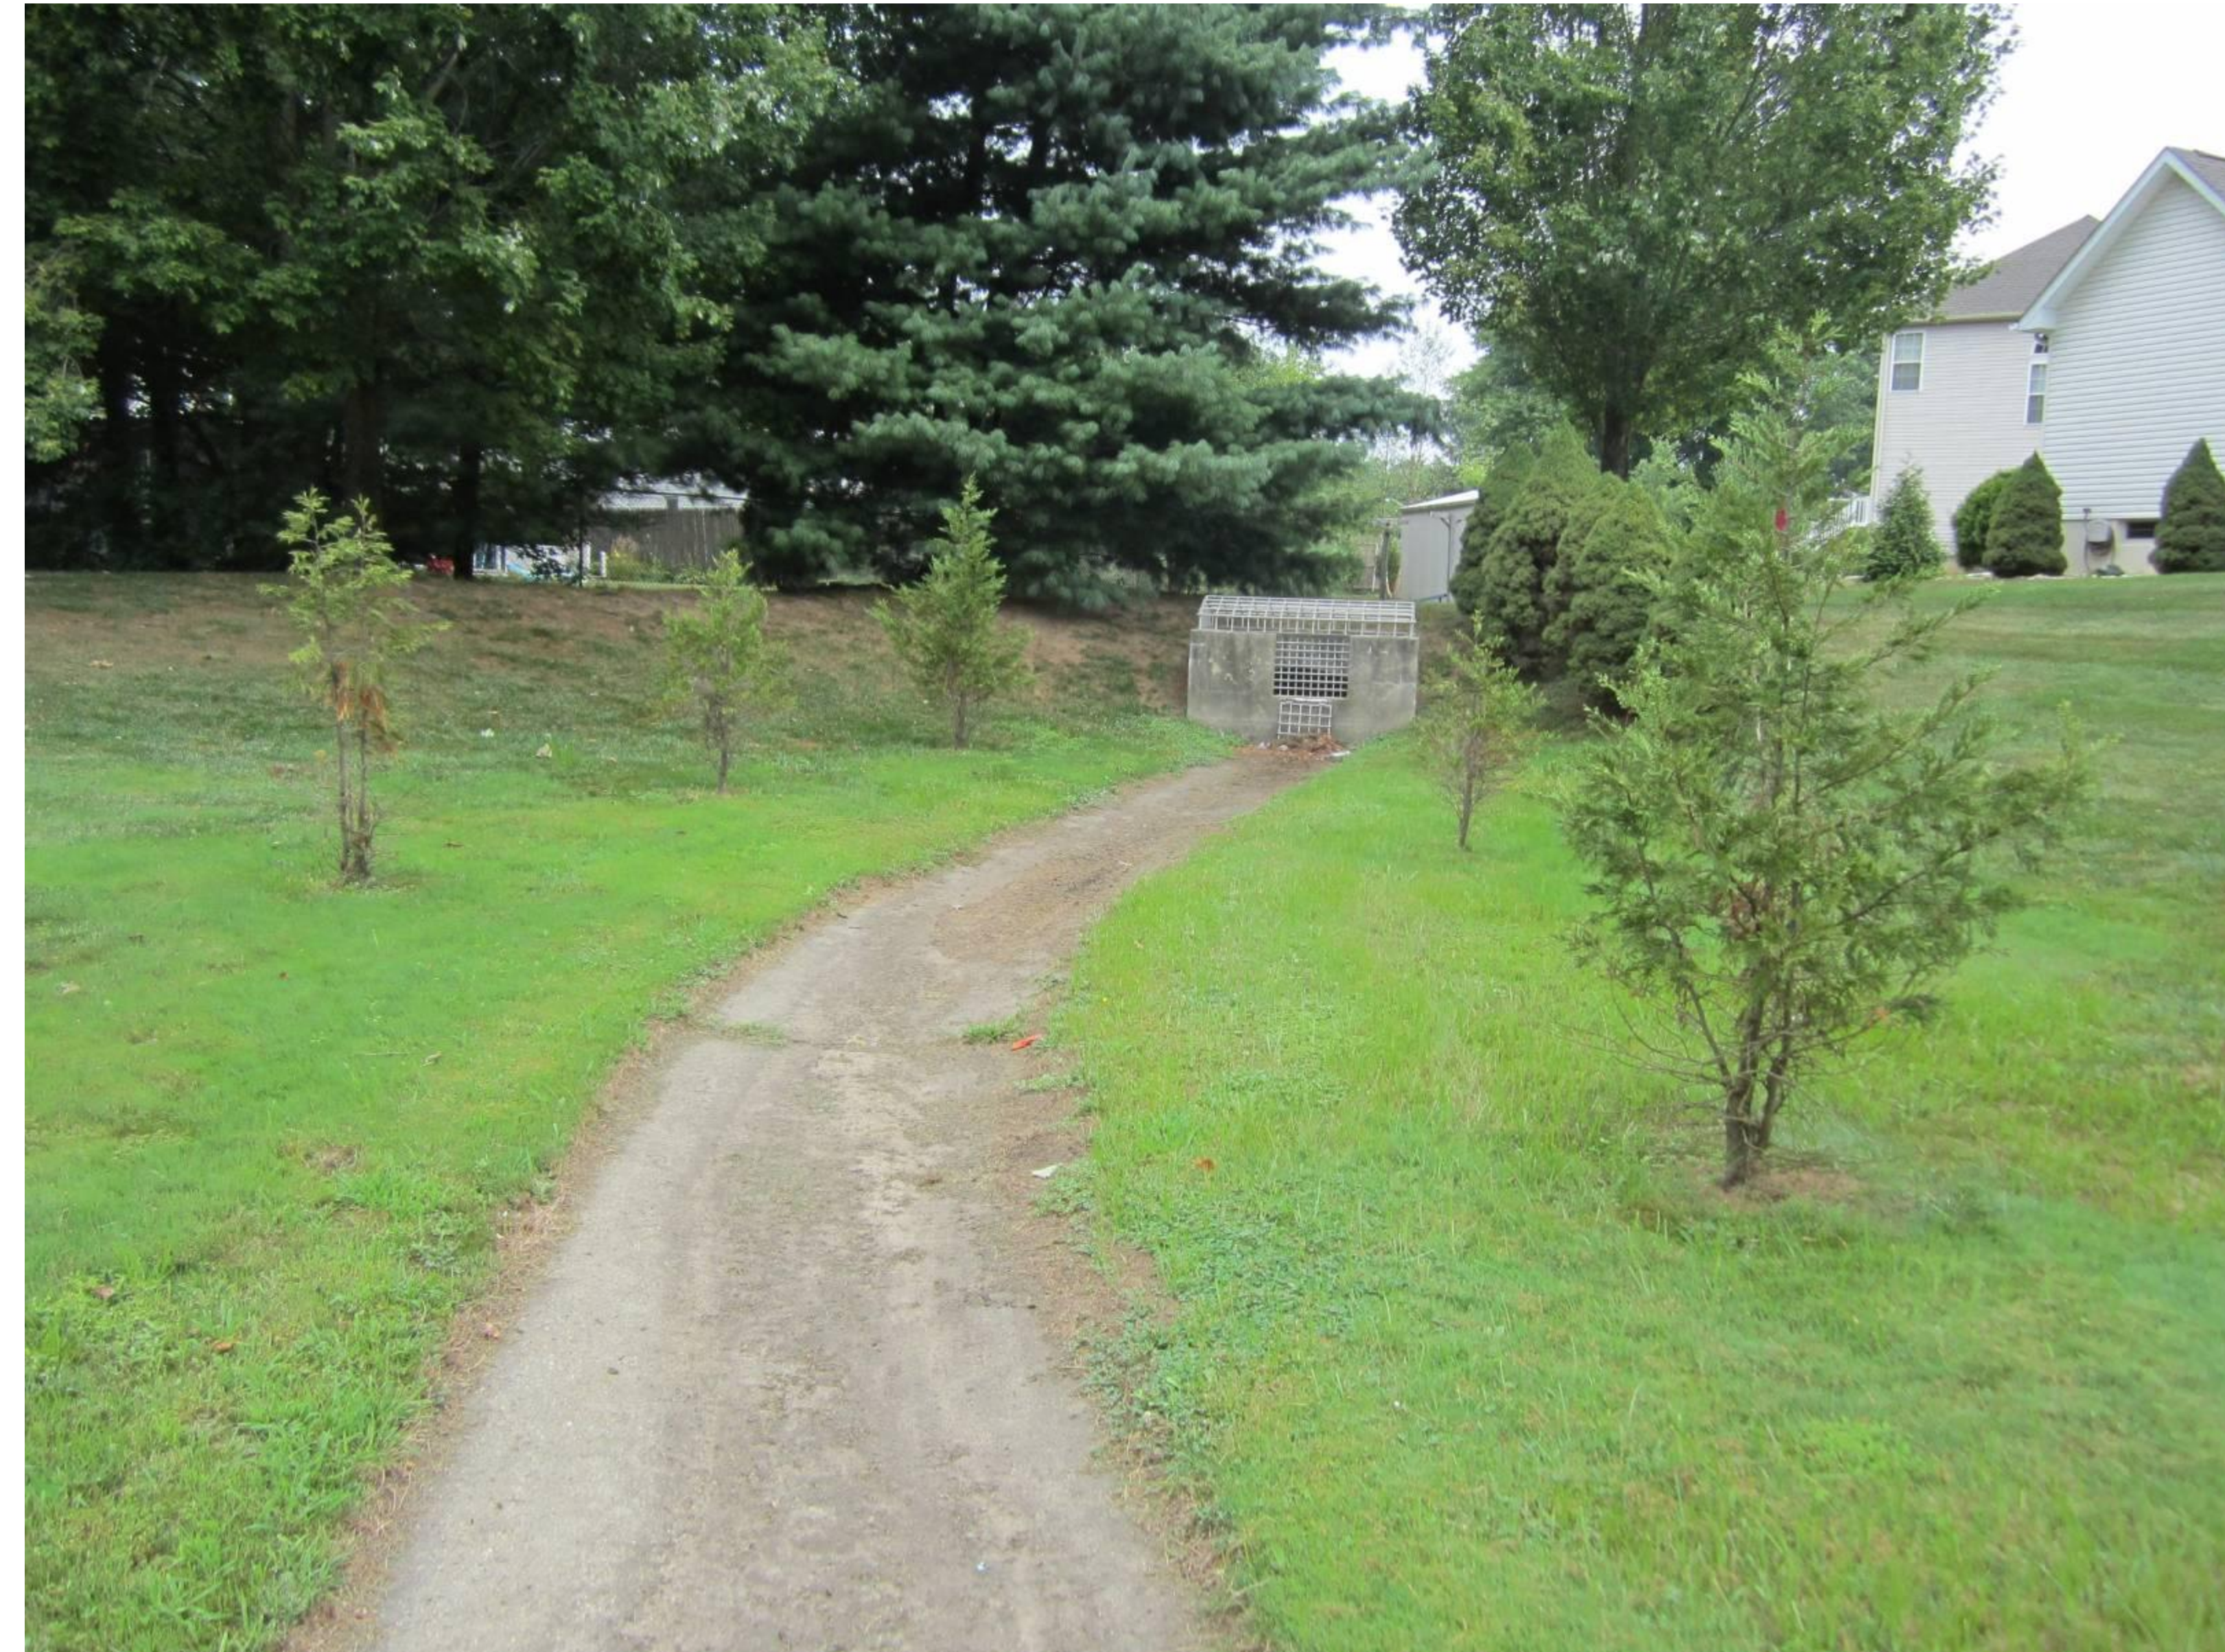
Low flow and outlet

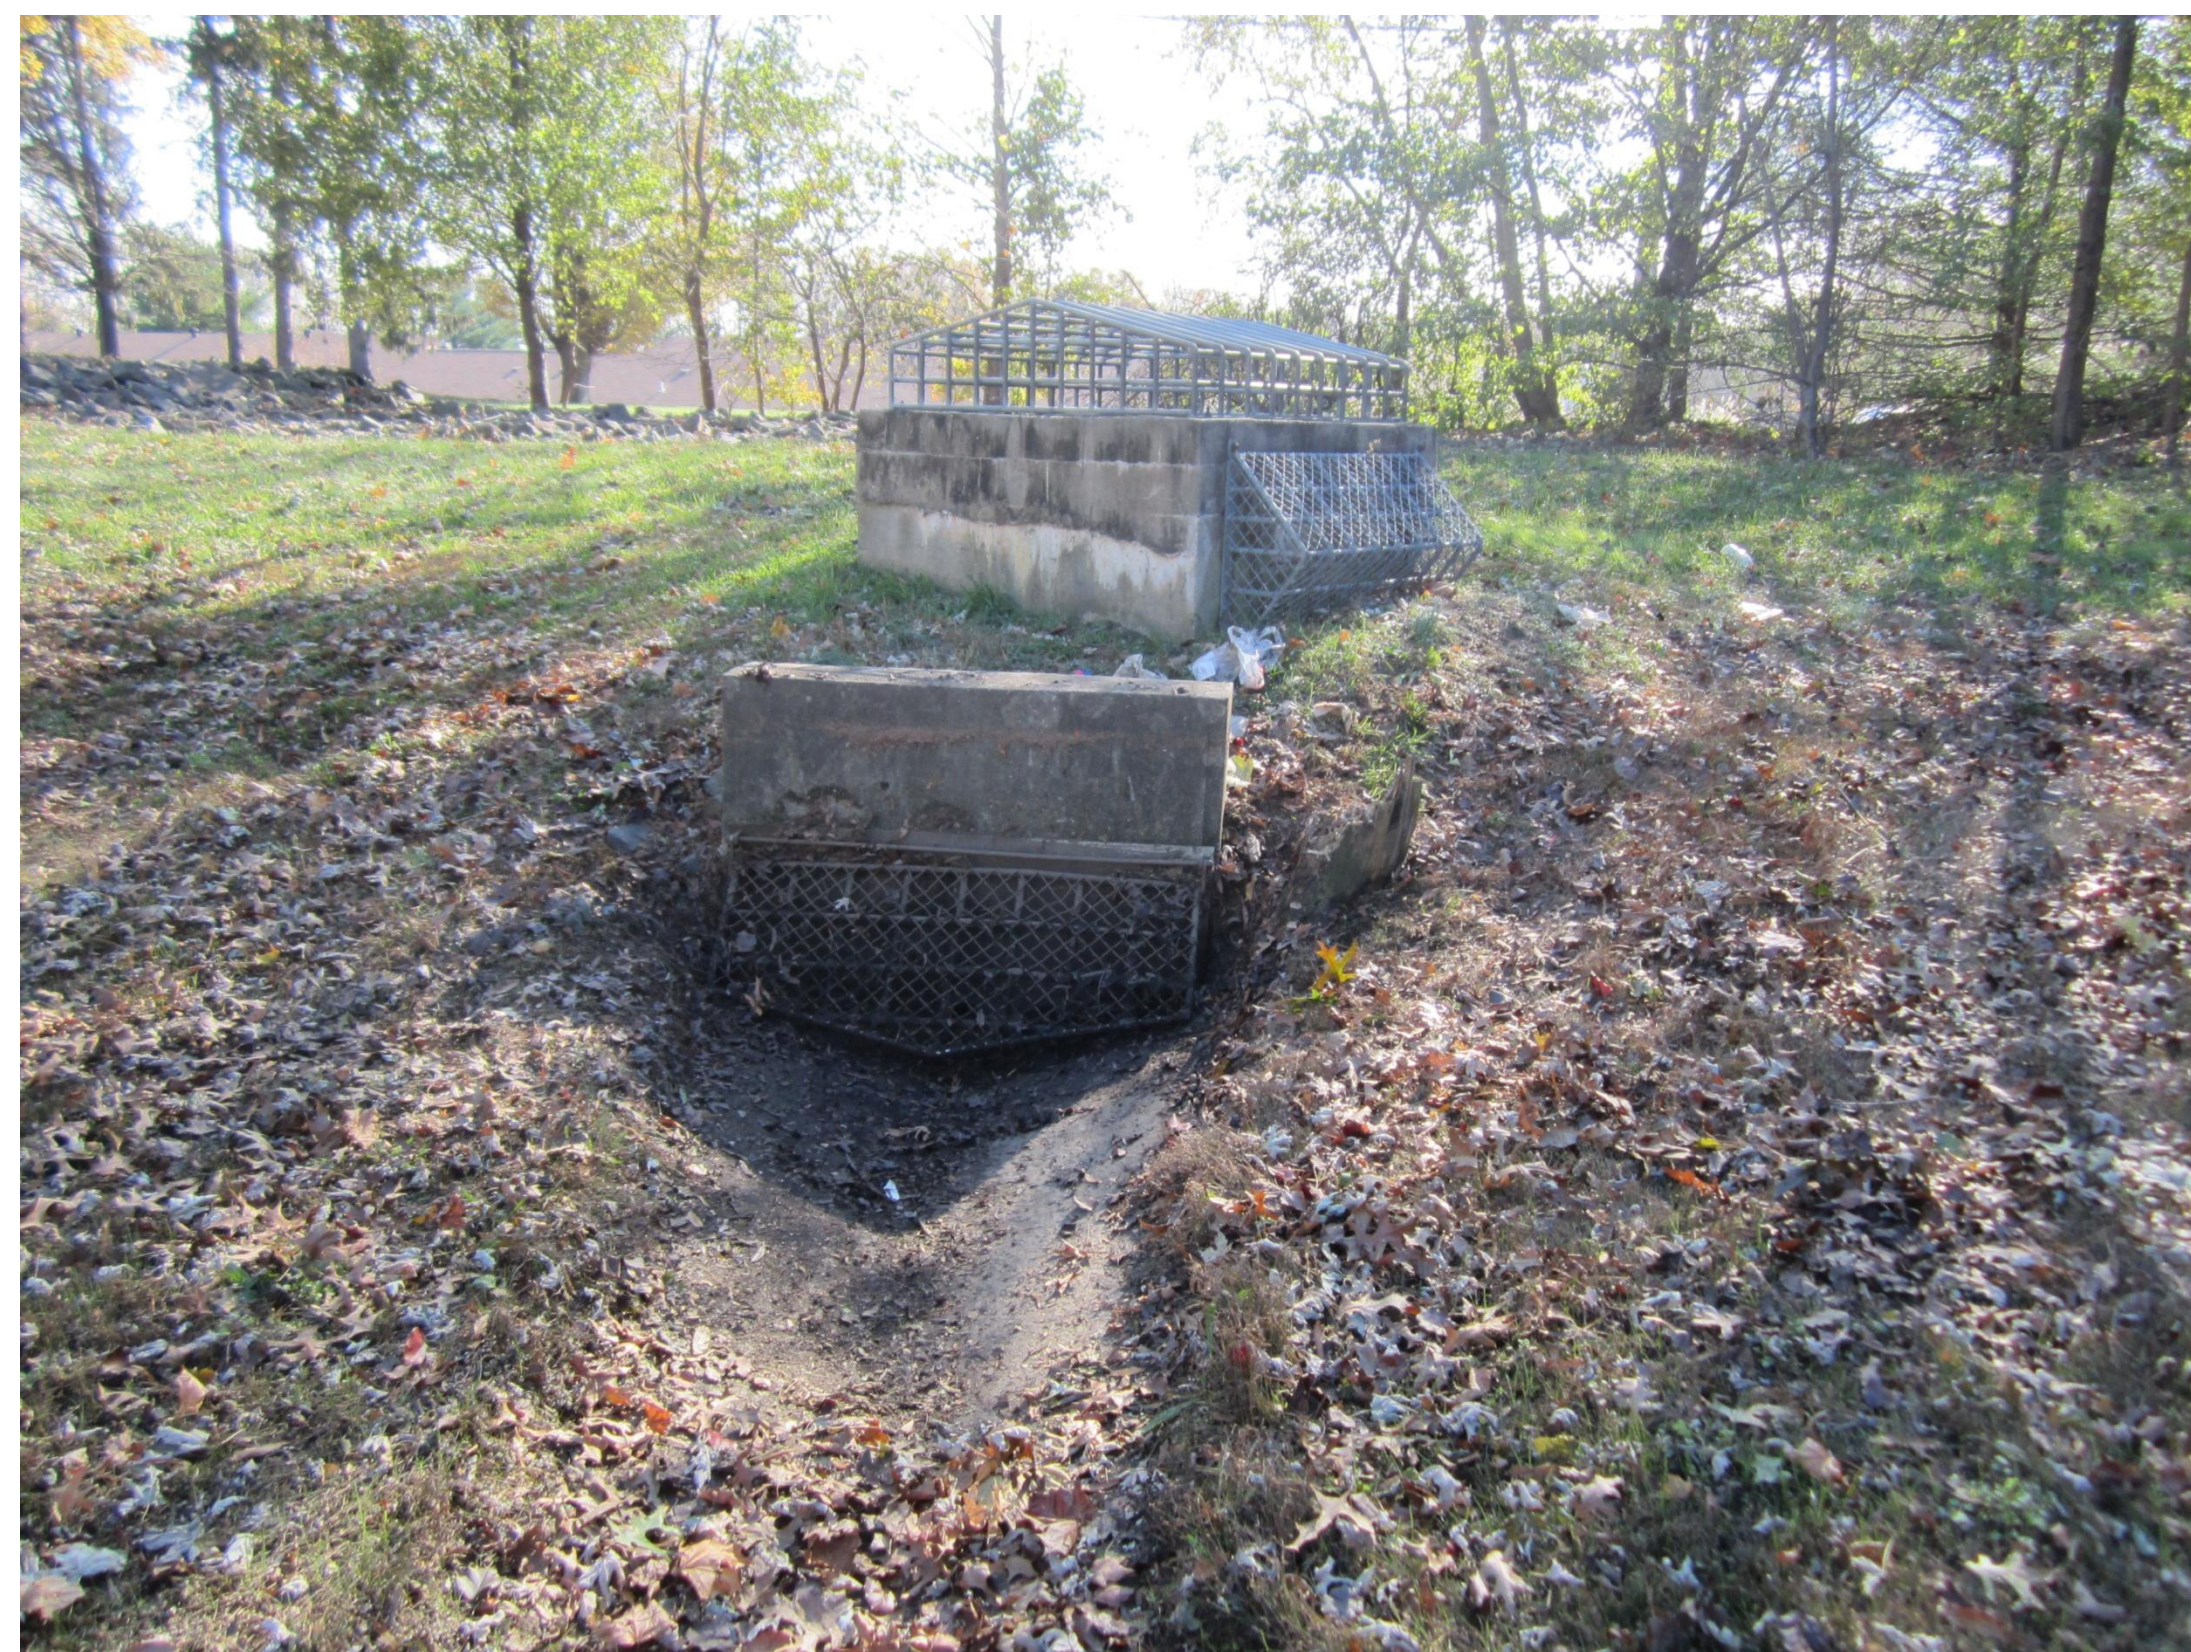
Outlet structure

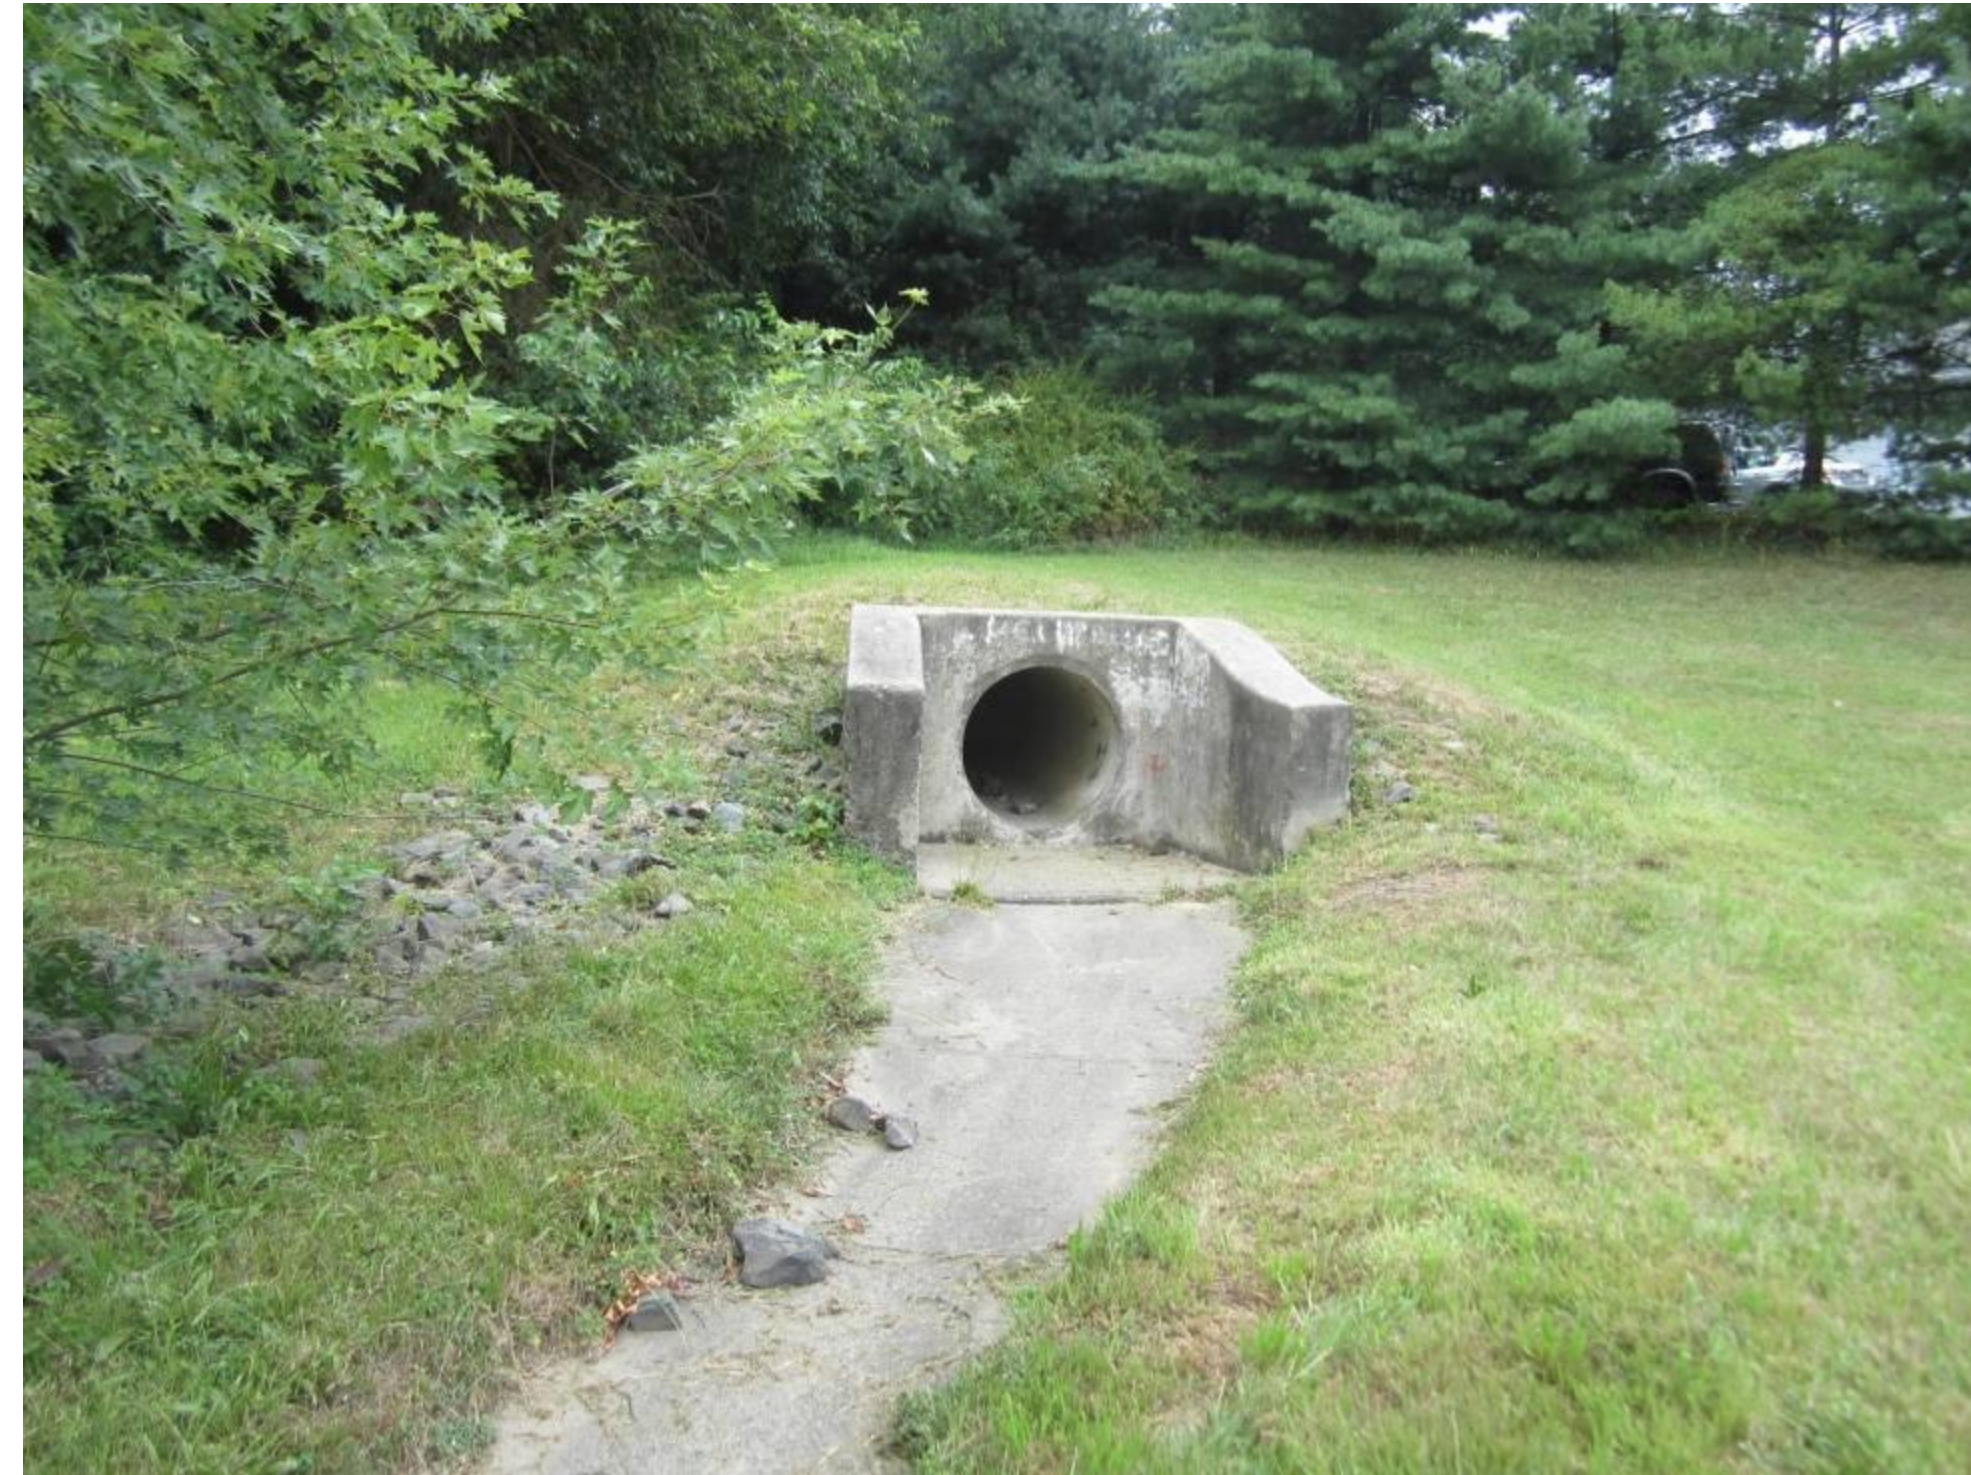
36" Diameter inlet

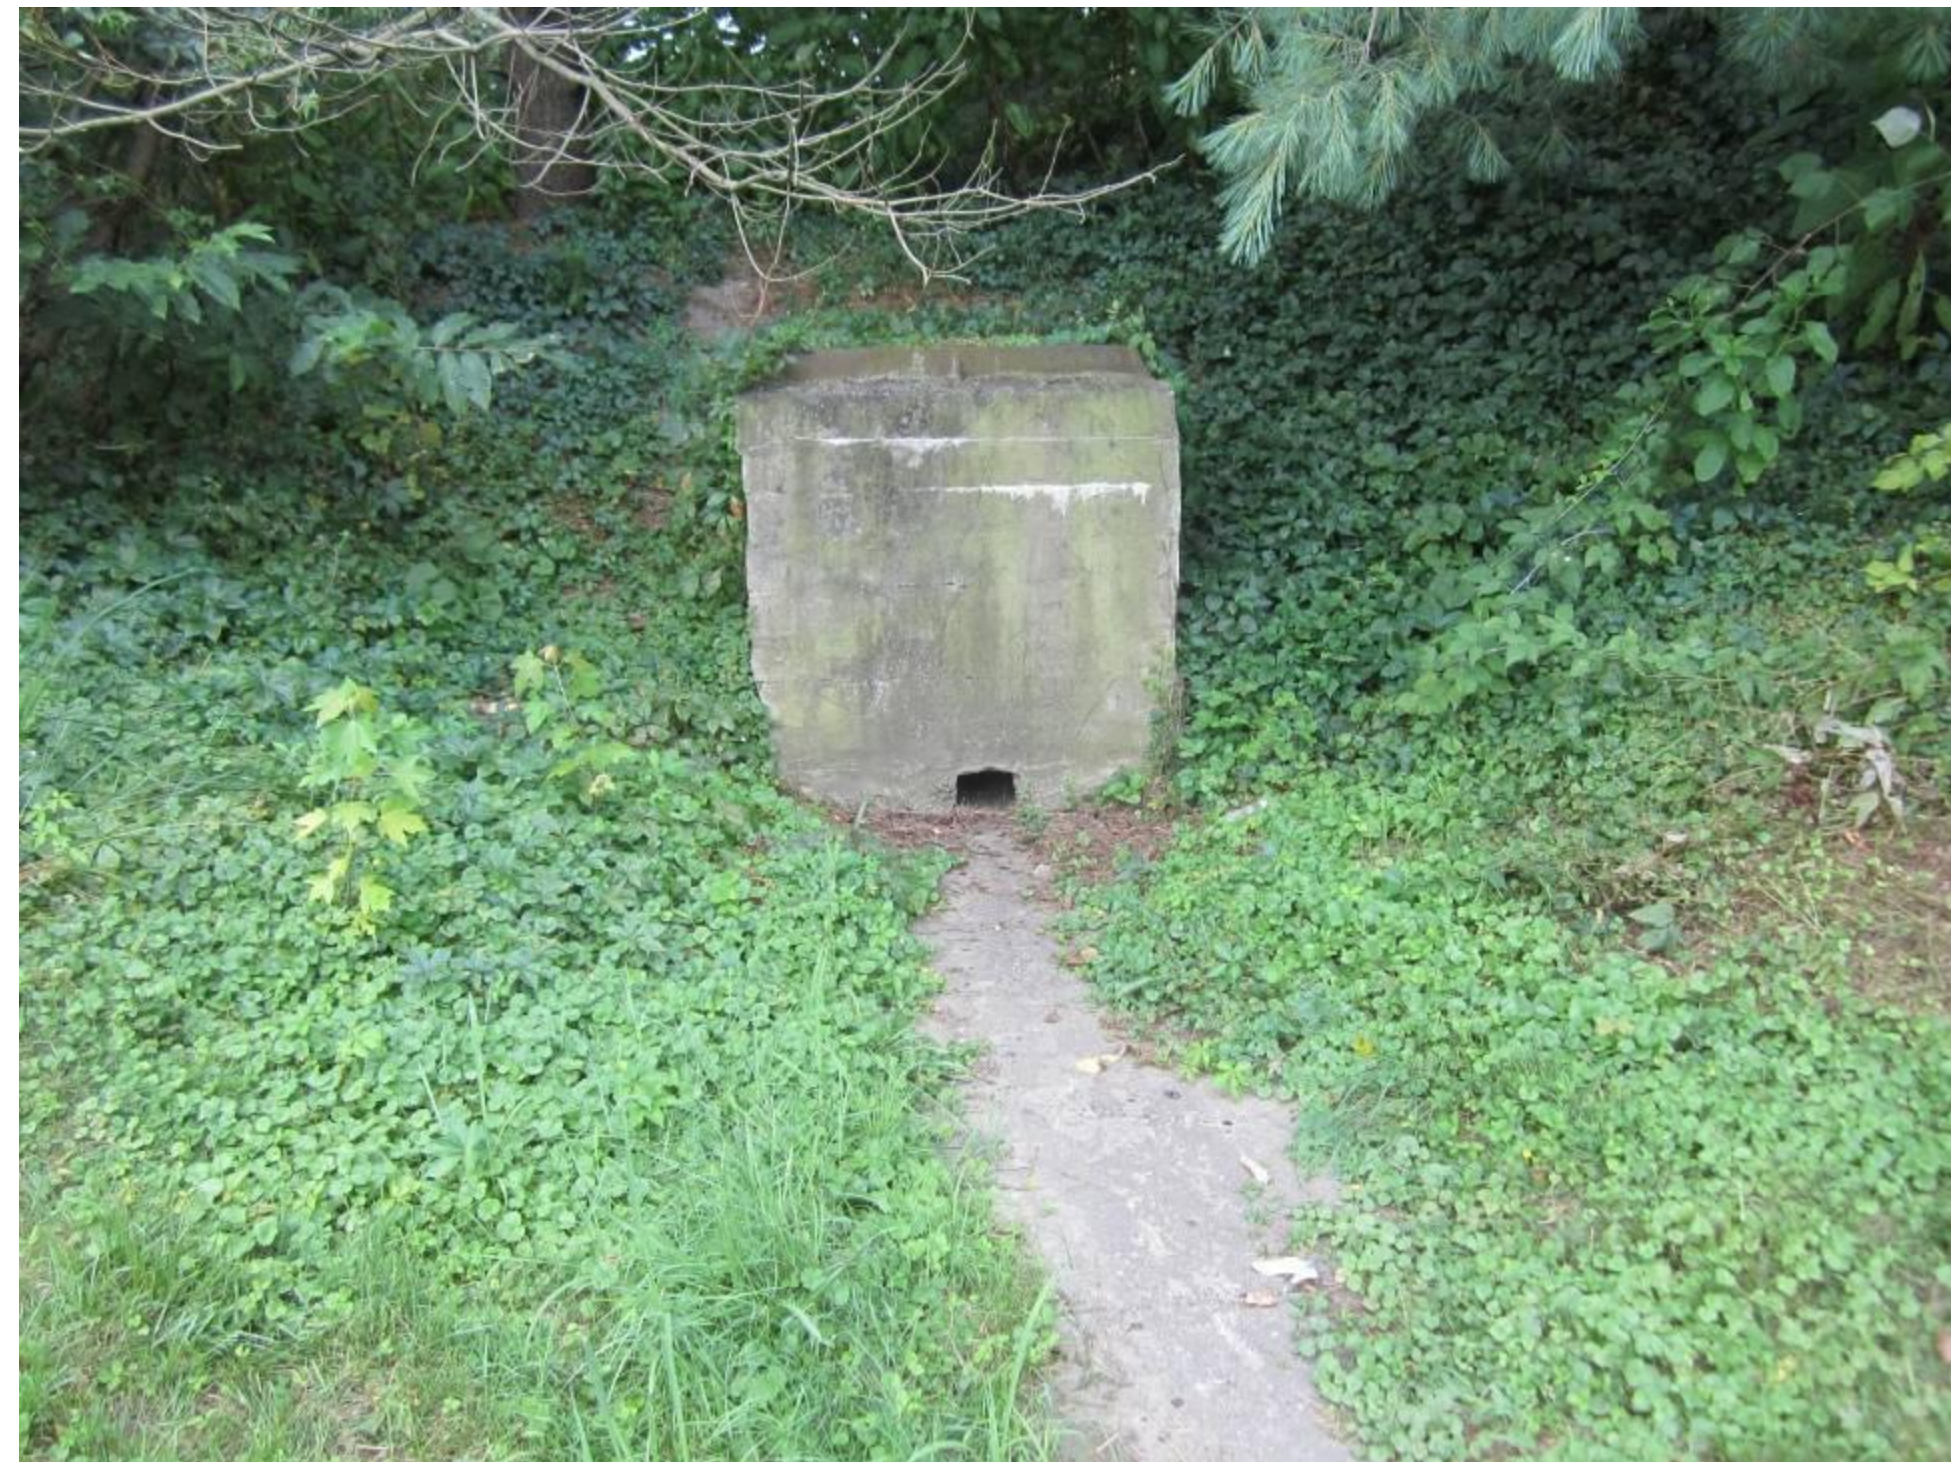
Outlet structure
