Hamilton Township (Mercer County) Stormwater Basin Assessment Summary (Year 1)

Developed by the Rutgers Cooperative Extension Water Resources Program
Funded by Hamilton Township, Mercer County, New Jersey

December 6, 2012

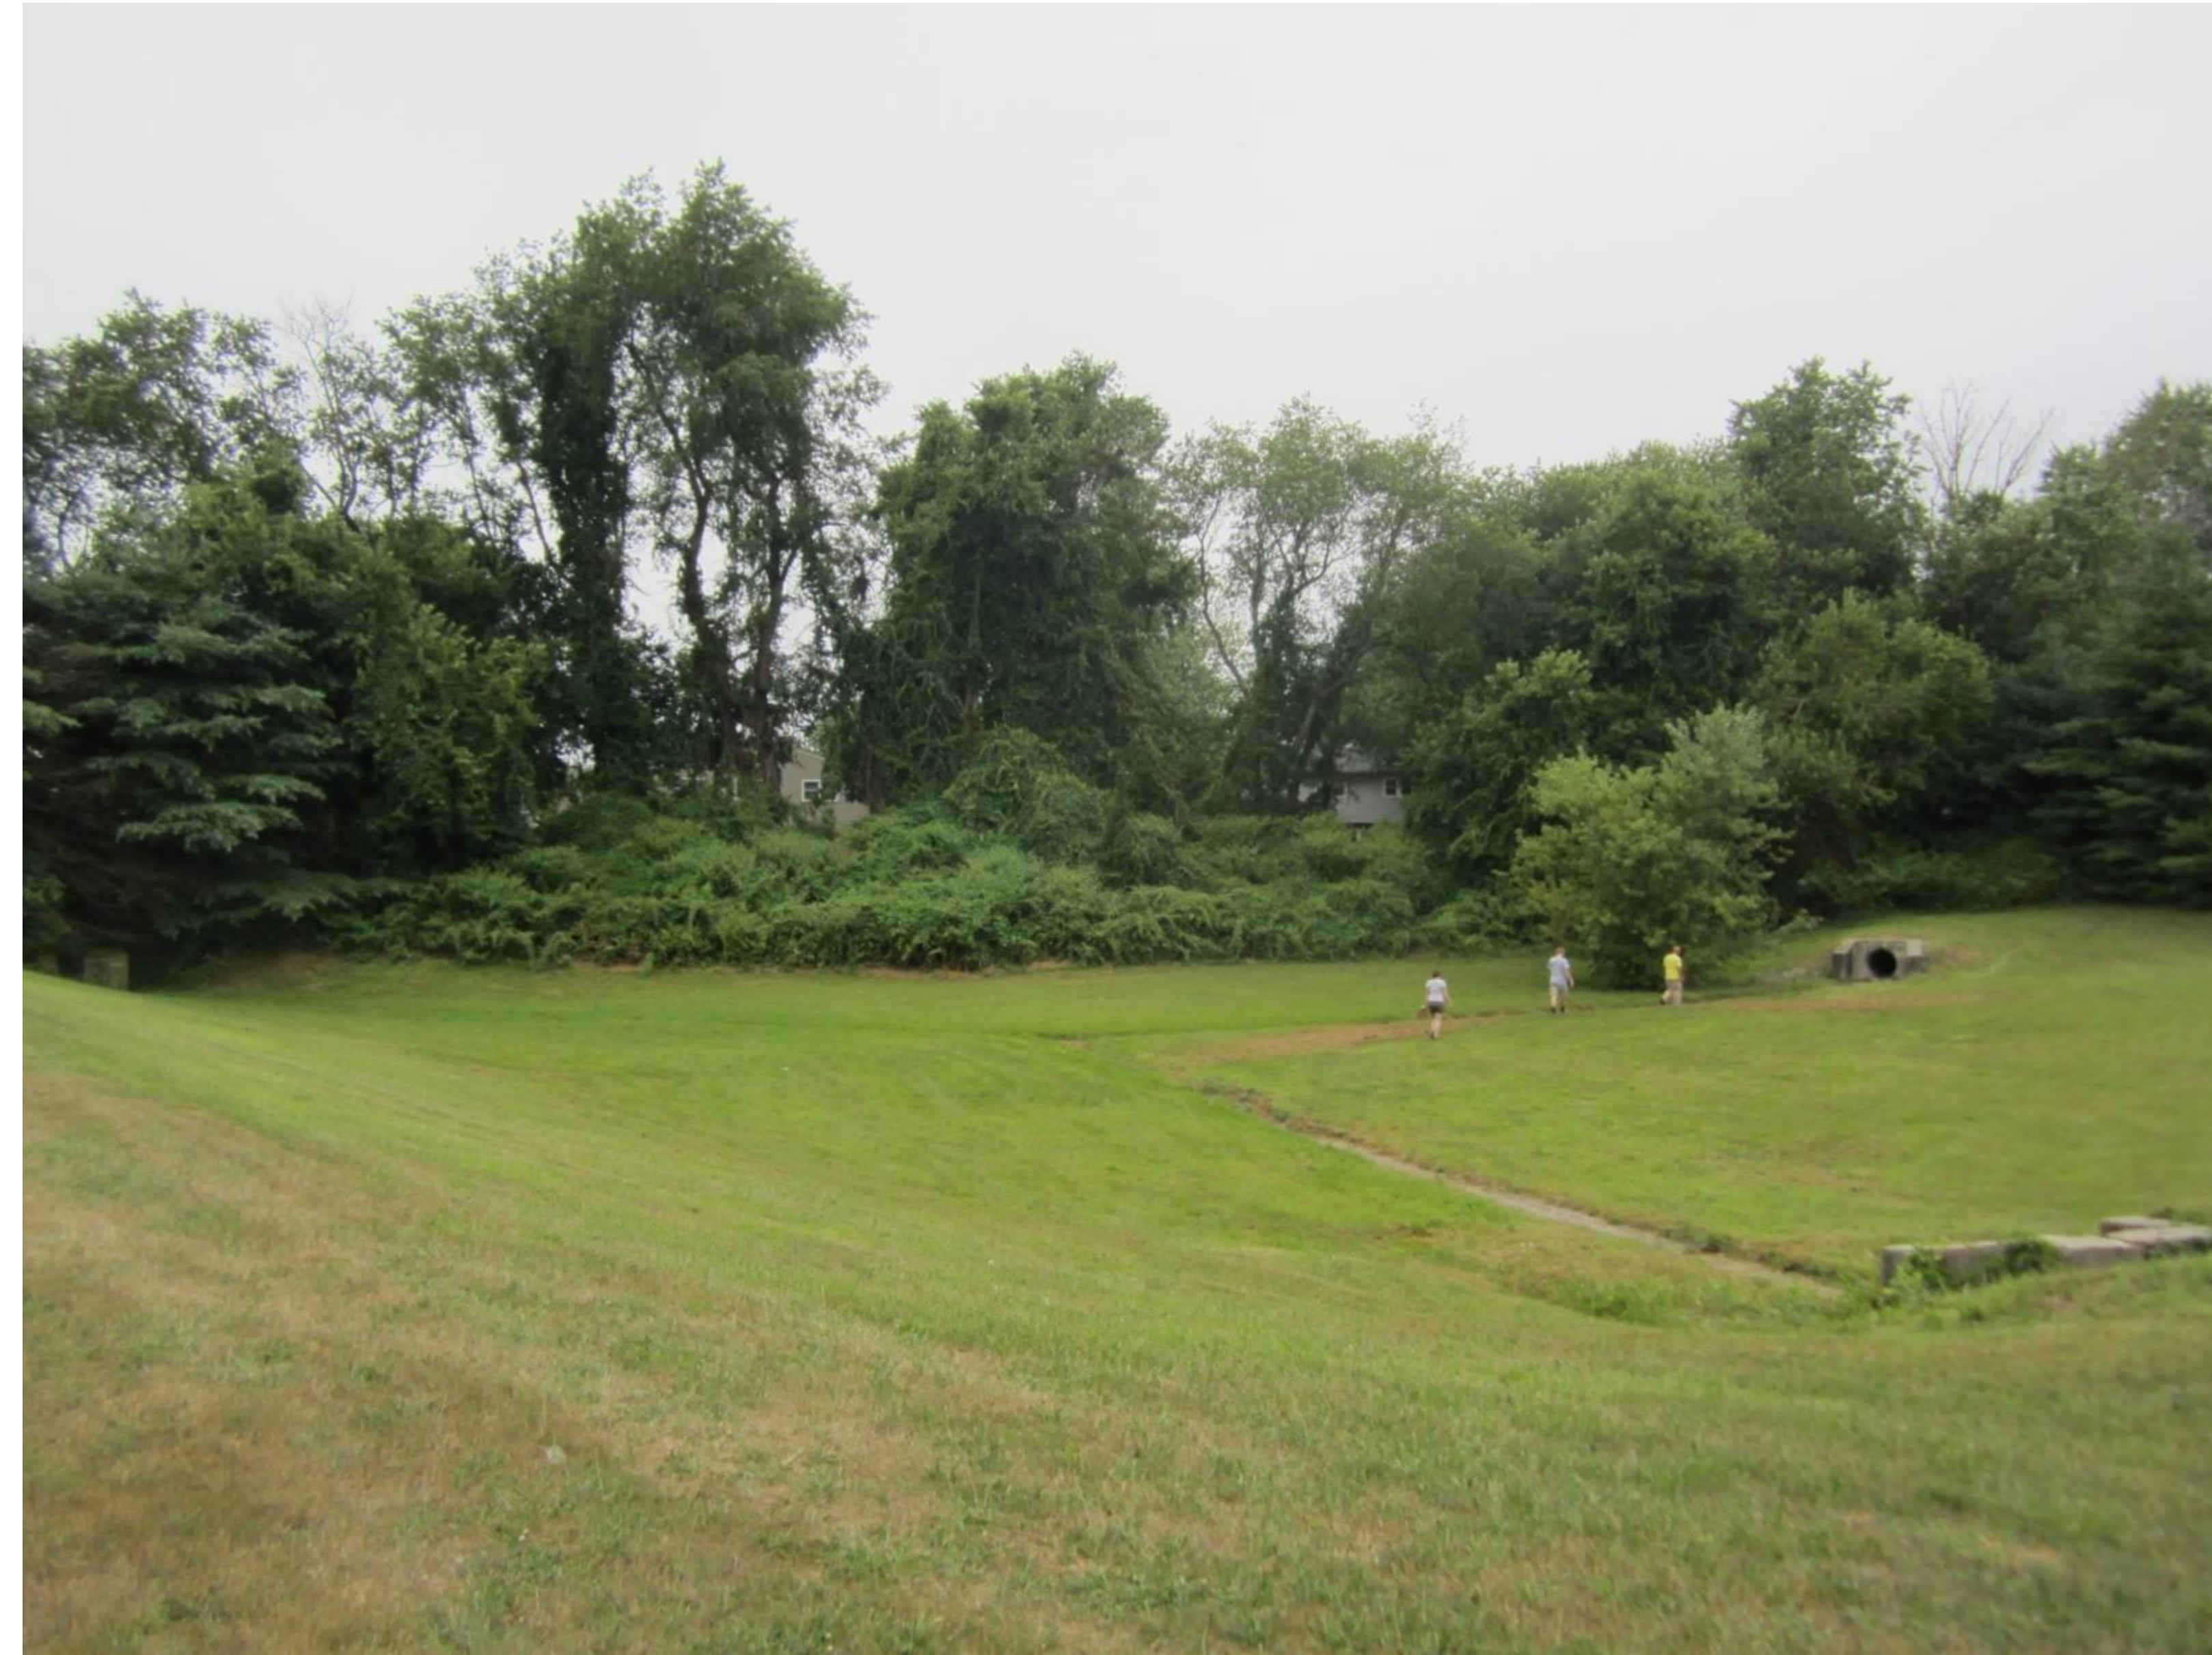
Entire basin looking southwest

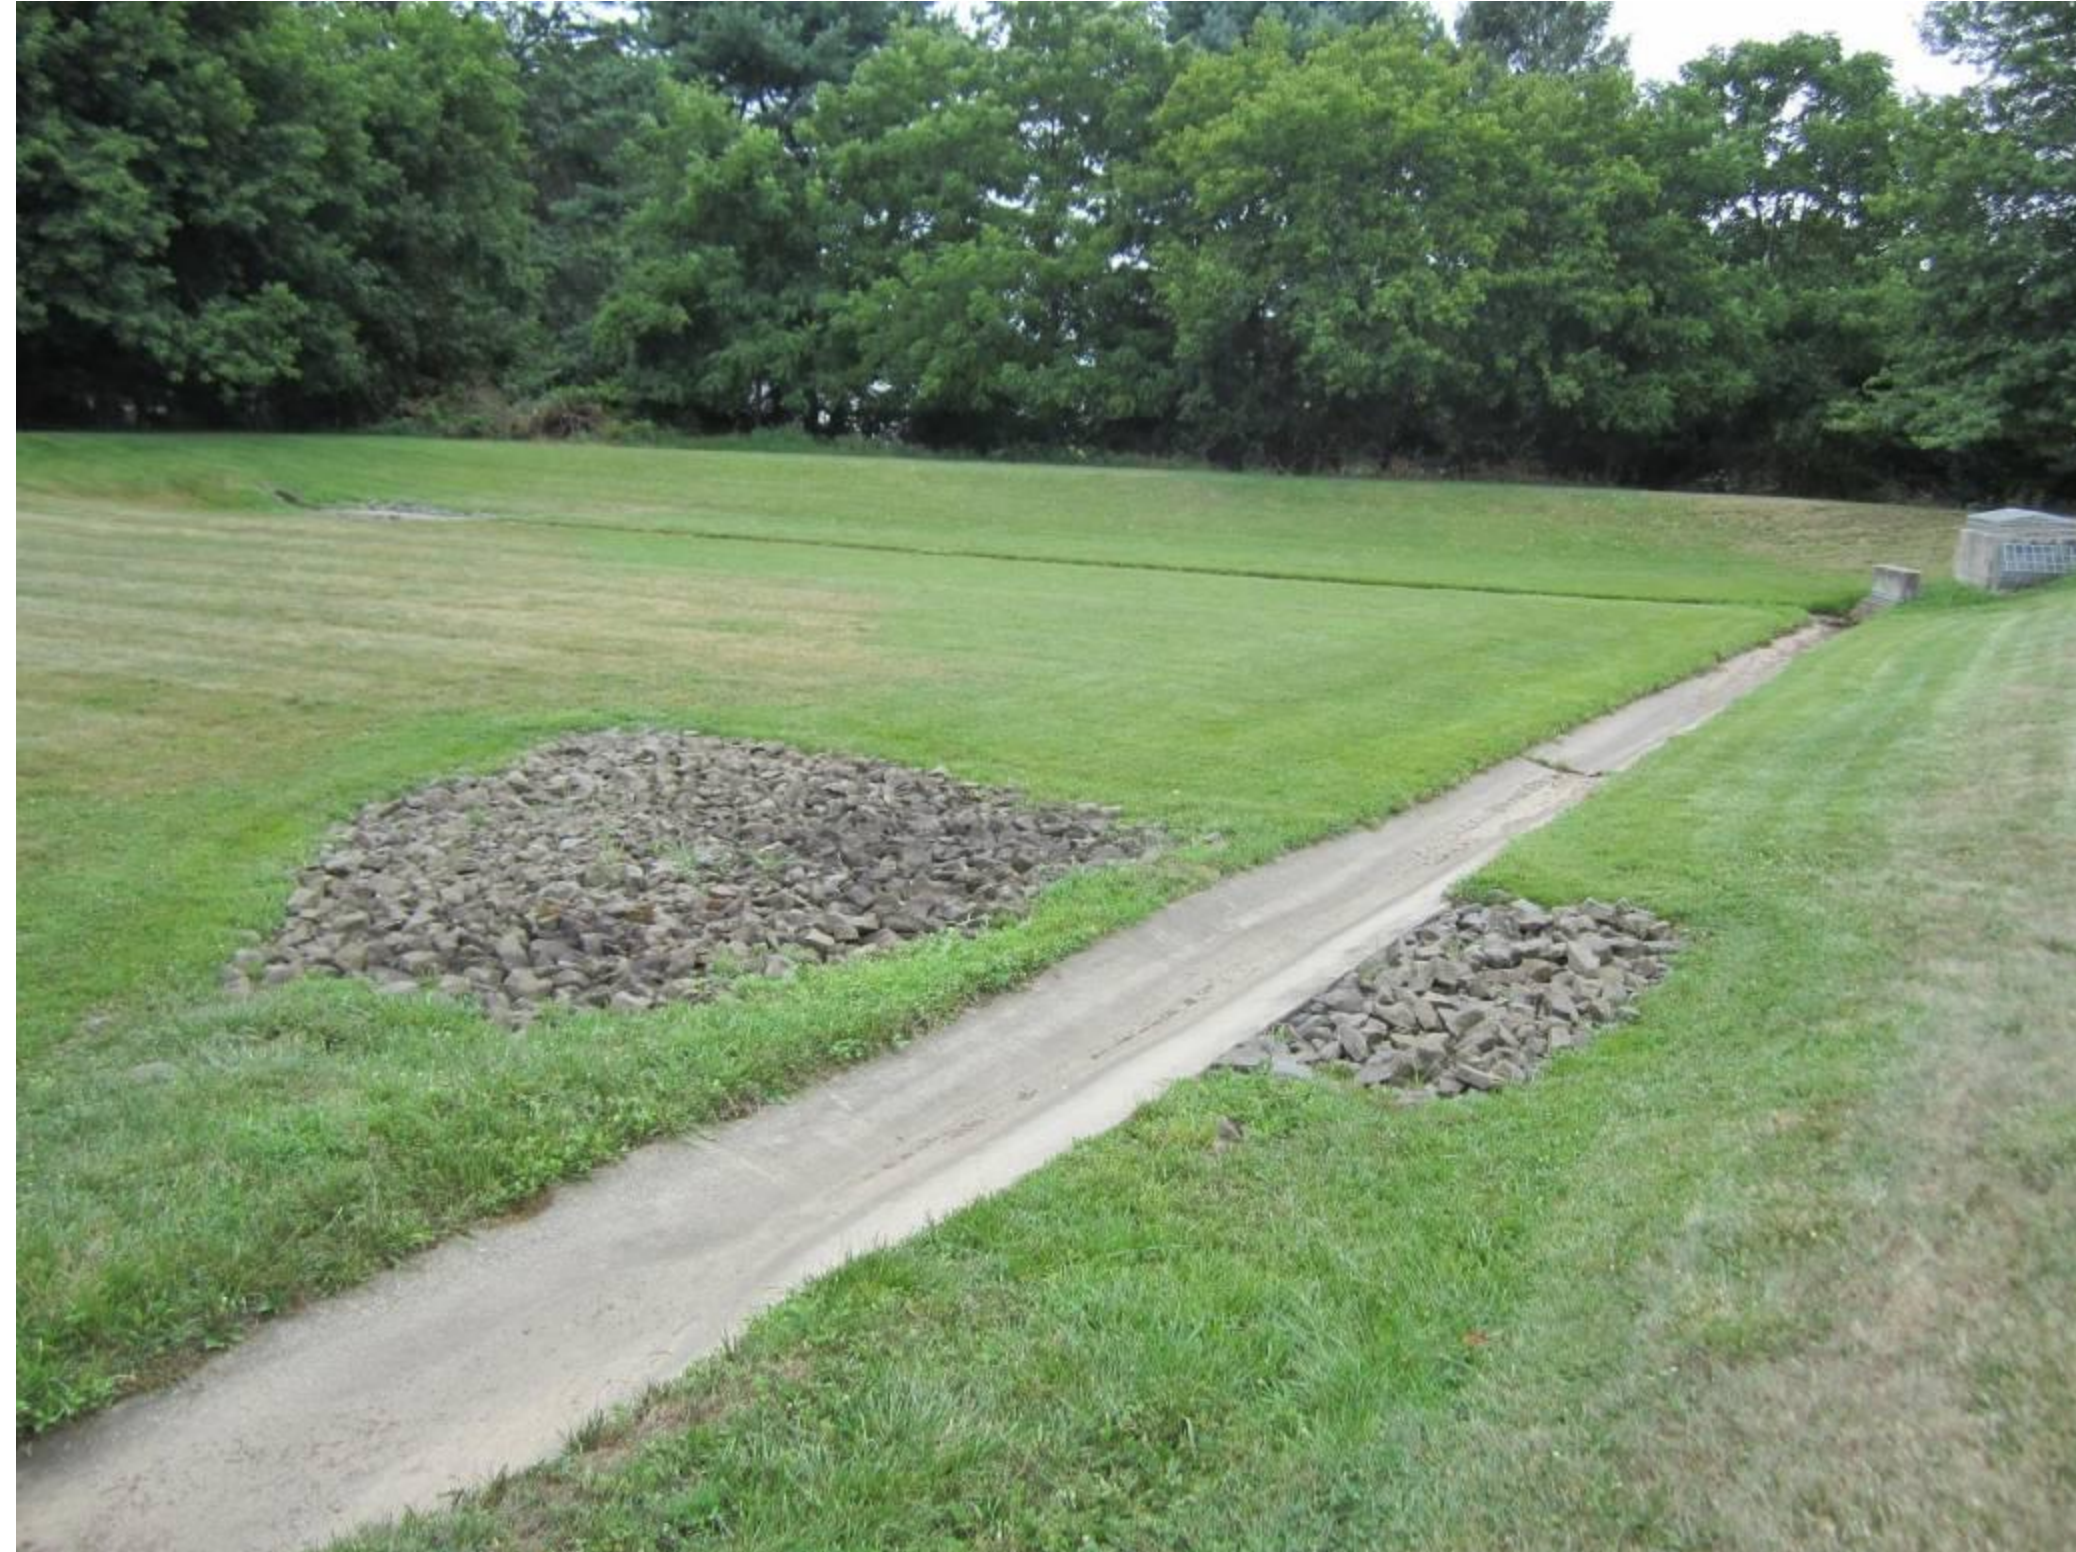
Low flow with rip rap protection

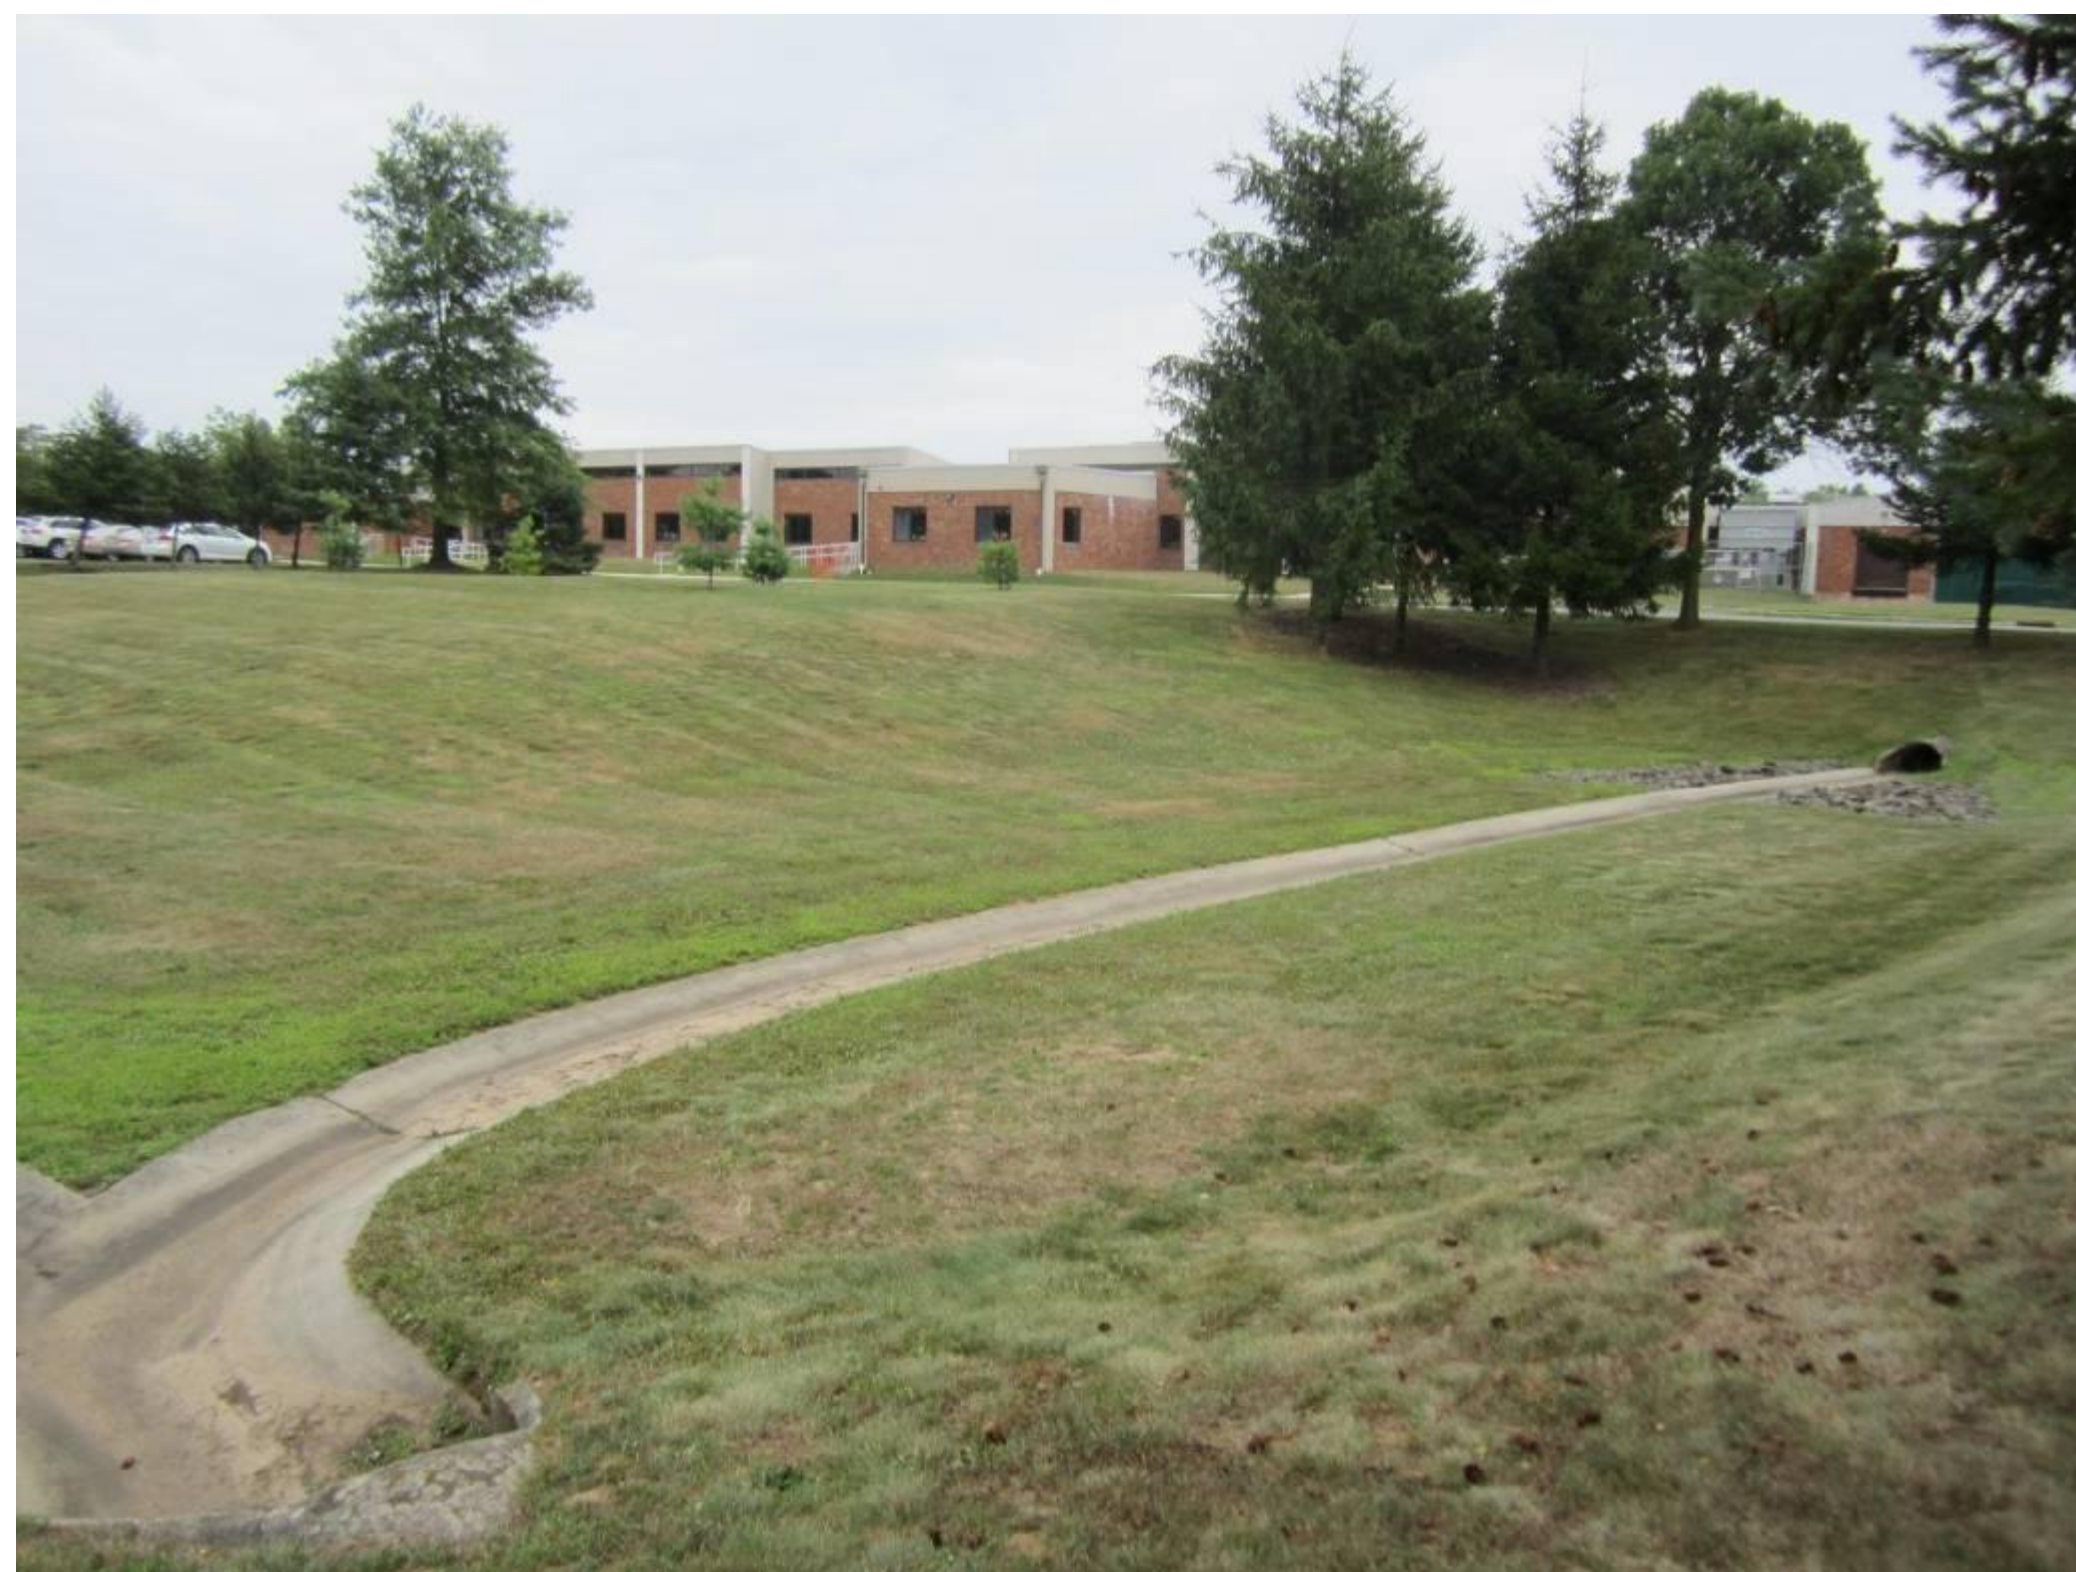
18" Diameter inlet and low flow

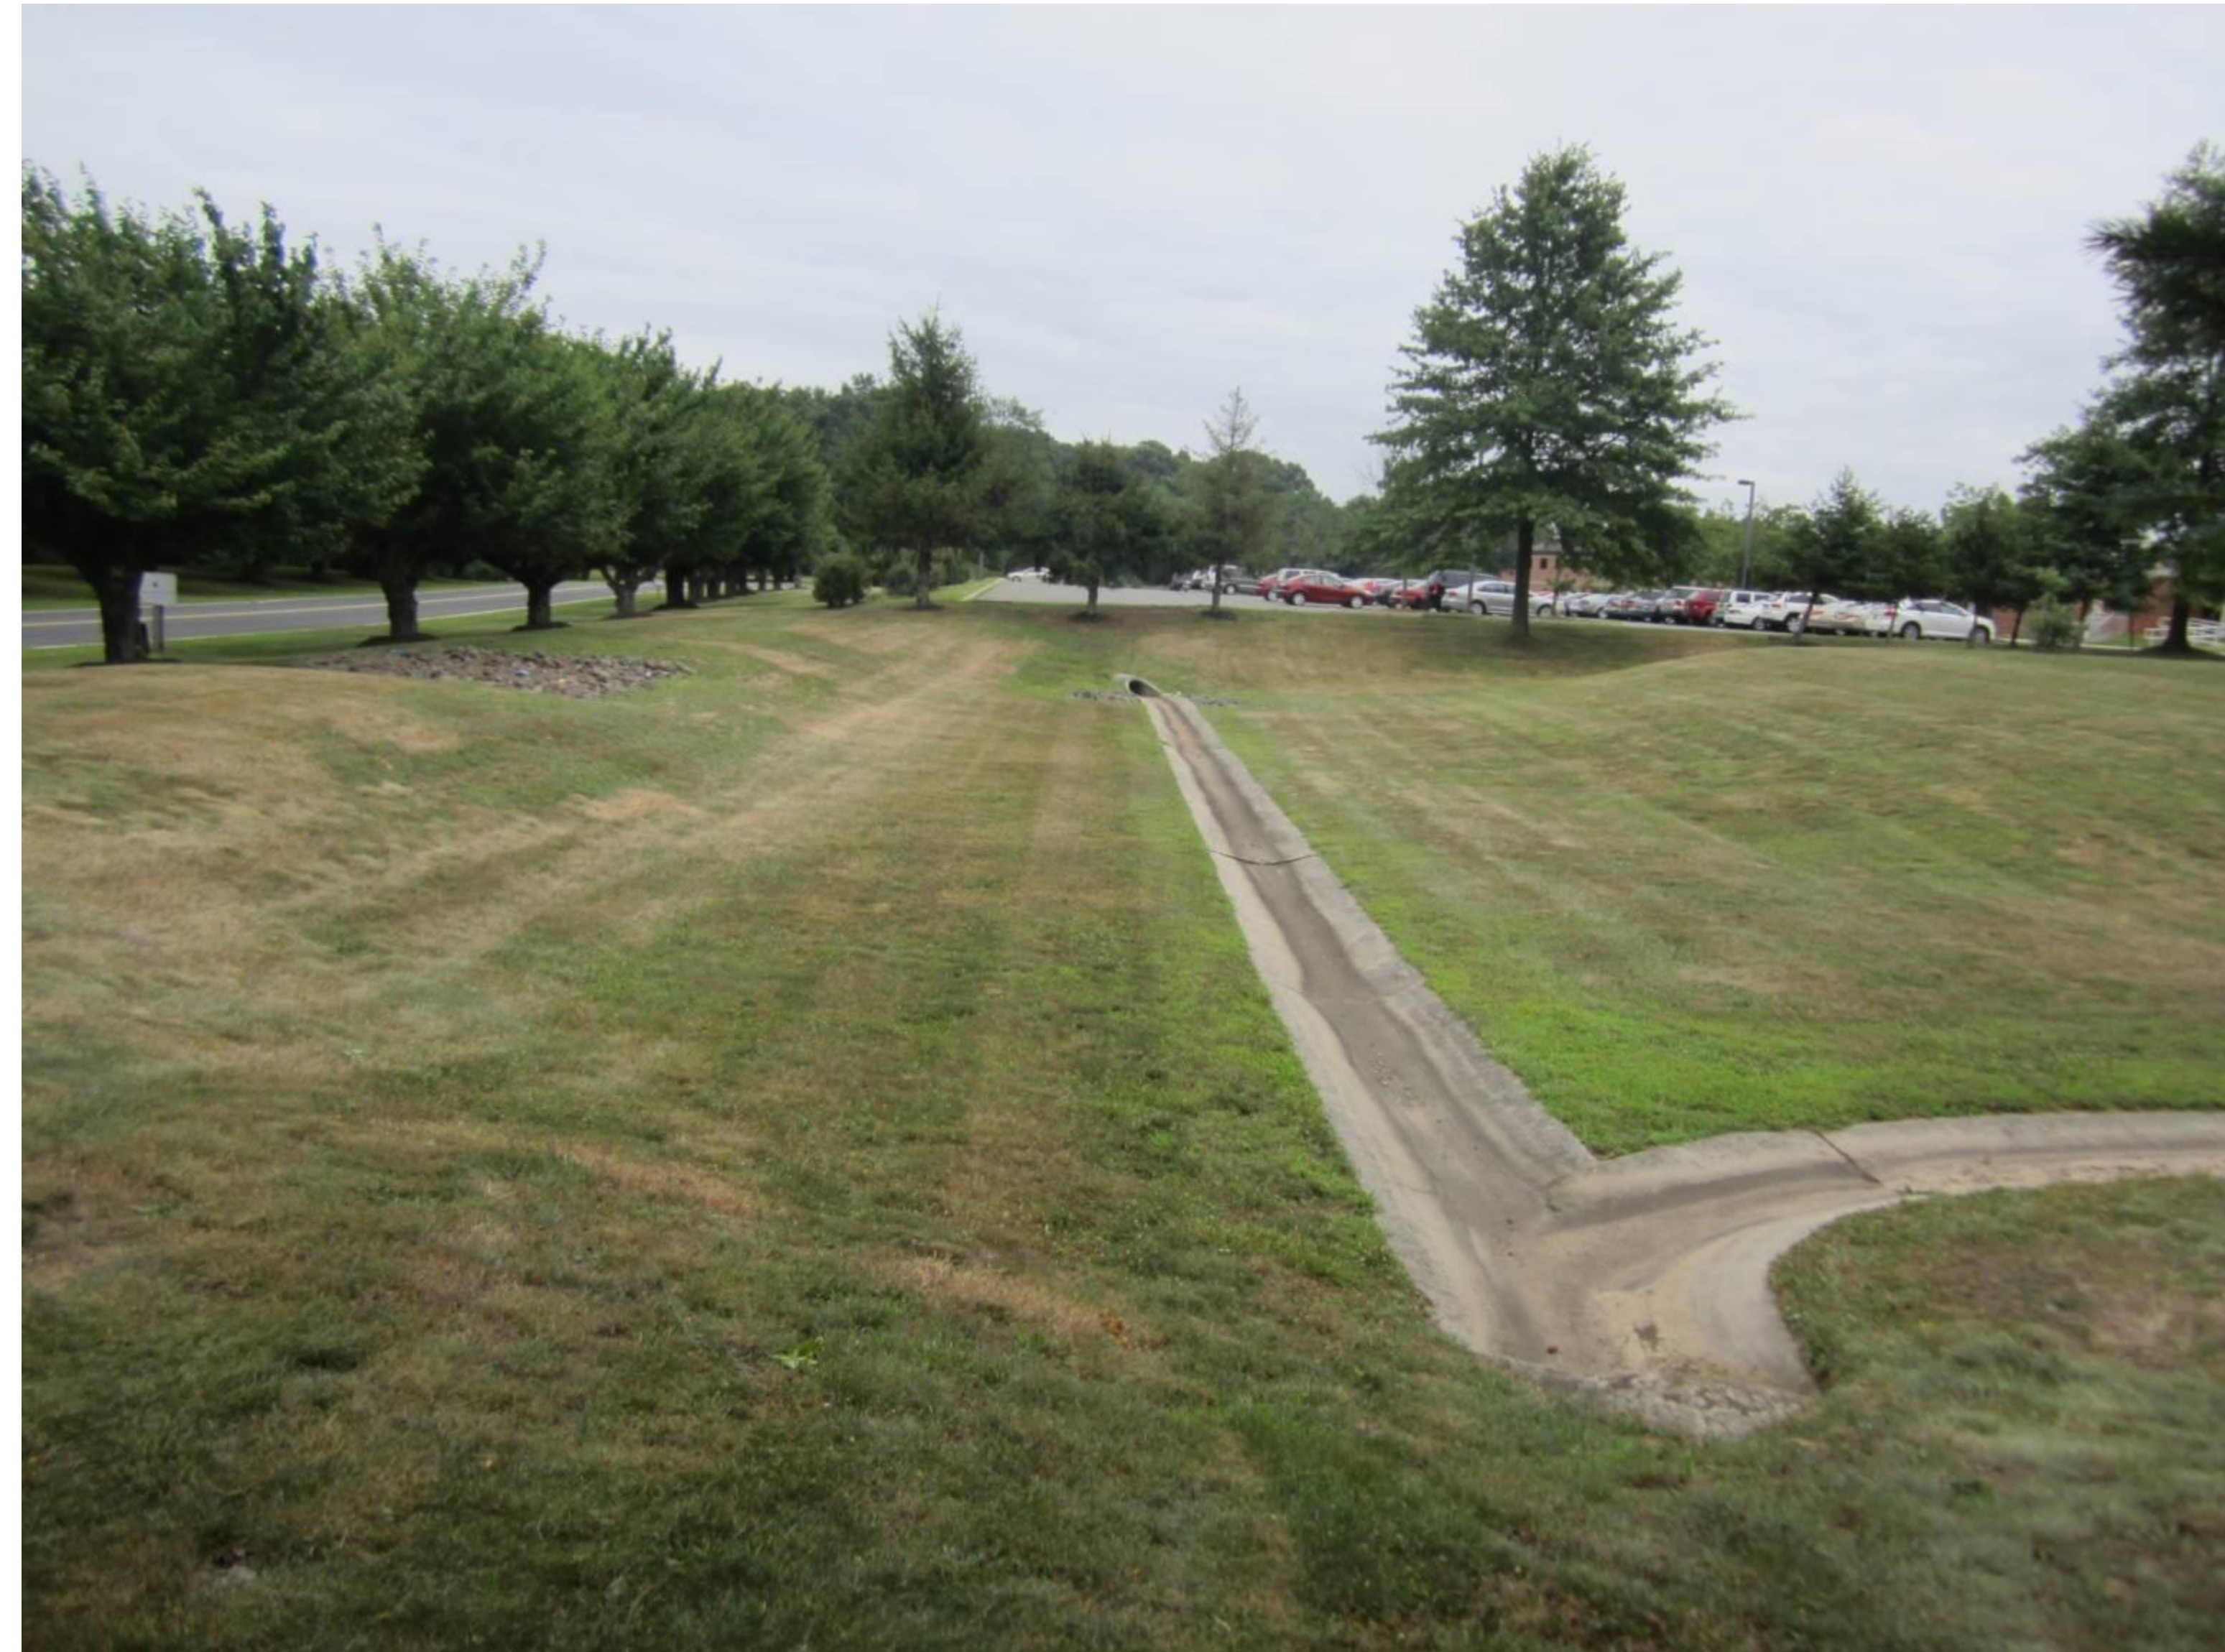
Eastern basin bottom

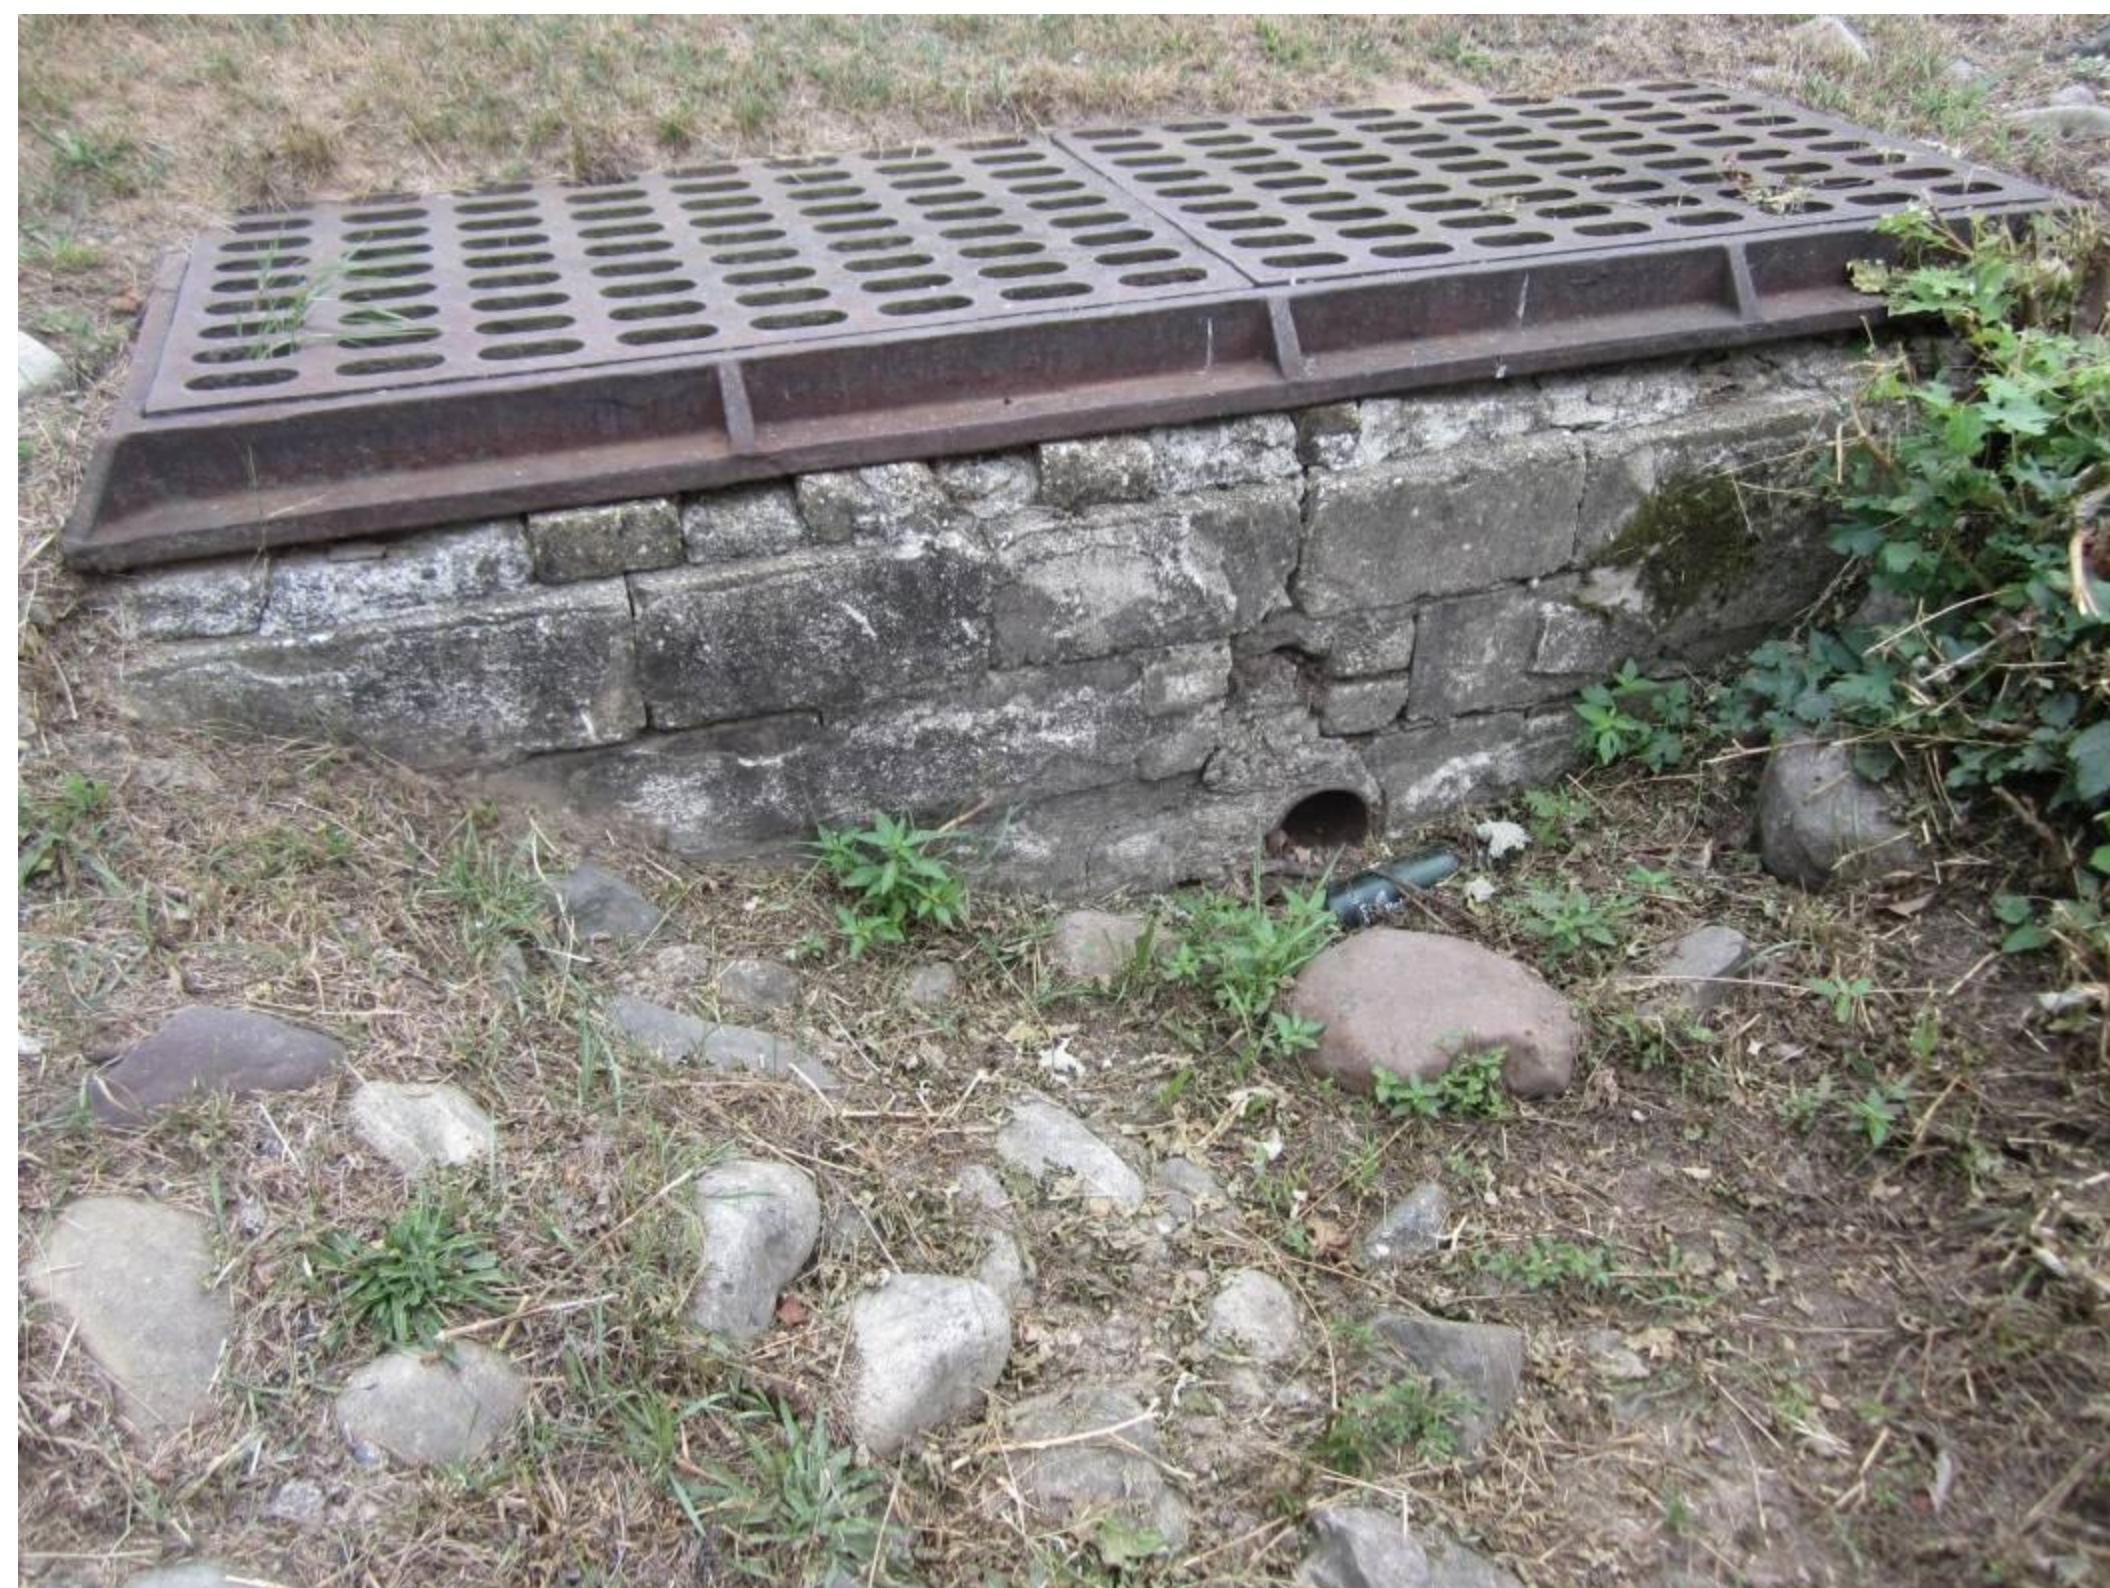
Outlet structure

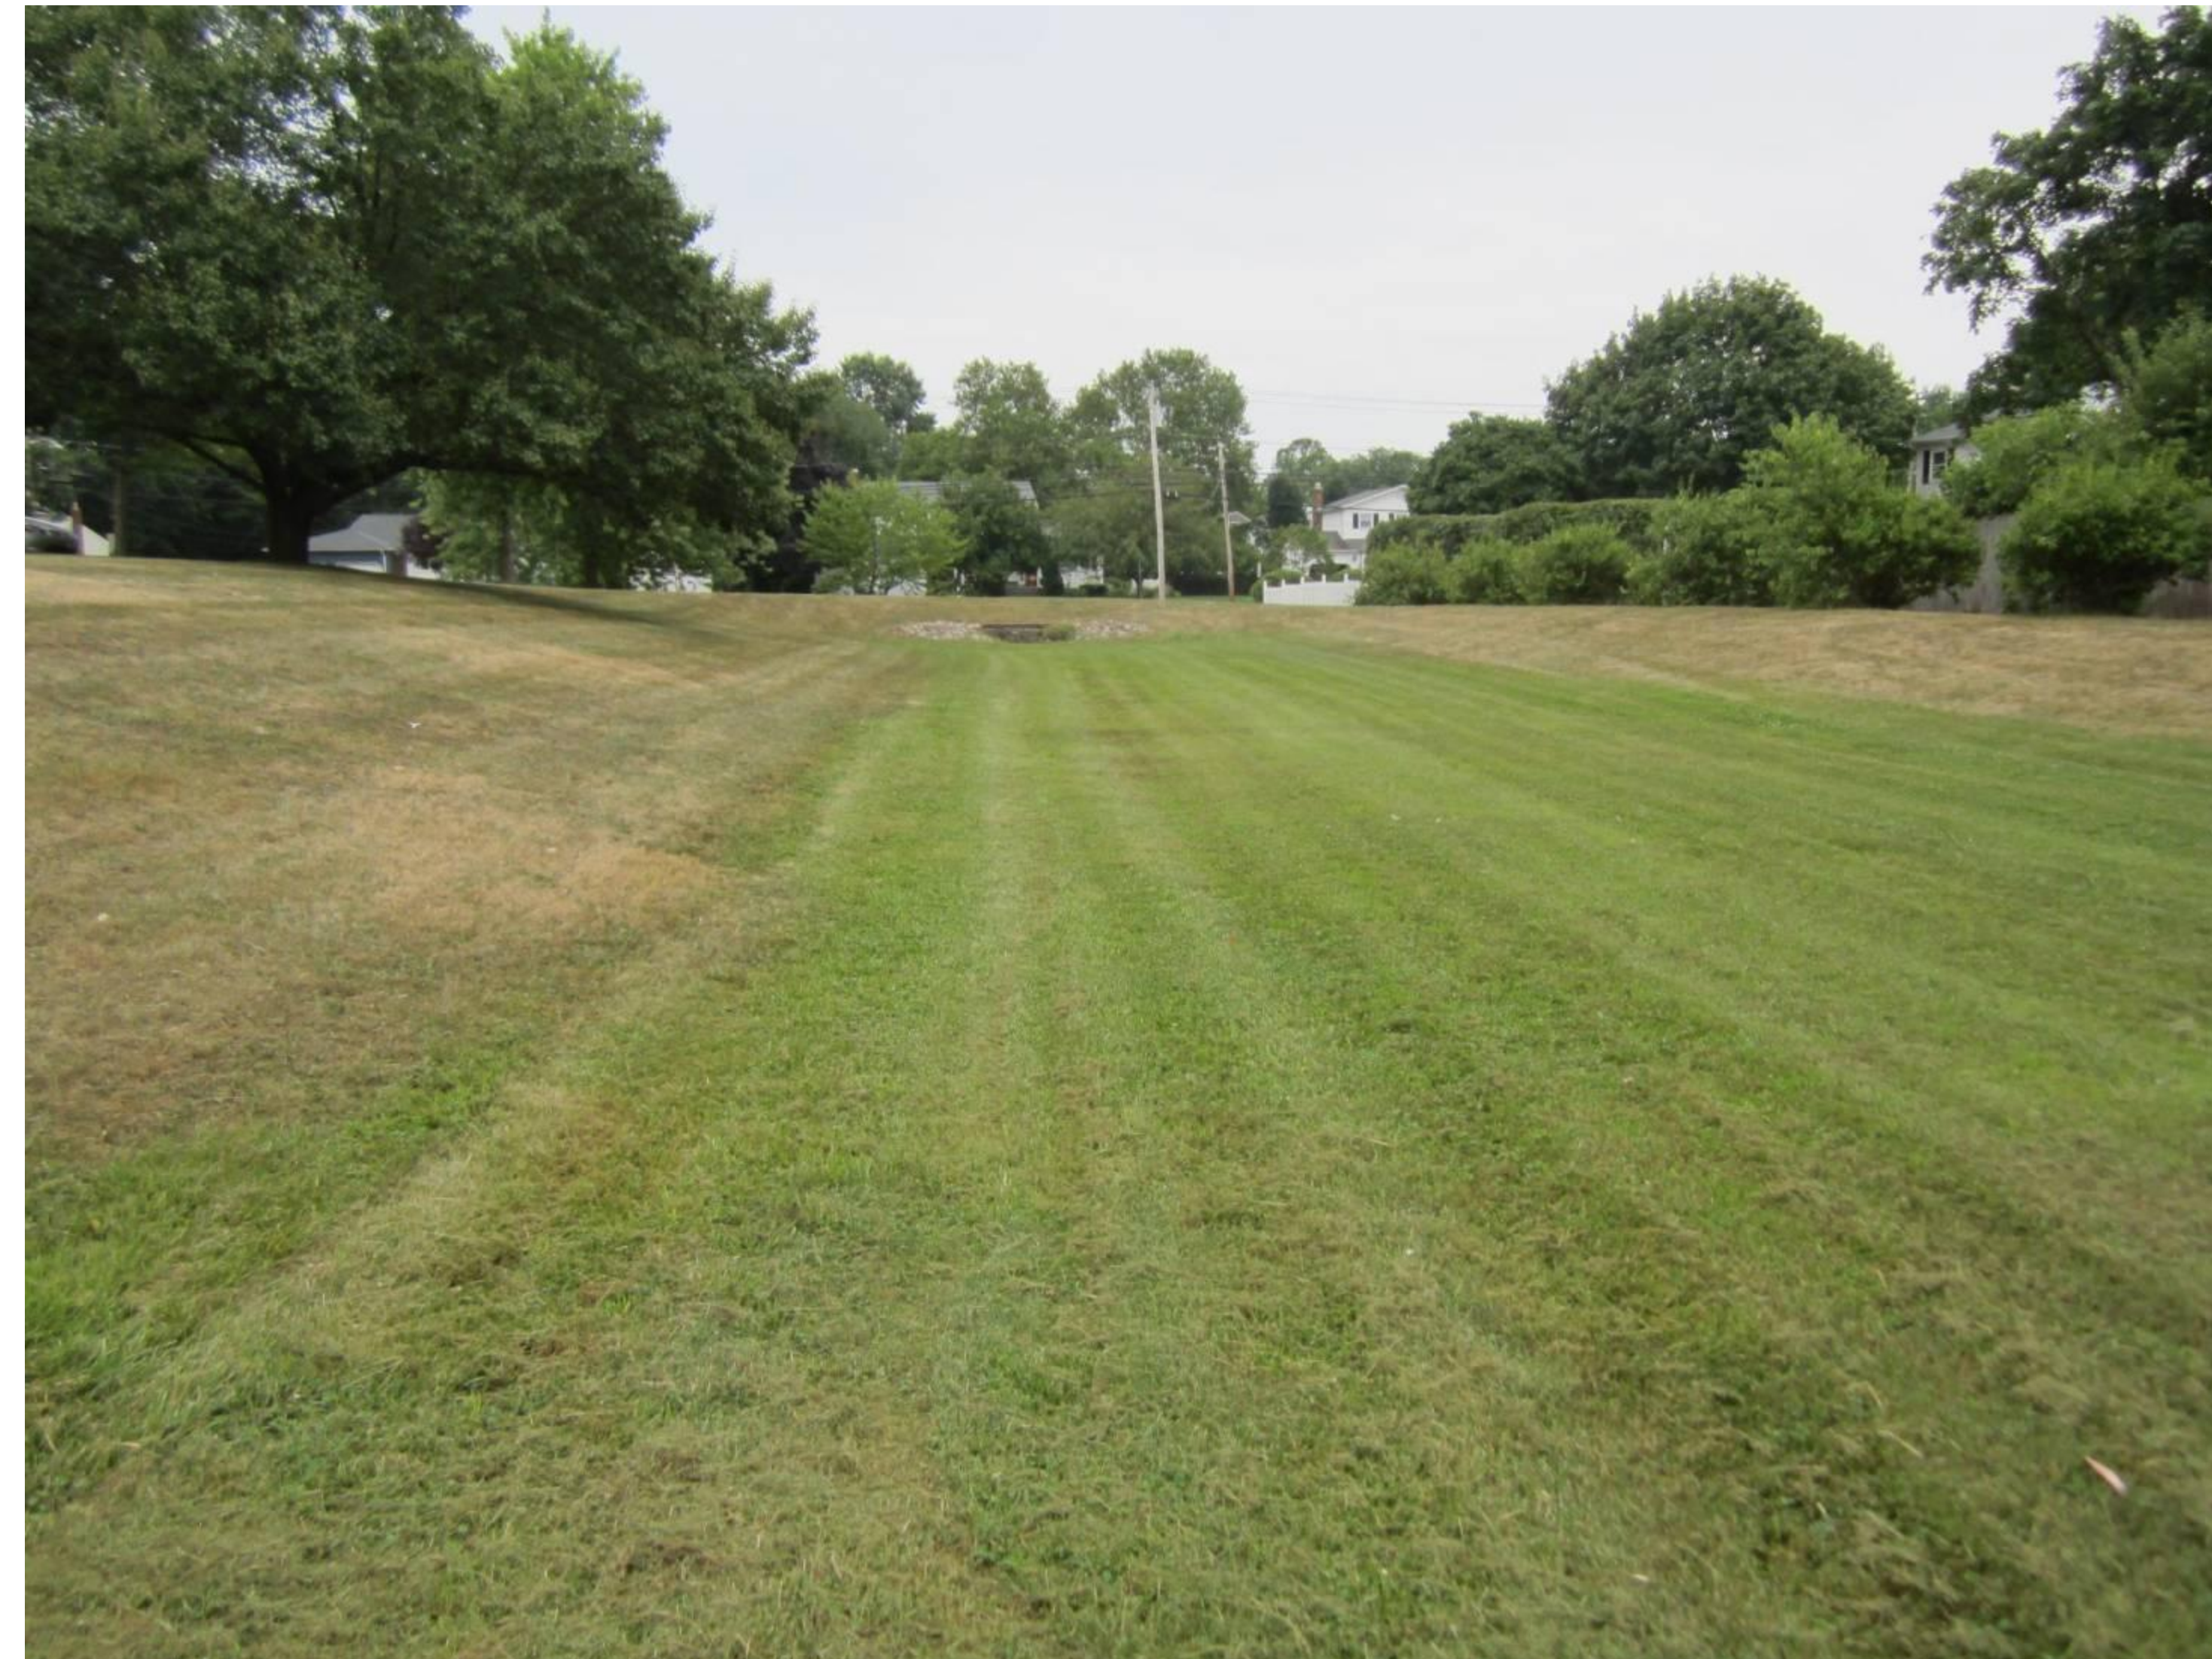
Looking north along basin bottom
