Hamilton Township (Mercer County) Stormwater Basin Assessment Summary (Year 1)

Developed by the Rutgers Cooperative Extension Water Resources Program
Funded by Hamilton Township, Mercer County, New Jersey

December 6, 2012

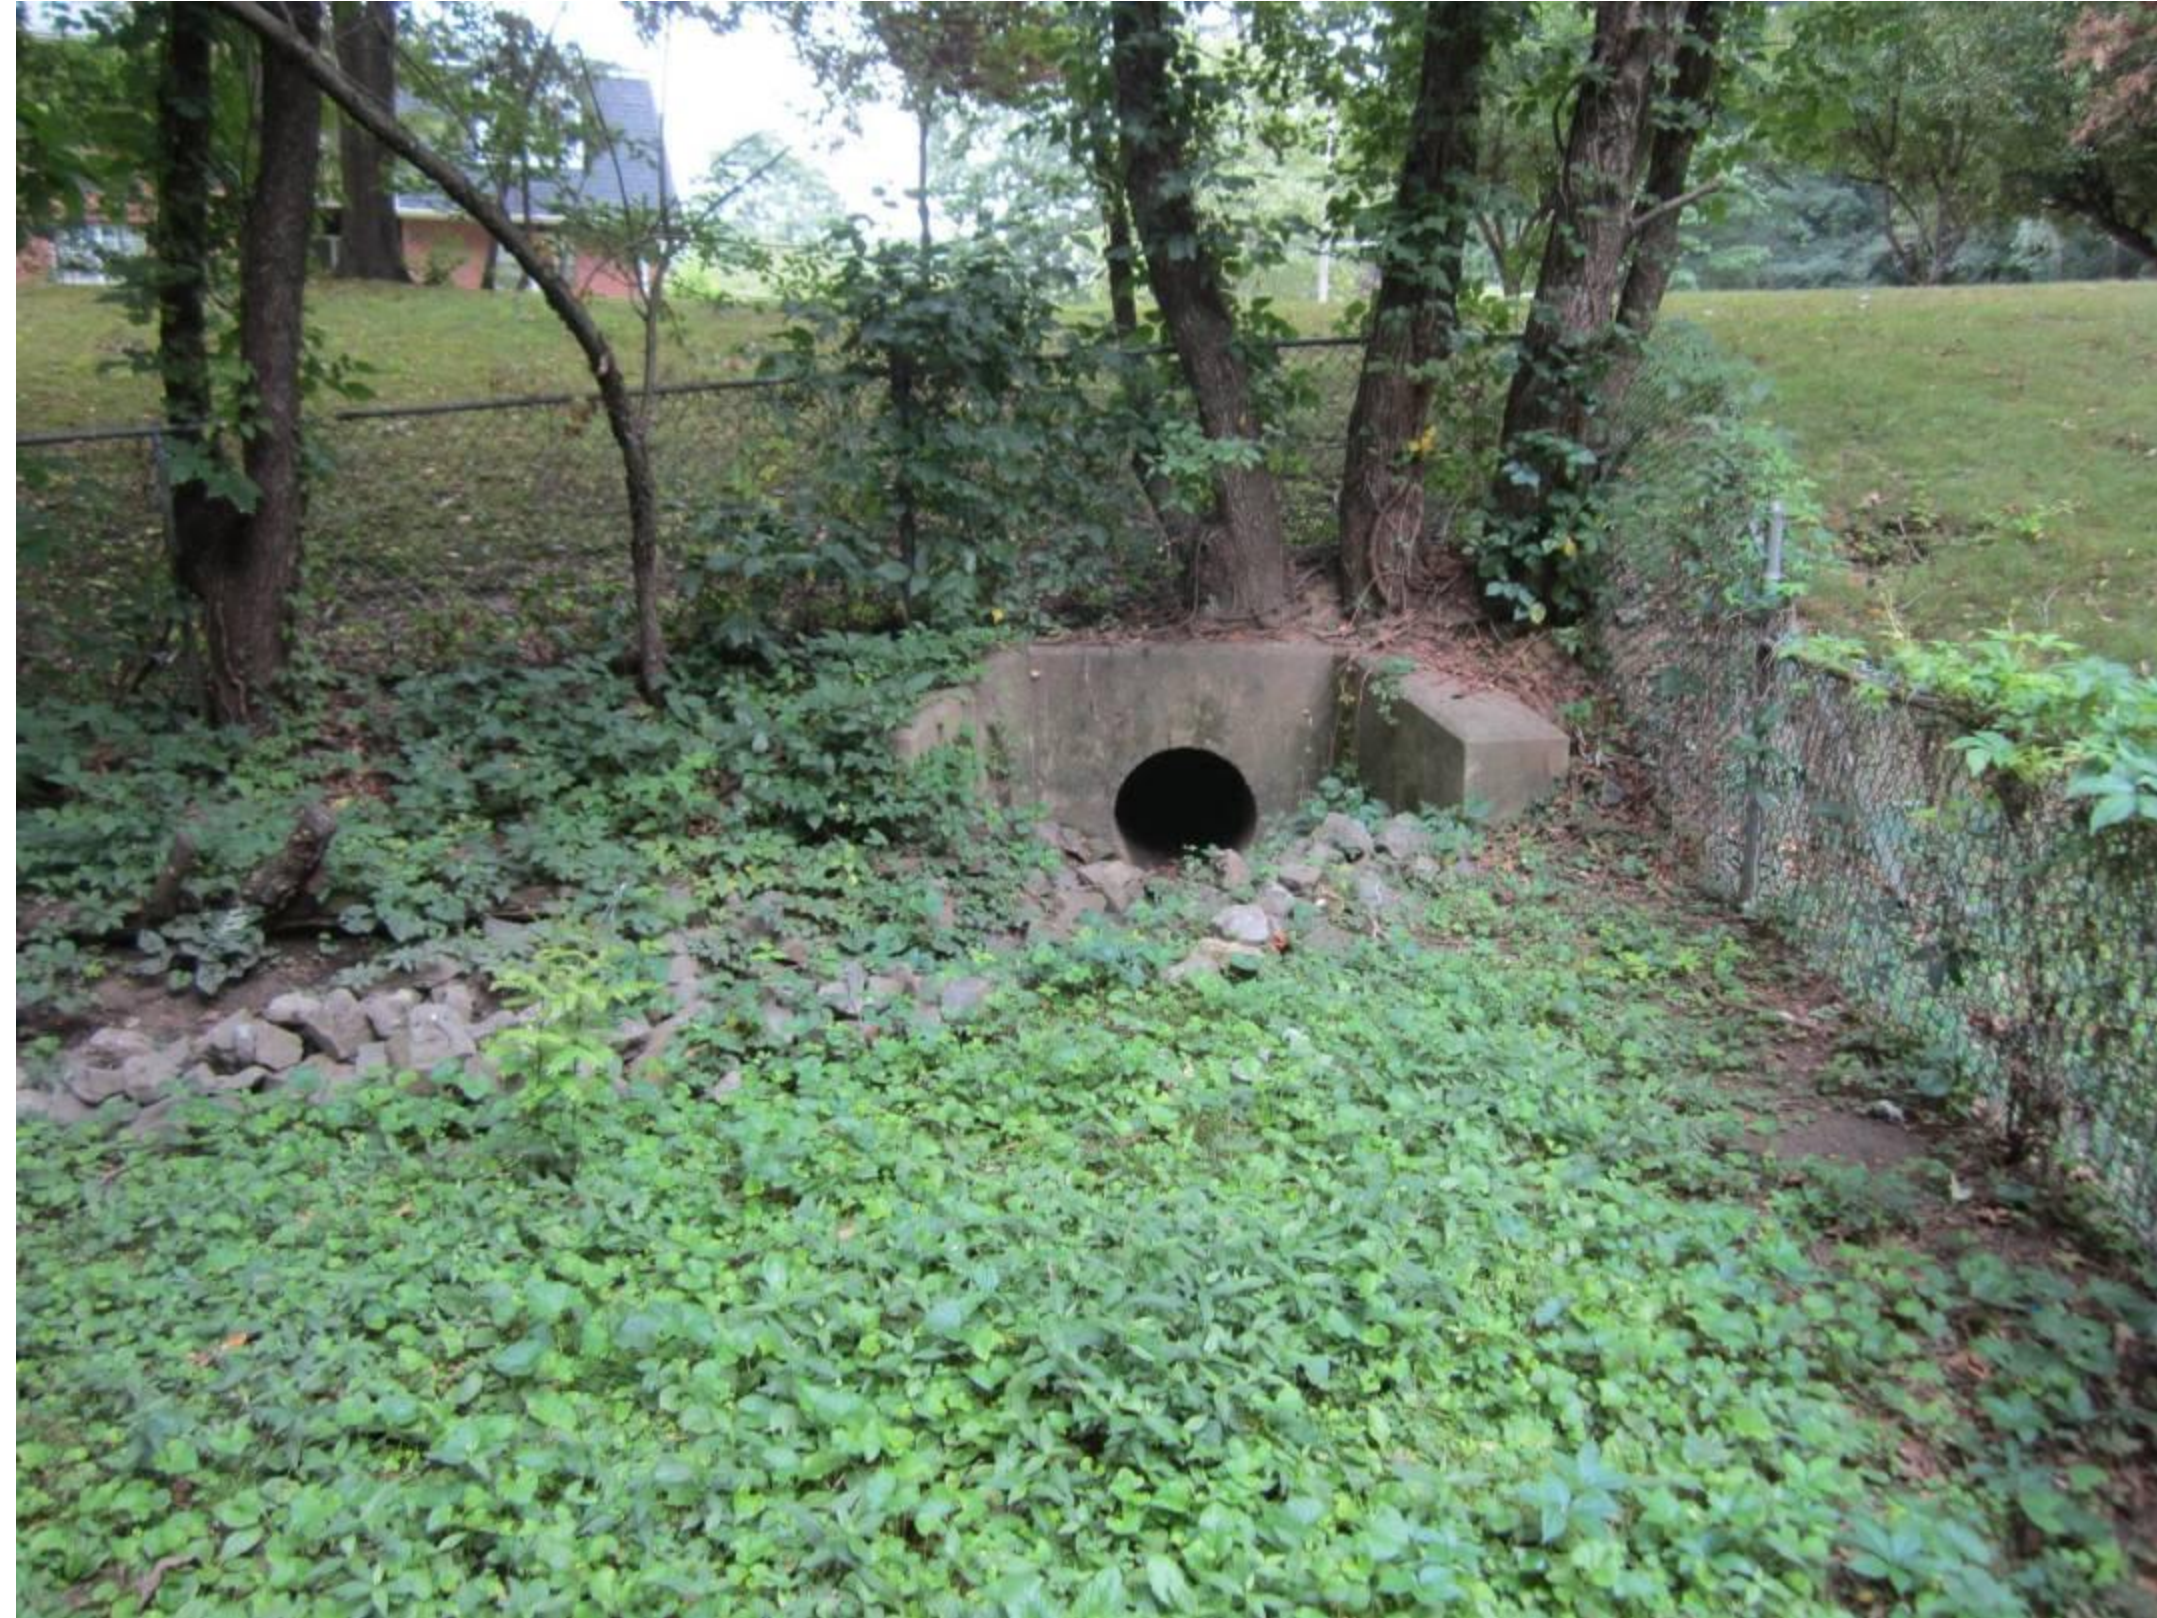
Inlet with woody vegetation

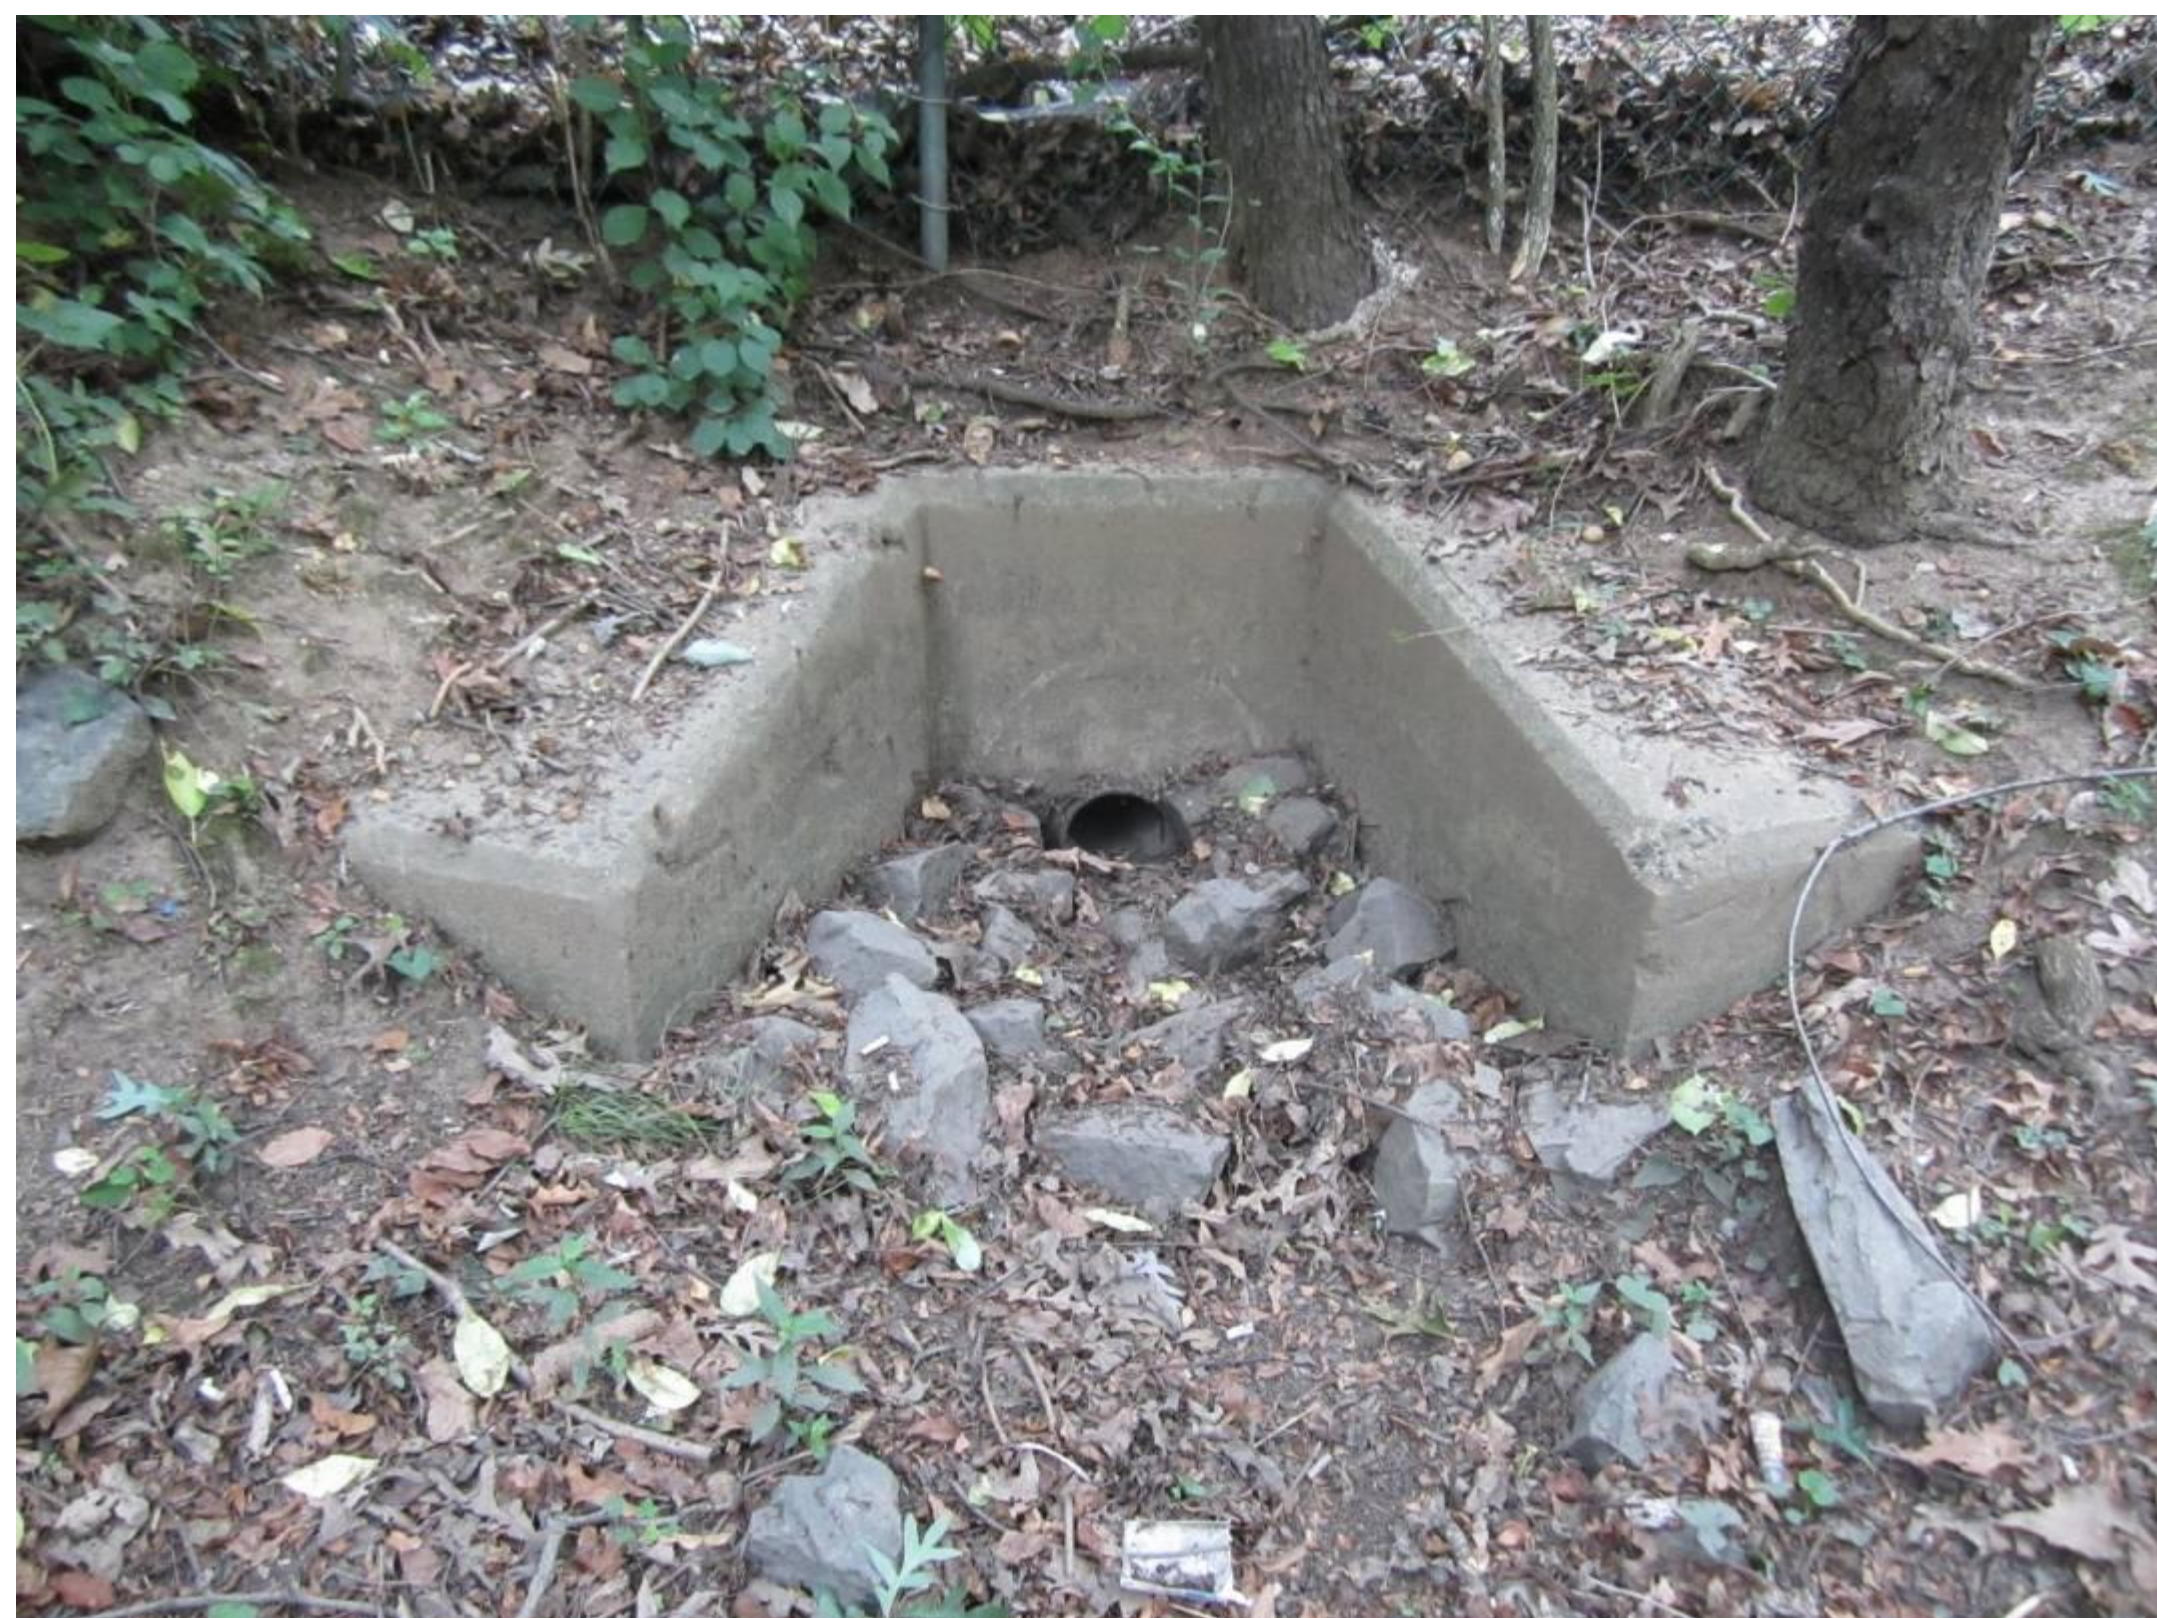
Outlet with woody vegetation and sediment

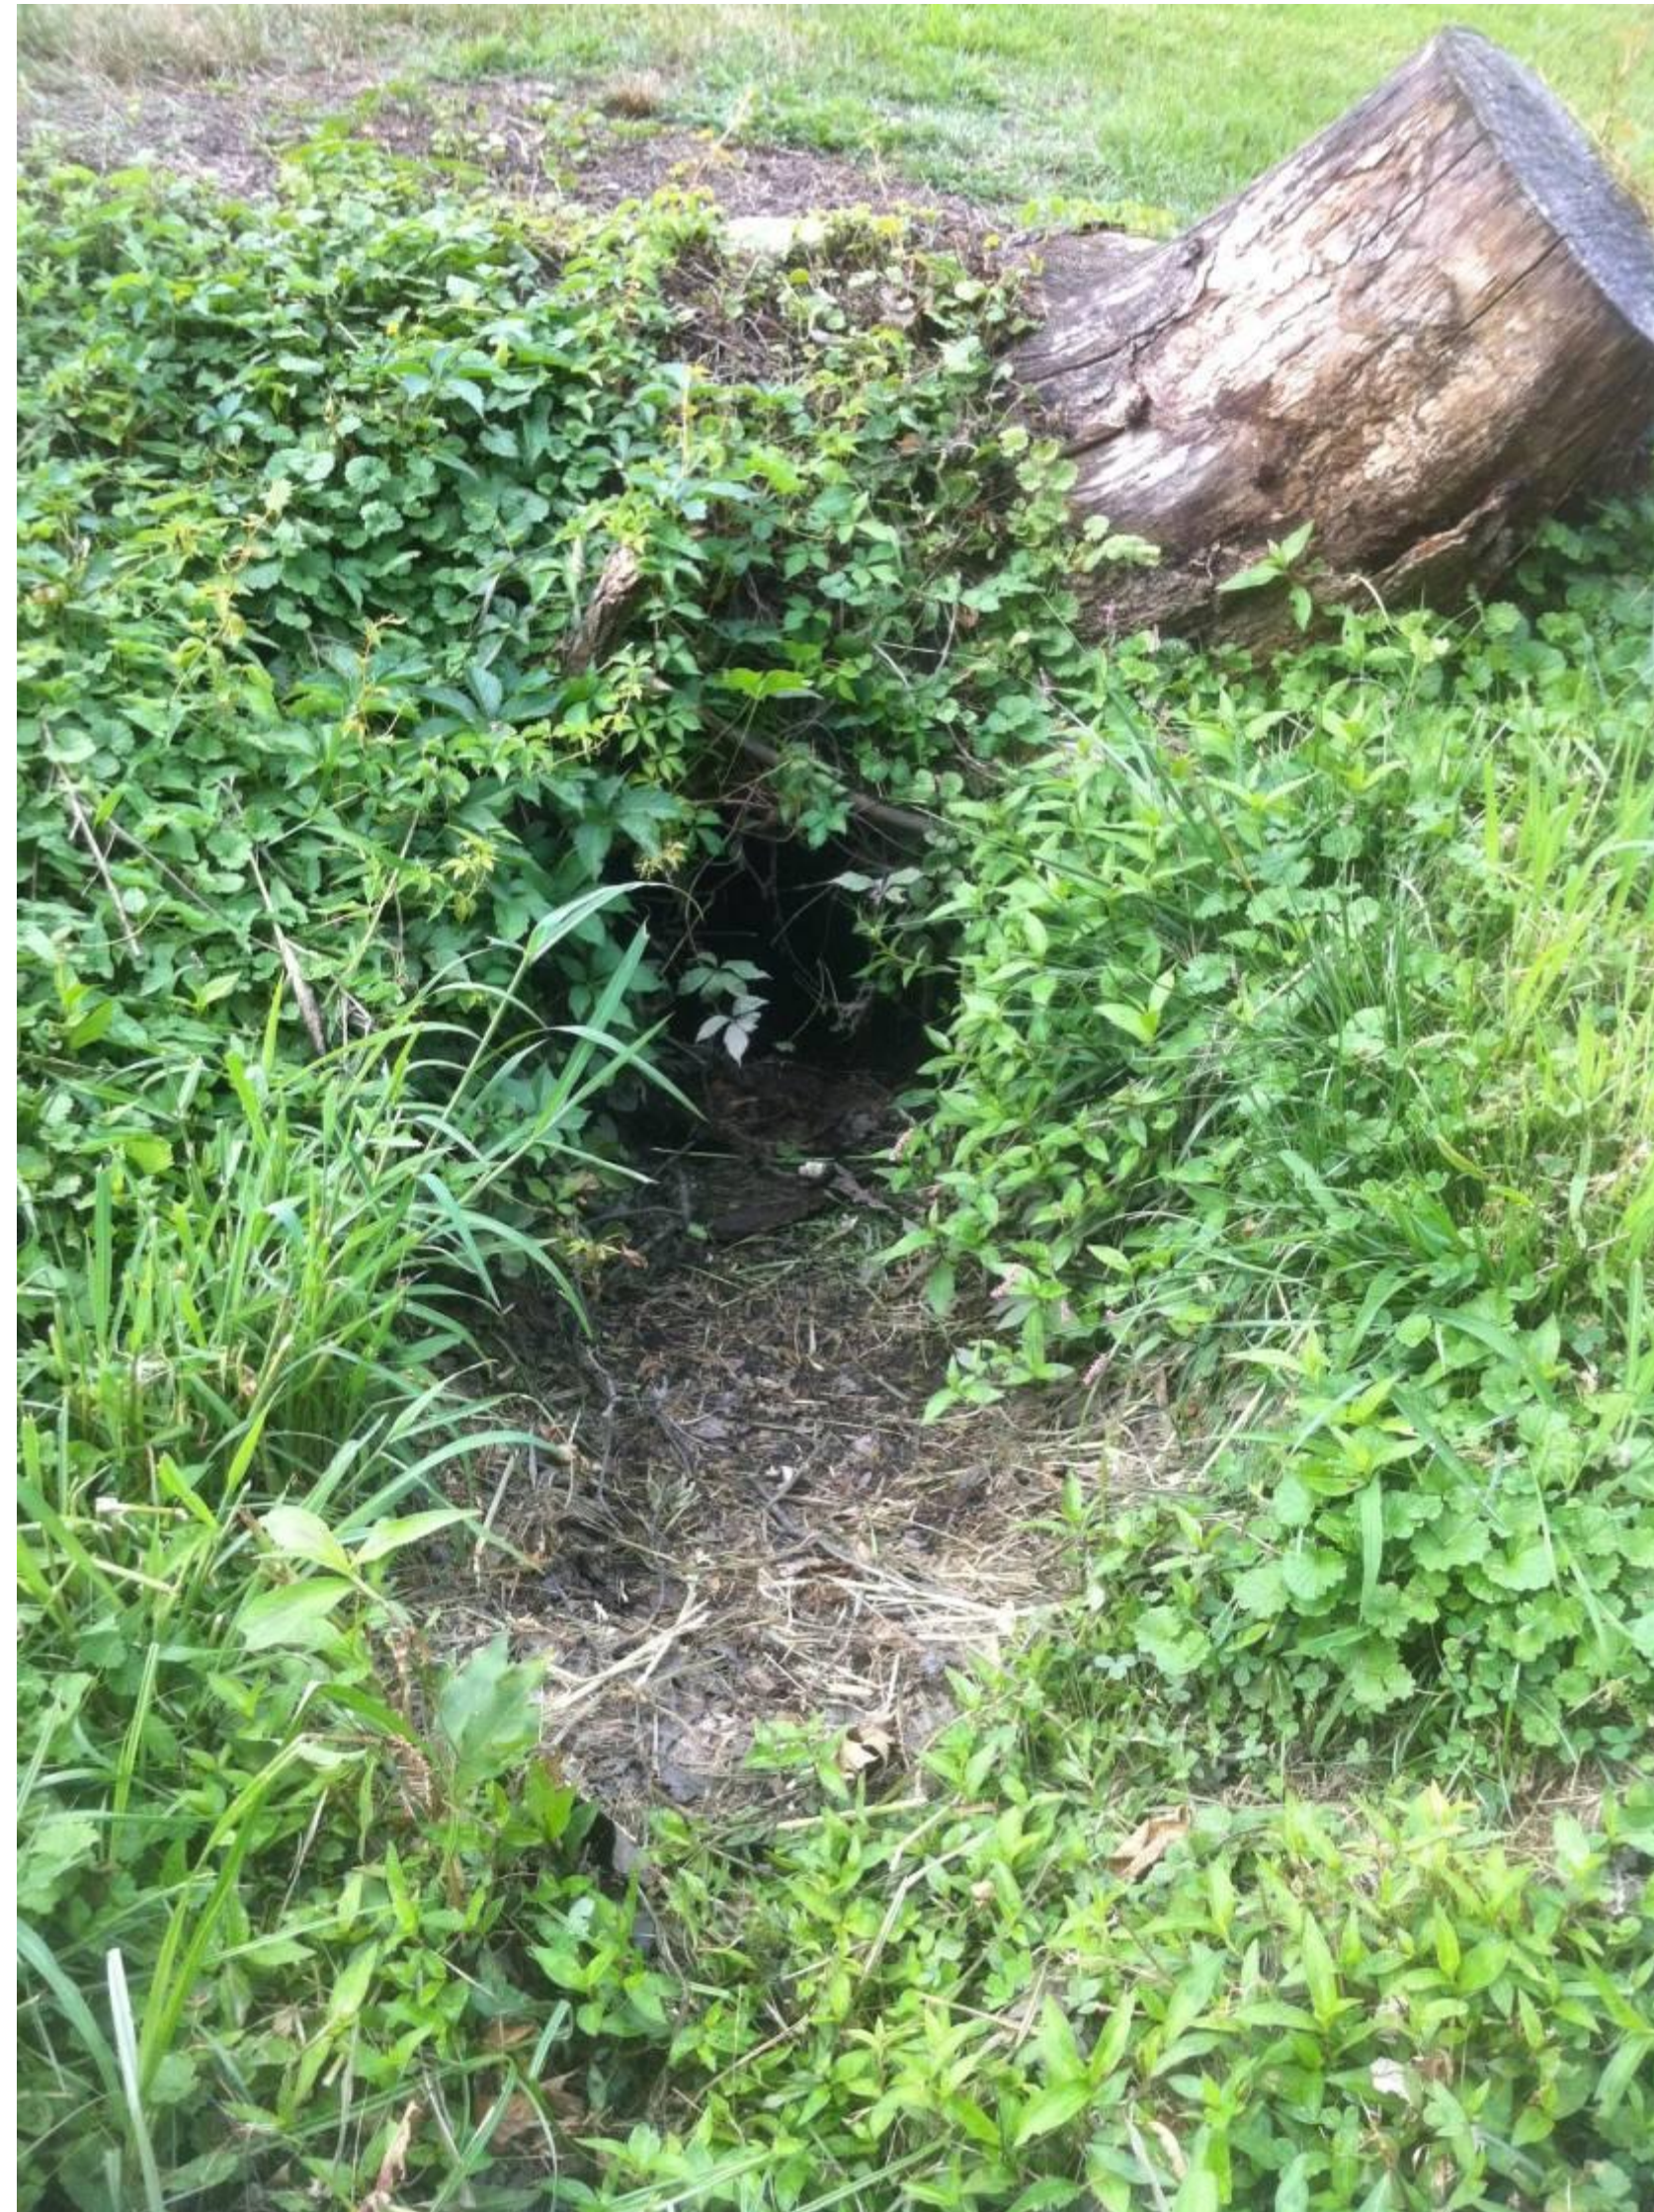
Overgrown inlet

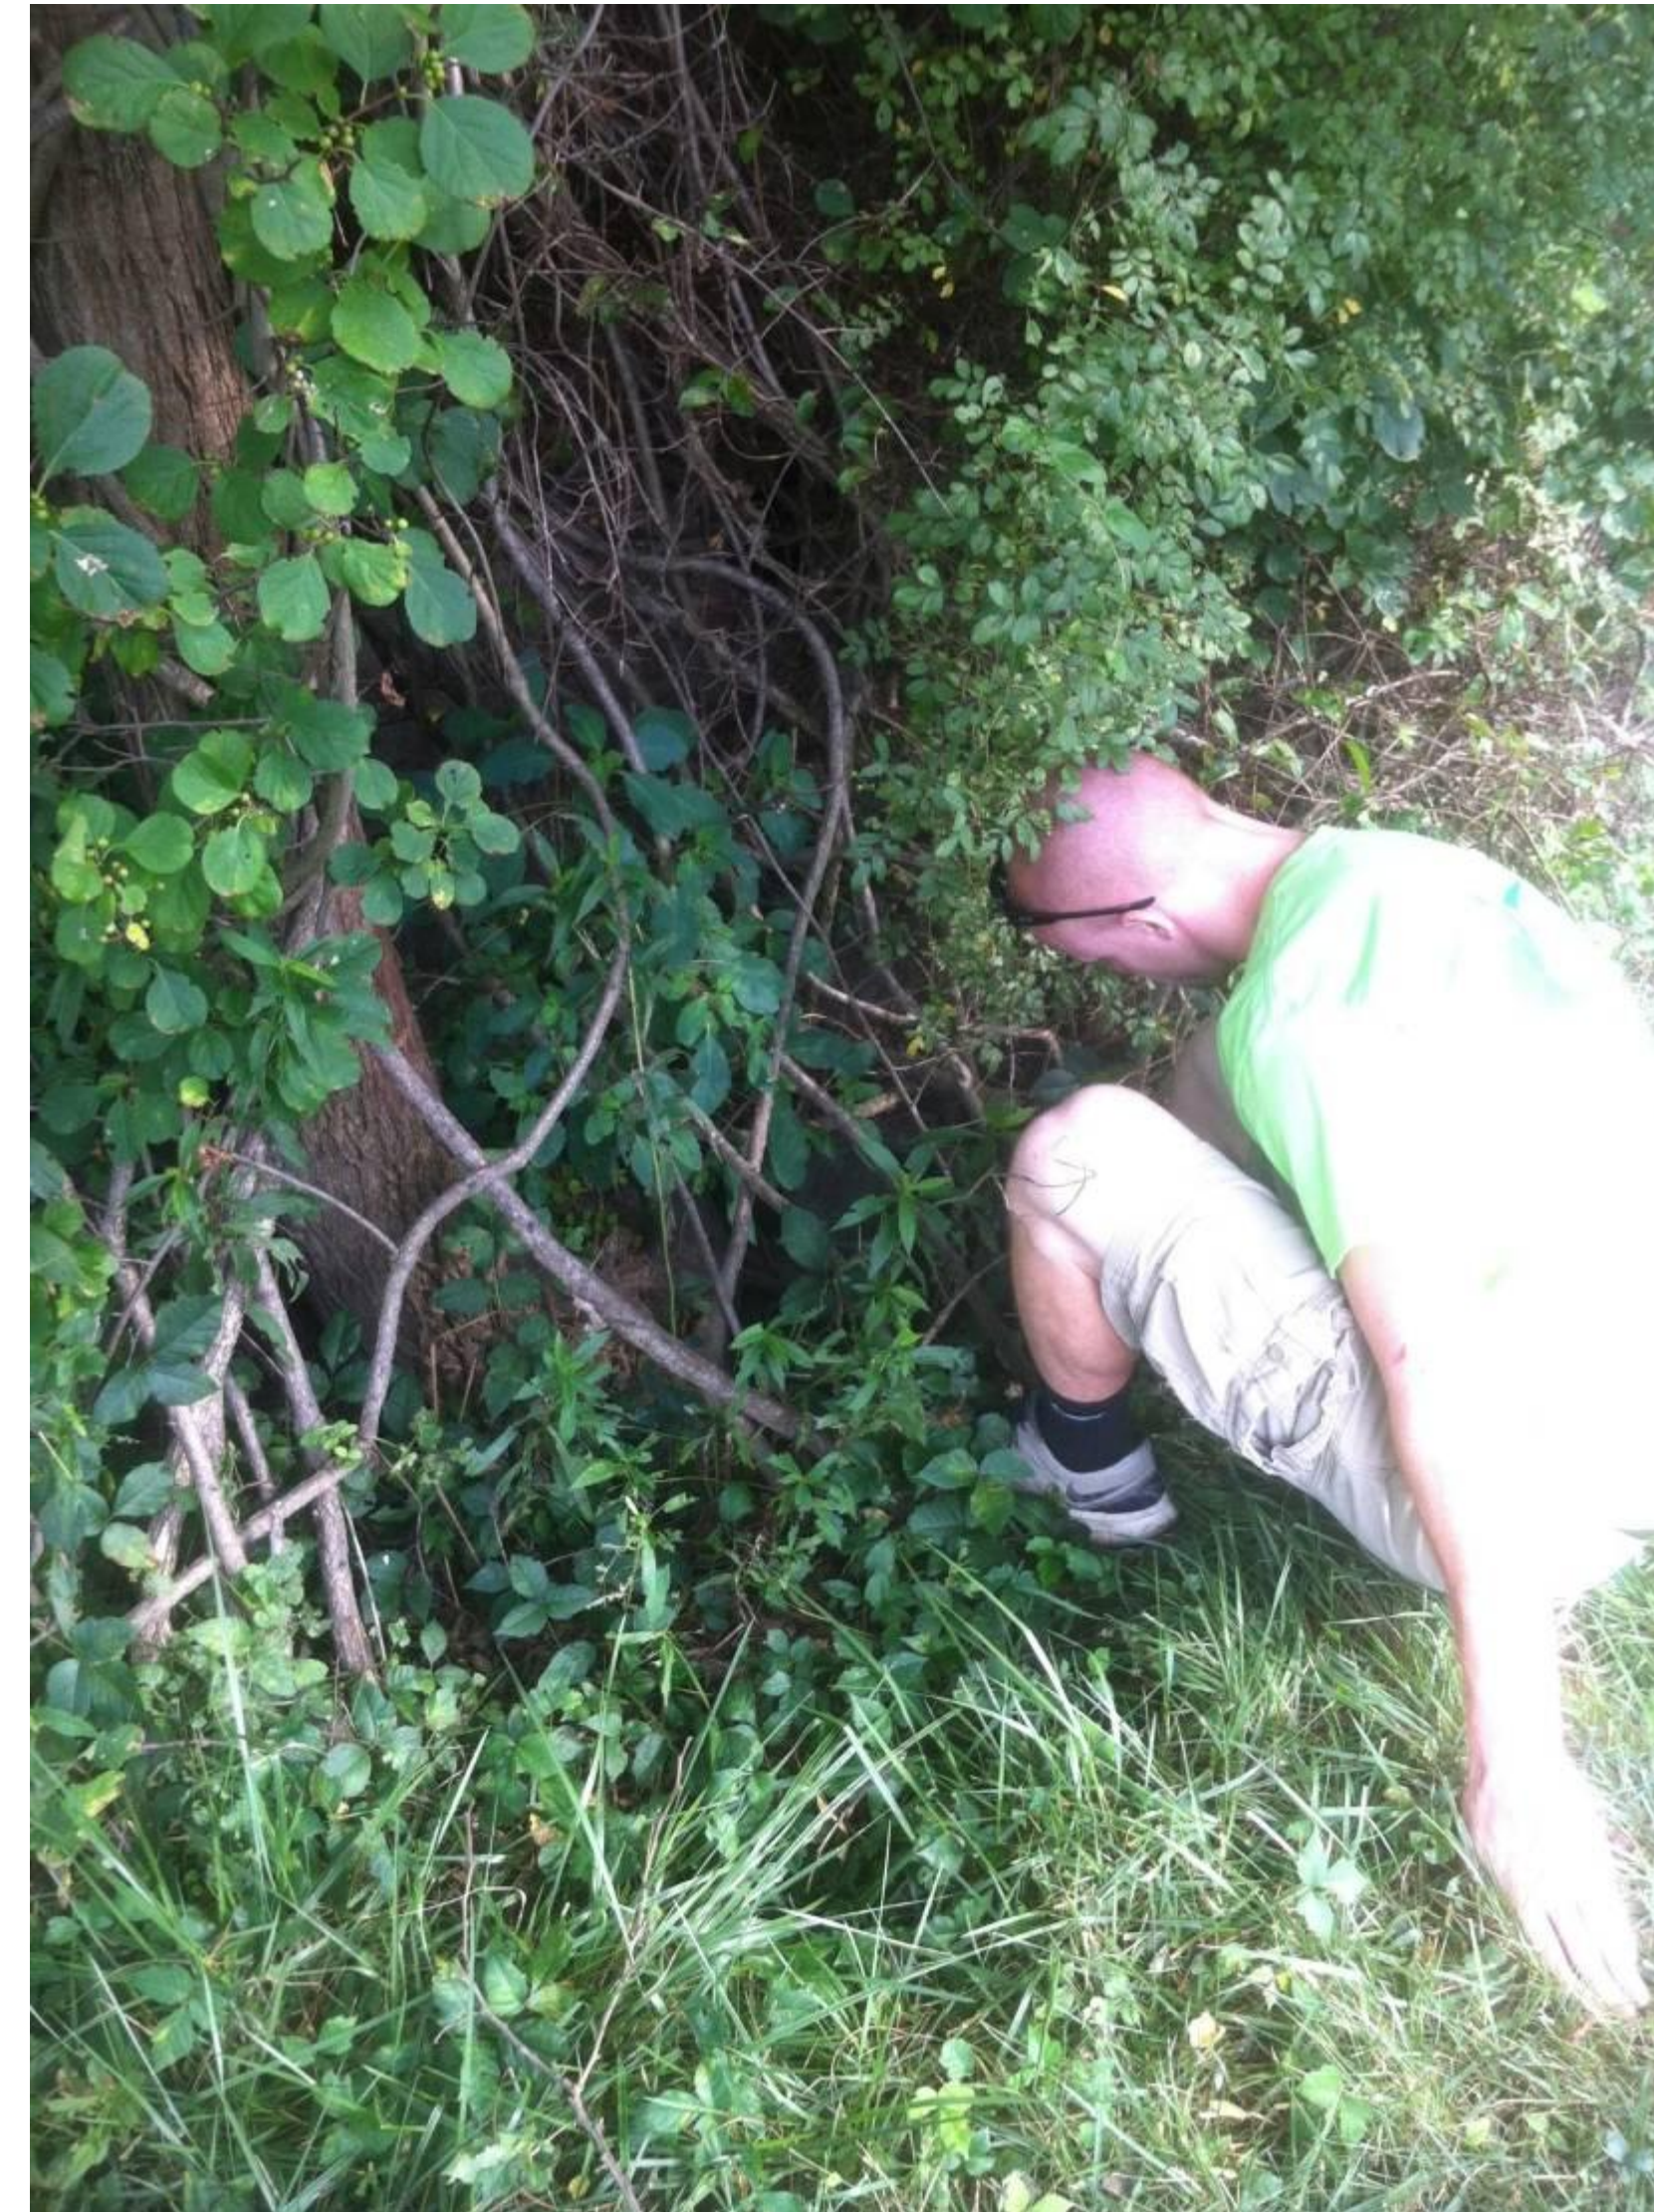
Outlet with woody vegetation

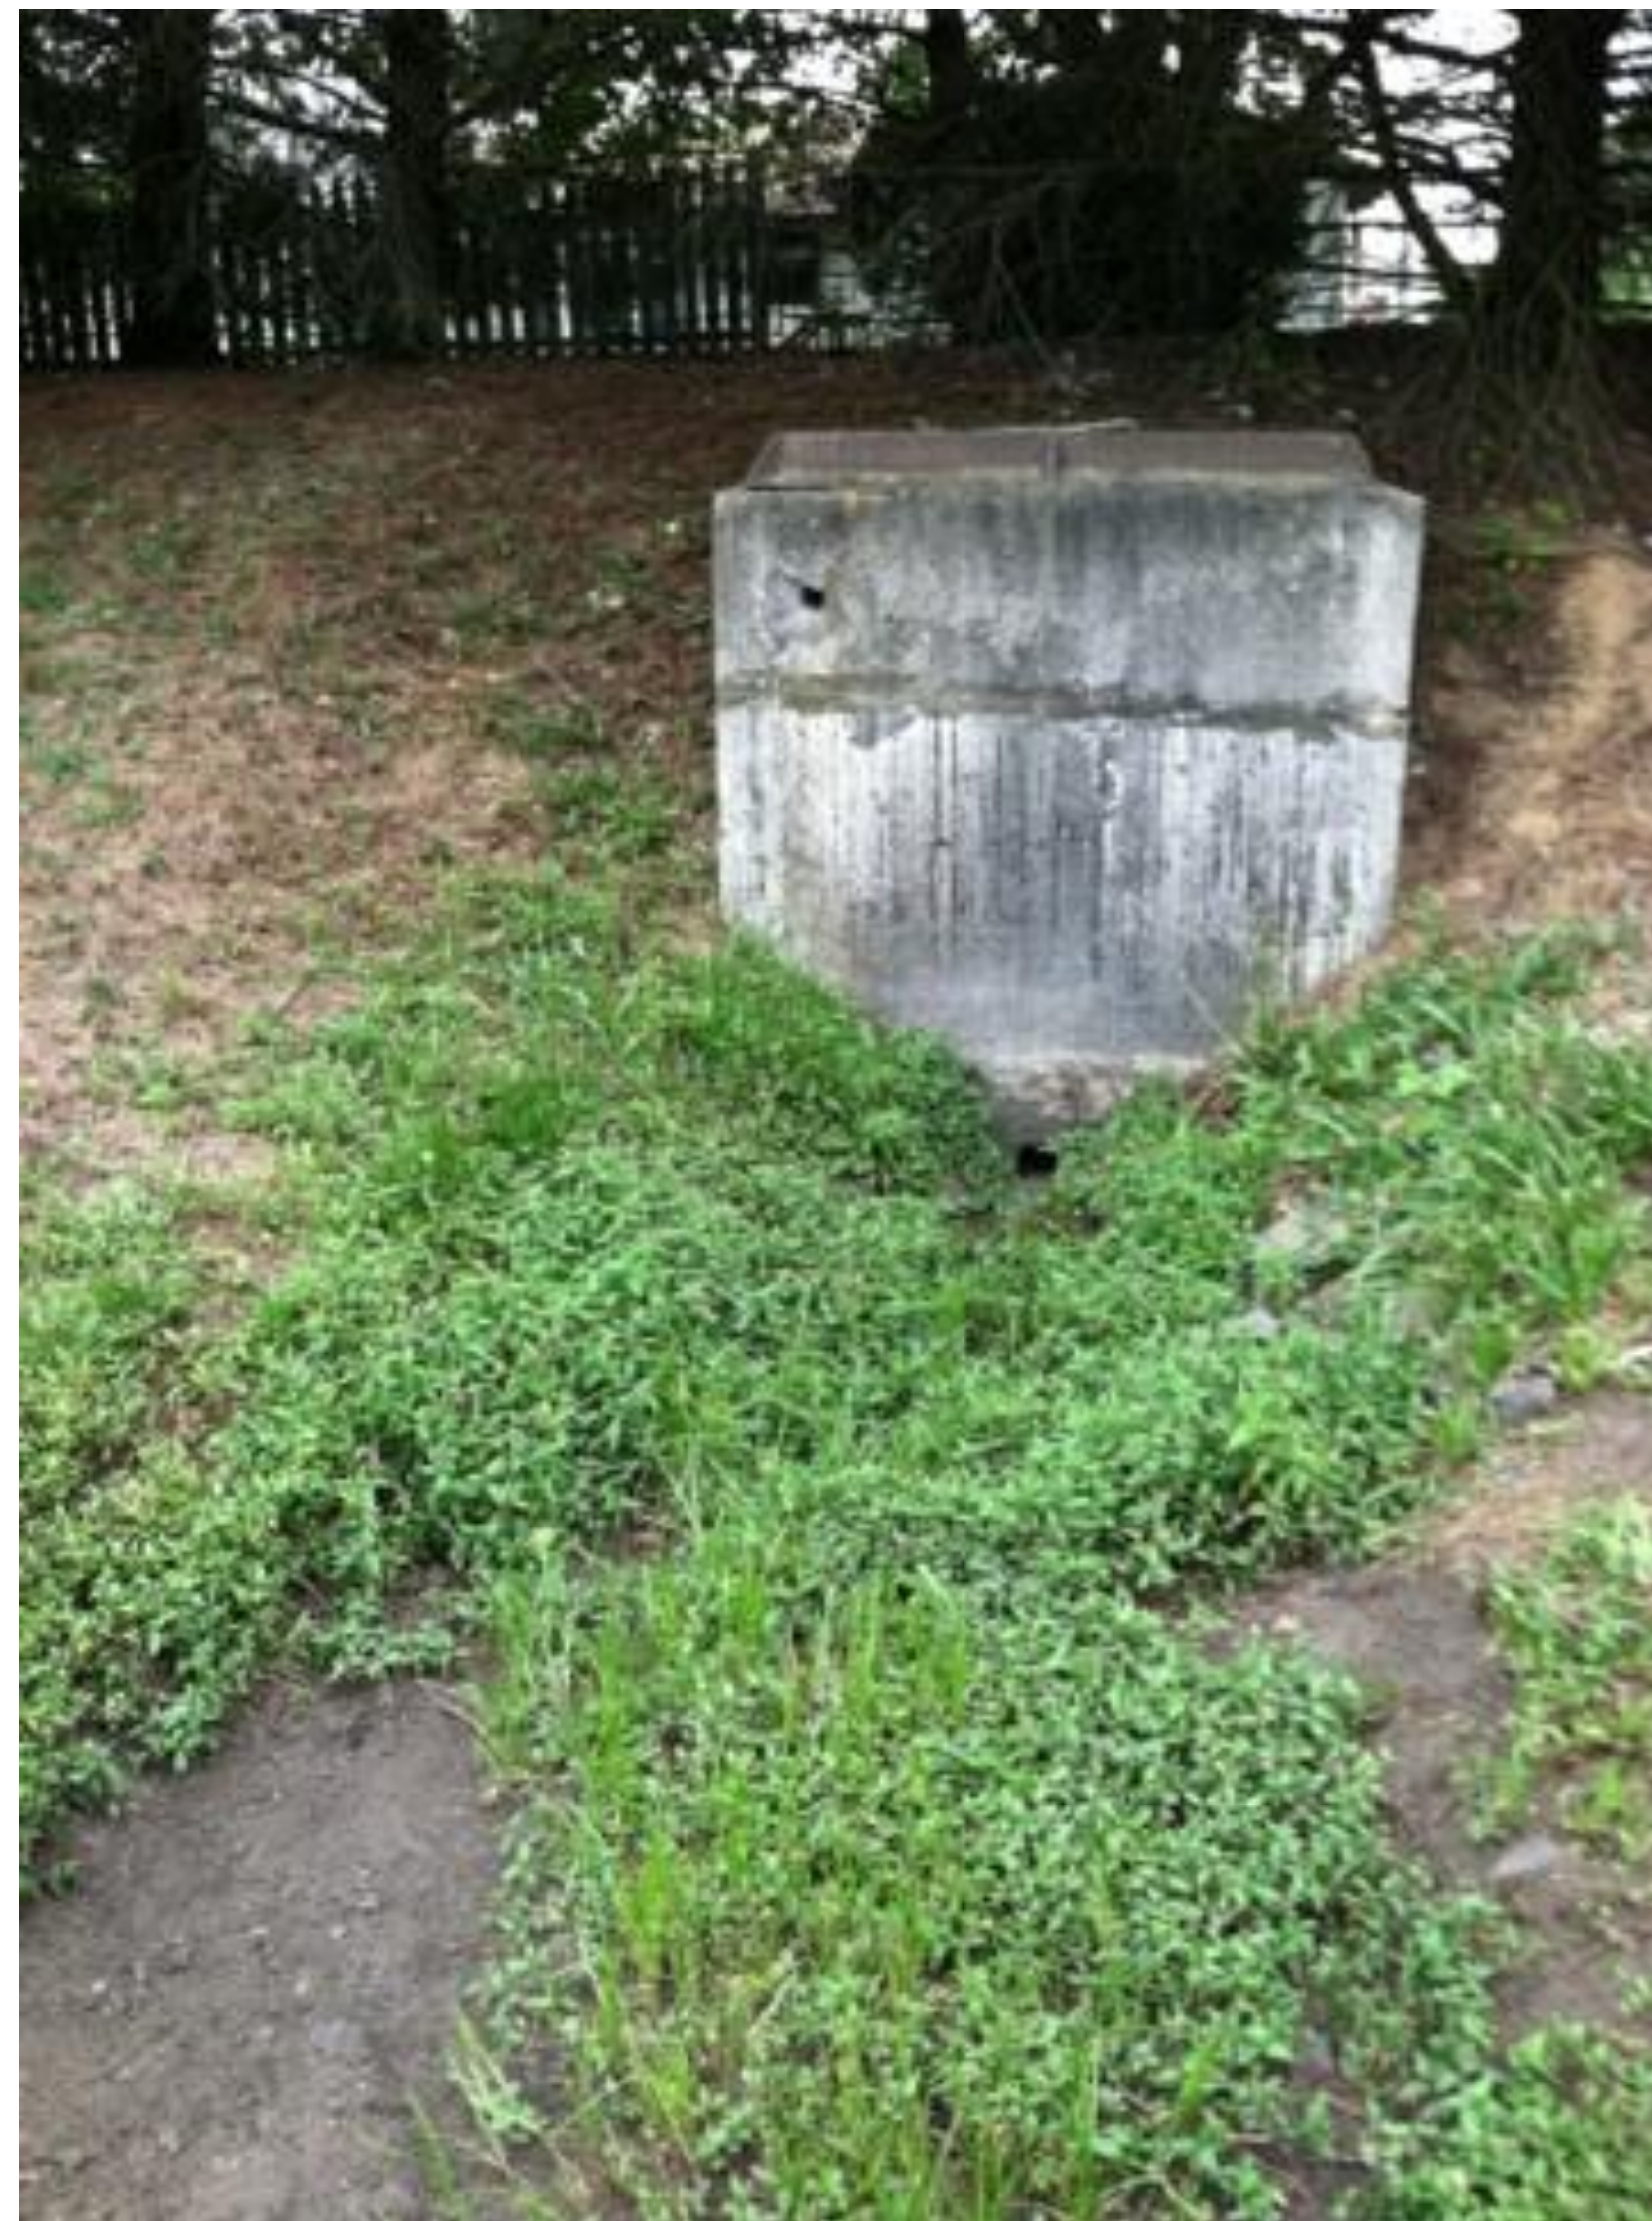
Outlet structure

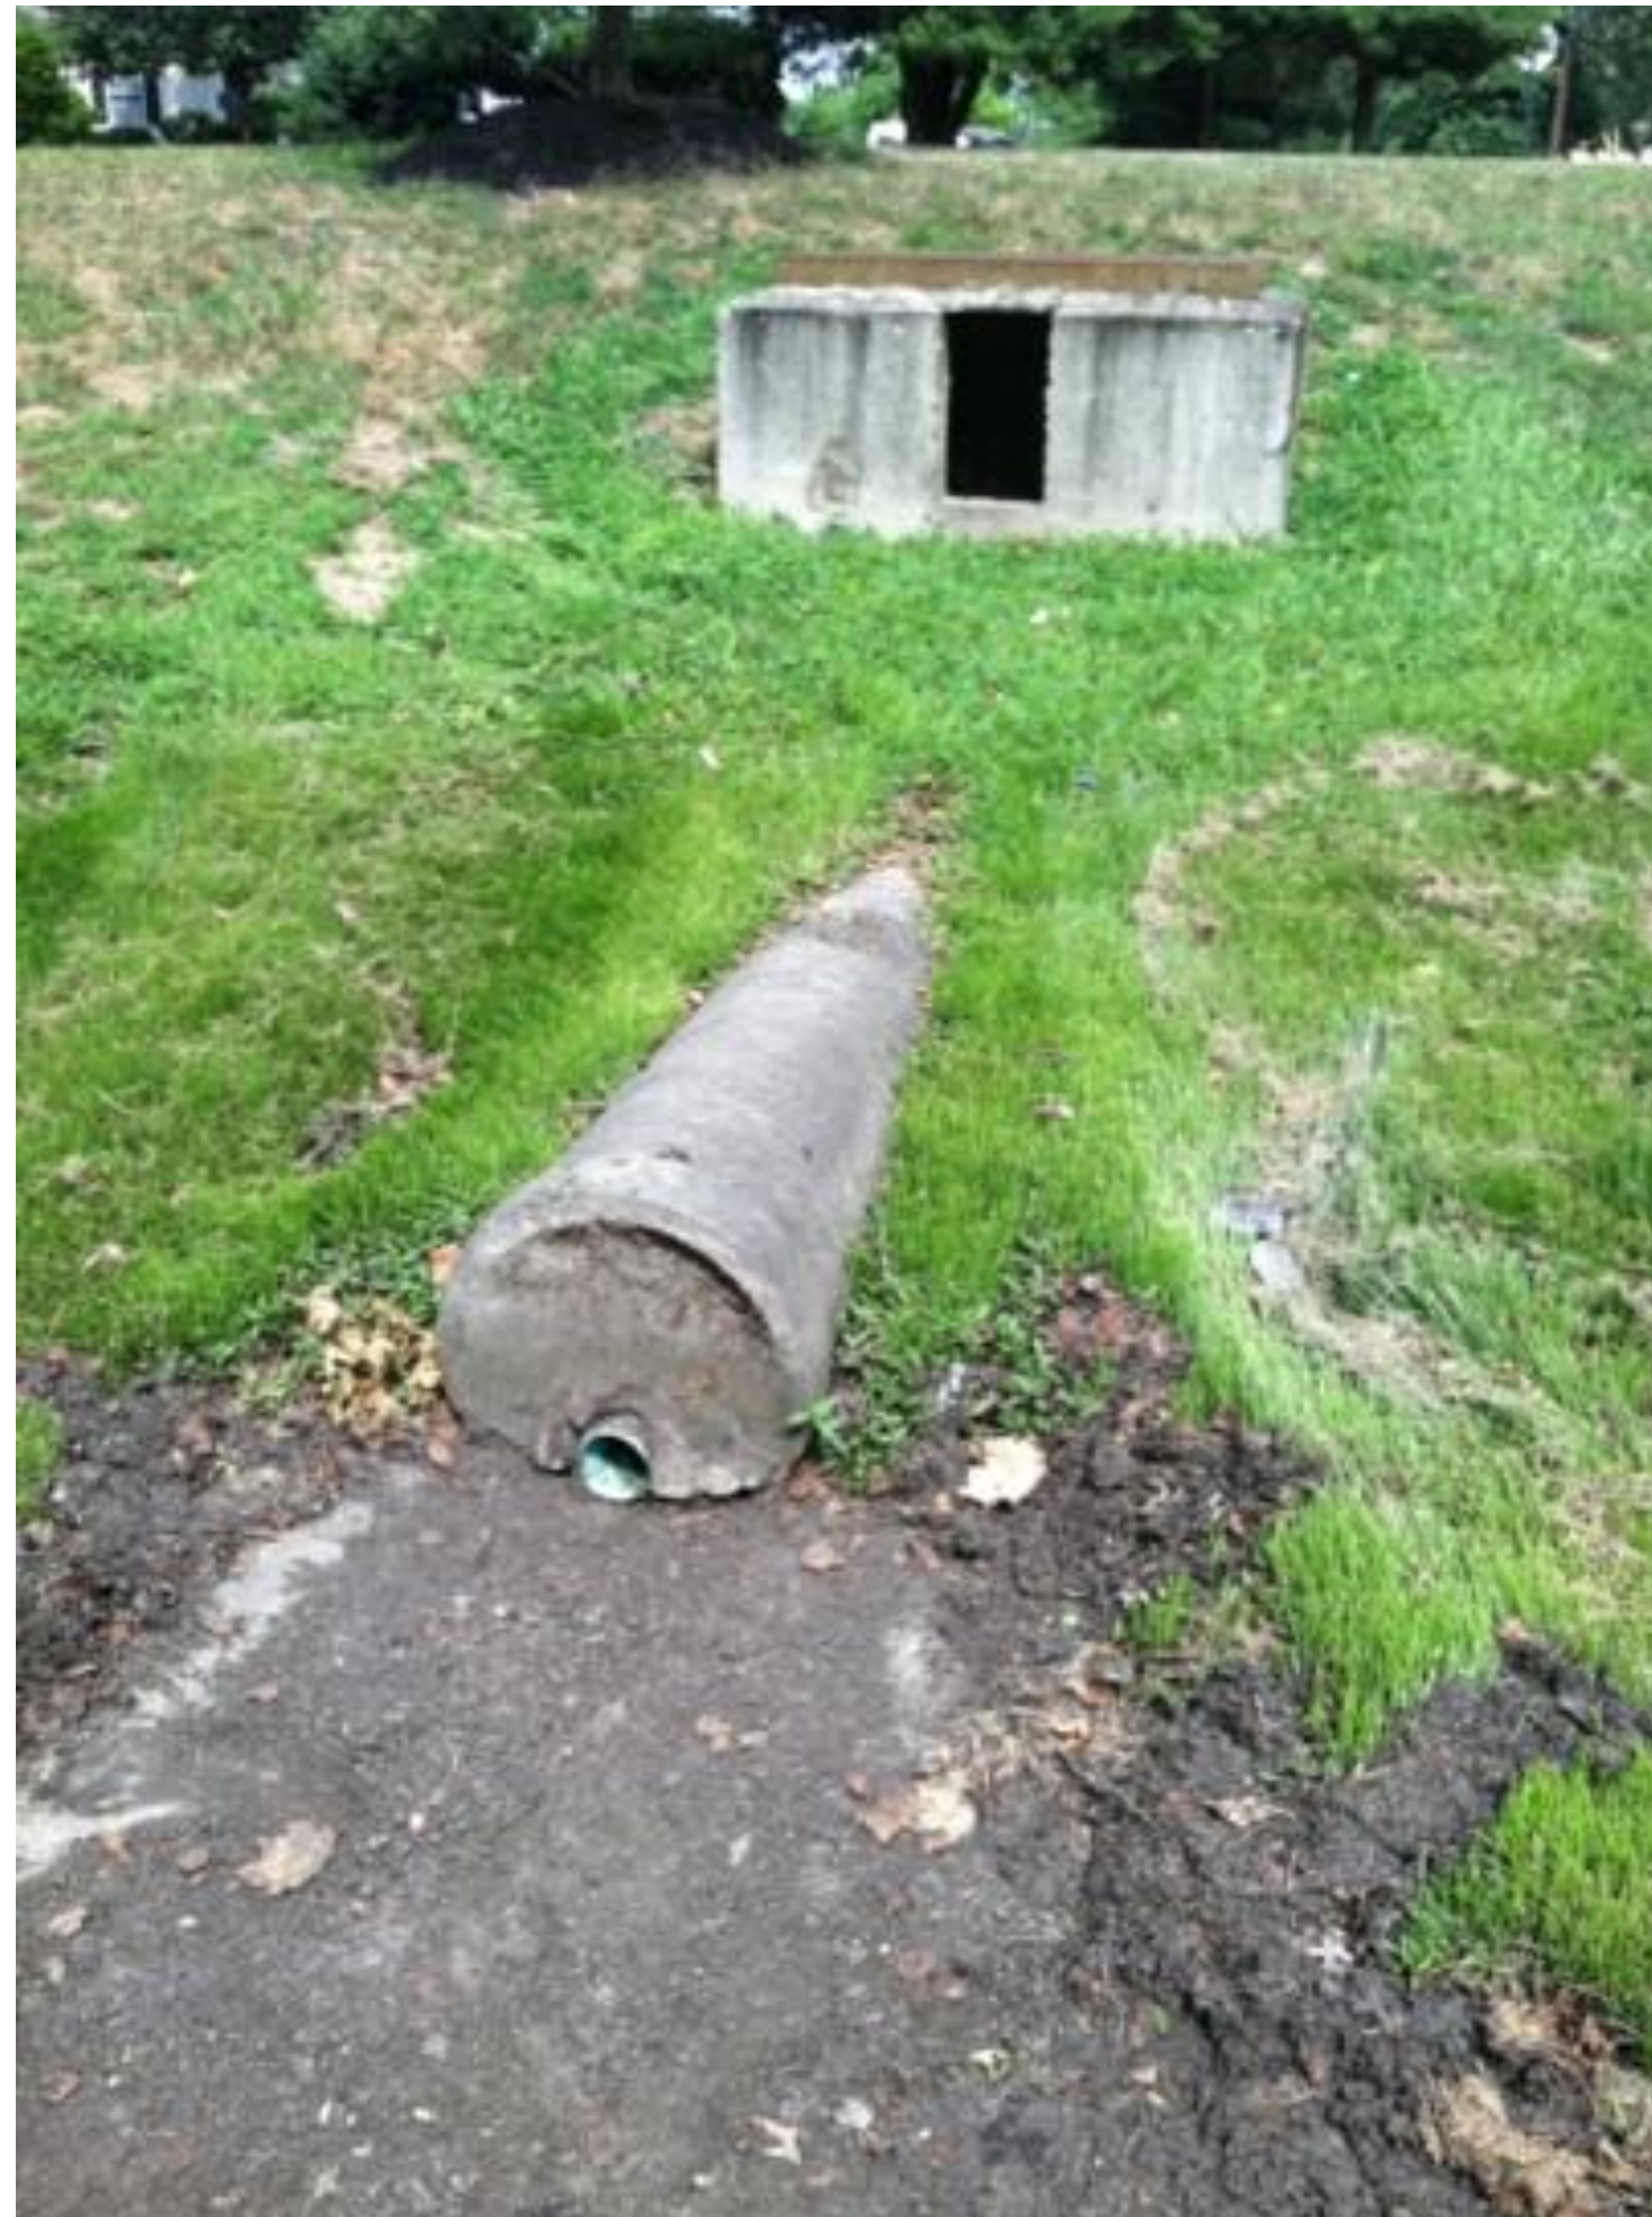
Outlet structure
