Hamilton Township (Mercer County) Stormwater Basin Assessment Summary (Year 1)

Developed by the Rutgers Cooperative Extension Water Resources Program
Funded by Hamilton Township, Mercer County, New Jersey

December 6, 2012

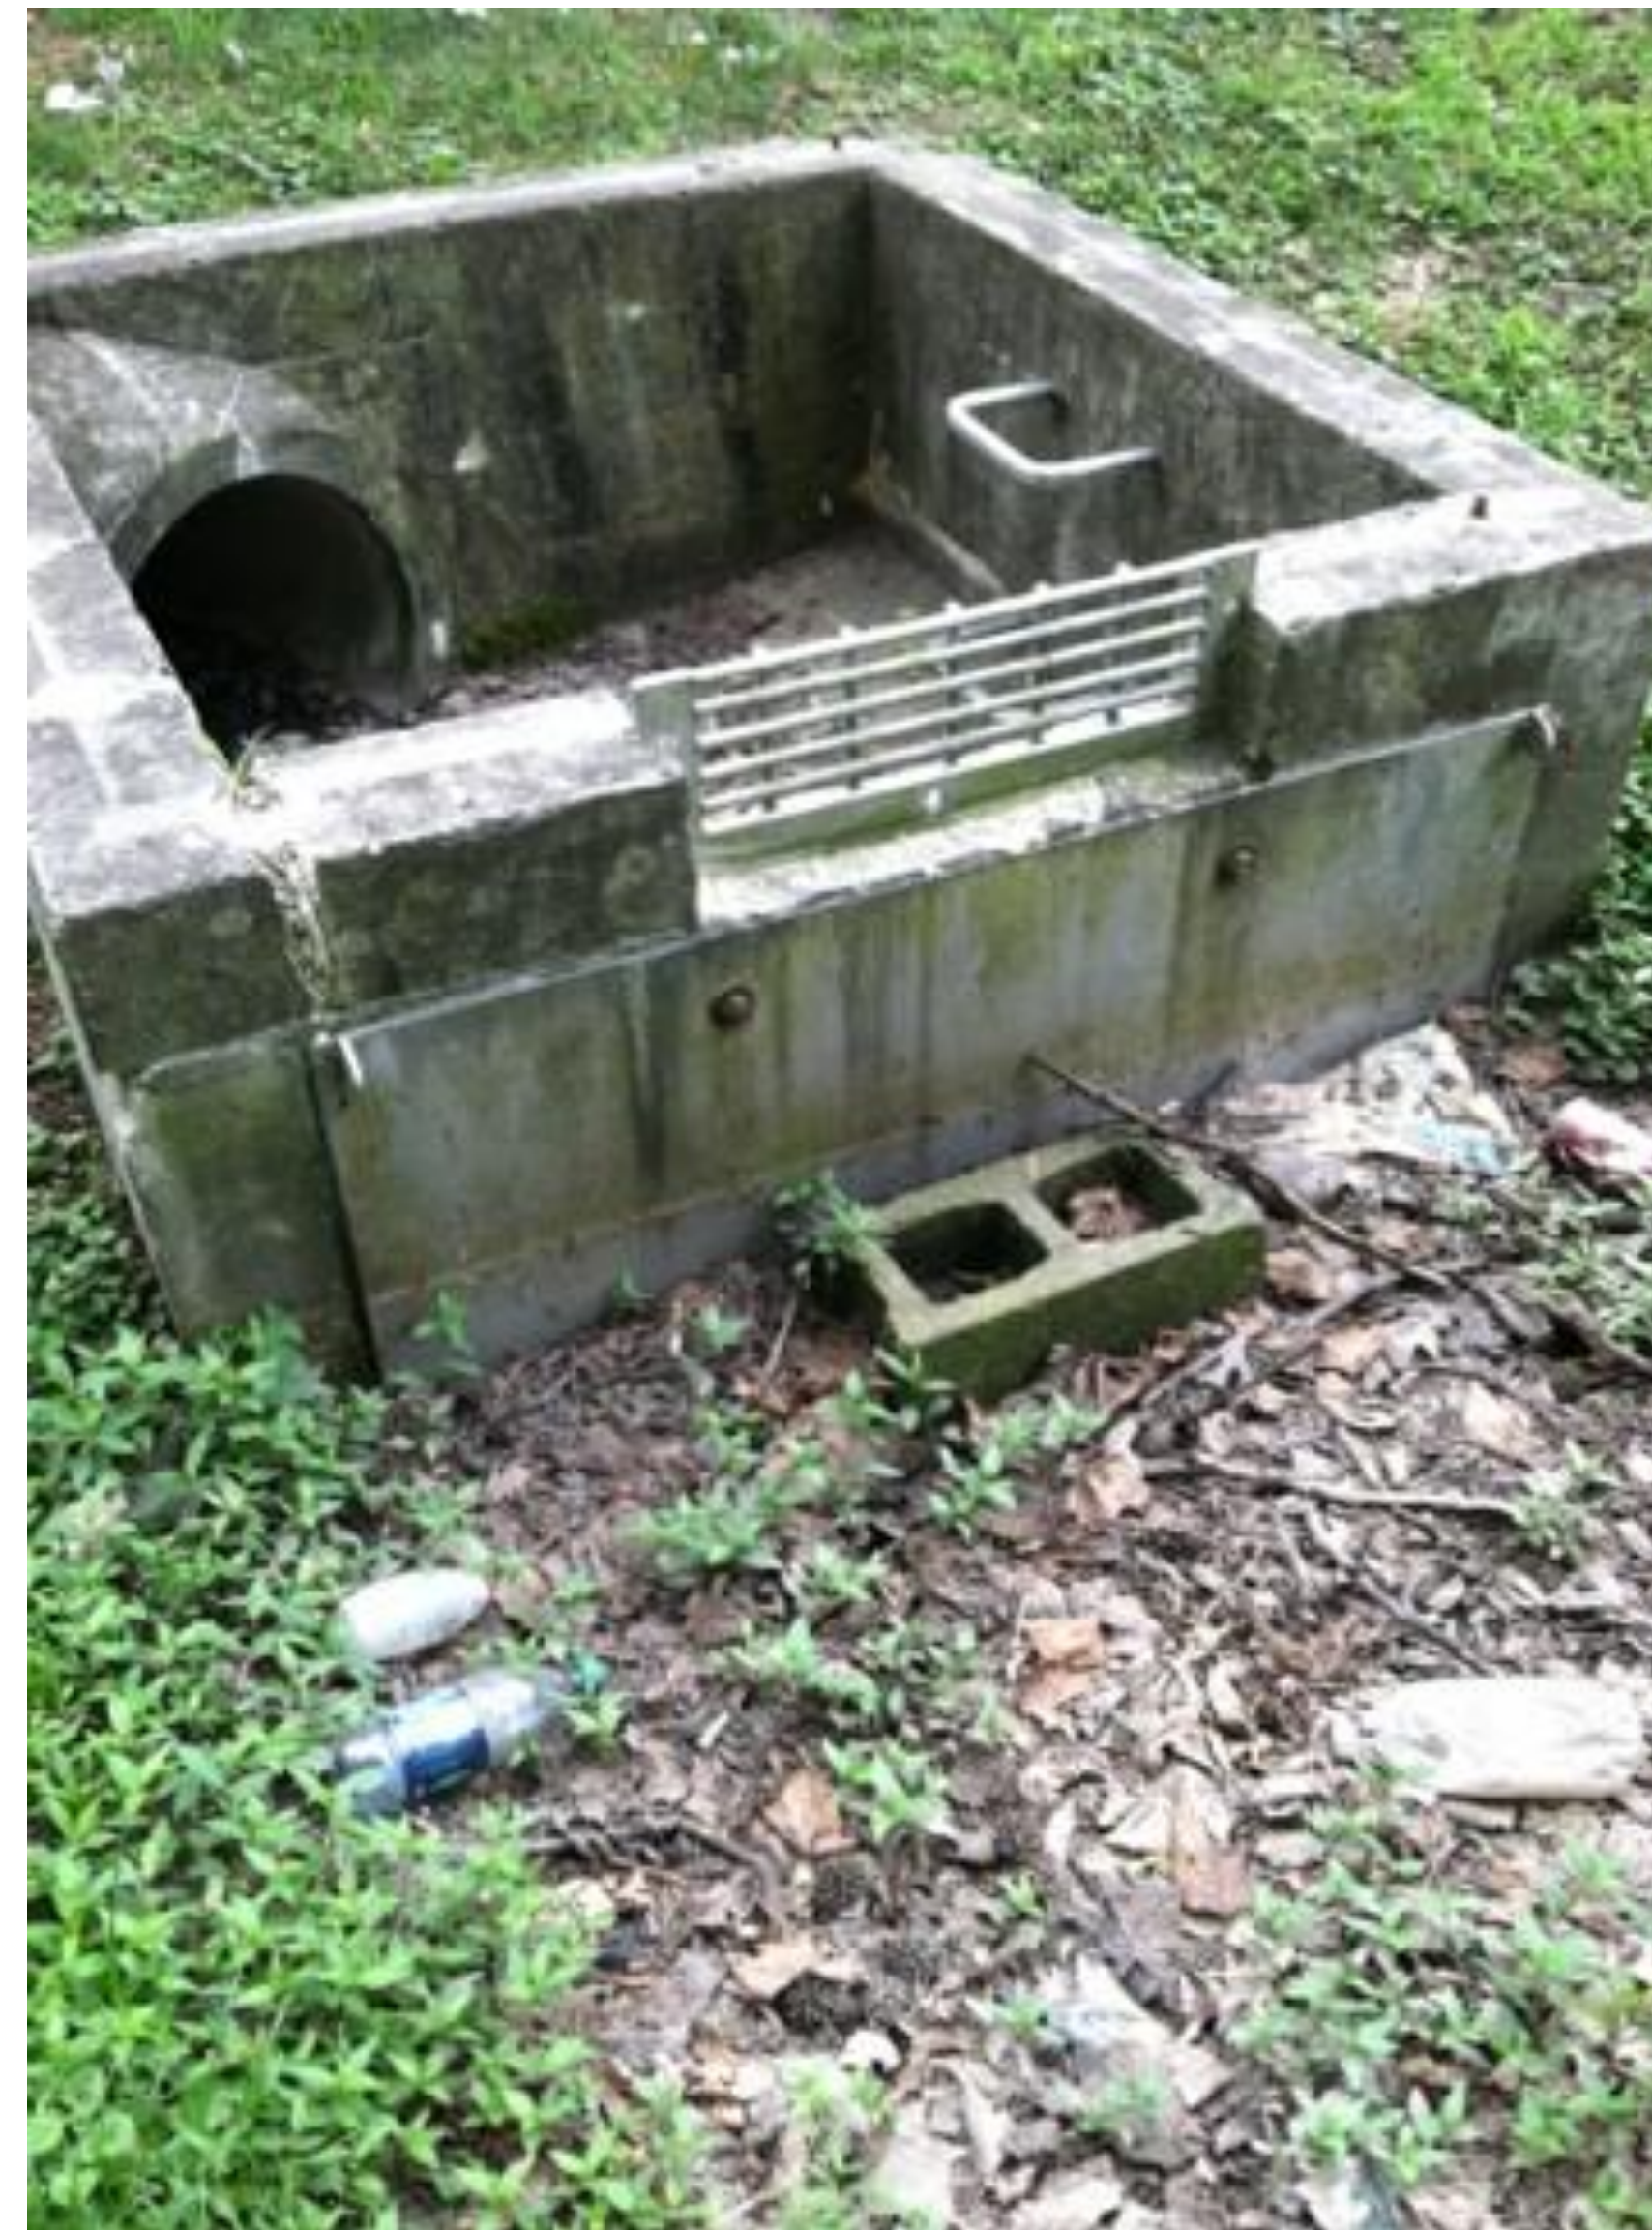
Outlet structure

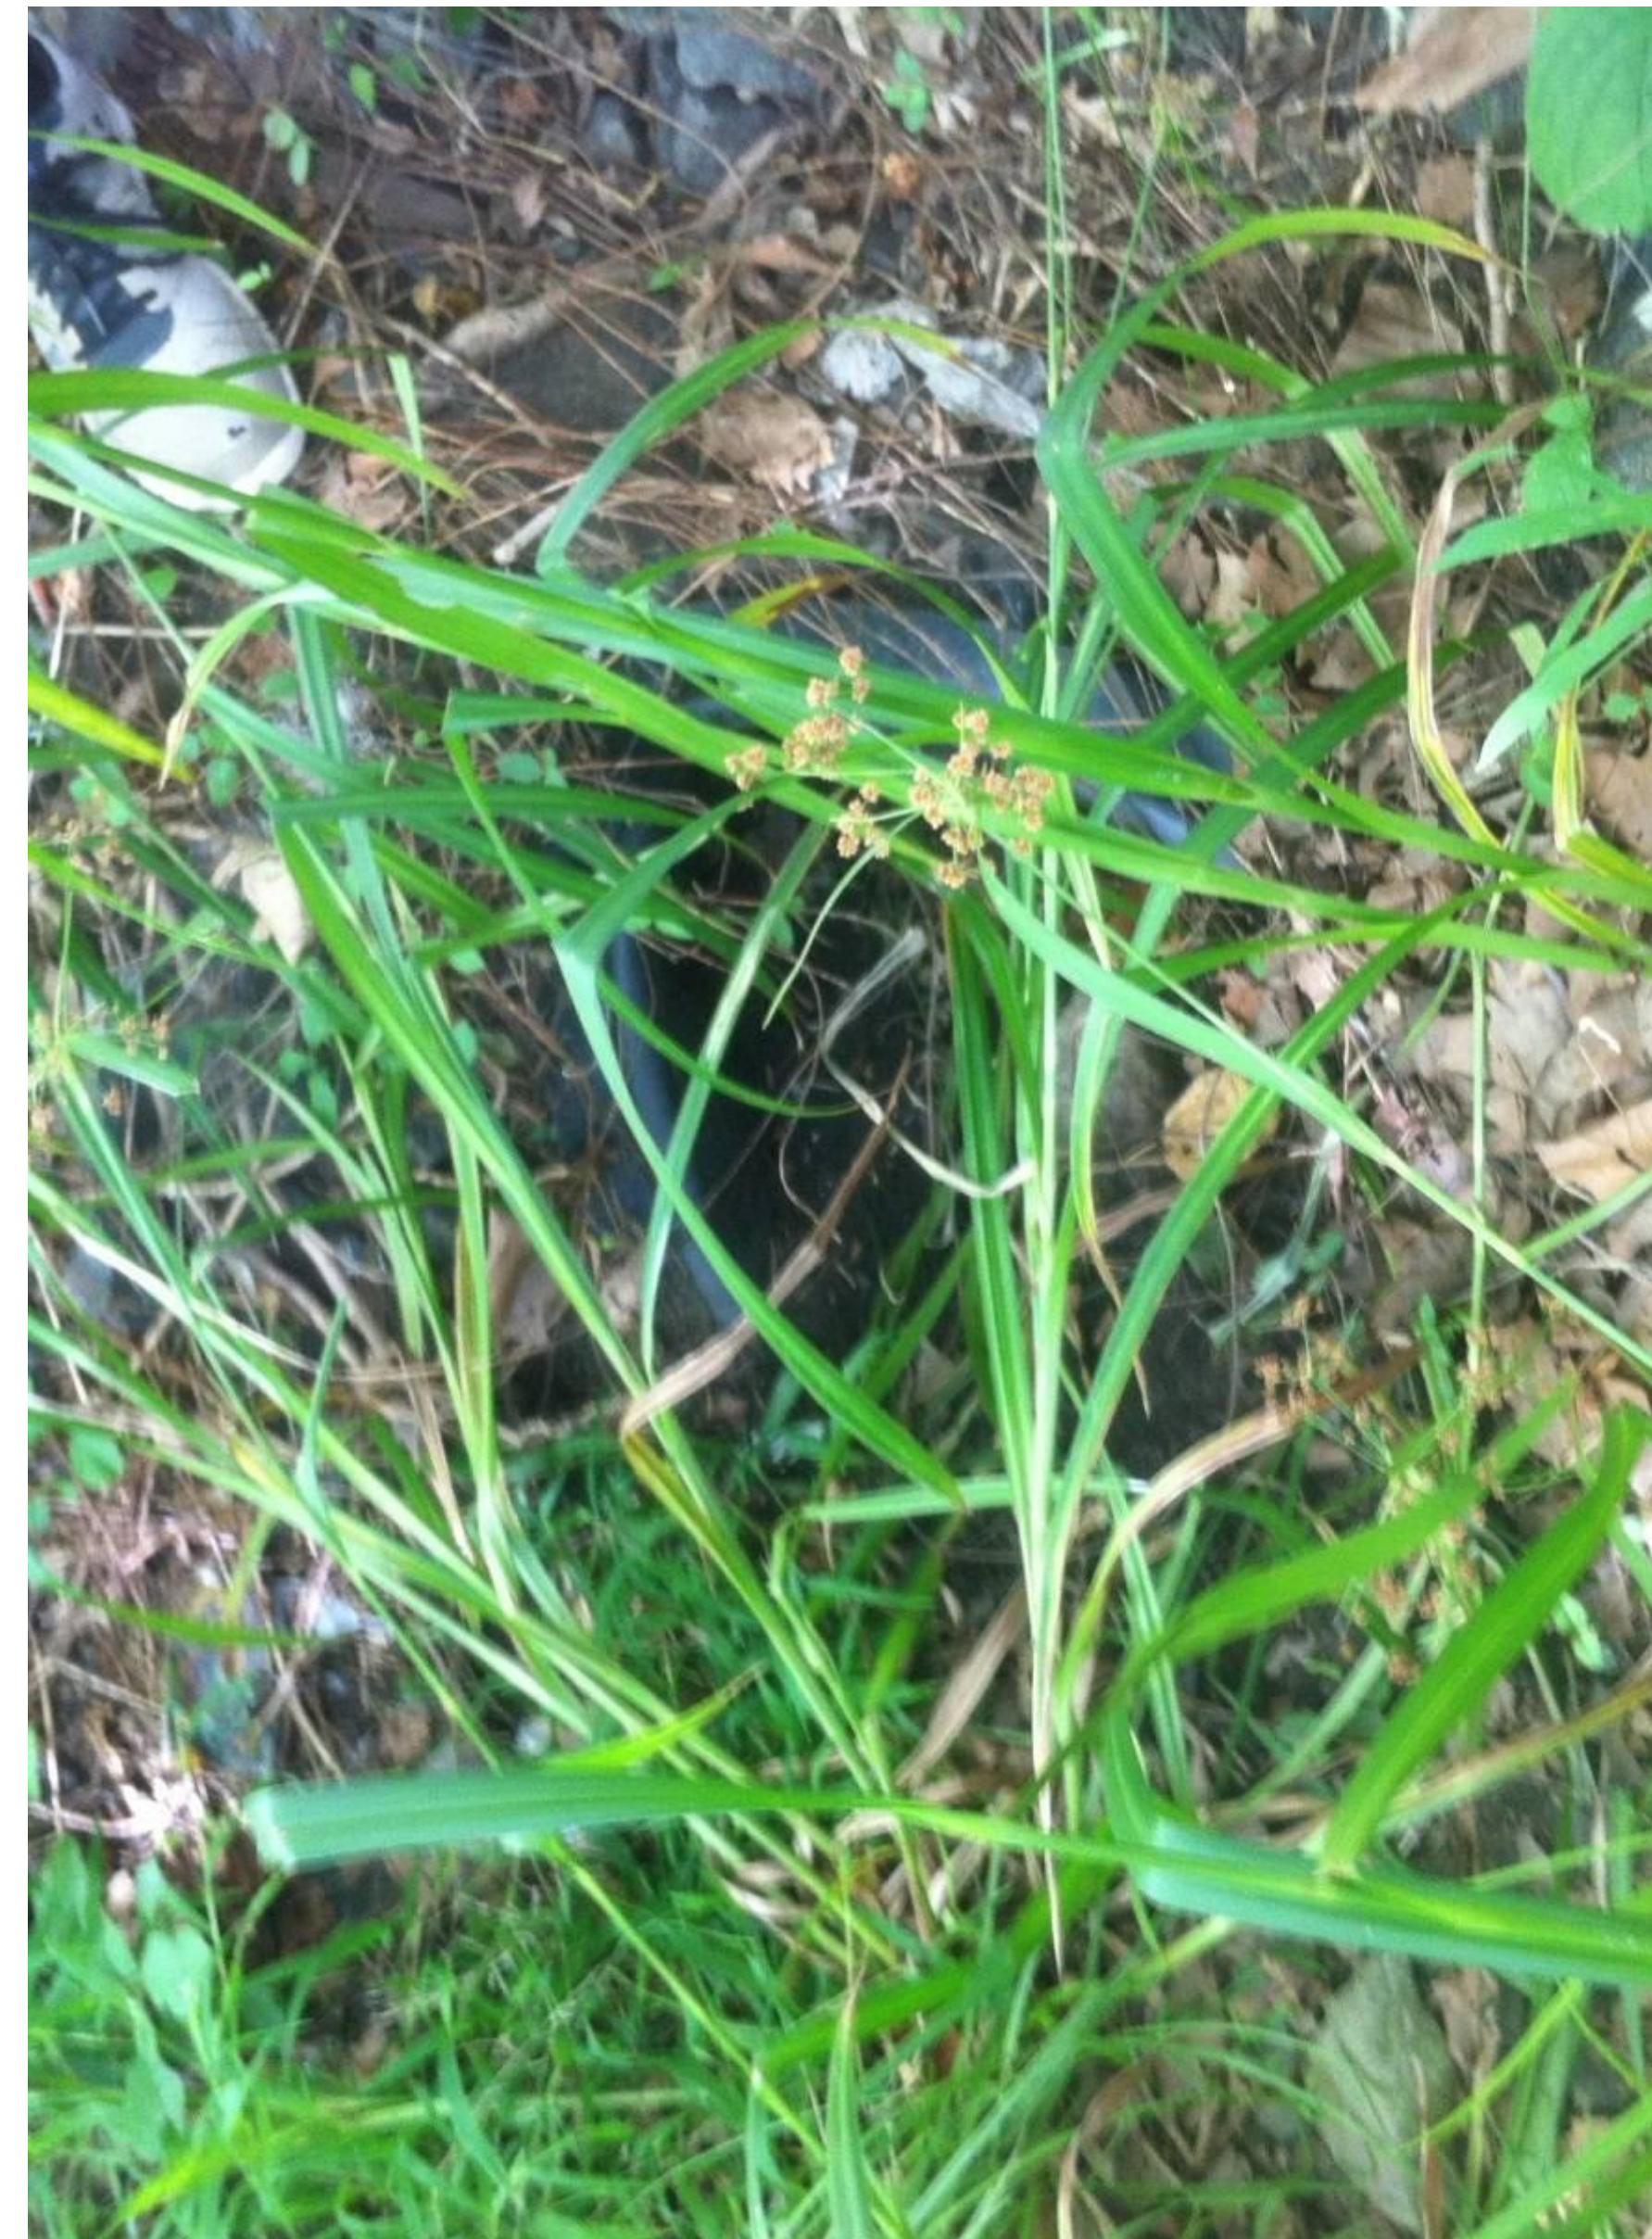
Inlet pipe

- Outlet has damage, signs of erosion, and woody vegetation growth
- Sediment and debris accumulation around inlet and outlet
- Invasive Purple Loosestrife colonizing basin

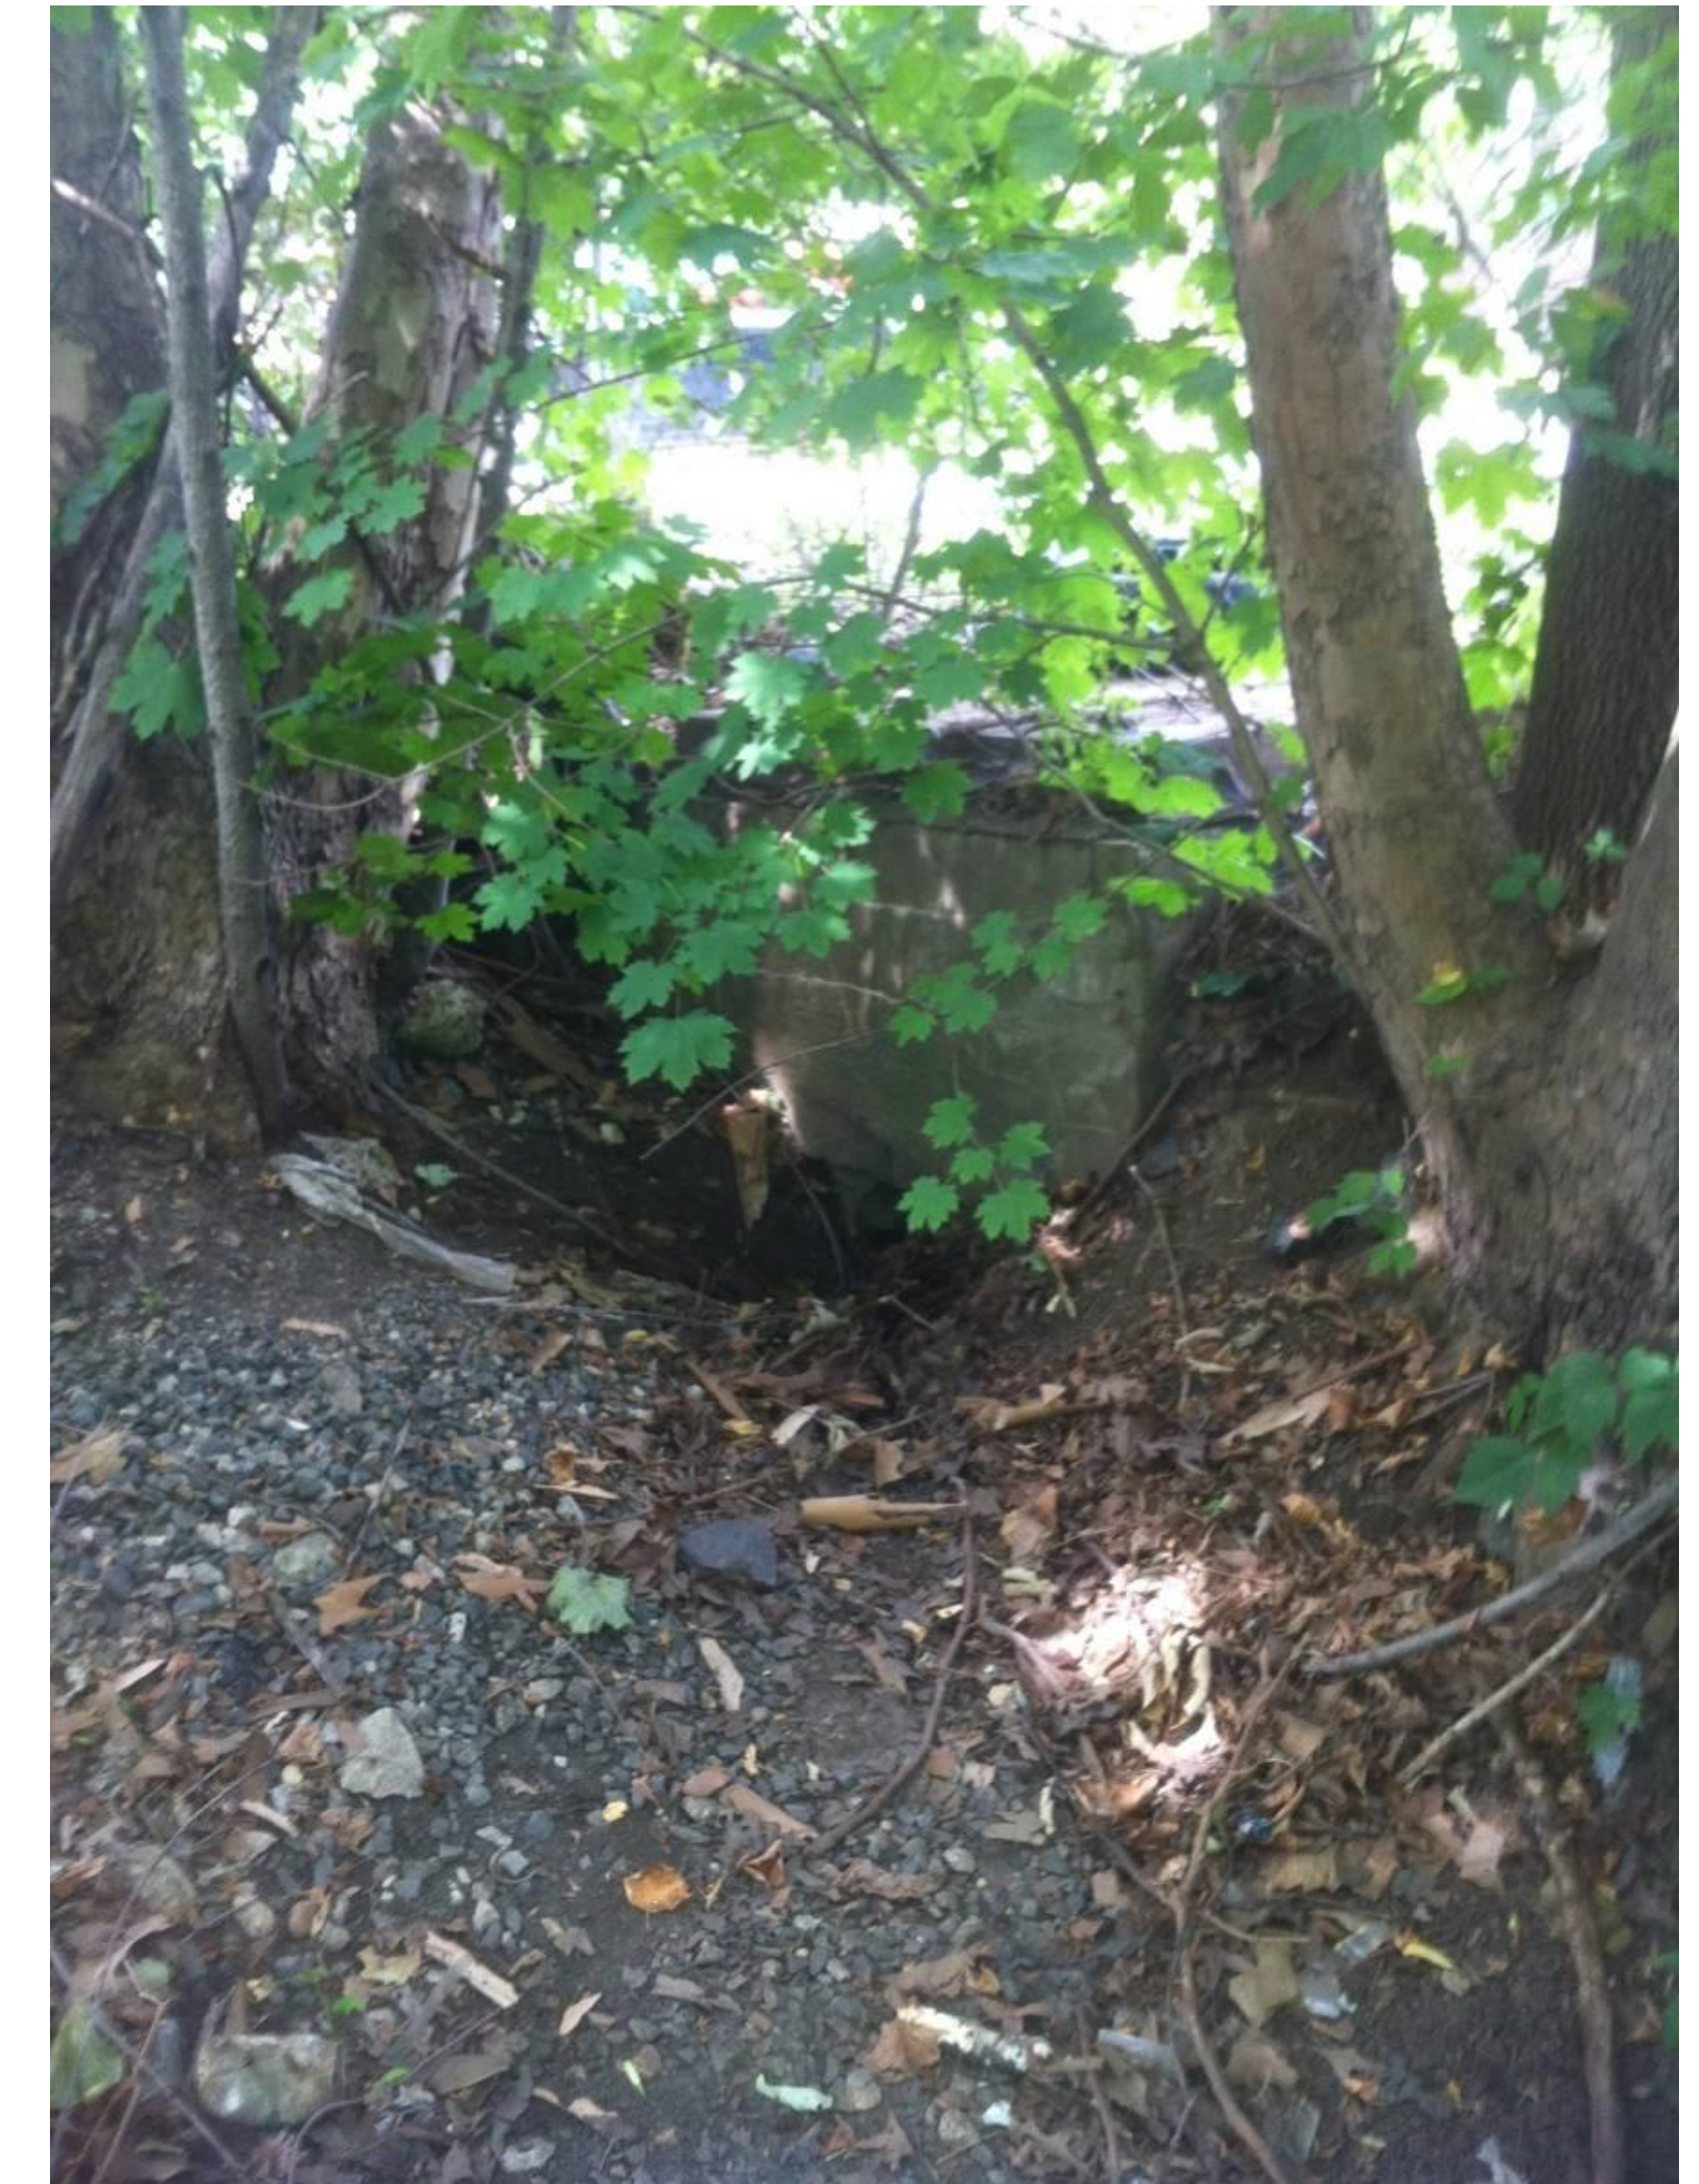
Outlet structure

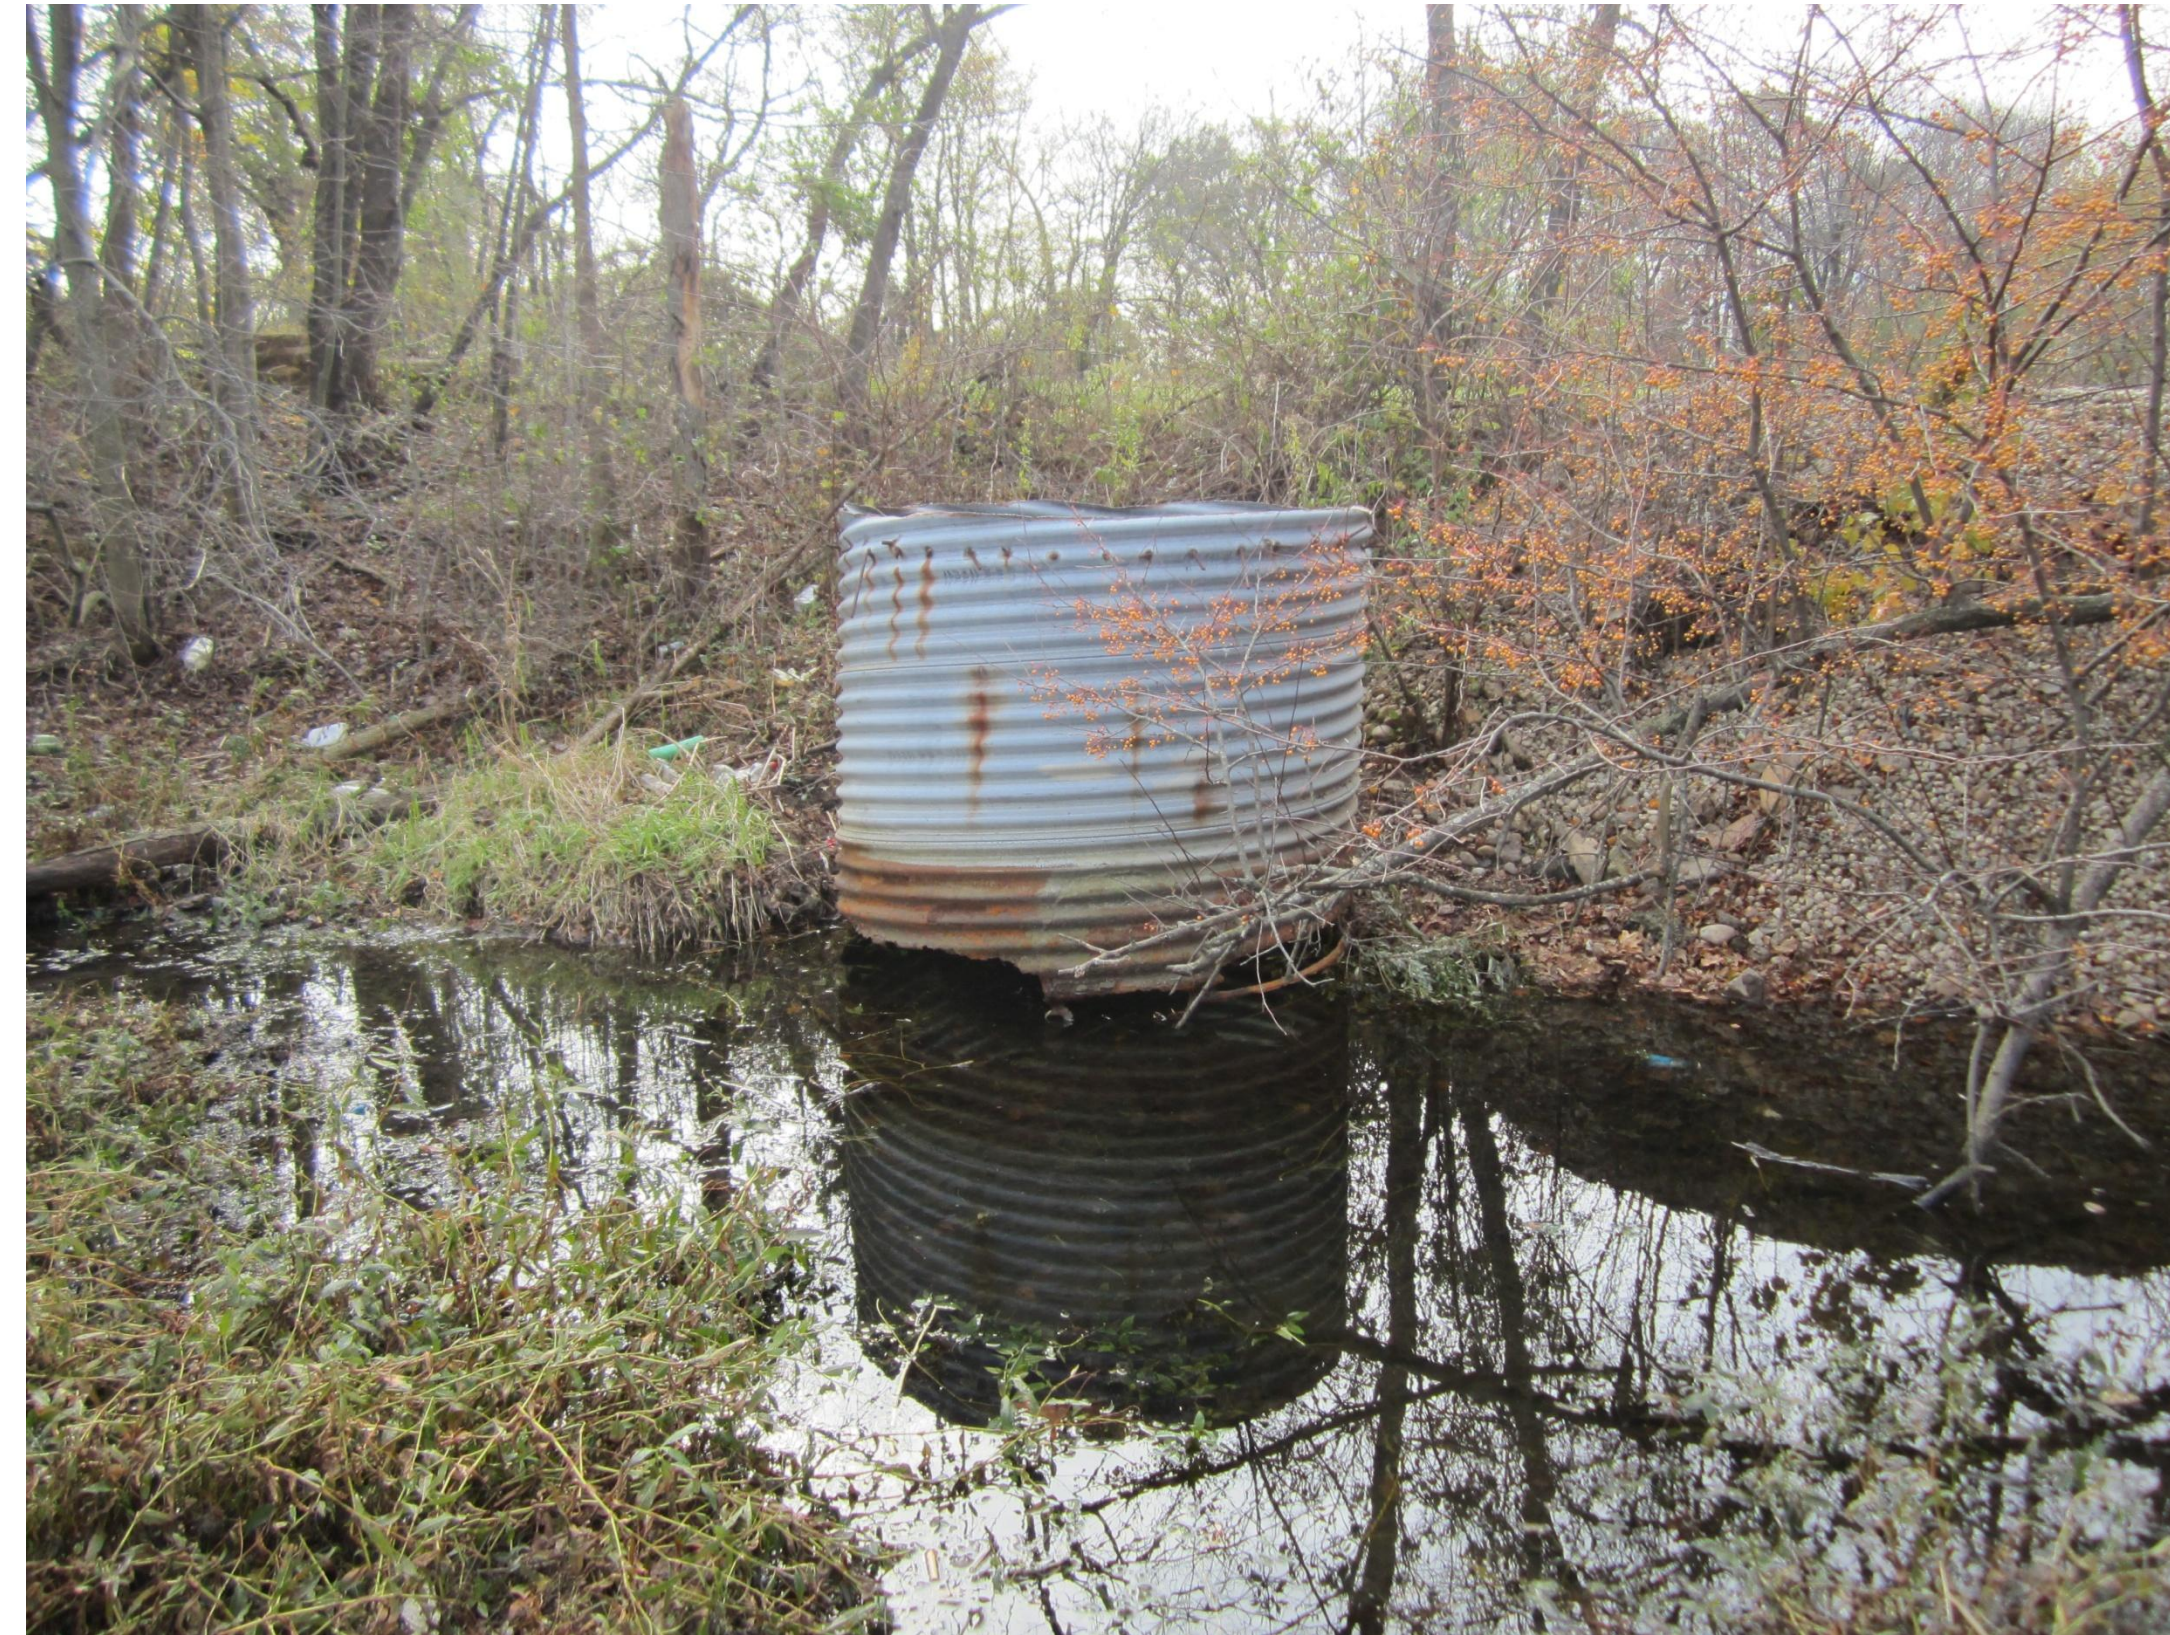
Outlet Structure

- Basin is naturalized with dense vegetation
- Inlets and outlets are inaccessible due to vegetation growth in warm months
- Invasive plant species present including Phragmites and Purple Loosestrife
- Erosion present

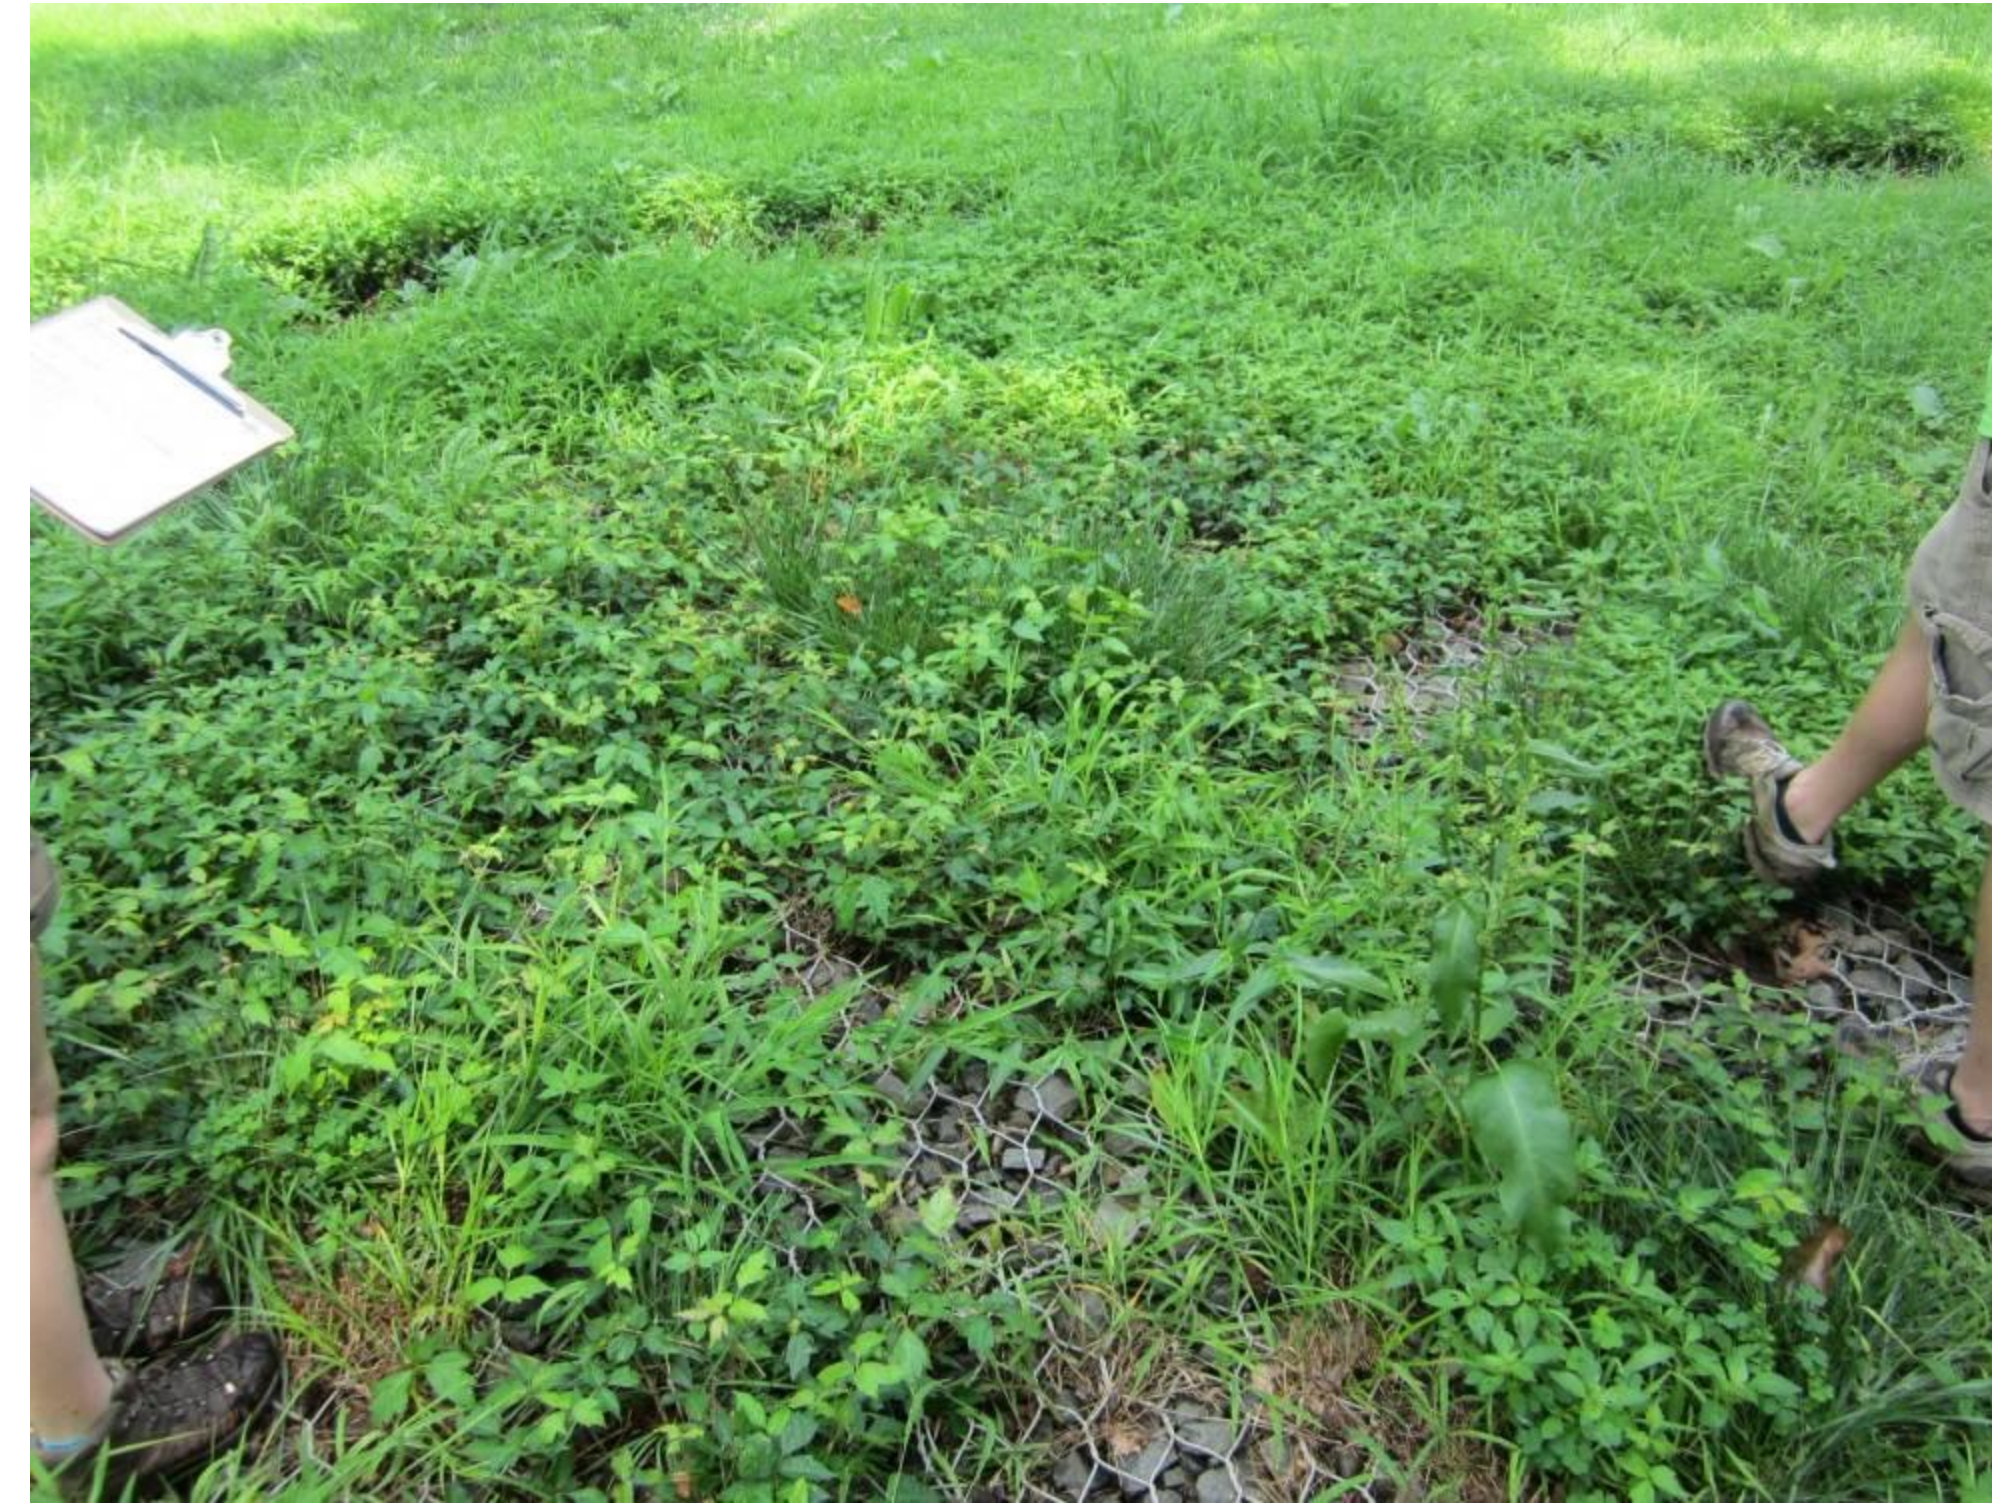
Inlet protection

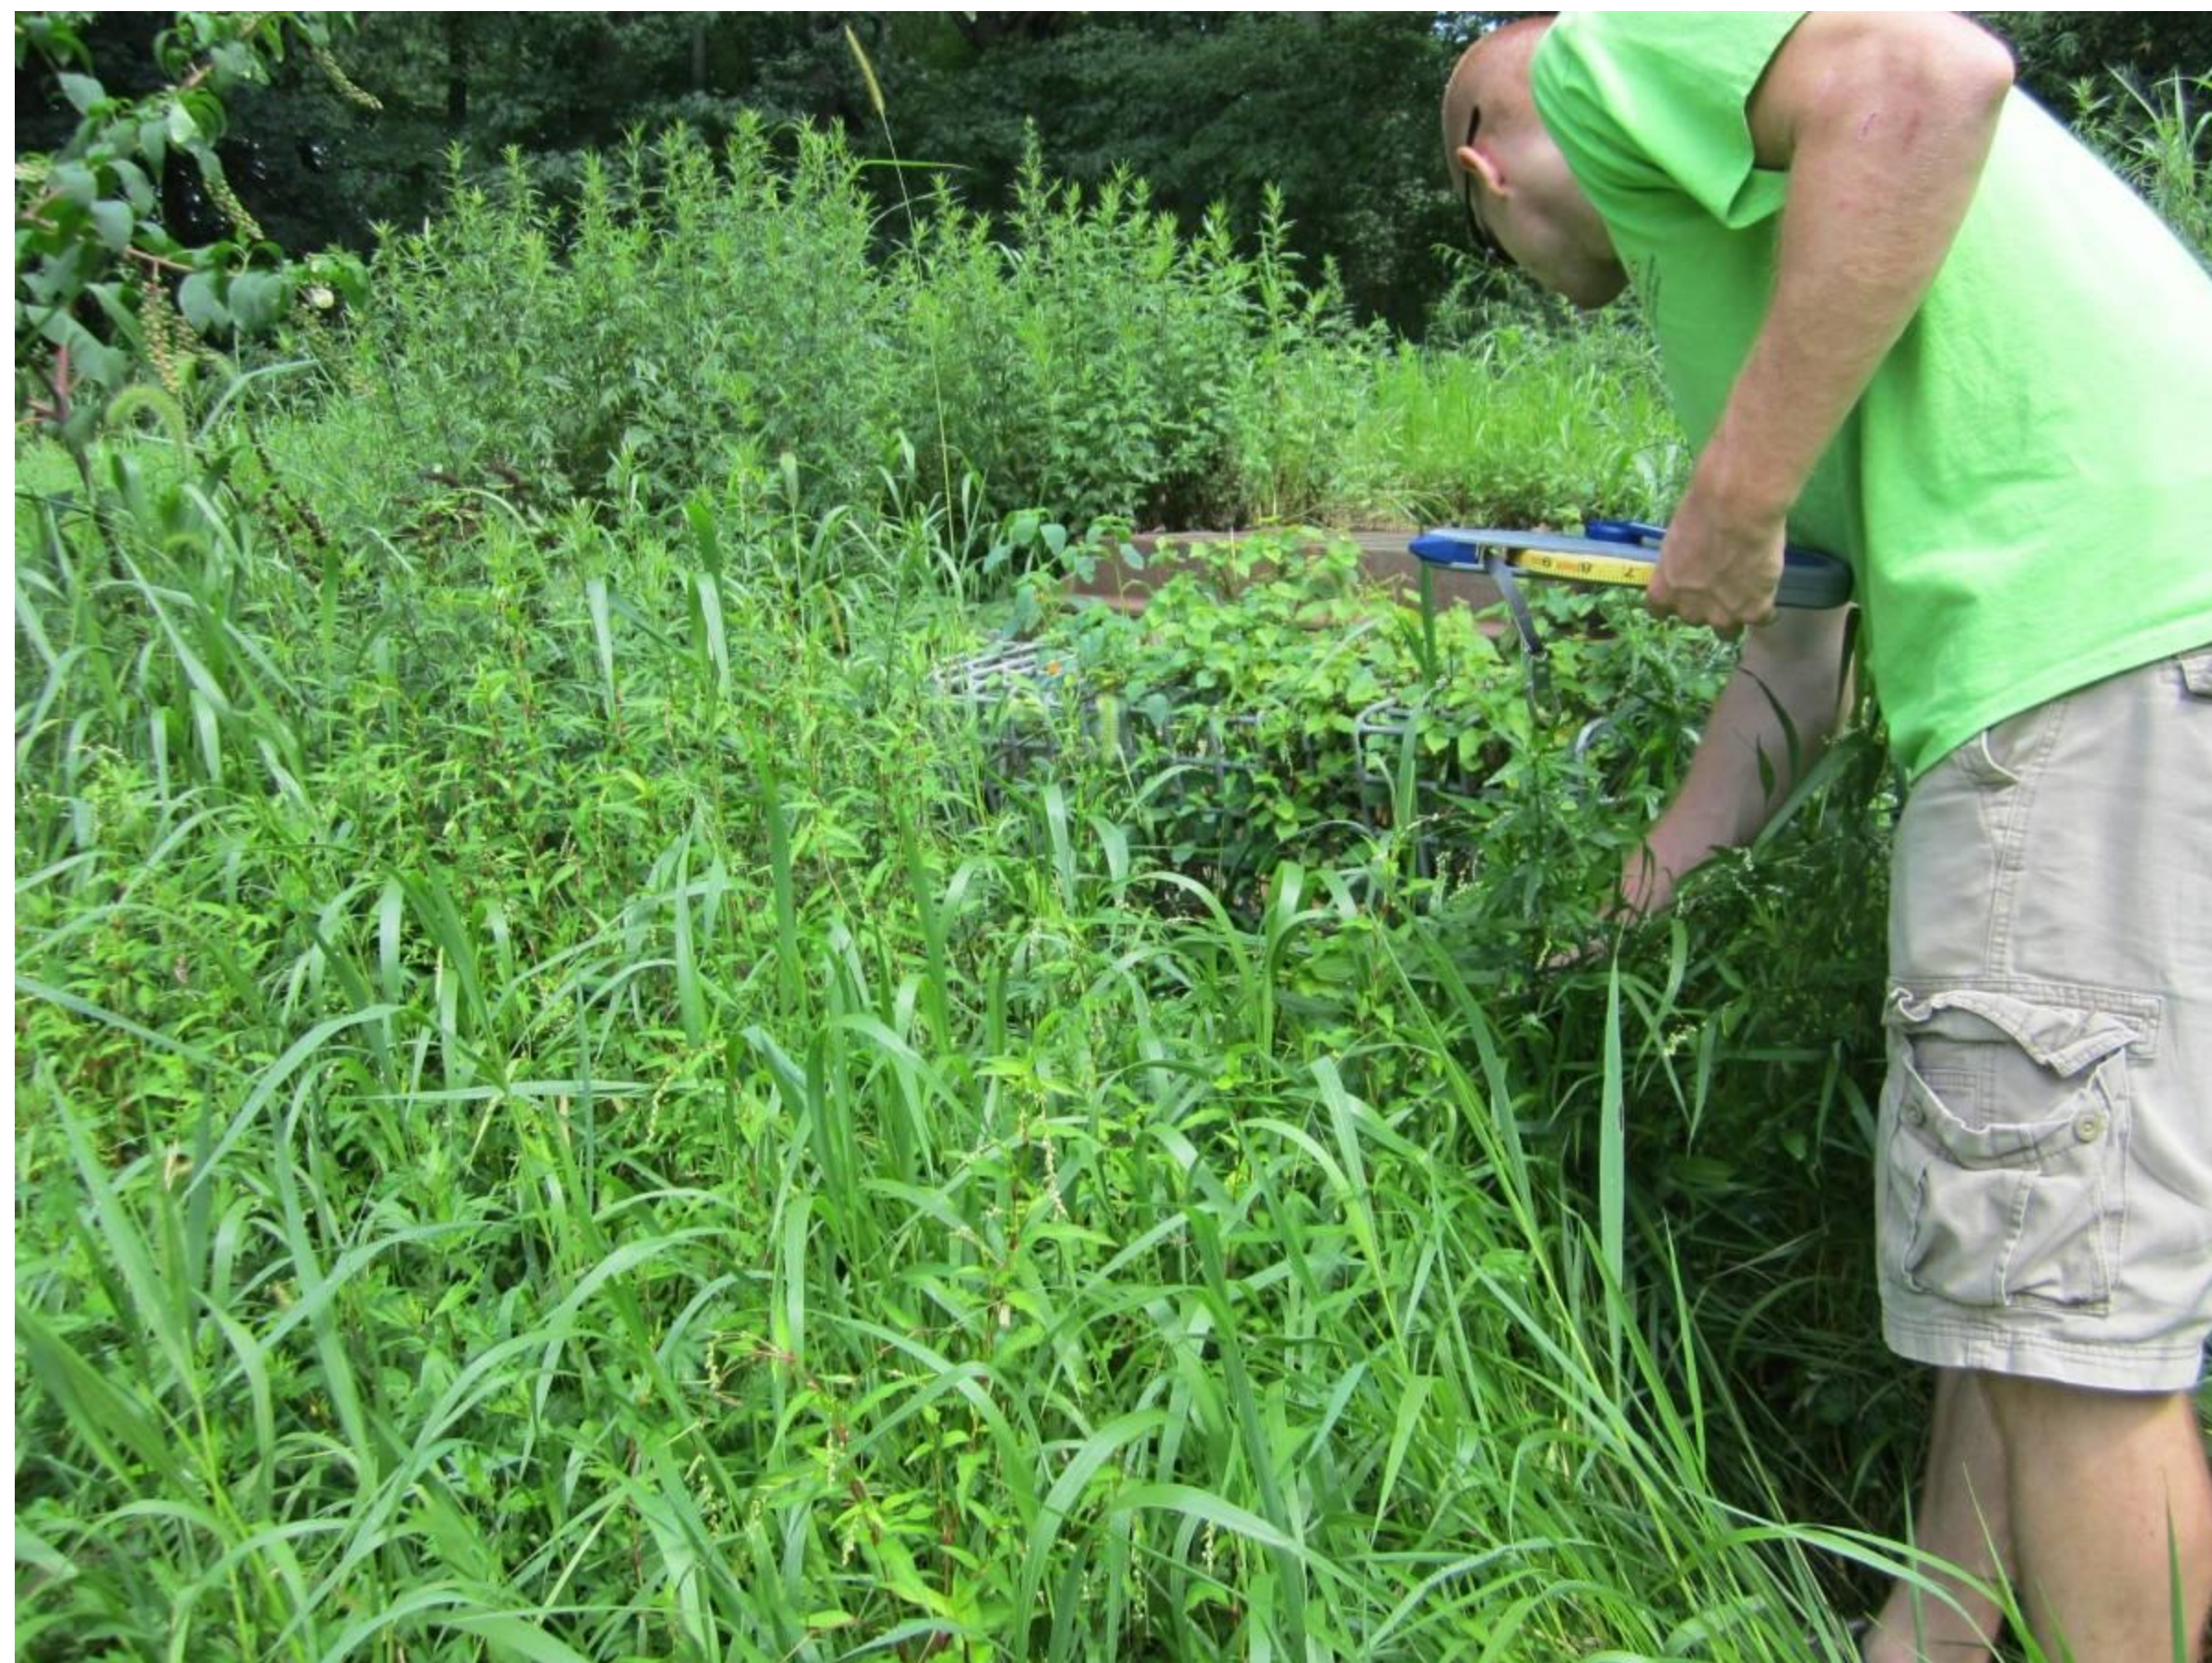
Overgrown outlet
