Hamilton Township (Mercer County) Stormwater Basin Assessment Summary (Year 1)

Developed by the Rutgers Cooperative Extension Water Resources Program
Funded by Hamilton Township, Mercer County, New Jersey

December 6, 2012

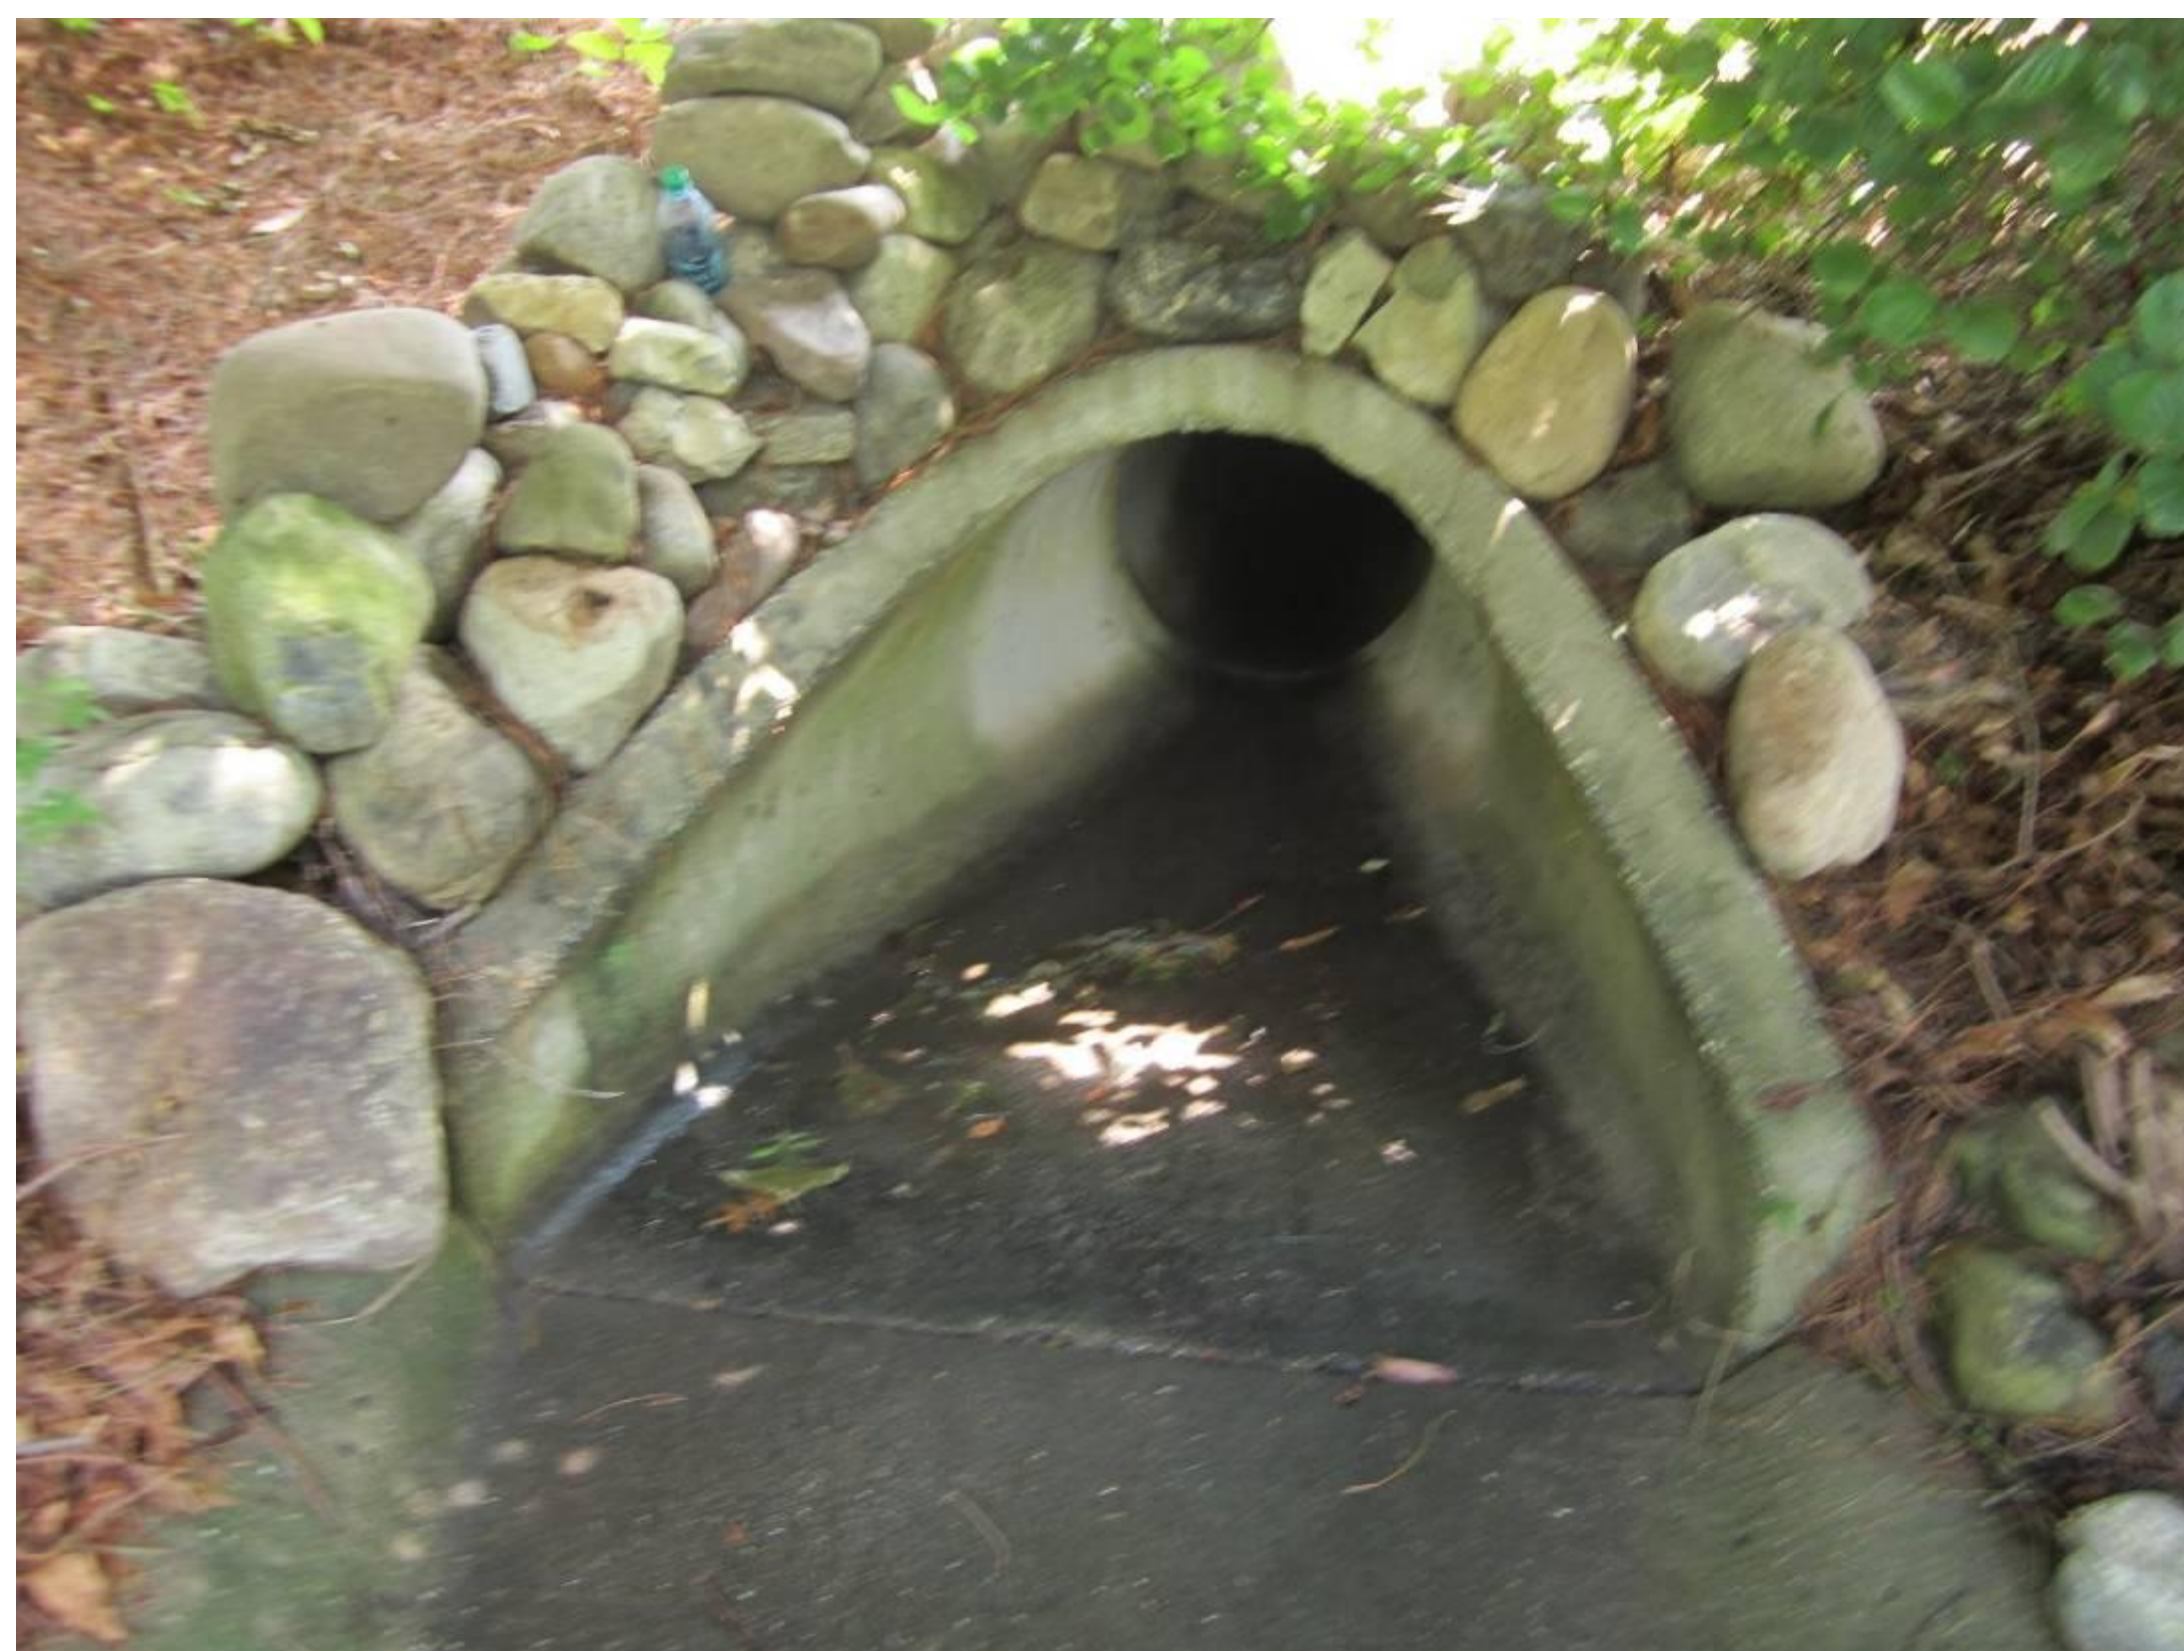
Inlet

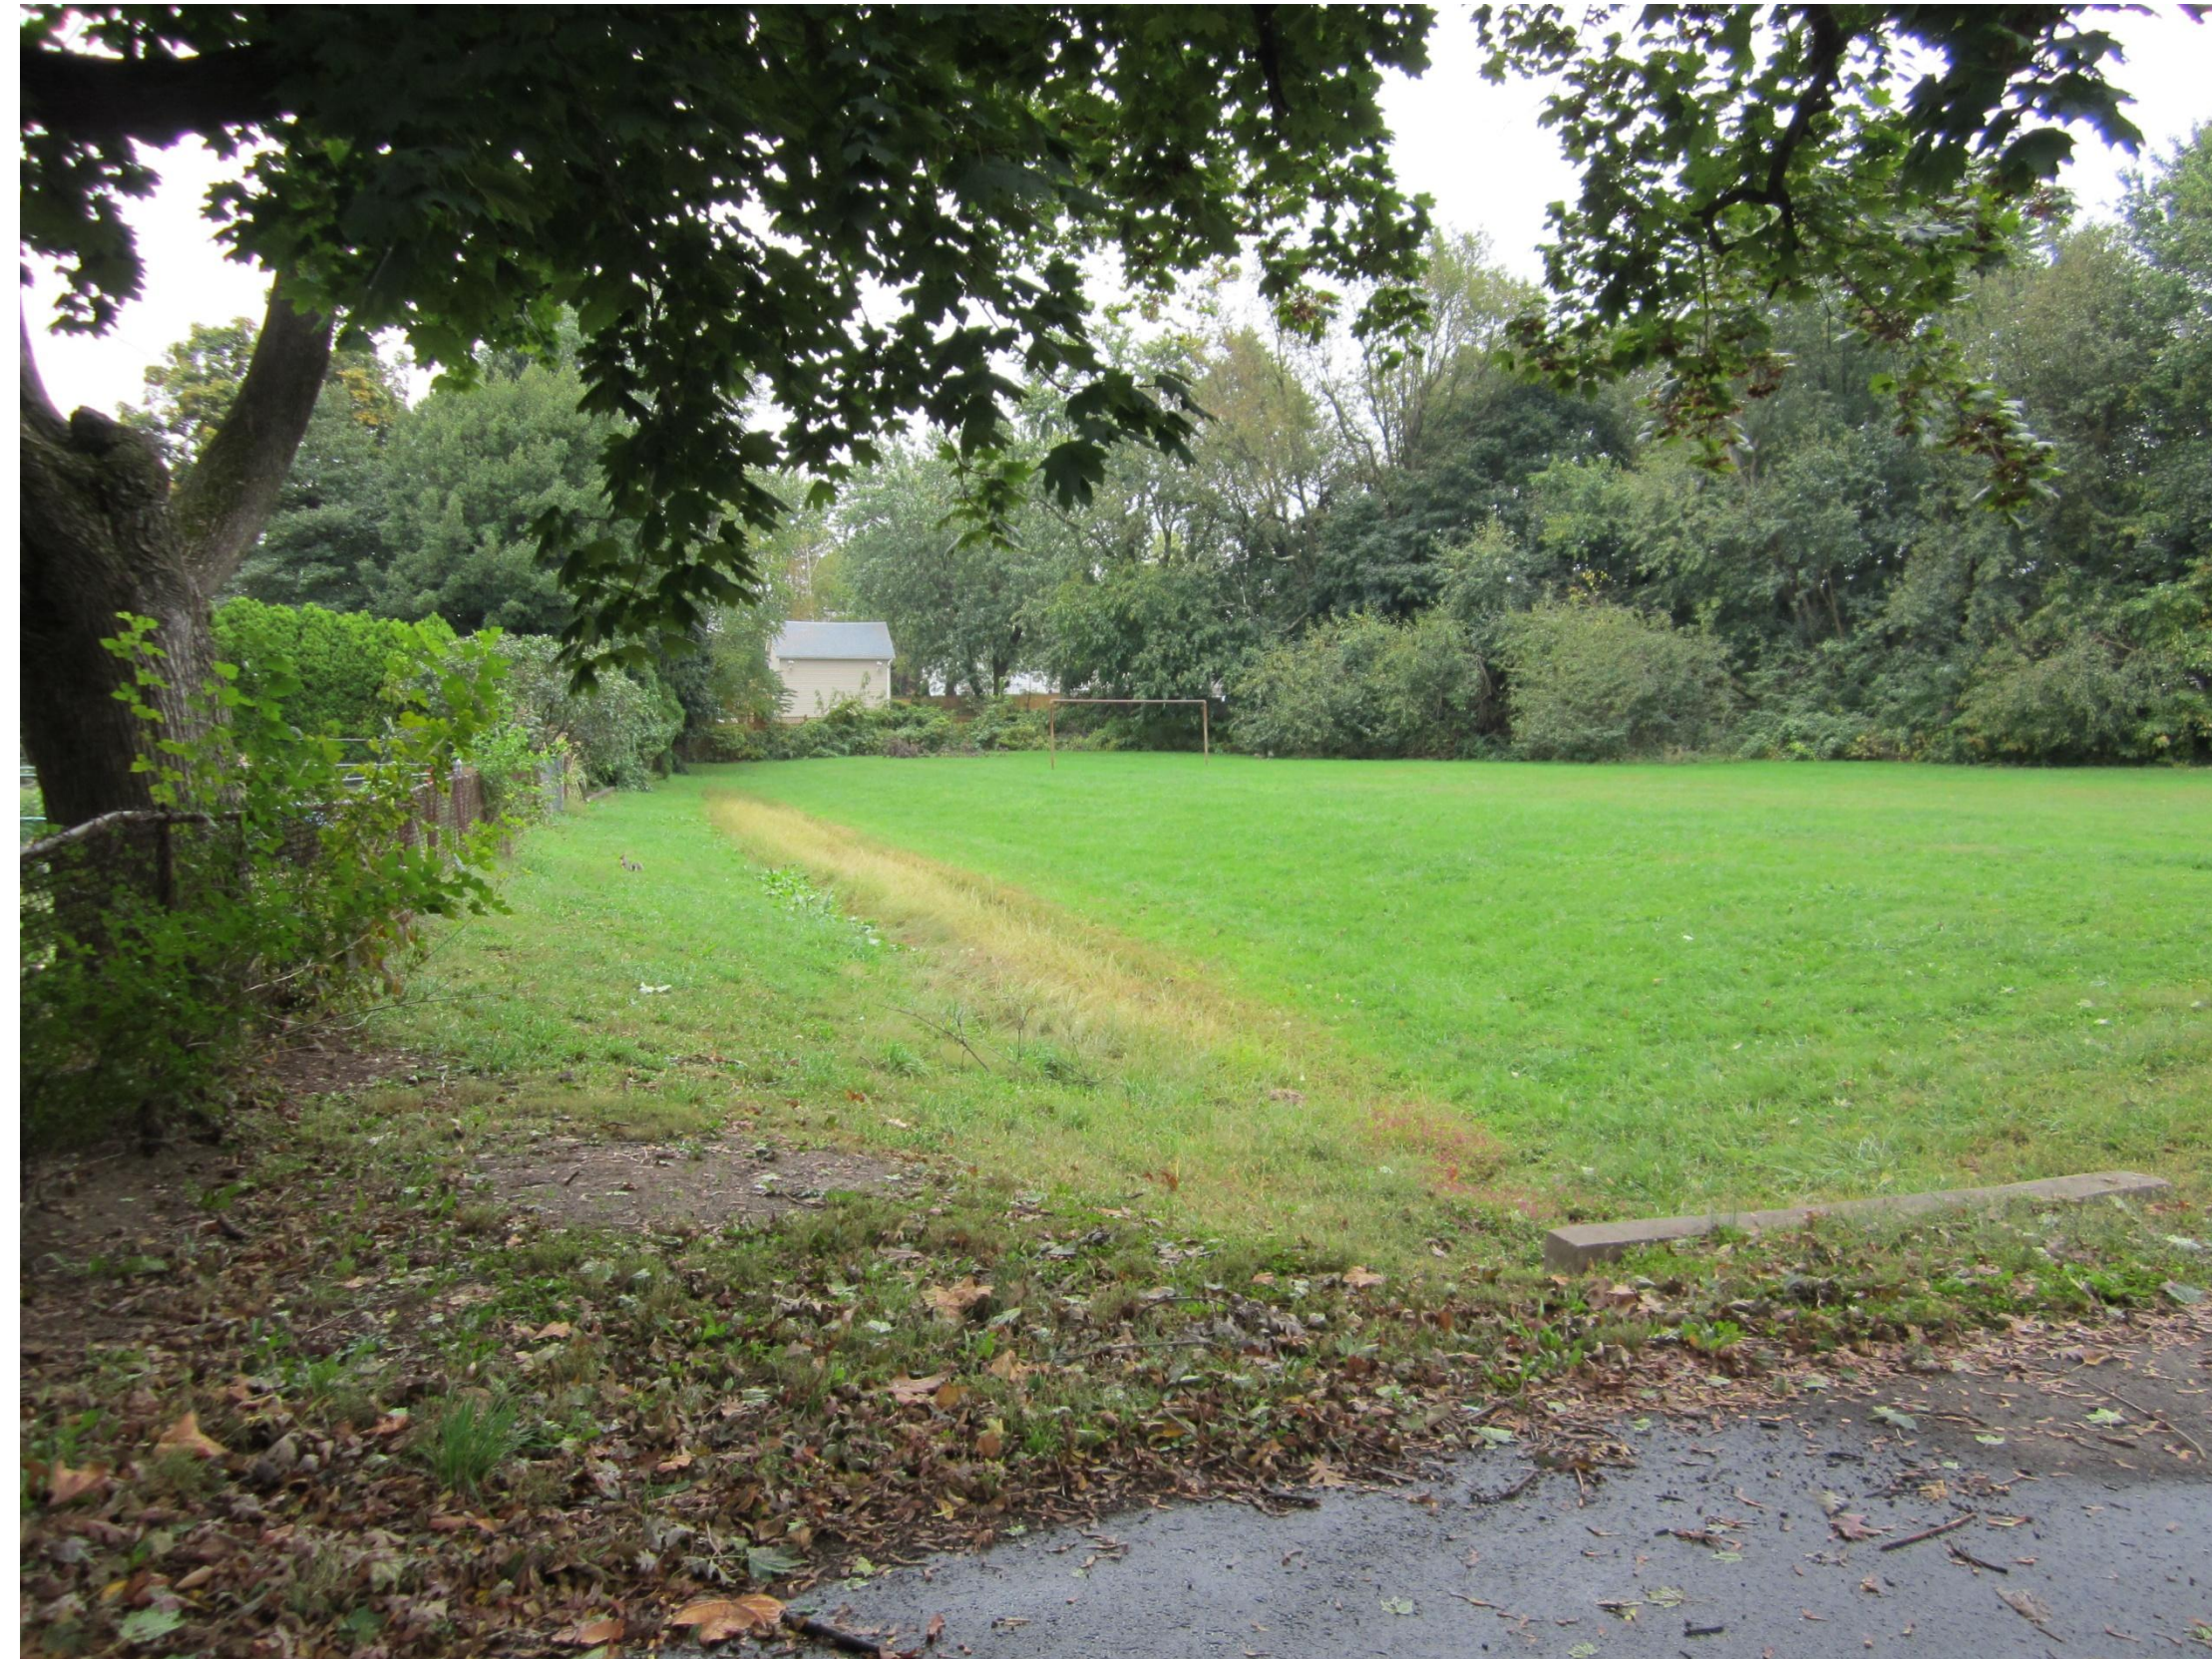
Basin looking west

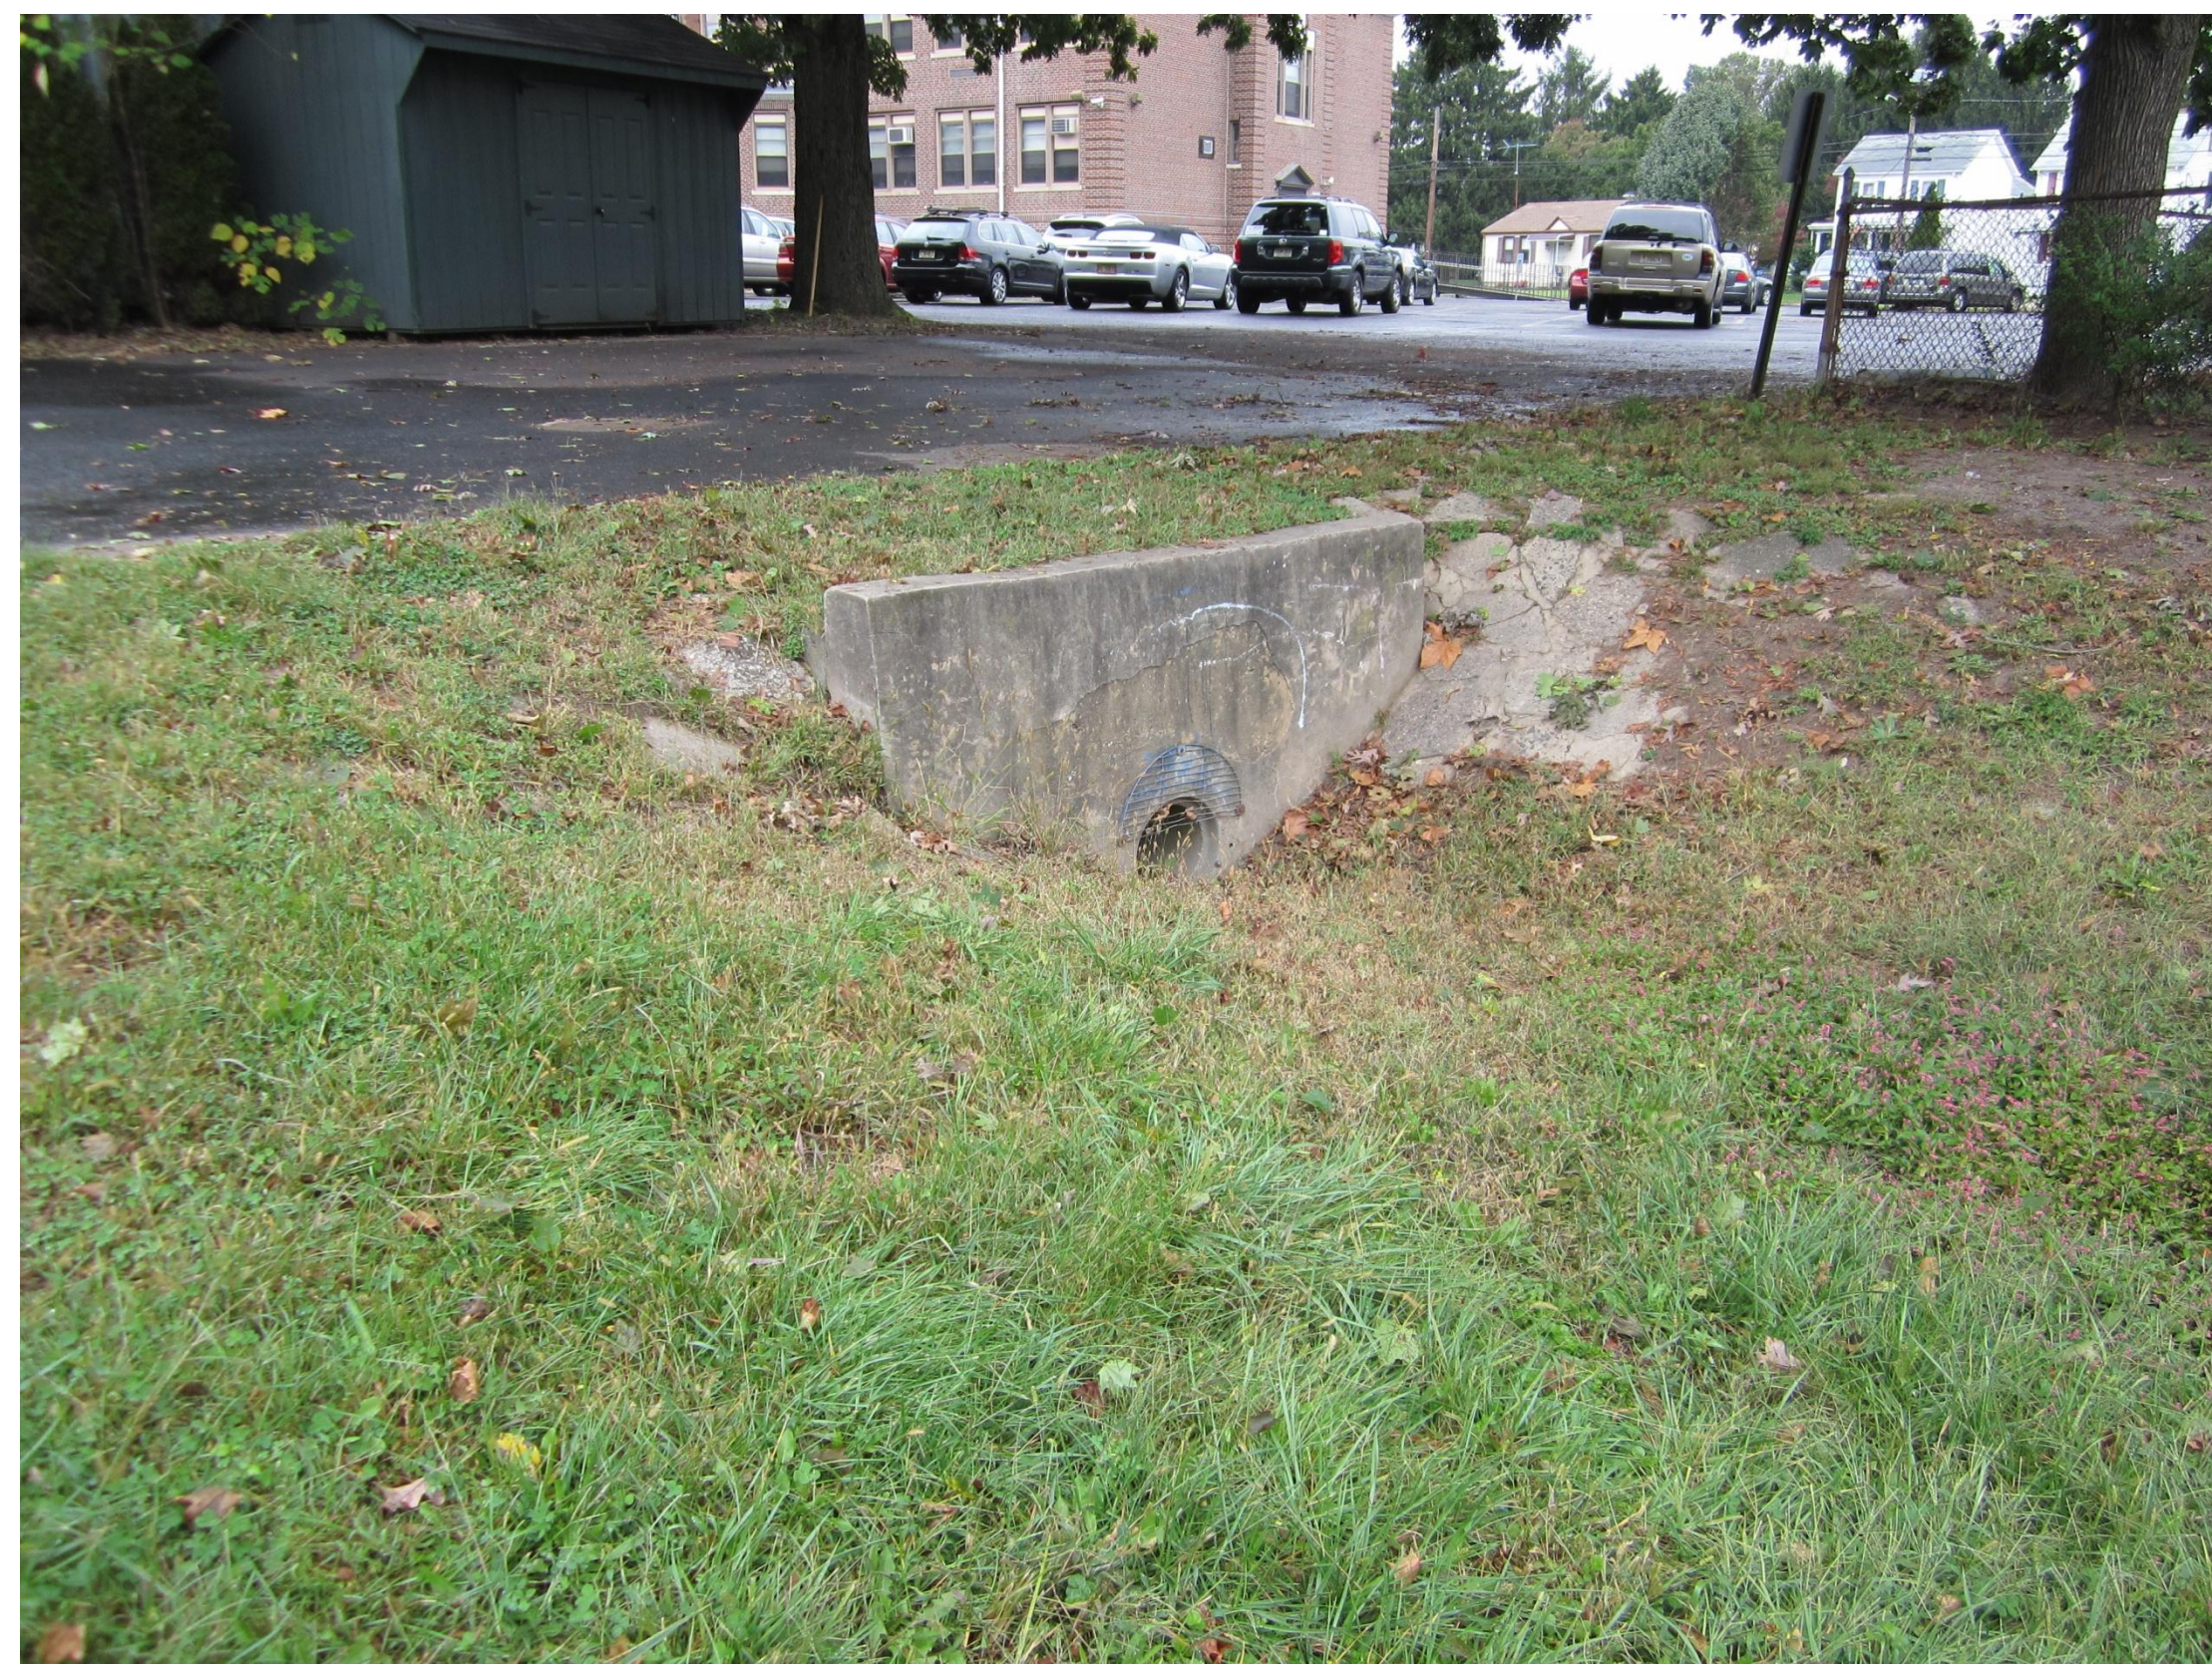
Outlet structure

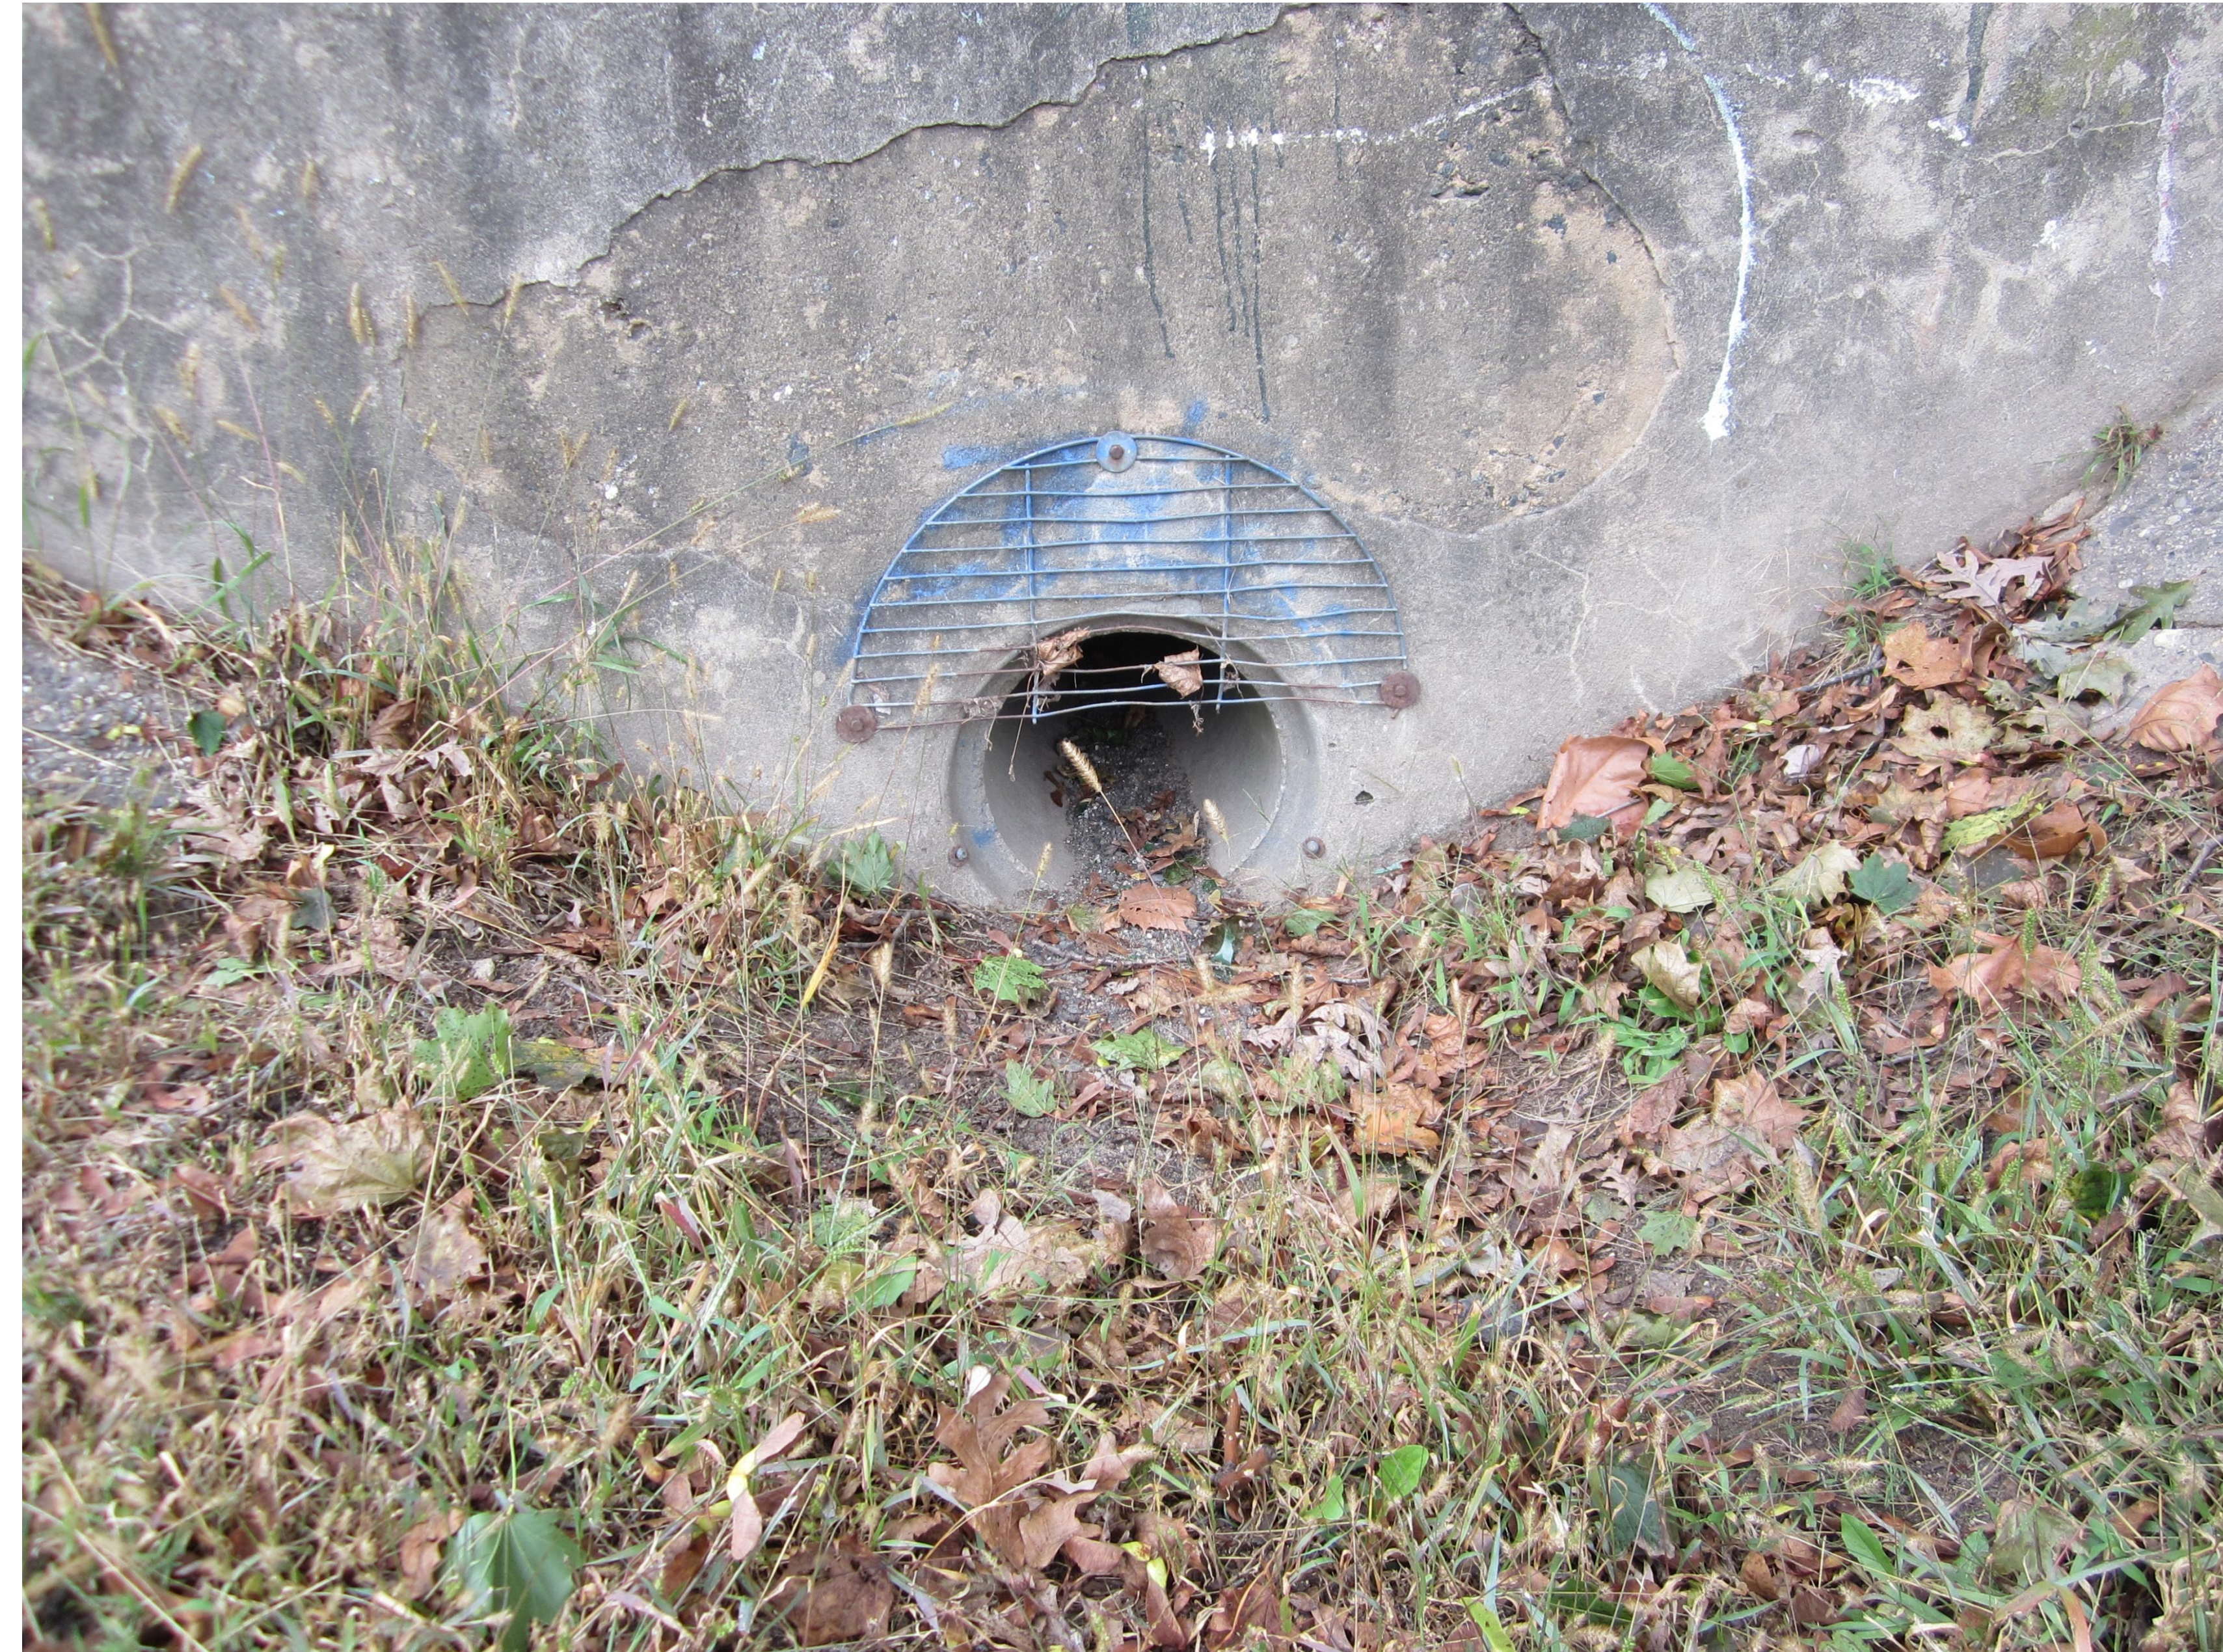
Outlet orifice

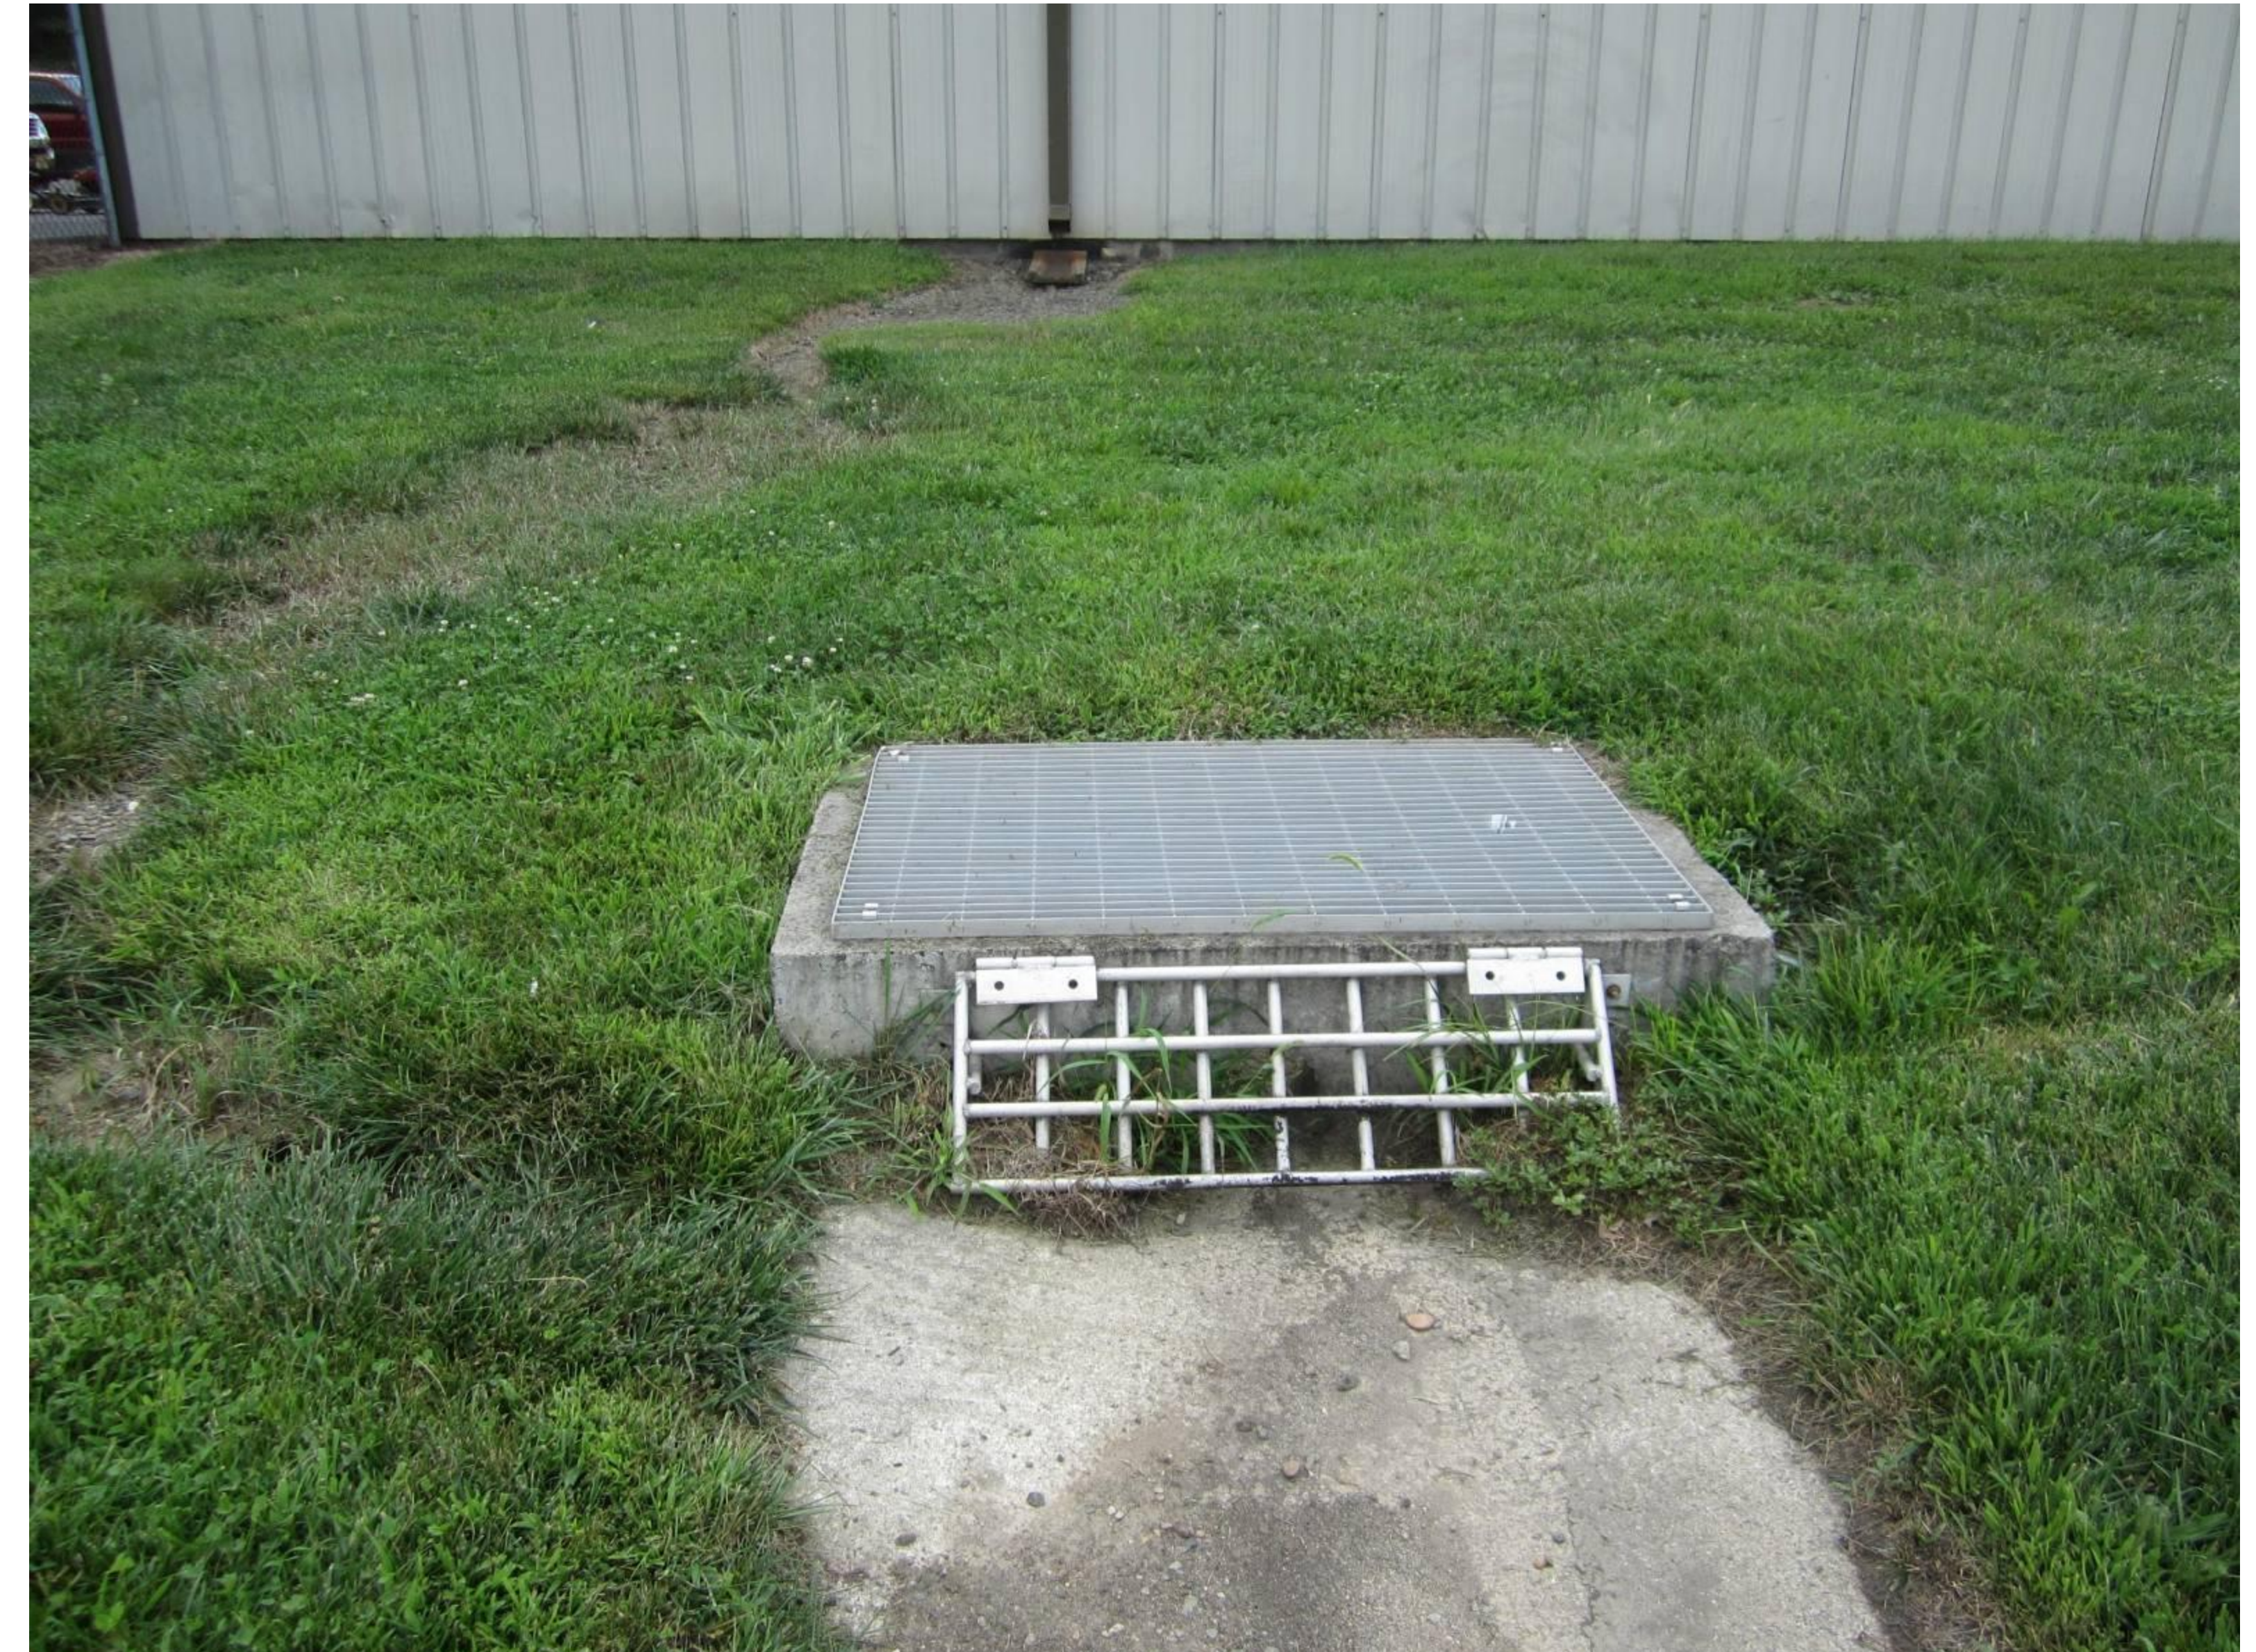
Outlet

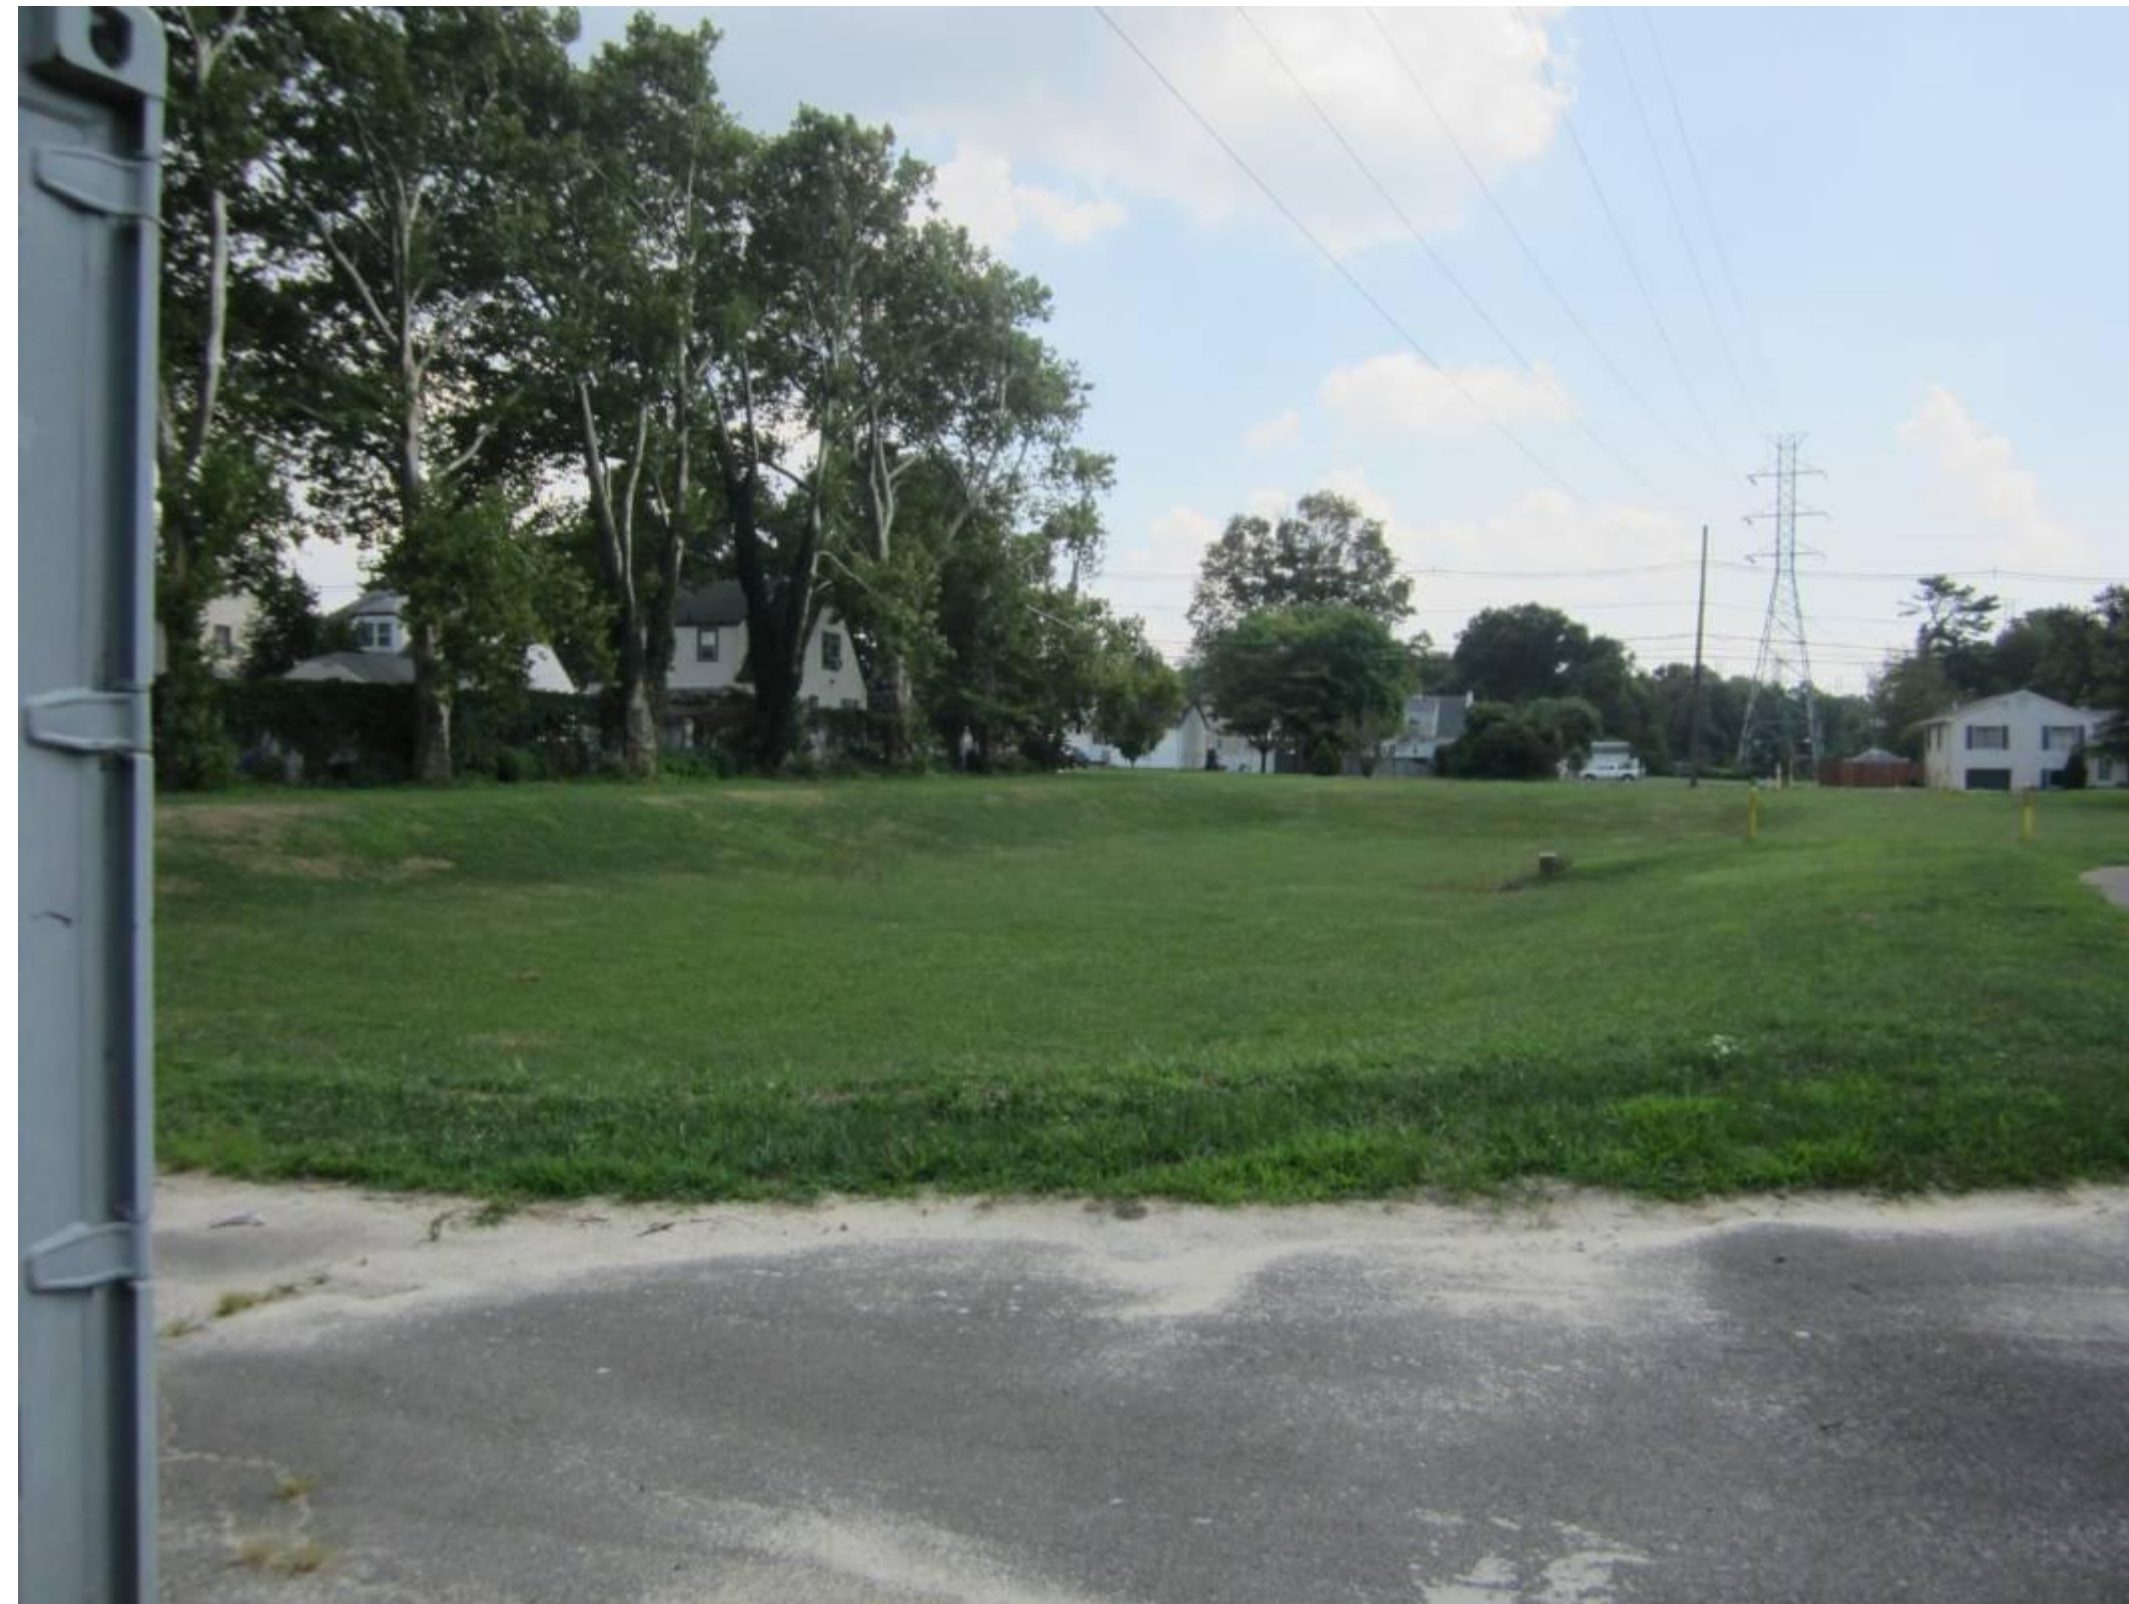
Southern basin
