Hamilton Township (Mercer County) Stormwater Basin Assessment Summary (Year 1)

Developed by the Rutgers Cooperative Extension Water Resources Program
Funded by Hamilton Township, Mercer County, New Jersey

December 6, 2012

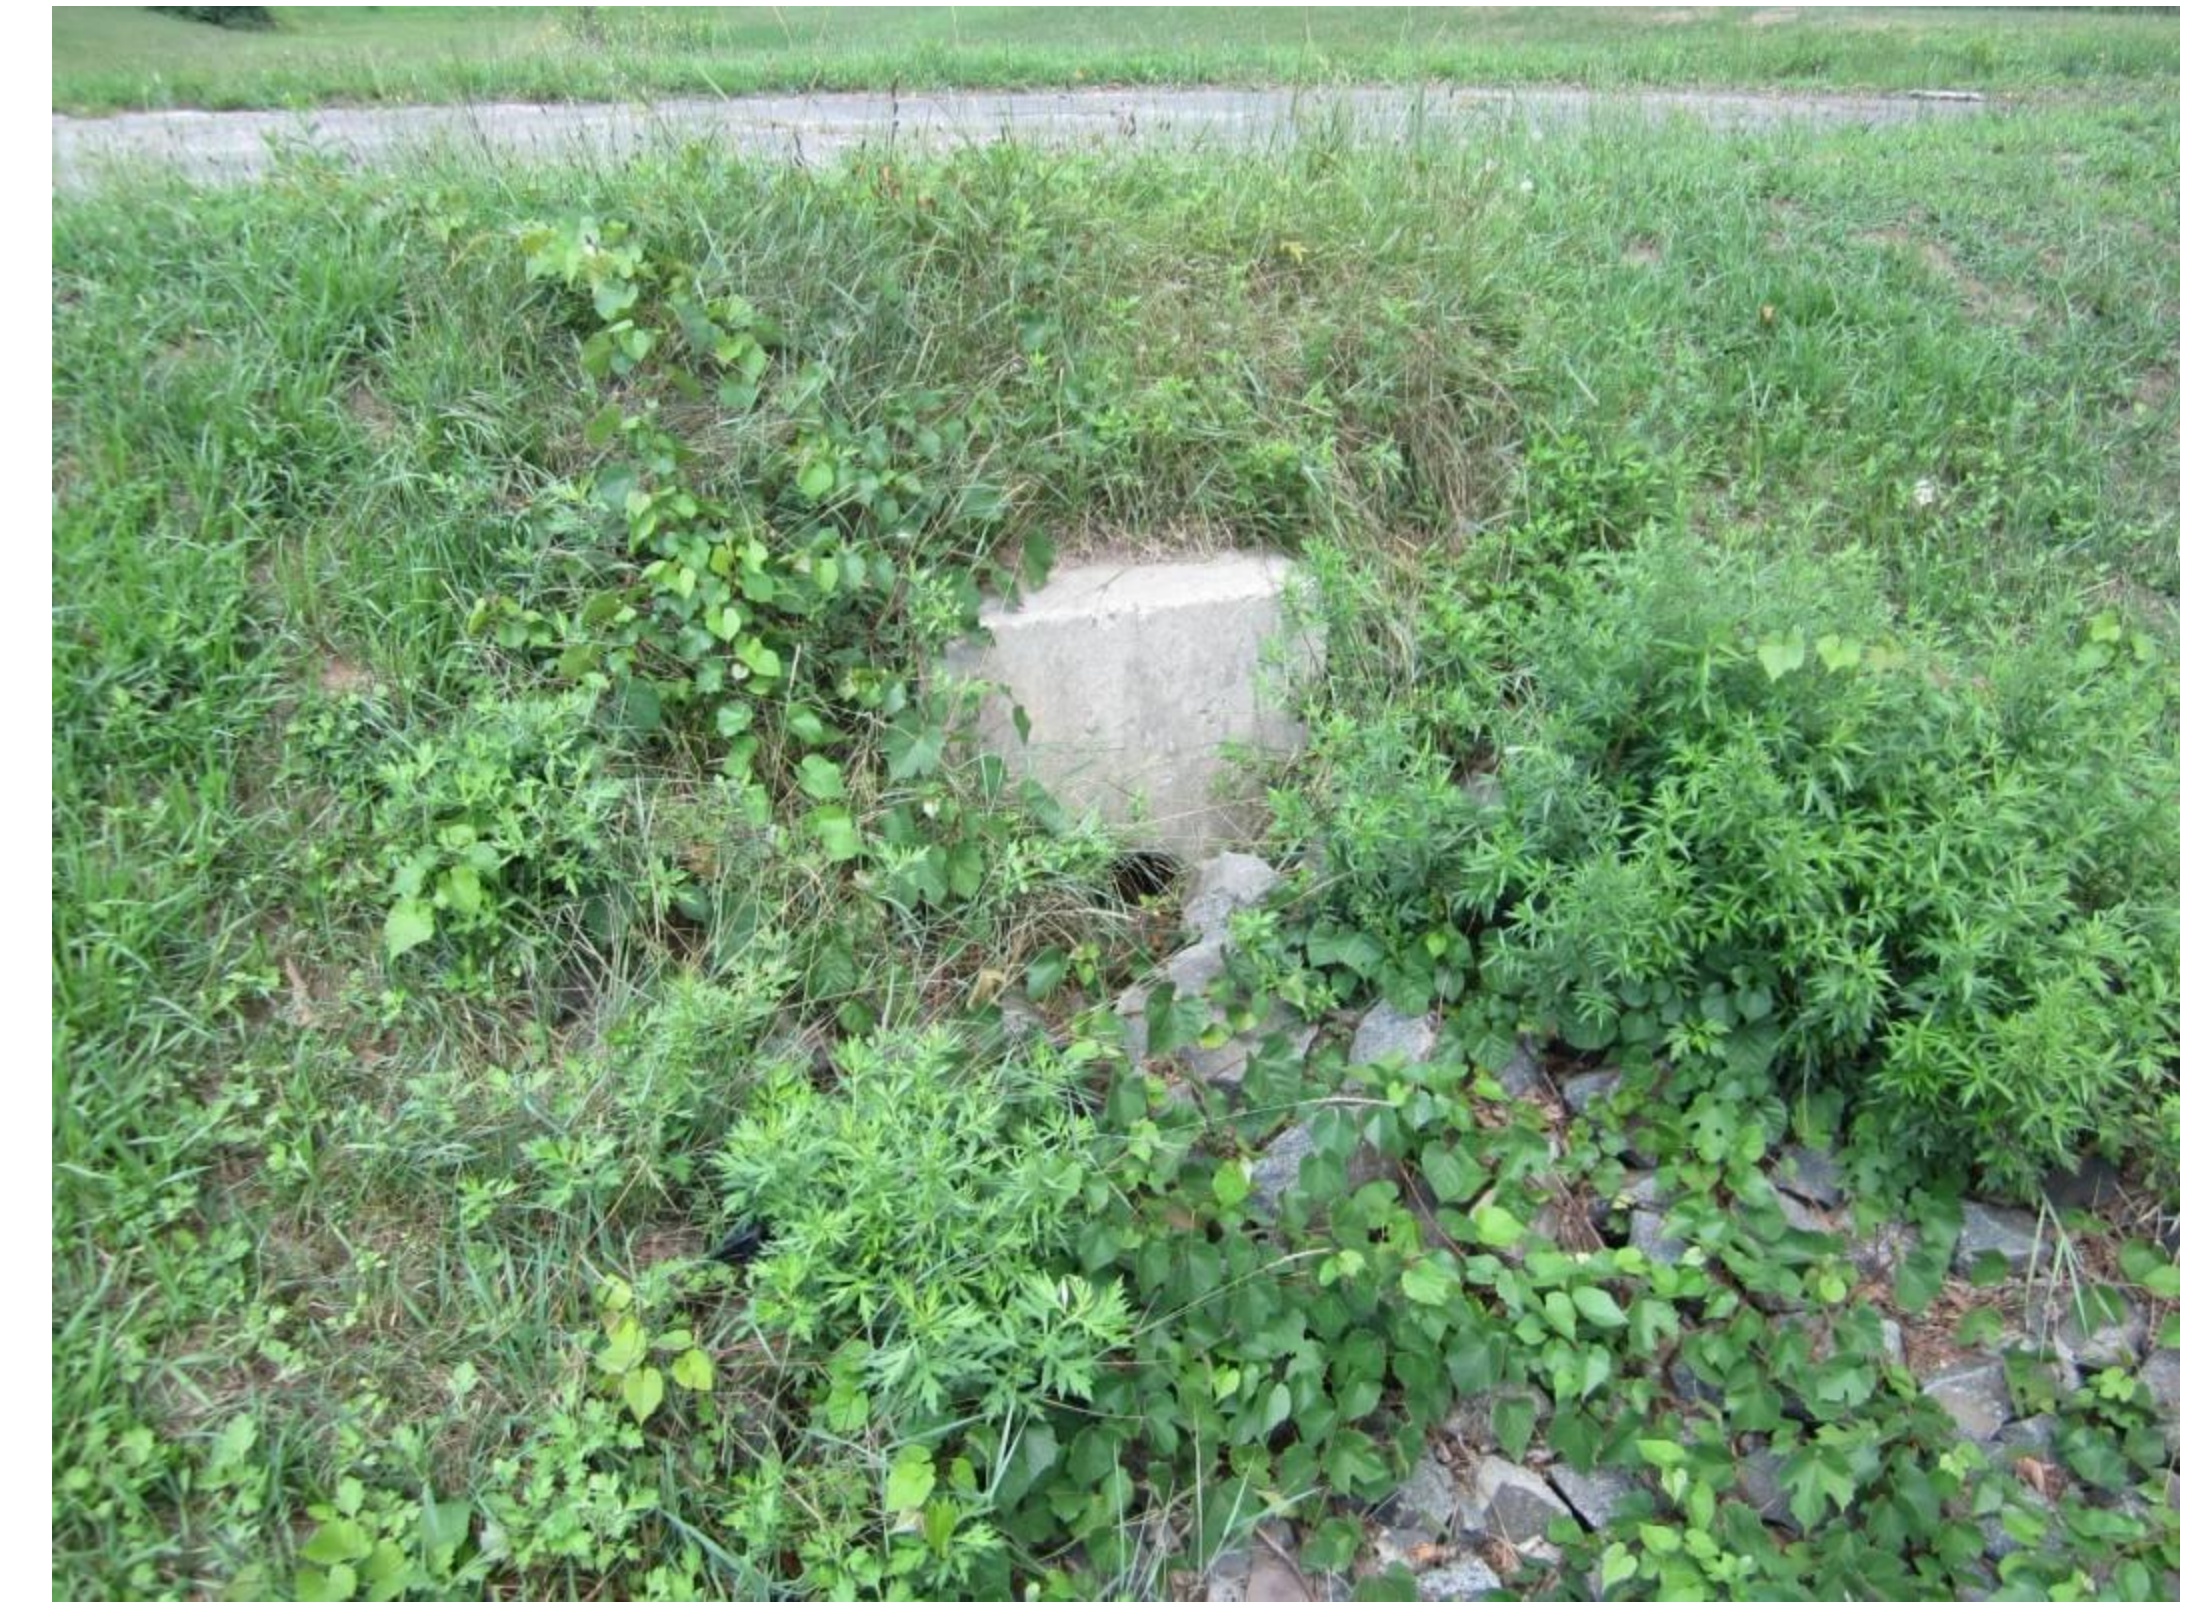
Clogged inlet

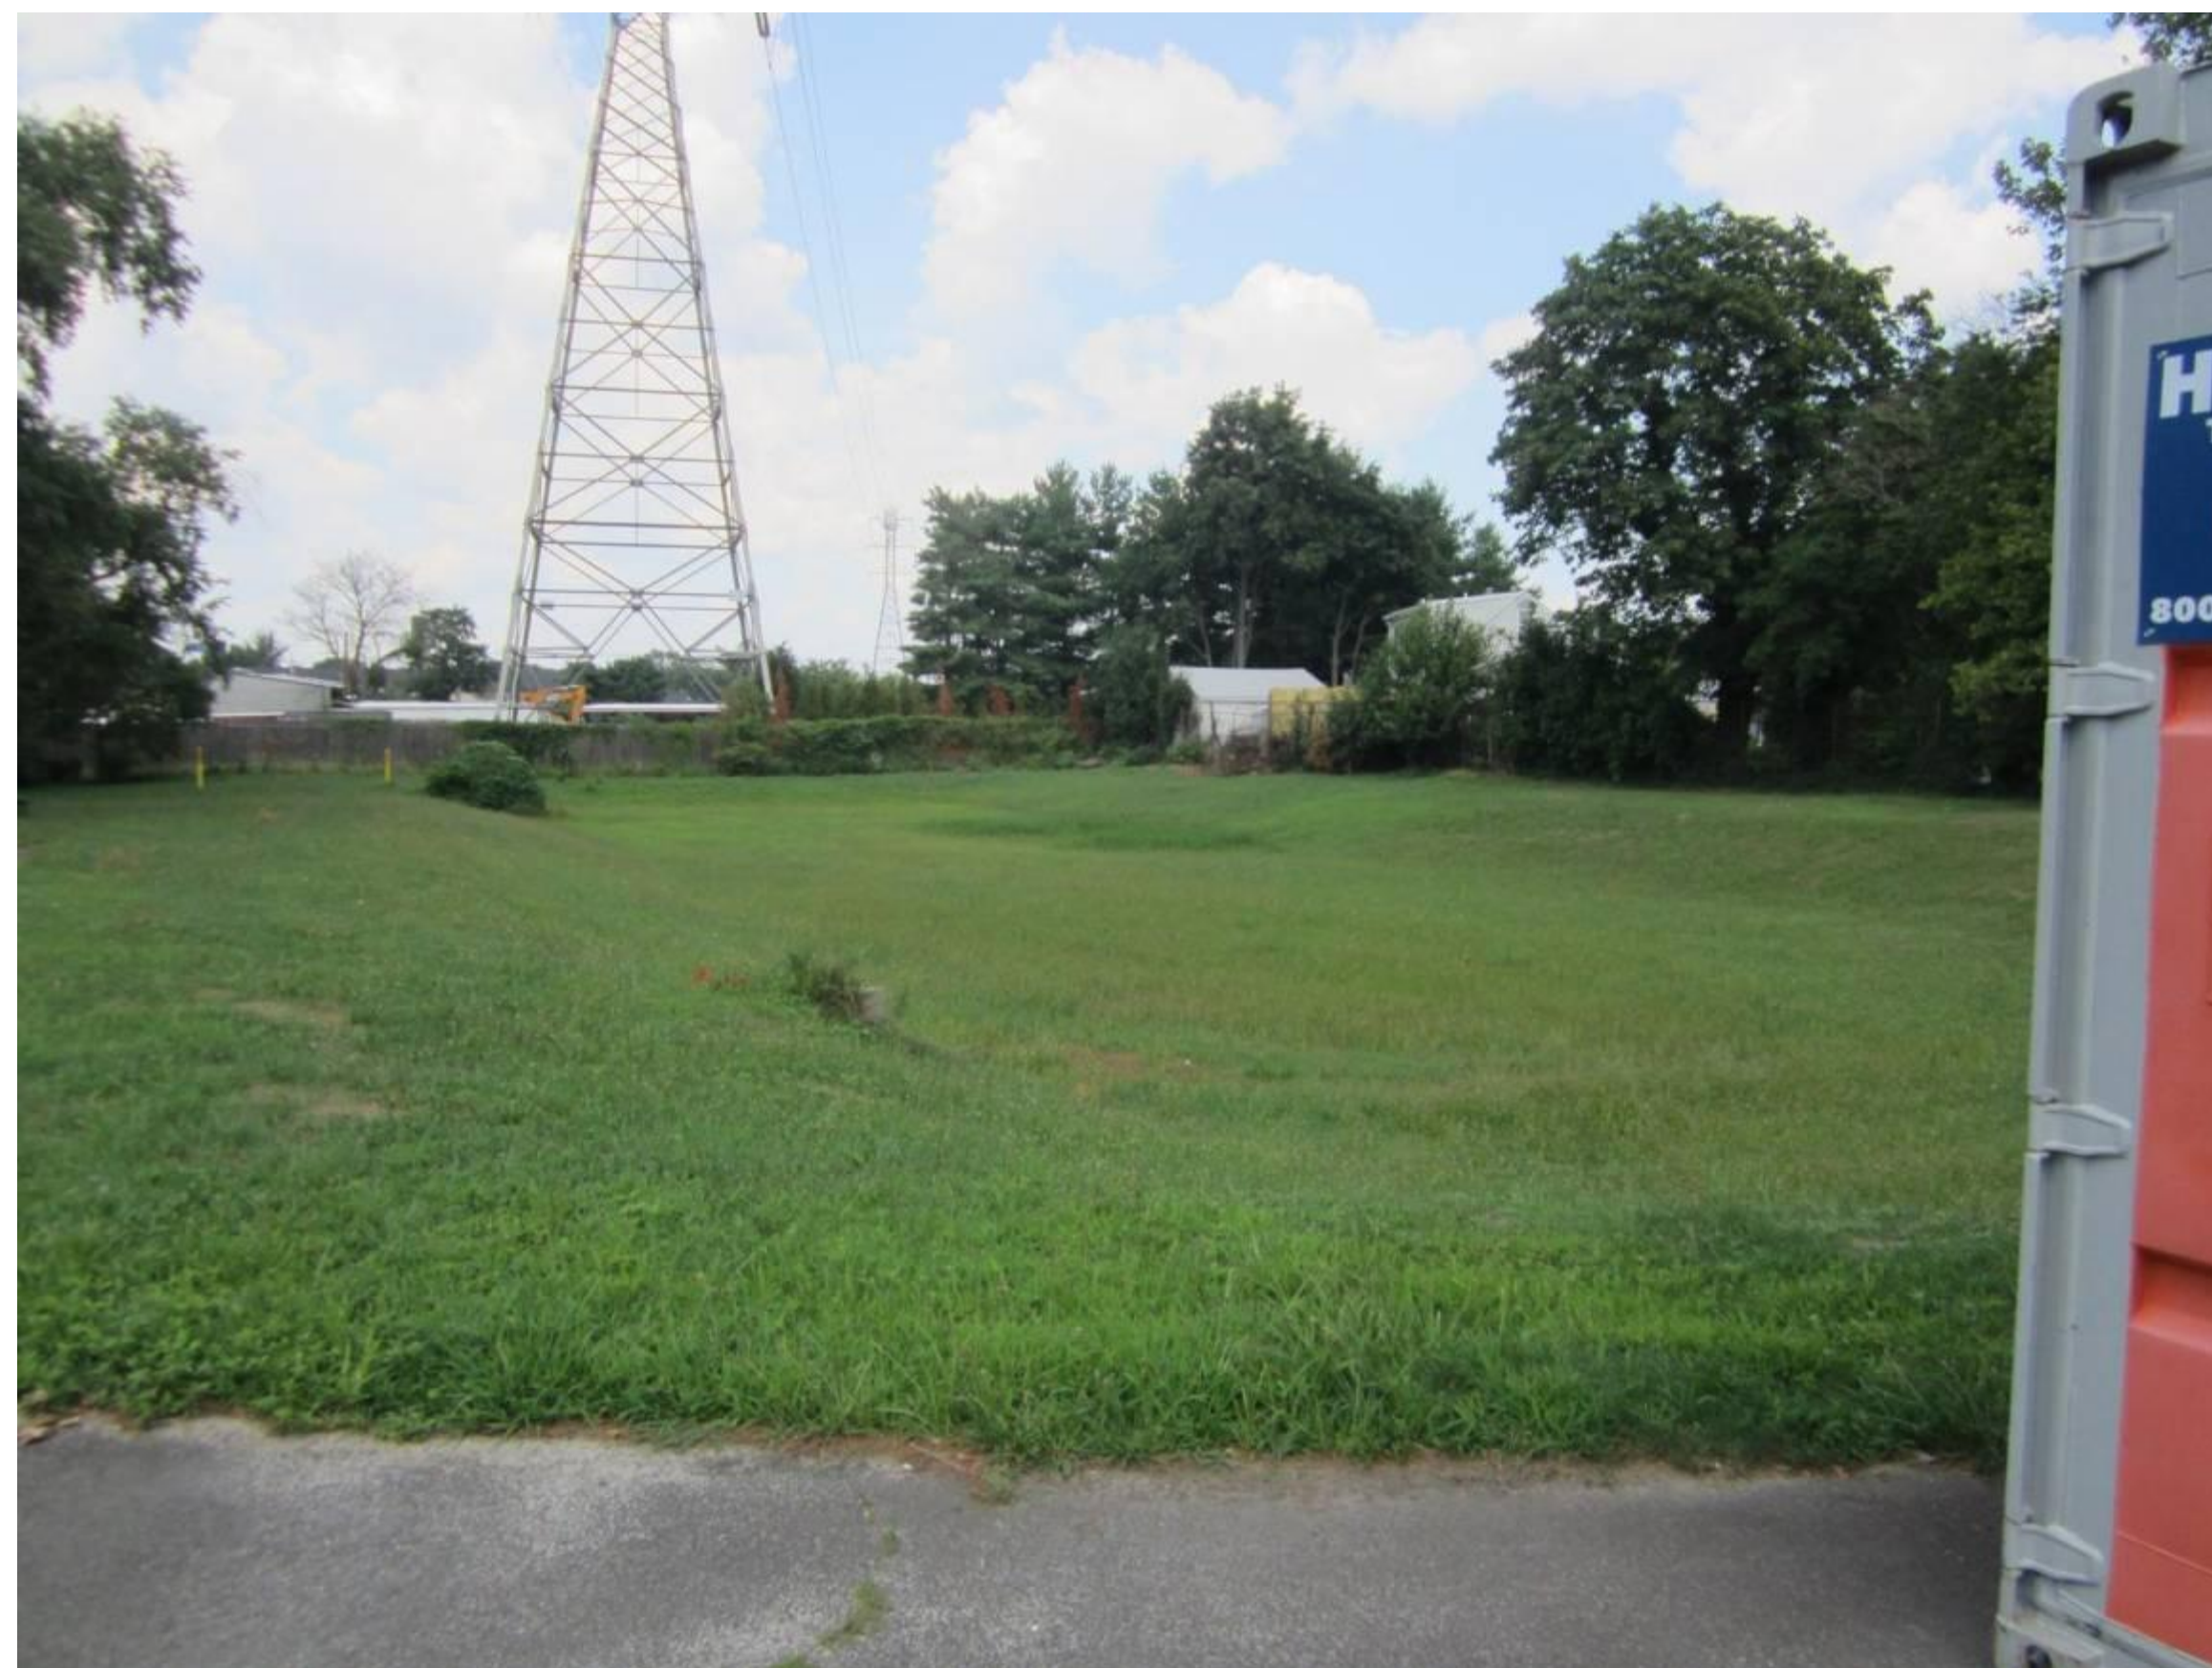
Northern basin

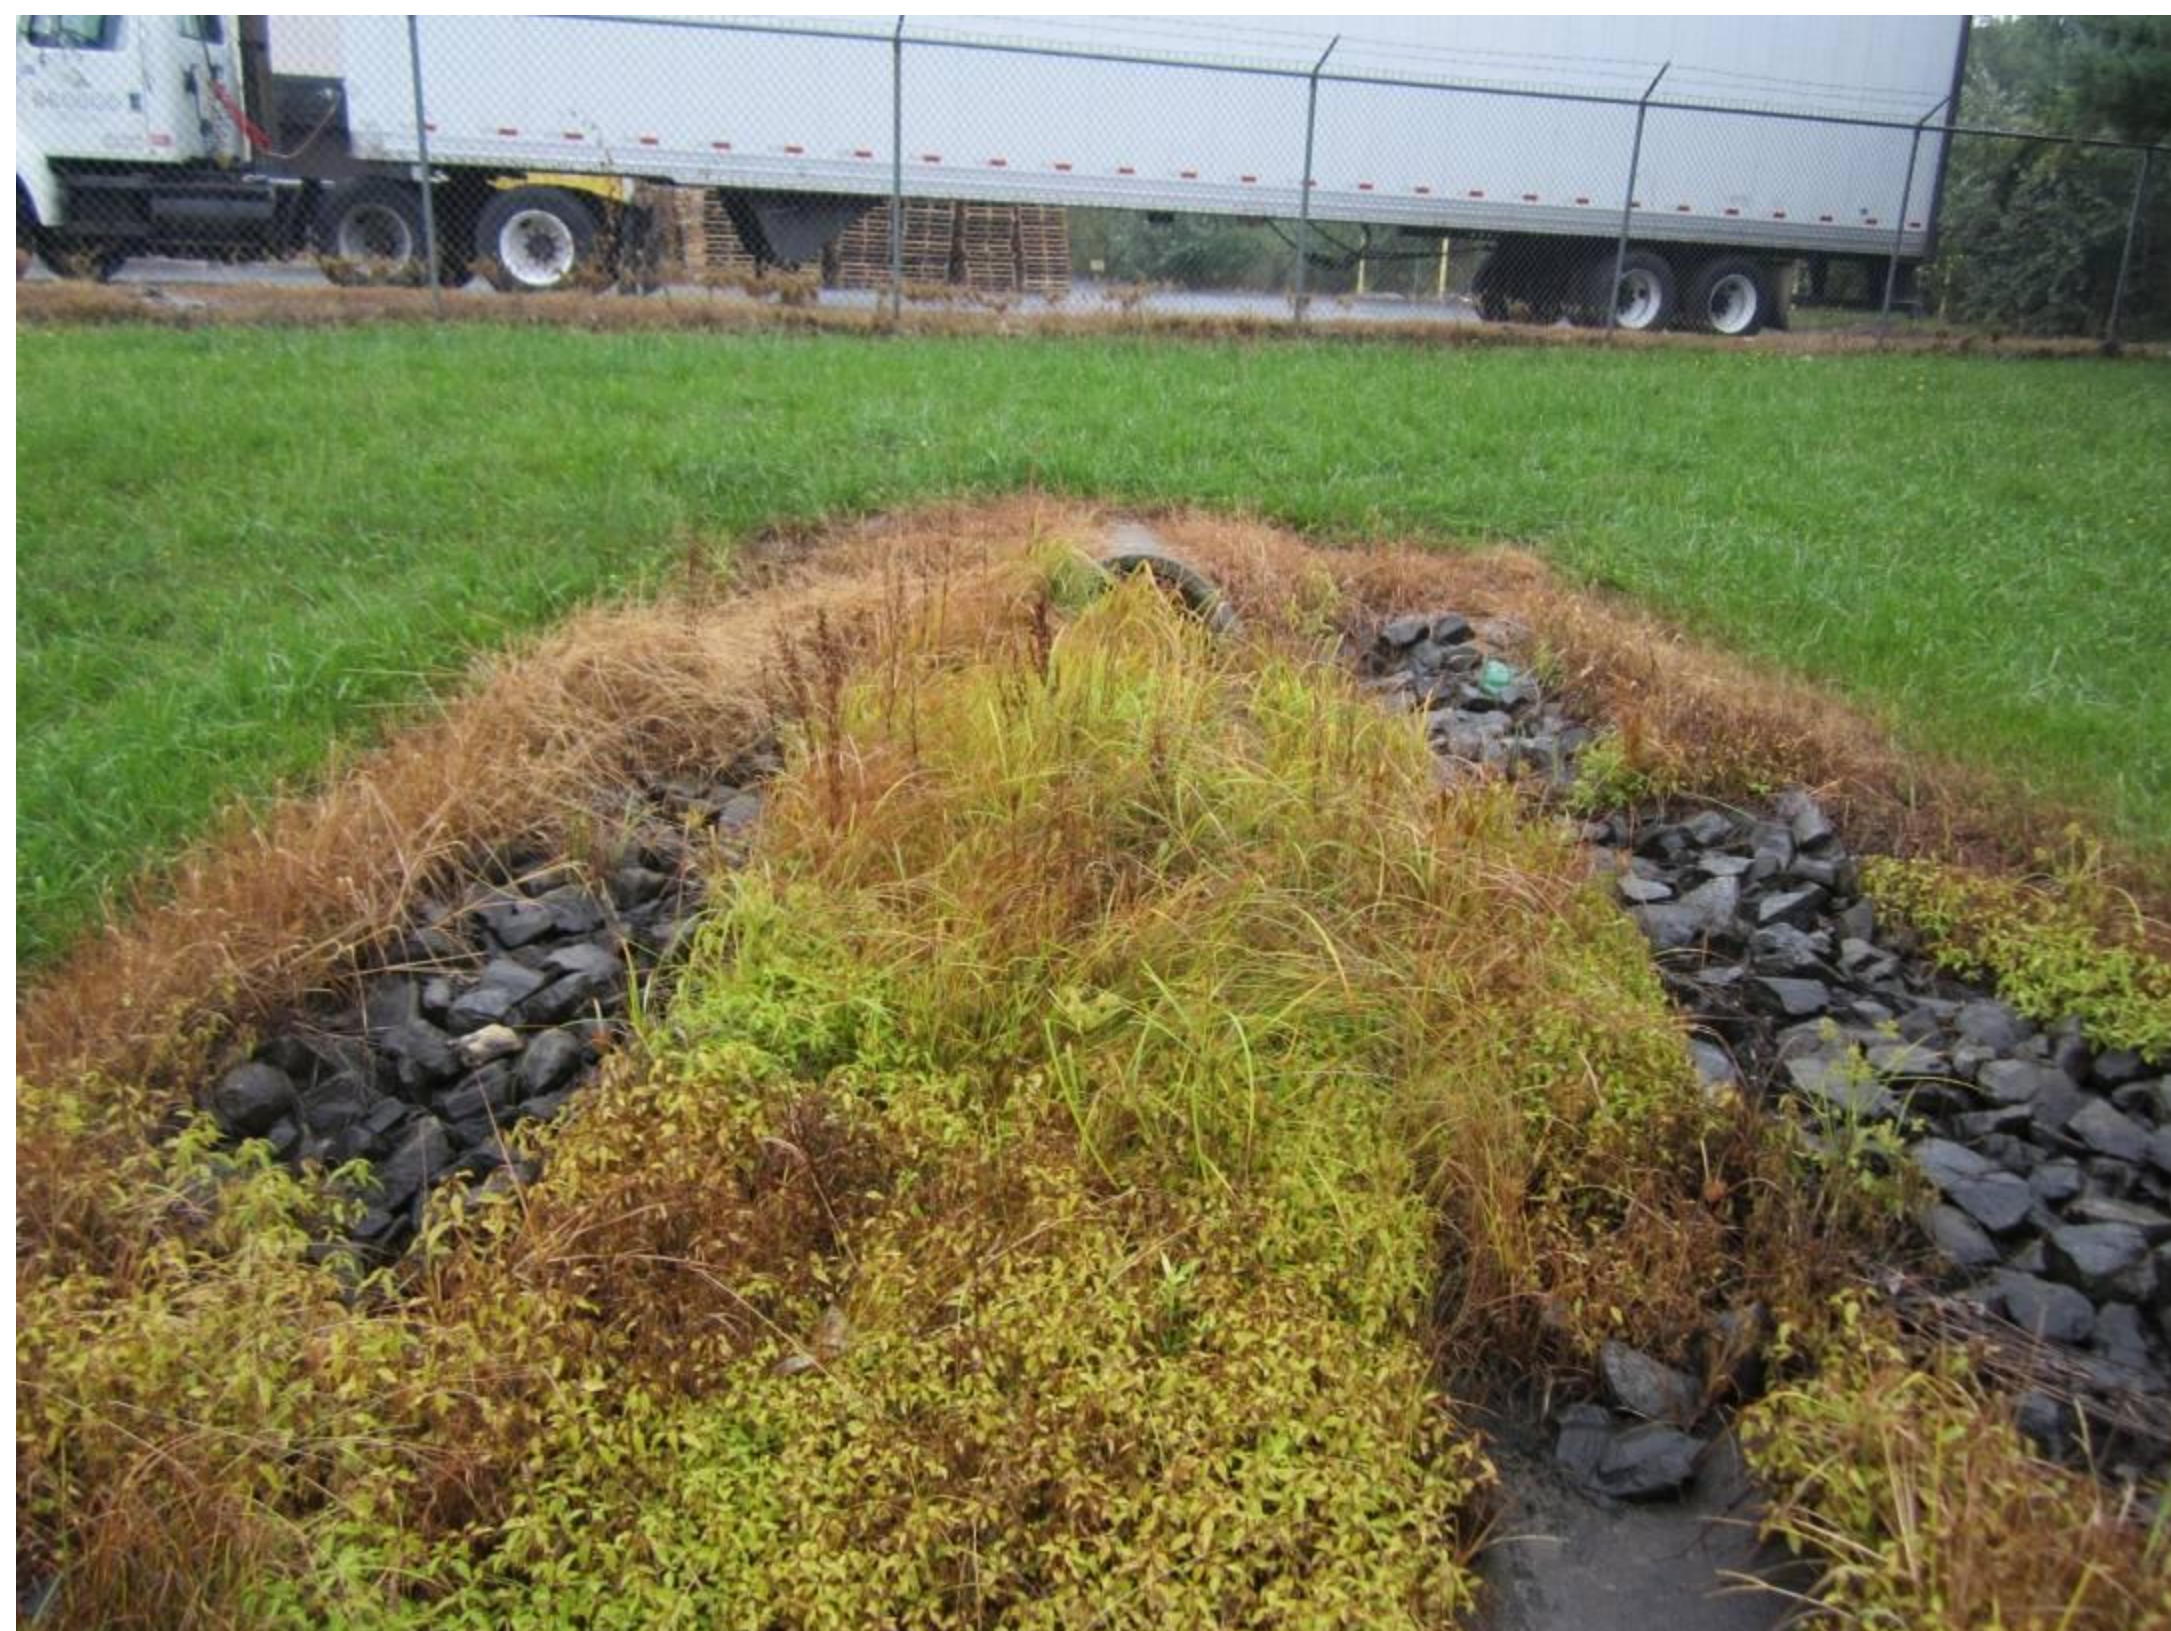
Clogged inlet

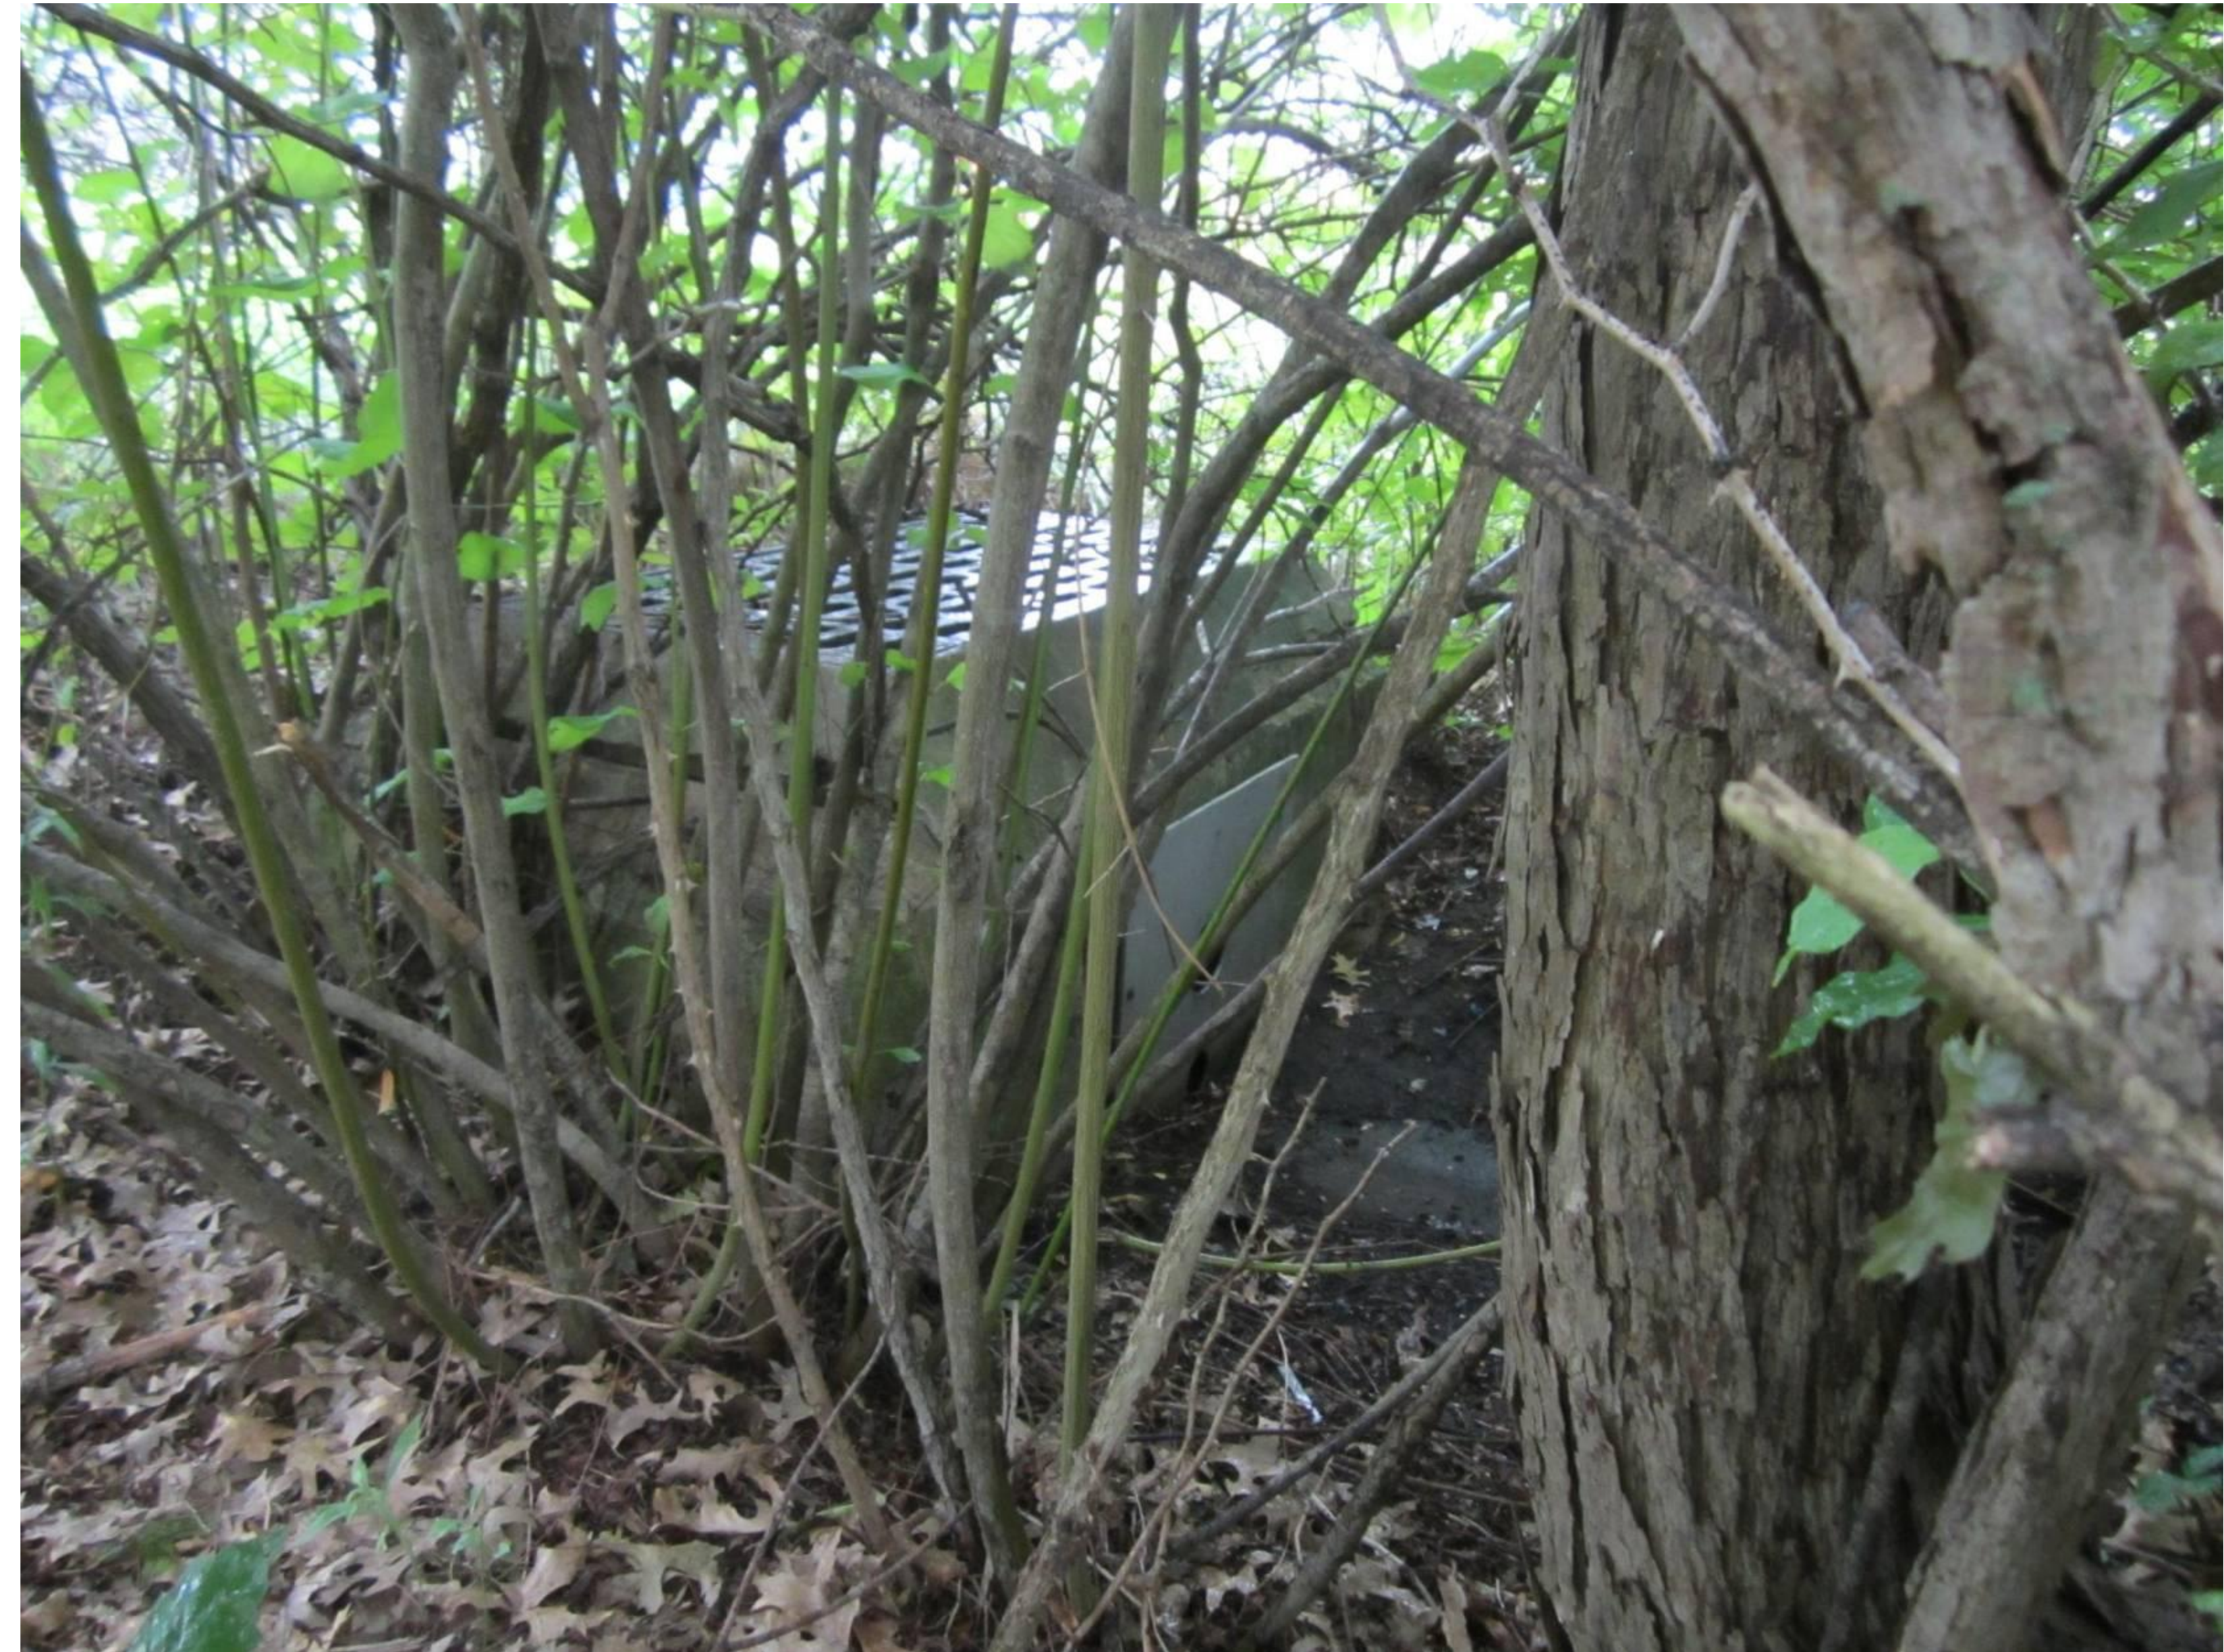
Woody vegetation around outlet

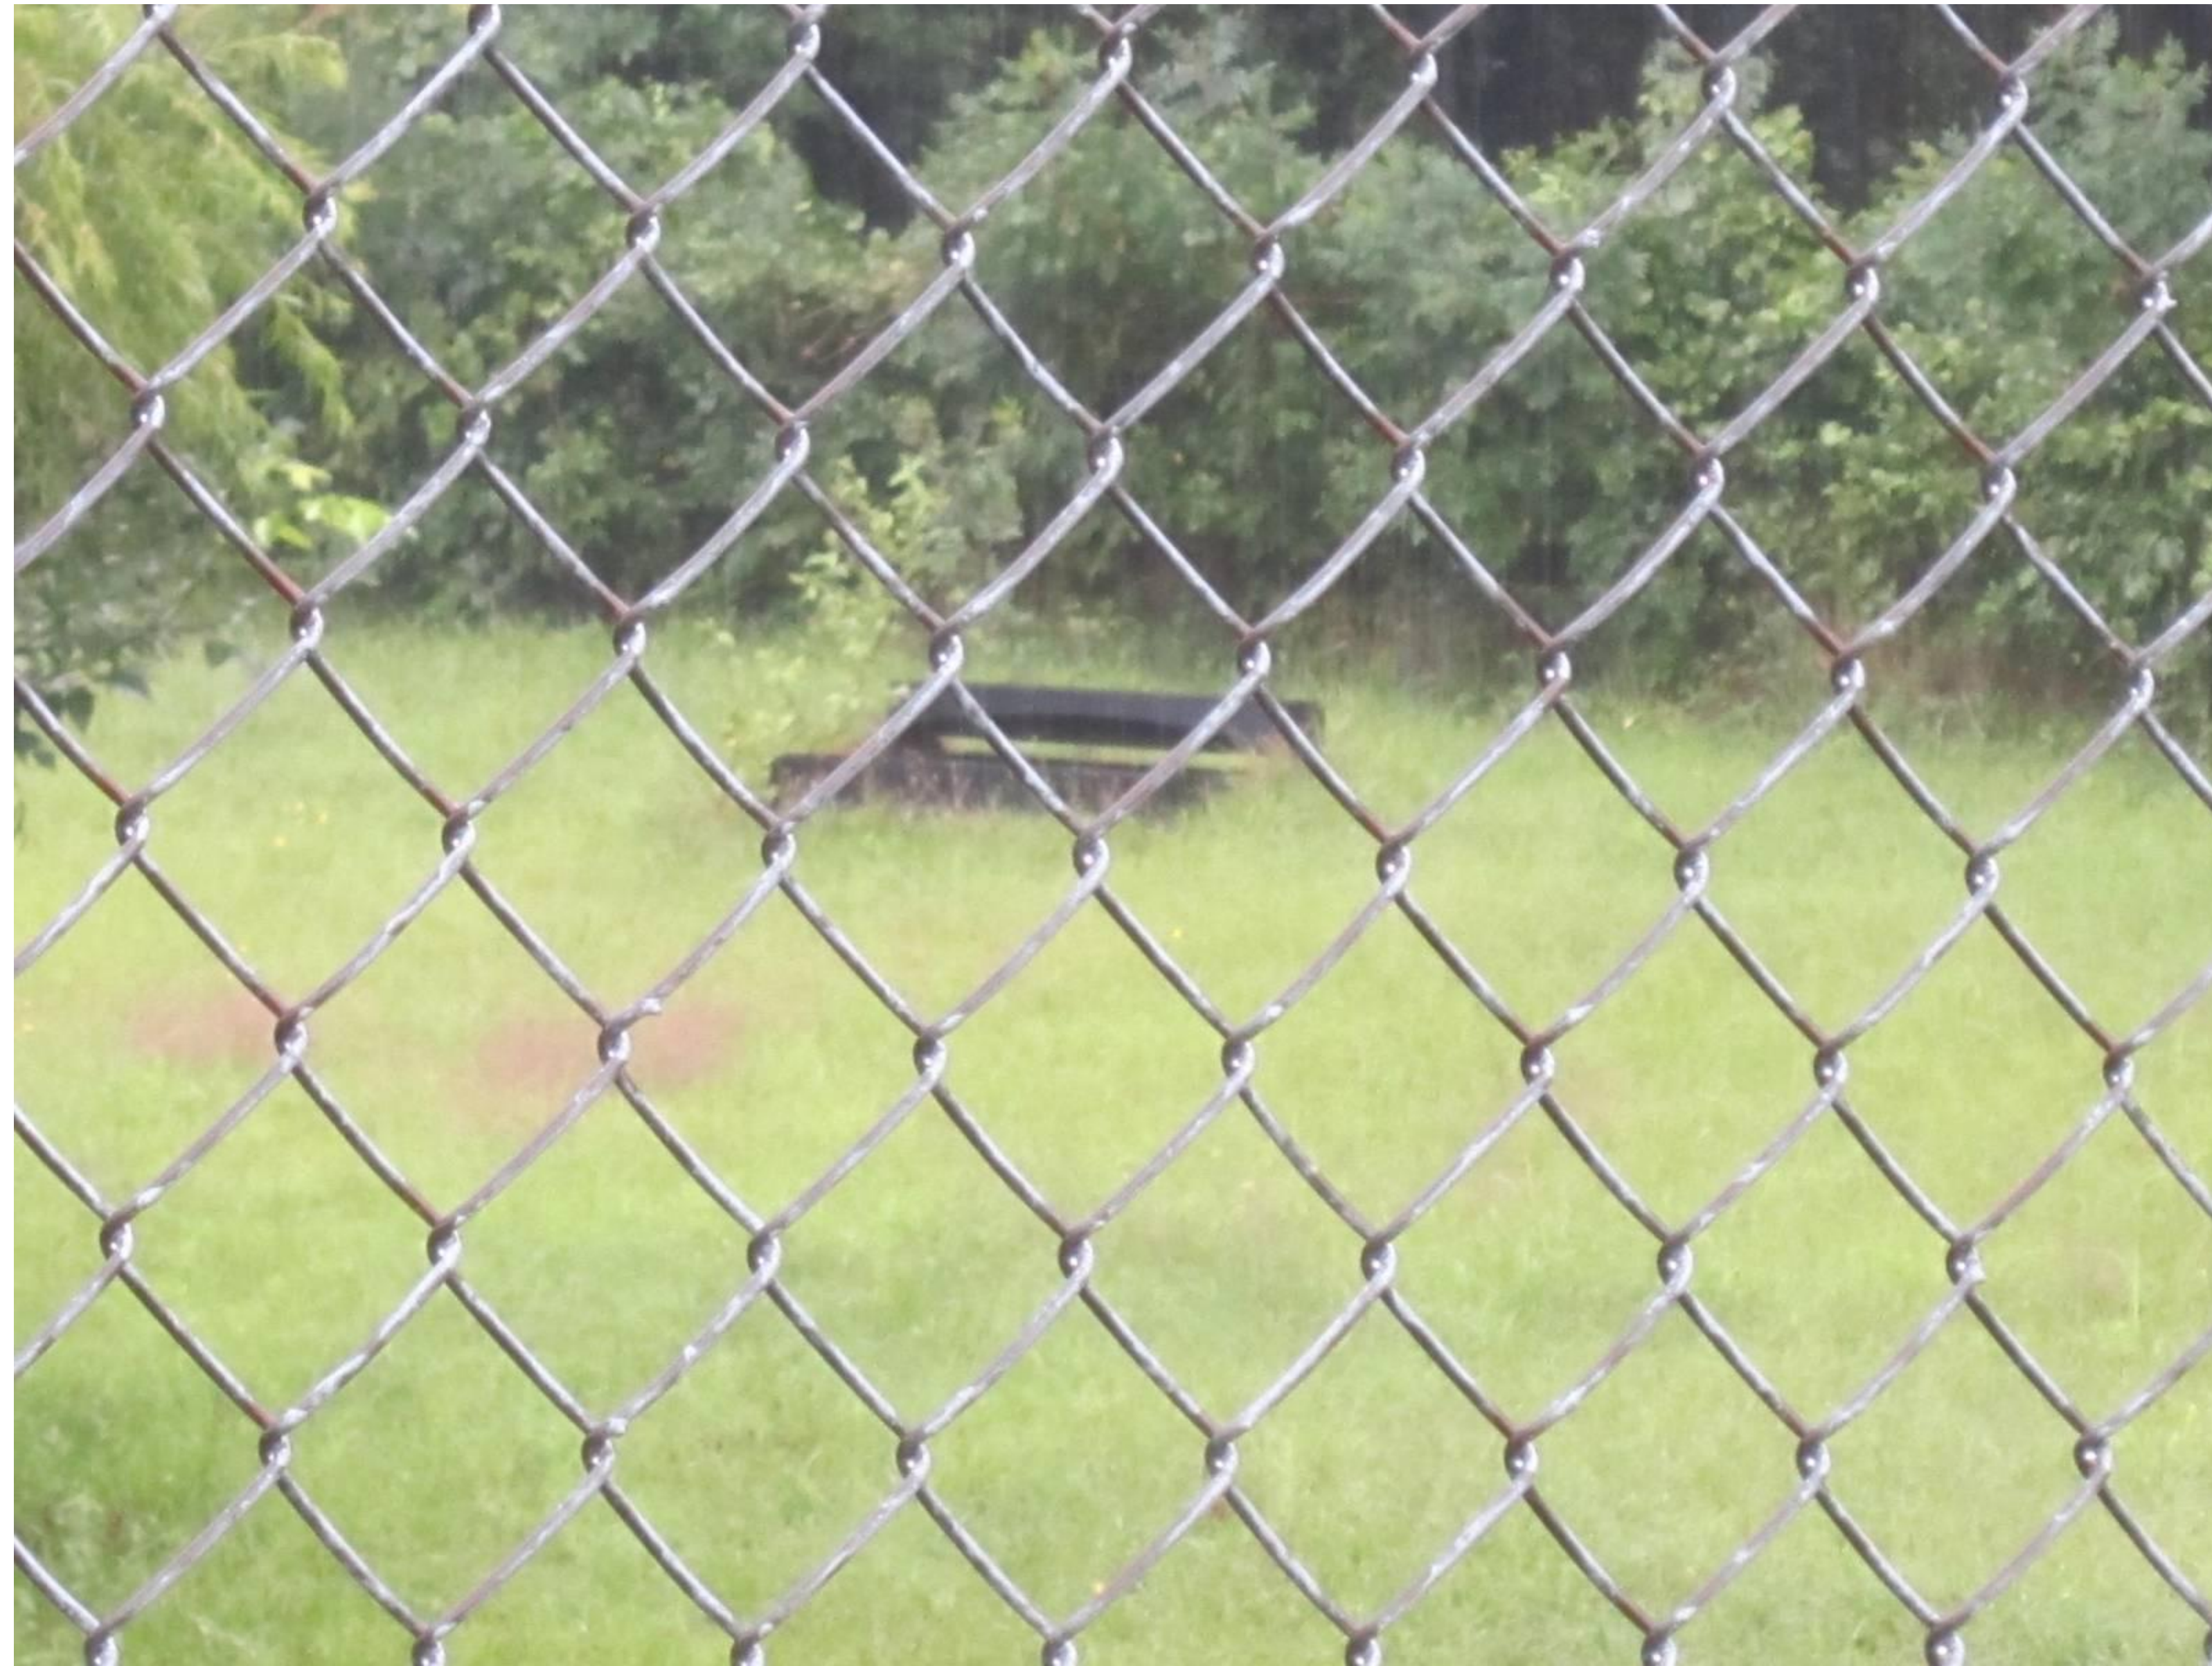
Outlet structure

- Woody vegetation growth around inlet
- Limited accessibility

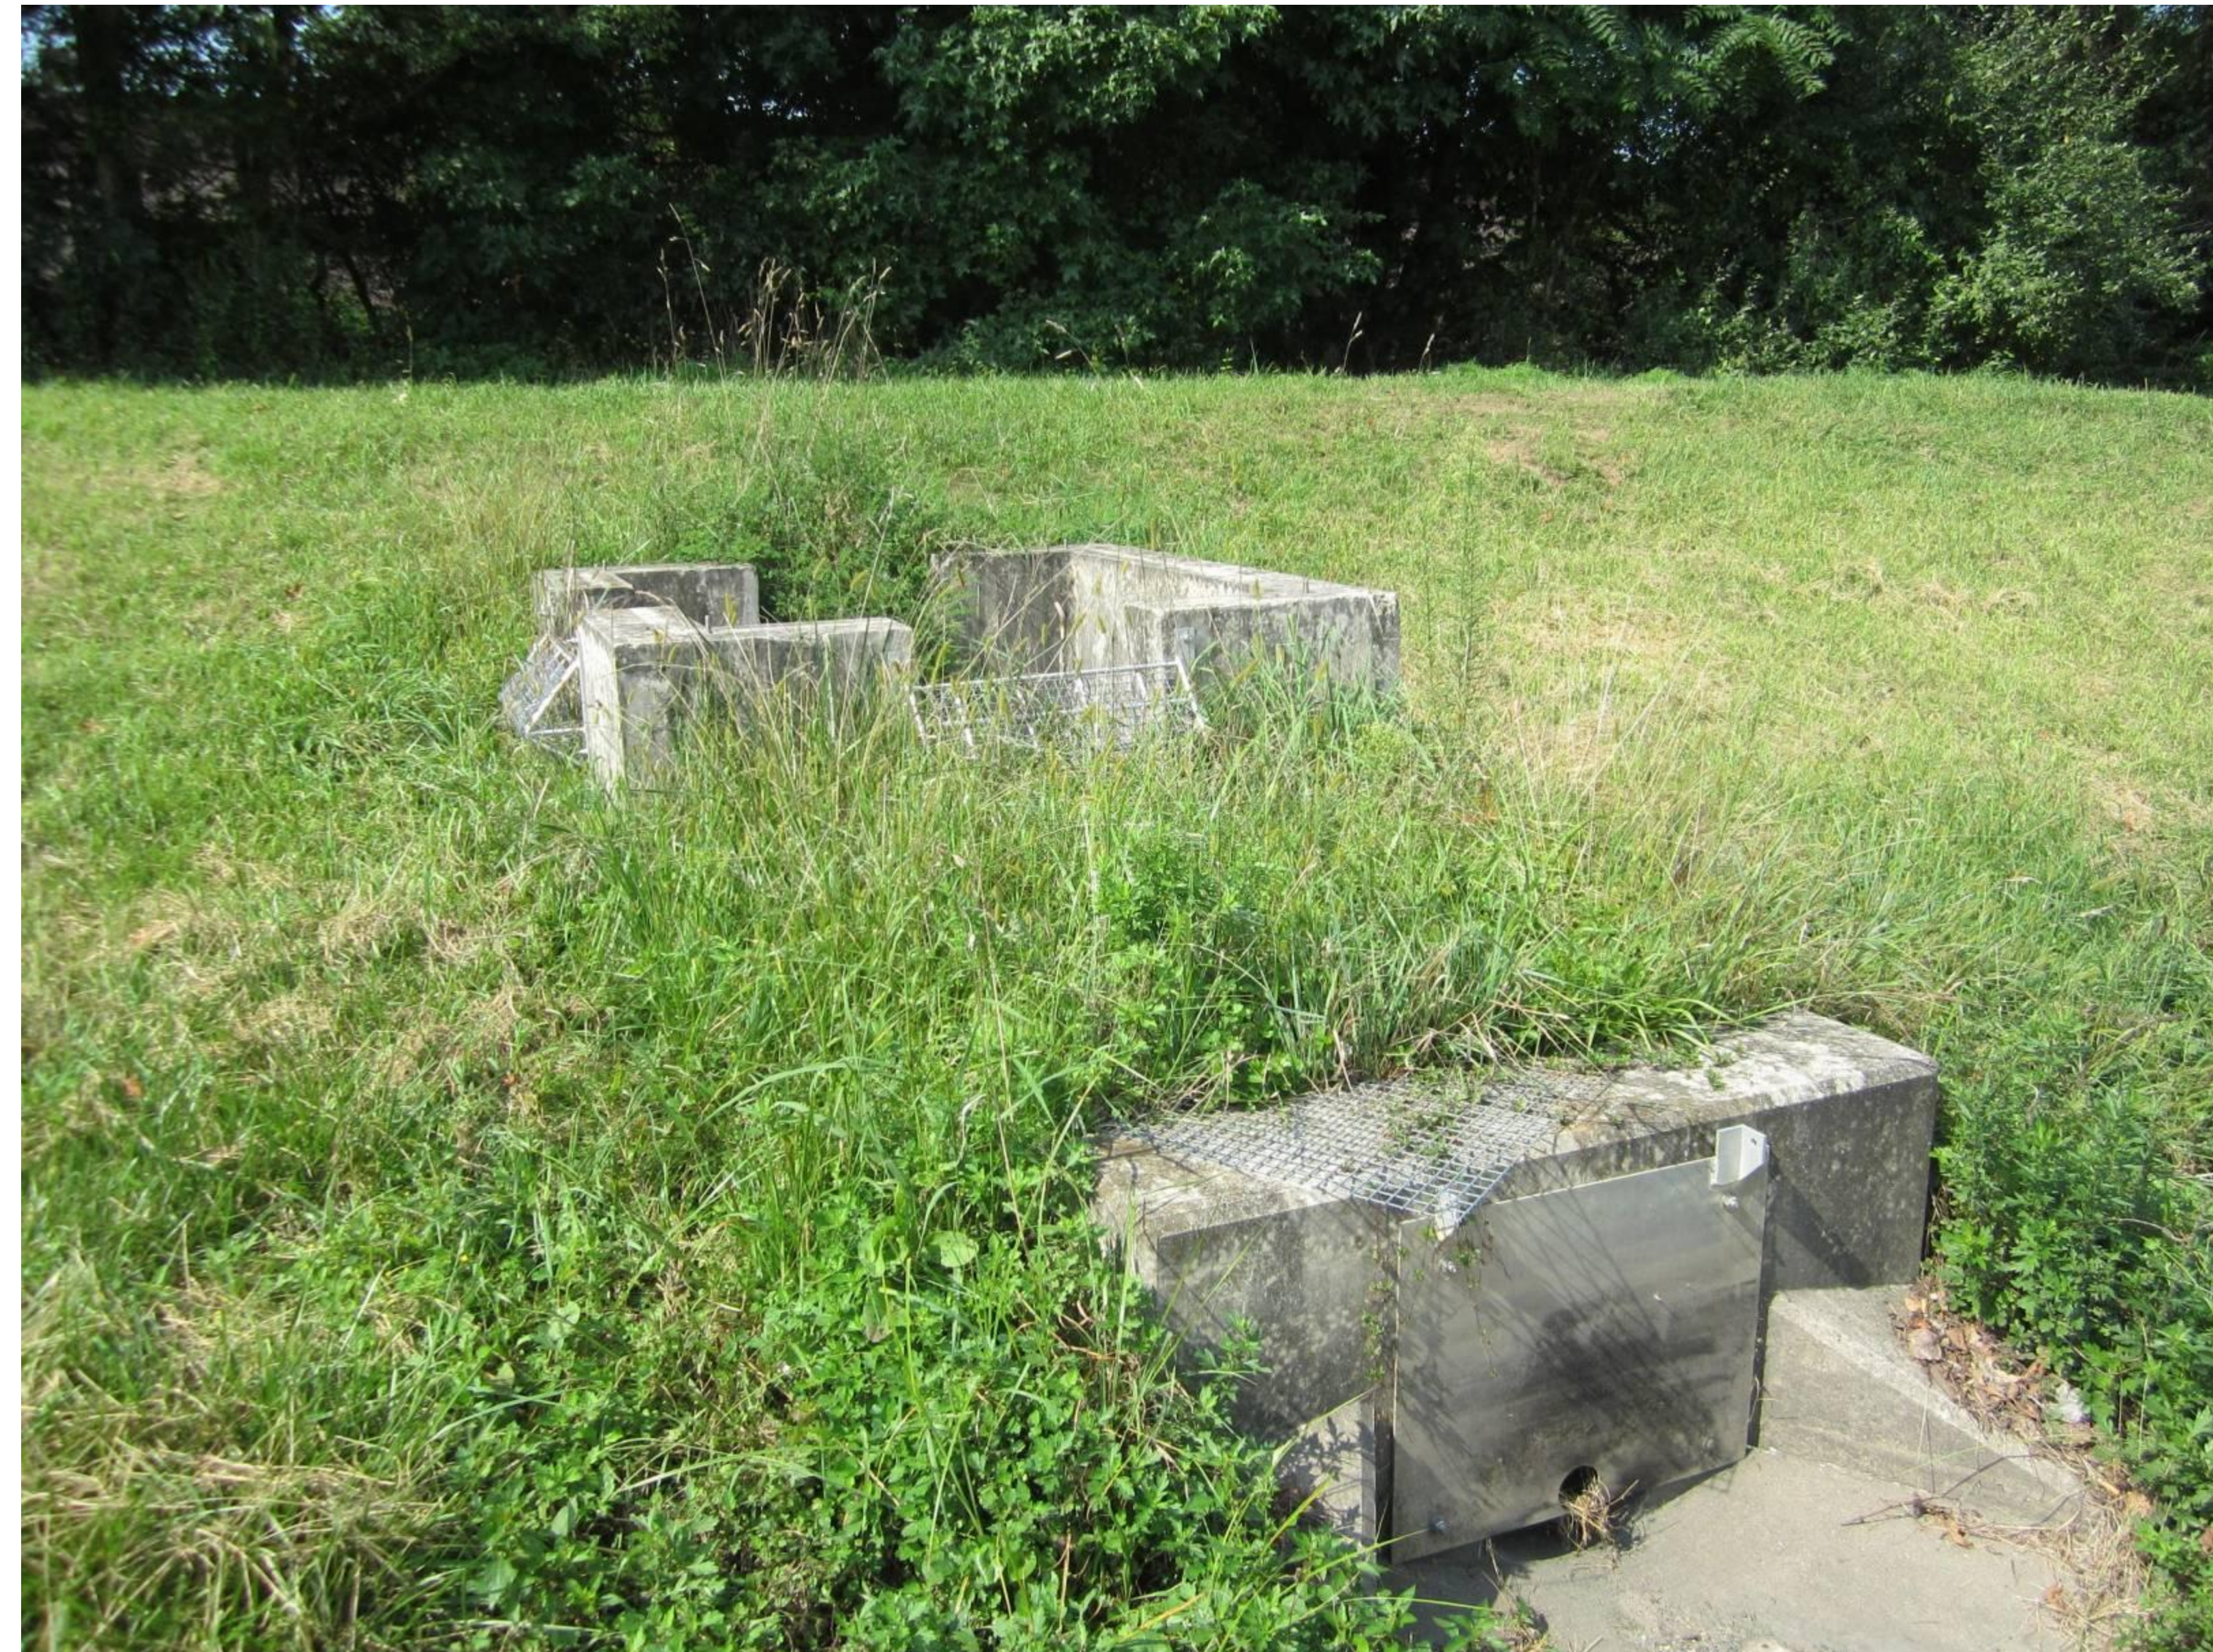
Outlet structure

- Outlet grate cover missing
- Debris/sediment accumulation in and around outlet structure
