Hamilton Township (Mercer County) Stormwater Basin Assessment Summary (Year 1)

Developed by the Rutgers Cooperative Extension Water Resources Program
Funded by Hamilton Township, Mercer County, New Jersey

December 6, 2012

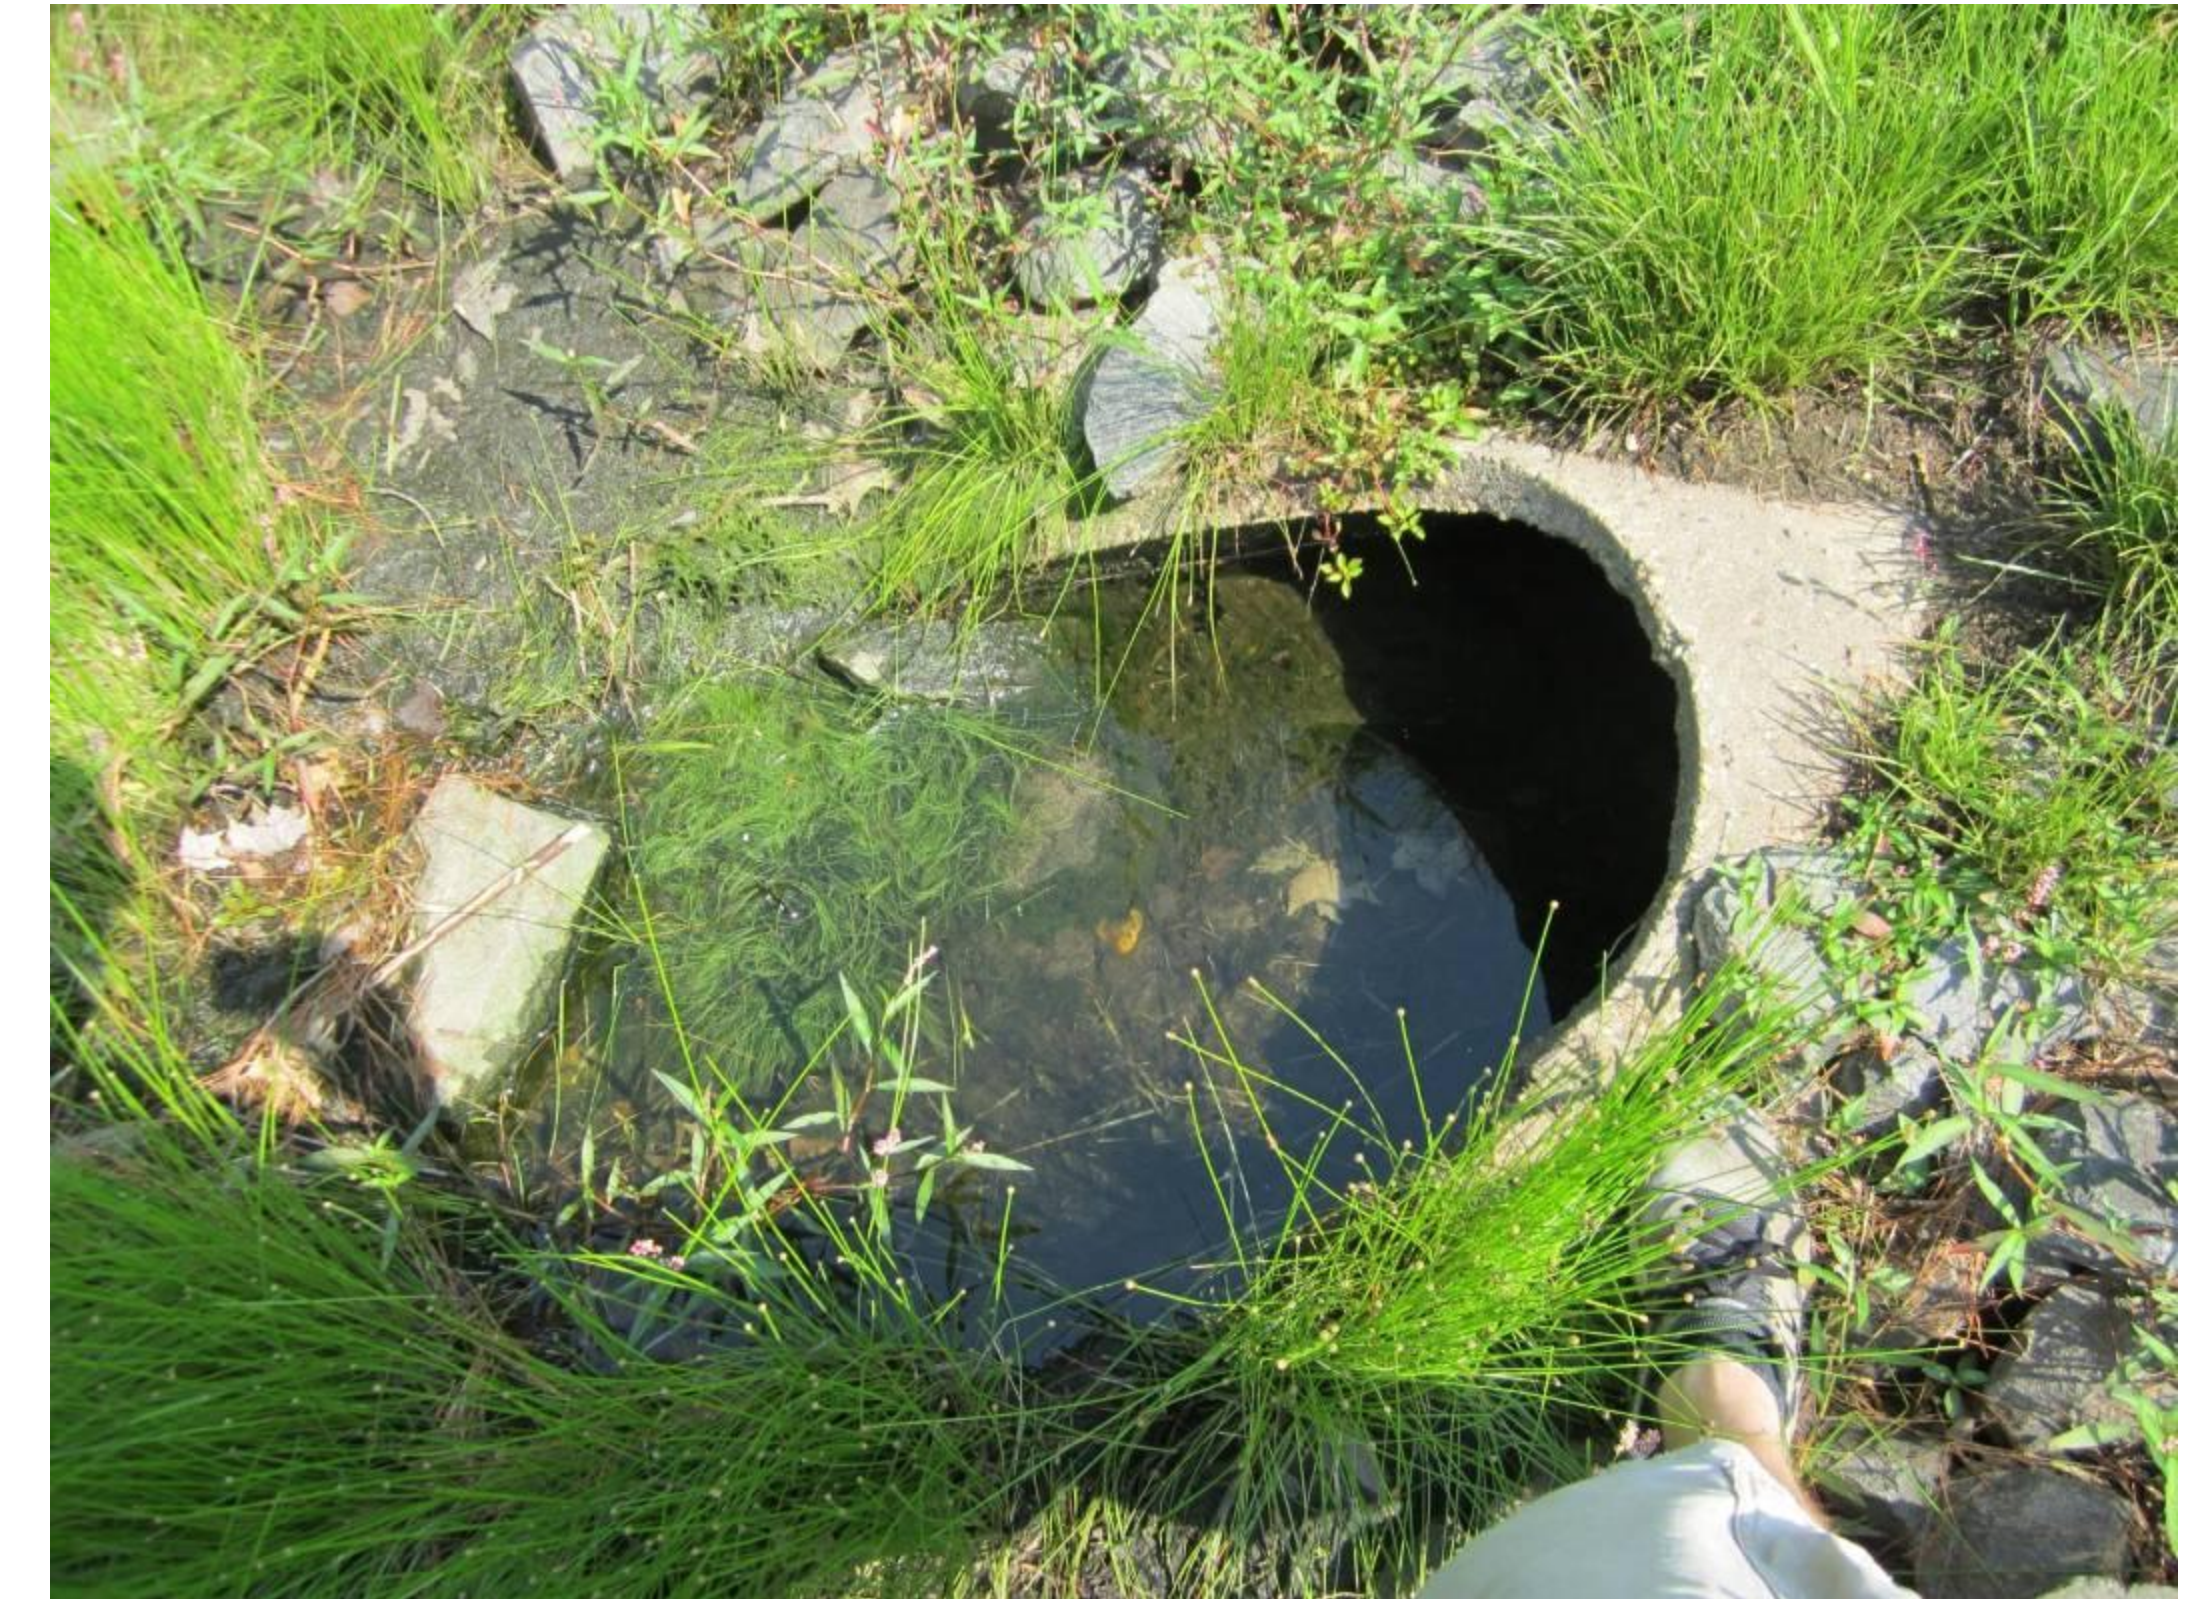
Clogged inlet

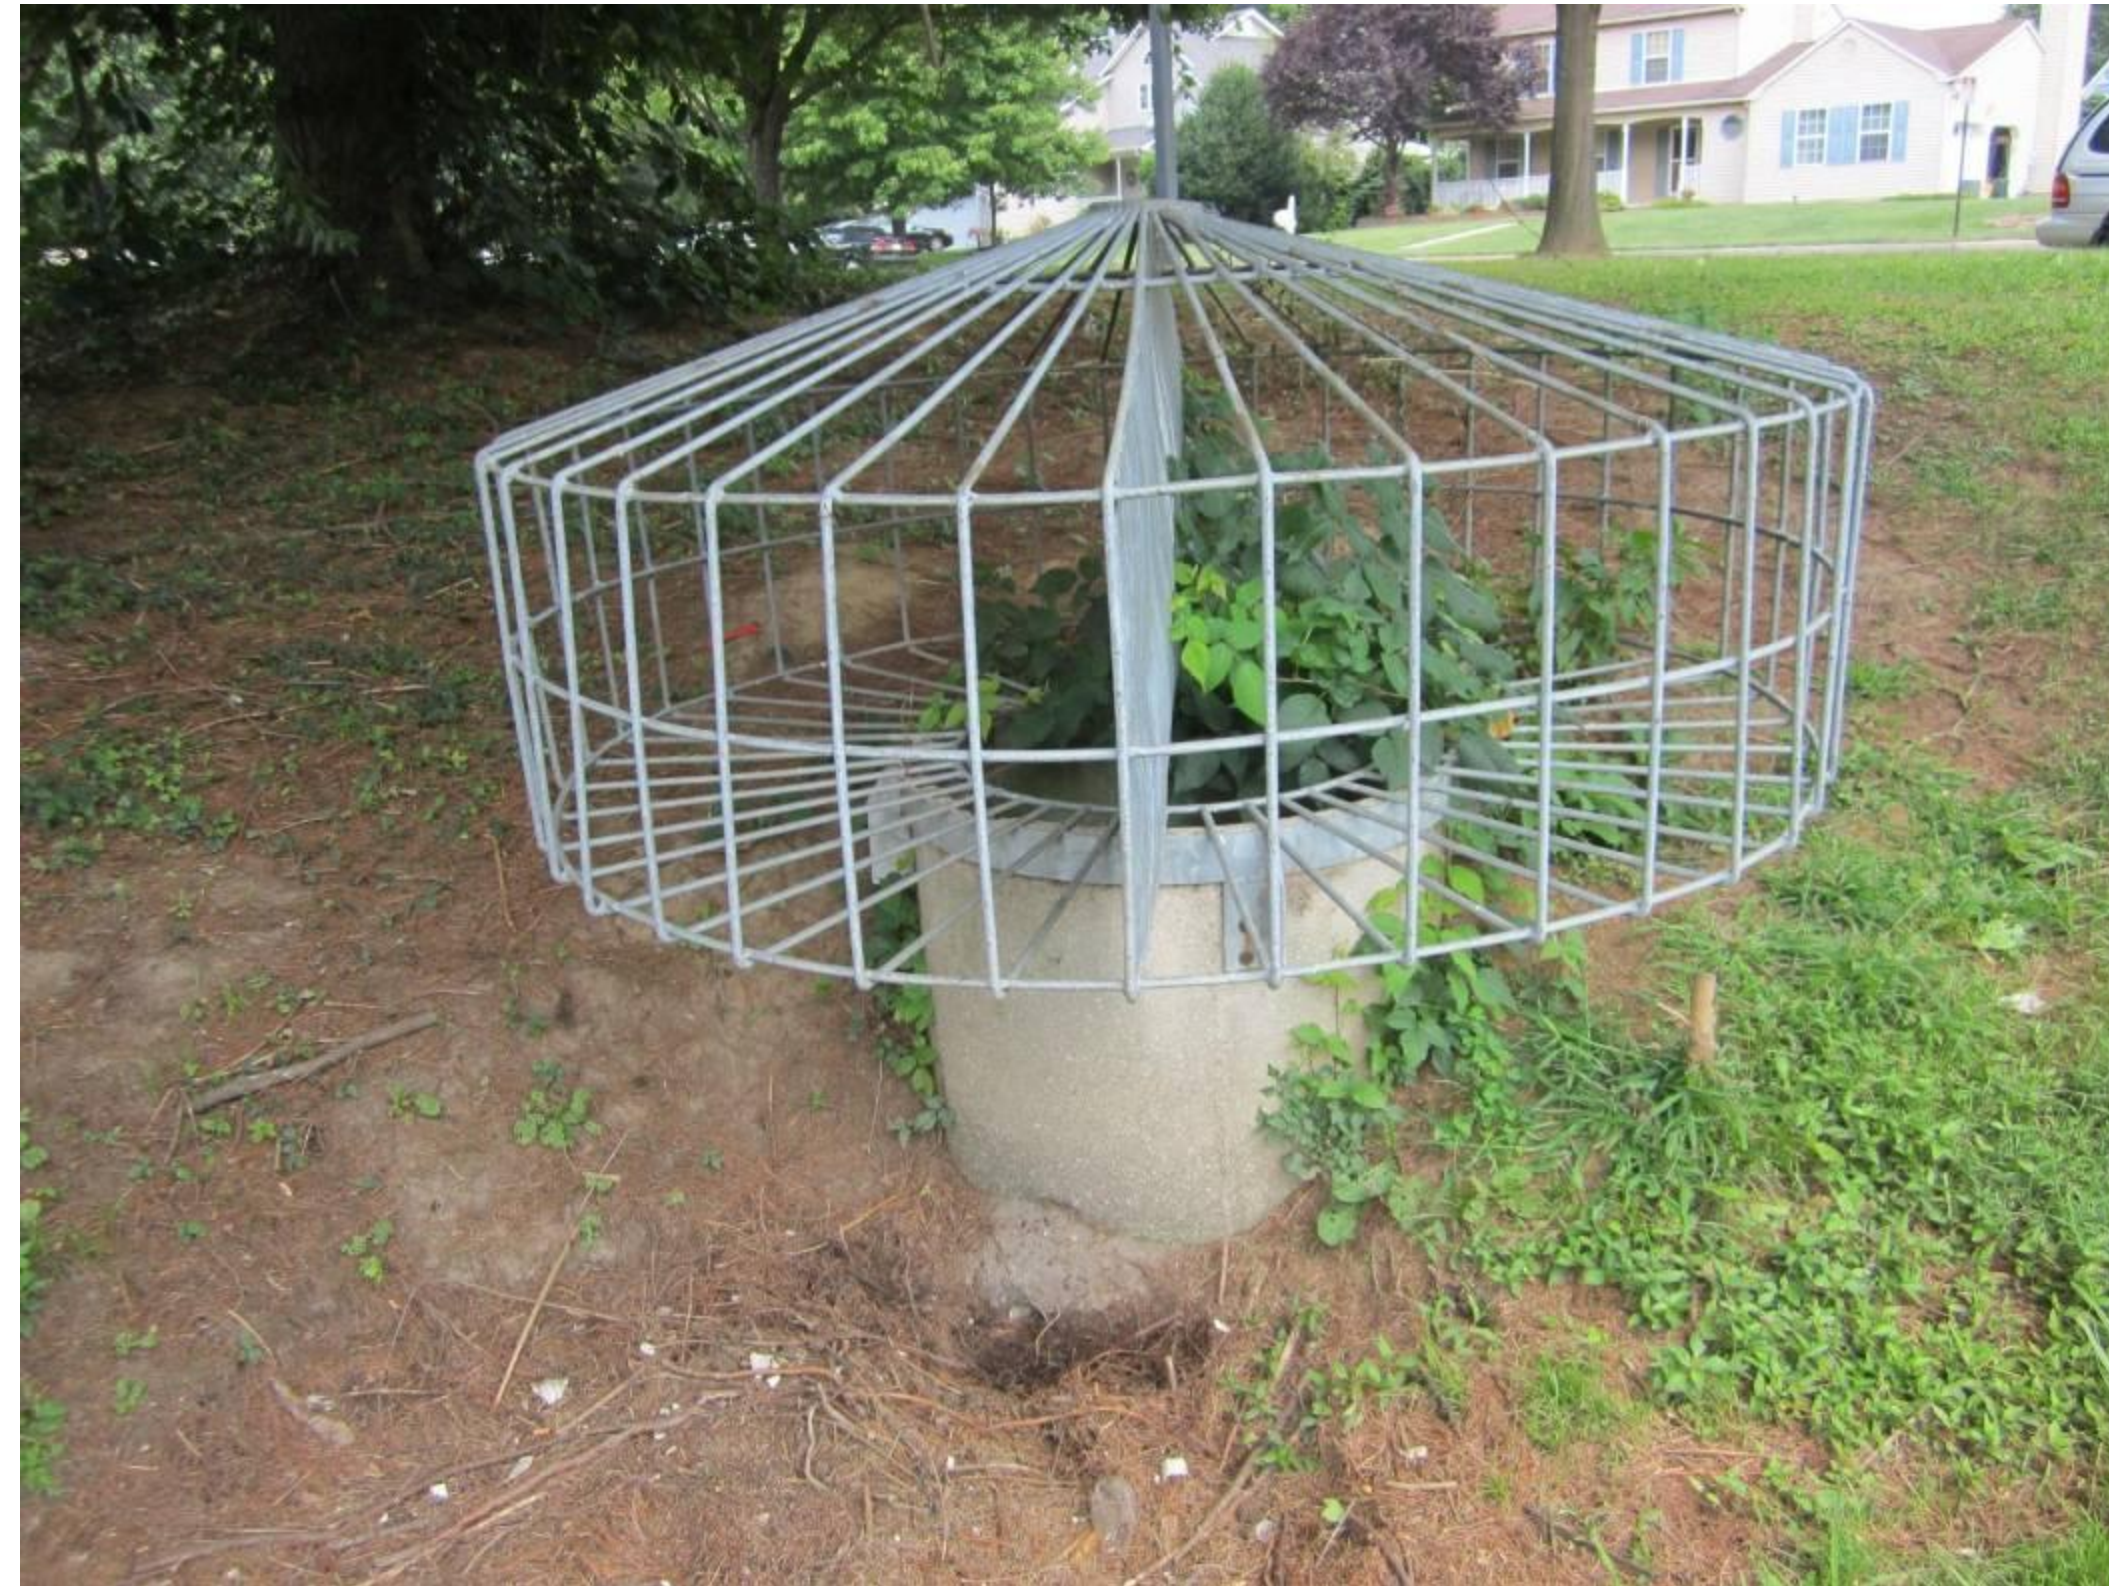
Outlet structure

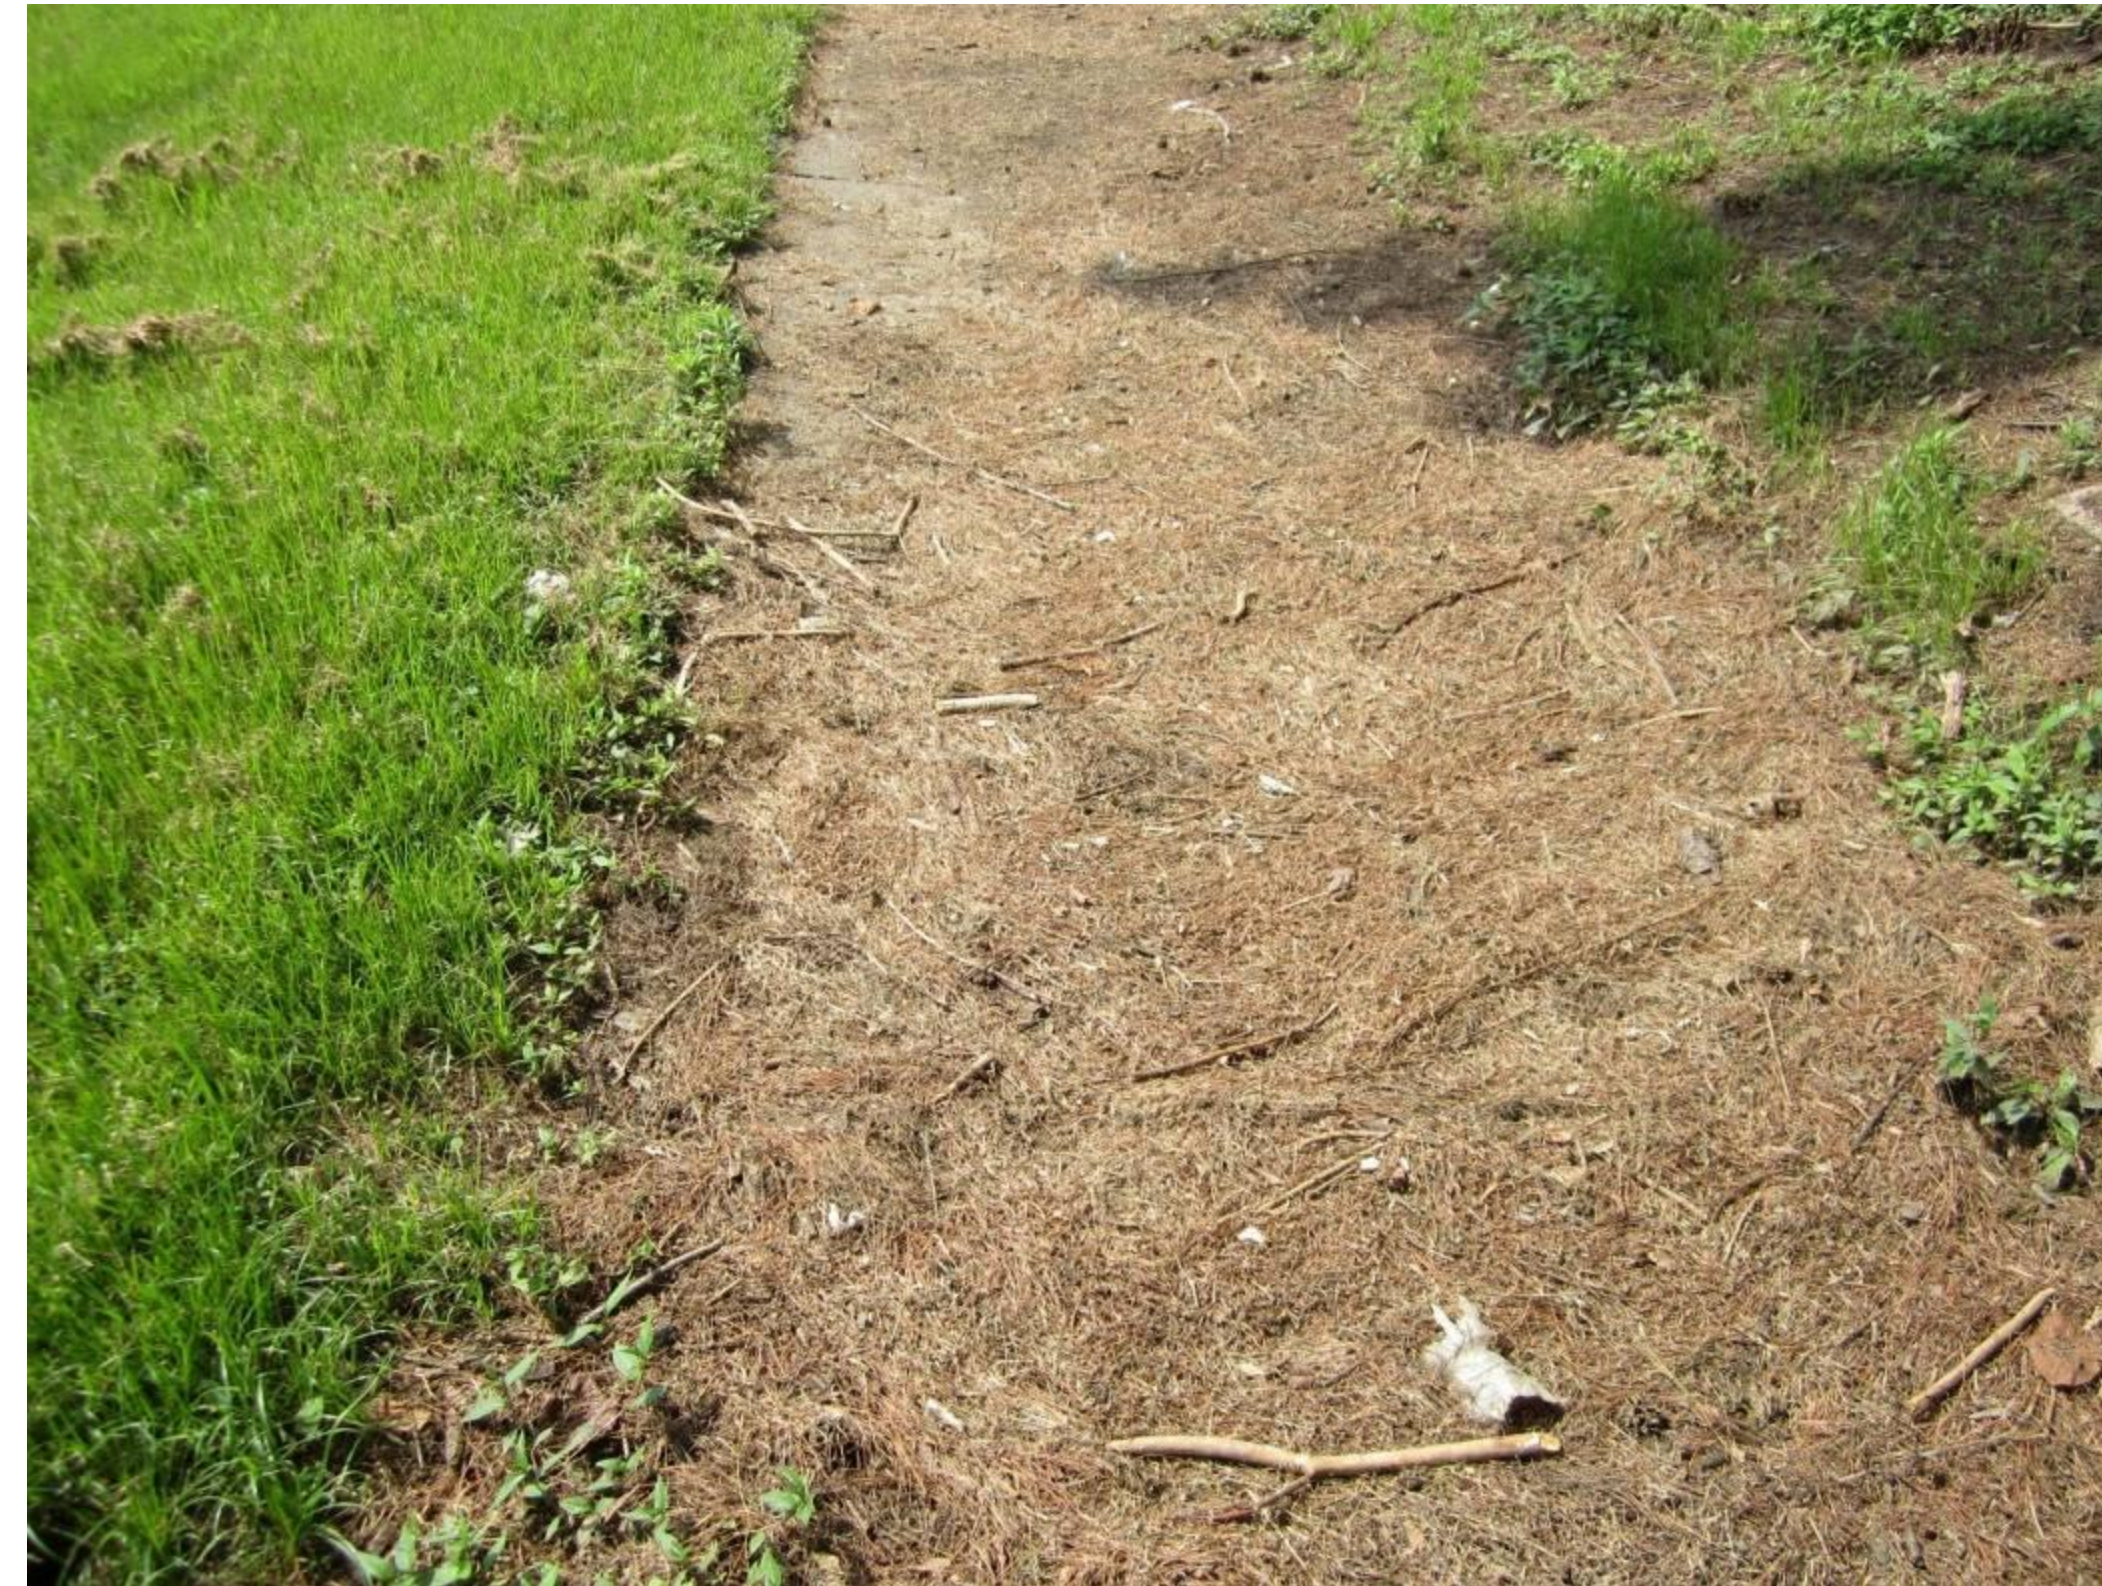
Pine needles in low flow channel

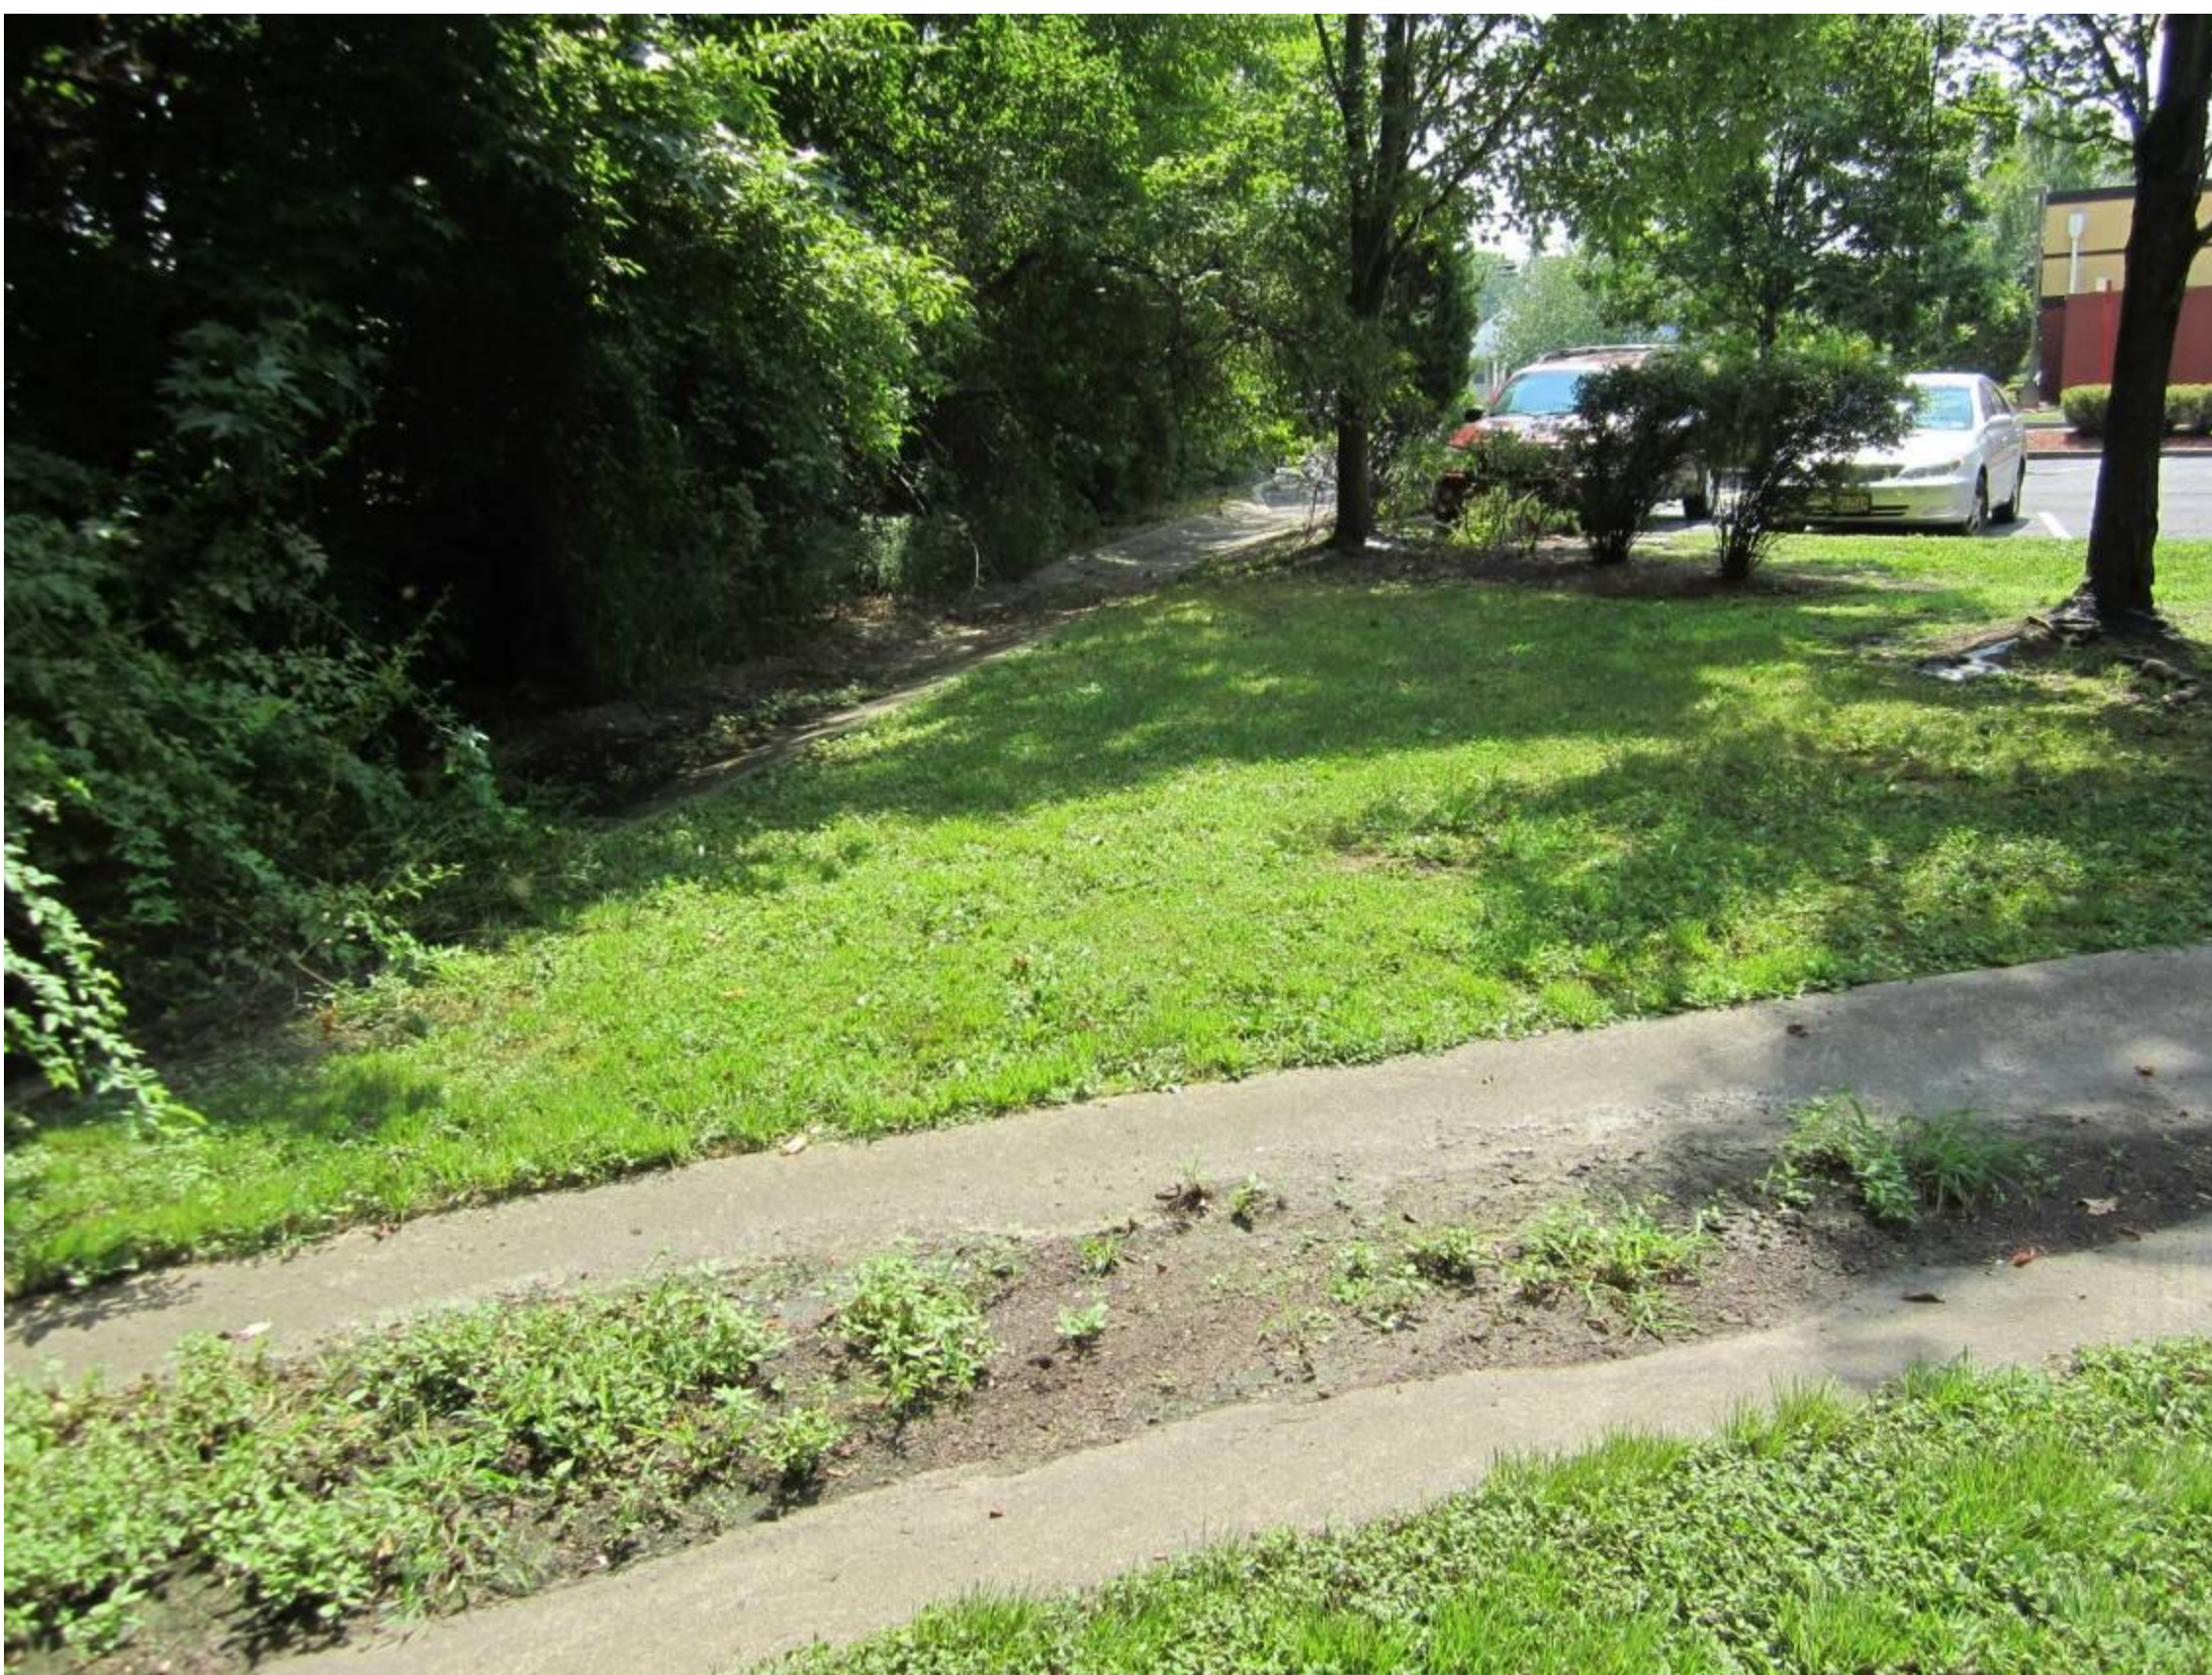
Low flow channel

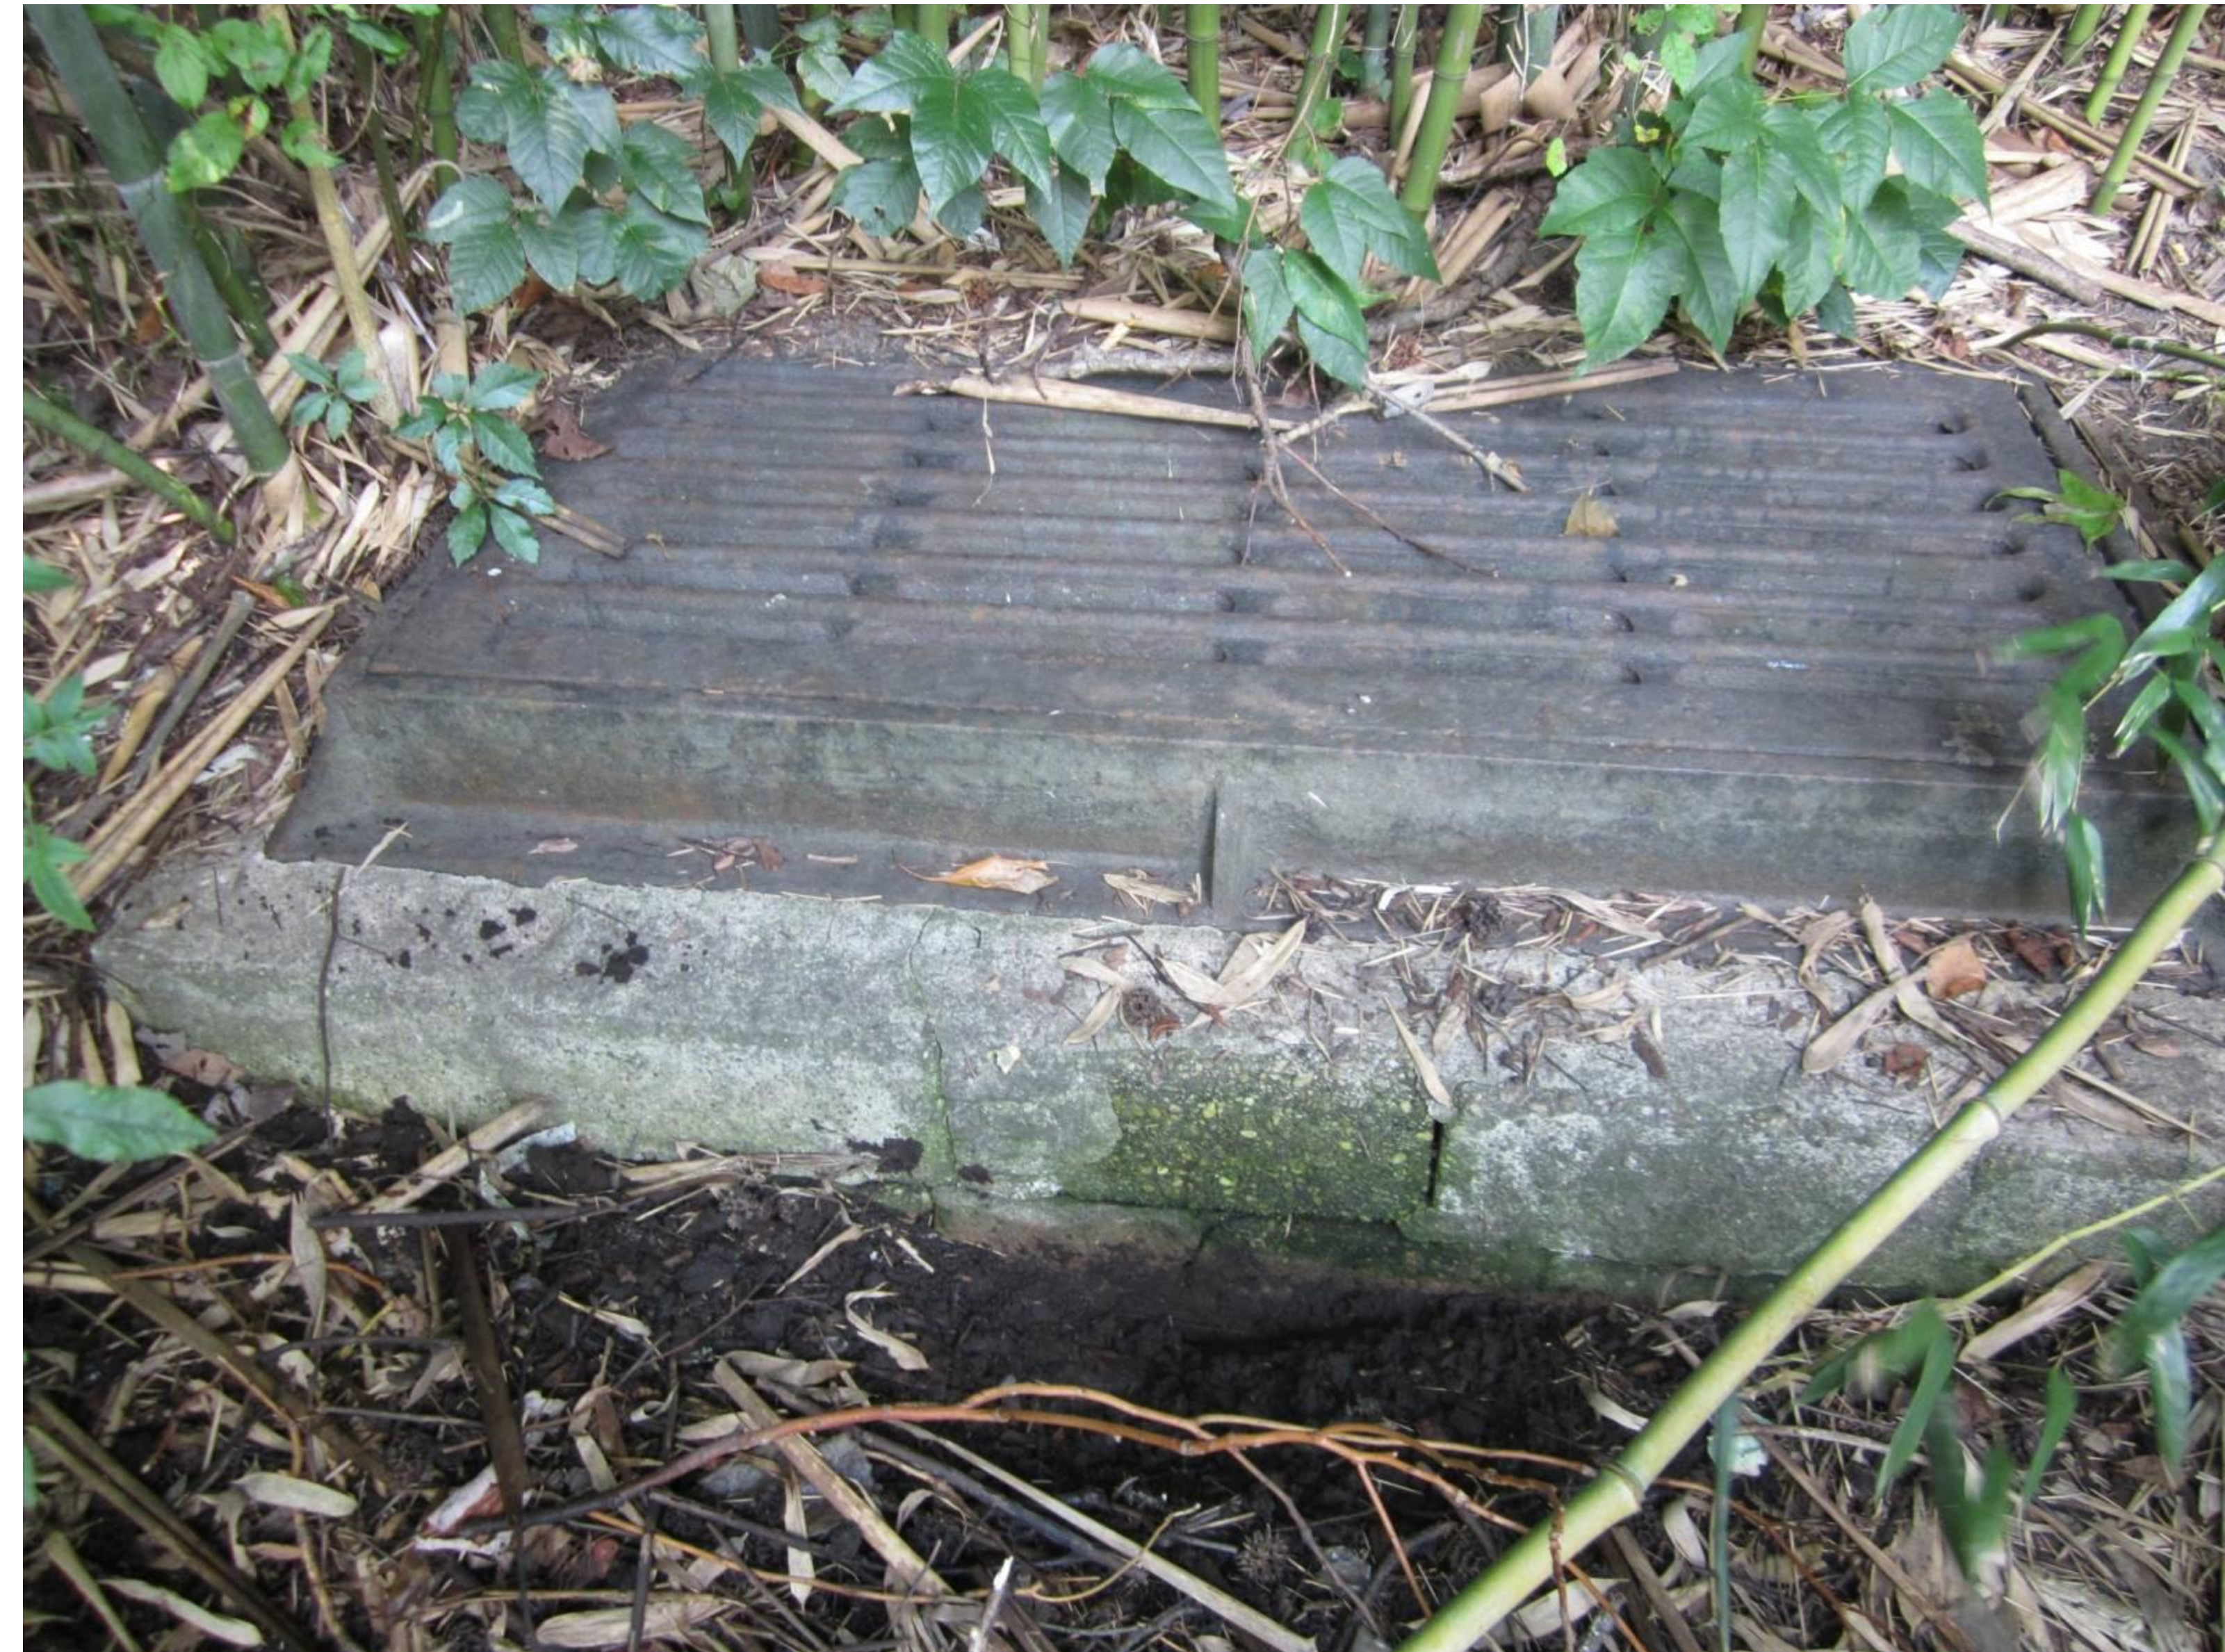
Outlet structure

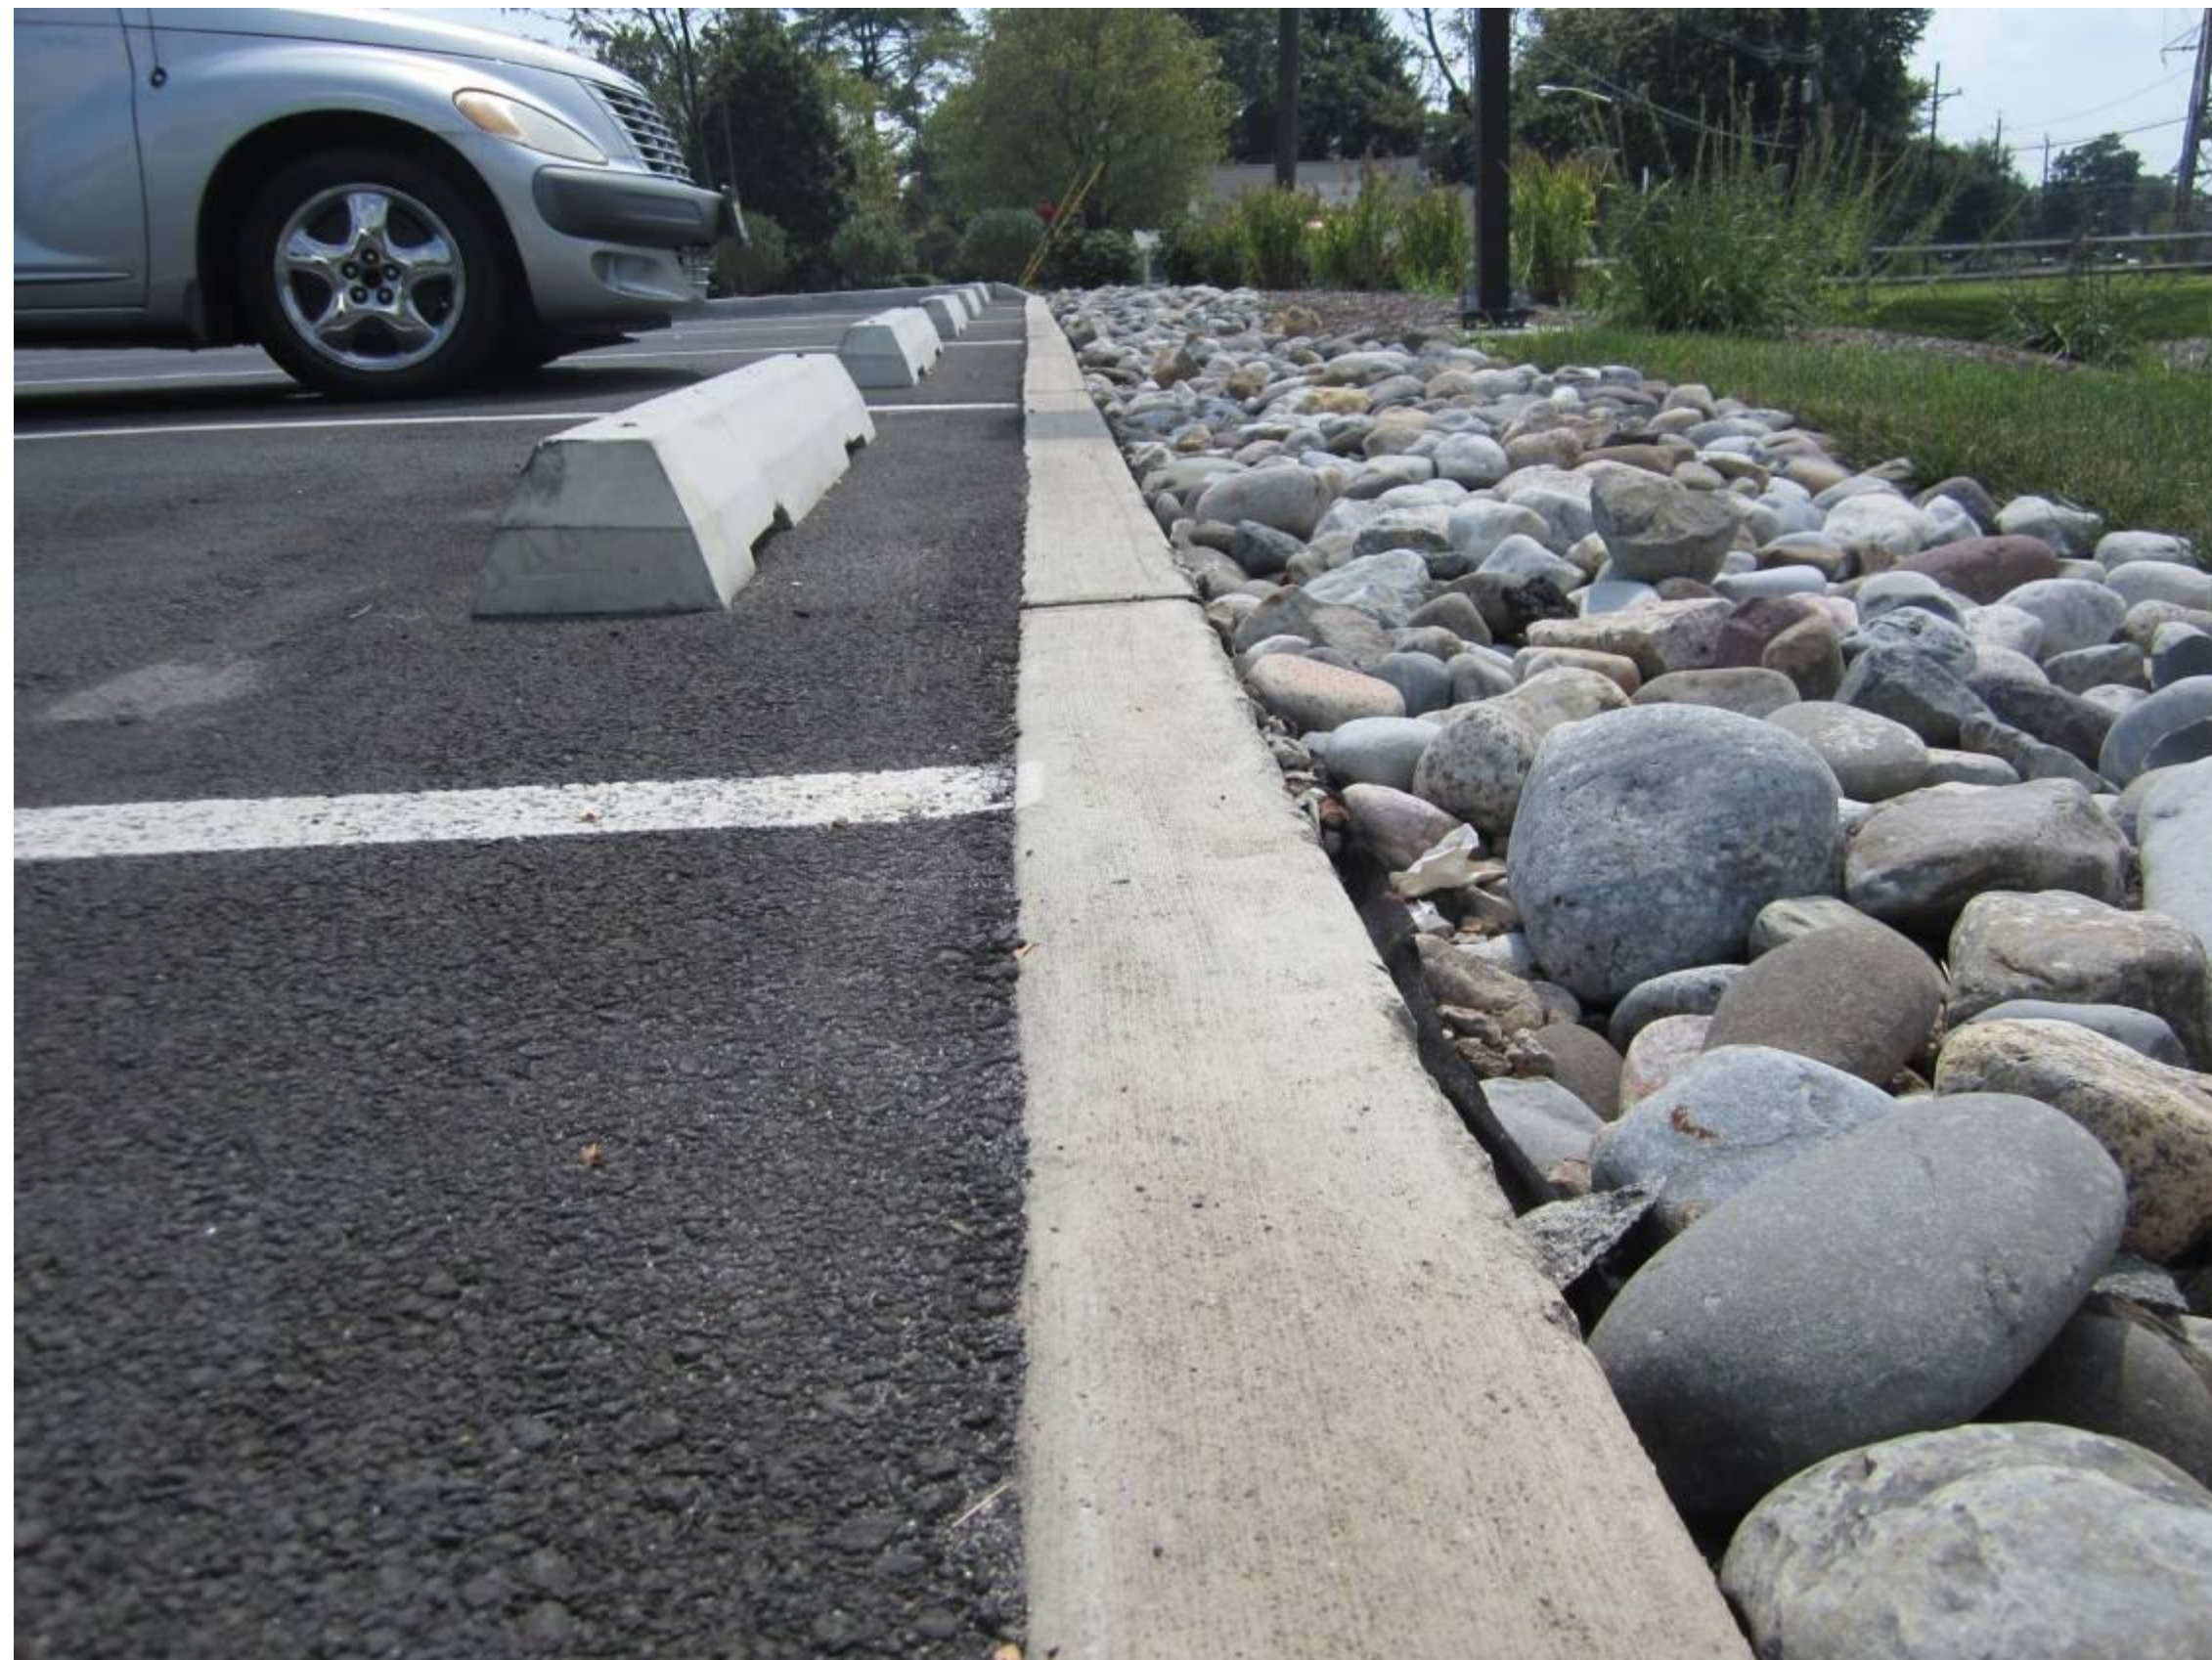
Parking lot edge lined with stone
