Hamilton Township (Mercer County) Stormwater Basin Assessment Summary (Year 1)

Developed by the Rutgers Cooperative Extension Water Resources Program
Funded by Hamilton Township, Mercer County, New Jersey

December 6, 2012

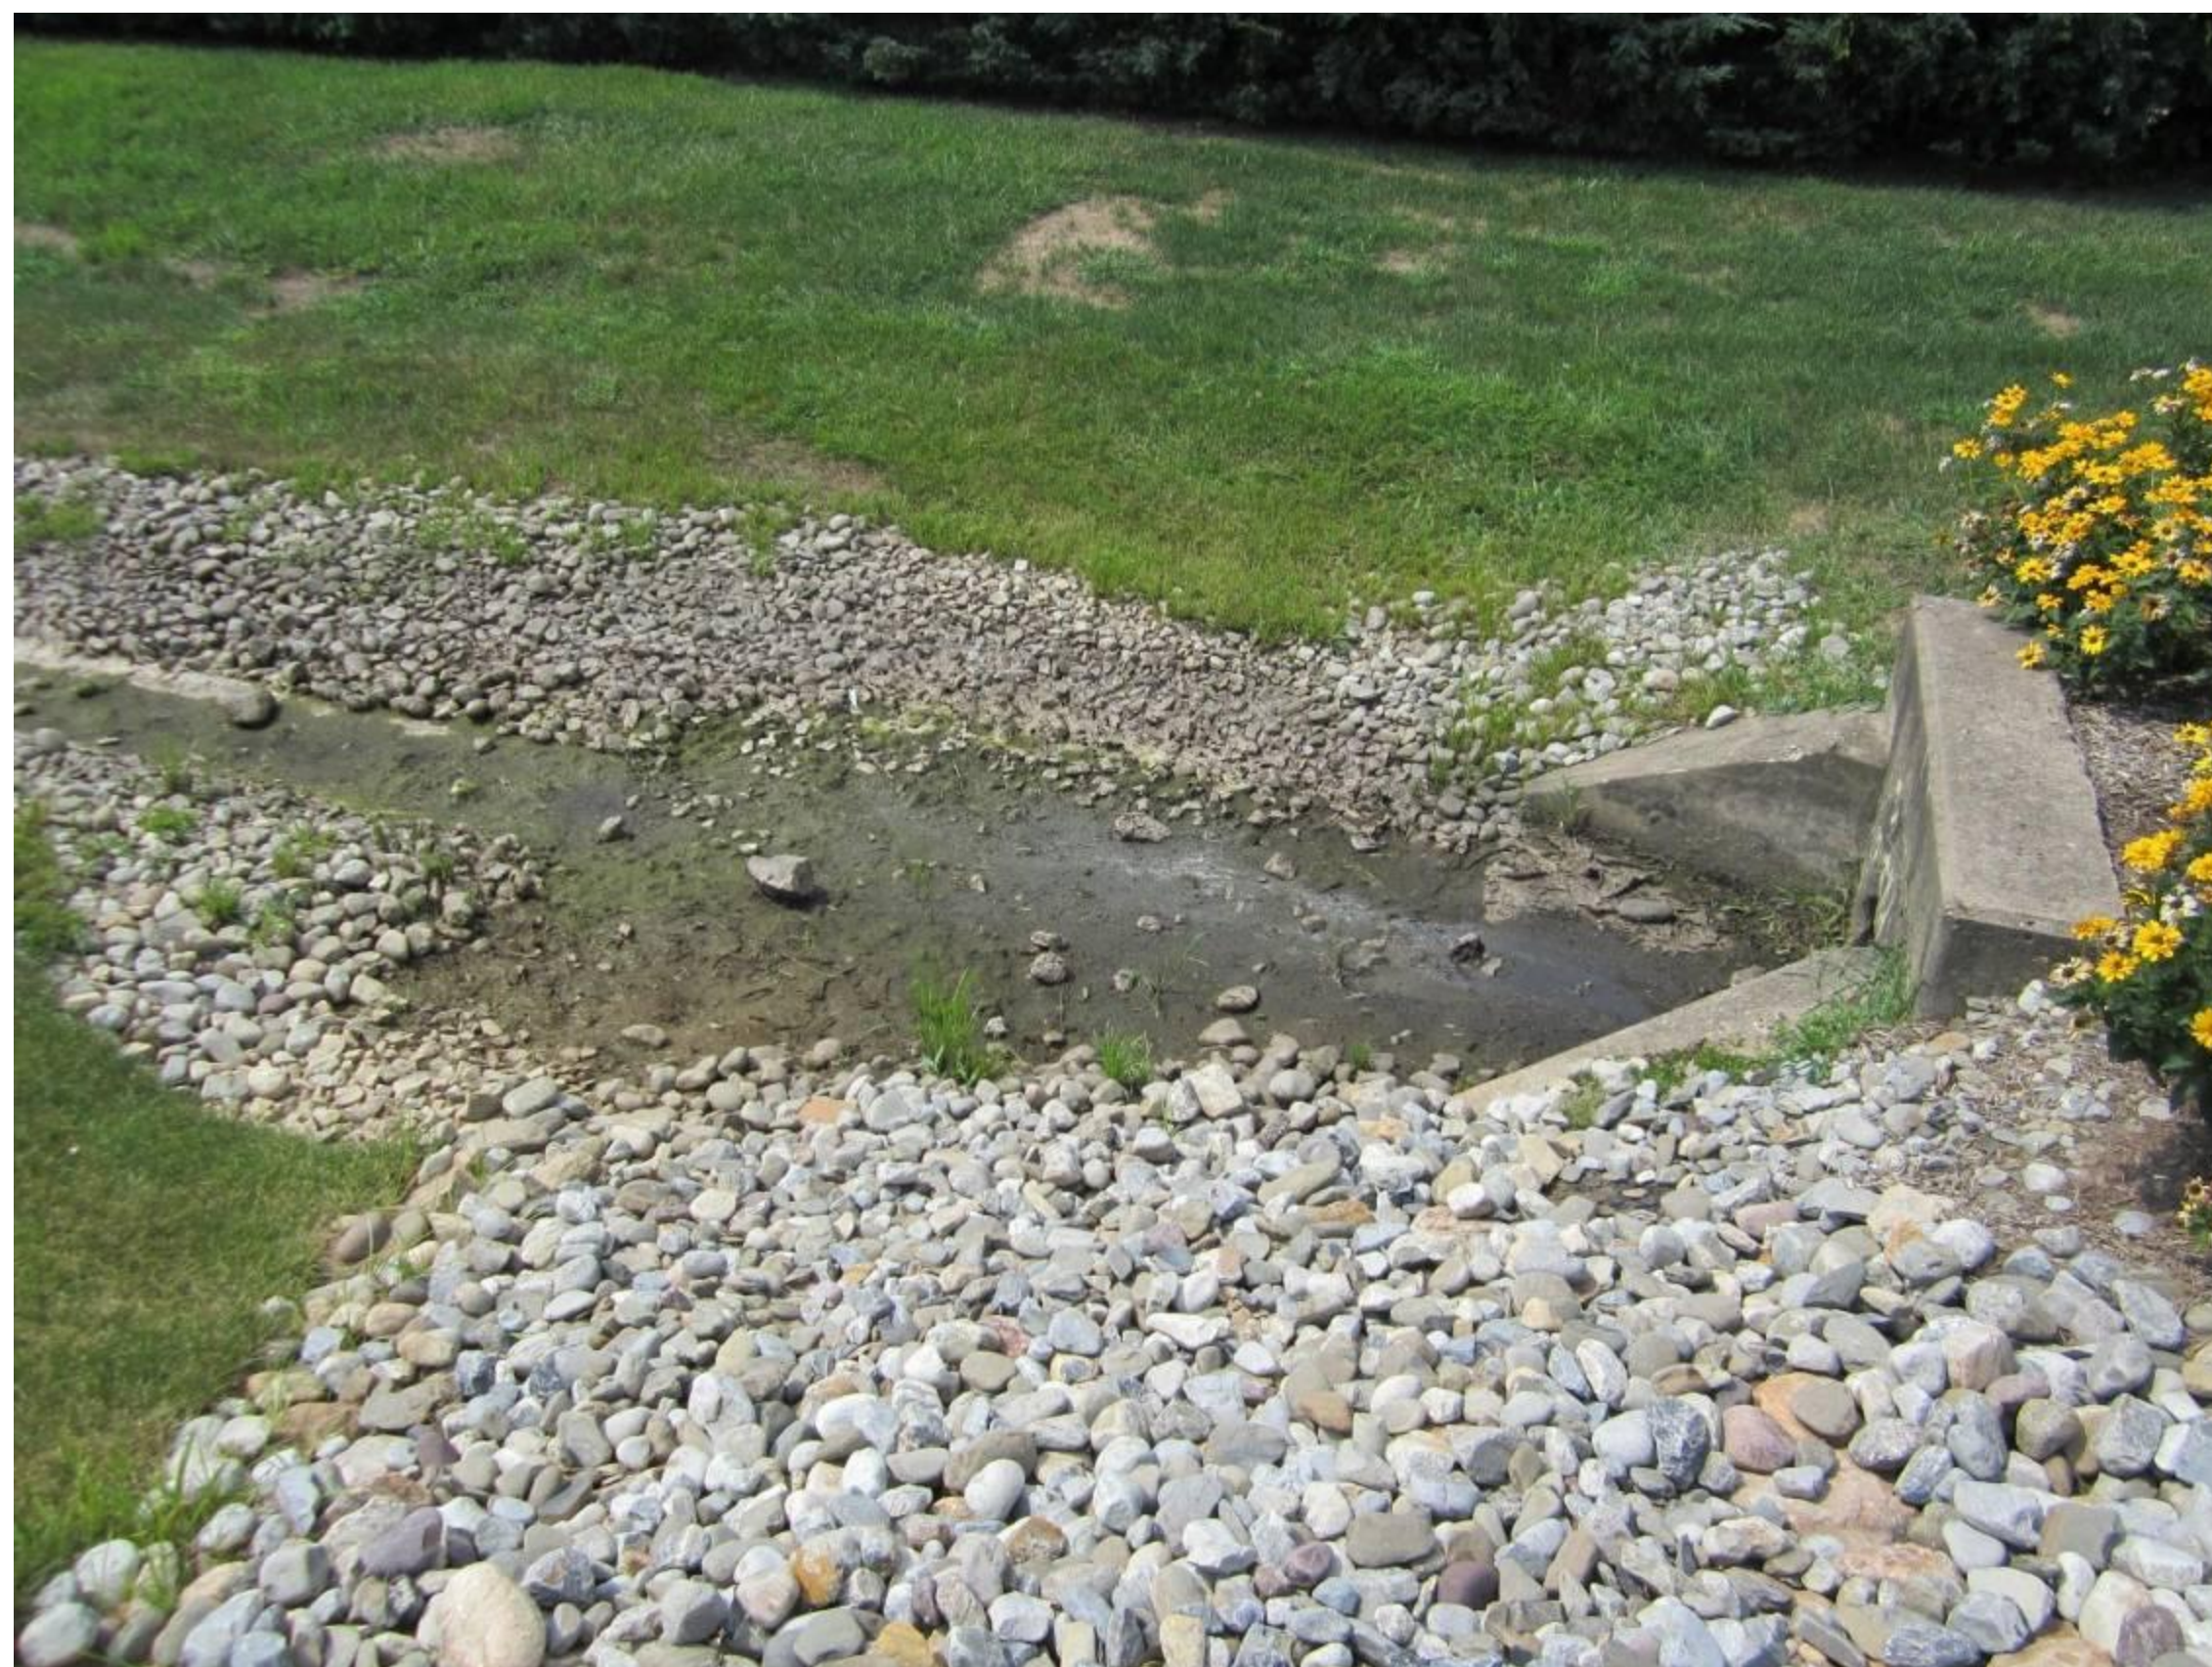
Outlet and low flow

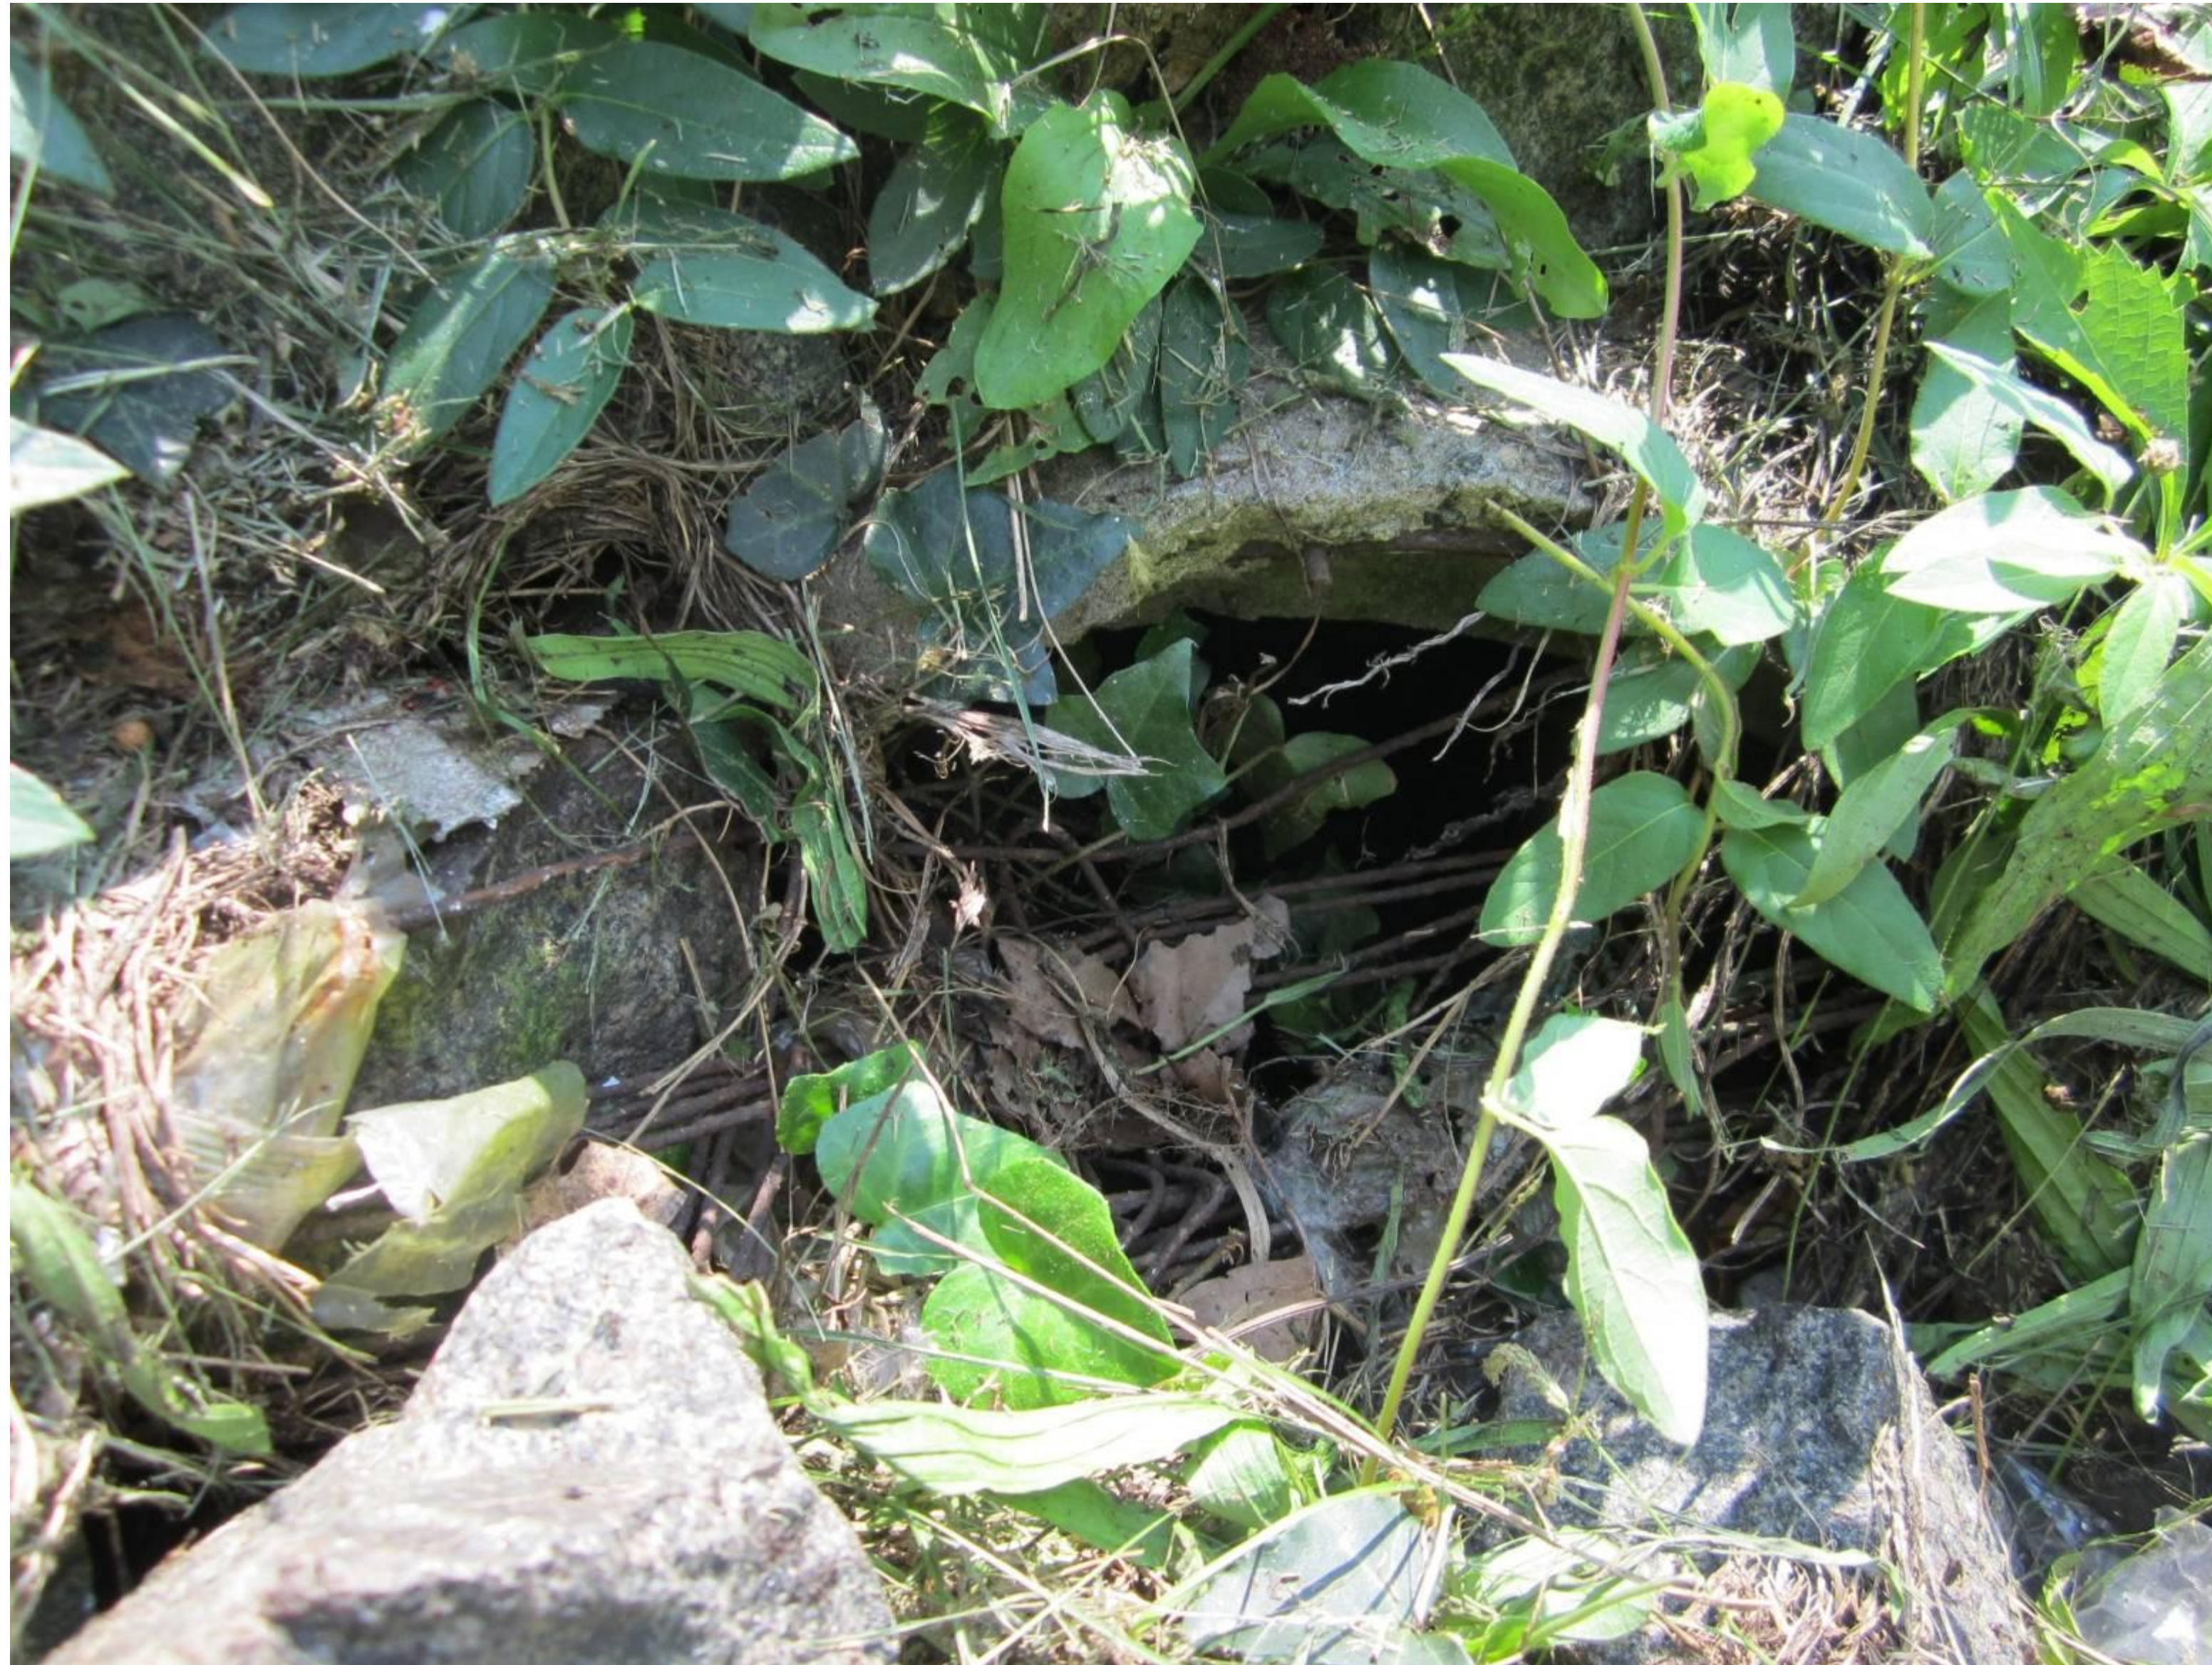
Clogged inlet

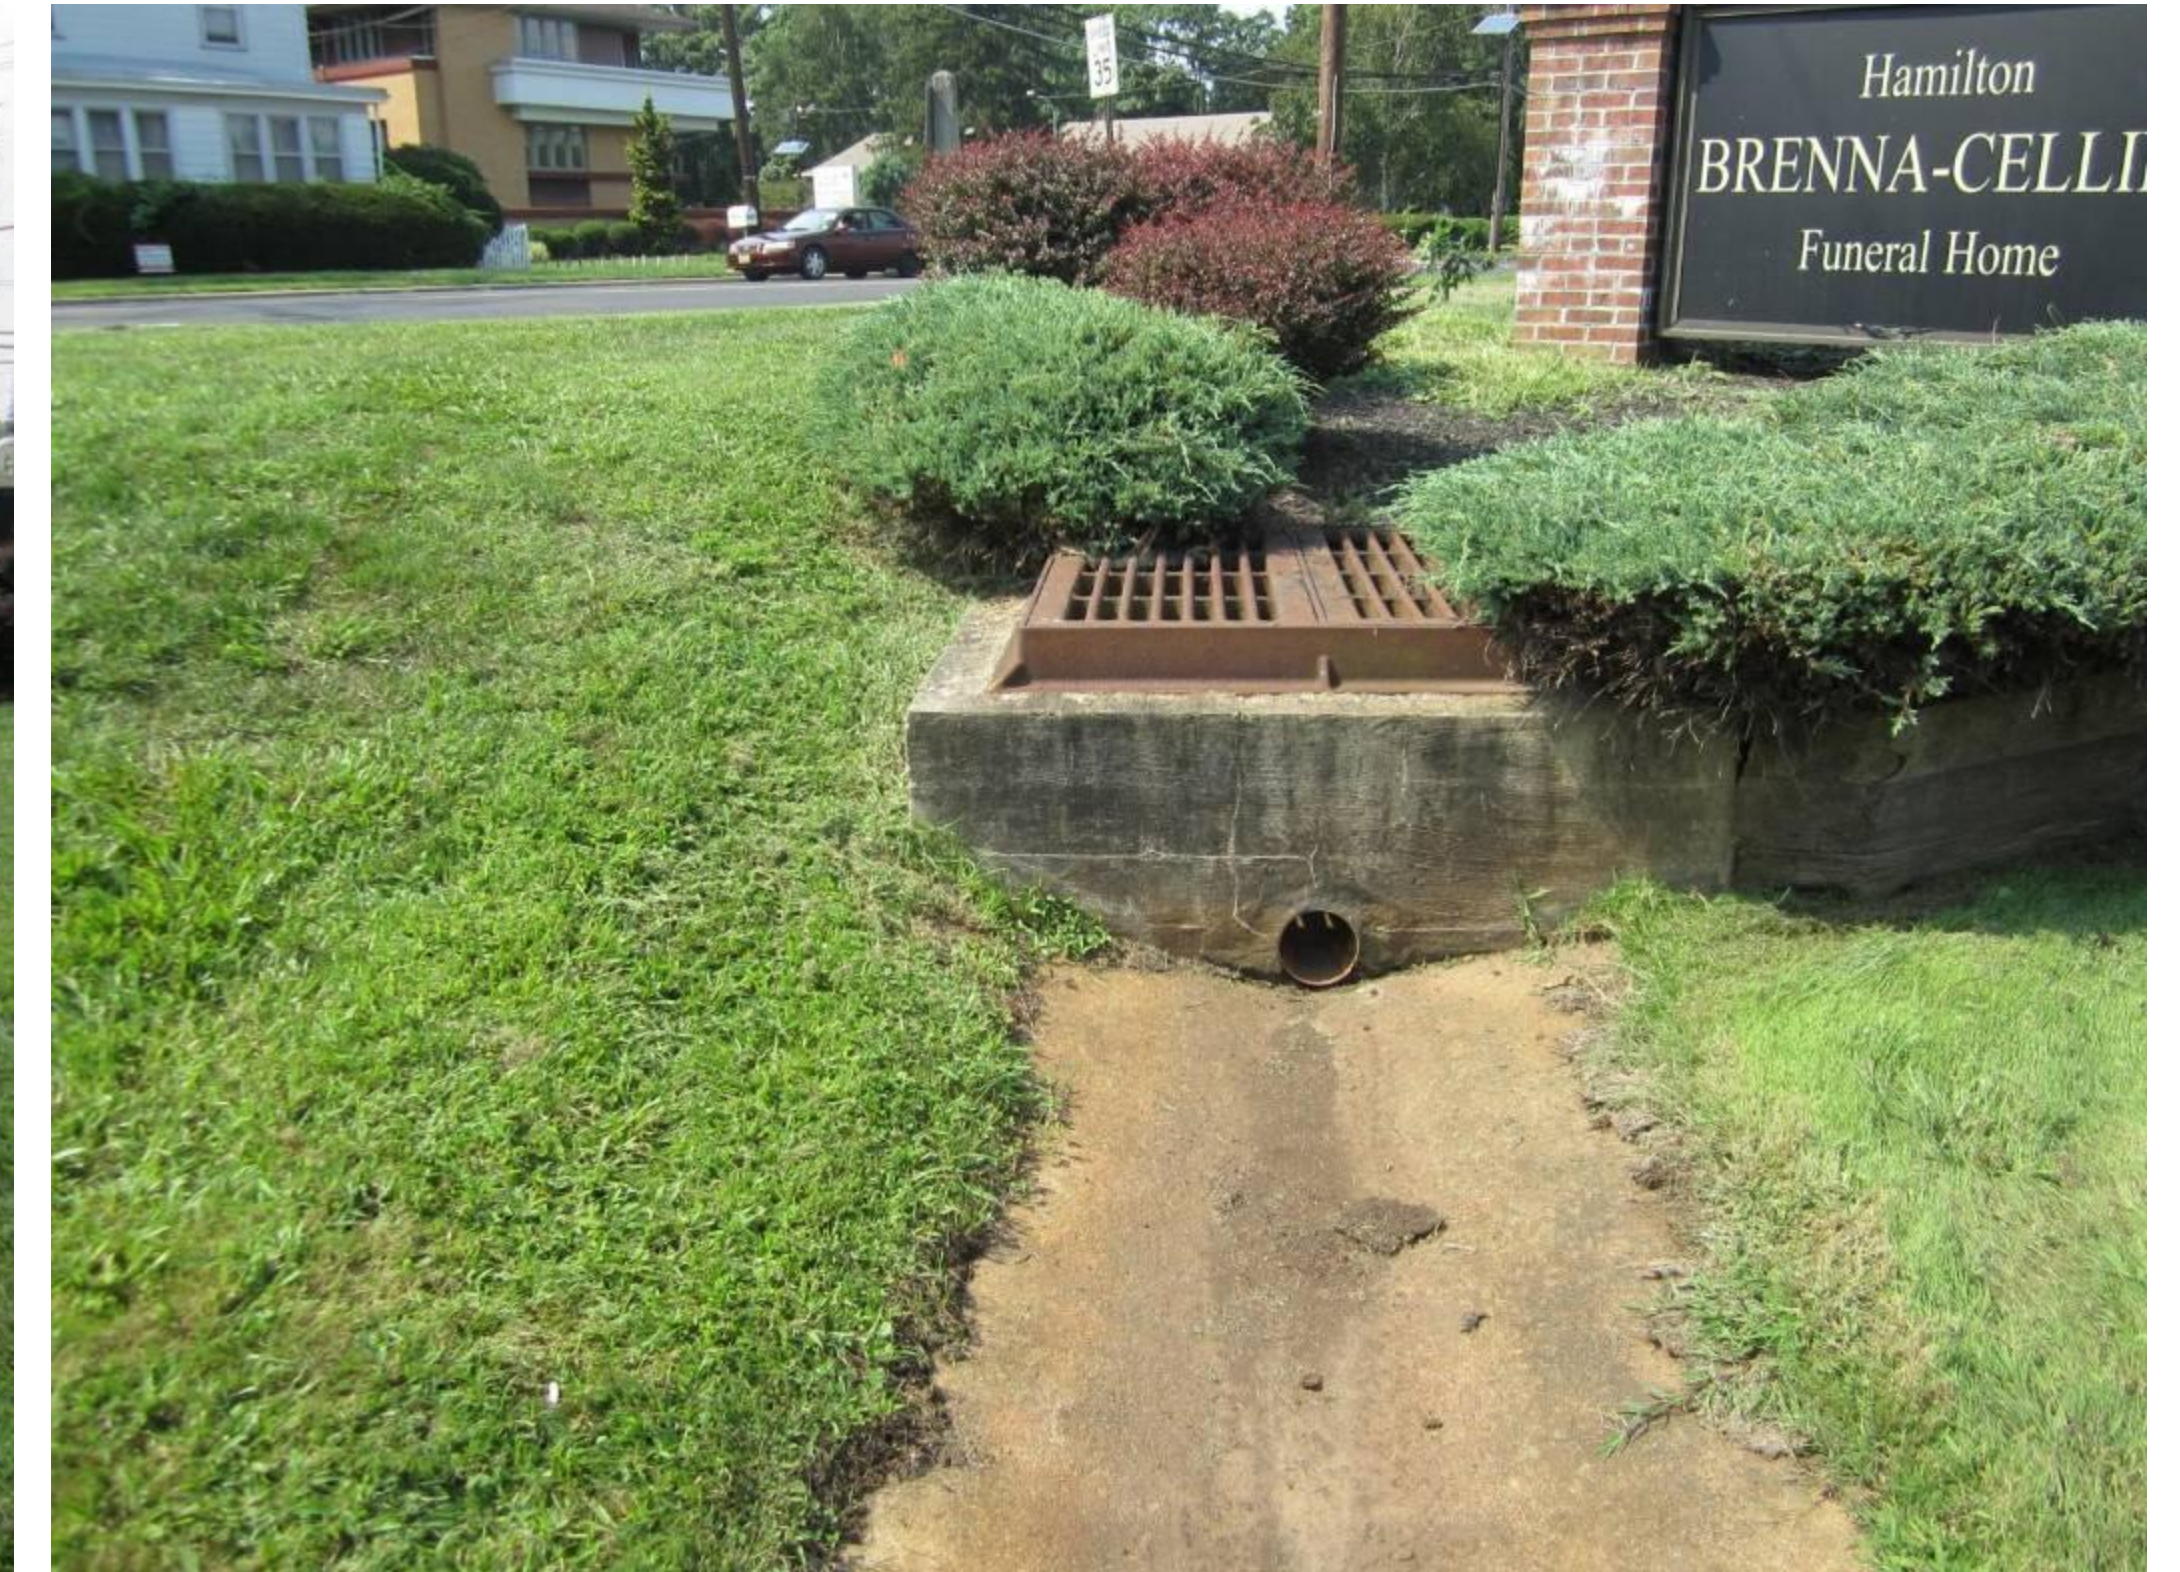
Outlet Structure

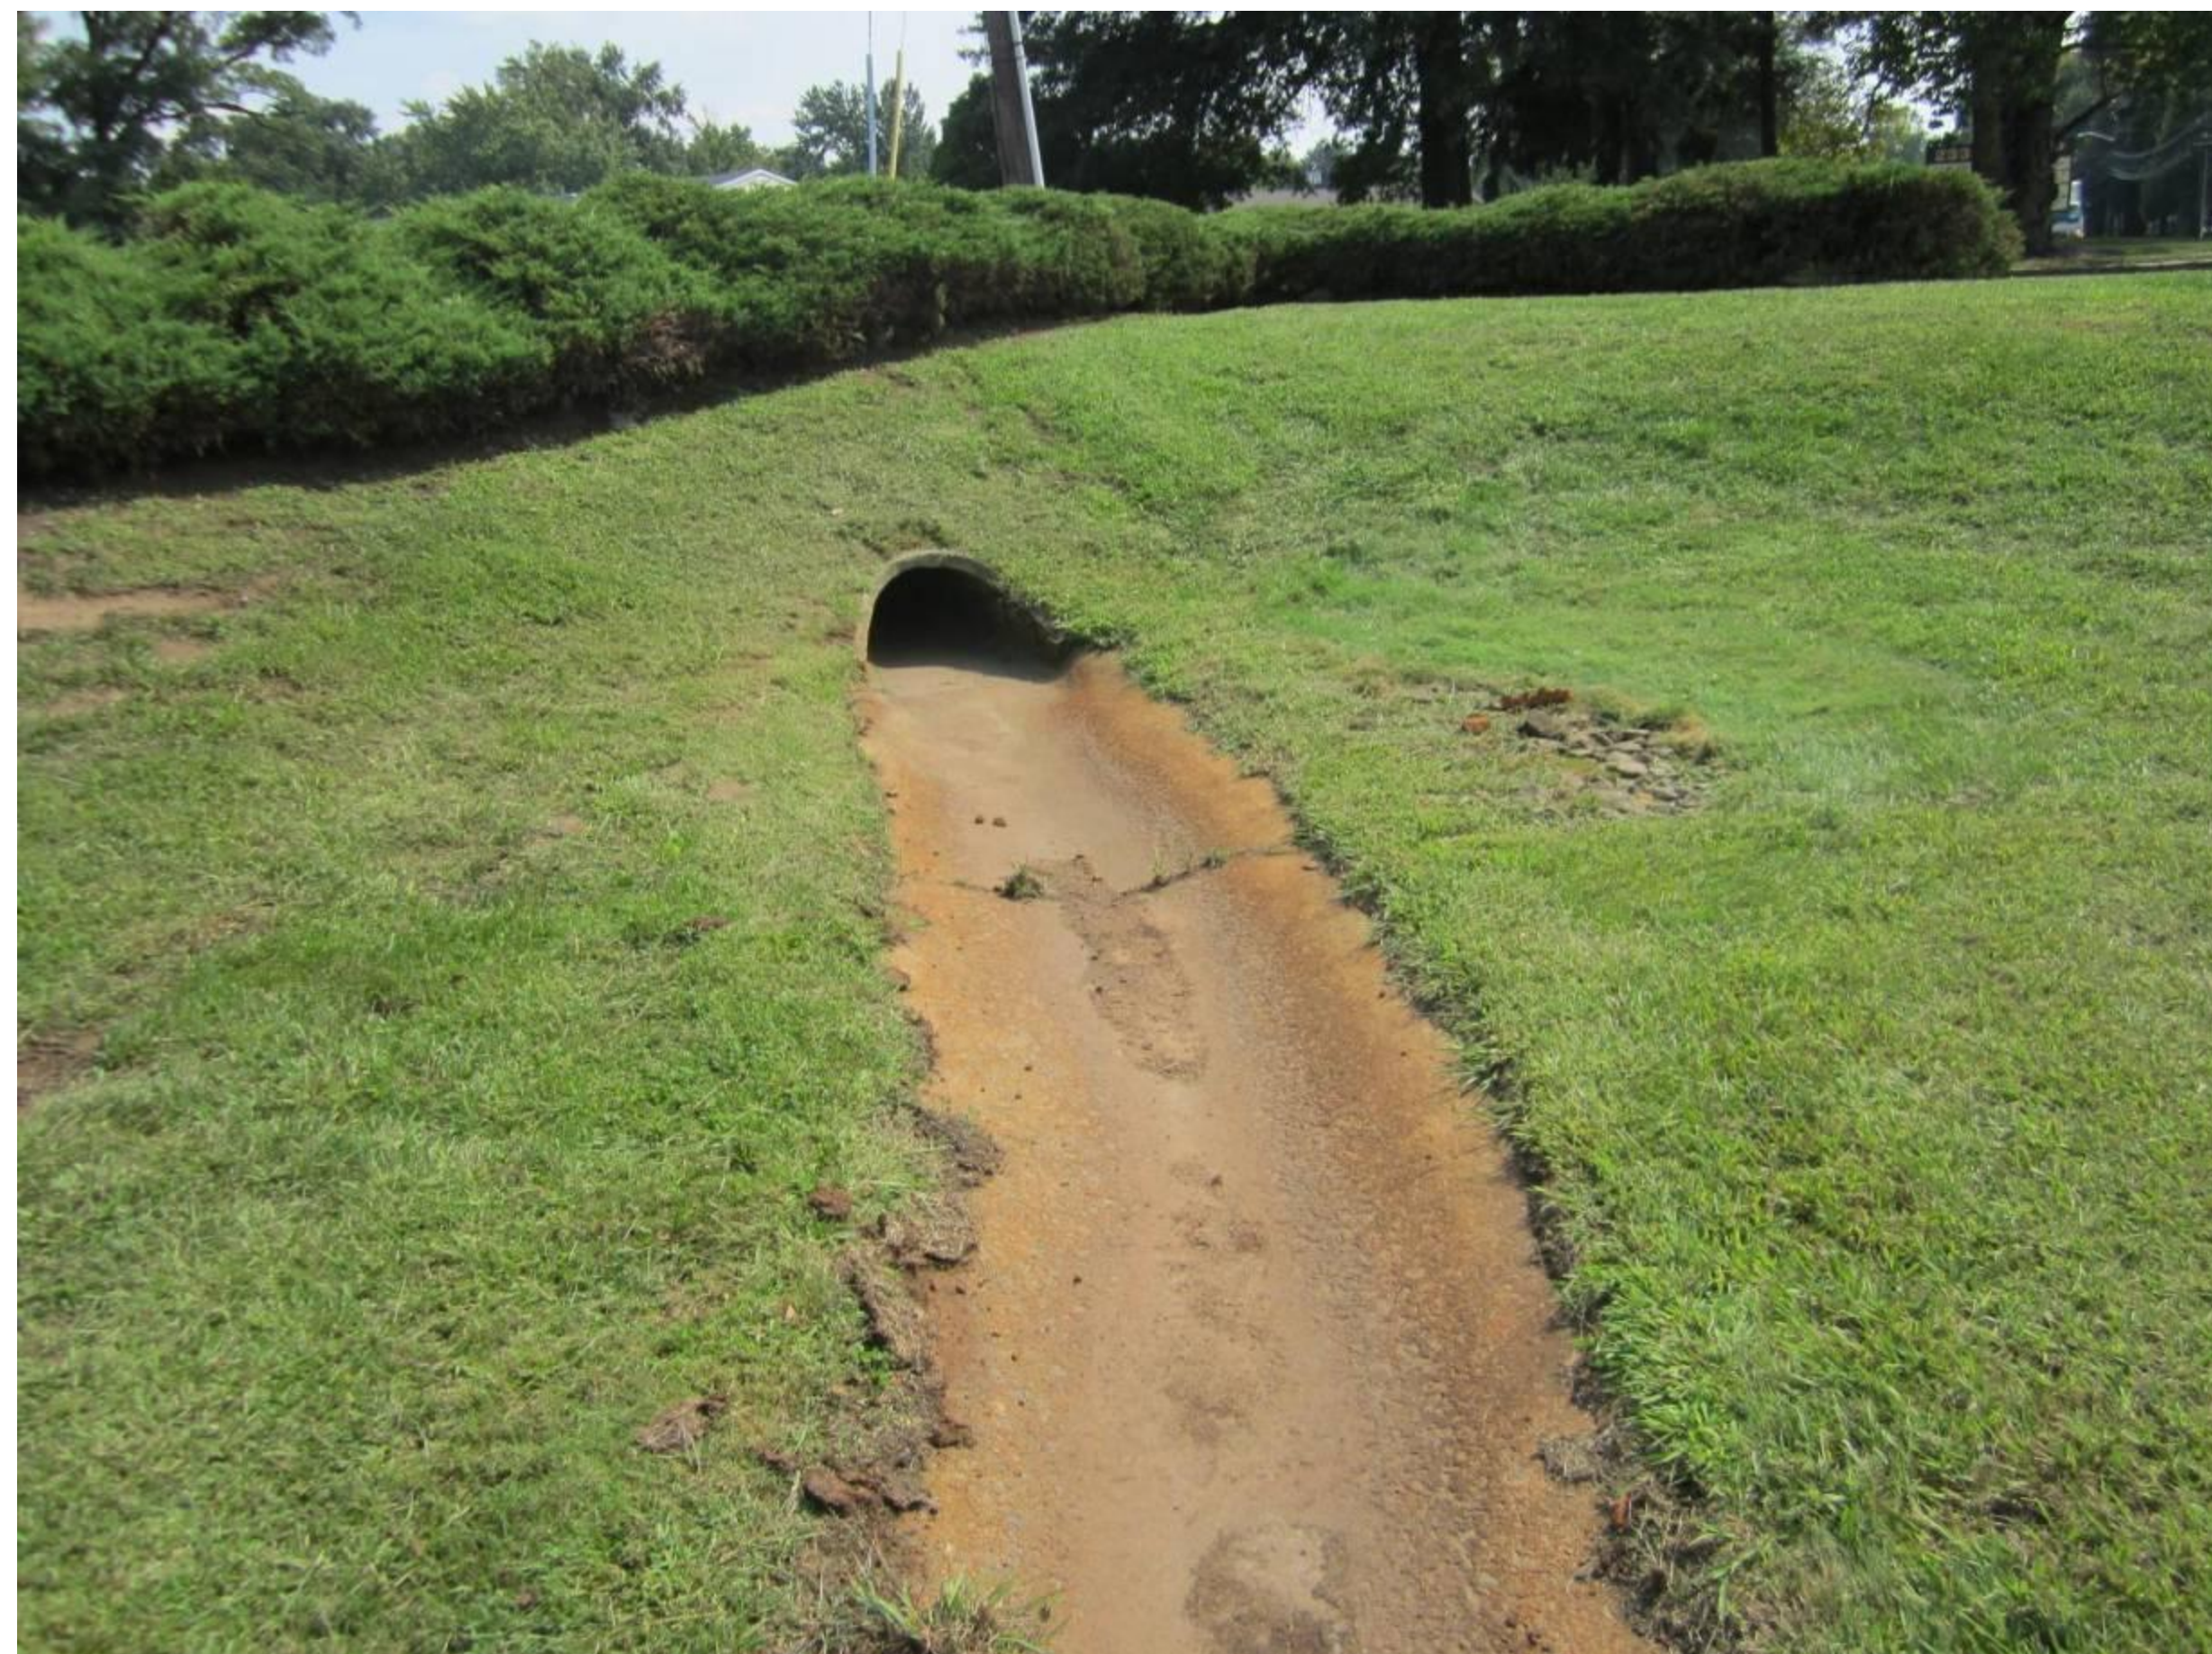
Inlet

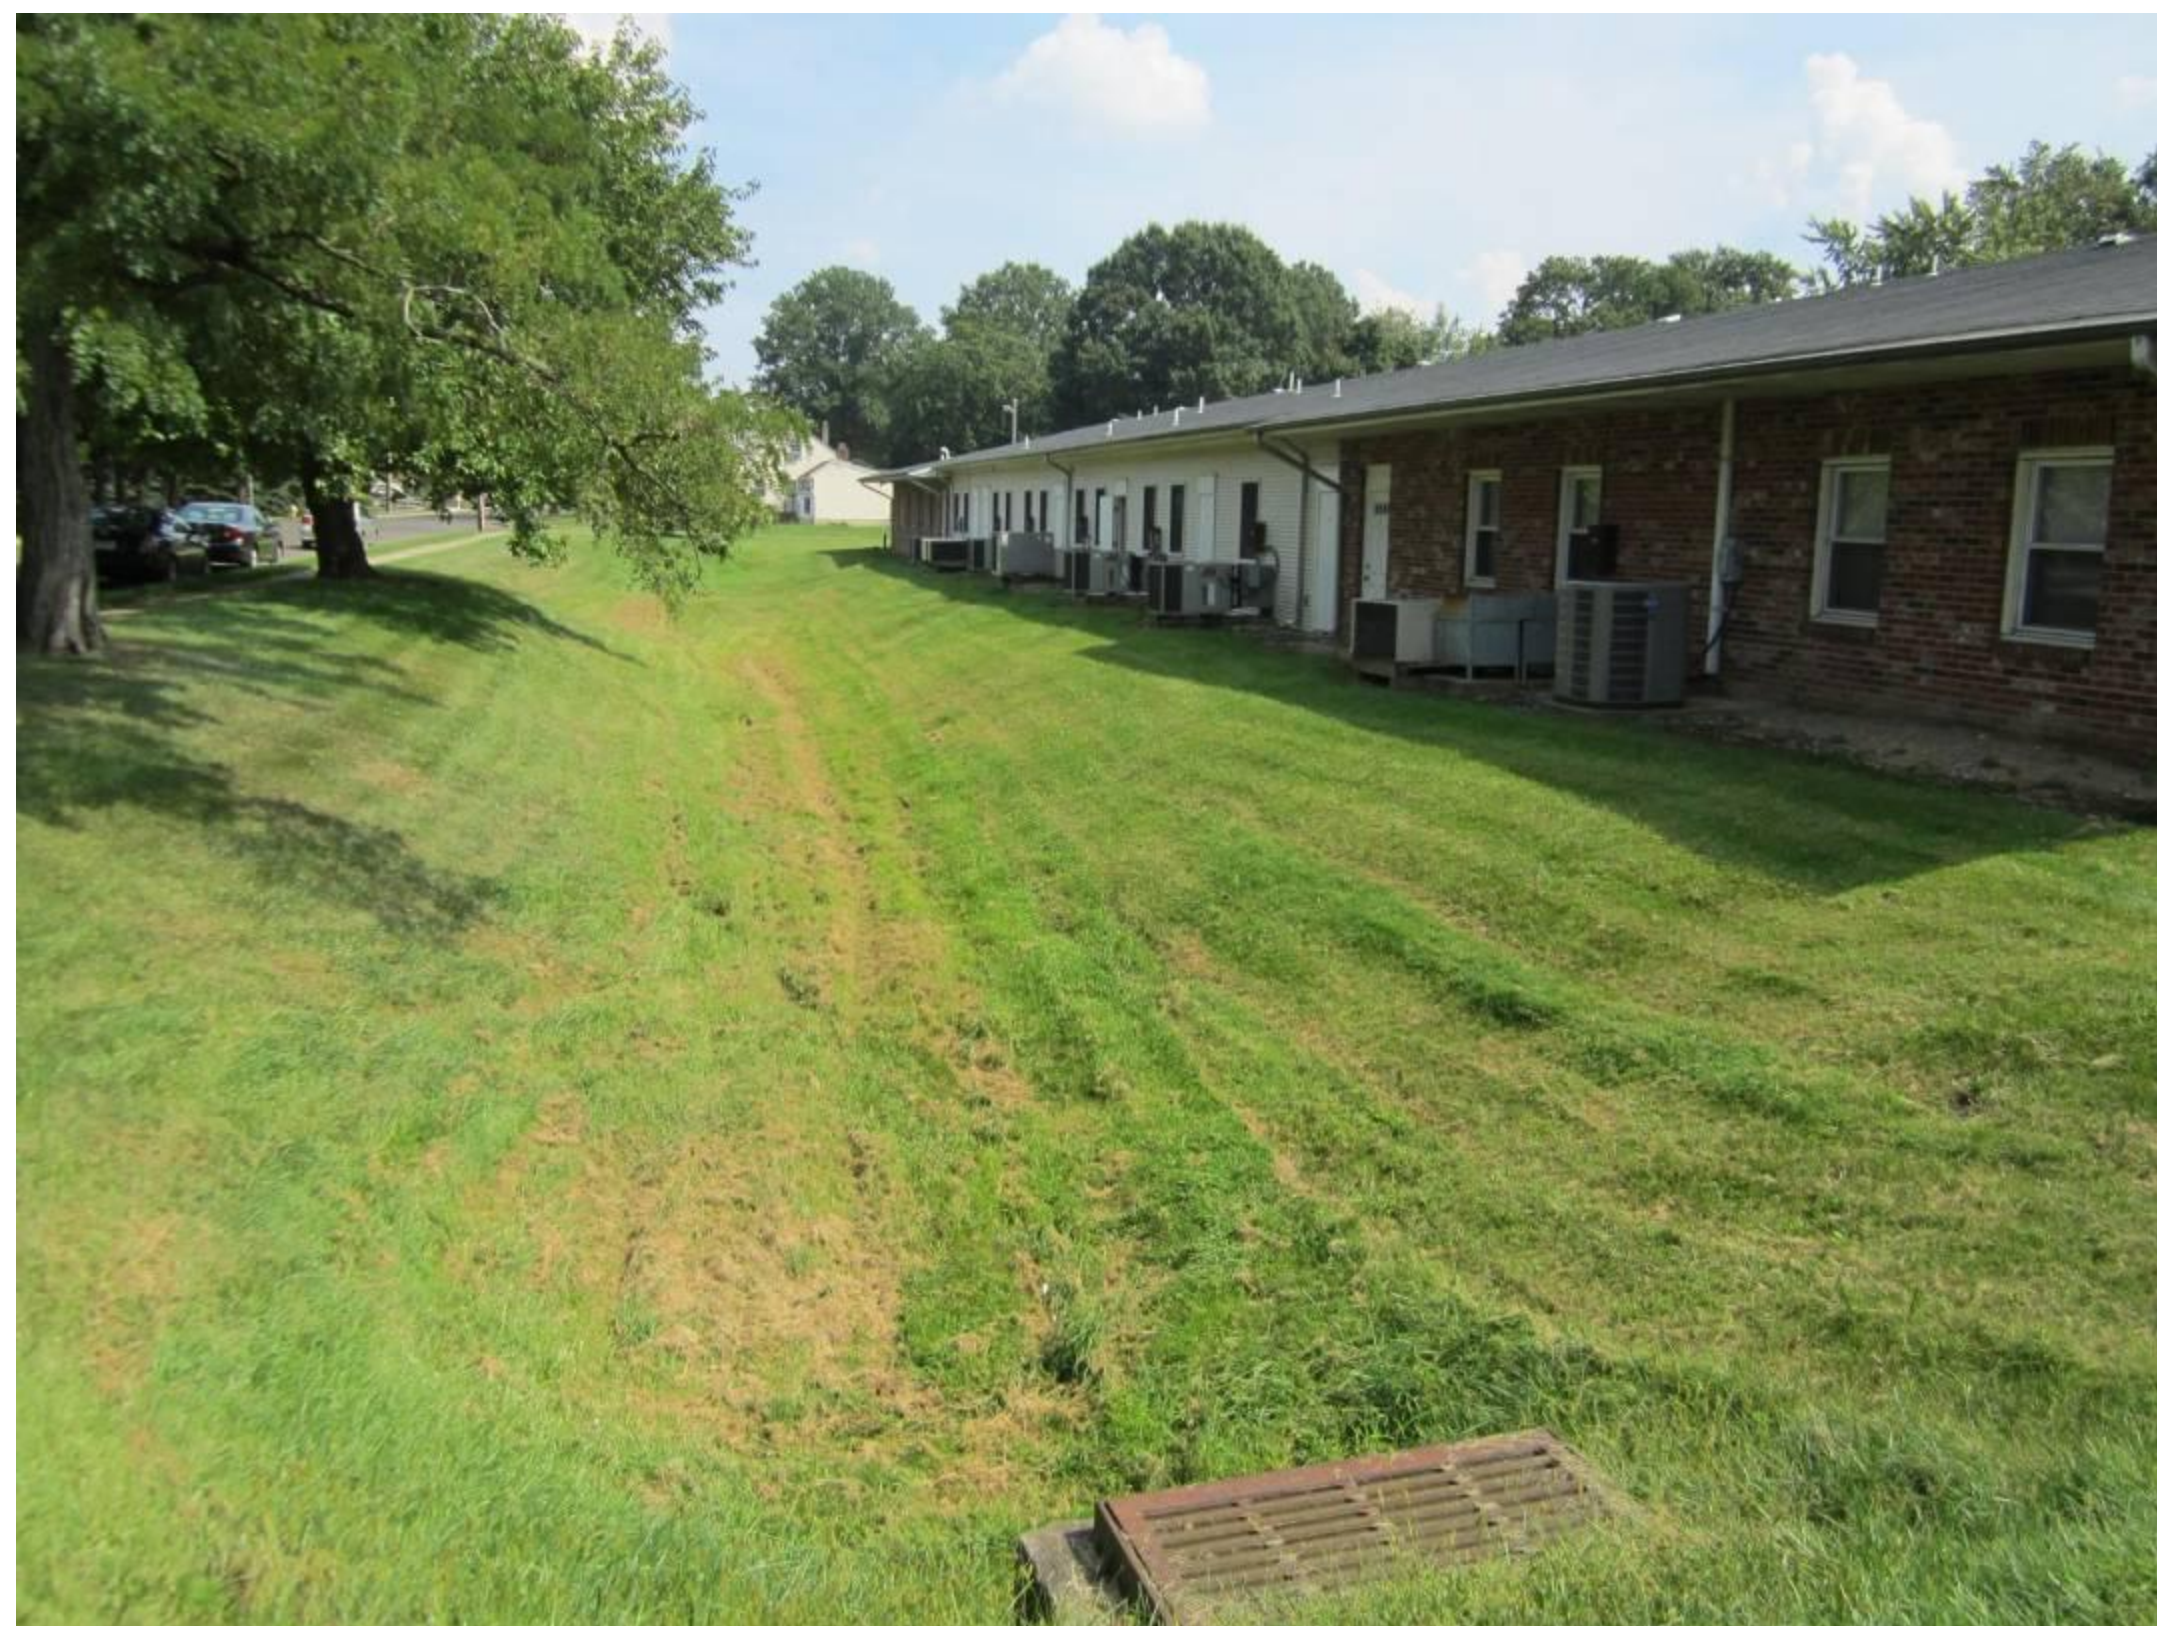
Eastern basin bottom

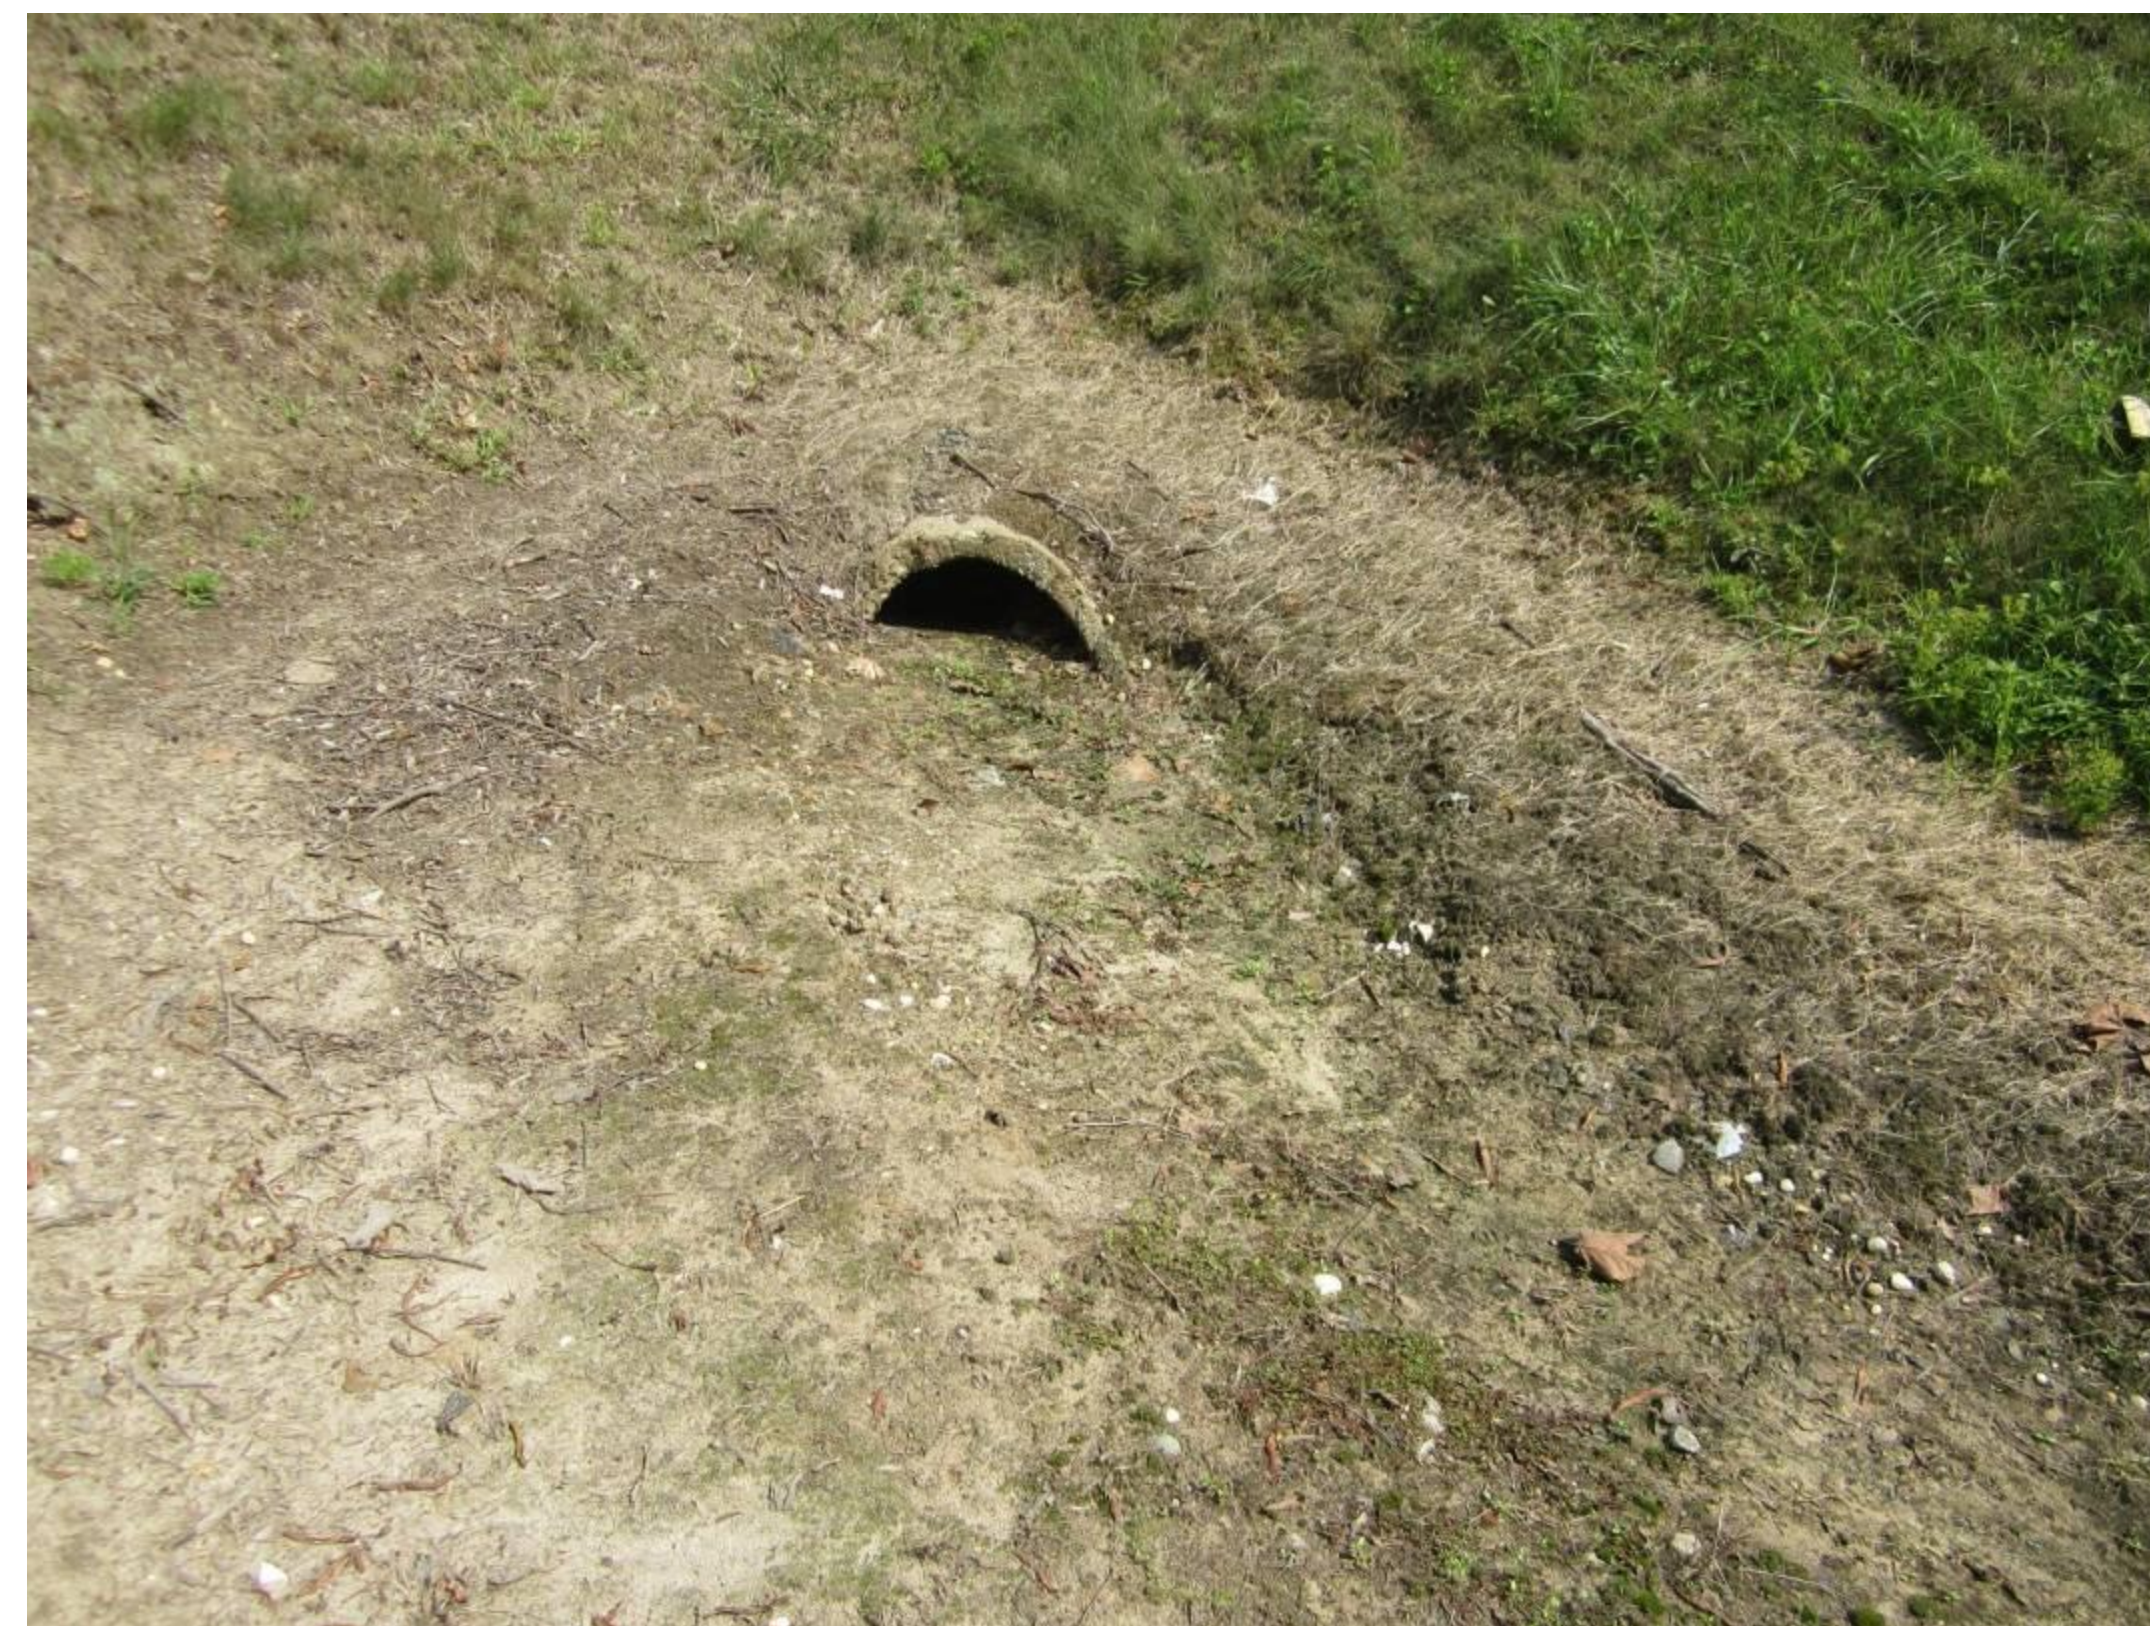
Clogged inlet
