Hamilton Township (Mercer County) Stormwater Basin Assessment Summary (Year 1)

Developed by the Rutgers Cooperative Extension Water Resources Program
Funded by Hamilton Township, Mercer County, New Jersey

December 6, 2012

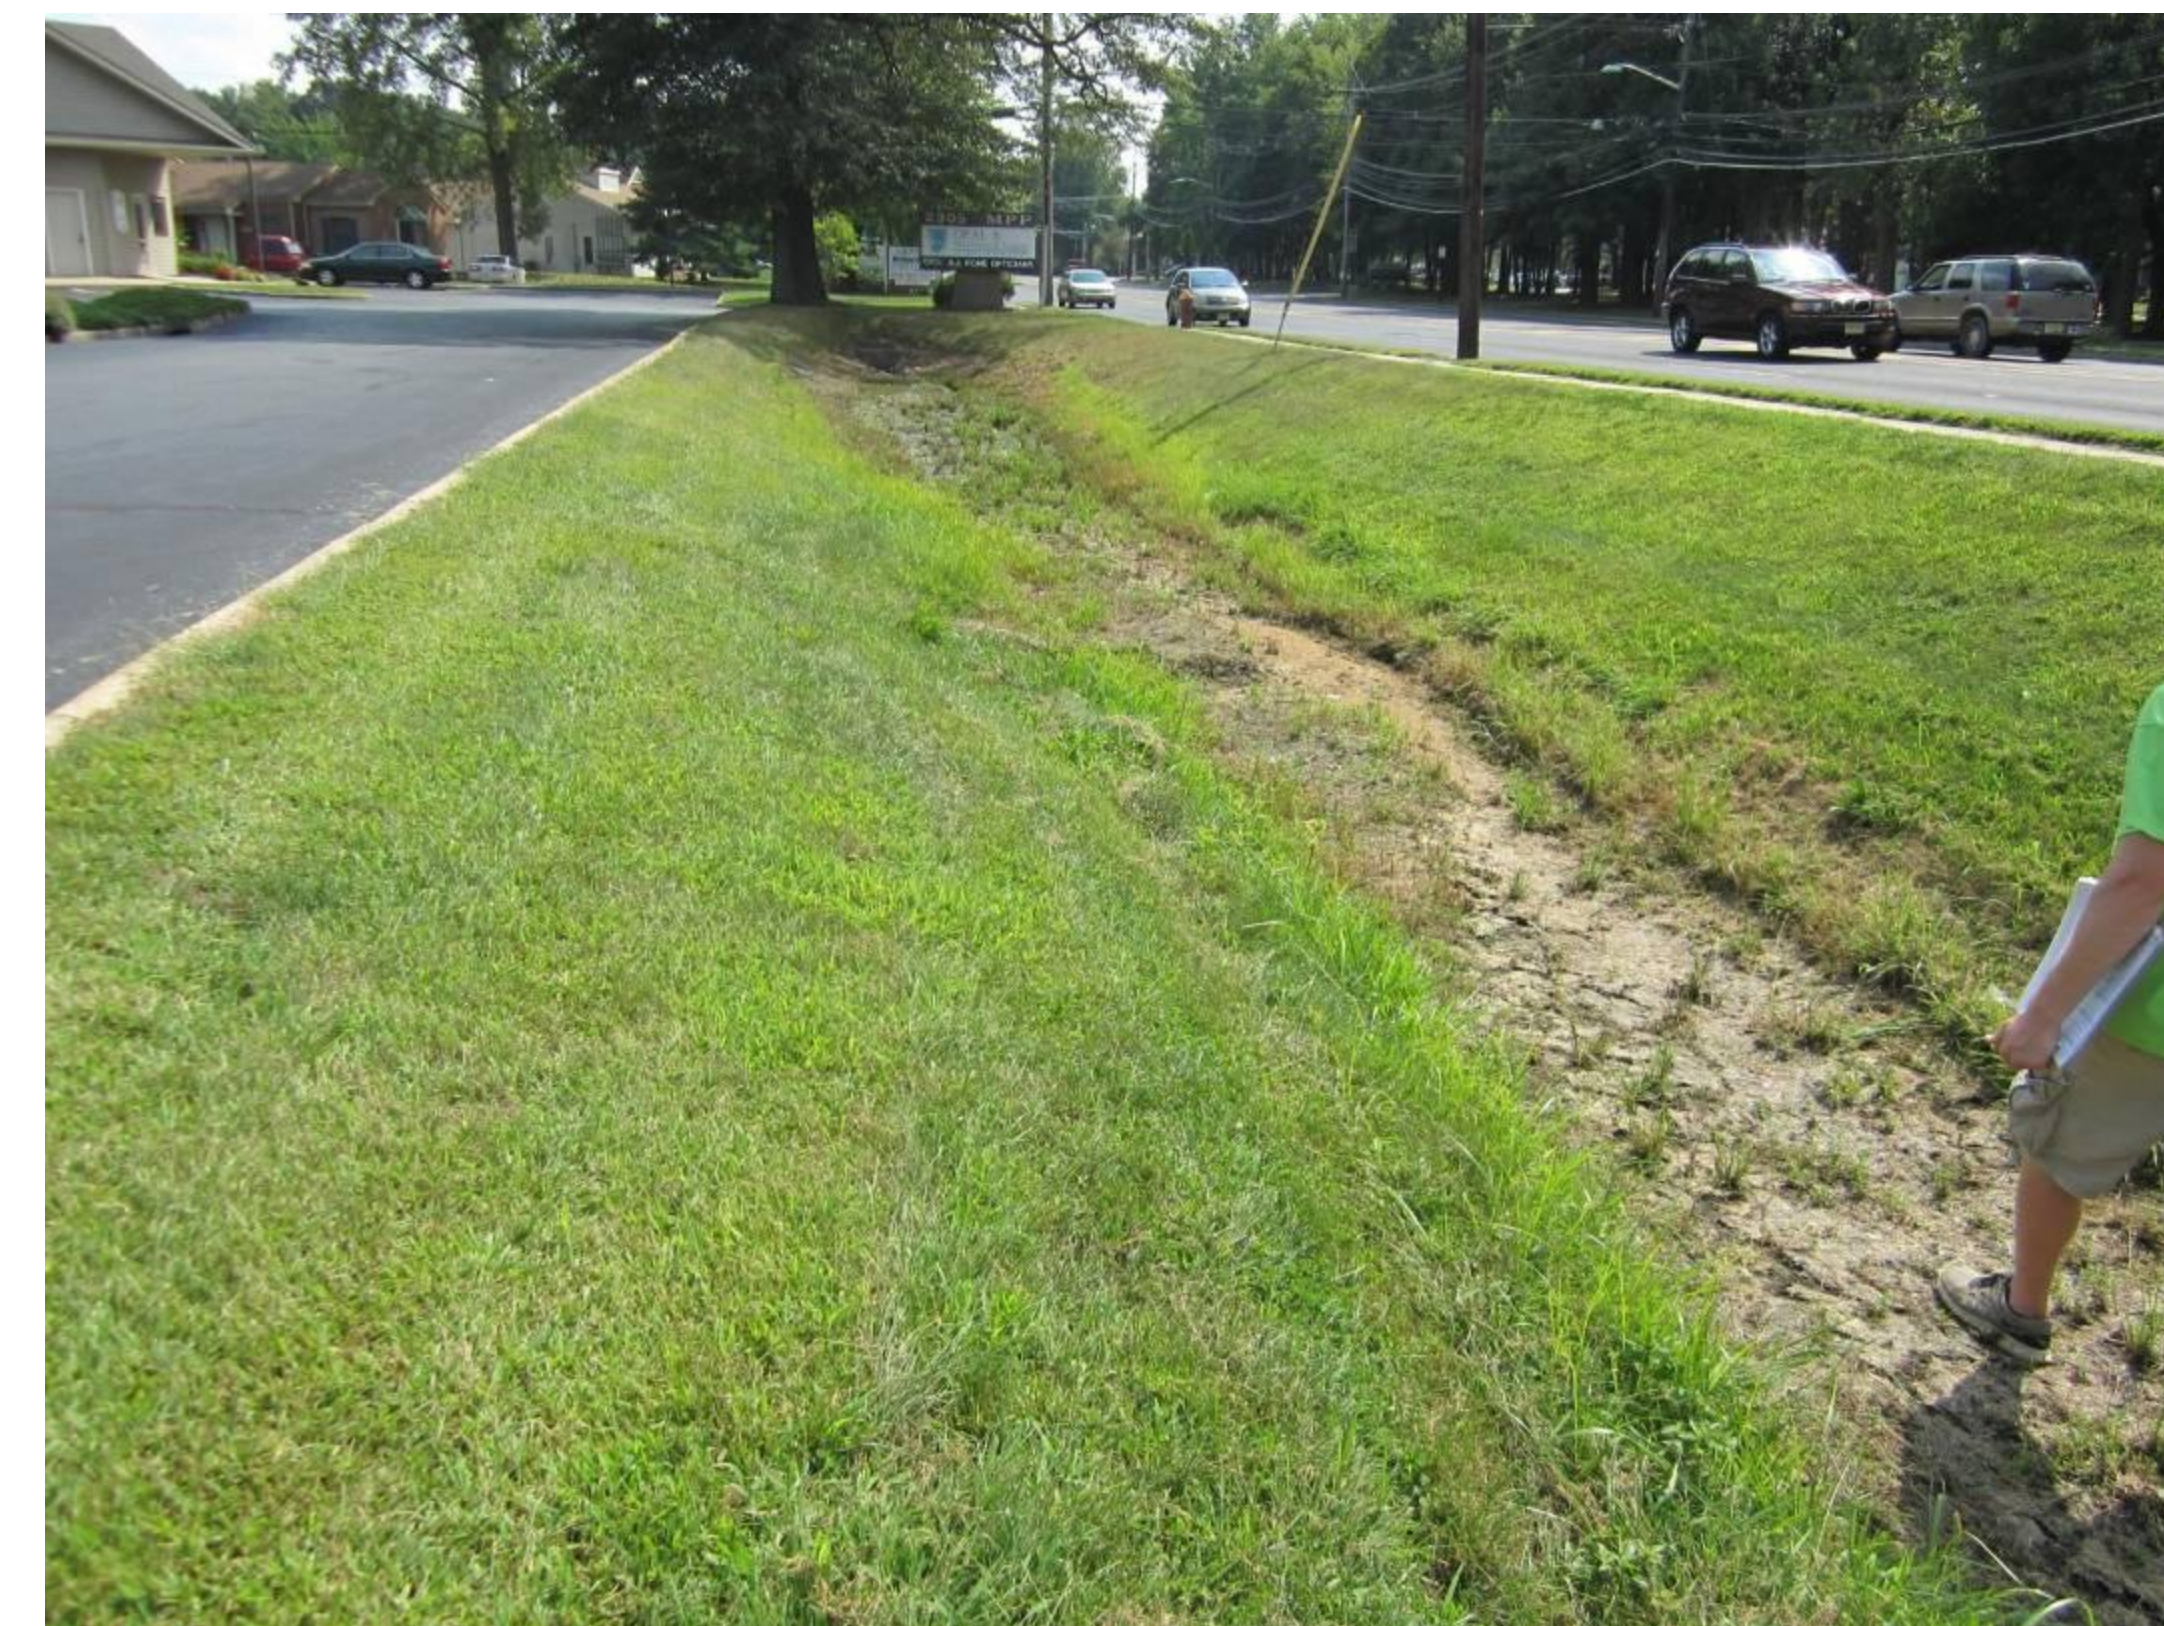
Western basin bottom

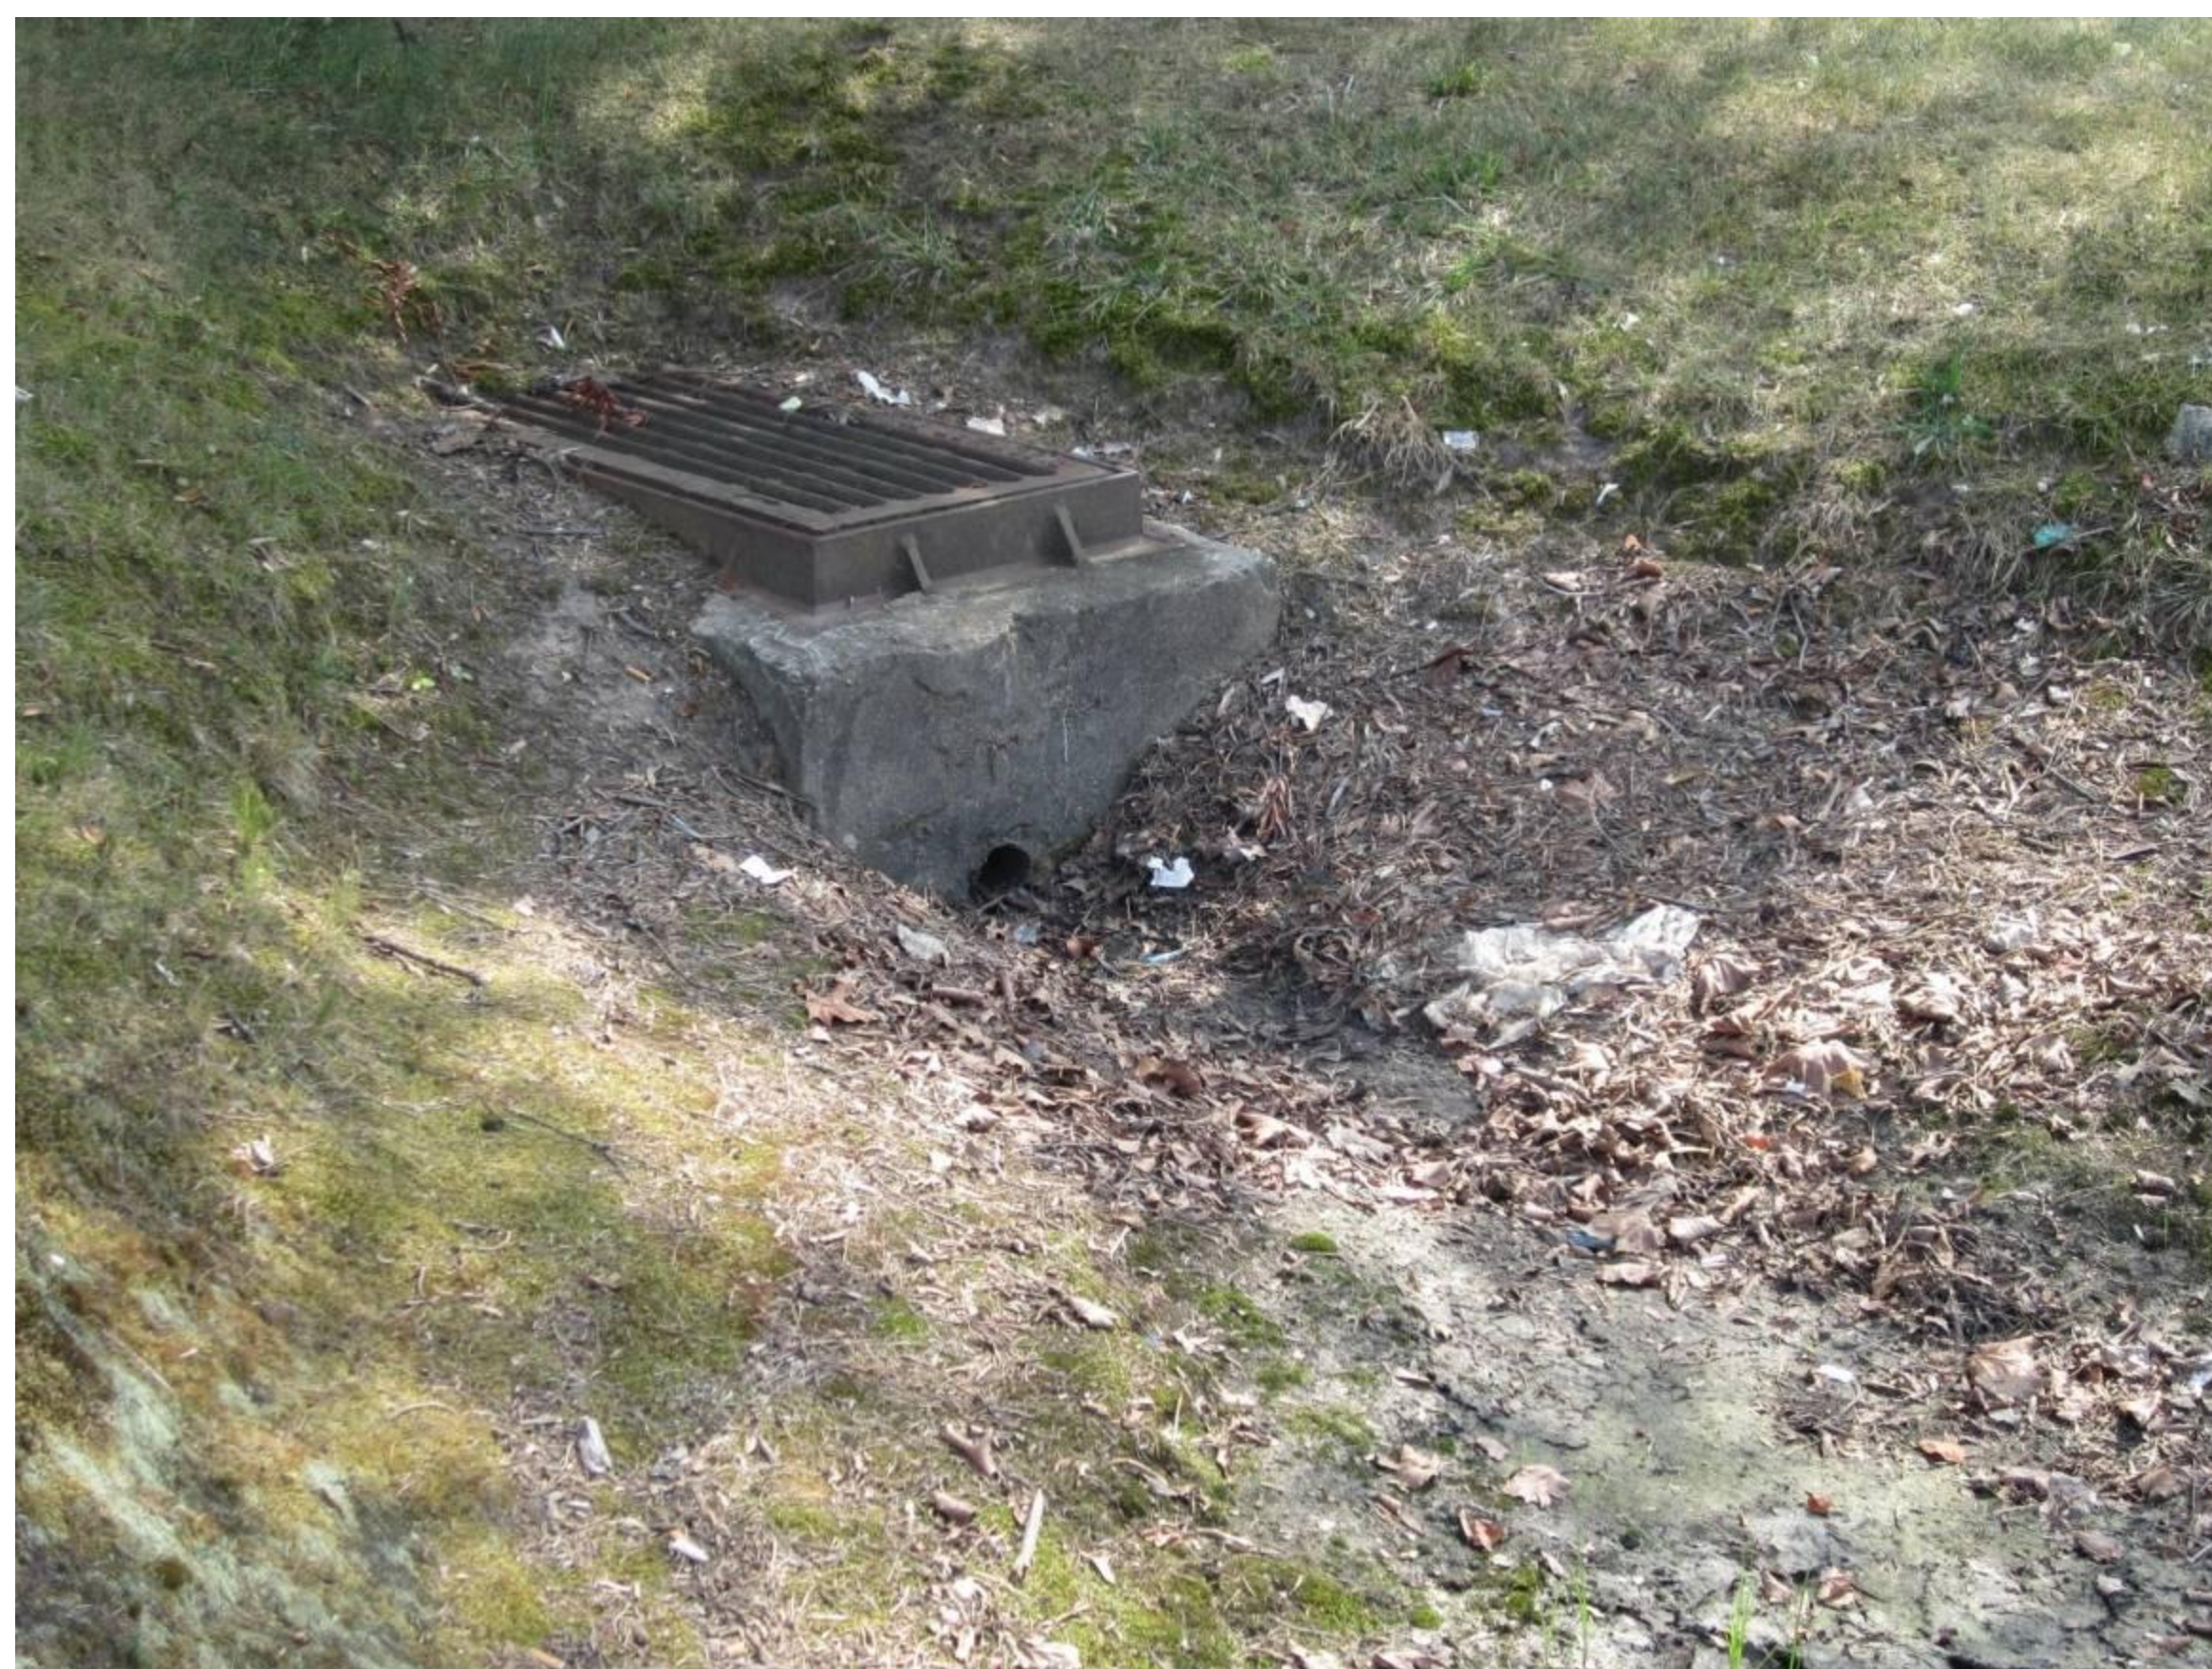
Outlet

- Sediment accumulation at inlet and outlet
- Exposed soil in basin bottom
- Outlet has structural damage

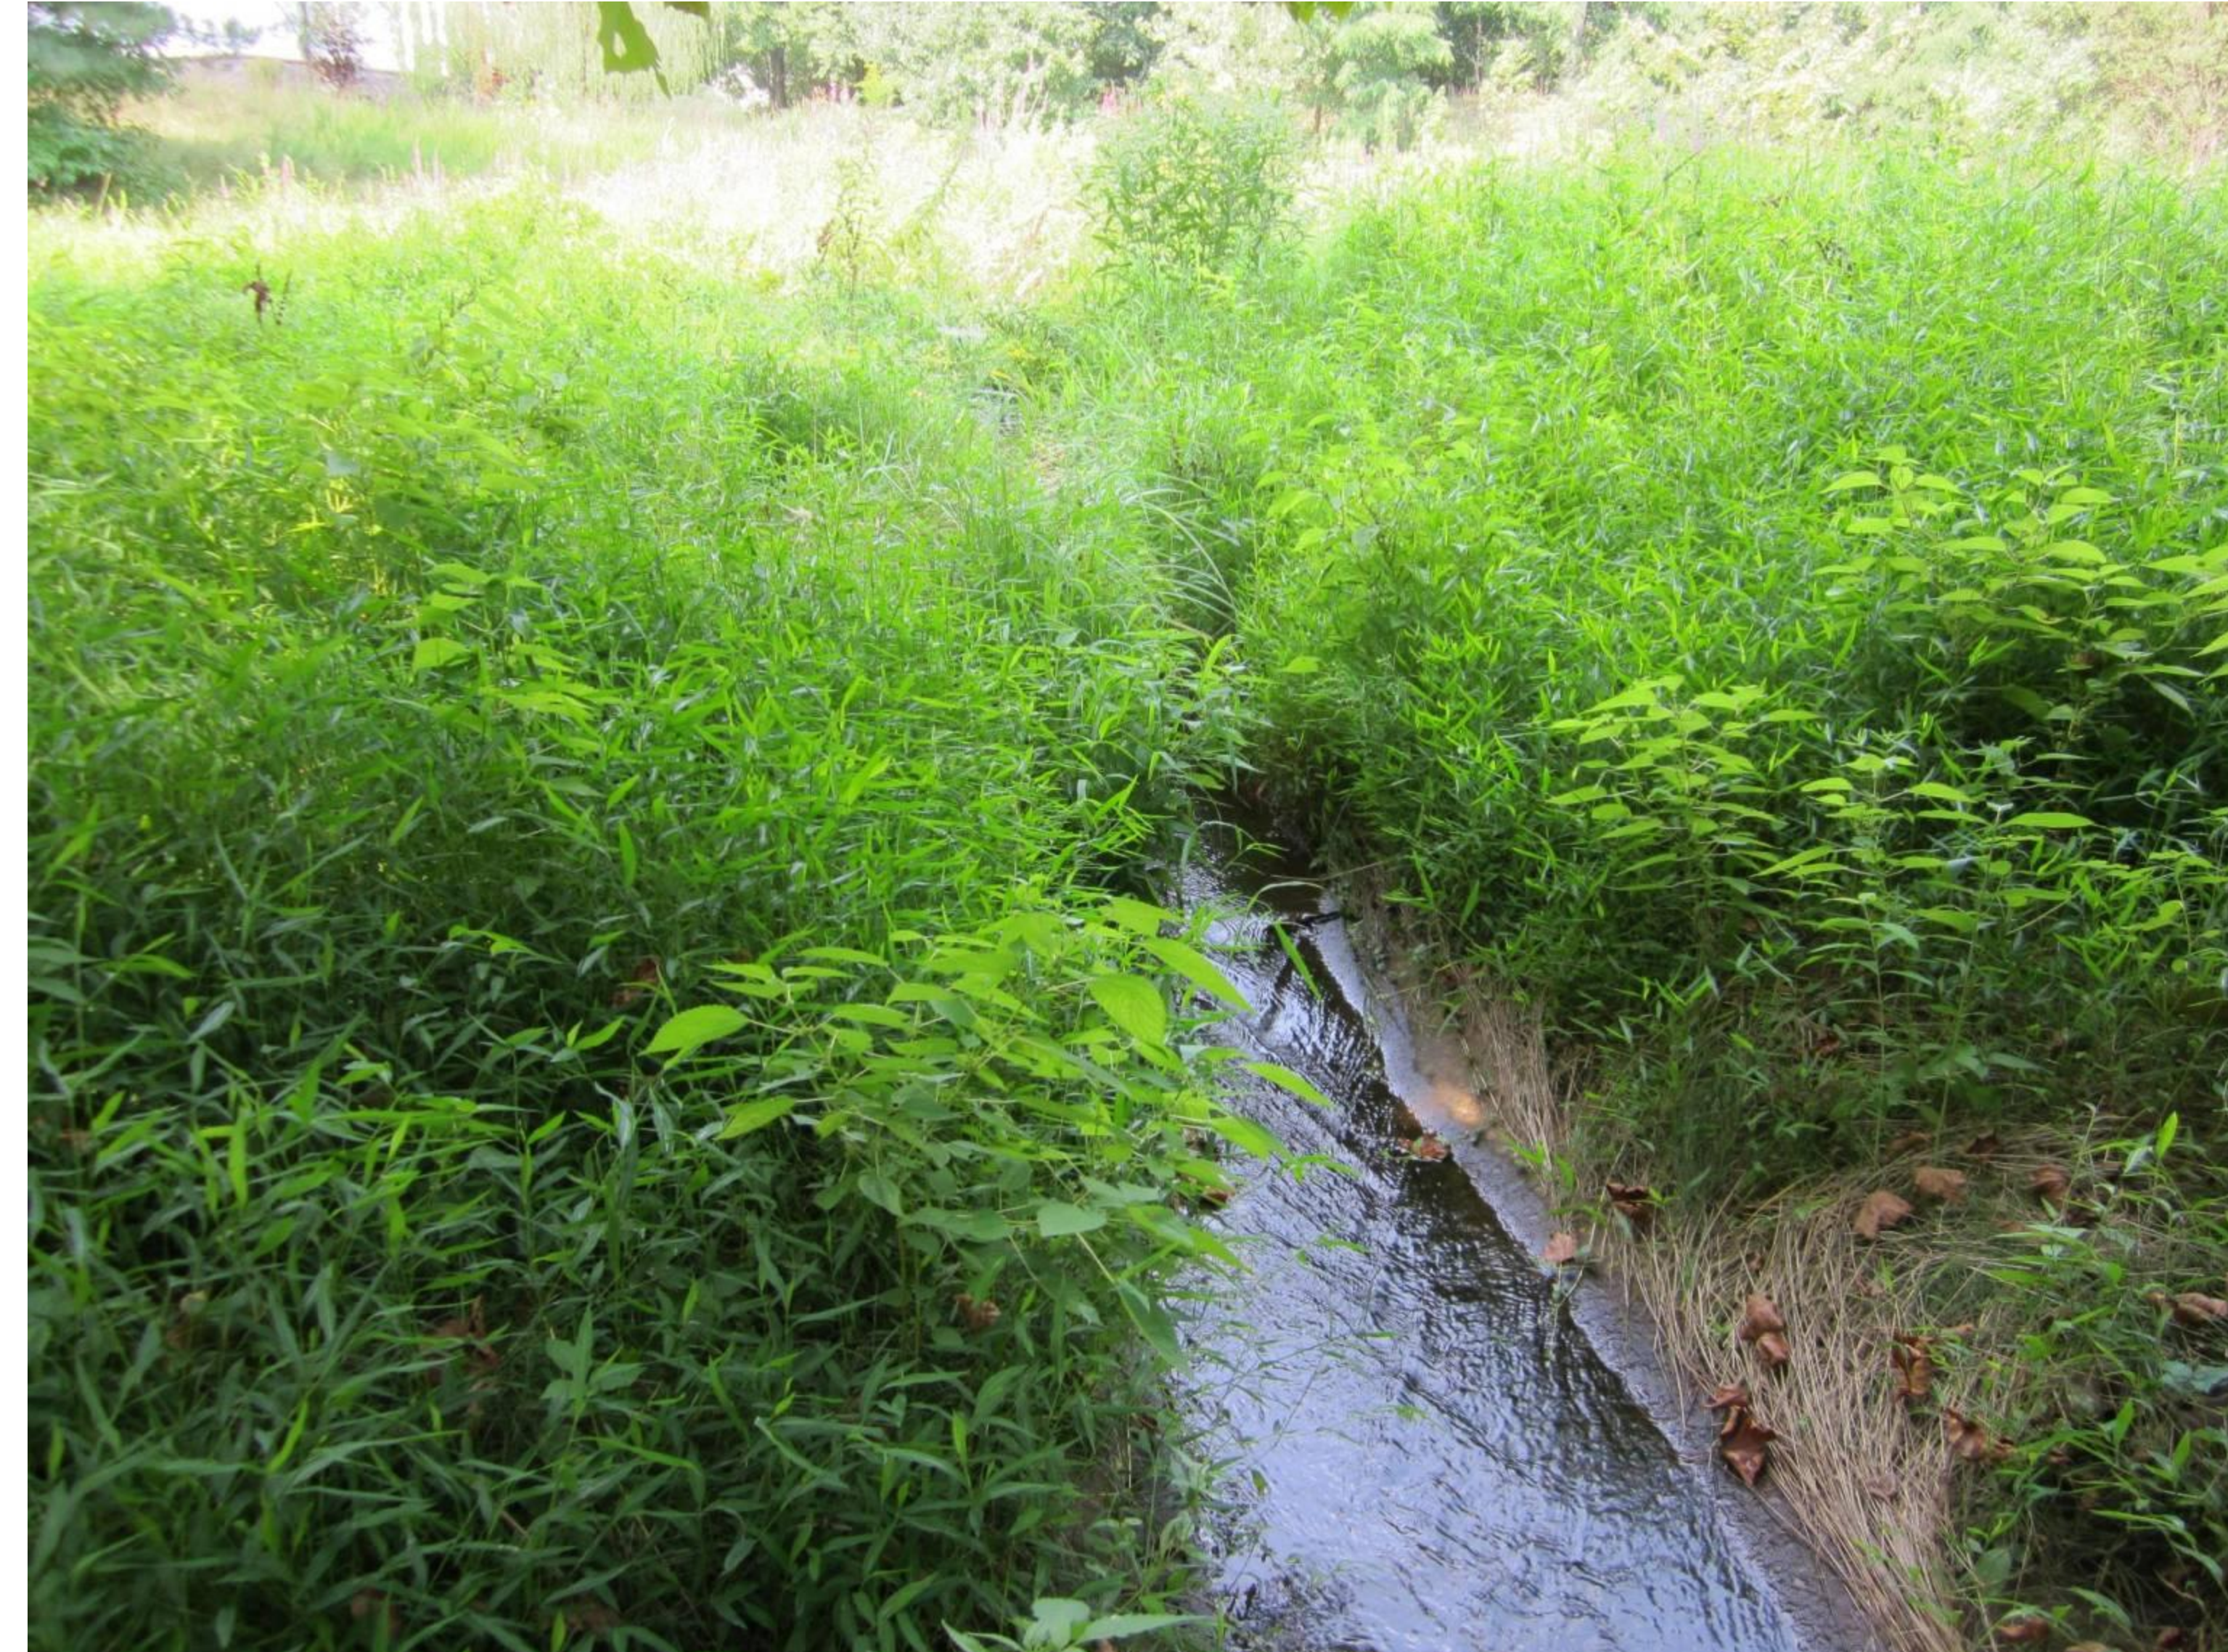
Low flow channel with flowing water

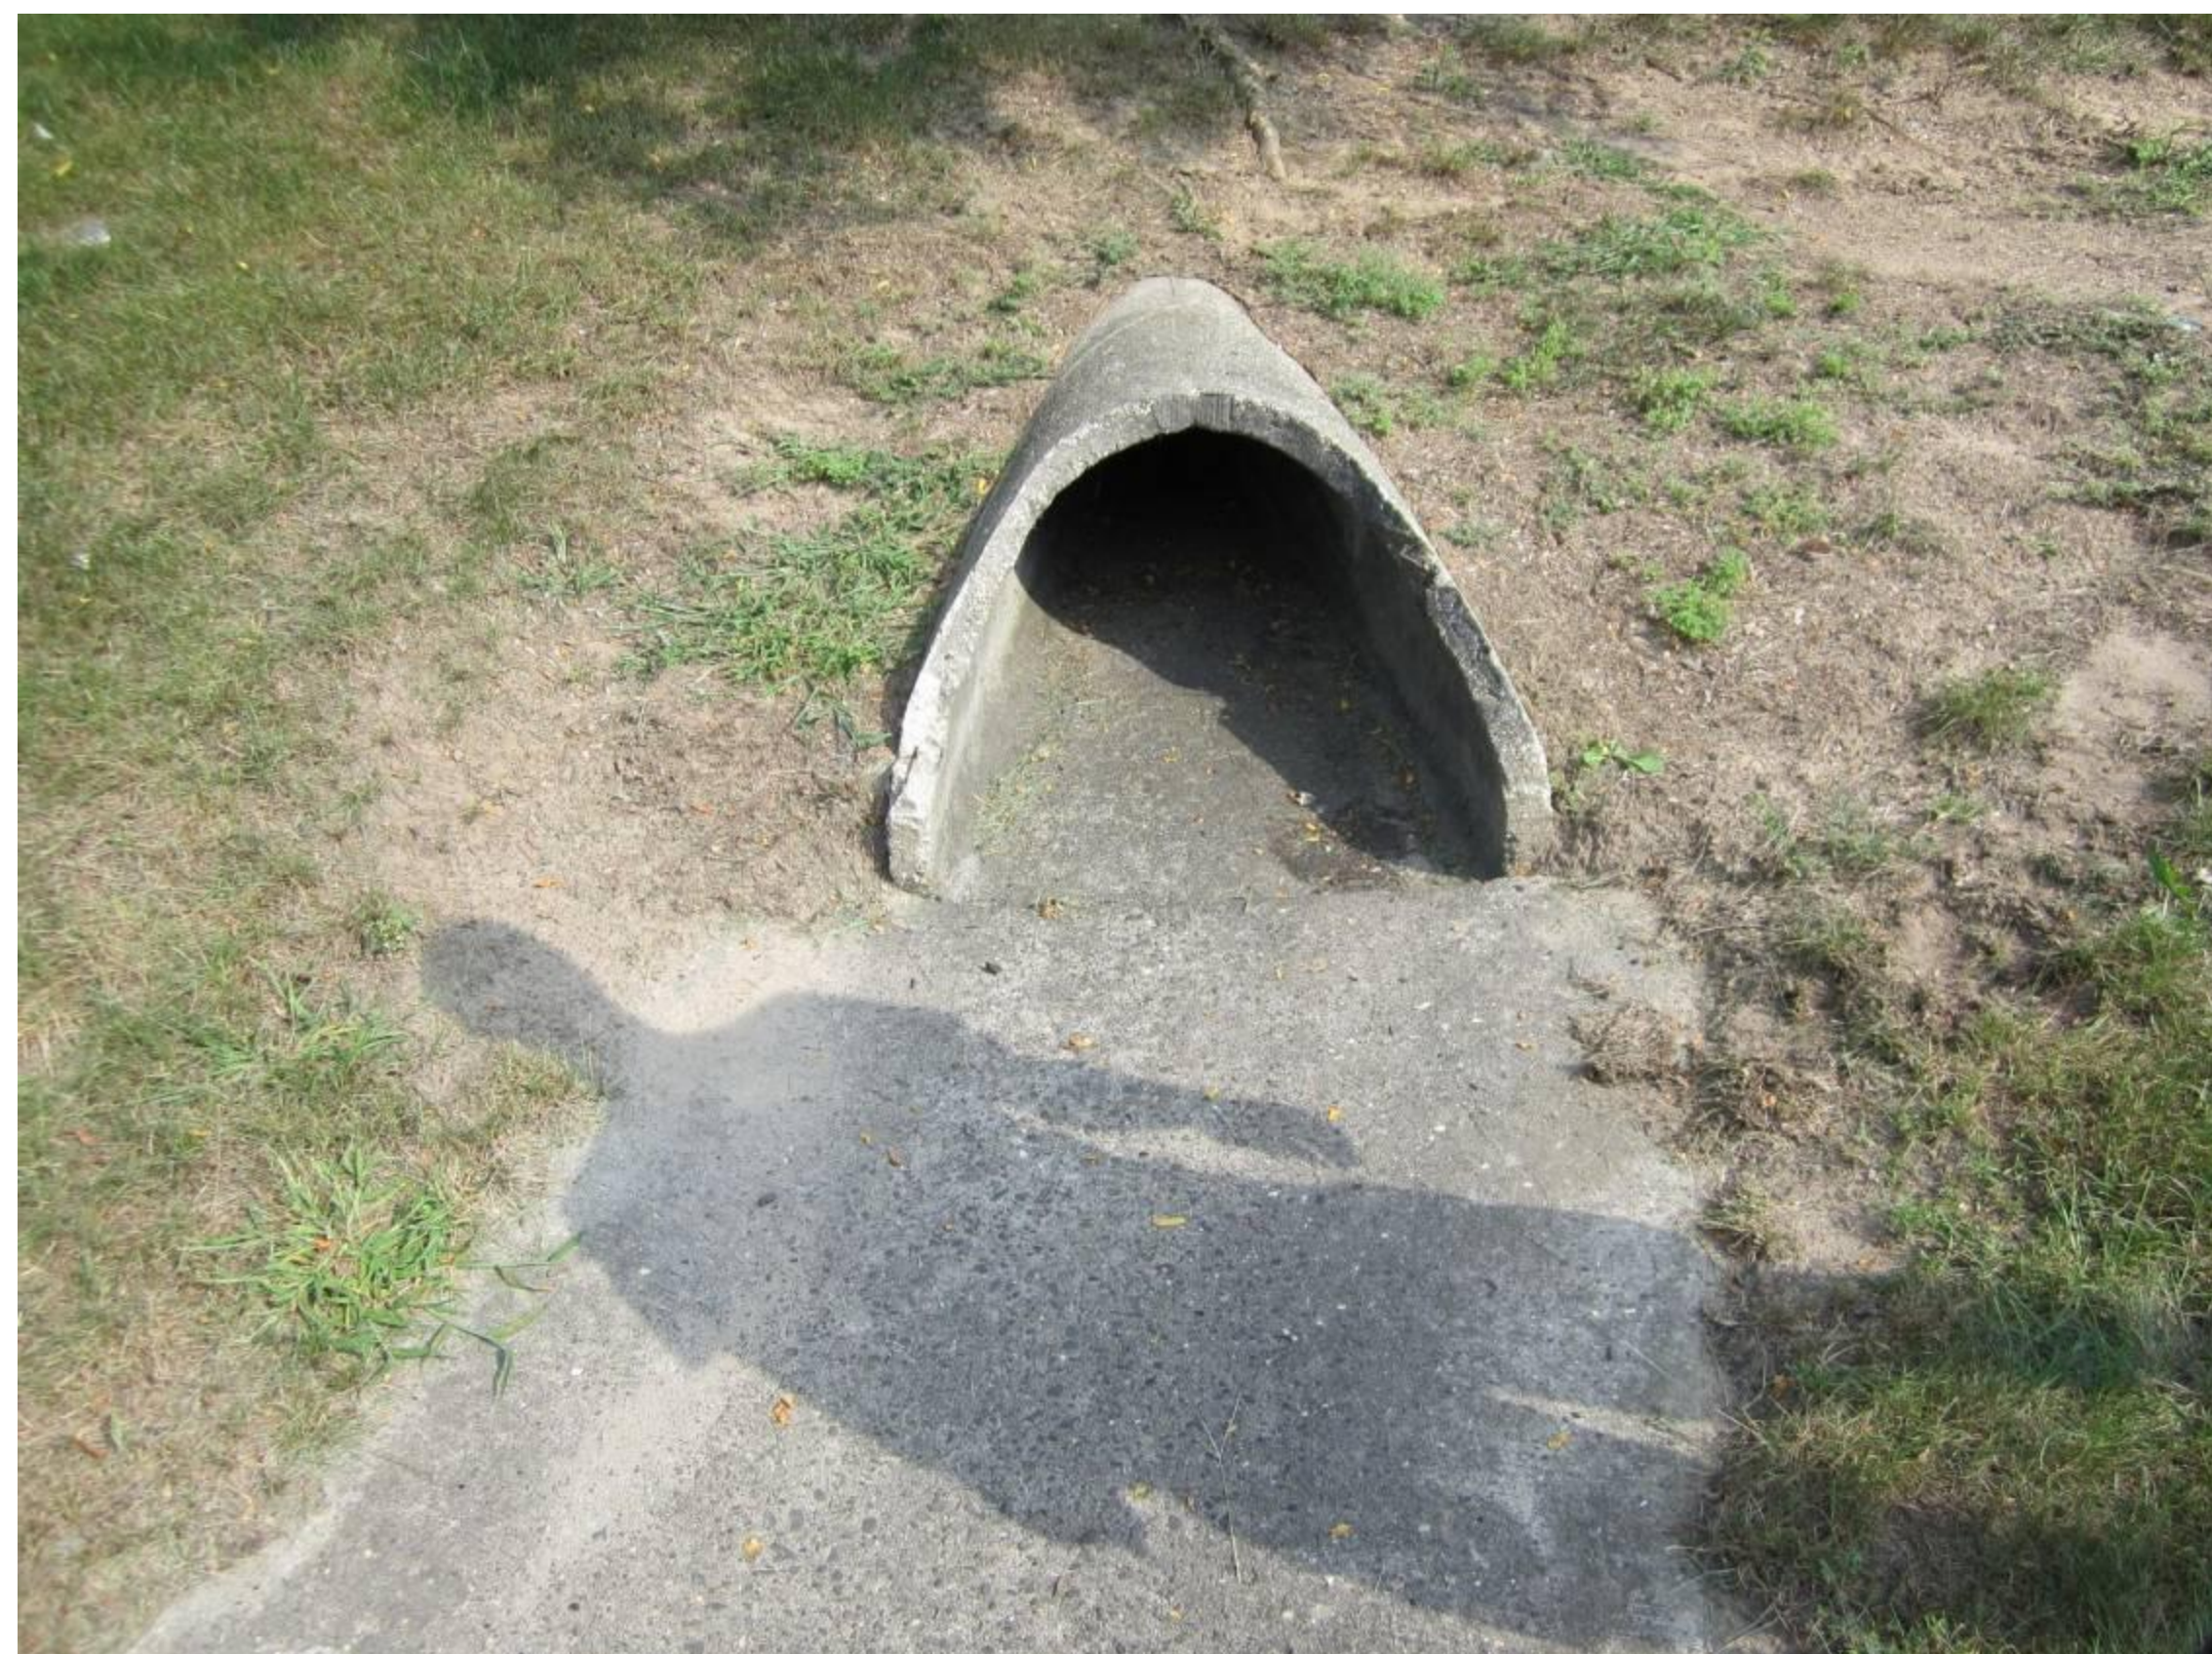
Inlet pipe

- Inlet and outlet show evidence of deterioration

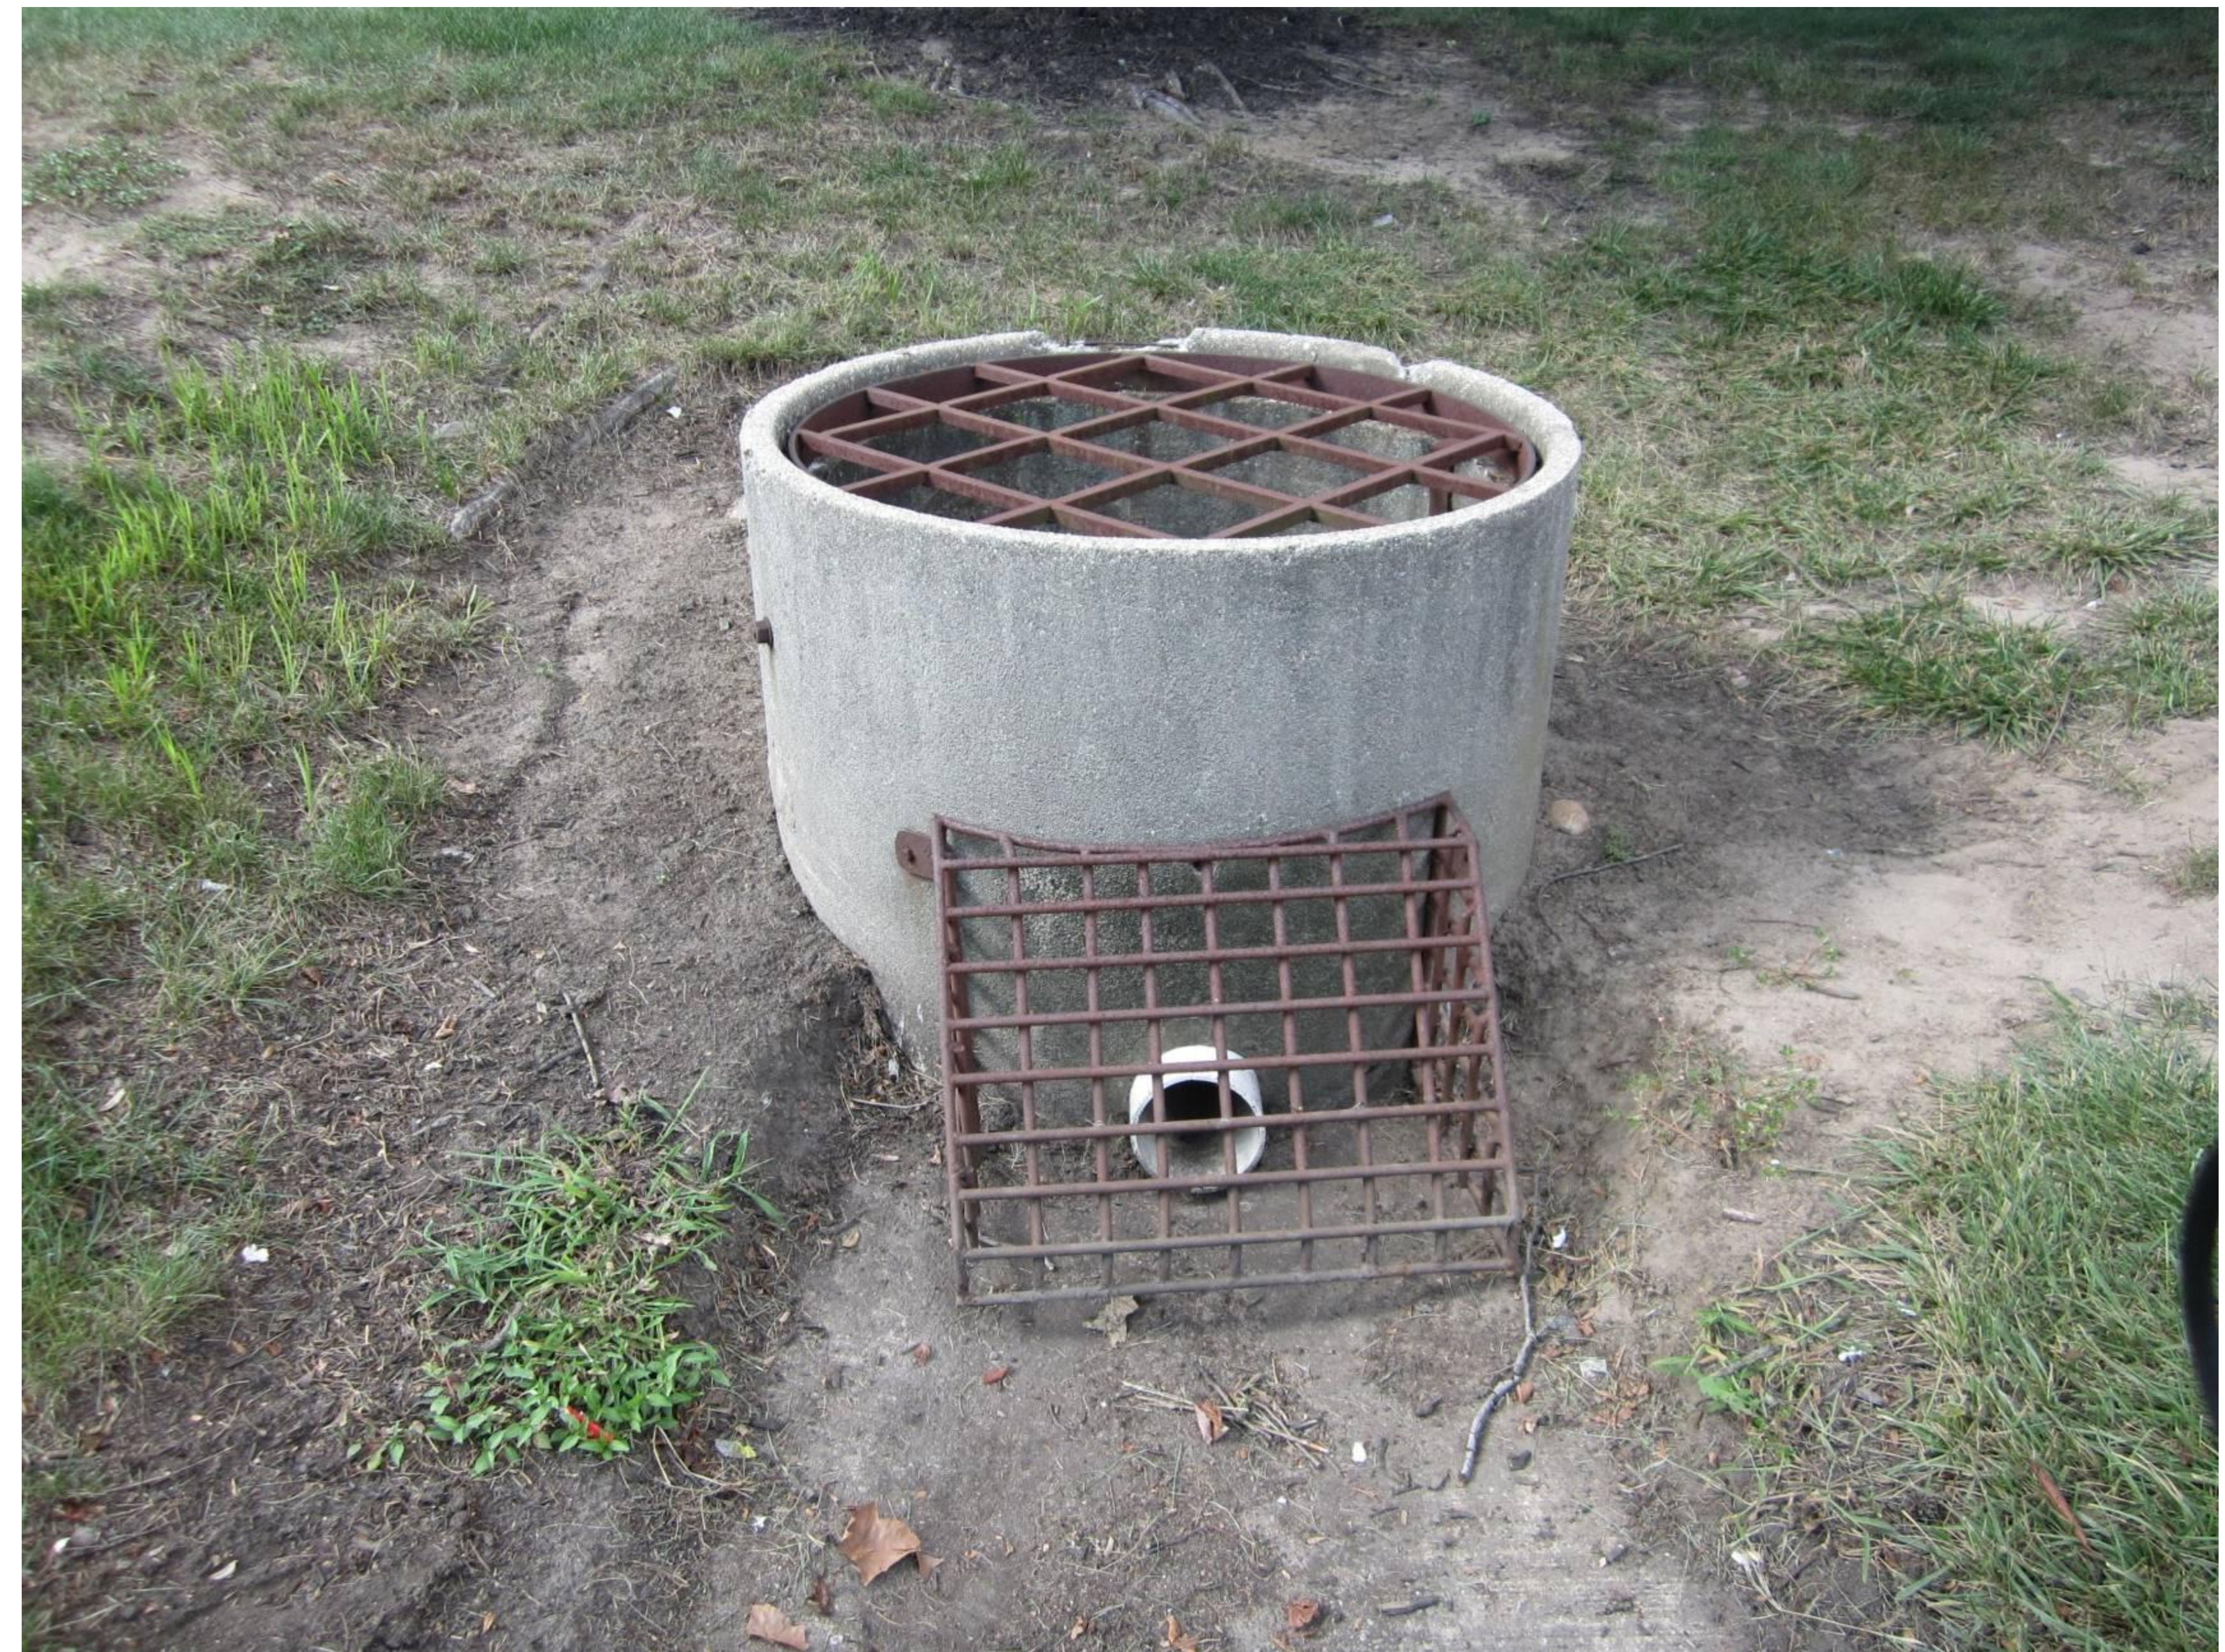
Outlet structure

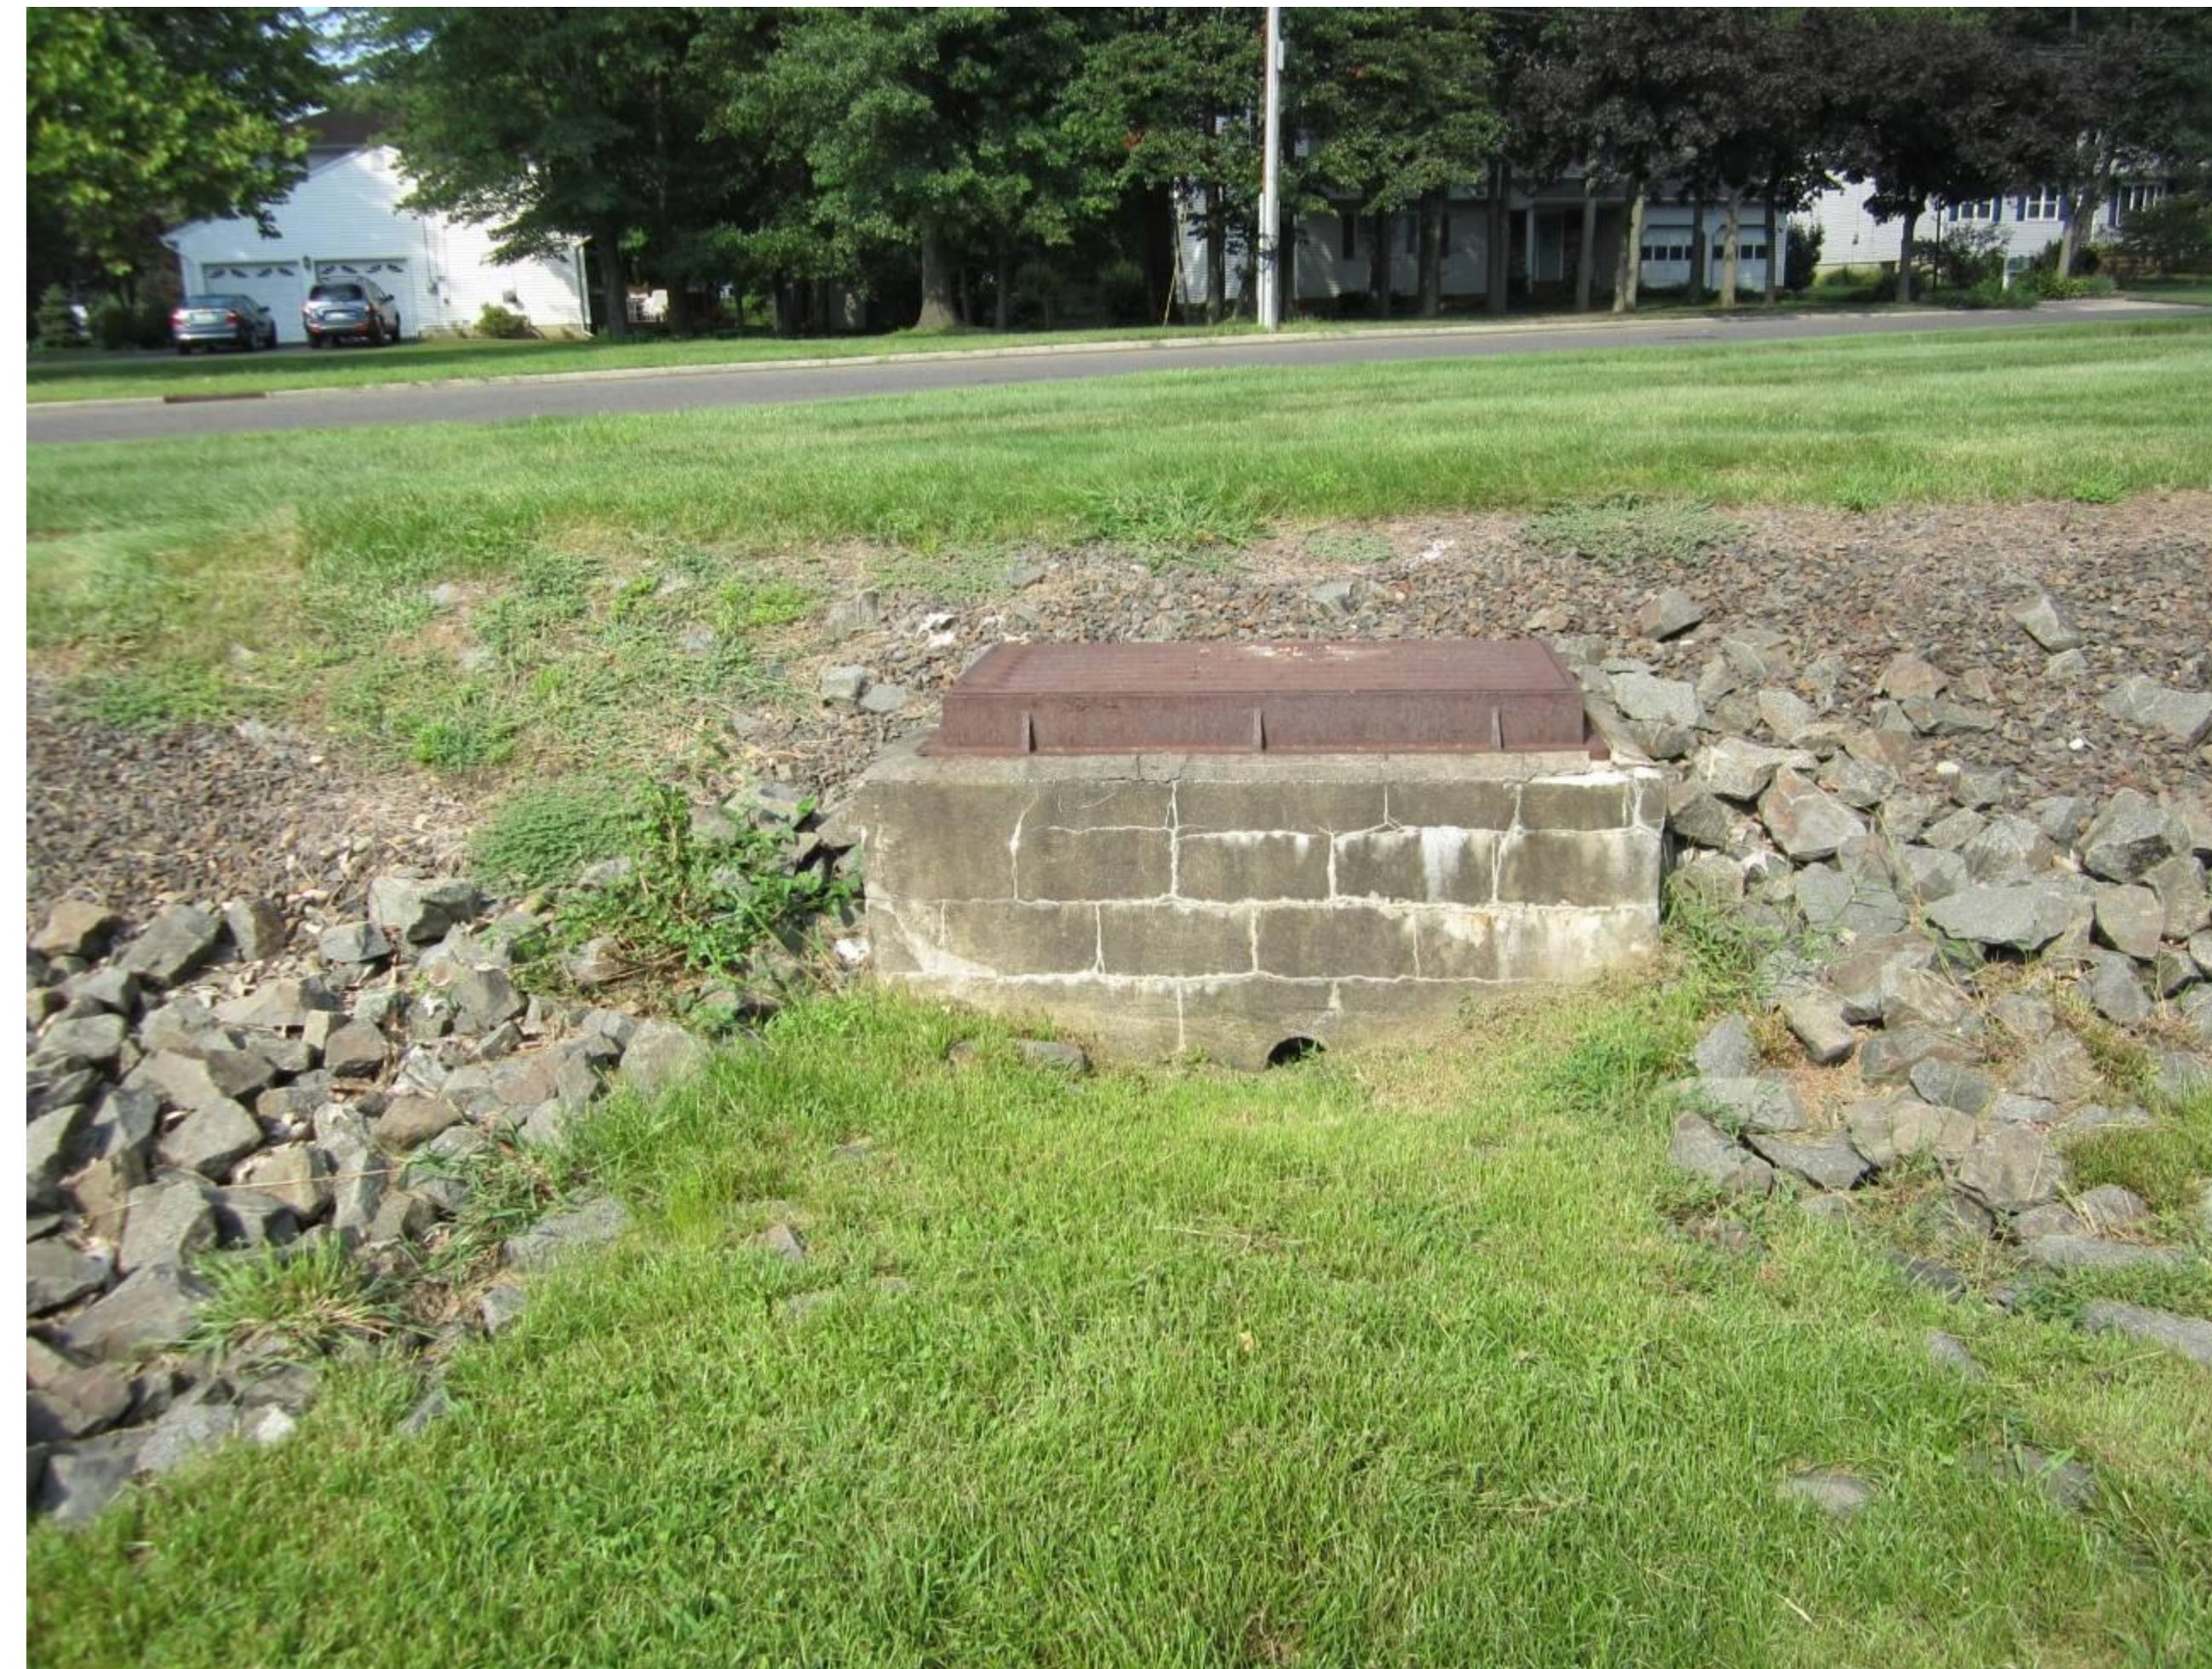
Outlet structure

- Standing water in inlet
- Accumulation of litter, sediment and debris AT outlet, inlet and basin bottom
- Exposed soil in basin bottom
- Evidence of erosion in front of inlet
- Inlet shows evidence of deterioration
