Hamilton Township (Mercer County) Stormwater Basin Assessment Summary (Year 1)

Developed by the Rutgers Cooperative Extension Water Resources Program
Funded by Hamilton Township, Mercer County, New Jersey

December 6, 2012

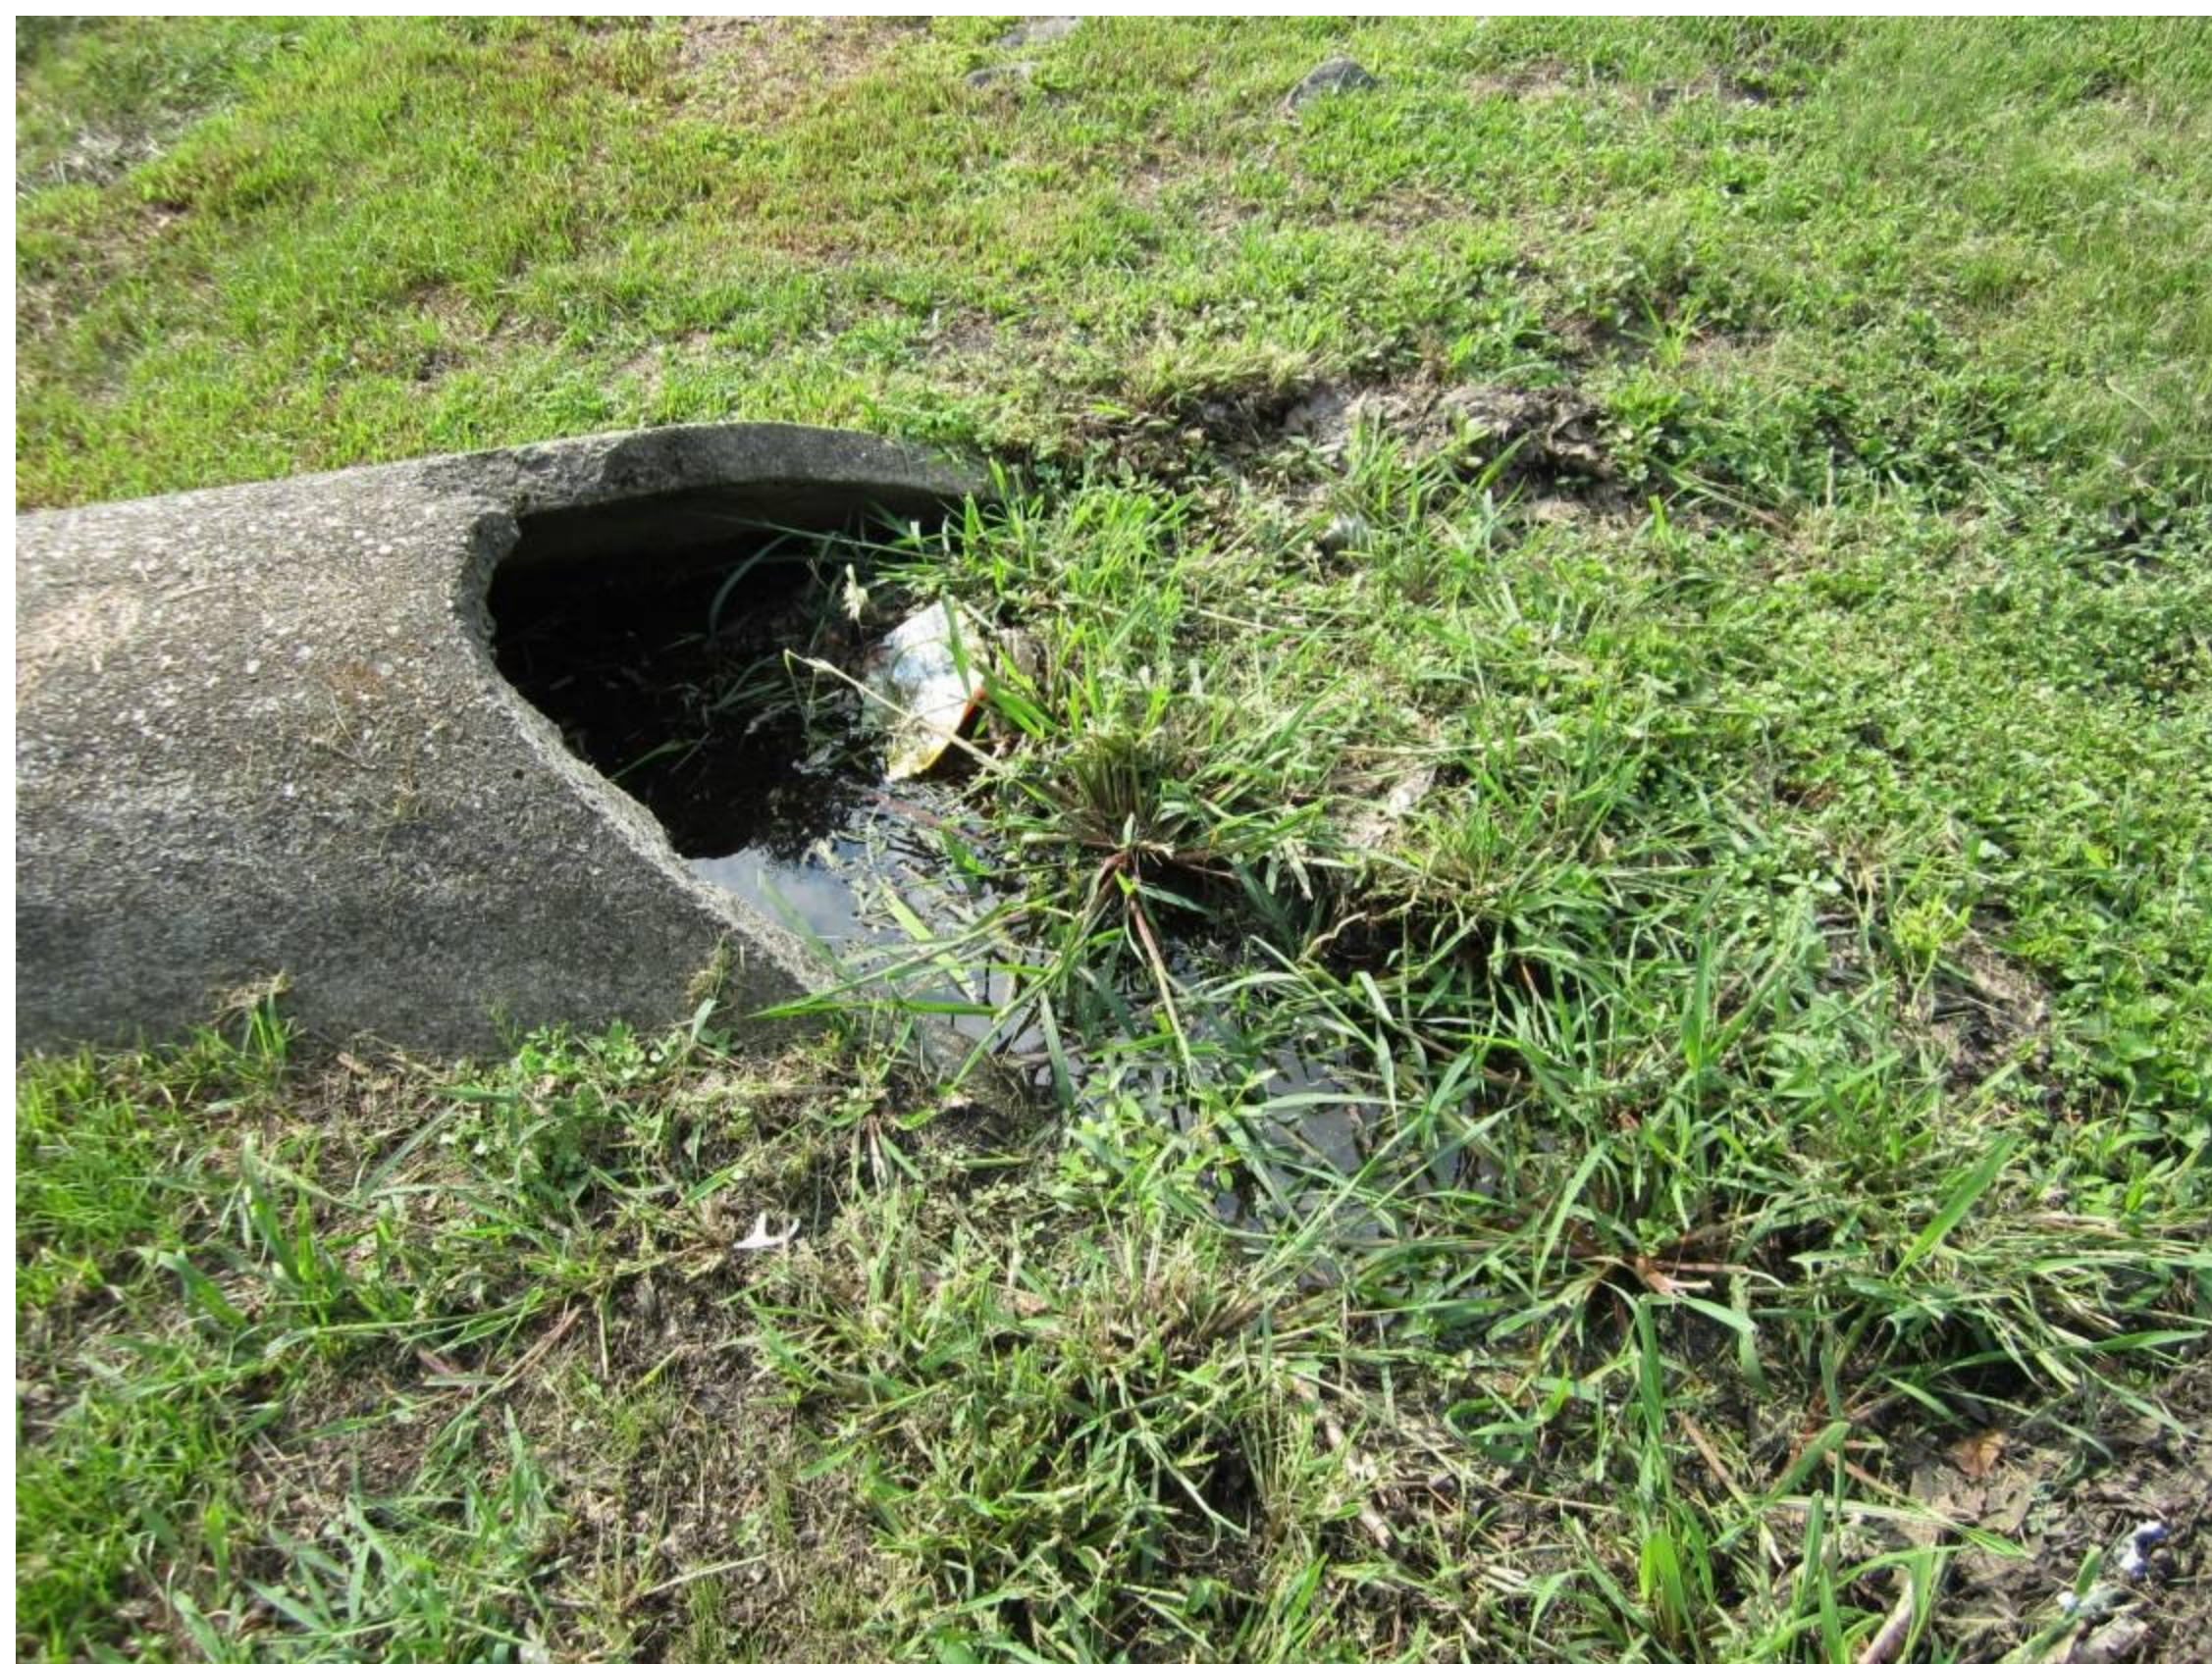
Inlet pipe

- Standing water in inlet
- Accumulation of litter, sediment and debris AT outlet, inlet and basin bottom
- Exposed soil in basin bottom
- Evidence of erosion in front of inlet
- Inlet shows evidence of deterioration

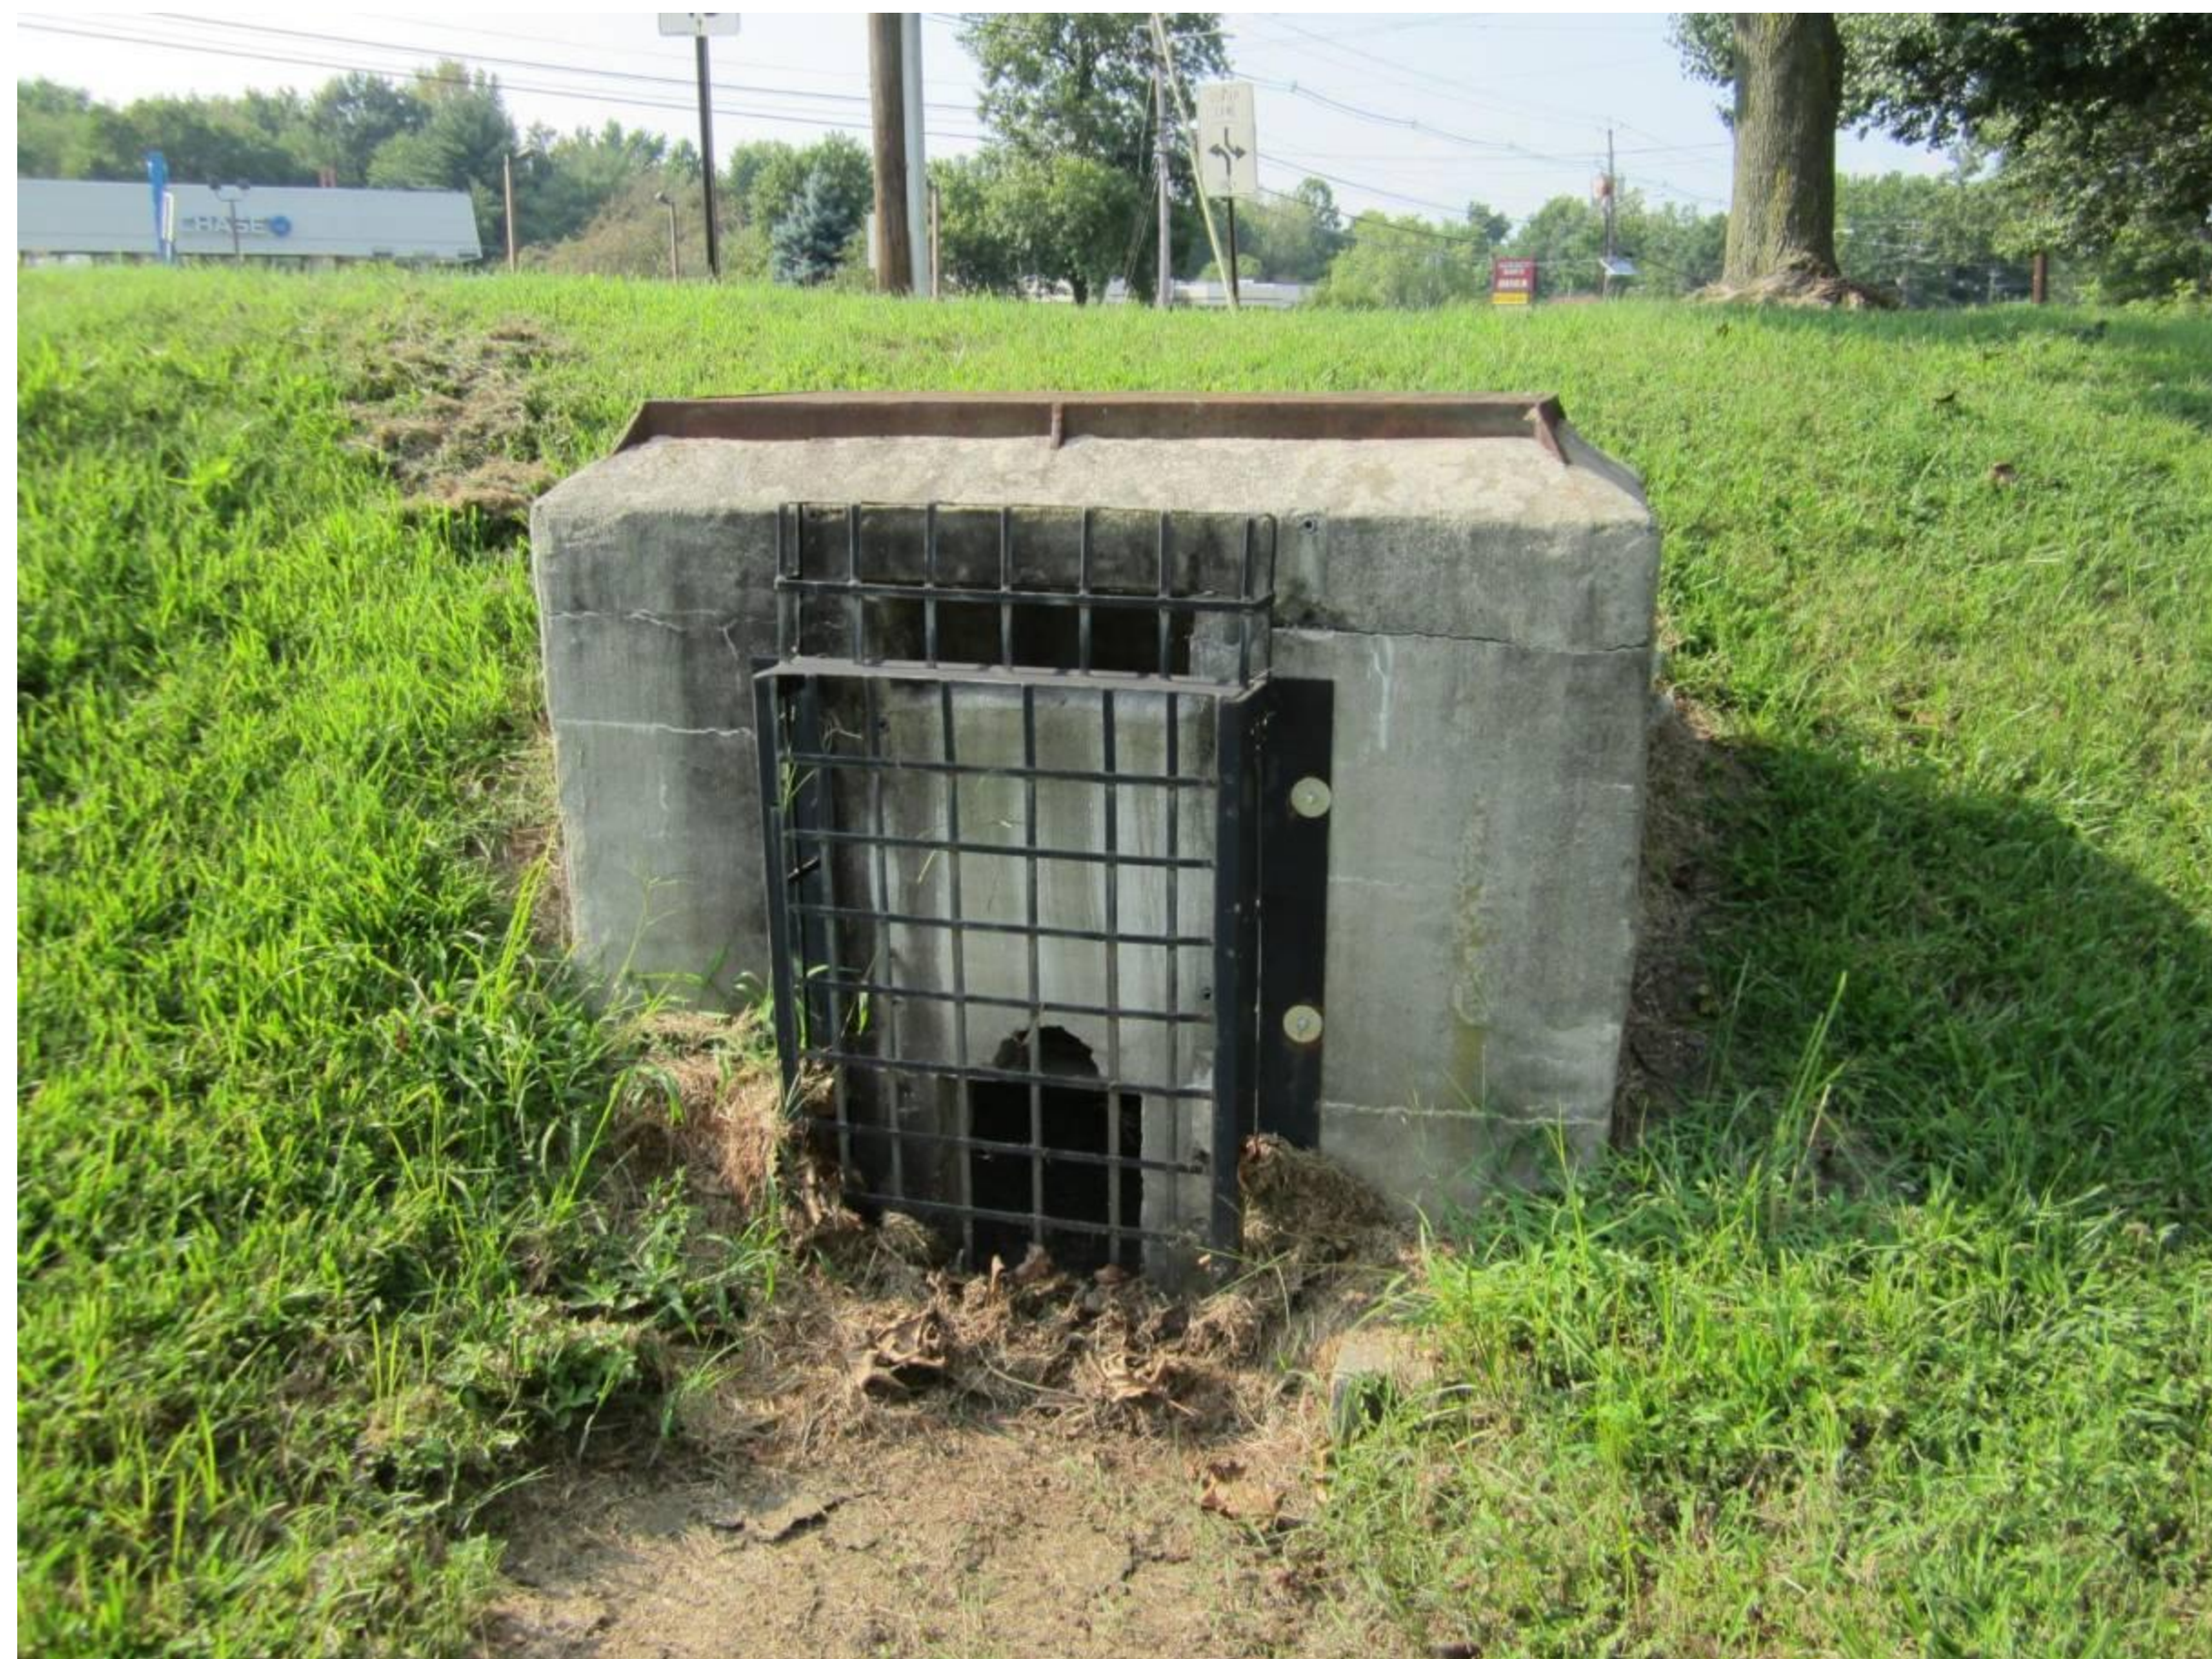
Outlet structure

- Outlet trash rack clogged with sediment and grass clippings
- Outlet has structural damage

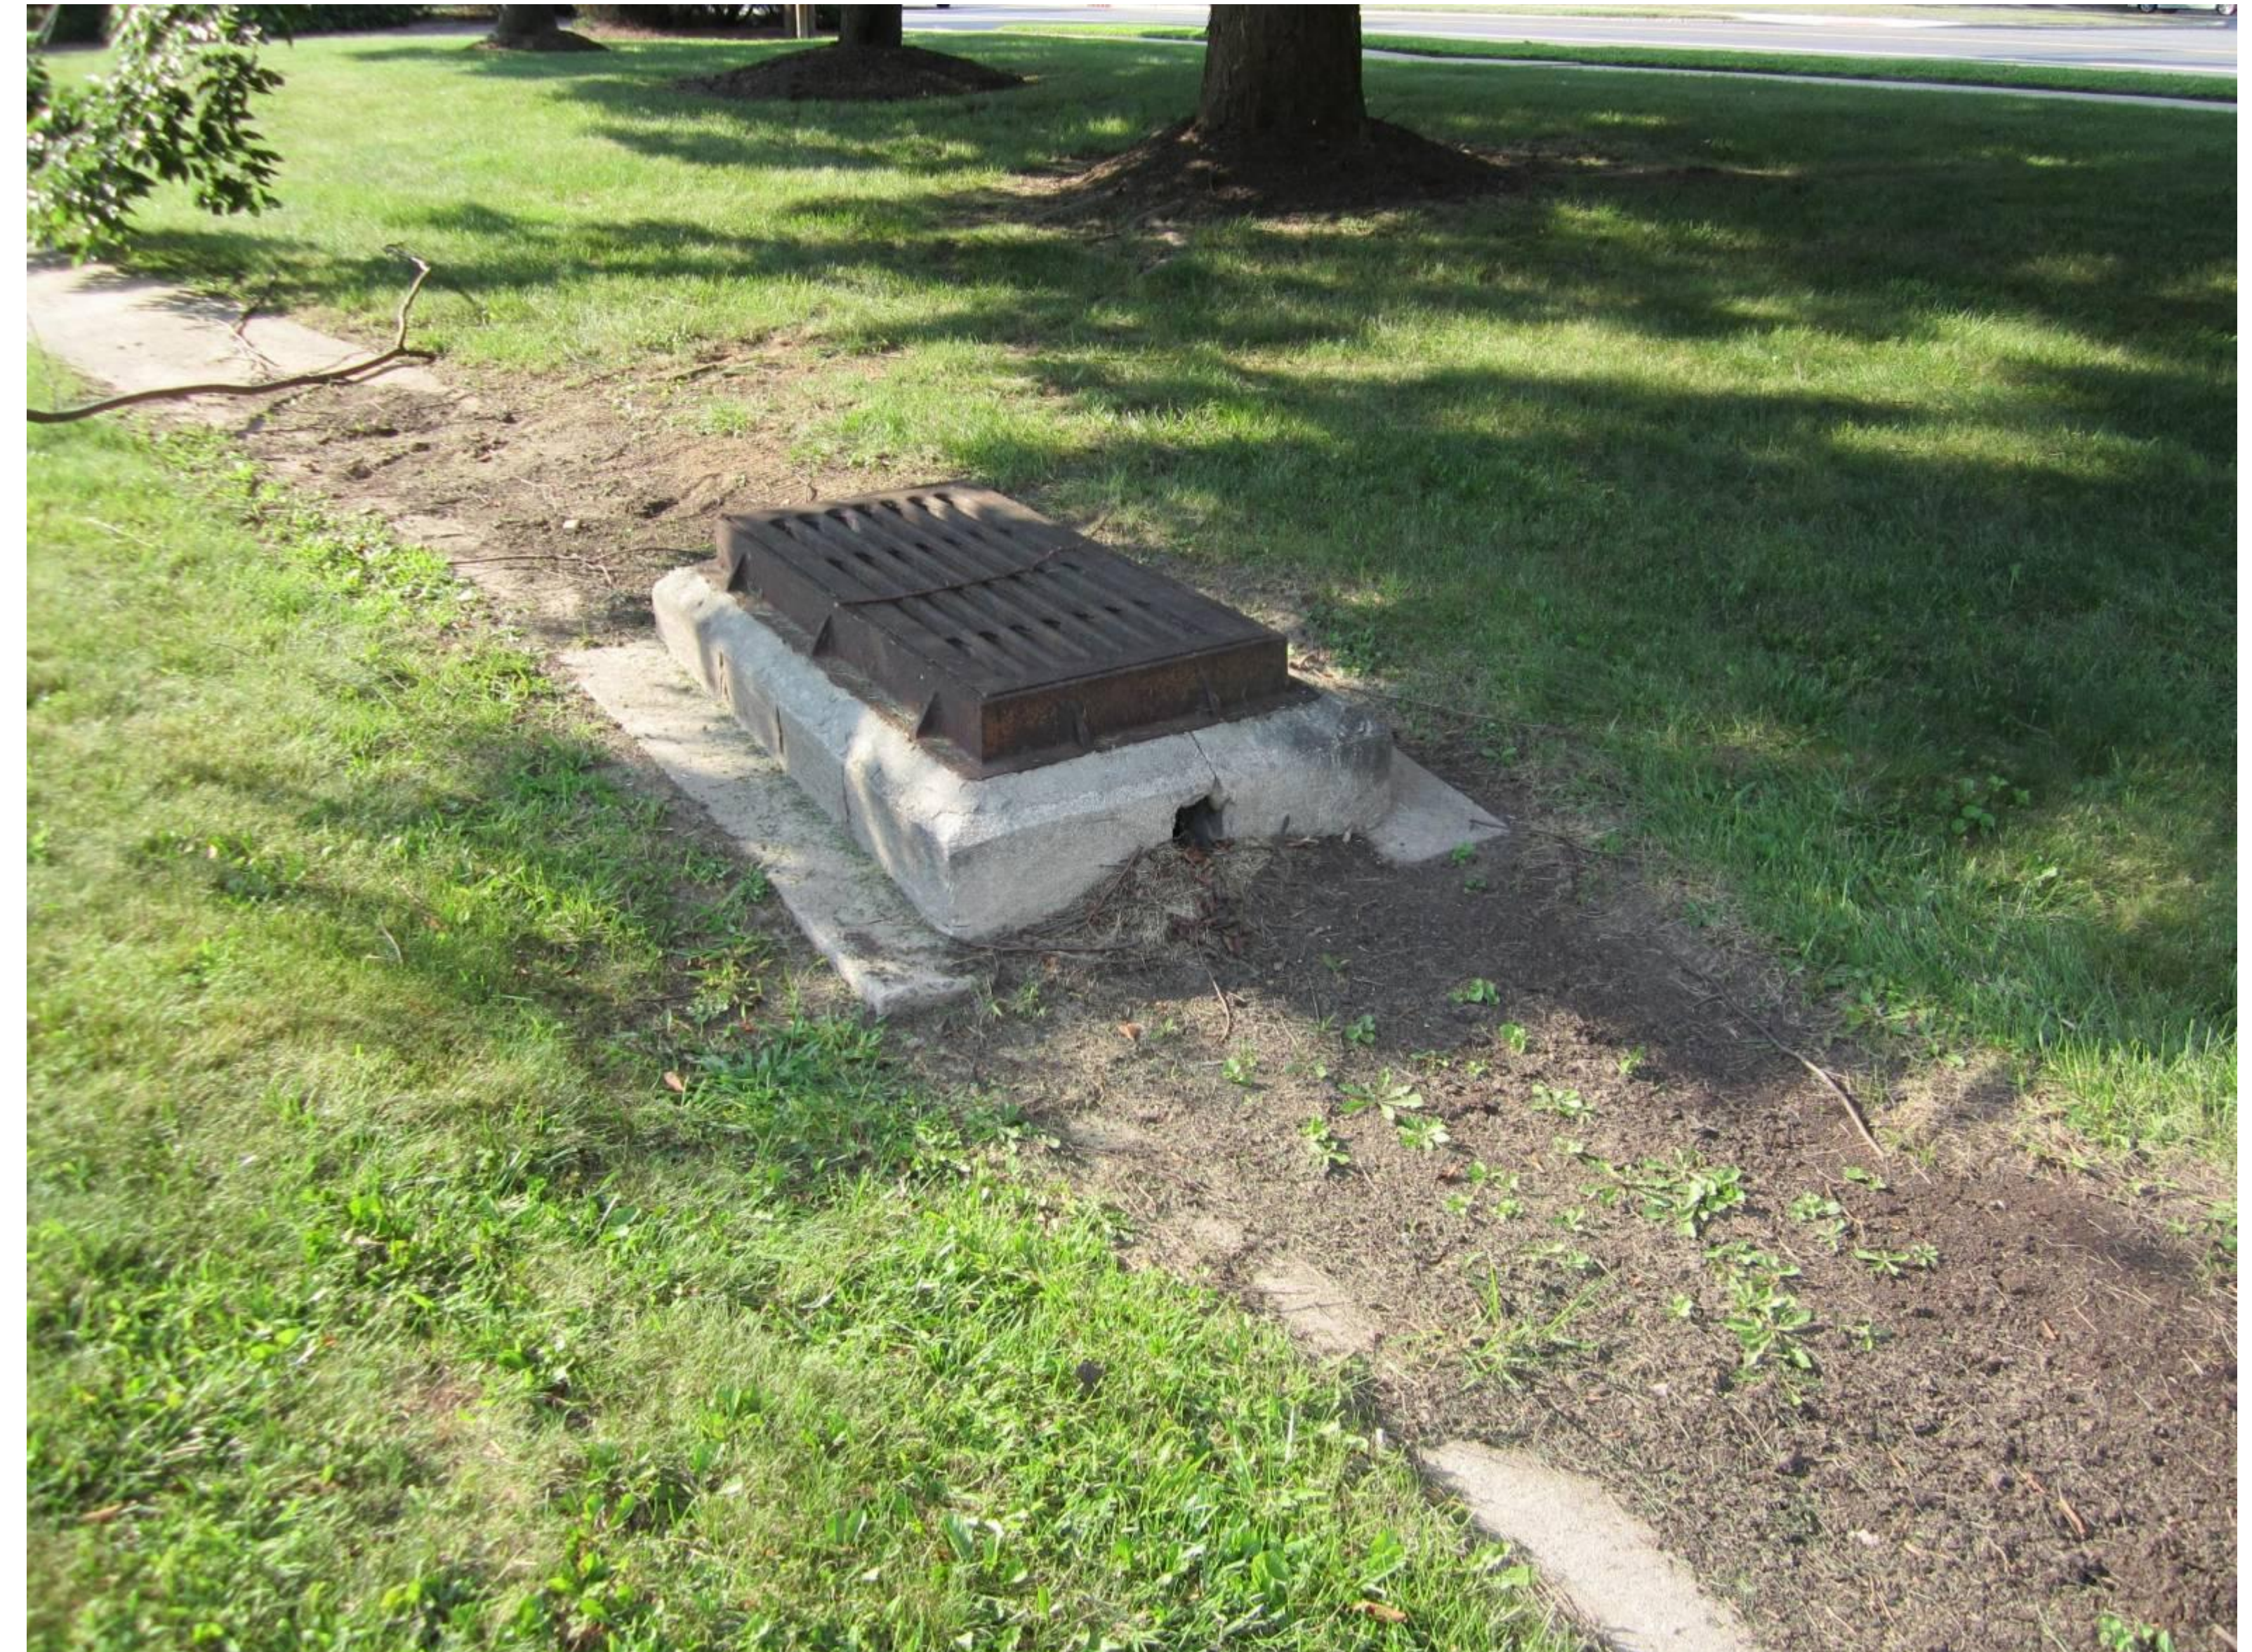
Outlet structure

- Sediment accumulation in low flow channel, inlet and outlet
- Outlet structure shows evidence of deterioration

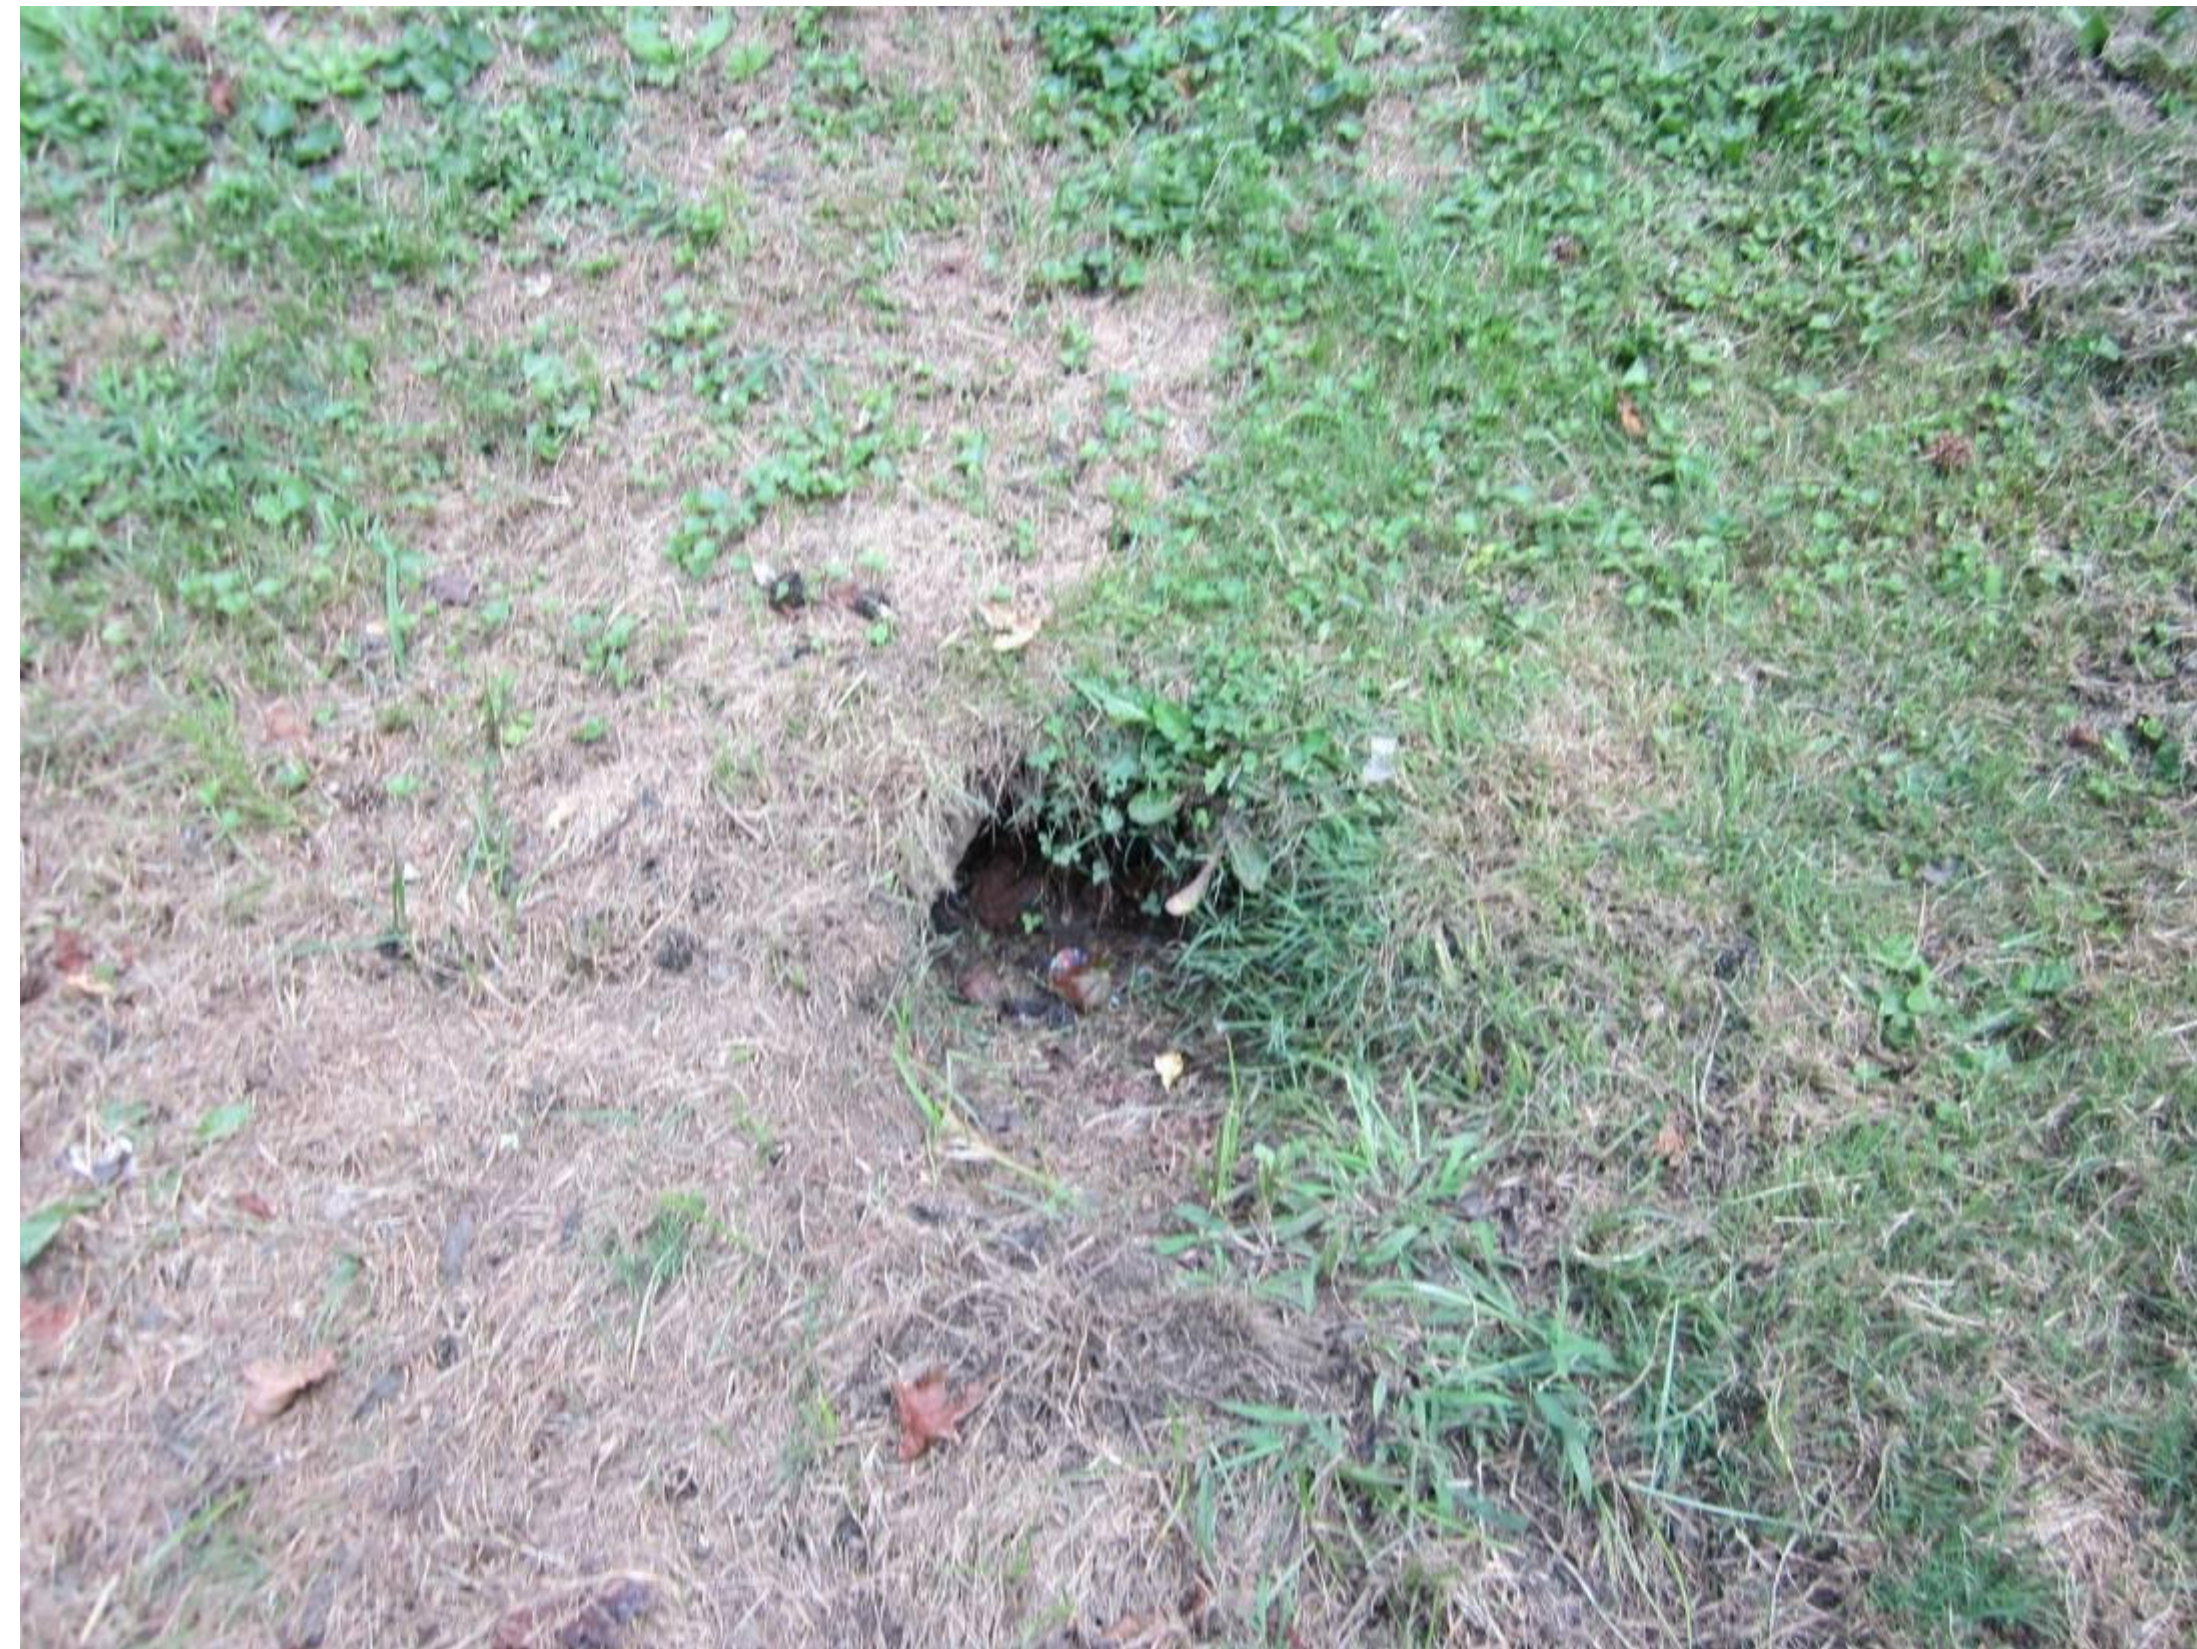
Inlet pipe

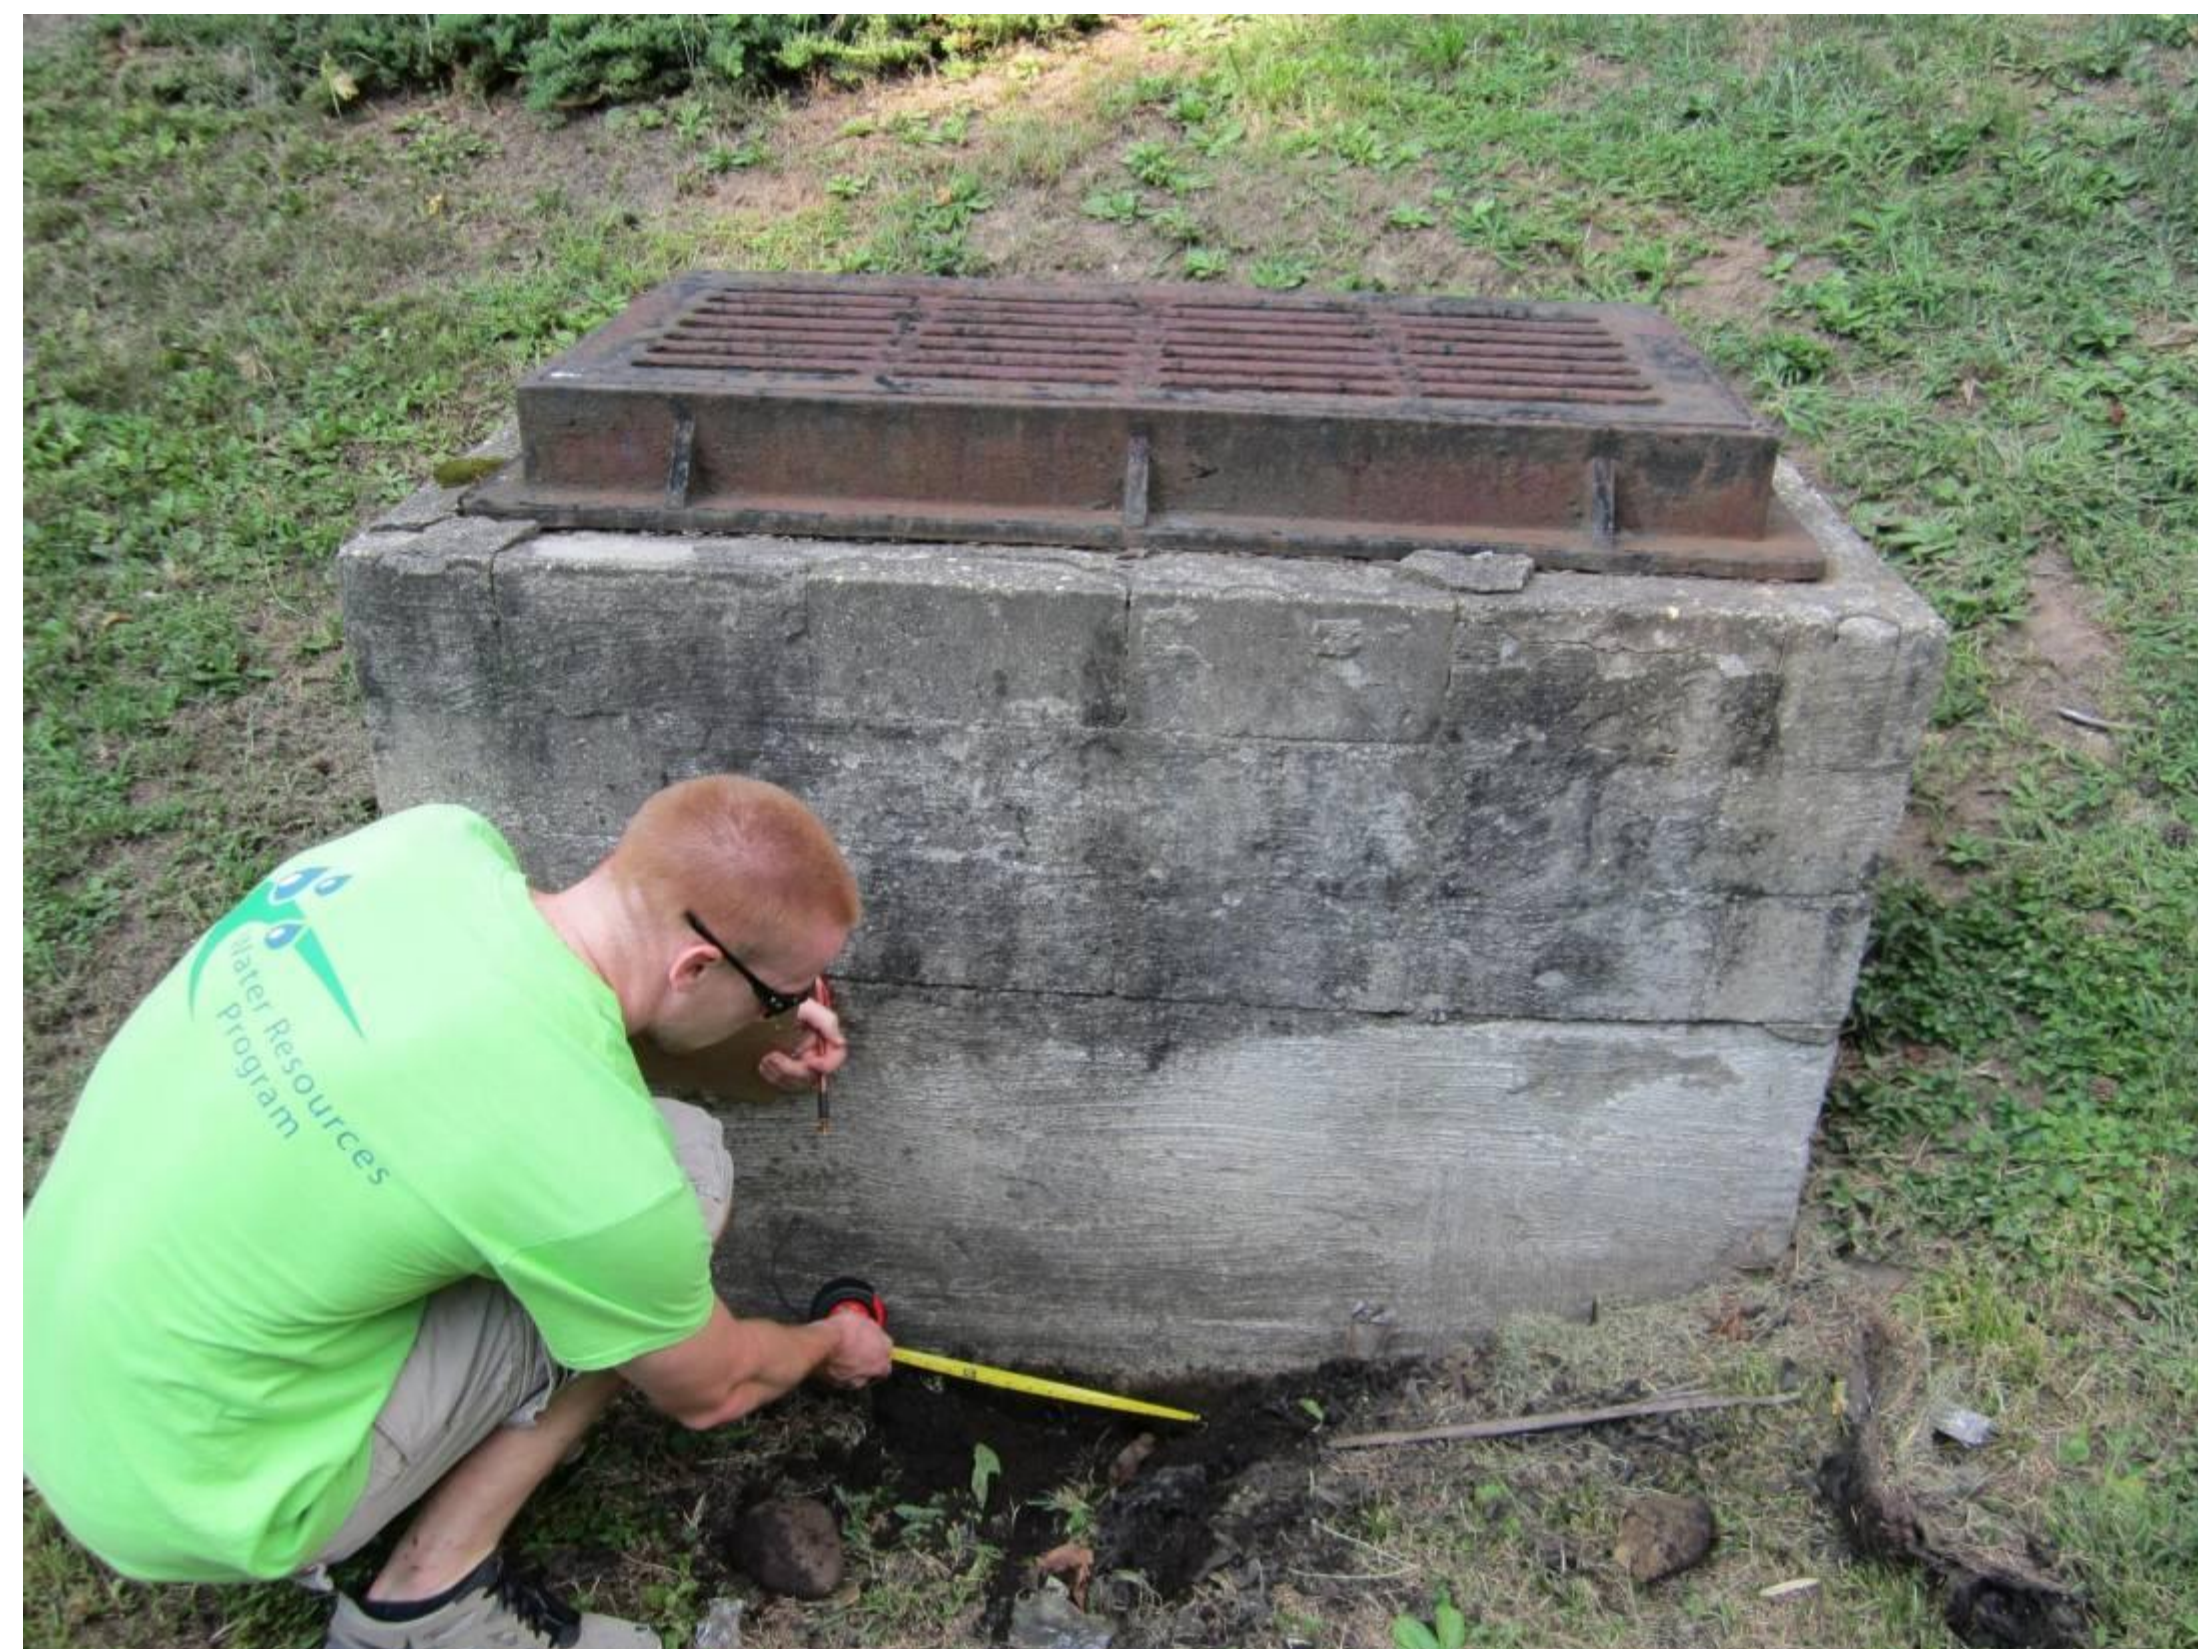
Outlet structure

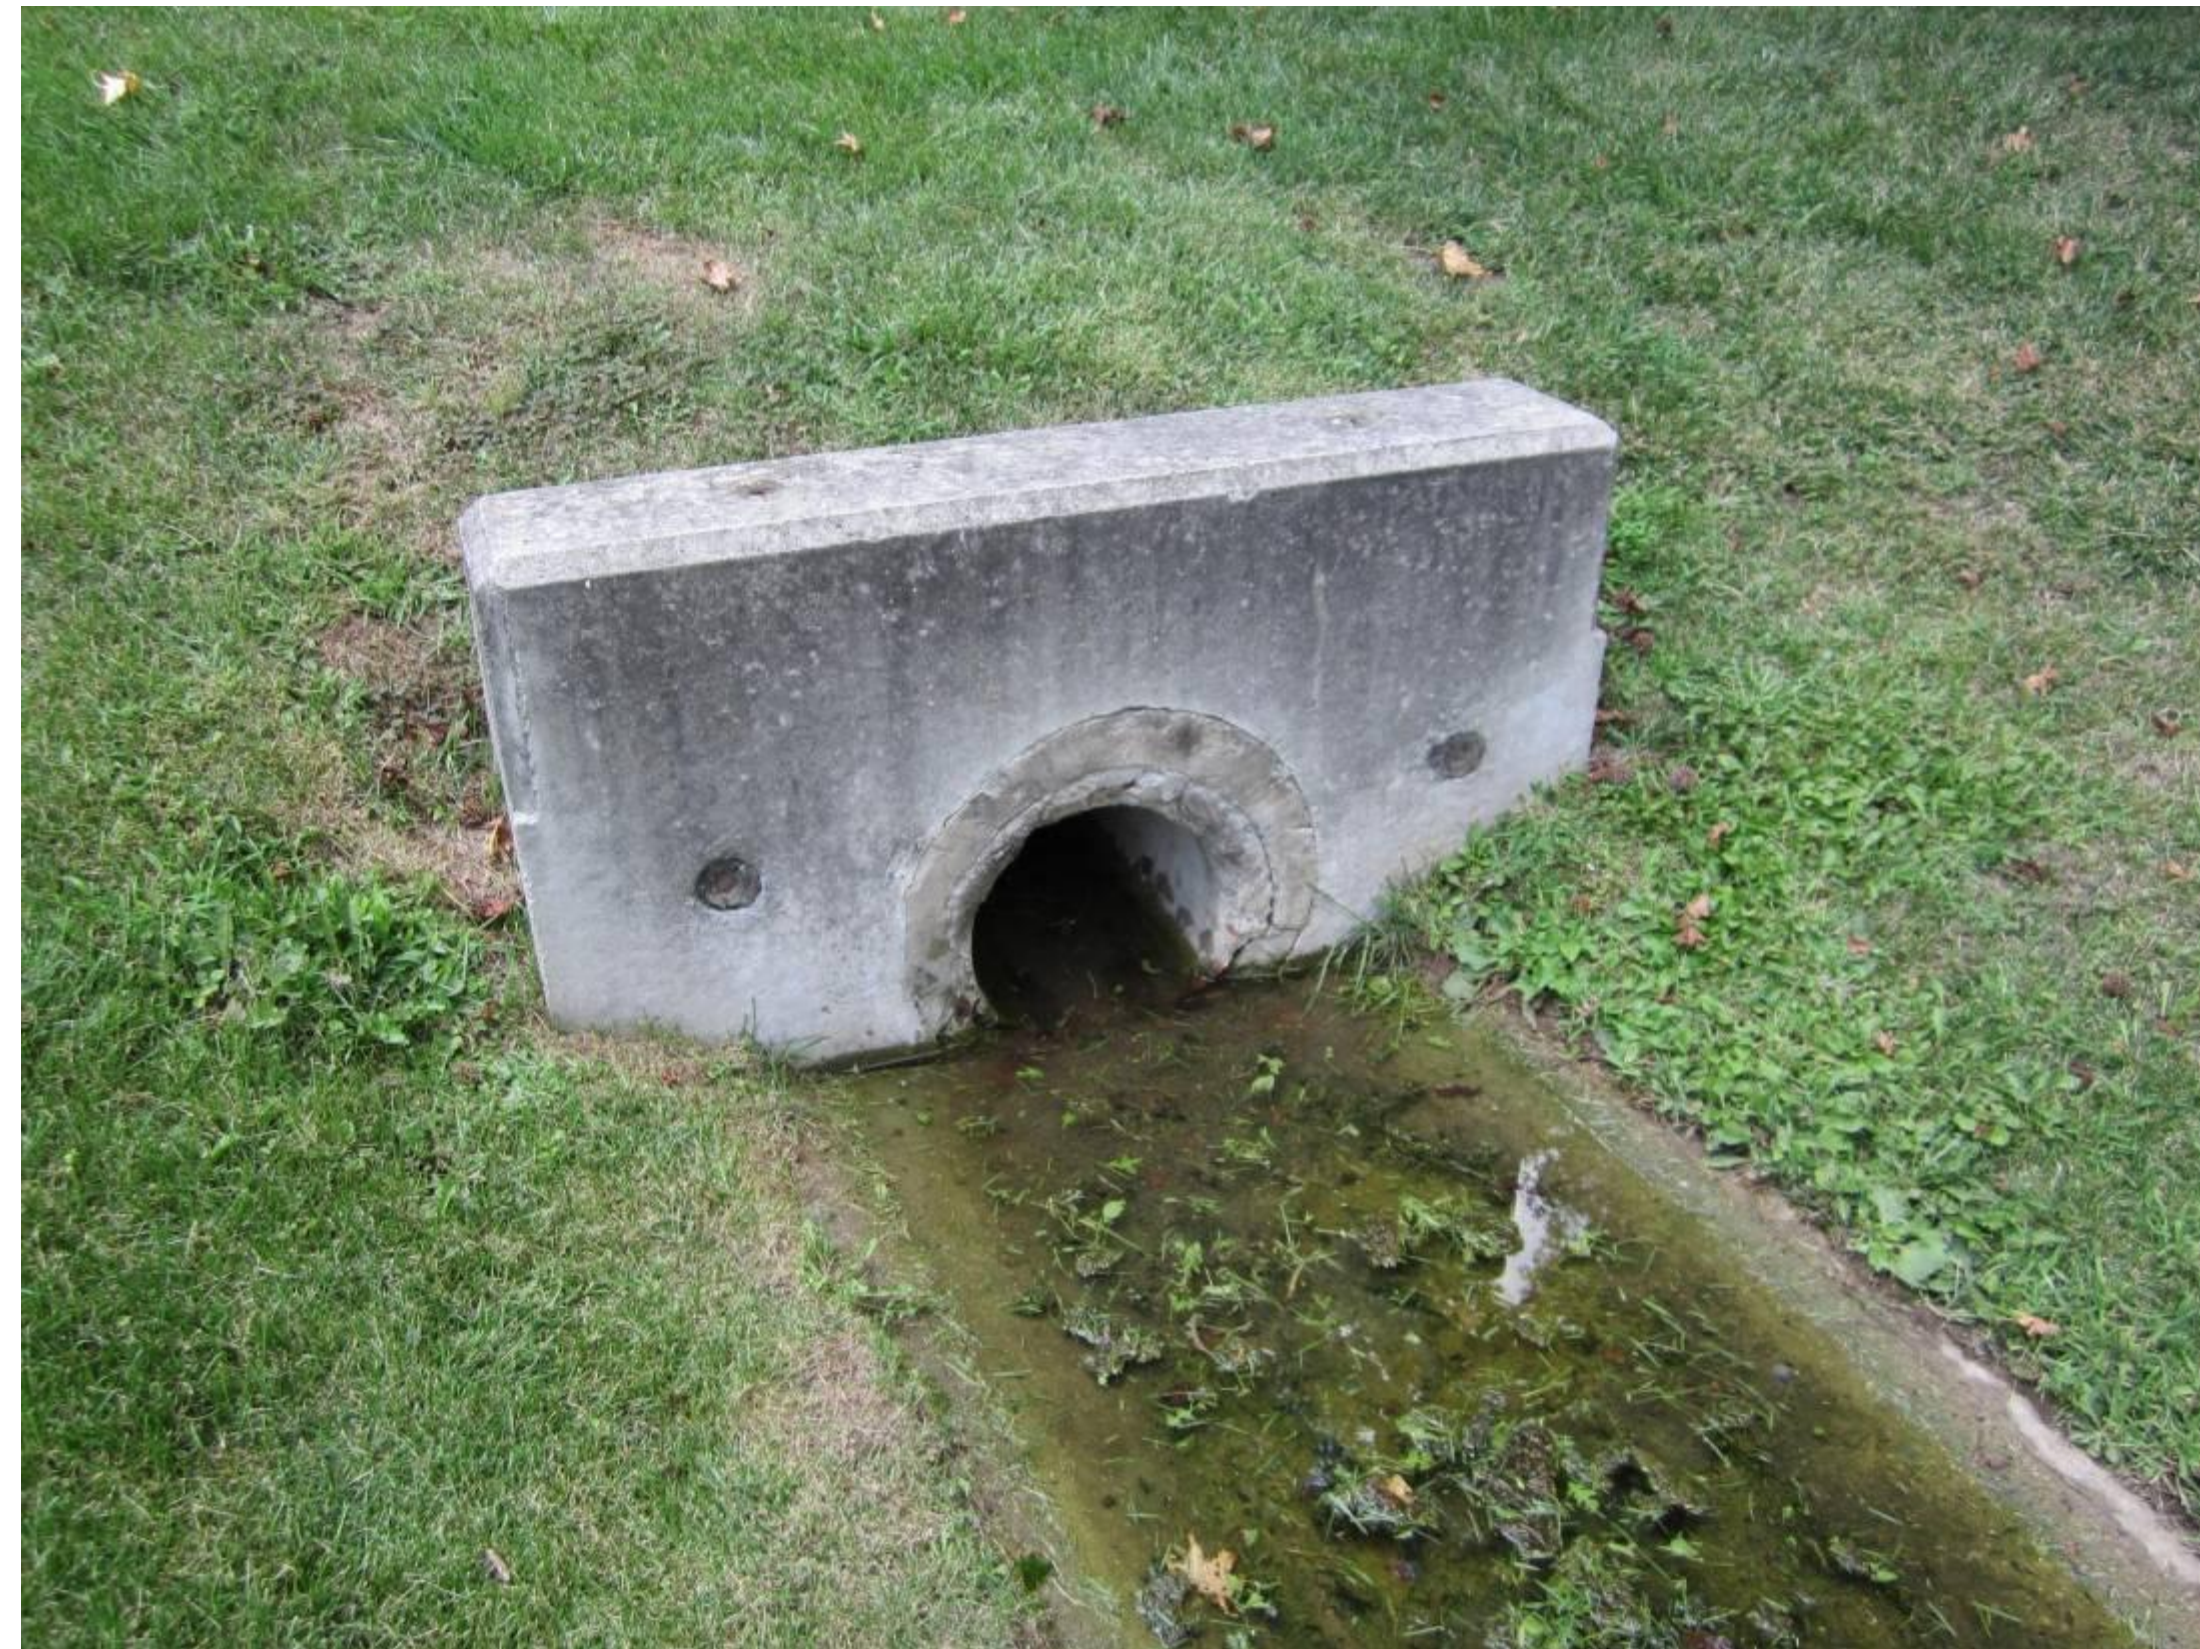
Inlet
