Hamilton Township (Mercer County) Stormwater Basin Assessment Summary (Year 1)

Developed by the Rutgers Cooperative Extension Water Resources Program
Funded by Hamilton Township, Mercer County, New Jersey

December 6, 2012

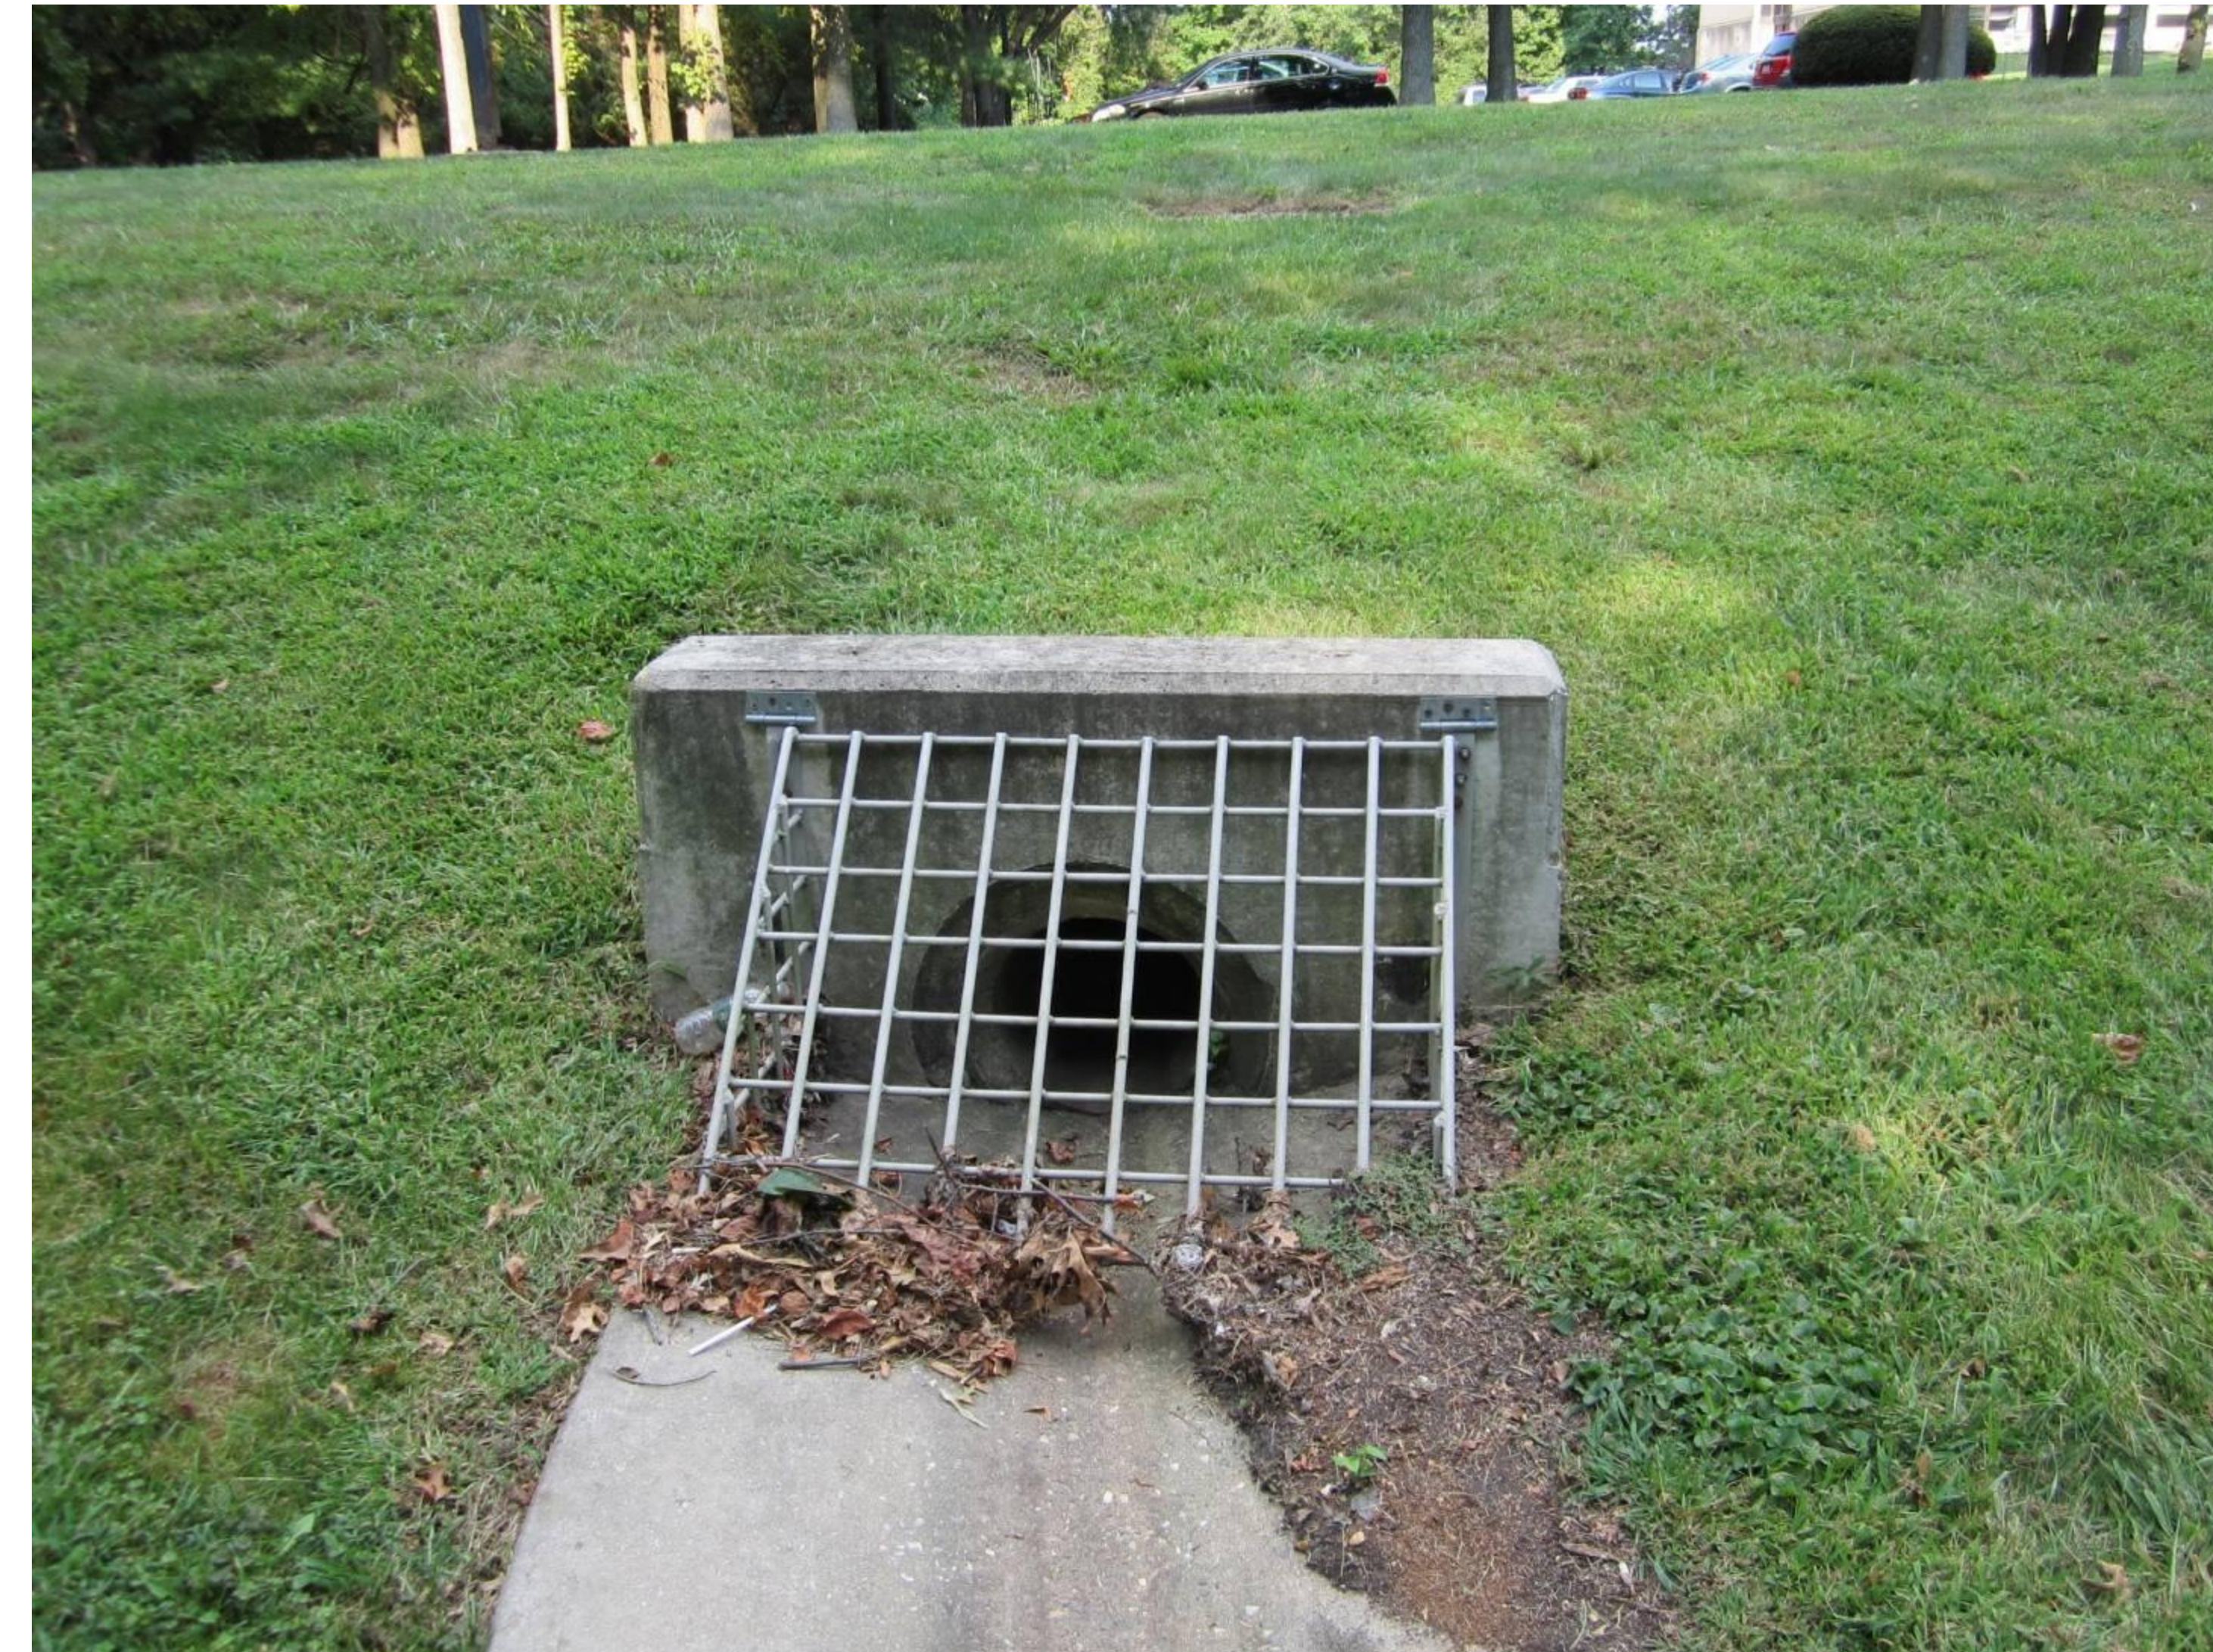
Outlet structure

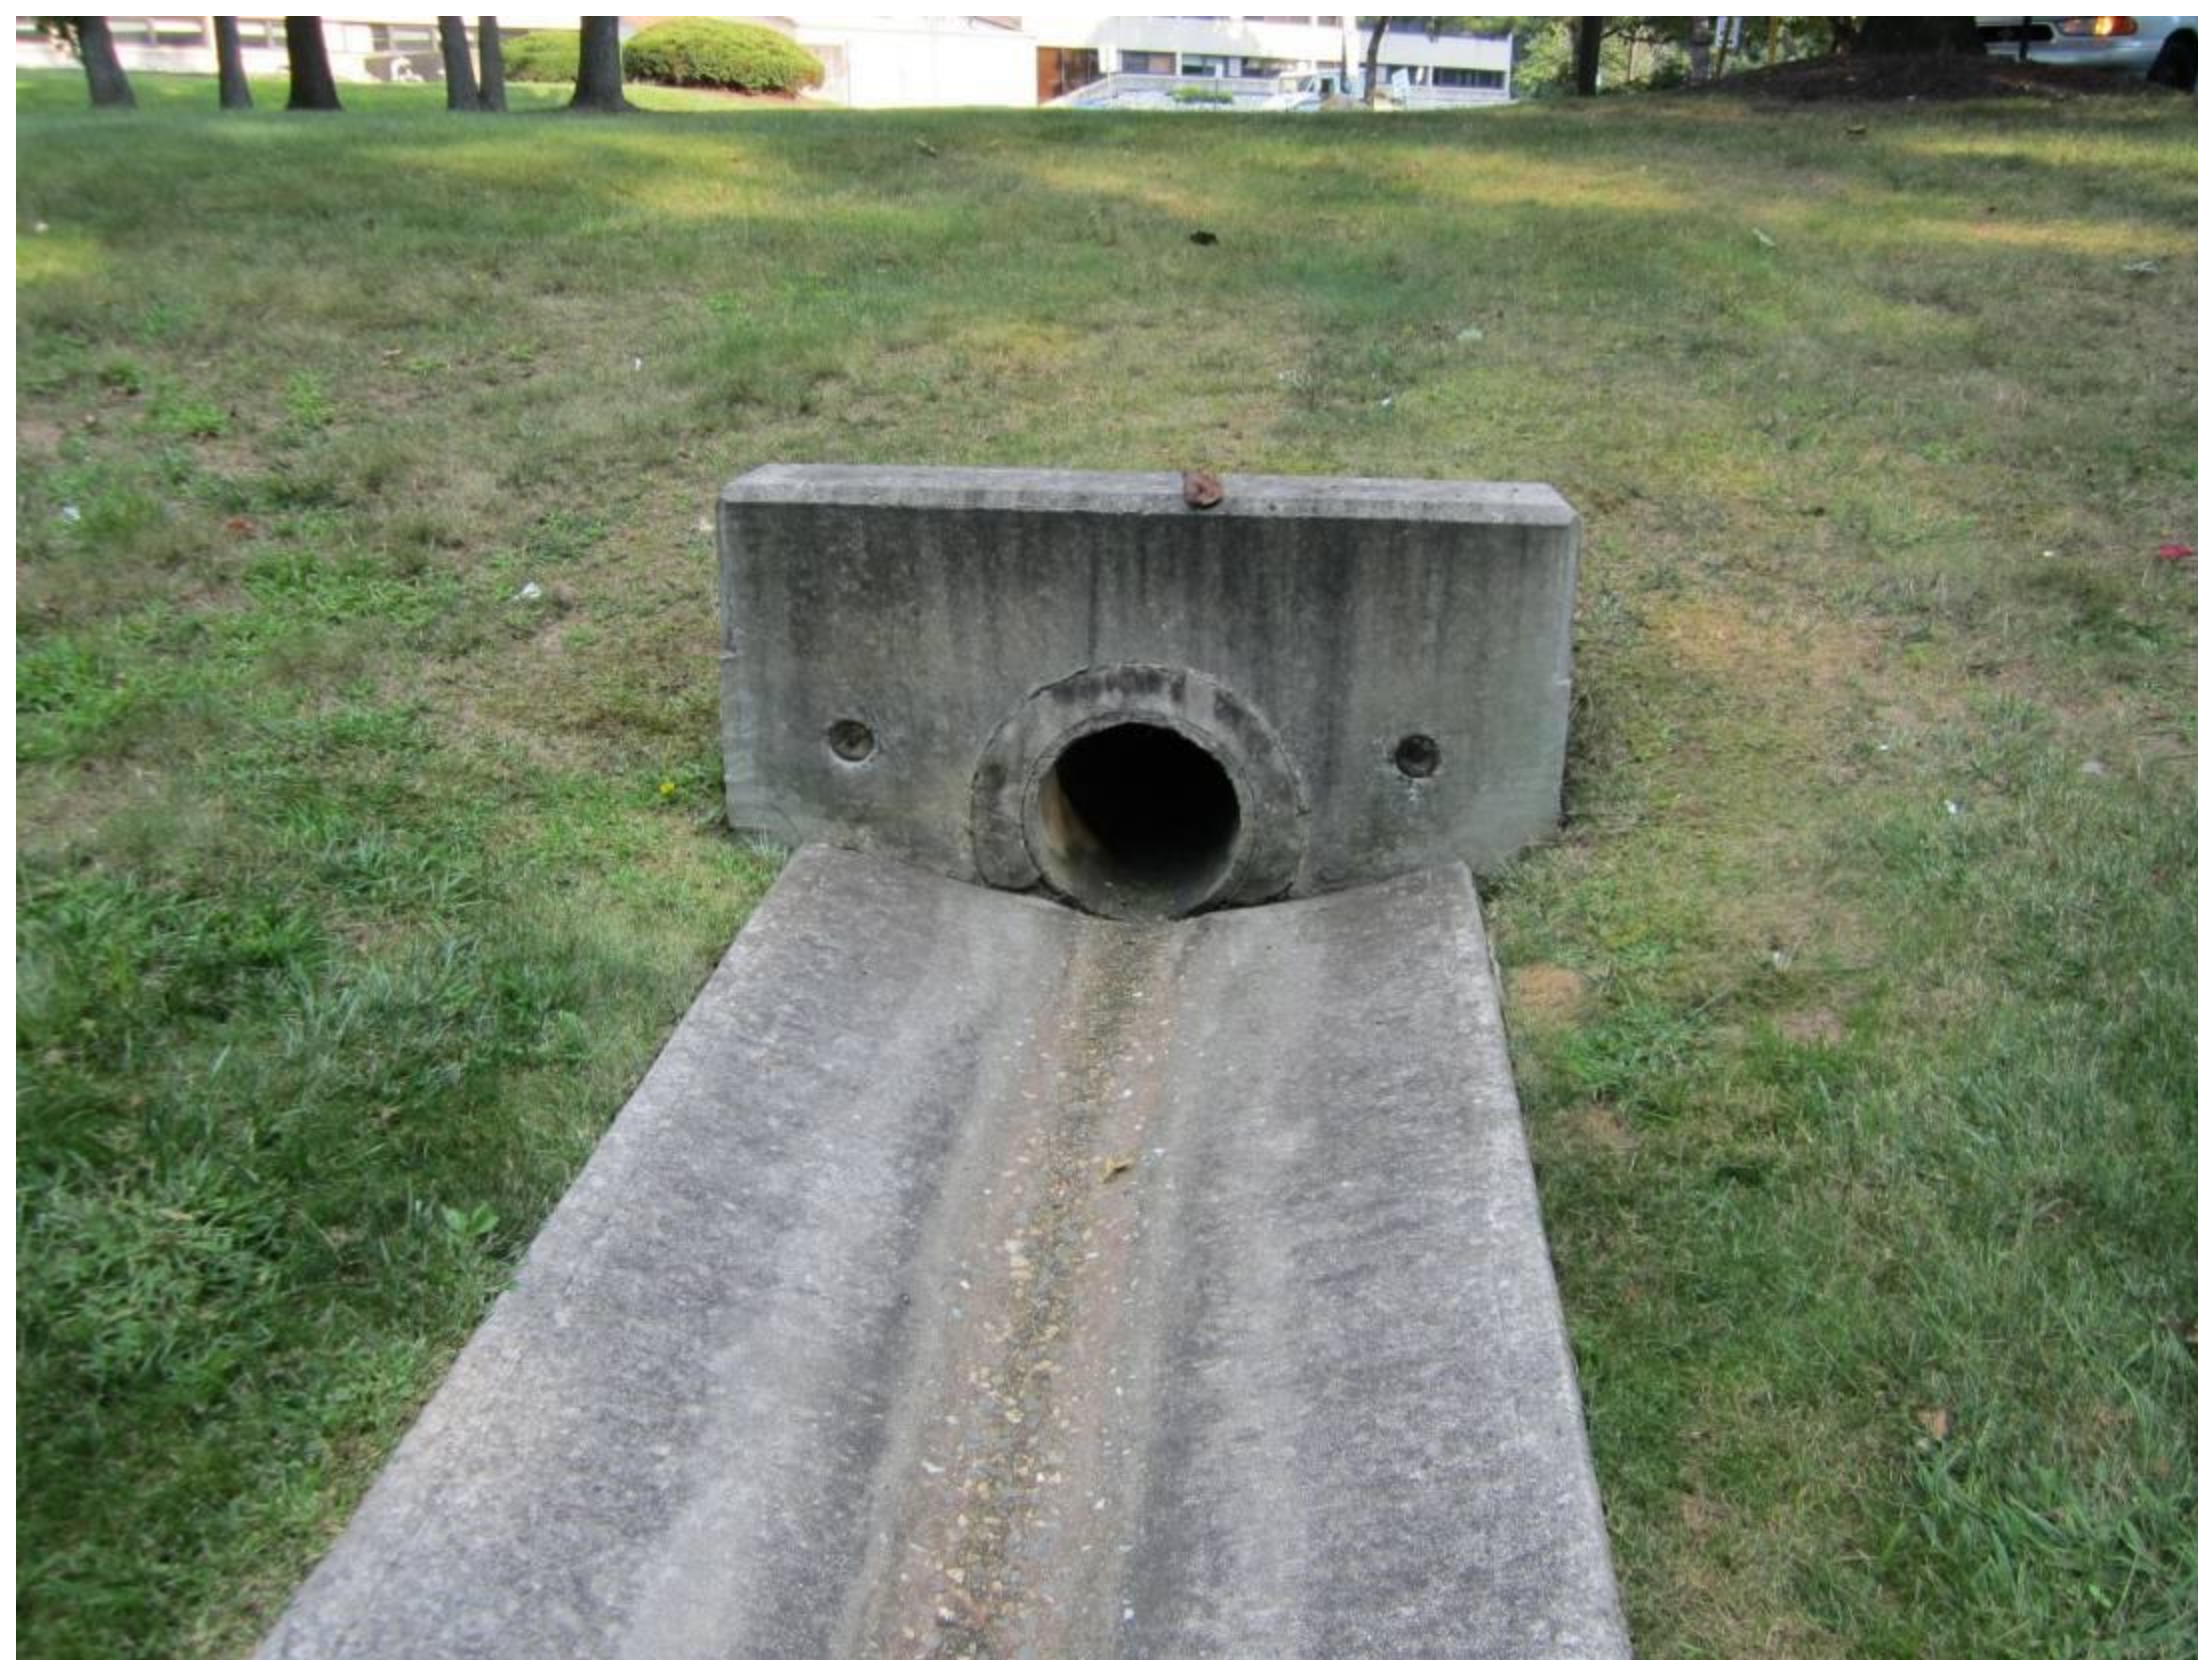
Inlet

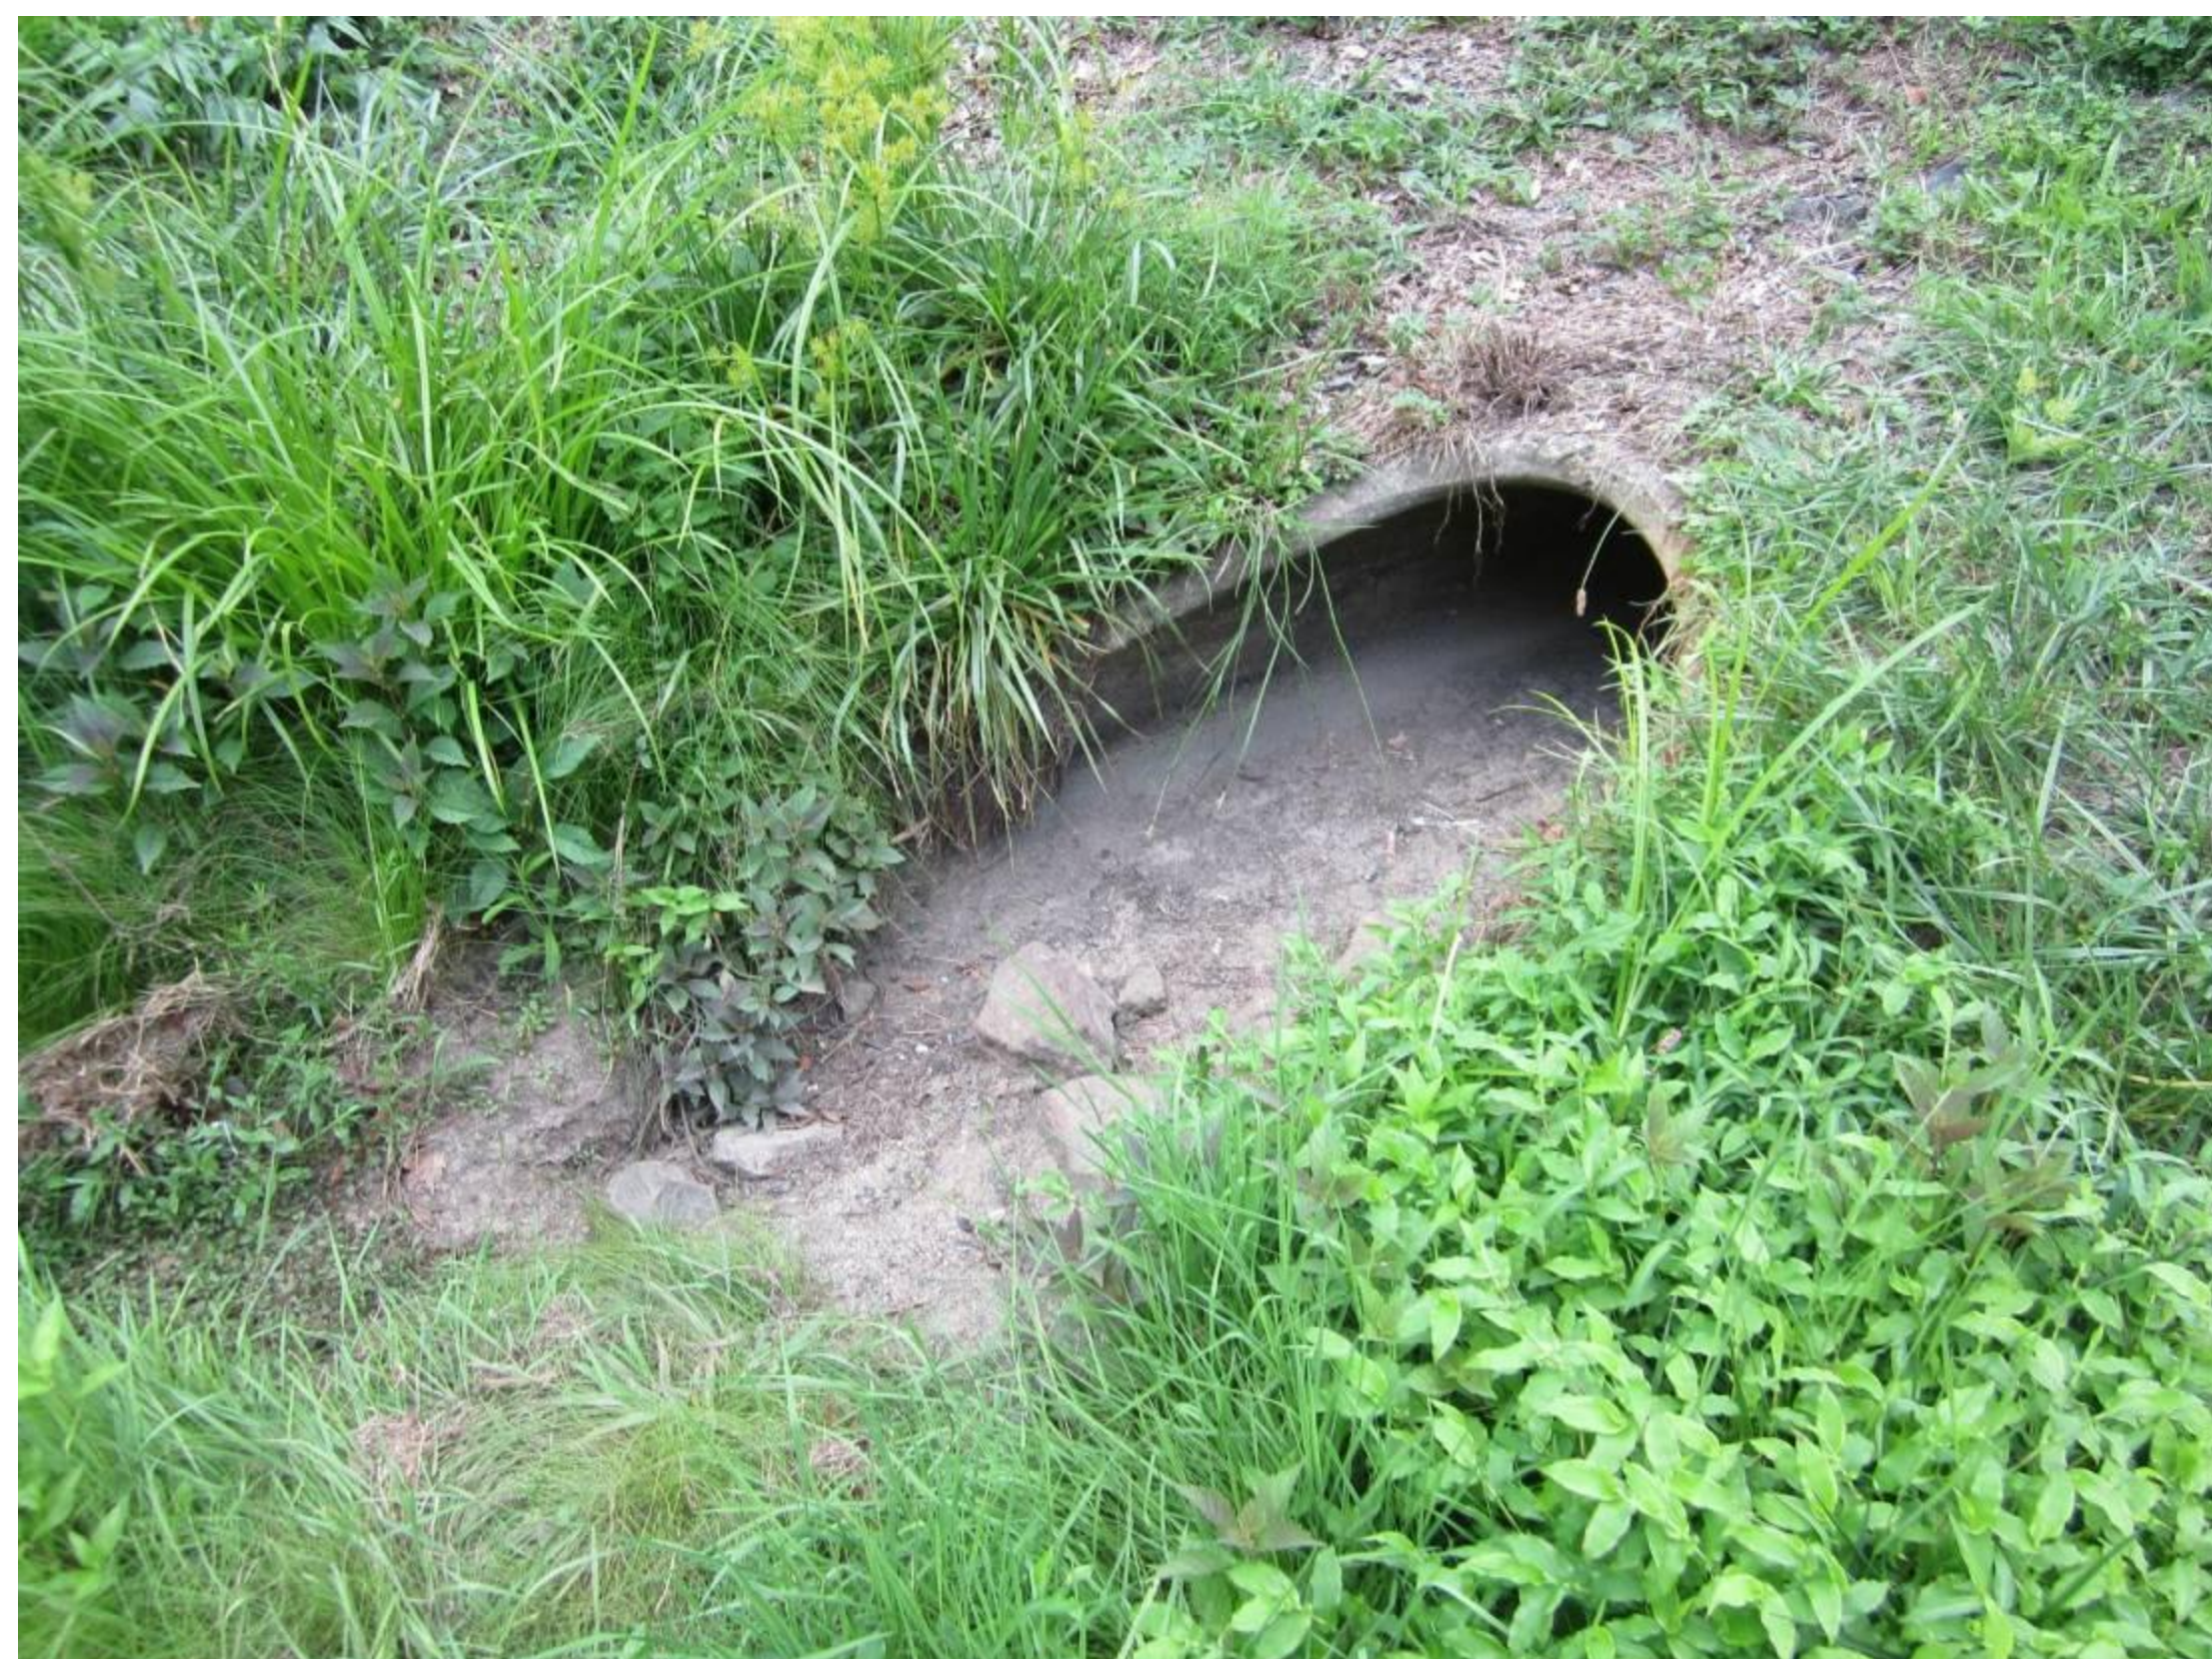
Inlet

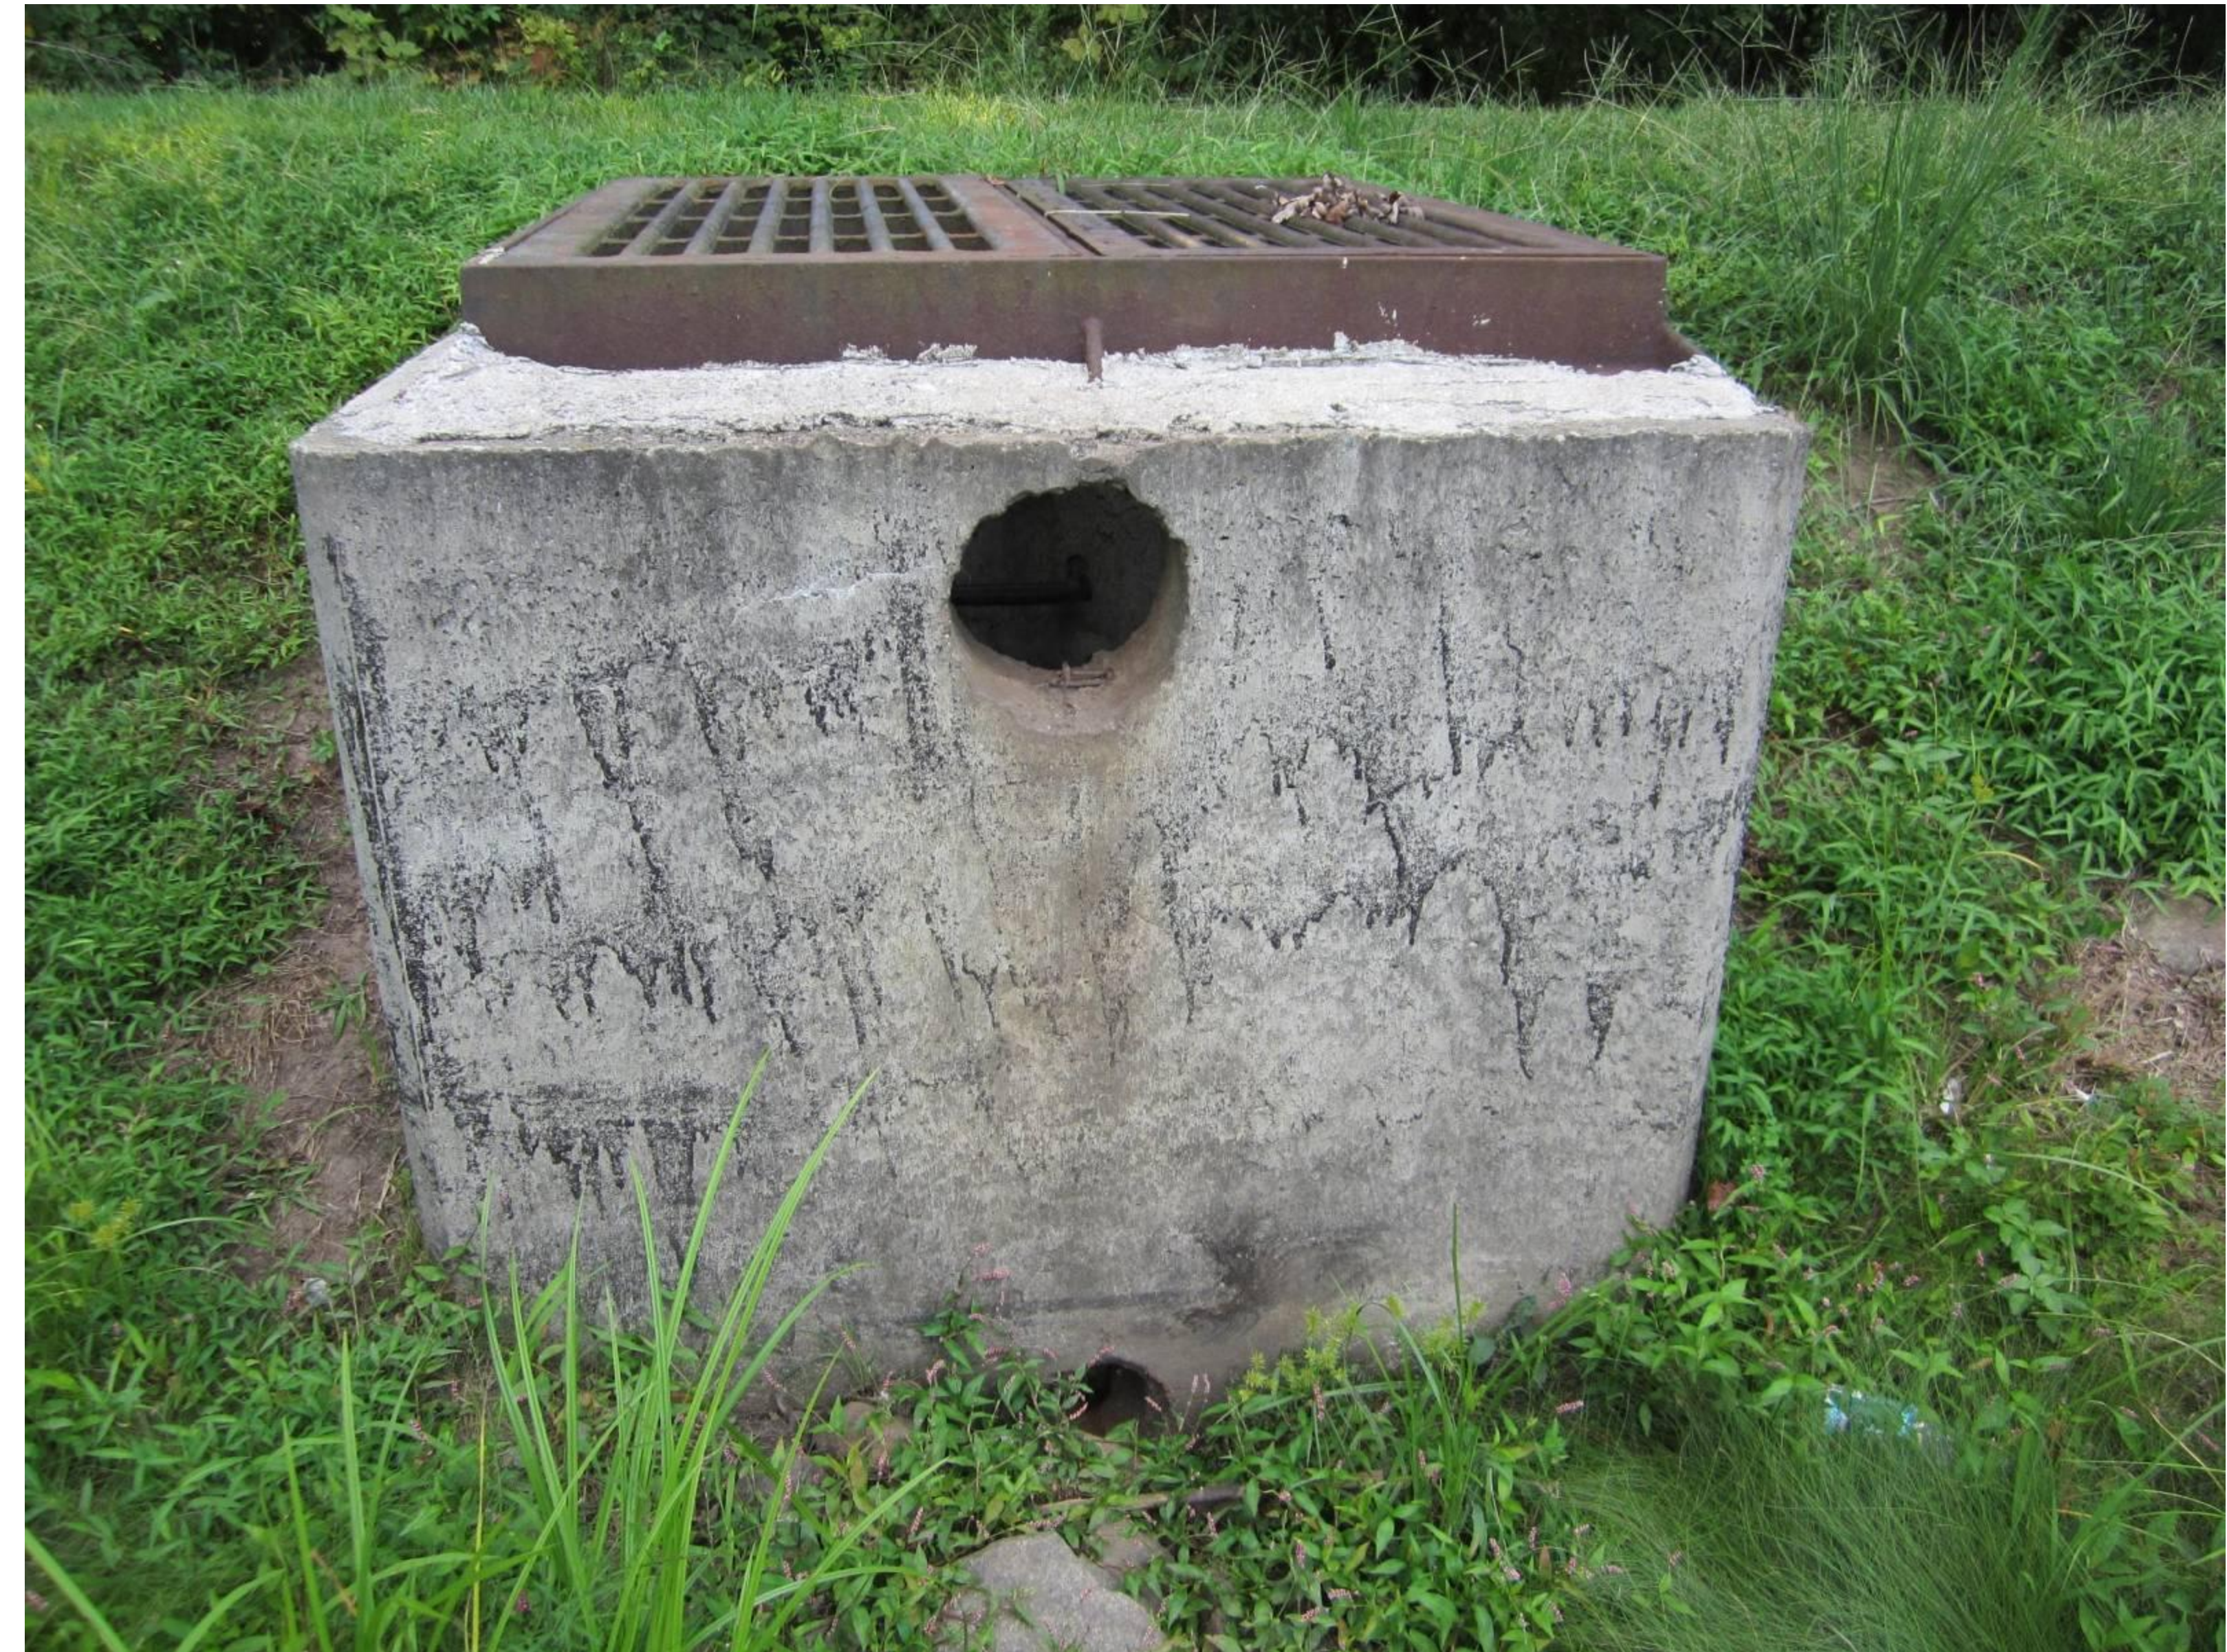
Outlet structure

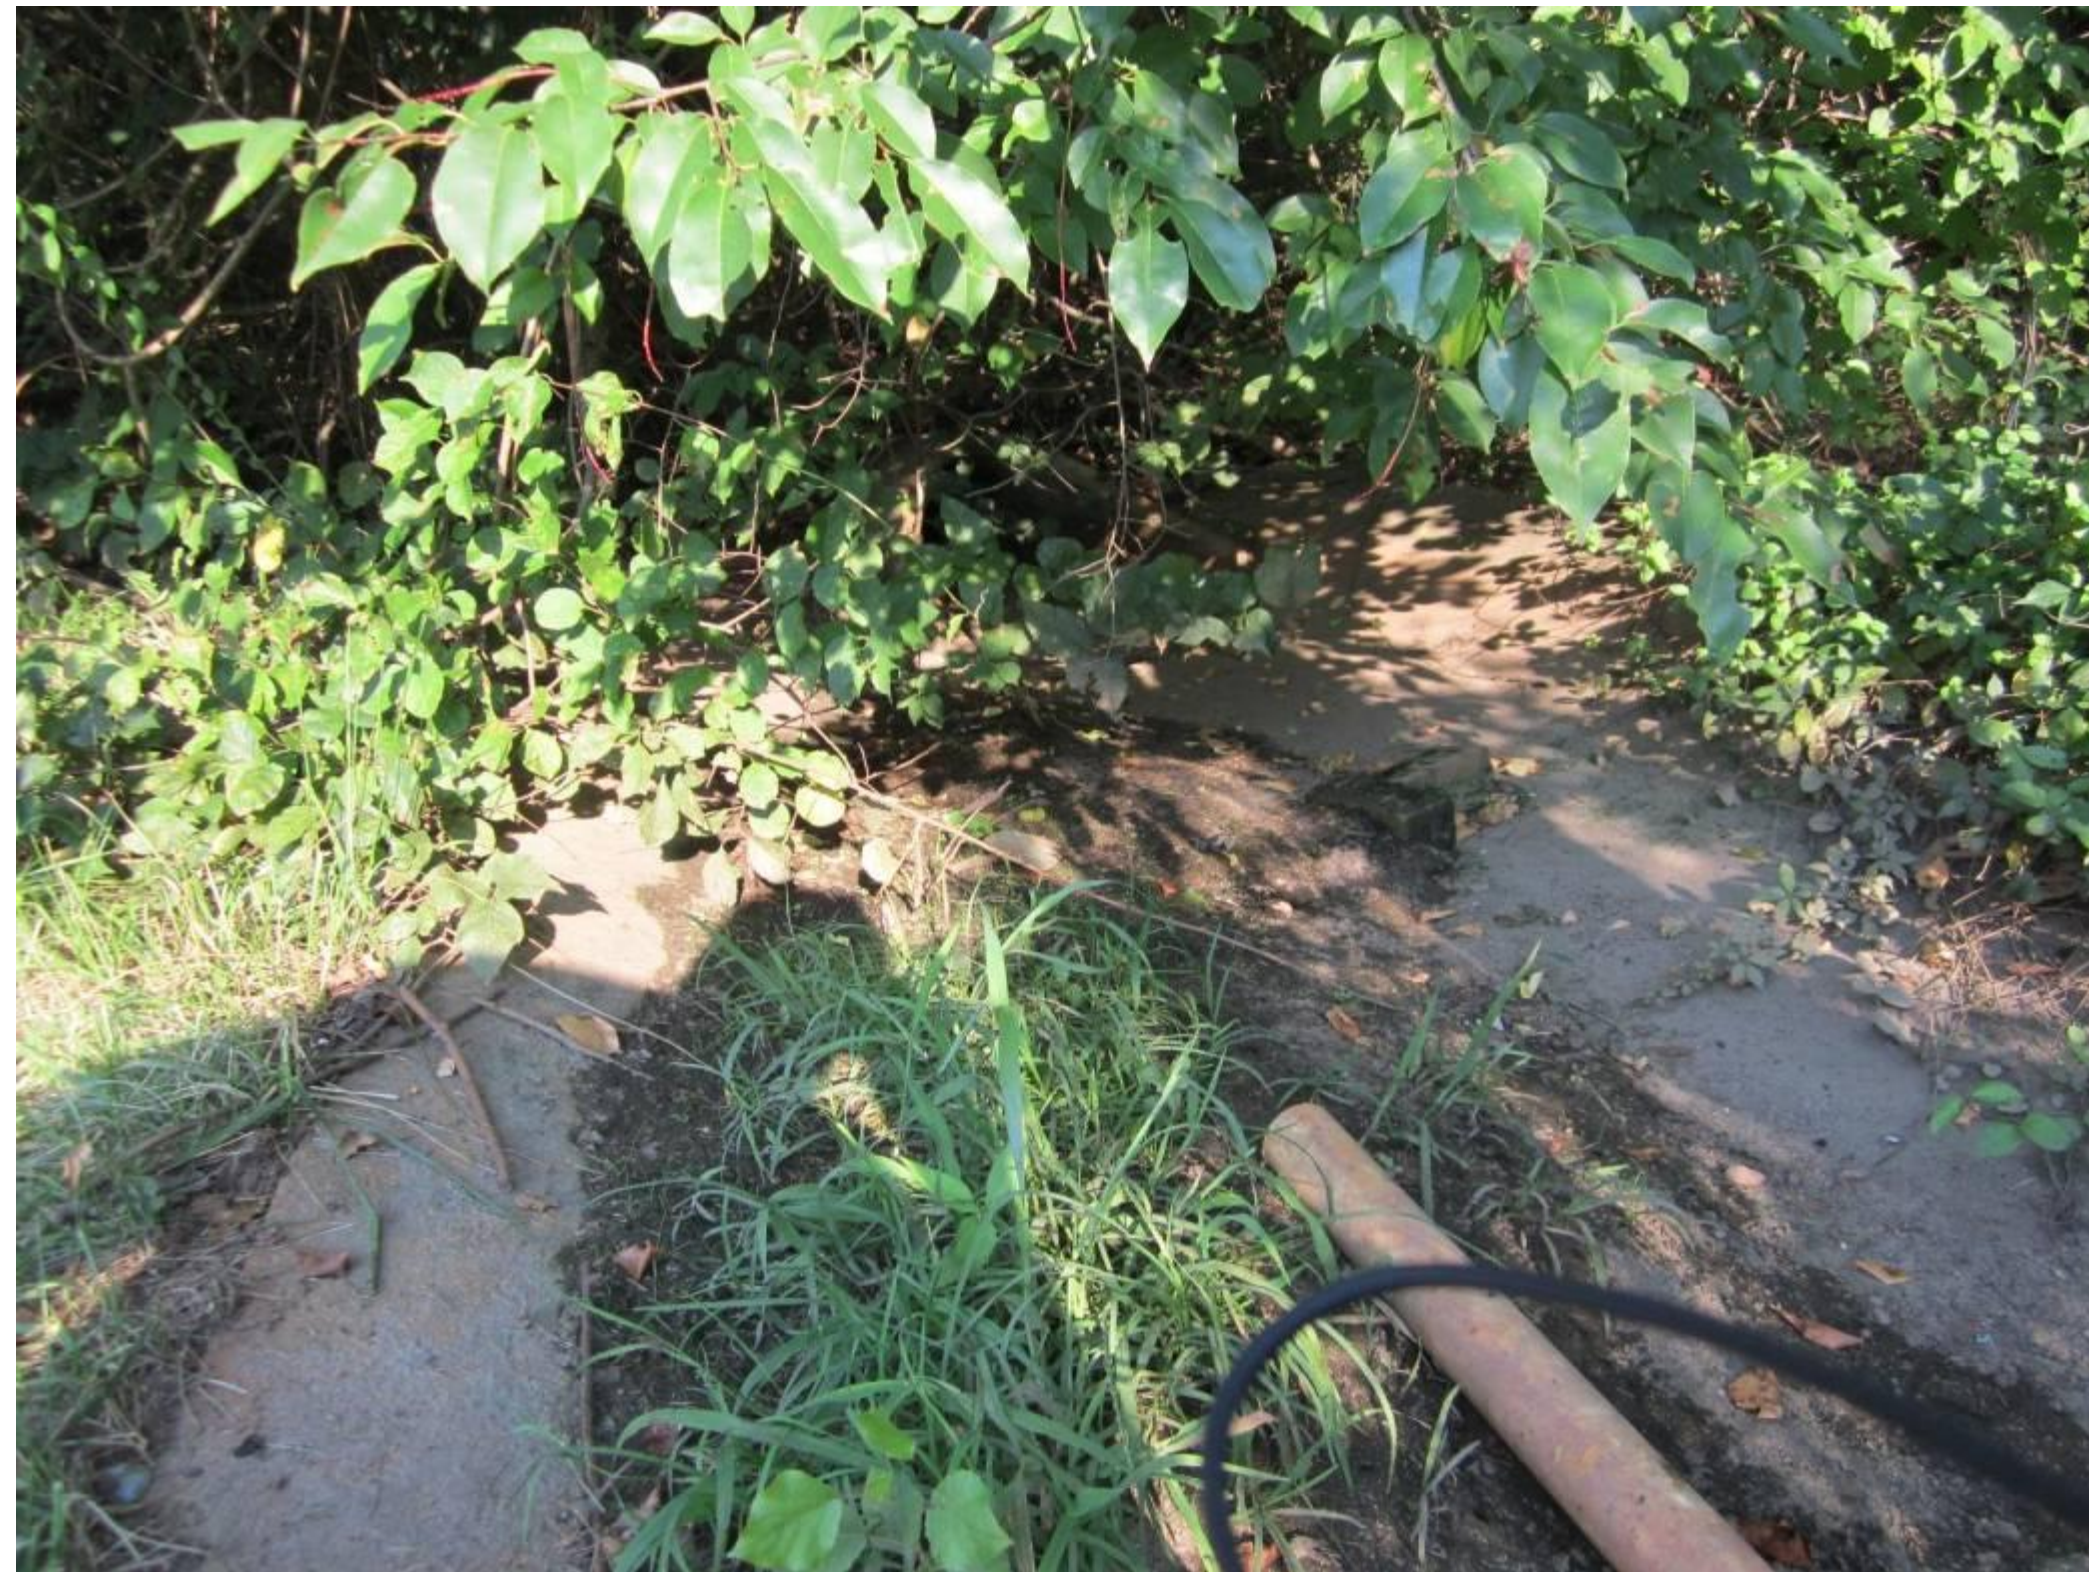
Inlet covered by plant growth

- Sediment, debris and litter accumulation at inlets and outlet
- Excess sediment accumulation and standing water in low flow channel with algae growth
- Northwestern basin embankment slumping/failing
- Evidence of deterioration at inlets
- Woody vegetation growth around outlet
- Basin outfall area shows evidence of erosion
